**FORMER RED DEVIL PAINT
30 NORTH WEST STREET
MOUNT VERNON, WESTCHESTER COUNTY, NEW YORK**

Final Engineering Report

BCP INDEX #W3-1079-05-09

SITE # C360031

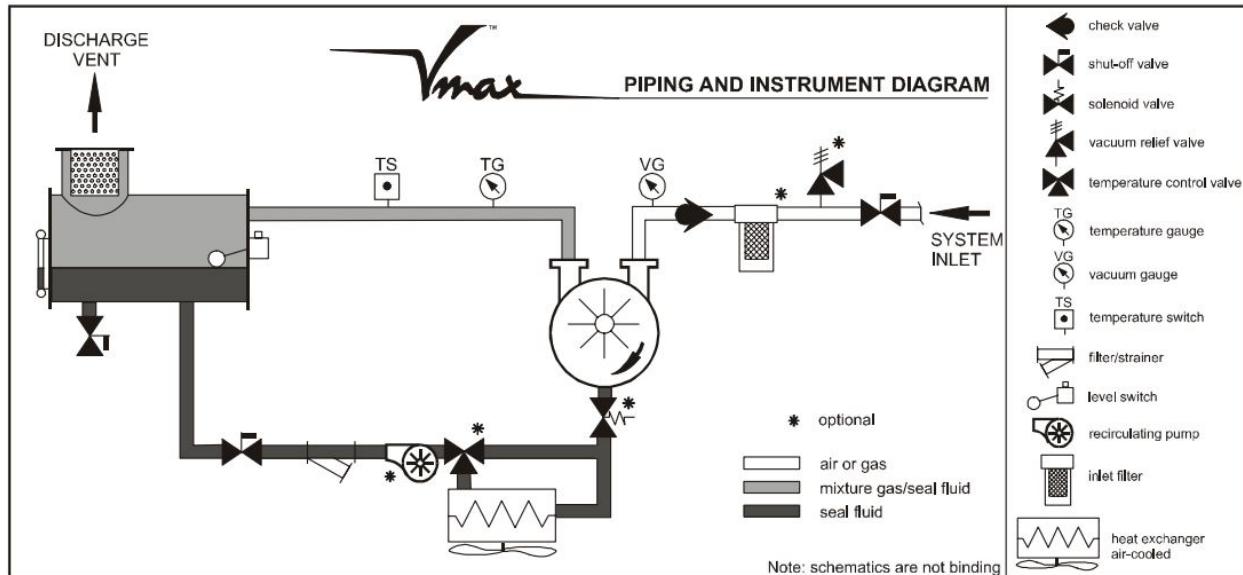
A piping and instrument diagram (typical) of the Vmax oil-sealed liquid ring vacuum pump system is presented below.

The LRP is capable of operating with an approximate extraction air flow volume of 100 CFM and a maximum vacuum of 28 inches of Hg. The high vacuum combined with the increased air flow extraction rate generates a vacuum within the horizontal wells. The imparted vacuum will increase the groundwater yield within the horizontal groundwater extraction wells which formerly relied on gravity drainage for recharge with the eductor pumps.

Incorporation of the LRP for the DPE (total fluids recovery) from HEW-1 and HEW-2 was completed in order to hydraulically control the offsite migration of contaminated groundwater along the downgradient perimeter of the Site, to control offsite migration of residual NAPL along the downgradient perimeter of the Site, and to actively remediate residual NAPL, groundwater and soil-vapor contamination from the subsurface beneath the Site.
