Periodic Review Report

**Austin Avenue Landfill BCP Site
(#C360066) September 27, 2020 to
September 27, 2021 Reporting Period**

Morris Westchester Junior Retail Associates, LLC
November 11, 2021

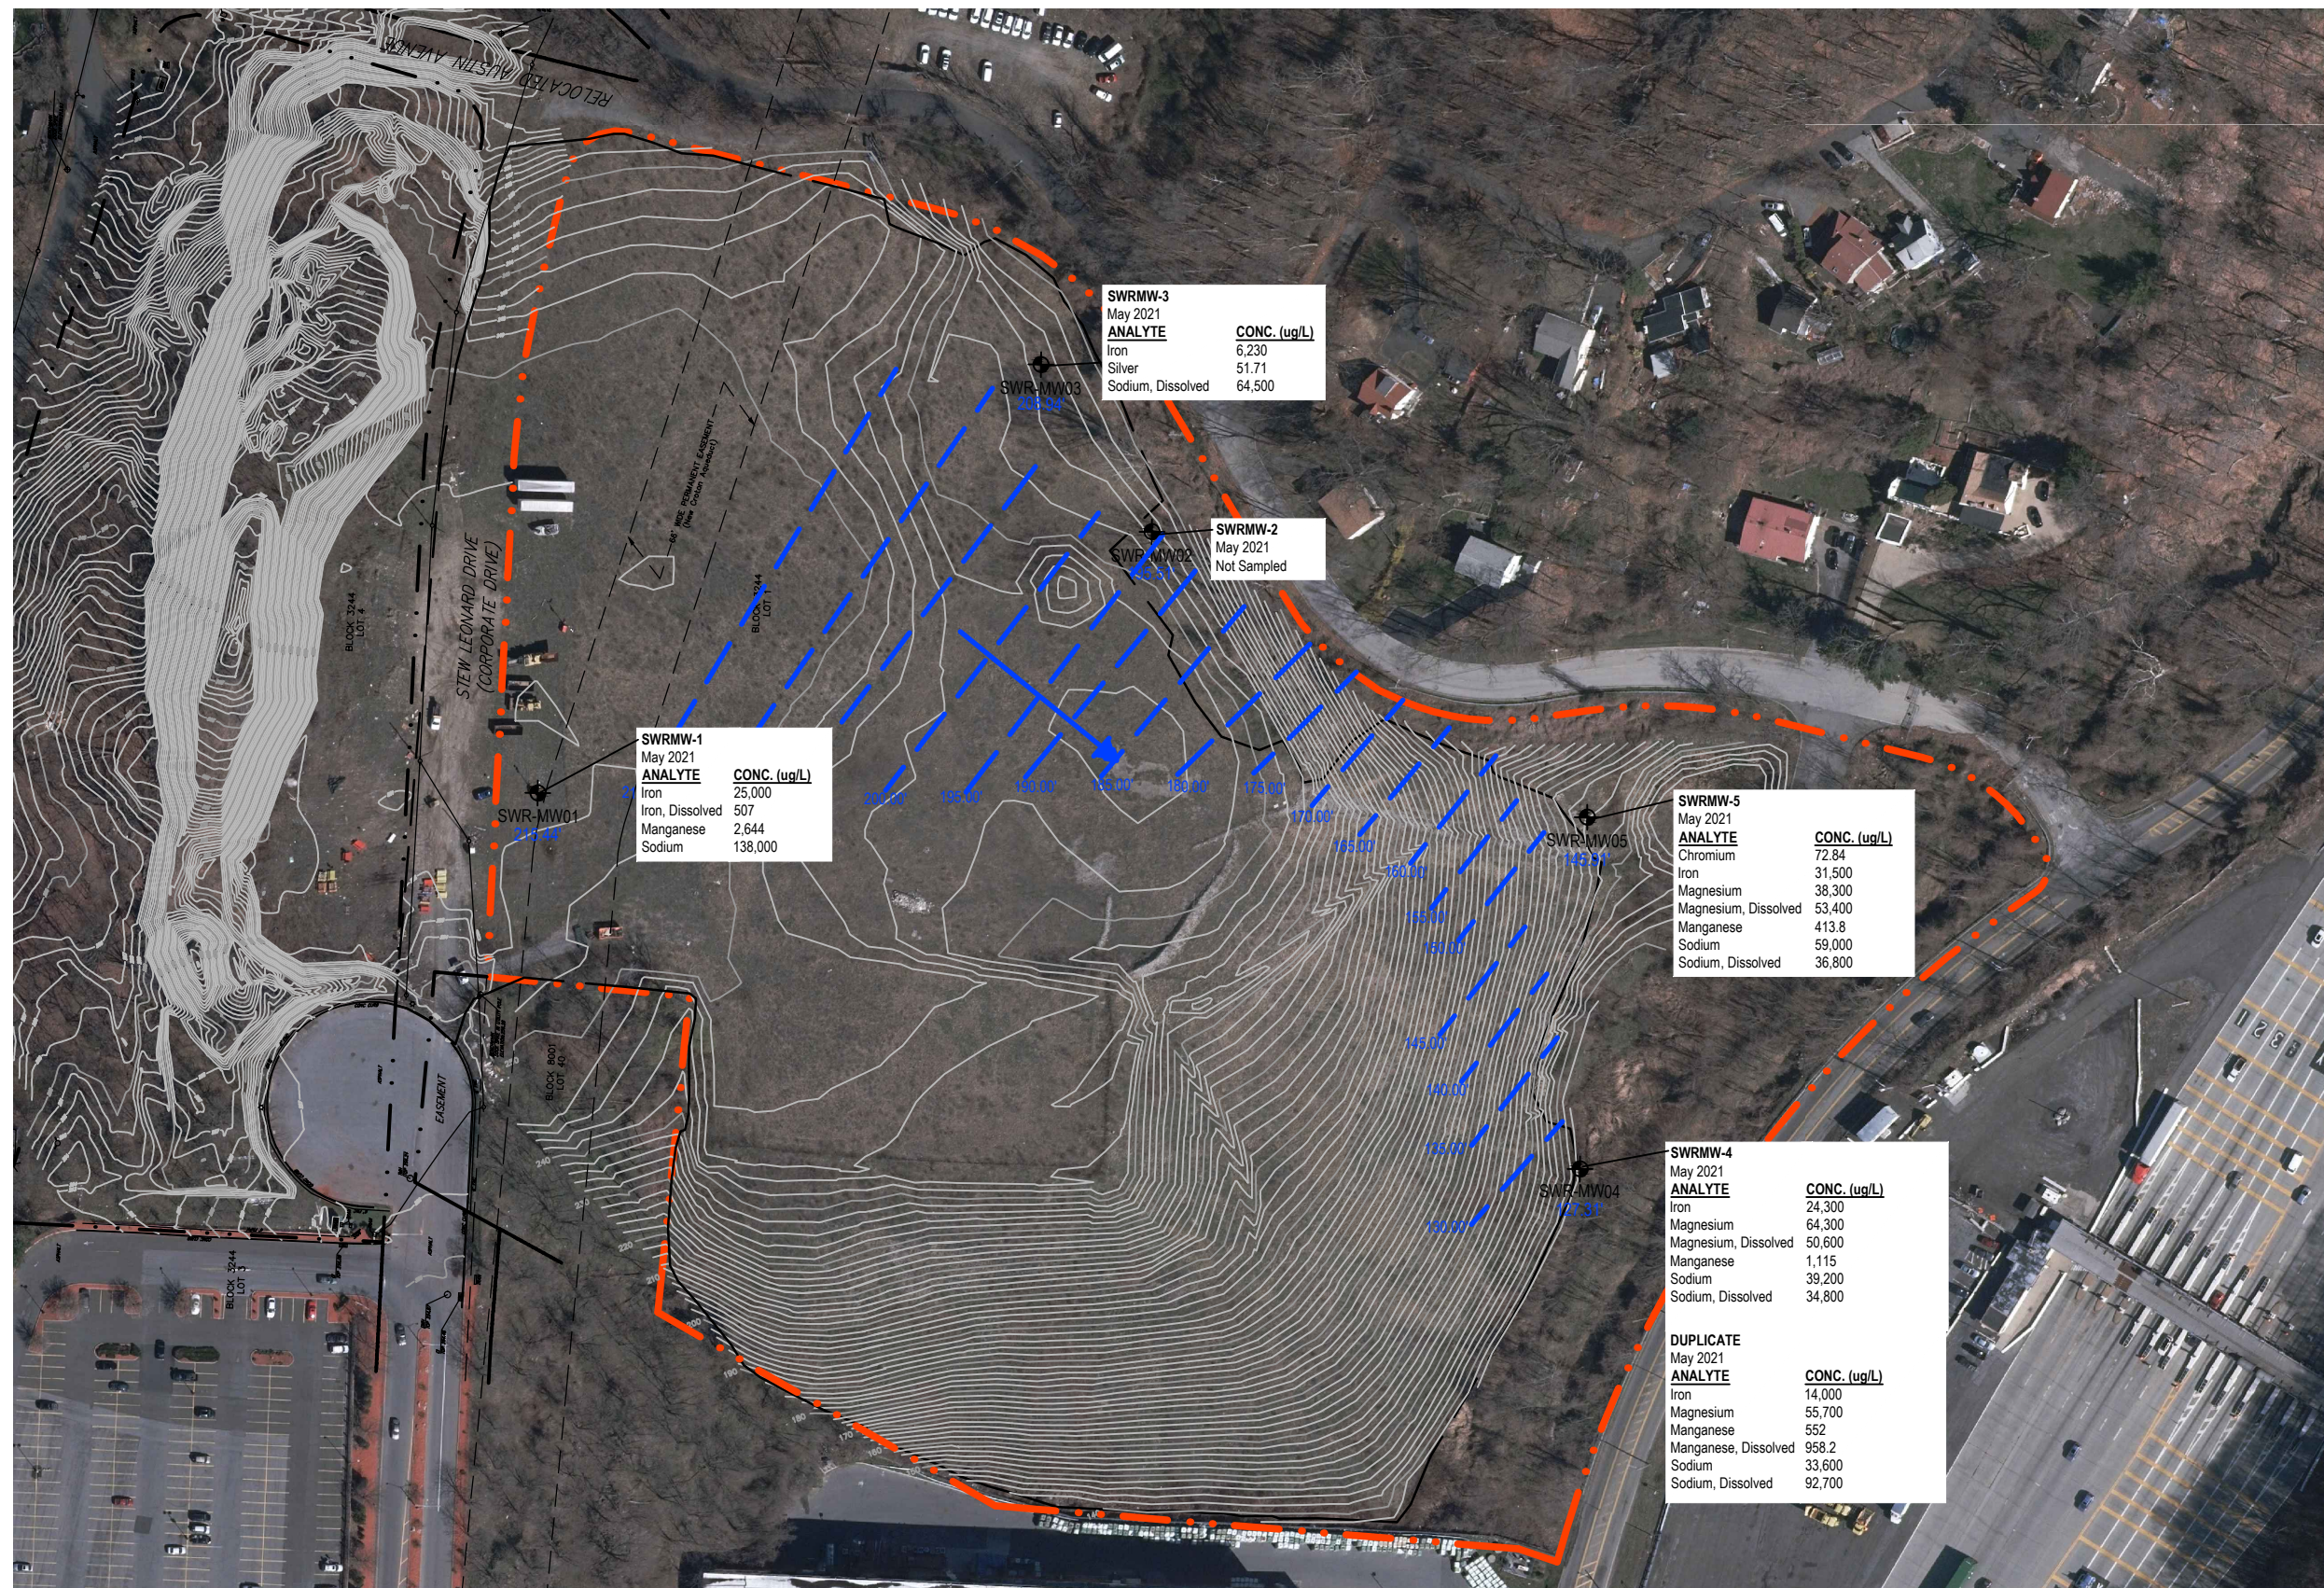
- LEGEND:**
- - - Property Boundary (Approximate)
 - Extent of Lot 1 Geotextile Demarcation Layer and BCP Site (Approximate)
 - + Groundwater Monitoring Well Location and ID (Approximate)
 - 195.27 Groundwater Elevation (May 2021 Sampling Event)
 - ↘ Groundwater Elevation Contour and Presumed Flow (May 2021 Sampling Event, Approximate)
 - CONC. (ug/L) Detected Concentration in ug/L (May 2021 Sampling Event)
ug/L - micrograms per liter, parts per billion

Only exceedances of the Class GA groundwater standards or guidance values are shown here. For a complete summary of analytical results, refer to the tables.

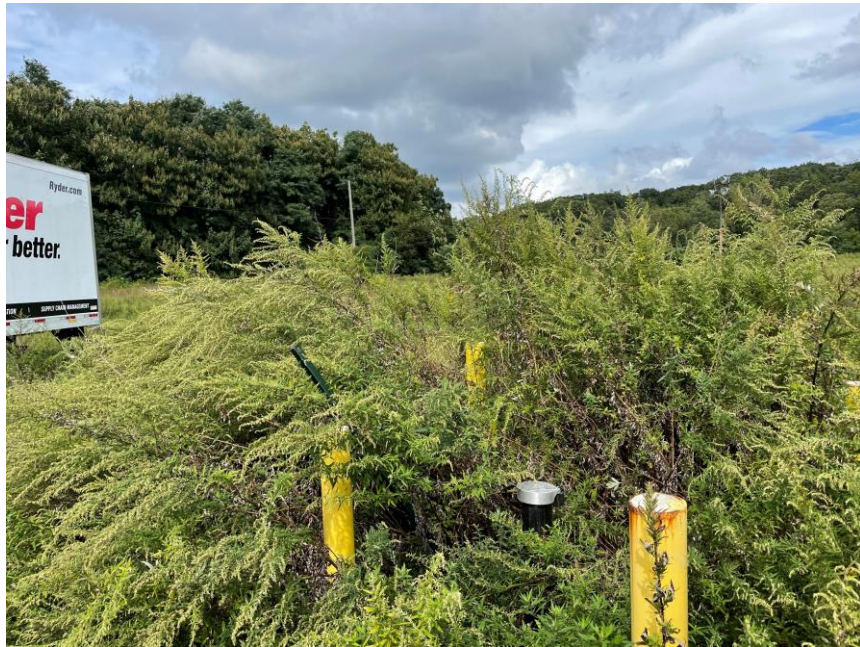
Photo 5 Typical Site groundwater monitoring well.

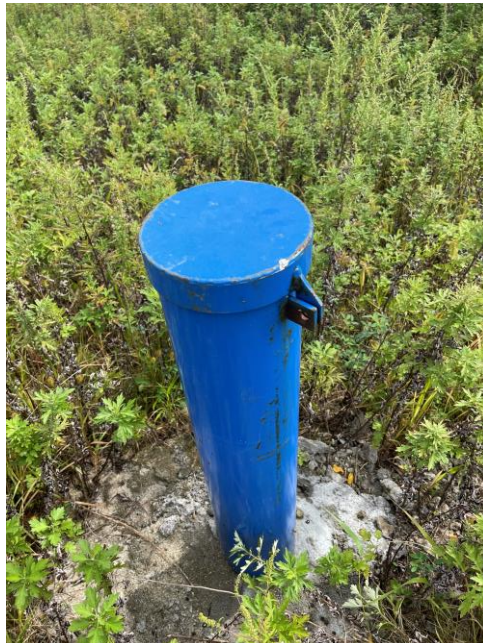
Photo 6 Piezometer installed by others during geotechnical investigation. Needs cover to be locked.

Found one 5-gallon plastic bucket with residual paint along
access road north of SWR-MW01. Found second 5 gallon plastic container
appeared to have petroleum located in proximity to the Austin Ave gate
Monitoring well installed by others during geotechnical assessment still on-site,
covered but no lock.

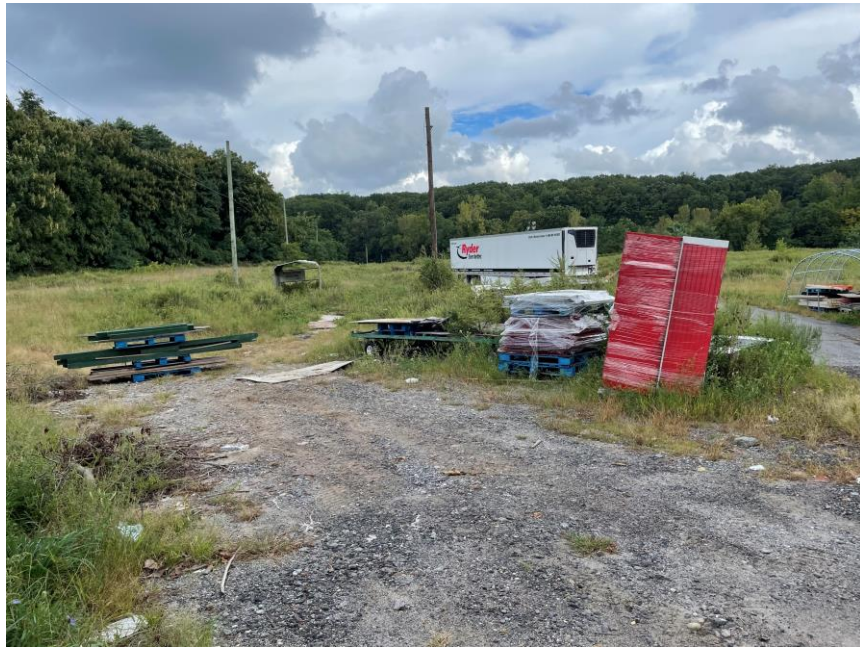
Photo 7 Typical material staging from adjacent business.

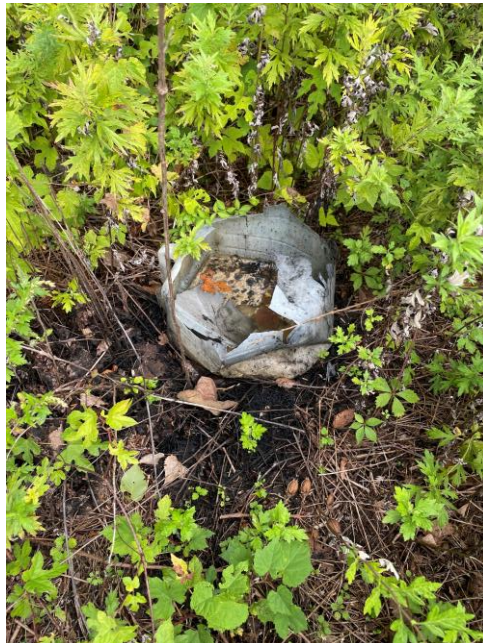
Photo 8 Remnants of 5-gallon bucket containing apparent petroleum product near Austin Avenue gate.

During the annual inspection it was noted that two plastic 5-gallon containers were left on the Site from unknown sources, one near the Stew Leonard Drive containing what appeared to be residual paint and one near the Austin Avenue gate containing what appeared to be a petroleum product. These containers should be removed and properly disposed of off-site.

- The two plastic 5-gallon containers observed near the entrance at Stew Leonard Drive and the gate at Austin Avenue should be removed and properly disposed of off-Site.

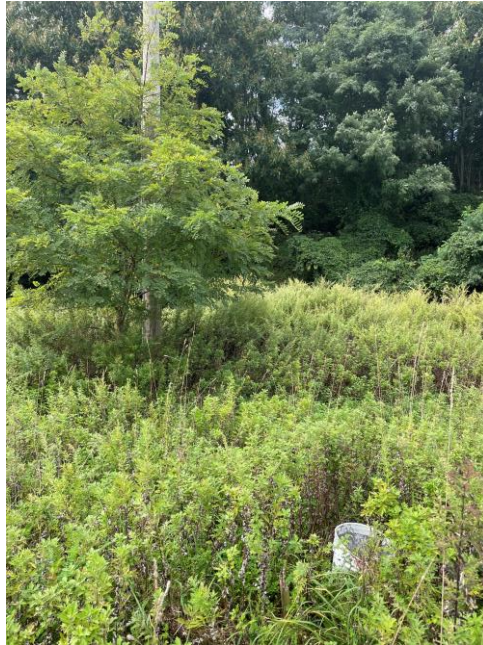
Photo 9 5-gallon bucket with residual paint near Site entrance from Stew Leonard Drive.
