Re: Progress Report – March 2021
Polychrome East Site
City of Yonkers, Westchester County
NYSDEC BCP Site No. C360098

This Progress Report has been prepared by AKRF, Inc. (AKRF) on behalf of Avalon Yonkers Sun Sites, LLC (AVB) to summarize the work performed at the Polychrome East site [Brownfield Cleanup Program (BCP) Site No. C360098] located at 80-94 Alexander Street, Yonkers, New York (the Site) during the month of March 2021.

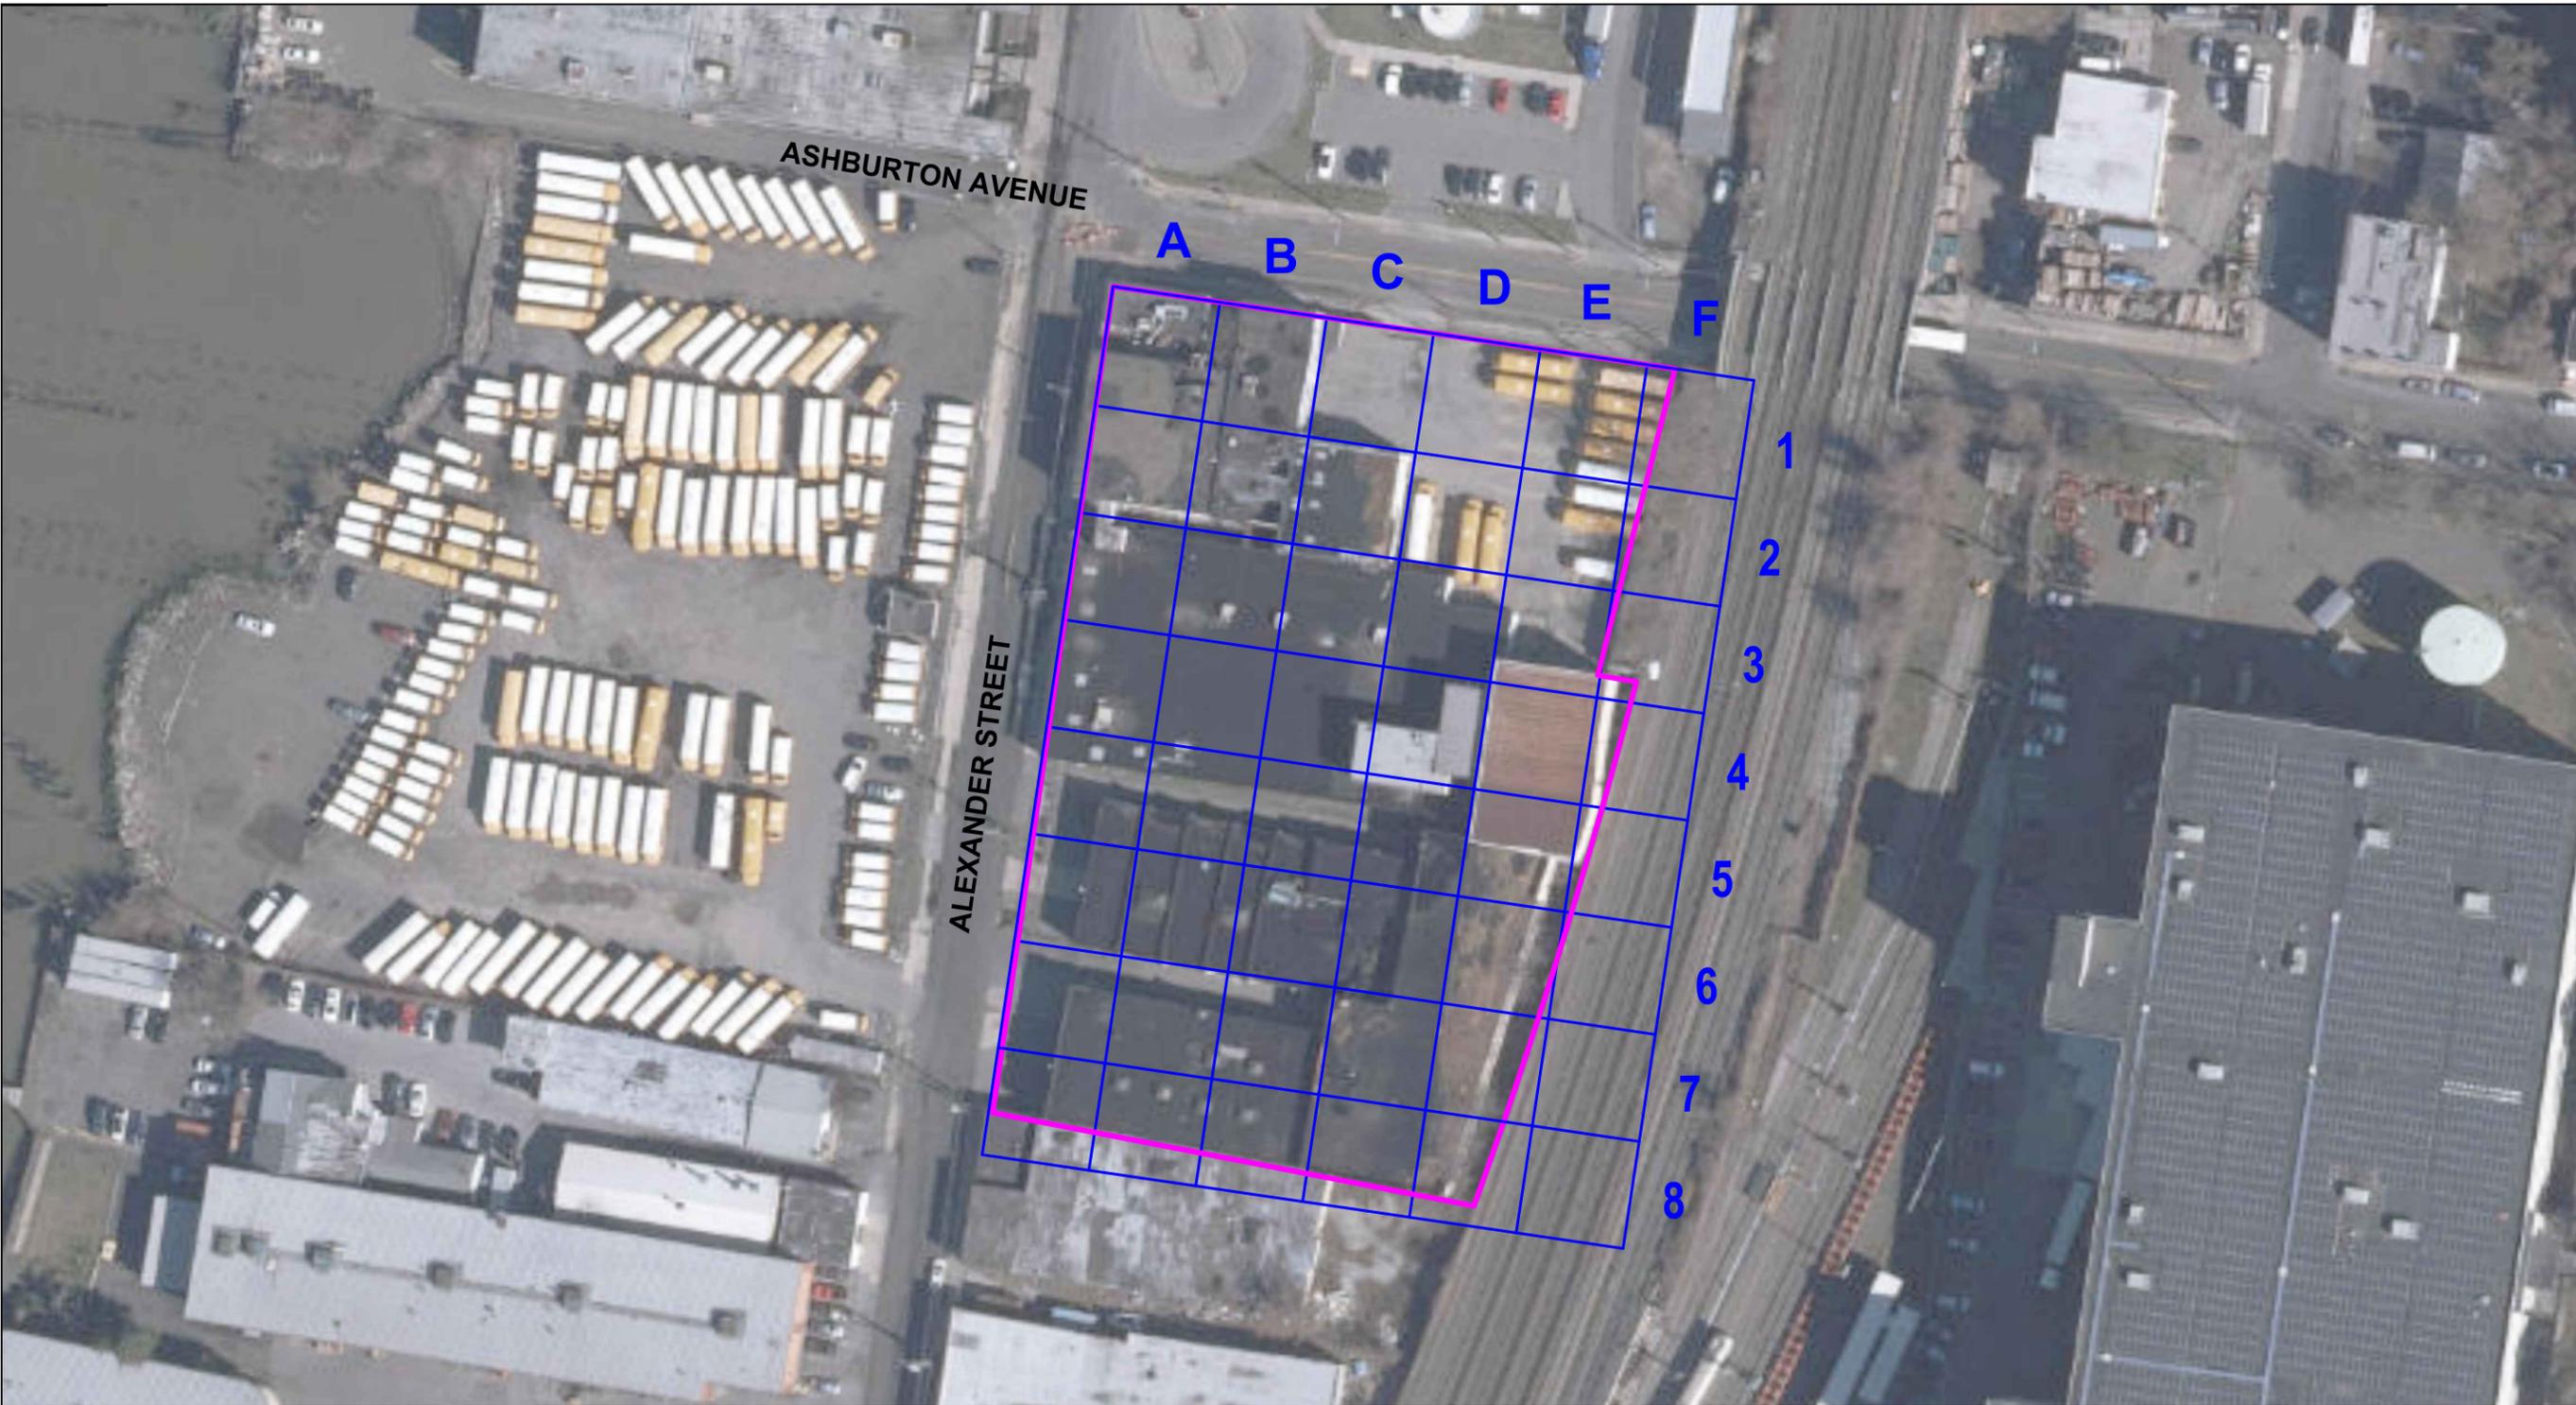
FIGURE
2

SITE PLAN WITH REFERENCE GRID

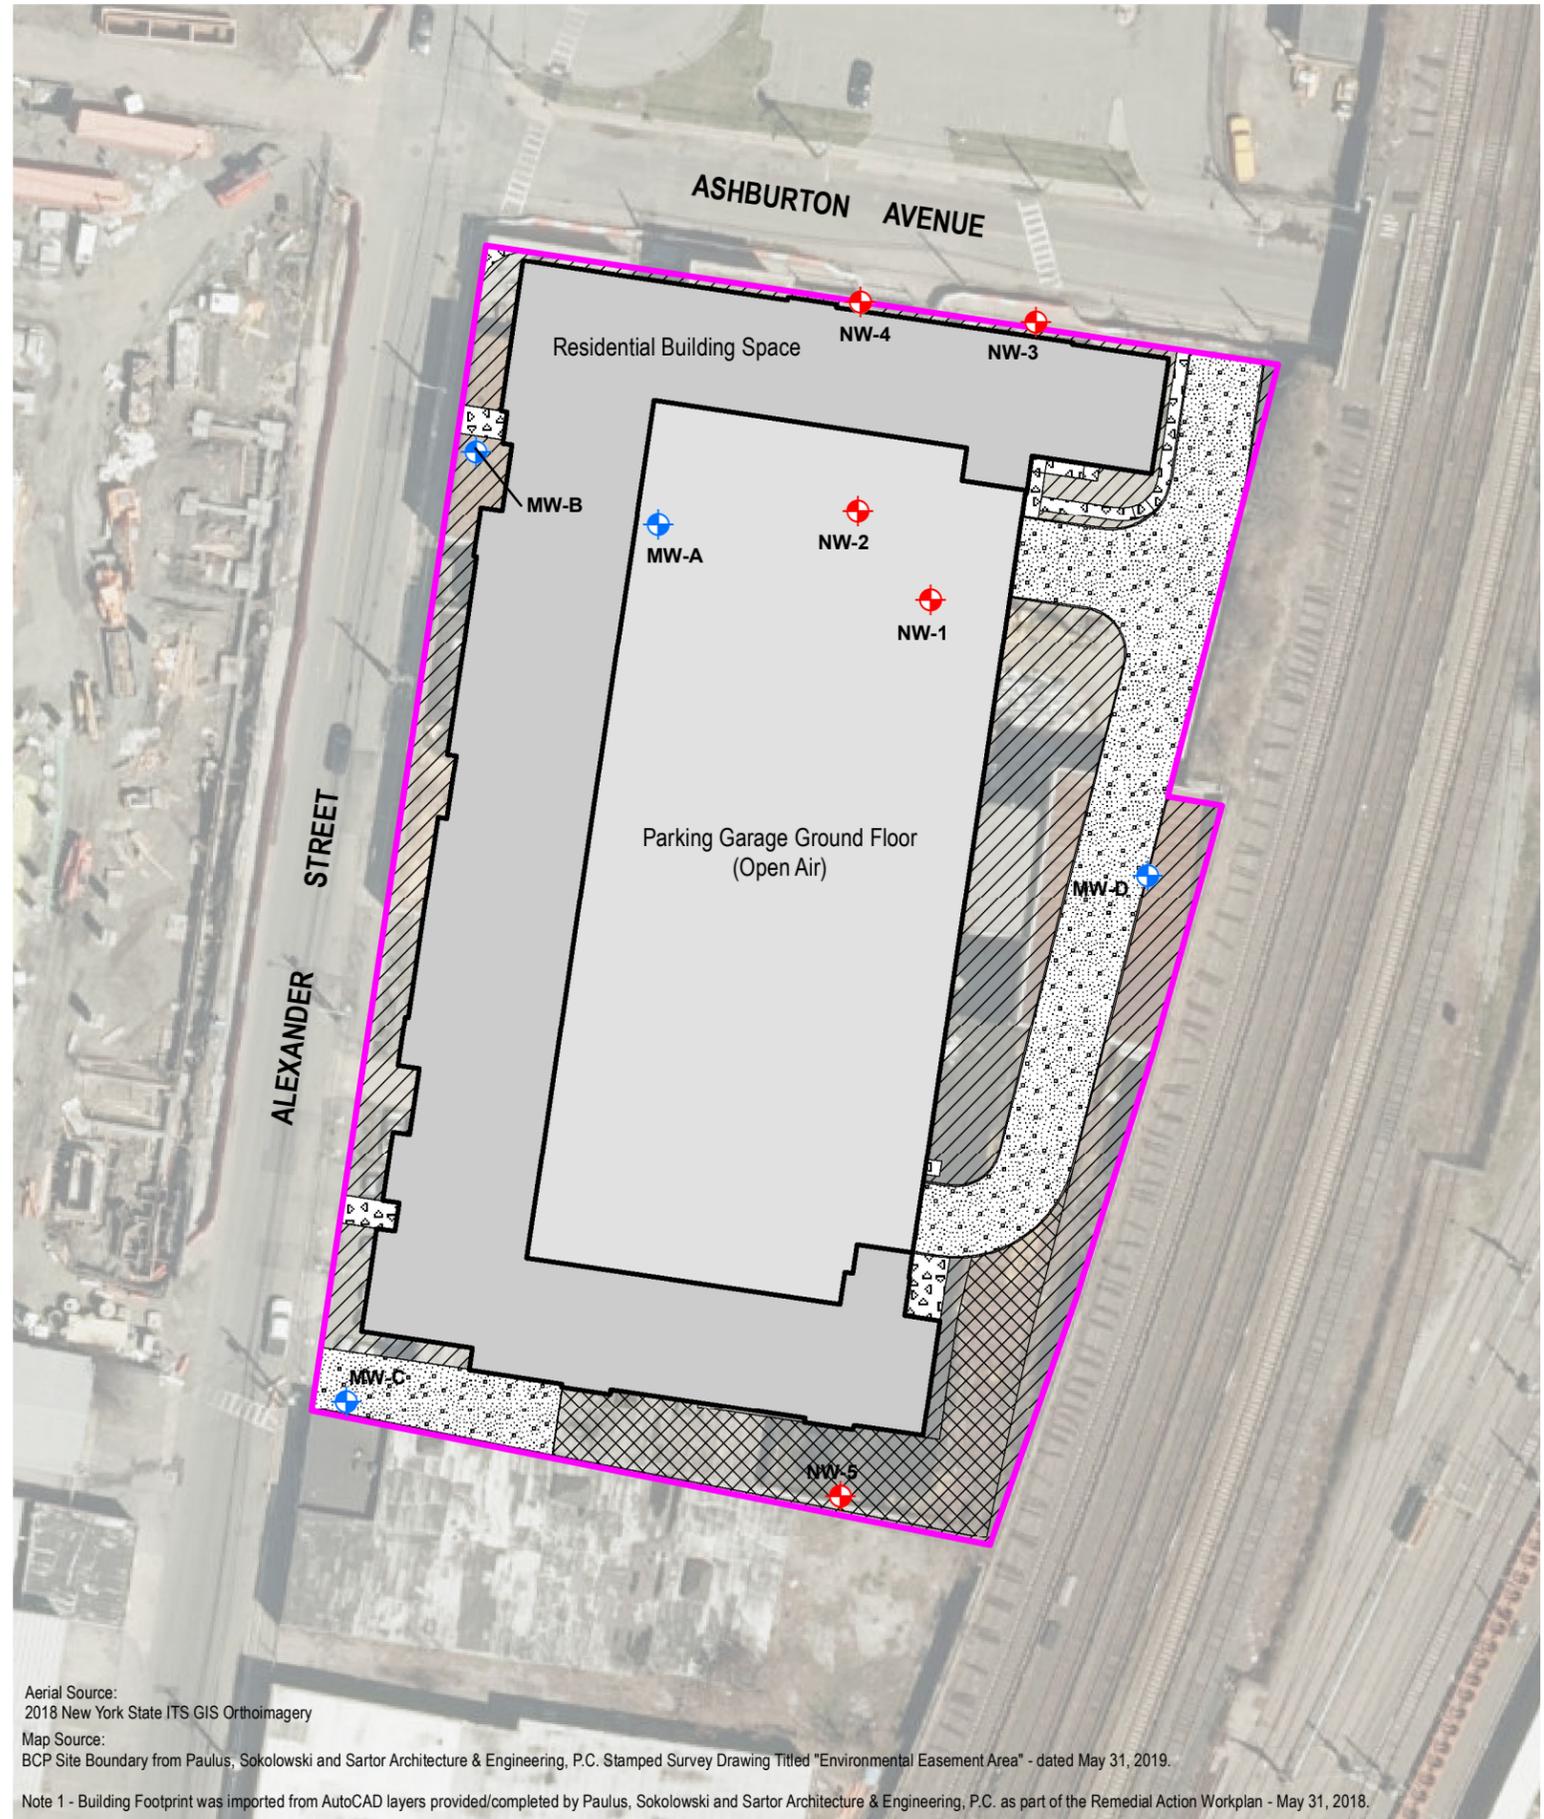
DATE
12/20/2019
PROJECT NO.
180132
FIGURE
3

NAPL RECOVERY AND GROUNDWATER MONITORING WELLS

- During the month of March 2021, no on-Site excavation activities below the final cover system occurred.
- On March 10 and 24, 2021, DNAPL gauging was conducted at NW-3 and NW-4, and monthly gauging was conducted at MW-A, MW-B, MW-C, MW-D, NW-1, NW-2, NW-3, NW-4, and NW-5. DNAPL recovery wells are equipped with 3-foot sumps. DNAPL was detected during the March 2021 monitoring events in NW-3 and NW-4 as summarized below and detailed in the attached Table 1.
