Well Evaluation Summary Report Polychrome West Site

NYSDEC BCP Site No. C360099
City of Yonkers, New York

February 2024
Project 2201010

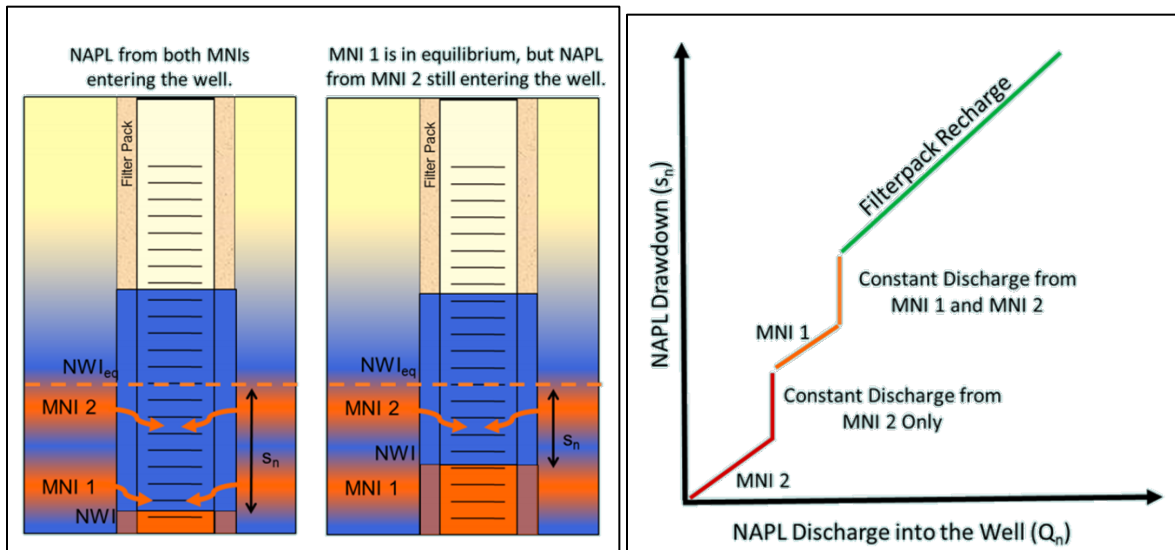
Example Drawdown vs Discharge Graph for Recovery Well with Two MNIs

The example graphic below depicts the flow of DNAPL into a well screen from multiple MNIs and the resulting DvD graph. It demonstrates that the DNAPL will fill the well to the top of the uppermost MNI (MNI-2). This condition typically results in an exaggeration of the DNAPL thickness present in the well relative to where the NAPL is actually present within the formation. As such, the thickness of DNAPL in the well may not reflect the true thickness of the impacted portion of the formation.

When a well is evacuated of DNAPL, the initial discharge of DNAPL into the well comes from the filter pack and all MNIs. Once the filter pack is recharged, the rate shifts to a constant rate of discharge into the well from all MNIs in the screen interval. When the NWI reaches the deepest MNI in the screen, then the discharge rate into the well changes until the NWI reaches the top of the MNI. If additional MNIs are present, then this effect is repeated until the well reached equilibrium. The intervals of constant discharge represent elevations within the well screen between MNIs and are depicted as a constant discharge on the DvD graphs. At these elevations, the apparent DNAPL drawdown is changing while the DNAPL discharge rate into the well is constant.

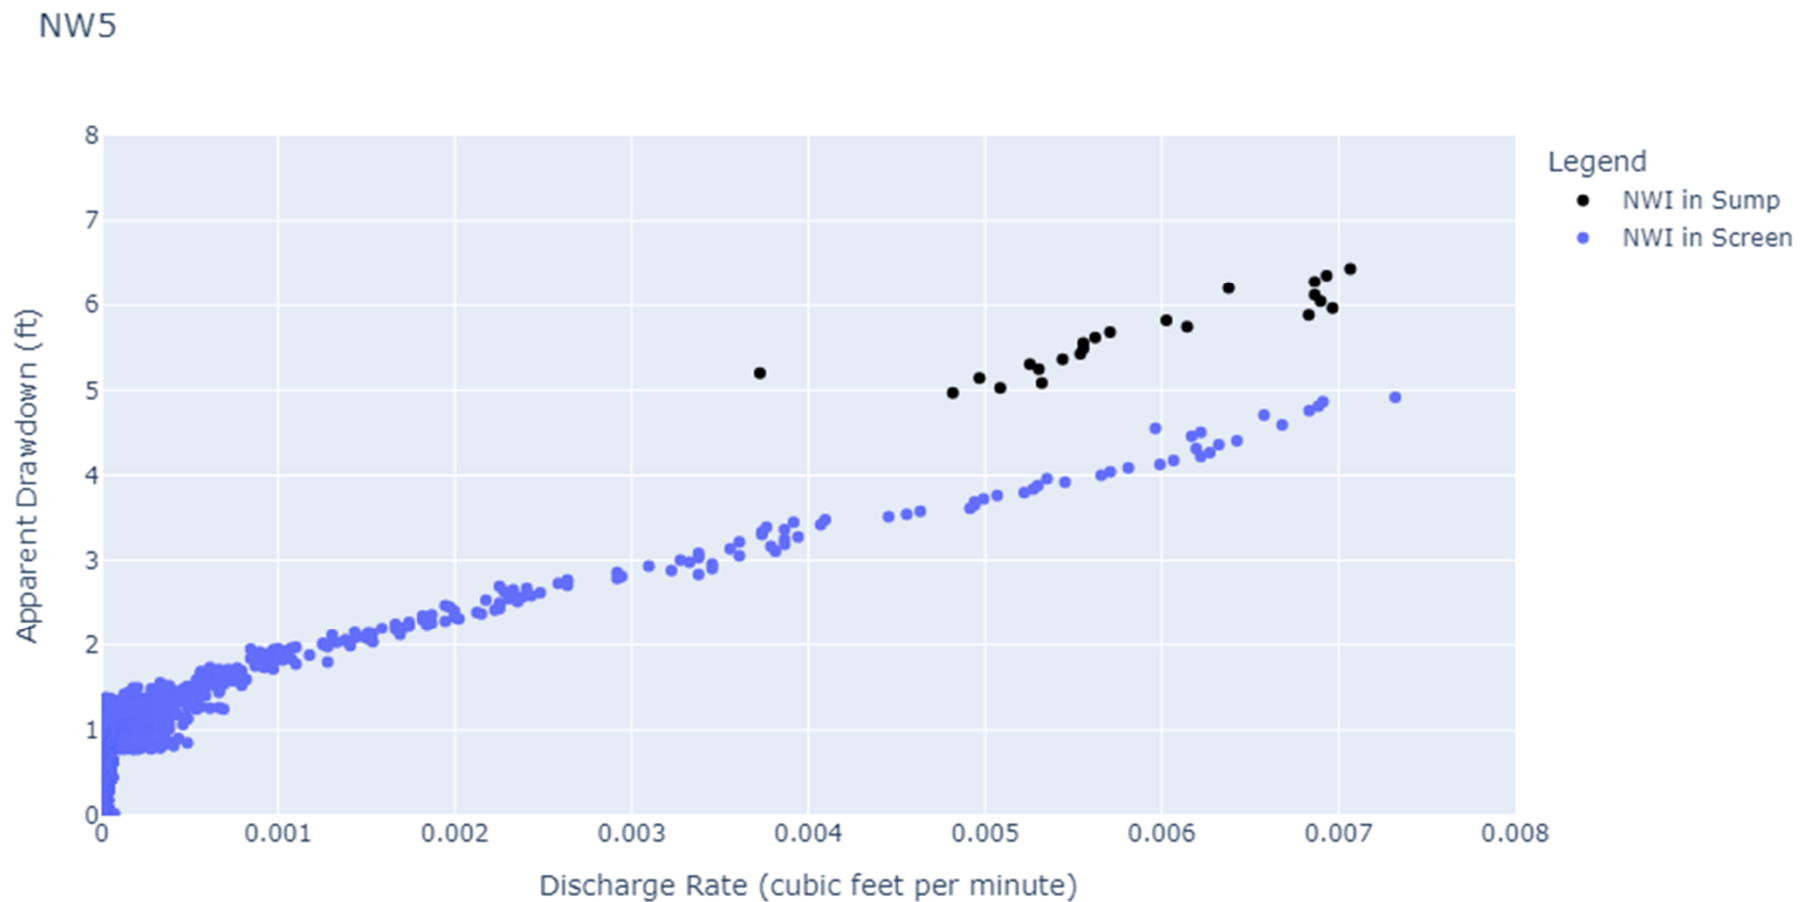
Fig. 6

NWI – NAPL-Water Interface

**Drawdown versus
Discharge
Well NW-5**

The ANT for NW-5 returned to within 1 foot of the pre-testing equilibrium thickness within a few hours and returned to equilibrium in approximately two weeks (See Fig. 4). The DvD graph for NW-5 initially shows a constant discharge rate of about 0.007 cubic feet per minute (ft³/min) or 75 gallons per day (GPD) while the NWI is within the sump (See Fig. 6).

However, then the discharge rate starts to decrease. This result indicates that the initial DNAPL discharge rate likely represents a combination of formation discharge into the well and emulsified DNAPL present as globules temporarily suspended in the water column following DNAPL removal settling within the well. Once, the NWI is within the screened interval, the DvD trend is a straight line until the thickness of DNAPL in the well reaches an apparent drawdown of about one foot. This result indicates the potential for a 3-foot MNI beginning at the bottom of the screen and extending to 3 ft above the bottom of the screen. However, due to the potential for emulsified DNAPL settling within the well, the lower elevation of the MNI cannot be definitively identified. Although the specific depth and thickness of the MNI is estimated for this well, it does not exceed the lower 3 ft of screen interval as the DNAPL reaches equilibrium with the formation at approximately 3 ft above the top of the sump.

The sustainable recovery rate, if the DNAPL were maintained in the sump below the bottom of the screen, was conservatively estimated from the maximum recovery rate on the DvD graphs when the NWI is within the screened interval. The estimated rates for NW-5 and NW-6 are 75 GPD and 215 GPD, respectively.

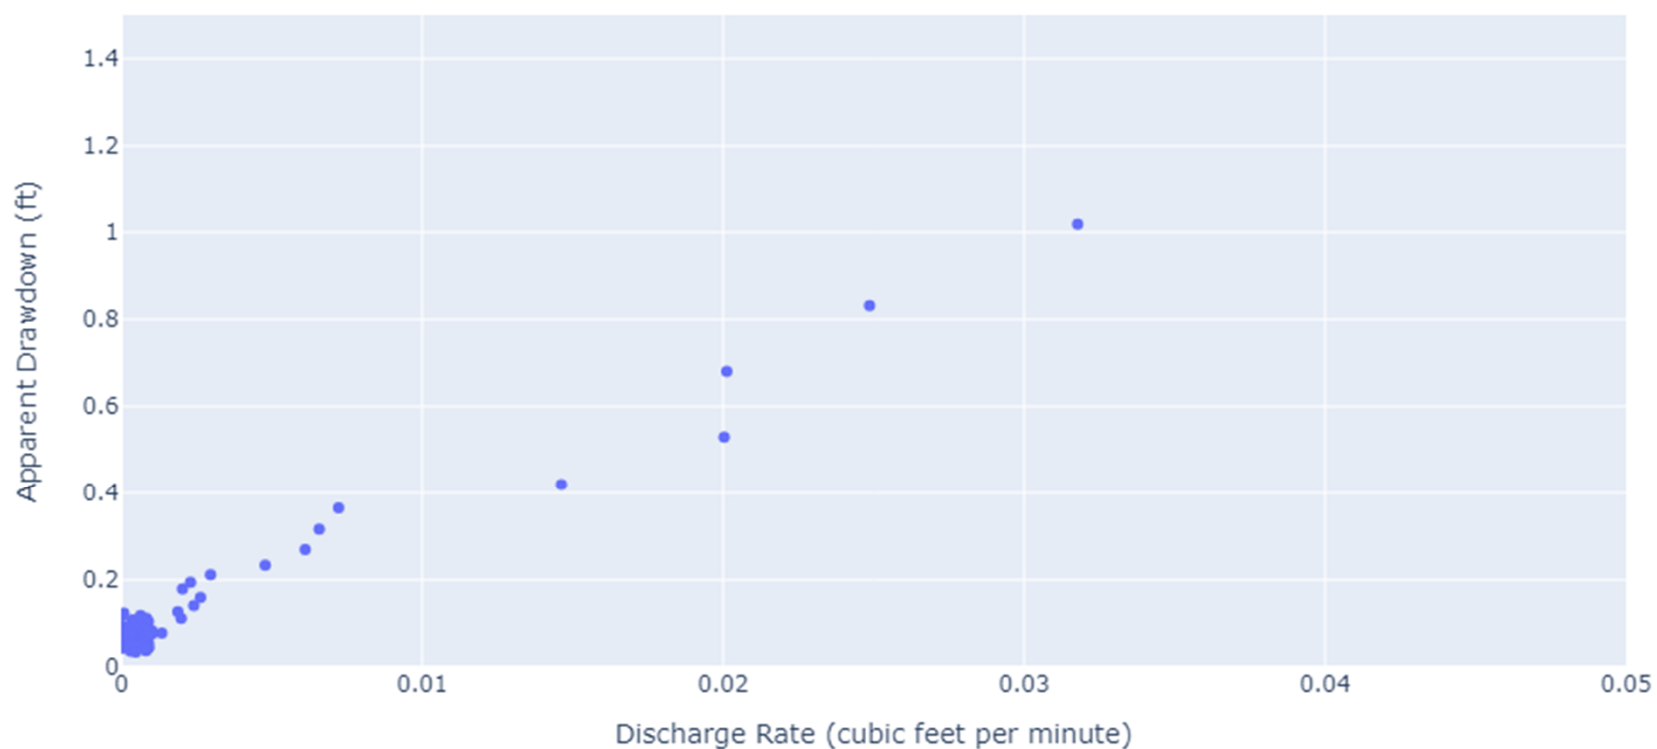
Fig. 7

NWI – NAPL-Water Interface

**Drawdown versus
Discharge
Well NW-6**

The ANT for NW-6 initially returned to equilibrium within a few hours. The well was disturbed for manual gauging after which the ANT showed an apparent reduction, returning to equilibrium within about two weeks (See Fig. 5). The DvD graph for NW-6 is based on the initial recovery to equilibrium. It shows a constant discharge rate of about 0.02 ft³/min (215 GPD) (See Fig. 7). This rate is the combined rate of recovery for all mobile NAPL intervals. It may also include a component from emulsified DNAPL settling within the well.
