# Remedial Investigation Report

**King Aristocrat (Operator/Dry Cleaners)**

**212 E. Hartsdale Avenue,**

**Spill Report Case No 0903393**

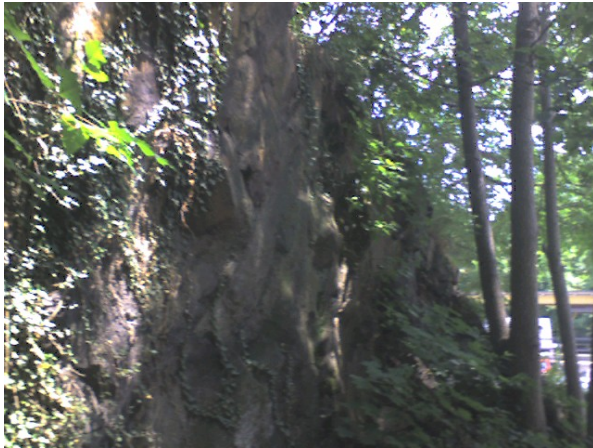
The bedrock under the site is a highly fractured metamorphic Shale, and Biotite Schists and Gneiss, injected with granite and quartz dikes. The rock strata steeply dip into the ground at @ 70° and a strike Southeast-Northwest parallel to the strike of the rail line and Bronx River valley.

Blocky Metamorphic shale & biotite gneiss injected with granite dikes dipping @ 70° Northwest parallel to the strike of the rail line and Bronx River valley.

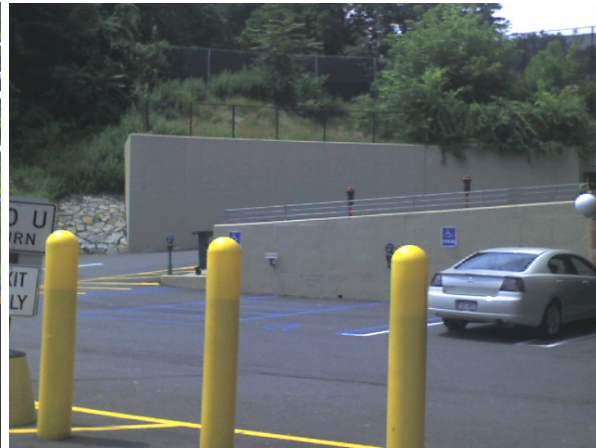
On the west side of the gorge, behind the dry cleaners, the rocky outcrops are stabilized with the retaining walls of the Parking Garage A.

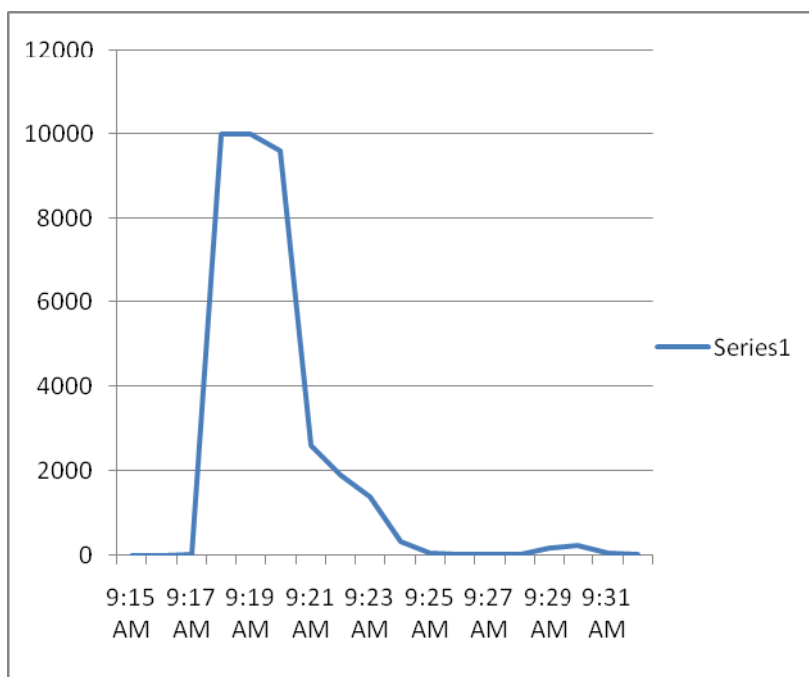
Date Time	Min(ppm)	Alarm	Avg(ppm)	Alarm	Max(ppm)	Alarm
8/12/2009 9:18	47.5		3777 H	<b>9999 ppm</b>		Air Quality Exceedance Basement Entrance
8/12/2009 9:19	6553 H		9969 H	<b>9999</b>		Air Quality Exceedance Basement Entrance
8/12/2009 9:20	2566.2 H		4769 H	<b>9613</b>		Air Quality Exceedance Basement Entrance
8/12/2009 9:21	1841.6 H		2119.3 H	<b>2608.9</b>		Air Quality Exceedance Basement Entrance
8/12/2009 9:22	1404.6 H		1634.2 H	<b>1908.1</b>		Air Quality Exceedance Basement Entrance
8/12/2009 9:23	333.6 H		844.7 H	<b>1401.4</b>		Air Quality Exceedance Basement Entrance
8/12/2009 9:24	63.4 L		154.7 H	326.5		Air Quality Exceedance Basement Entrance
8/12/2009 9:25	30.6		42.4	61.9		Air Quality Exceedance Basement Entrance
8/12/2009 9:26	21.7		26	32.8		Air Quality Exceedance Basement Entrance

Time	Concentration ppm
9:15 AM	1.7
9:16 AM	0.6
9:17 AM	32.7
9:18 AM	9999
9:19 AM	9999
9:20 AM	9613
9:21 AM	2608.9
9:22 AM	1908.1
9:23 AM	1401.4
9:24 AM	326.5
9:25 AM	61.9
9:26 AM	32.8
9:27 AM	30.4
9:28 AM	22.4
9:29 AM	182.4
9:30 AM	239.4
9:31 AM	61.1
9:32 AM	37.4

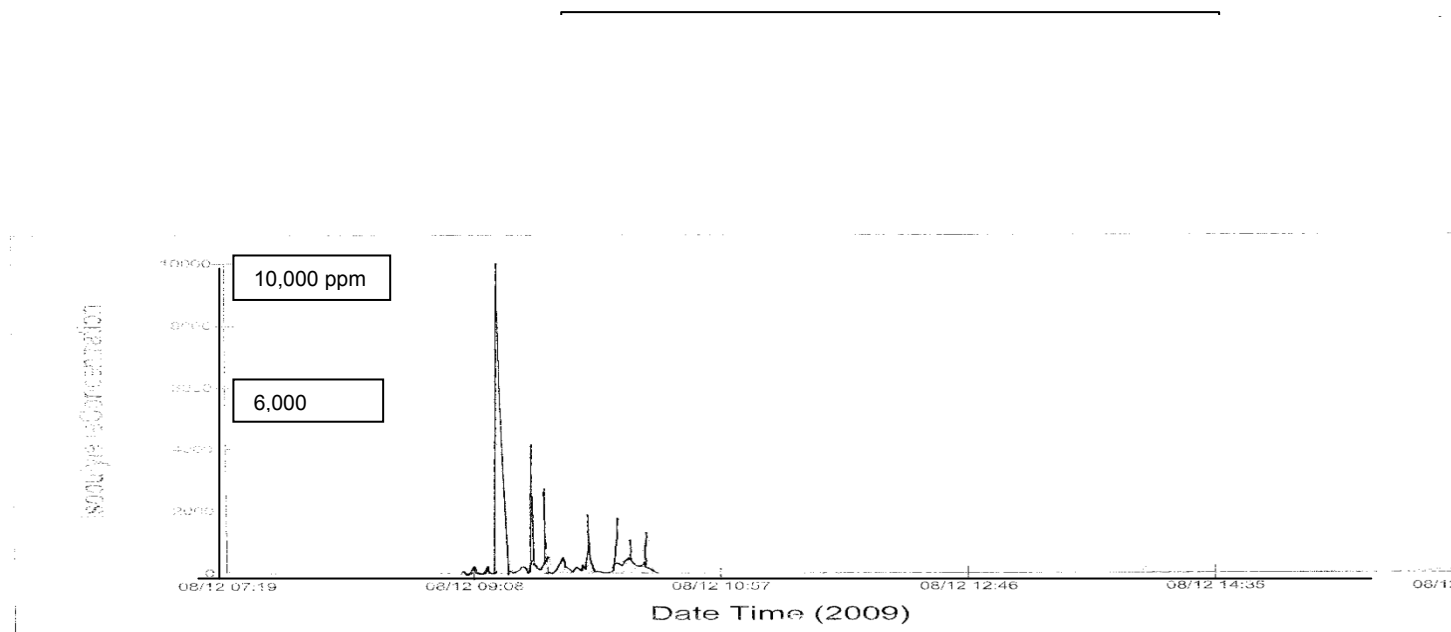
Figure 3.4 Total Volatile Organic Concentration  
8-hour work day August 12 2009

Data from MiniRae monitor was downloaded to a field laptop computer on a daily basis. The recorded logs were reviewed for any exceedances. During the RI, because CAMP action levels (PID readings greater than 1 ppm) were exceeded at the work site, the work was stopped and samples taken of the water vapor issuing from the condensate pipe (no exceedance) and the soil under the condensate pipe (only trace solvents).

Date Time	Min(ppm)	Alarm	Avg(ppm)	Alarm	Max(ppm)
8/12/2009 9:30	52.4 L	182.4 H	239.4ppm	H	Soil from under Steam Pipe

Based on the air quality monitoring data, the assessment was made that we could not at that time determine the source of the TVo exceedance but it was not a passing vehicle. The boring activity was not the source of the negatively impacted air quality at the Site but it did not extend to the environs.
