**Hartsdale Village Square Aristocrat Cleaners**  
Westchester, New York

**Remedial Investigation/  
Interim Remedial Measures/  
Alternatives Analysis  
Report**

**NYSDEC BCP Number: C360111**

**December 5, 2014**

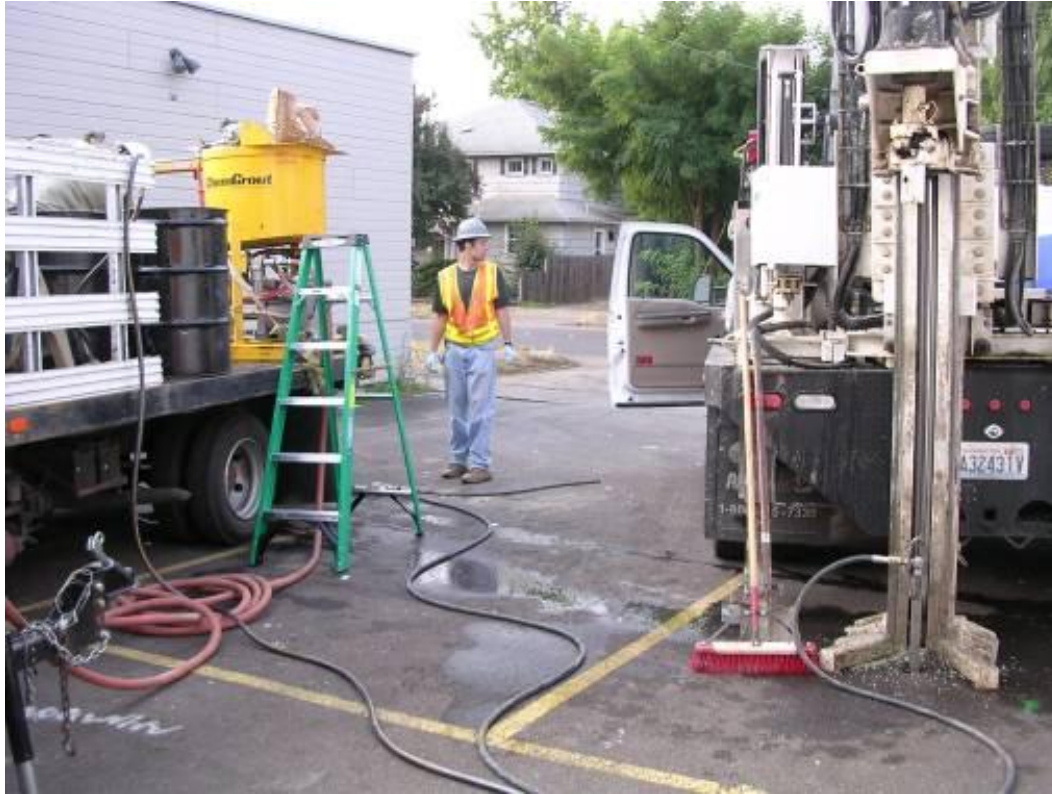
There were no perched water conditions noted at the Site and the water table is normally found approximately 10 feet below grade, an elevation corresponding to just beneath the basement floor slab of the dry cleaner, except during flooding conditions when it can temporarily rise to higher elevations.

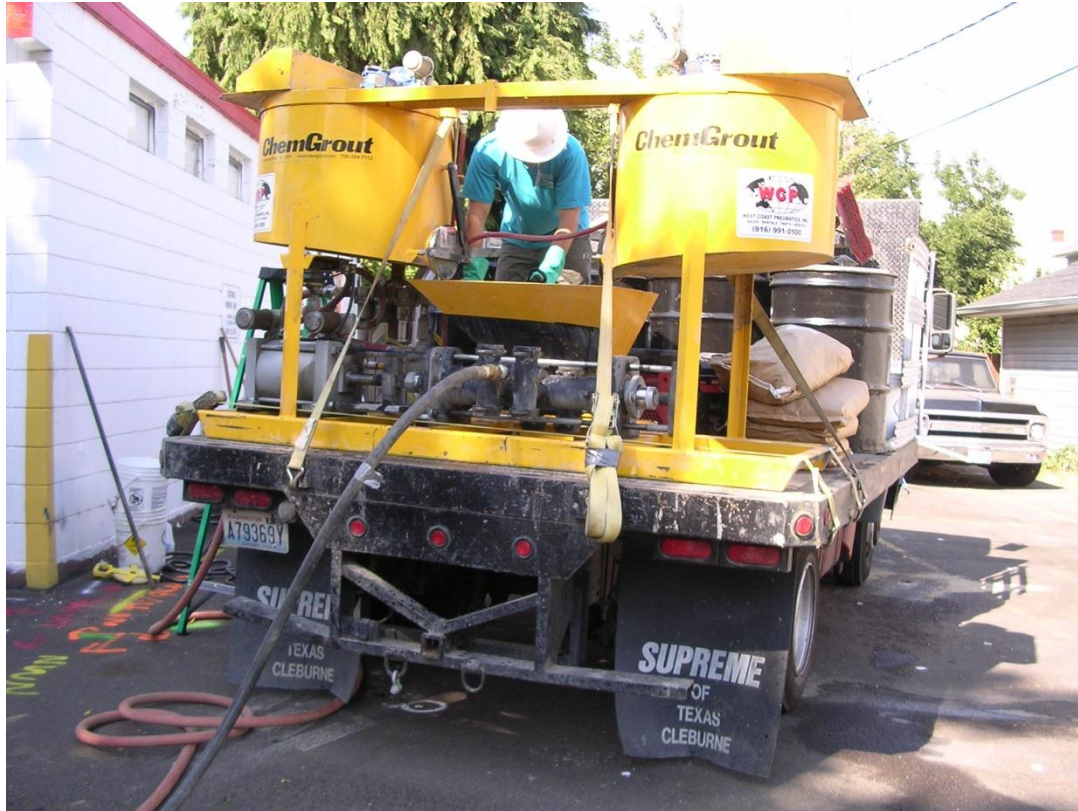
### 5.1 Soil

- Phase I testing analytical parameters included VOCs, SVOCs, inorganics, PCBs and organochlorine pesticides. Results for samples SS-1 (1-3') and SSV-2 (0.5-2.5') are provided in Tables 5-1 and 5-2.
- Phase II testing analytical parameters included VOCs. Results for samples MW-2D (9-11') and MW-2D (19-21') are provided in Table 5-3.
