Remedial Investigation Report
Lot 4 – Austin Avenue and Prior Place
Brownfield Cleanup Program Site
City of Yonkers, Westchester County, NY
BCP Site #C360116

GHD CONSULTING ENGINEERS, LLC
ONE REMINGTON PARK DRIVE
CAZENOVIA, NY 13035
315.679.5800

Project No. 8614908.00

August 2012

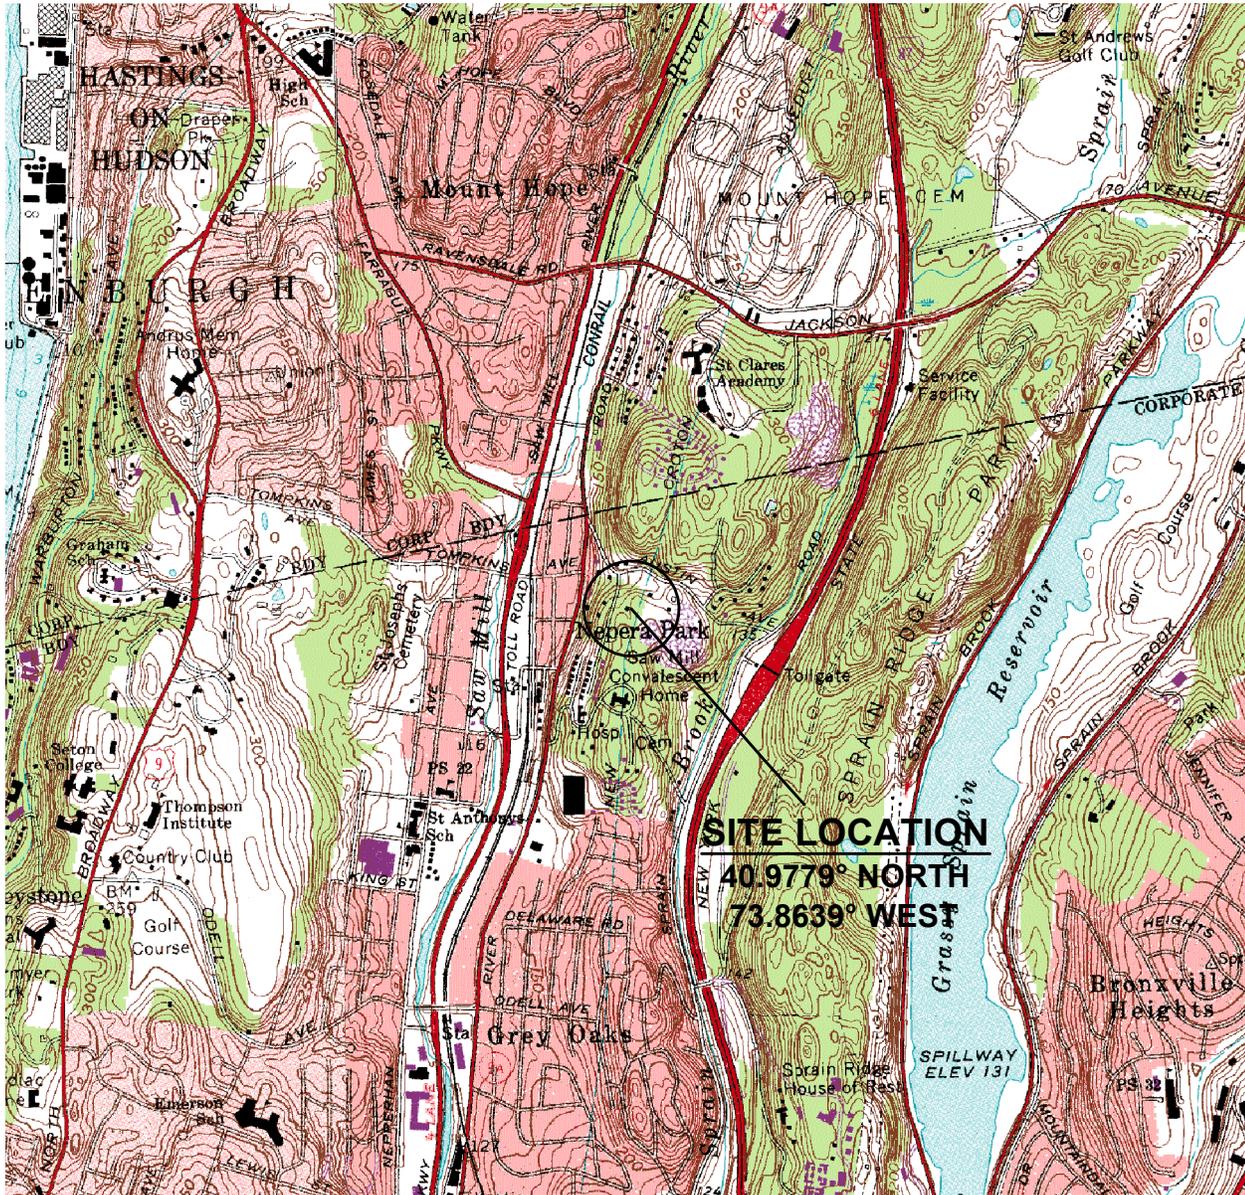
Figure 1-1

MAP TAKEN FROM: USGS 7.5 MINUTE SERIES
 TOPOGRAPHIC QUADRANGLES:
 MOUNT VERNON (1966, PHOTOREVISED 1979) &
 YONKERS (1966, PHOTOREVISED 1979)
 (www.nysgis.state.ny.us/quads/usgsdrgr.htm)

The Site is approximately 250 feet above mean sea level, according to a 1966 United States Geological Survey topographic map (Figure 1-1); however, elevation information obtained during a land survey identified elevations that ranged from 250 to 290 feet above mean sea level due to the shot rock stockpile. As a result of the site being located on top of a ridge, area topography dips steeply away from the Site to the east and west, gently towards the Site from the South, and steeply away from the Site to the north. The houses closest to the Site are located across Prior Place and are at a lower elevation than the Site, with bedrock outcrops occurring between the Site and the houses.

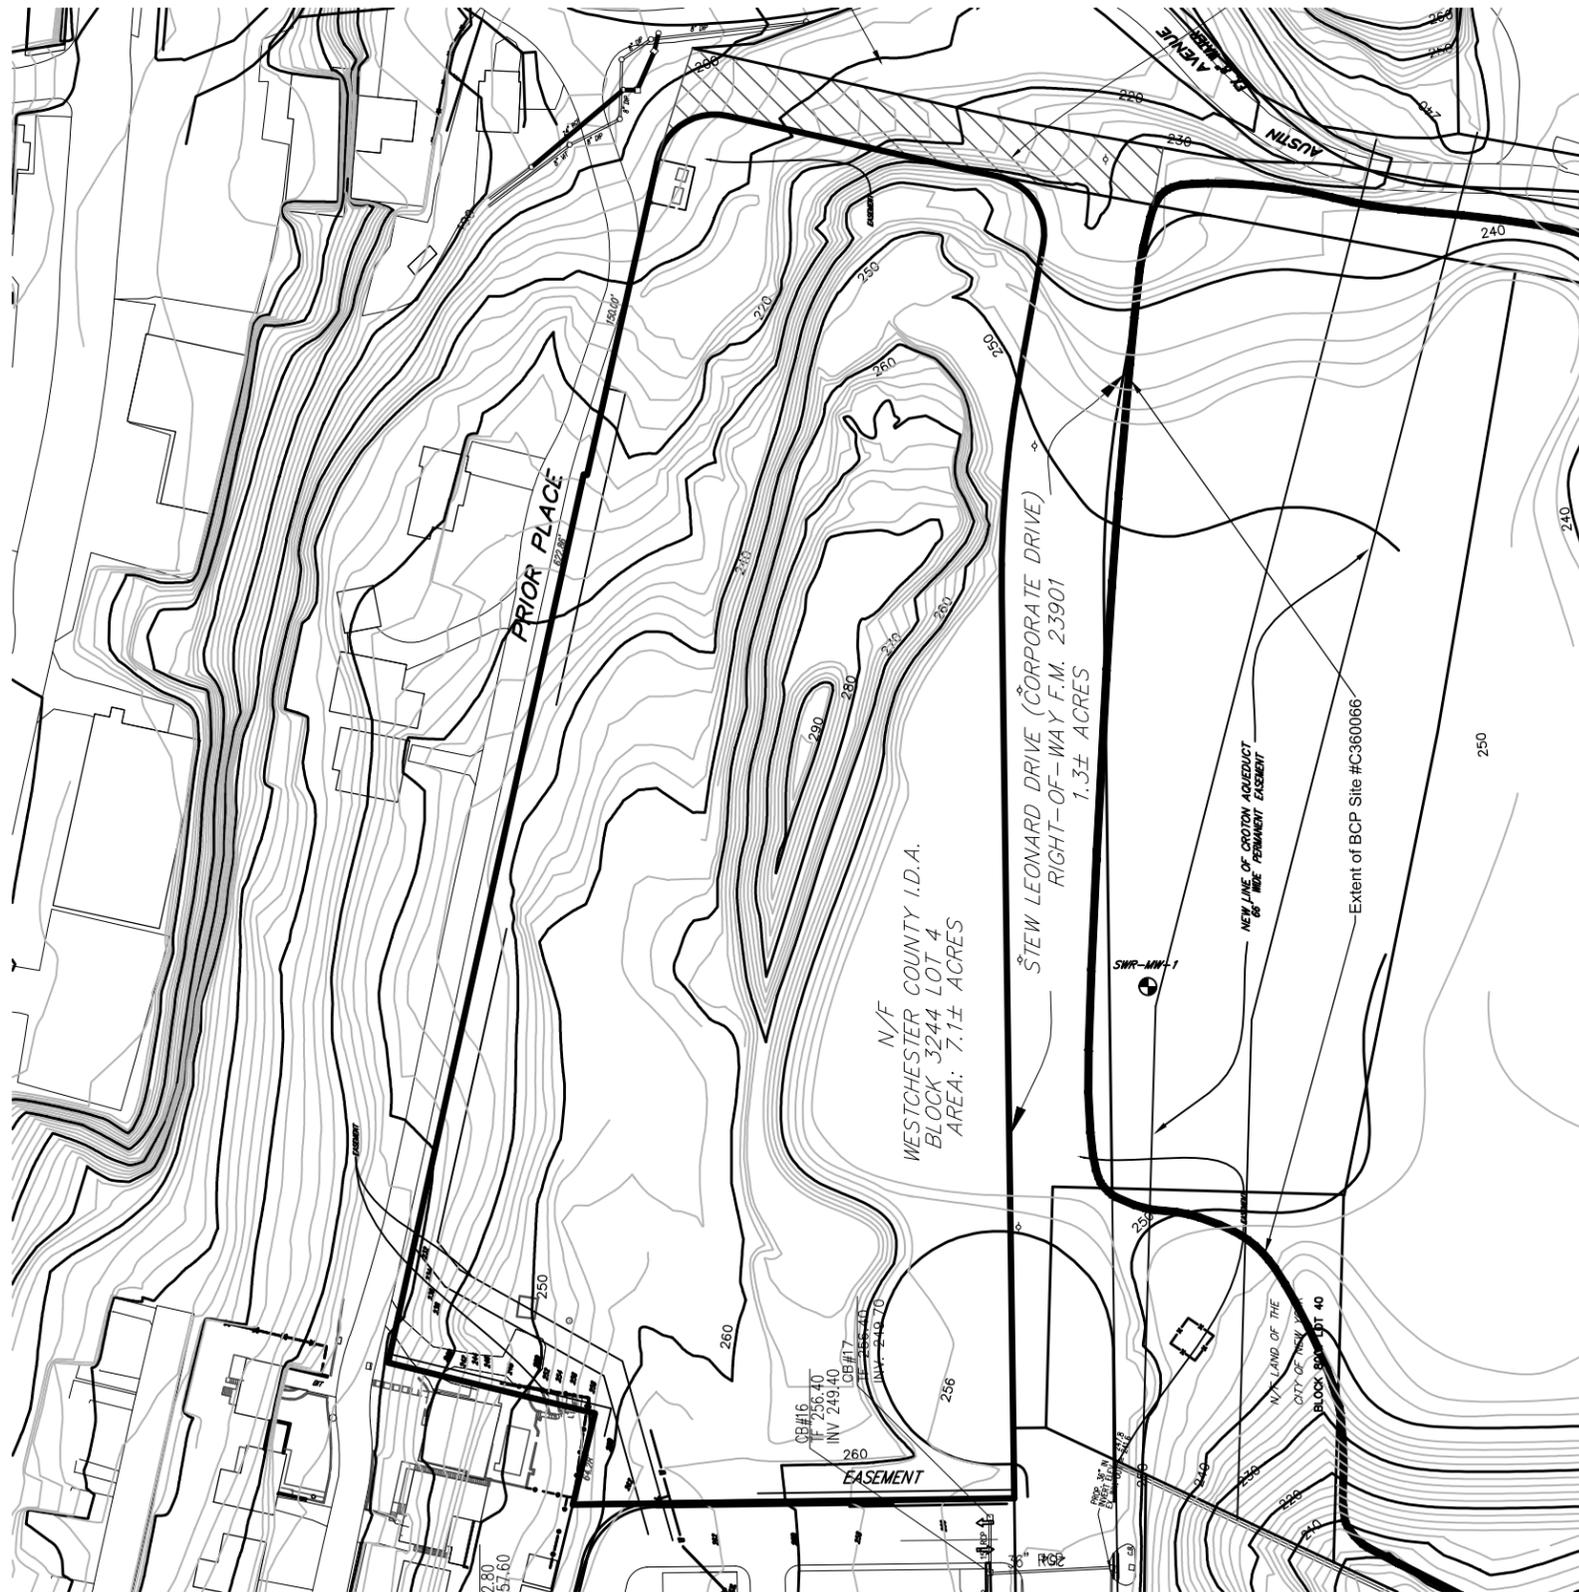
Figure 1-2

- EXISTING GROUNDWATER MONITORING WELL (LOT 1)
- SURFACE CONTOURS (APPROXIMATE)
- PROPERTY BOUNDARY (APPROXIMATE)

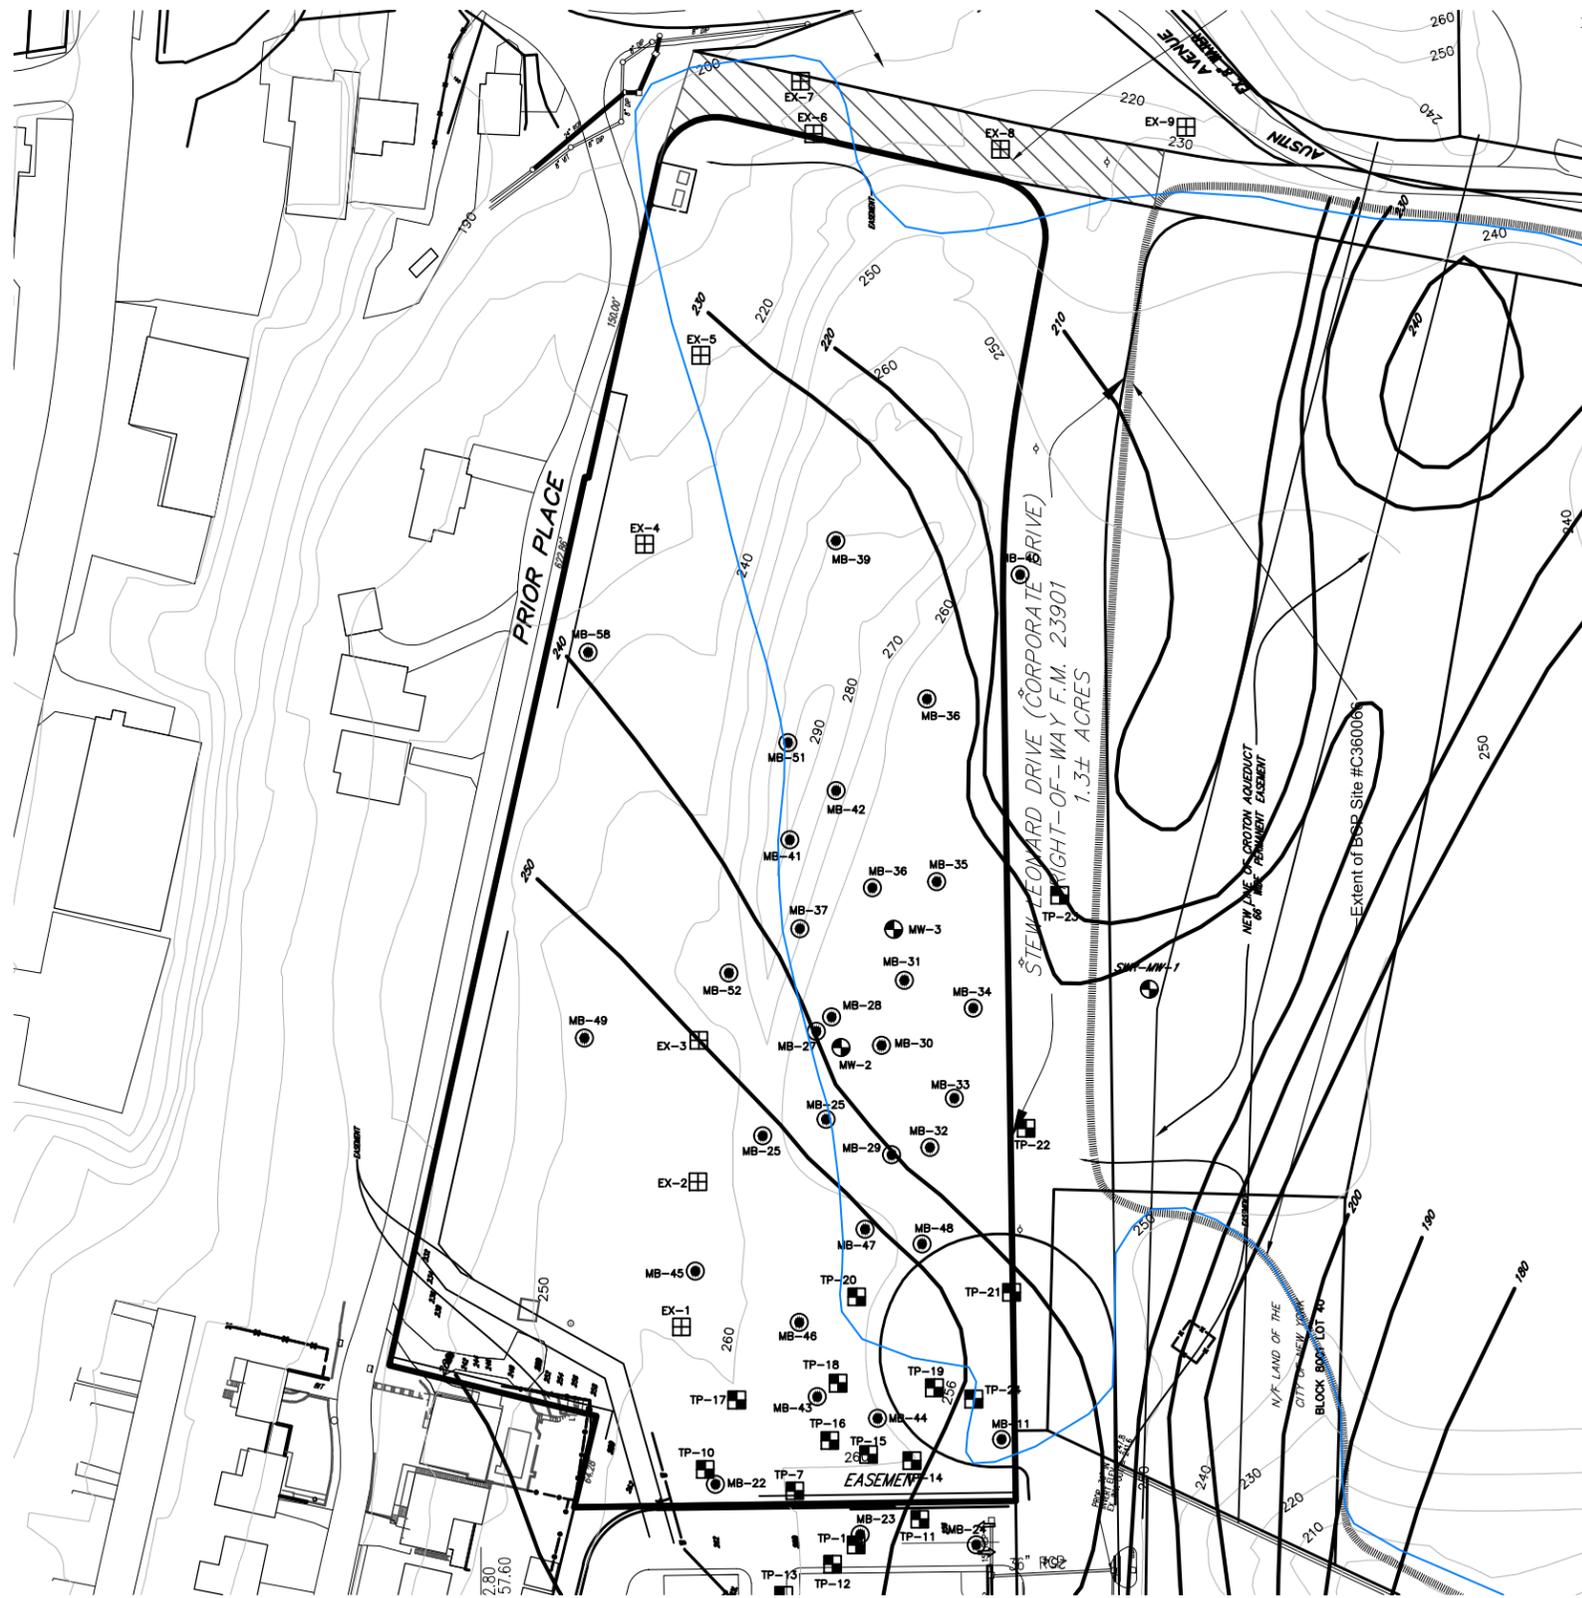
Figure 2-1

BASE MAP FROM A FIELD SURVEY CONDUCTED BY JOHN MEYER CONSULTING, P.C. JUNE 30, 2011.
 BEDROCK CONTOURS FROM ROCK CONTOUR MAP, PLATE 3, SOILS AND FOUNDATION INVESTIGATION, MELICK-TULLY AND ASSOCIATES, P.C. DECEMBER 8, 1988.
 SAMPLE LOCATIONS AND EXTENT OF FILL FROM EXISTING CONDITIONS, PLATE 1, MORRIS WESTCHESTER CONSTRUCTION COMPANY, L.L.P. HISTORIC AUSTIN AVENUE LANDFILL CLOSURE PLAN, LEGGETTE, BRASHEARS, & GRAHAM ENGINEERING SERVICES, P.C. MARCH 8, 2000.

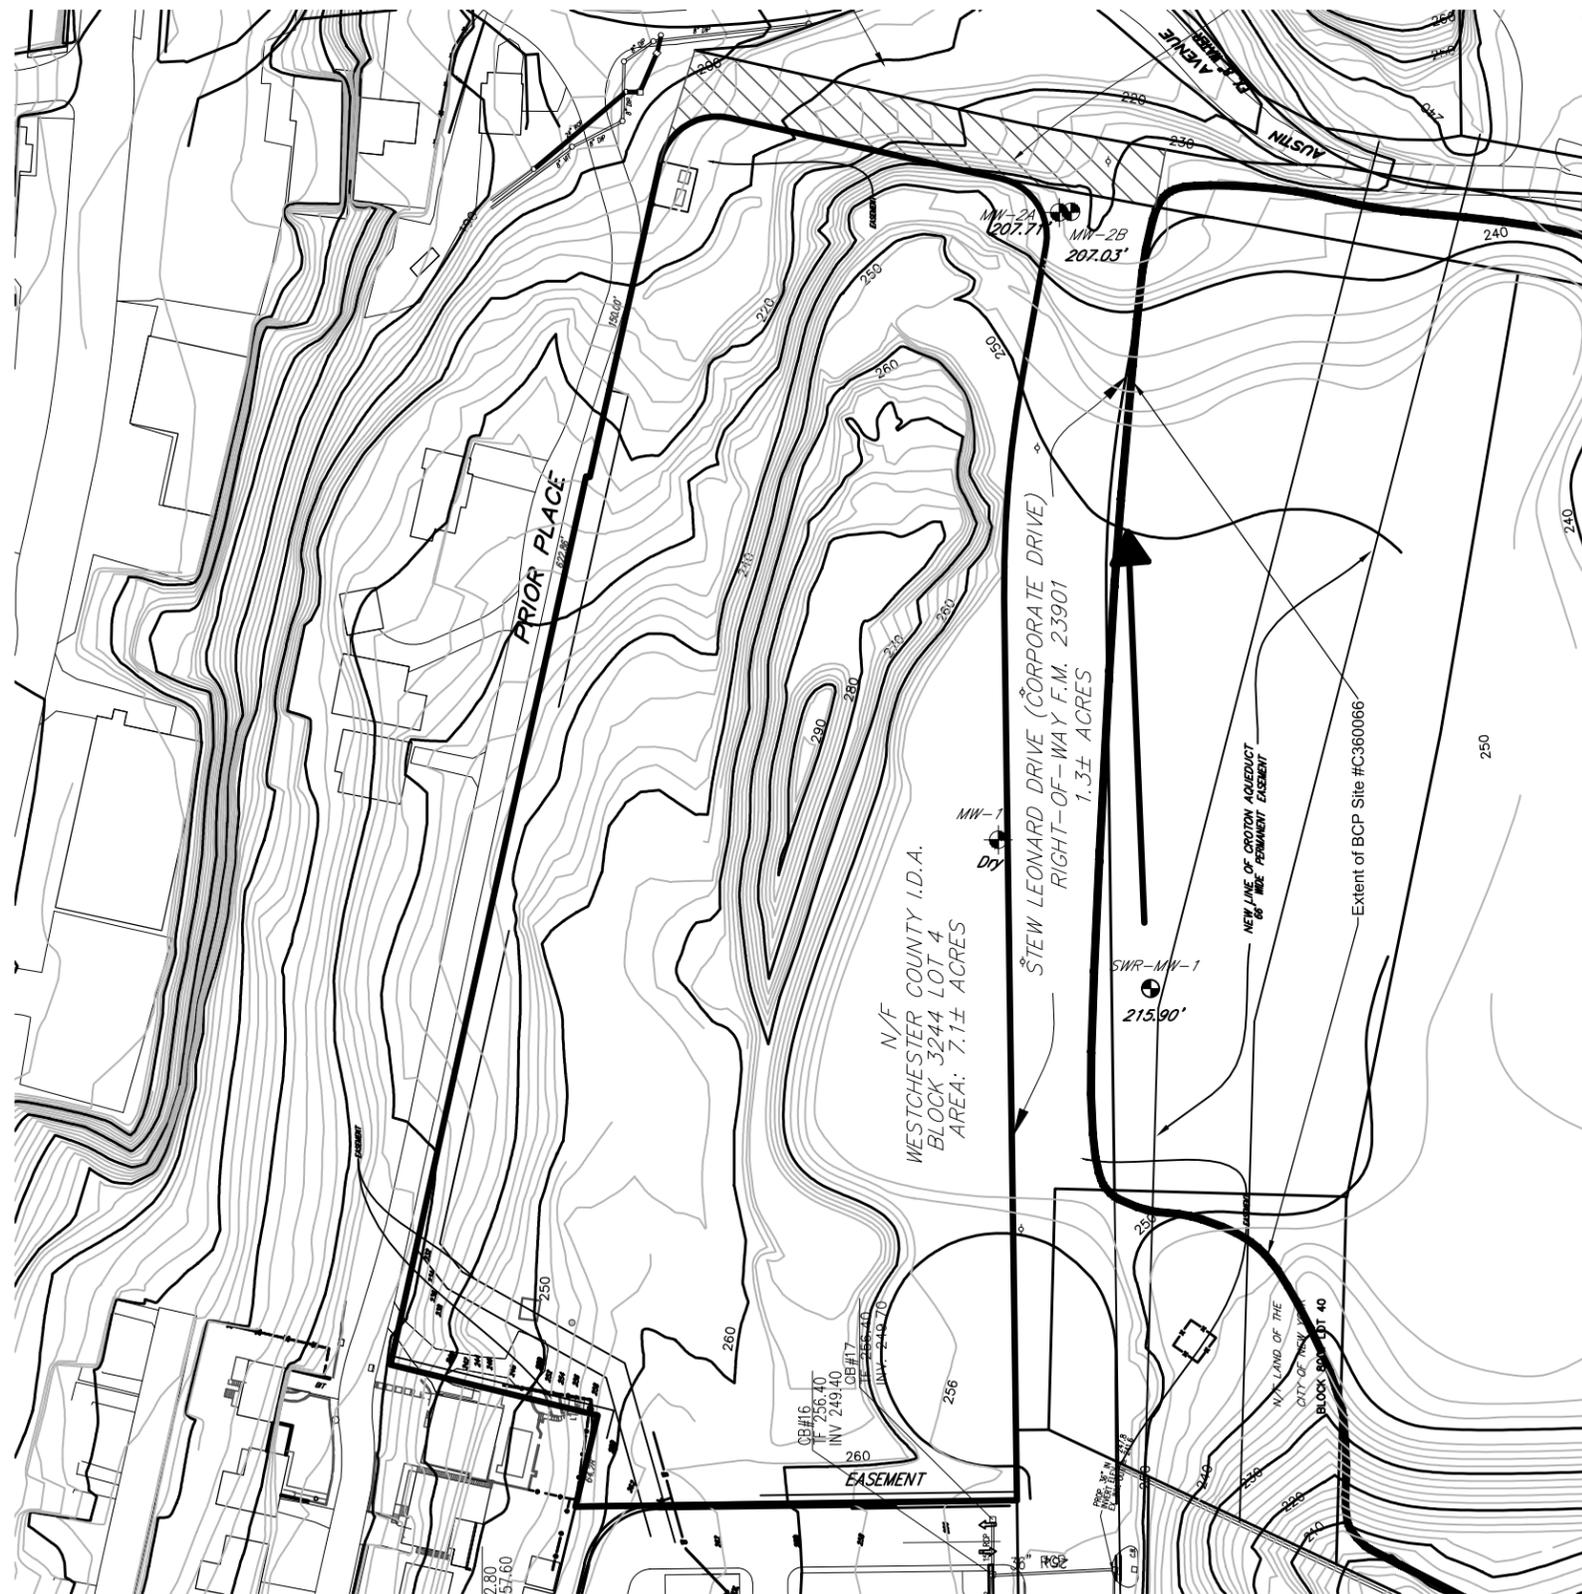
Figure 3-1

Eight (8) soil borings were completed at the Site during investigation activities. These borings were intended to facilitate the collection of representative soil samples and installation of groundwater and soil vapor monitoring wells. The borings included three (3) soil borings (SB-1, SB-4, and SB-5), three (3) soil boring completed as groundwater monitoring wells (MW-1/SB-2, MW-2A, and MW-2B/SB-3), and two (2) soil borings completed as soil vapor wells (SV-1 and SV-2). Three (3) surface soil samples (SS-6, SS-7, and SS-8) were also collected during investigation activities. Soil boring, monitoring well, soil vapor well, and surface soil sample locations are shown on Figure 3-1.

The location and elevation of new groundwater monitoring wells, soil vapor monitoring wells, soil borings, and surface soil samples were surveyed by Contractors Line and Grade South, LLC of Elmsford, New York (Appendix A). Survey data was used to update a base map for the Site (Figure 3-1).

Logs of borings advanced during the RI are presented in Appendix C, and their locations are shown on Figure 3-1.

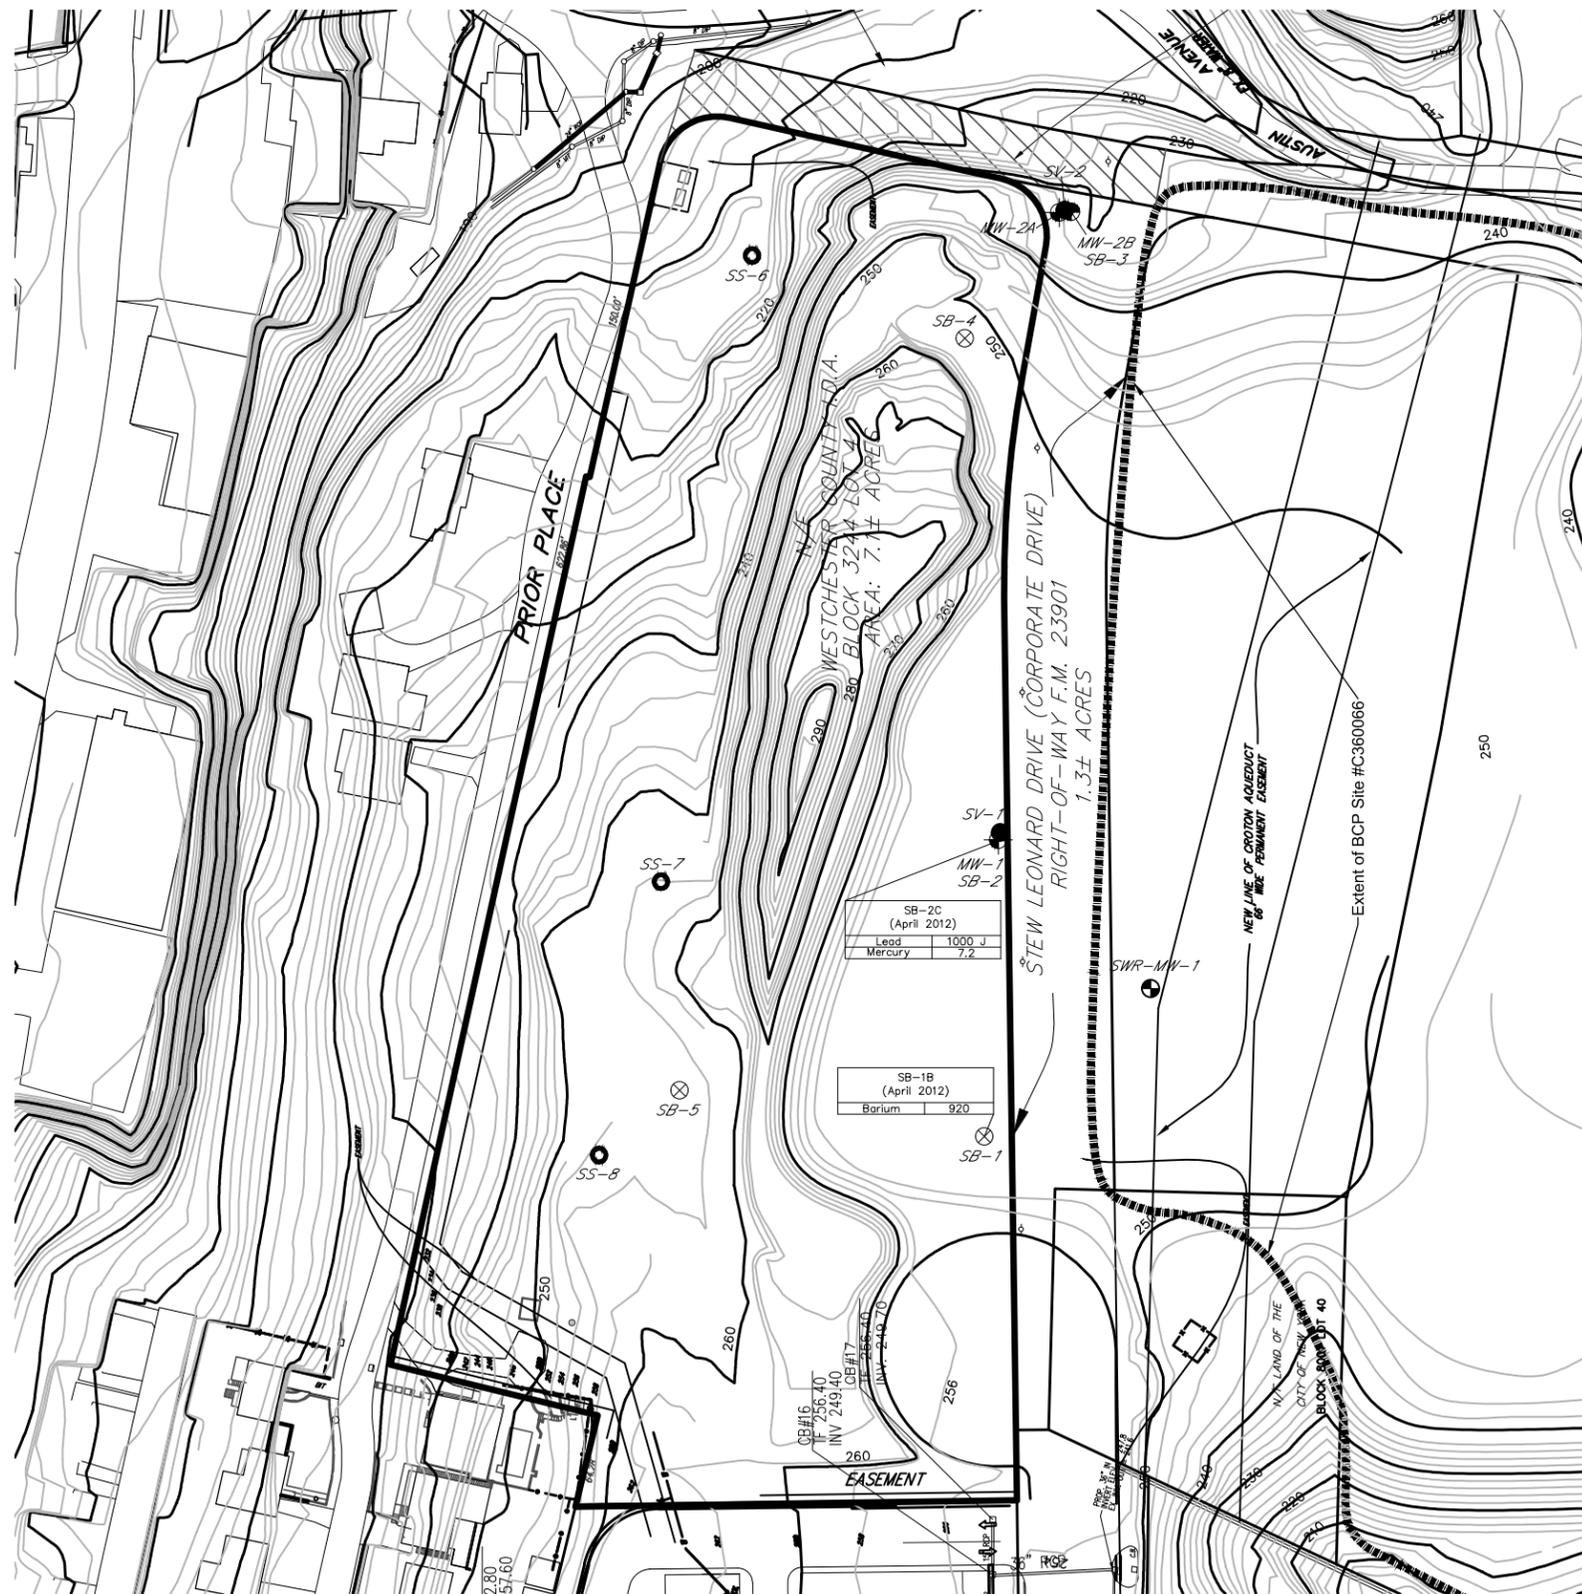
However, since the site is located on top of a ridge, it is likely a groundwater recharge zone and groundwater flow will likely follow topography and flow away from the site to the east, west, and north. Groundwater likely discharges to the Saw Mill River west of the Site or Sprain Brook immediately east of the former Austin Avenue Landfill. Groundwater elevation data is provided on Table 4-1 and Figure 4-1 shows presumed groundwater flow direction.

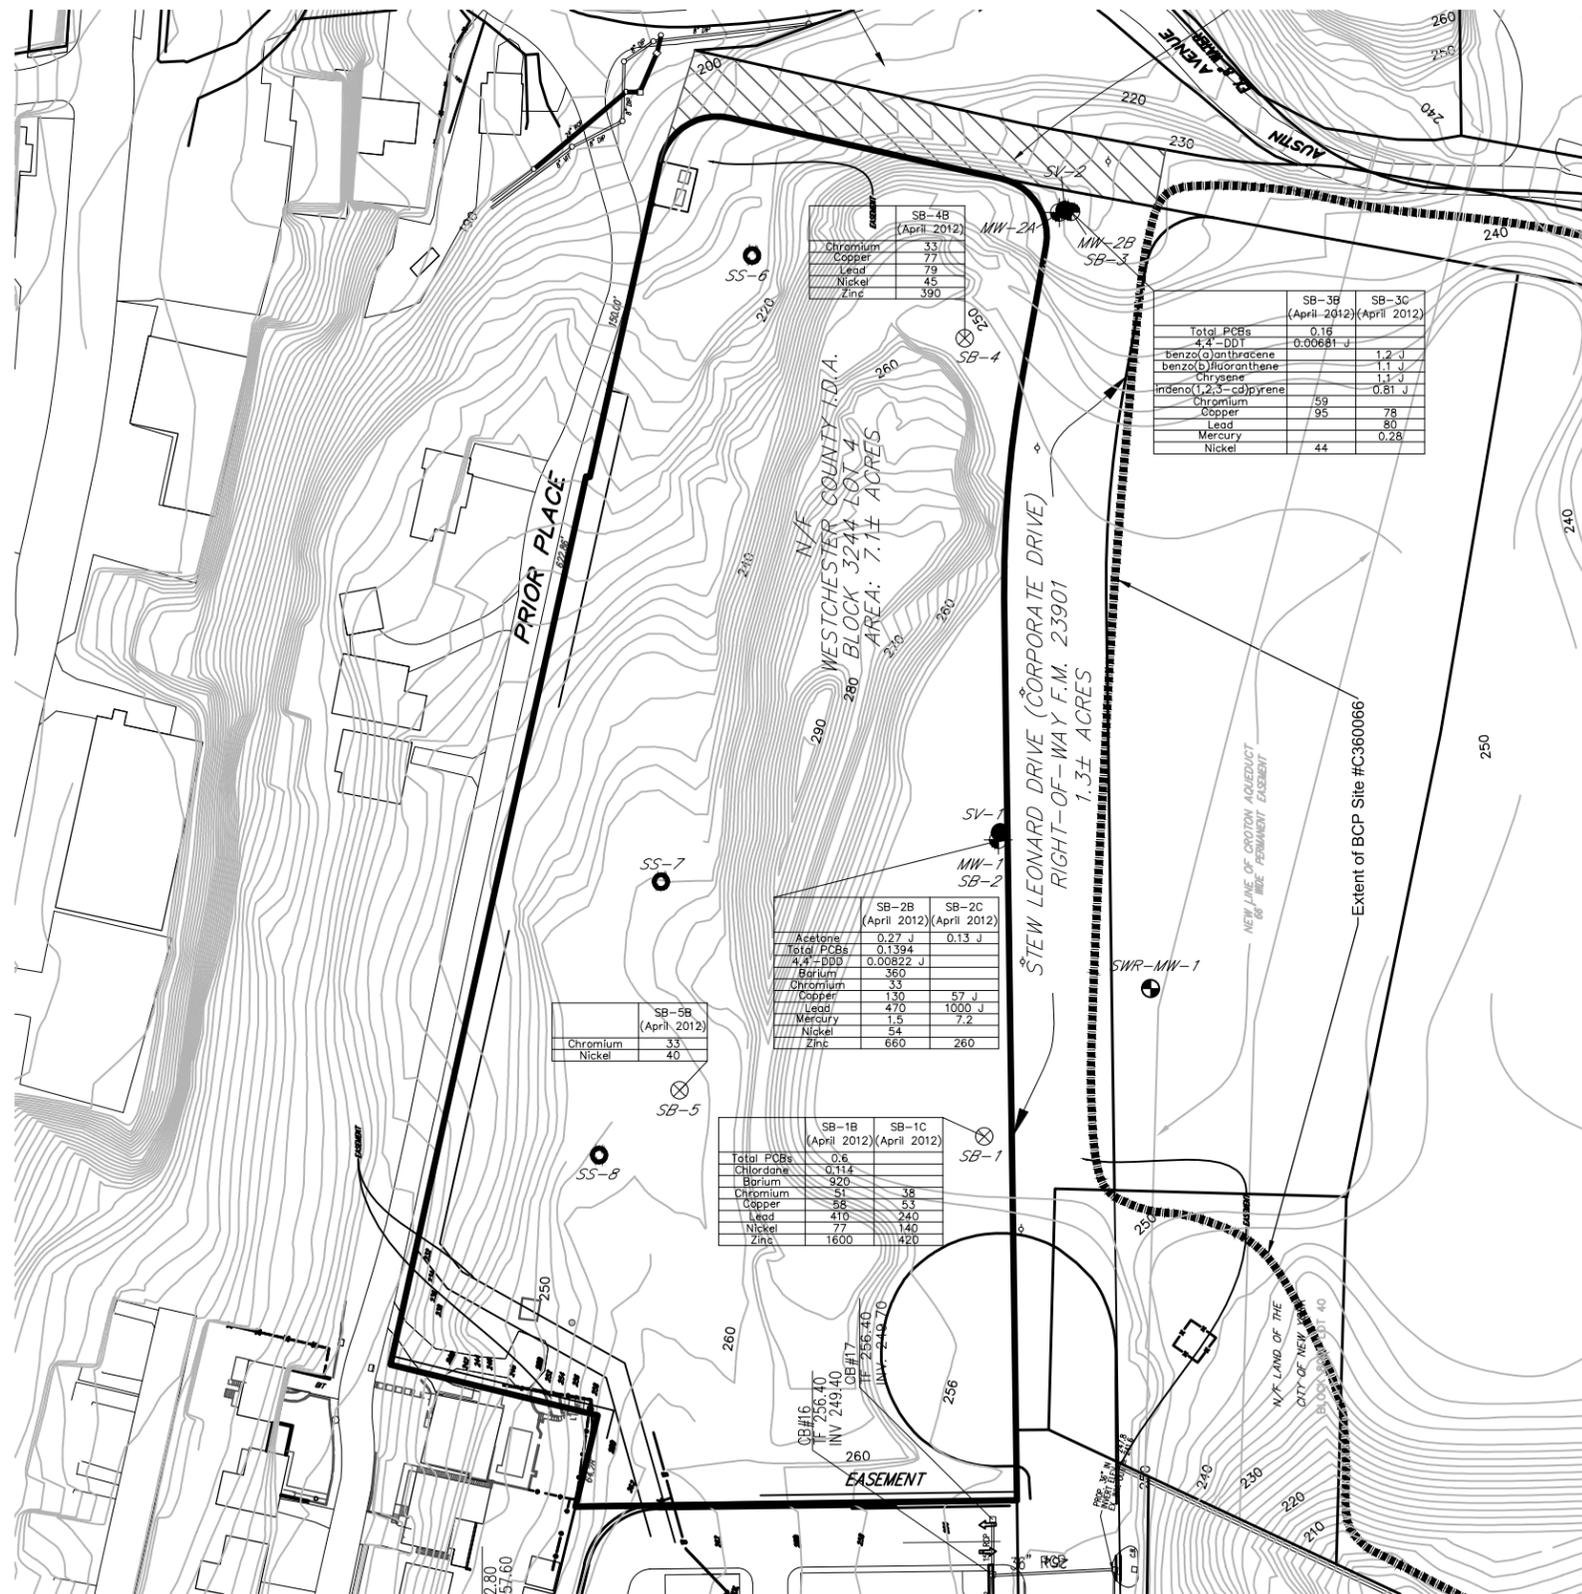
Job Number | 86-14908.00
Revision | A
Date | 05.10.12
Figure 4-3

- OVERBURDEN MONITORING WELL LOCATION AND ID
- BEDROCK MONITORING WELL LOCATION AND ID
- SURFACE SOIL SAMPLE LOCATION AND ID
- SOIL BORING SAMPLE AND SURFACE SOIL SAMPLE LOCATION AND ID
- SOIL VAPOR WELL LOCATION AND ID
- EXISTING GROUNDWATER MONITORING WELL (LOT 1)
- SURFACE CONTOURS (APPROXIMATE)
- PROPERTY BOUNDARY (APPROXIMATE)
- UTILITY POLE

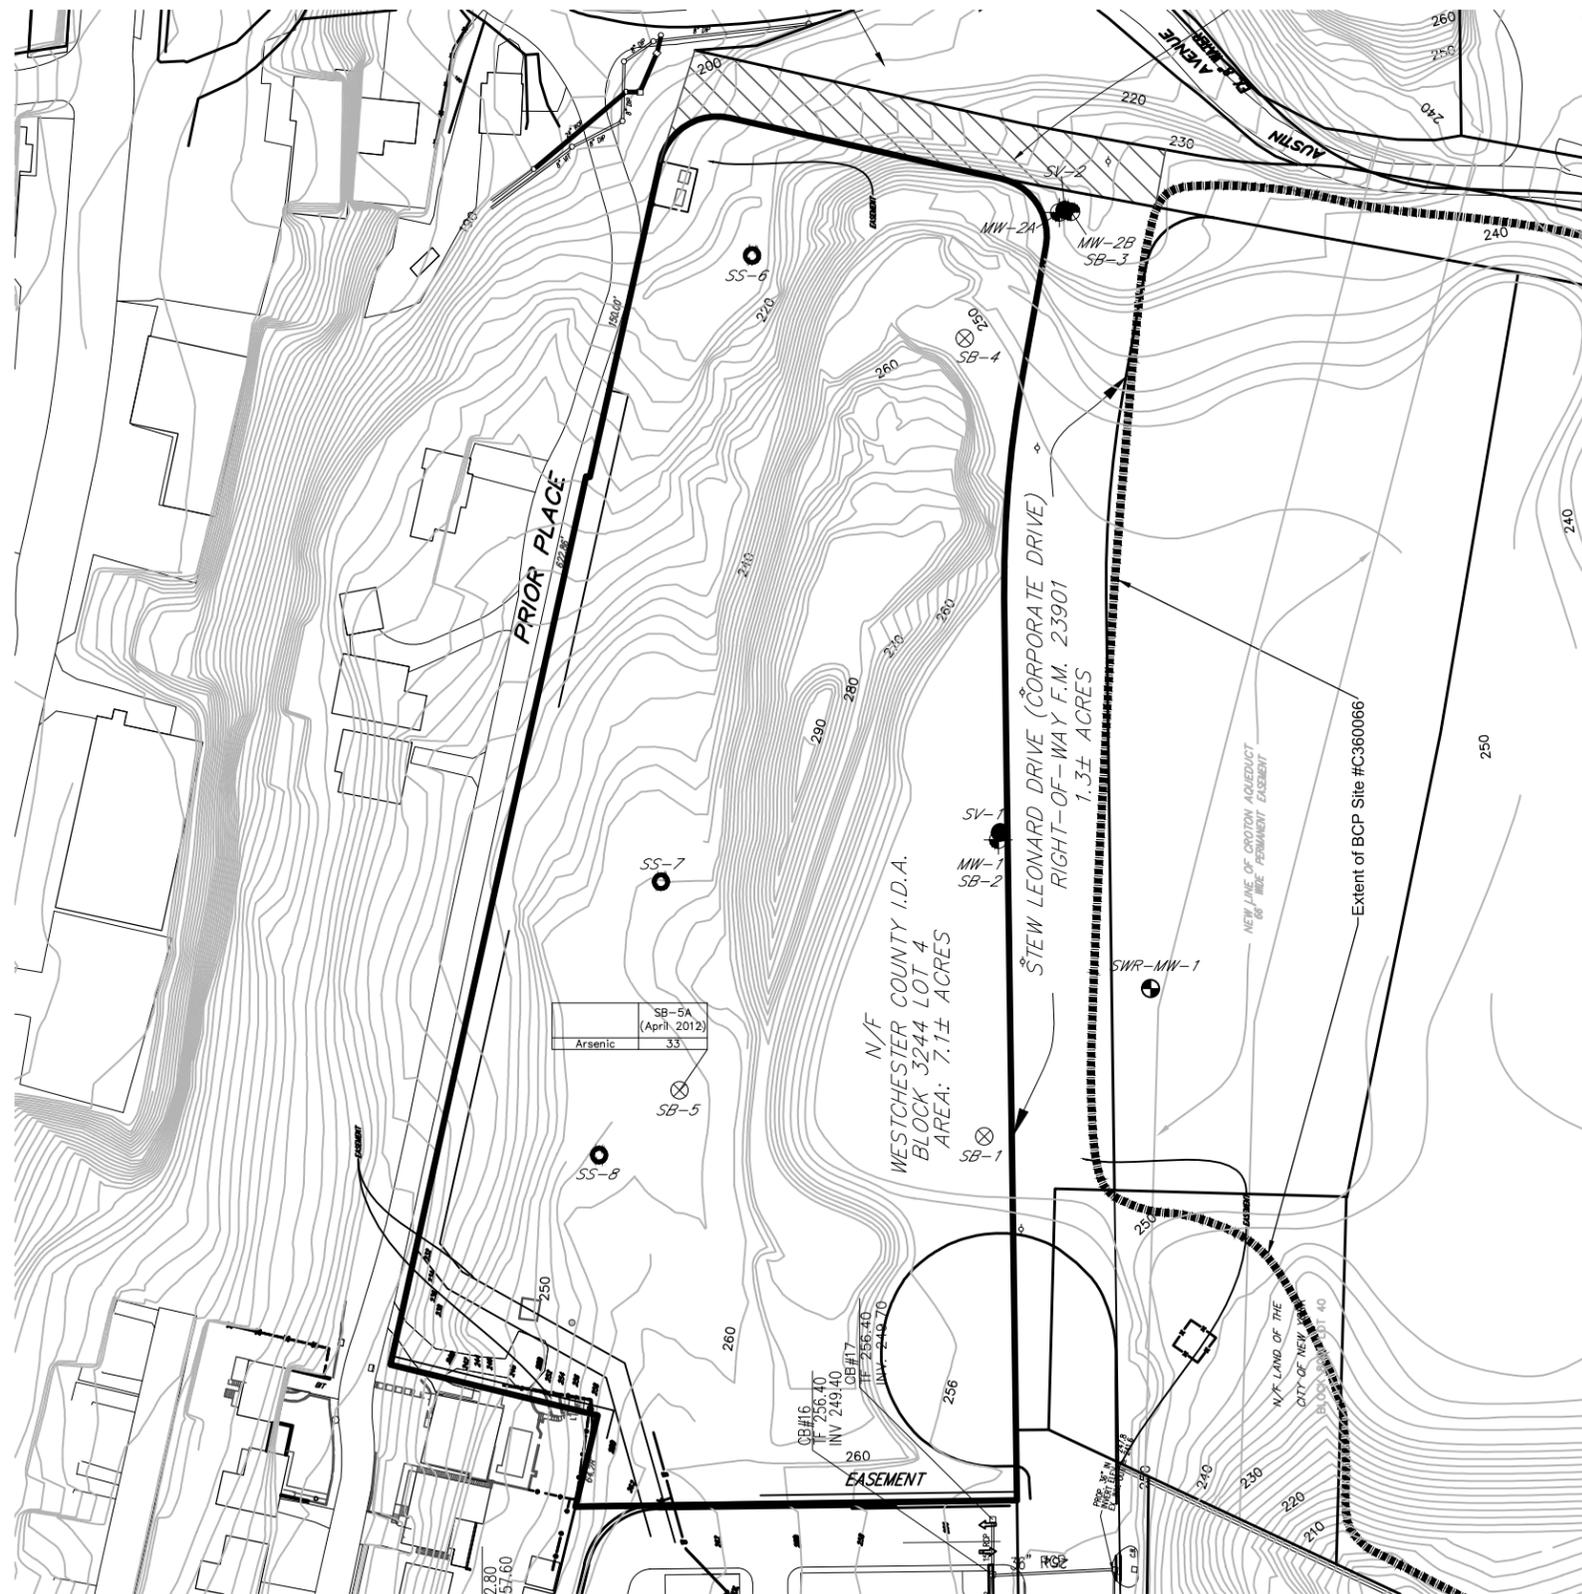
Subsurface soil samples were collected to characterize Site soil quality. Laboratory results are compared to the Commercial Use and Unrestricted Use Soil Cleanup Objectives (SCOs) in Table 4-2. Figure 4-2 depicts subsurface soil sample locations and analytes that exceed Commercial Use SCOs. Figure 4-3 depicts subsurface soil sample locations and analytes that exceed Unrestricted Use SCOs. Laboratory analytical reports for soil samples are included in Appendix D-1.

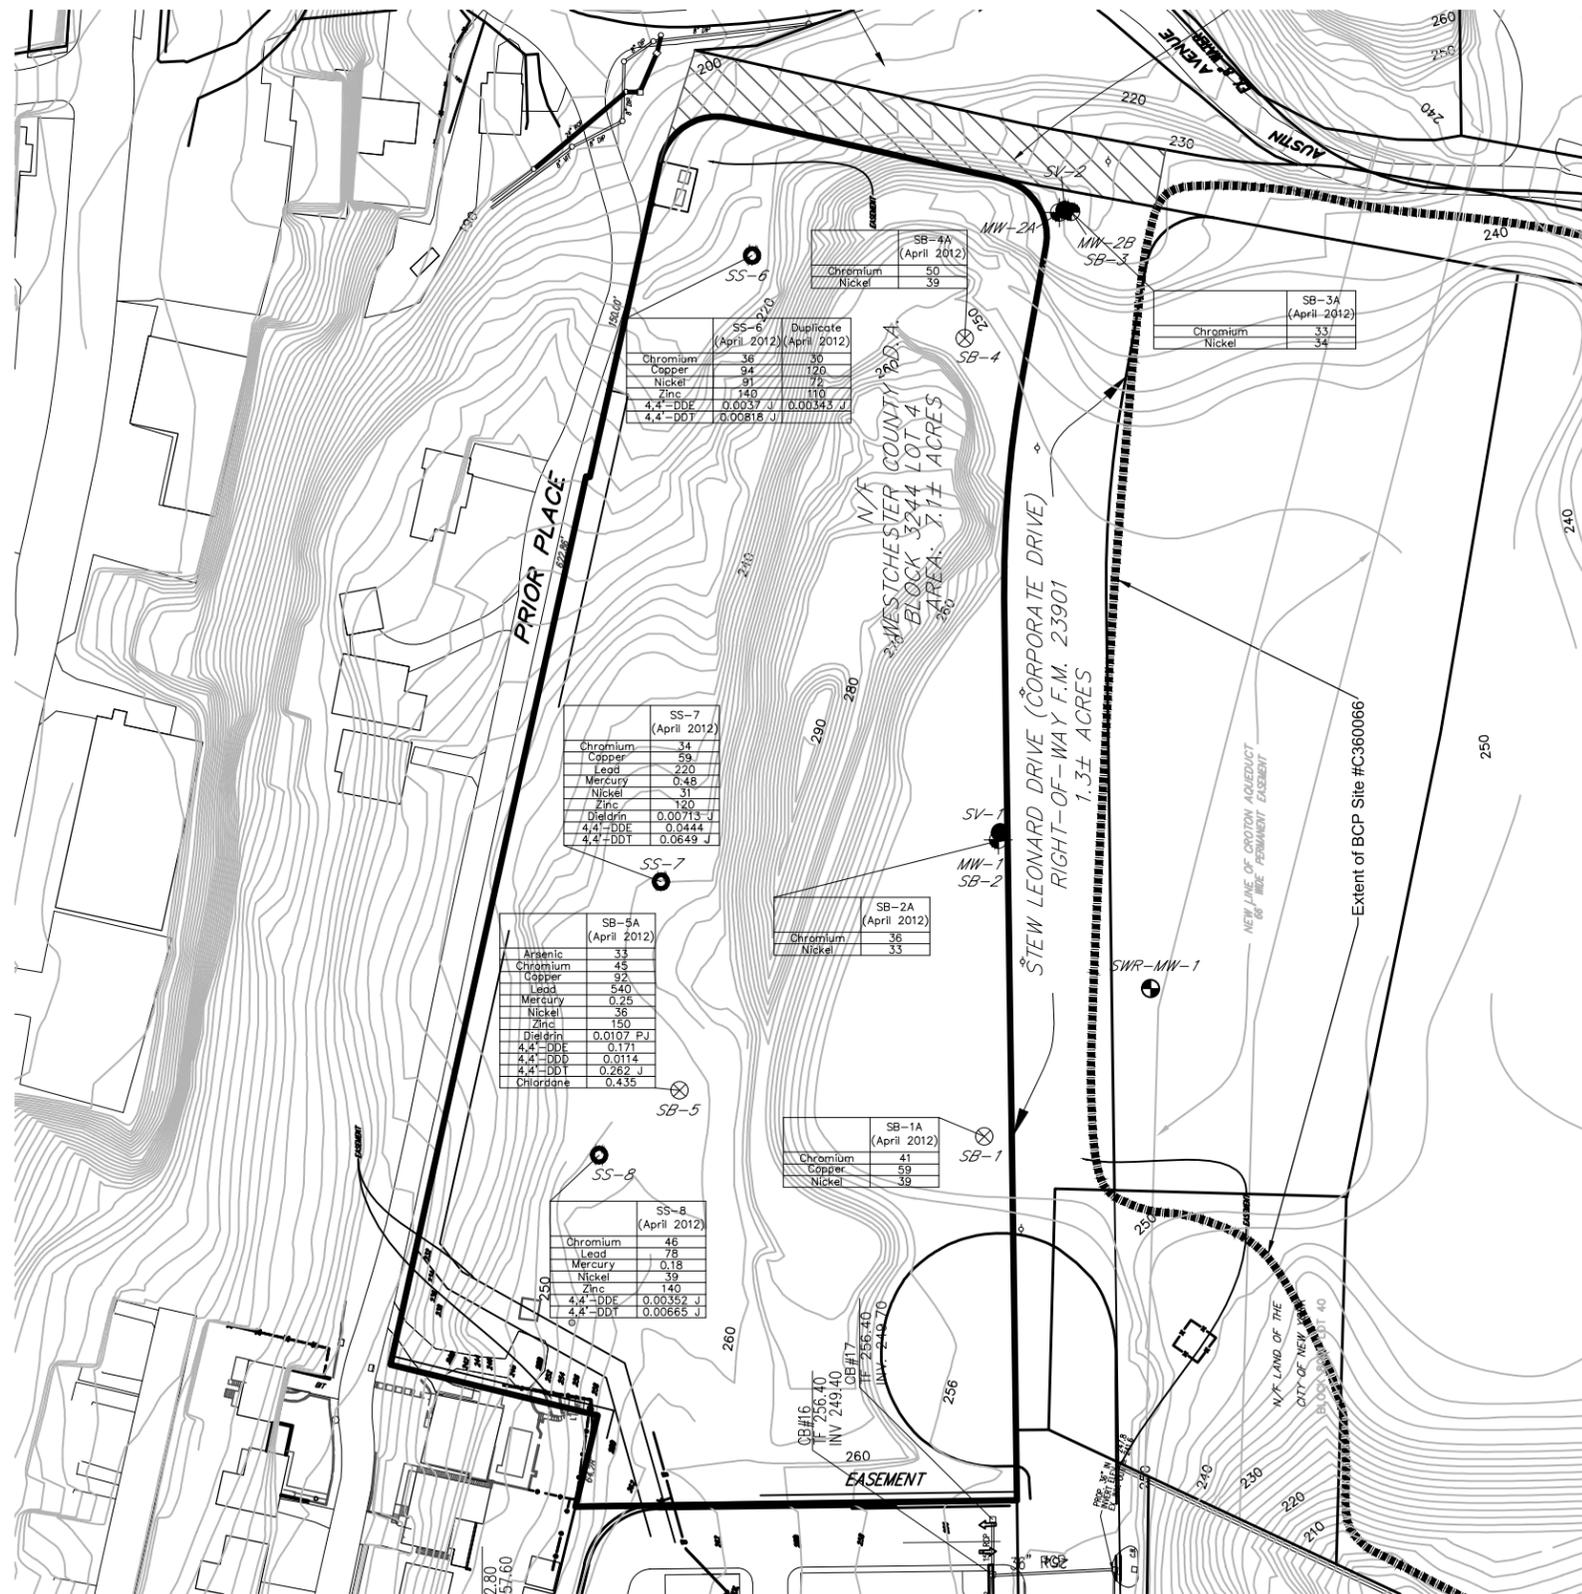
Figure 4-4

- MW-1A OVERBURDEN MONITORING WELL LOCATION AND ID
- MW-1B BEDROCK MONITORING WELL LOCATION AND ID
- SS-6 SURFACE SOIL SAMPLE LOCATION AND ID
- SB-1 SOIL BORING SAMPLE AND SURFACE SOIL SAMPLE LOCATION AND ID
- SV-1 SOIL VAPOR WELL LOCATION AND ID
- SWR-MW-1 EXISTING GROUNDWATER MONITORING WELL (LOT 1)
- 260 SURFACE CONTOURS (APPROXIMATE)
- PROPERTY BOUNDARY (APPROXIMATE)
- UTILITY POLE
