Periodic Review Report

Lot 4 – Austin Ave. and Prior Place BCP Site

BCP Site #C360116

Morris Westchester Retail
Associates, LLC

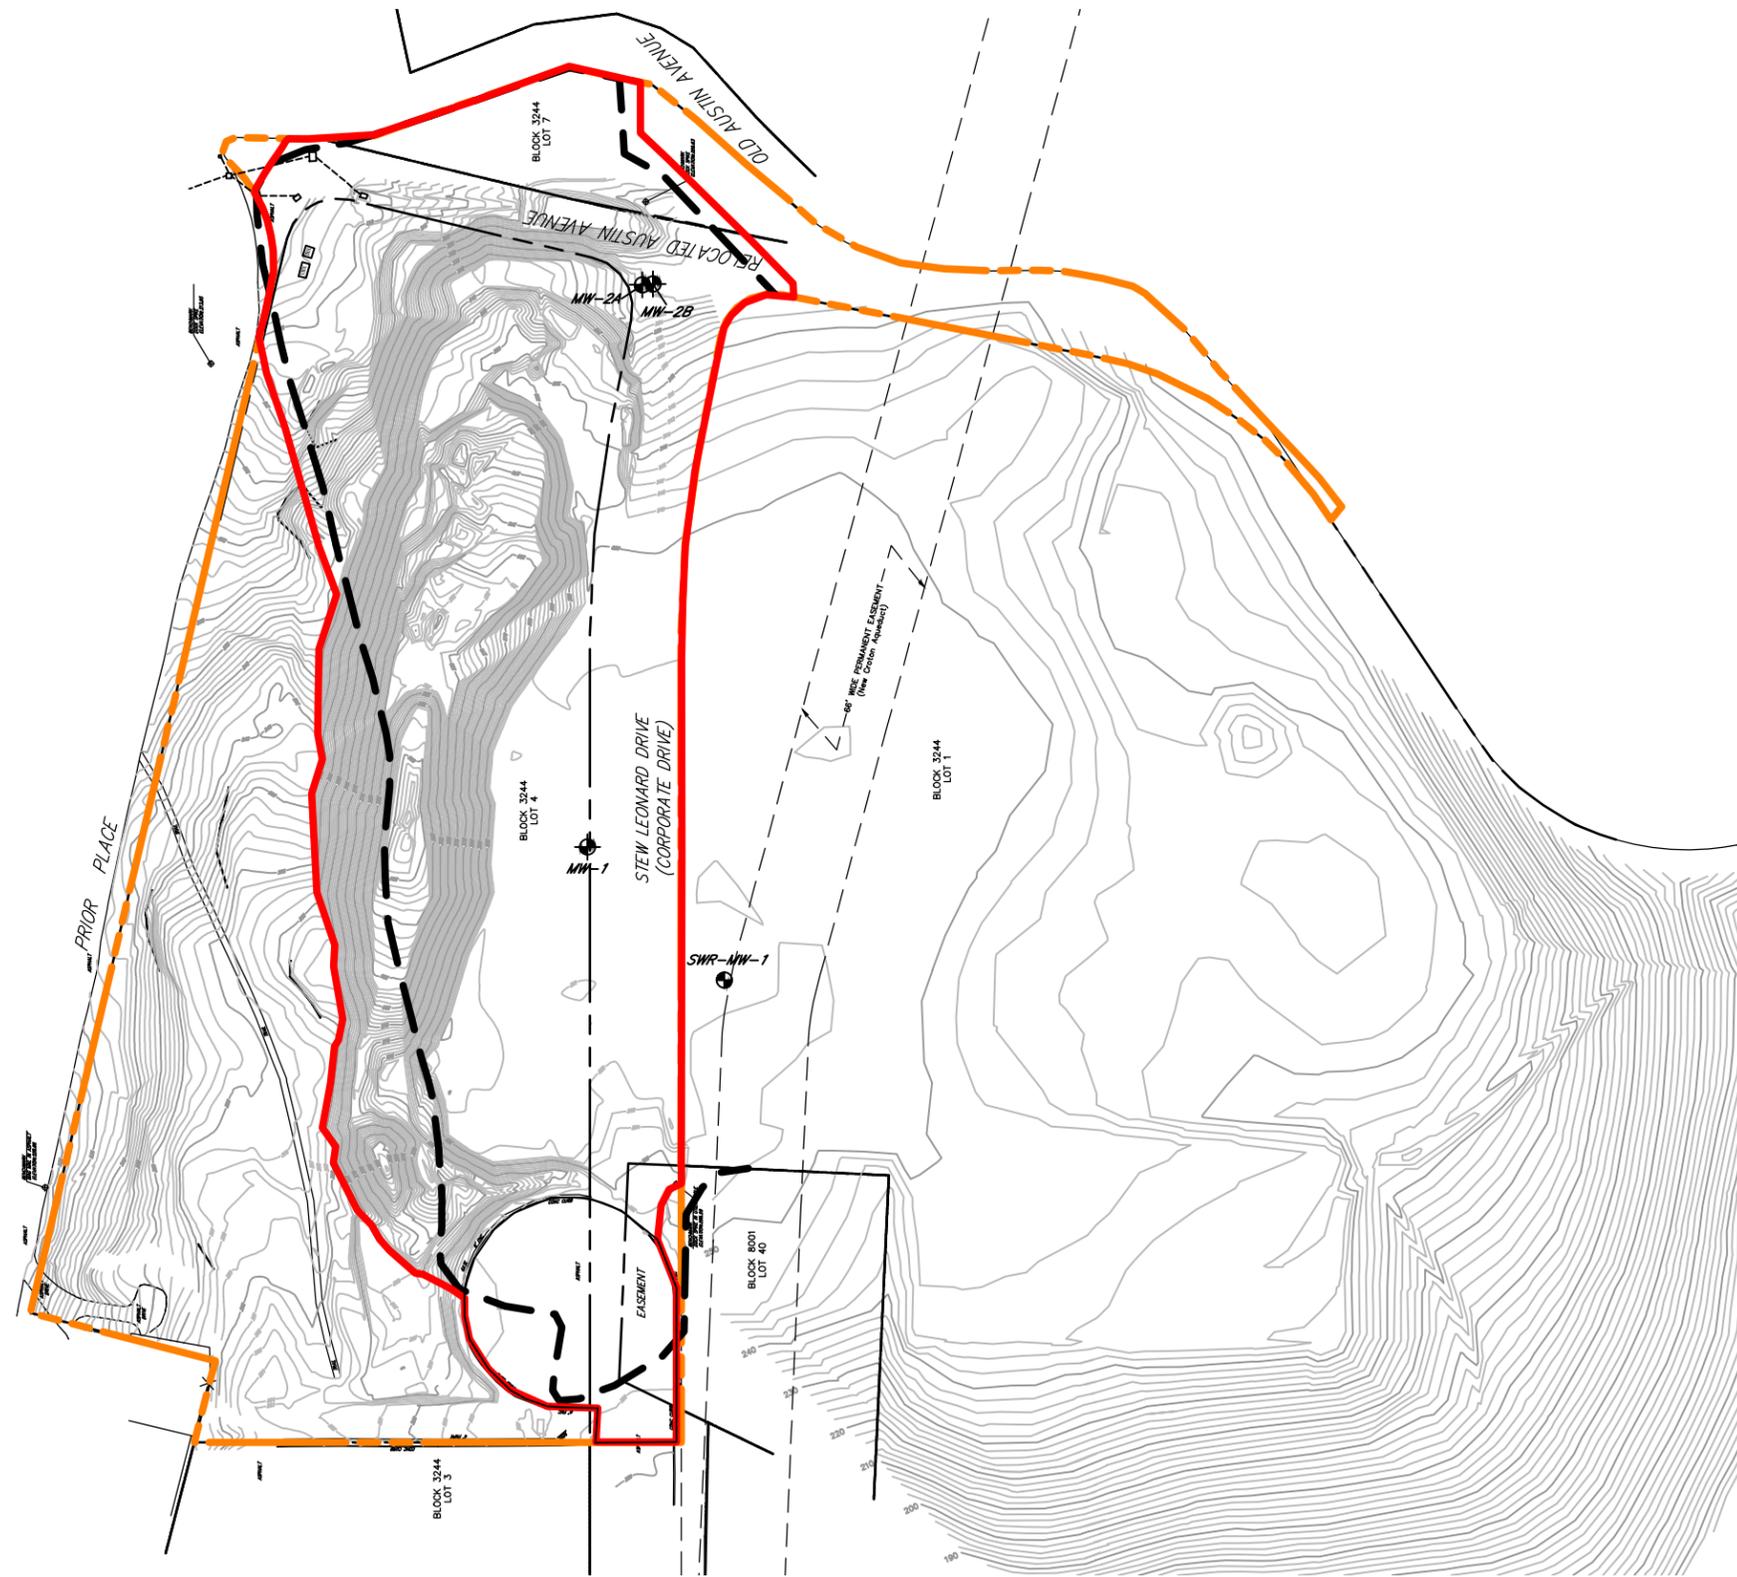
Figure 2

The Site is located in the City of Yonkers, Westchester County, New York and encompasses three (3) parcels reportedly owned/operated by Morris Westchester Retail Associates, LLC, identified as Parcel 3-3244-4, Parcel 3-3244-7, and a portion of Parcel 3-8001-40 on the NYSDEC Institutional and Engineering Controls Certification Form, and is currently undeveloped. A tax map amendment was applied for by the Site Owner in June 2016, prior to issuance of the COC, which combined the Site into a single tax parcel (3-3244-4). The Site is bound by Austin Avenue to the north, Stew Leonard's parking lot to the south, an unimproved road and similar vacant land (Lot 1 – Austin Avenue Landfill BCP Site, Site #C360006) to the east, and Prior Place to the west (Figure 2).

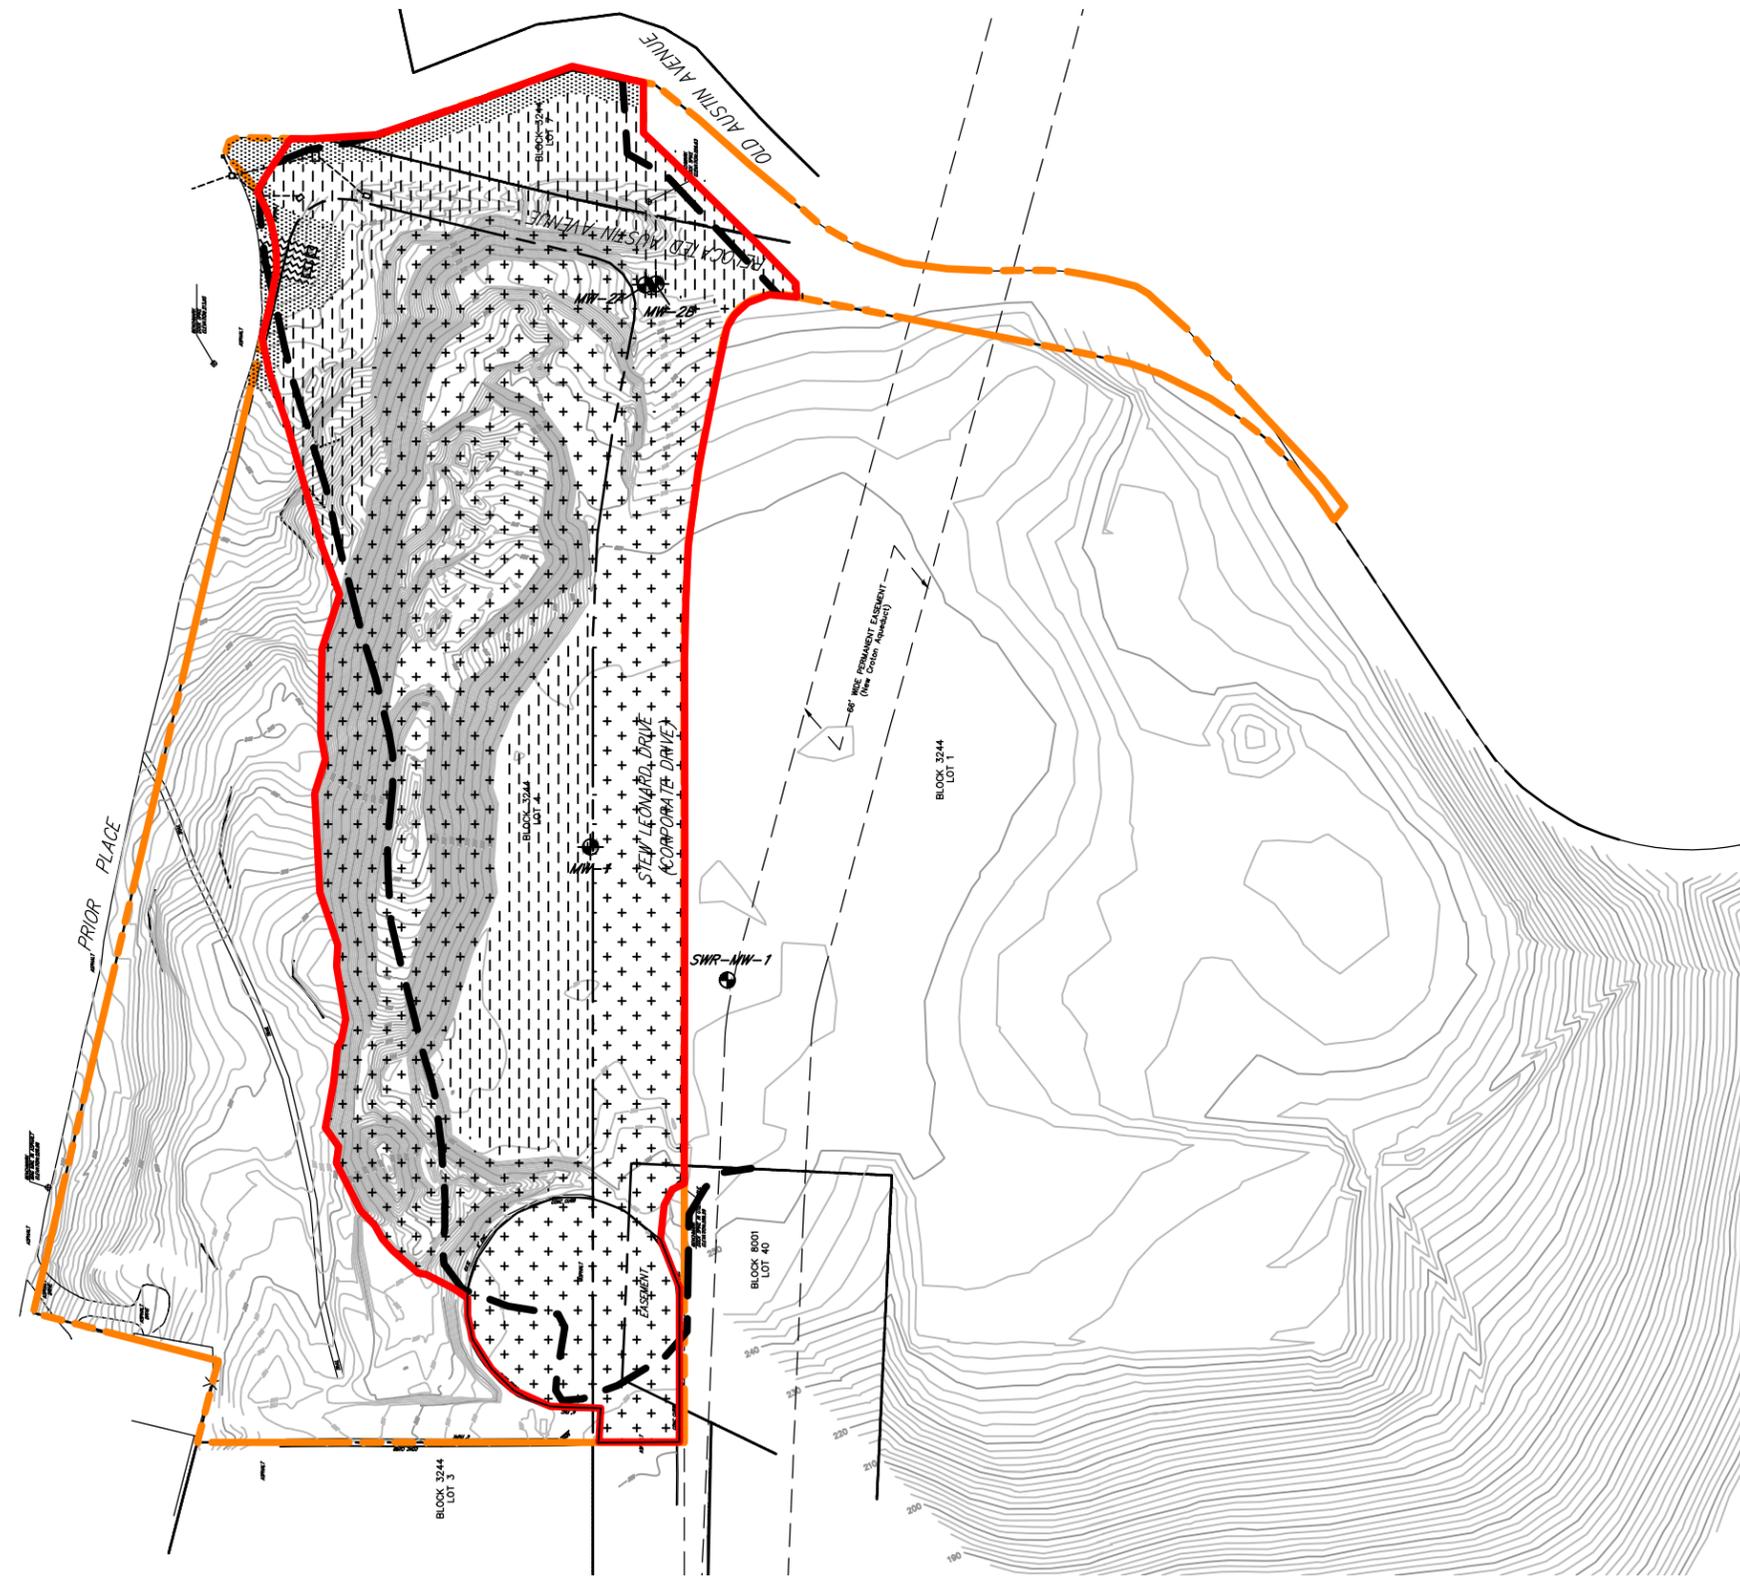
Figure 3

Direct contact with potentially contaminated soil/historic fill at the Site is mitigated by a soil cover system in place over an approximately 6.24 acre portion of the larger approximately 9.93-acre BCP Site. This soil cover system is comprised of either a minimum of 1 foot of clean fill underlain by a geotextile demarcation layer and seeded to promote vegetative growth, a minimum of 3-feet of large diameter shot rock debris, or a minimum of 6-inches of asphalt pavement. The extent of the soil cover system is depicted in Figure 3.

An annual inspection was completed on September 21, 2018 by GHD Consulting Services Inc. personnel. There was no record of the soil cover system being breached during the reporting period. Based on field observations, the soil cover system was generally unchanged for the duration of this certification period, and no maintenance was required to amend the soil cover system. The vegetative cover on-Site is well established, and no substantive erosion was observed. In general, the soil cover system should be periodically mowed to discourage woody growth.

- Mowing/brush hogging should be performed periodically to discourage woody growth on the soil cover system (excluding the shot rock pile).
- Woody vegetative growth that forms in areas of the Site soil cover system where steep slopes (excluding the large shot rock pile) preclude periodic mowing/brush hogging should be cut and removed on a periodic basis.
- Periodic trimming (i.e., annually) should also occur around the groundwater monitoring wells to provide free and easy access during future sampling events and to maintain the integrity of the monitoring points.
- The monitoring wells should be periodically inspected and maintained, including replacing locks or damaged covers. In addition, the location of the monitoring wells should be staked and flagged for ease of identification in the field.

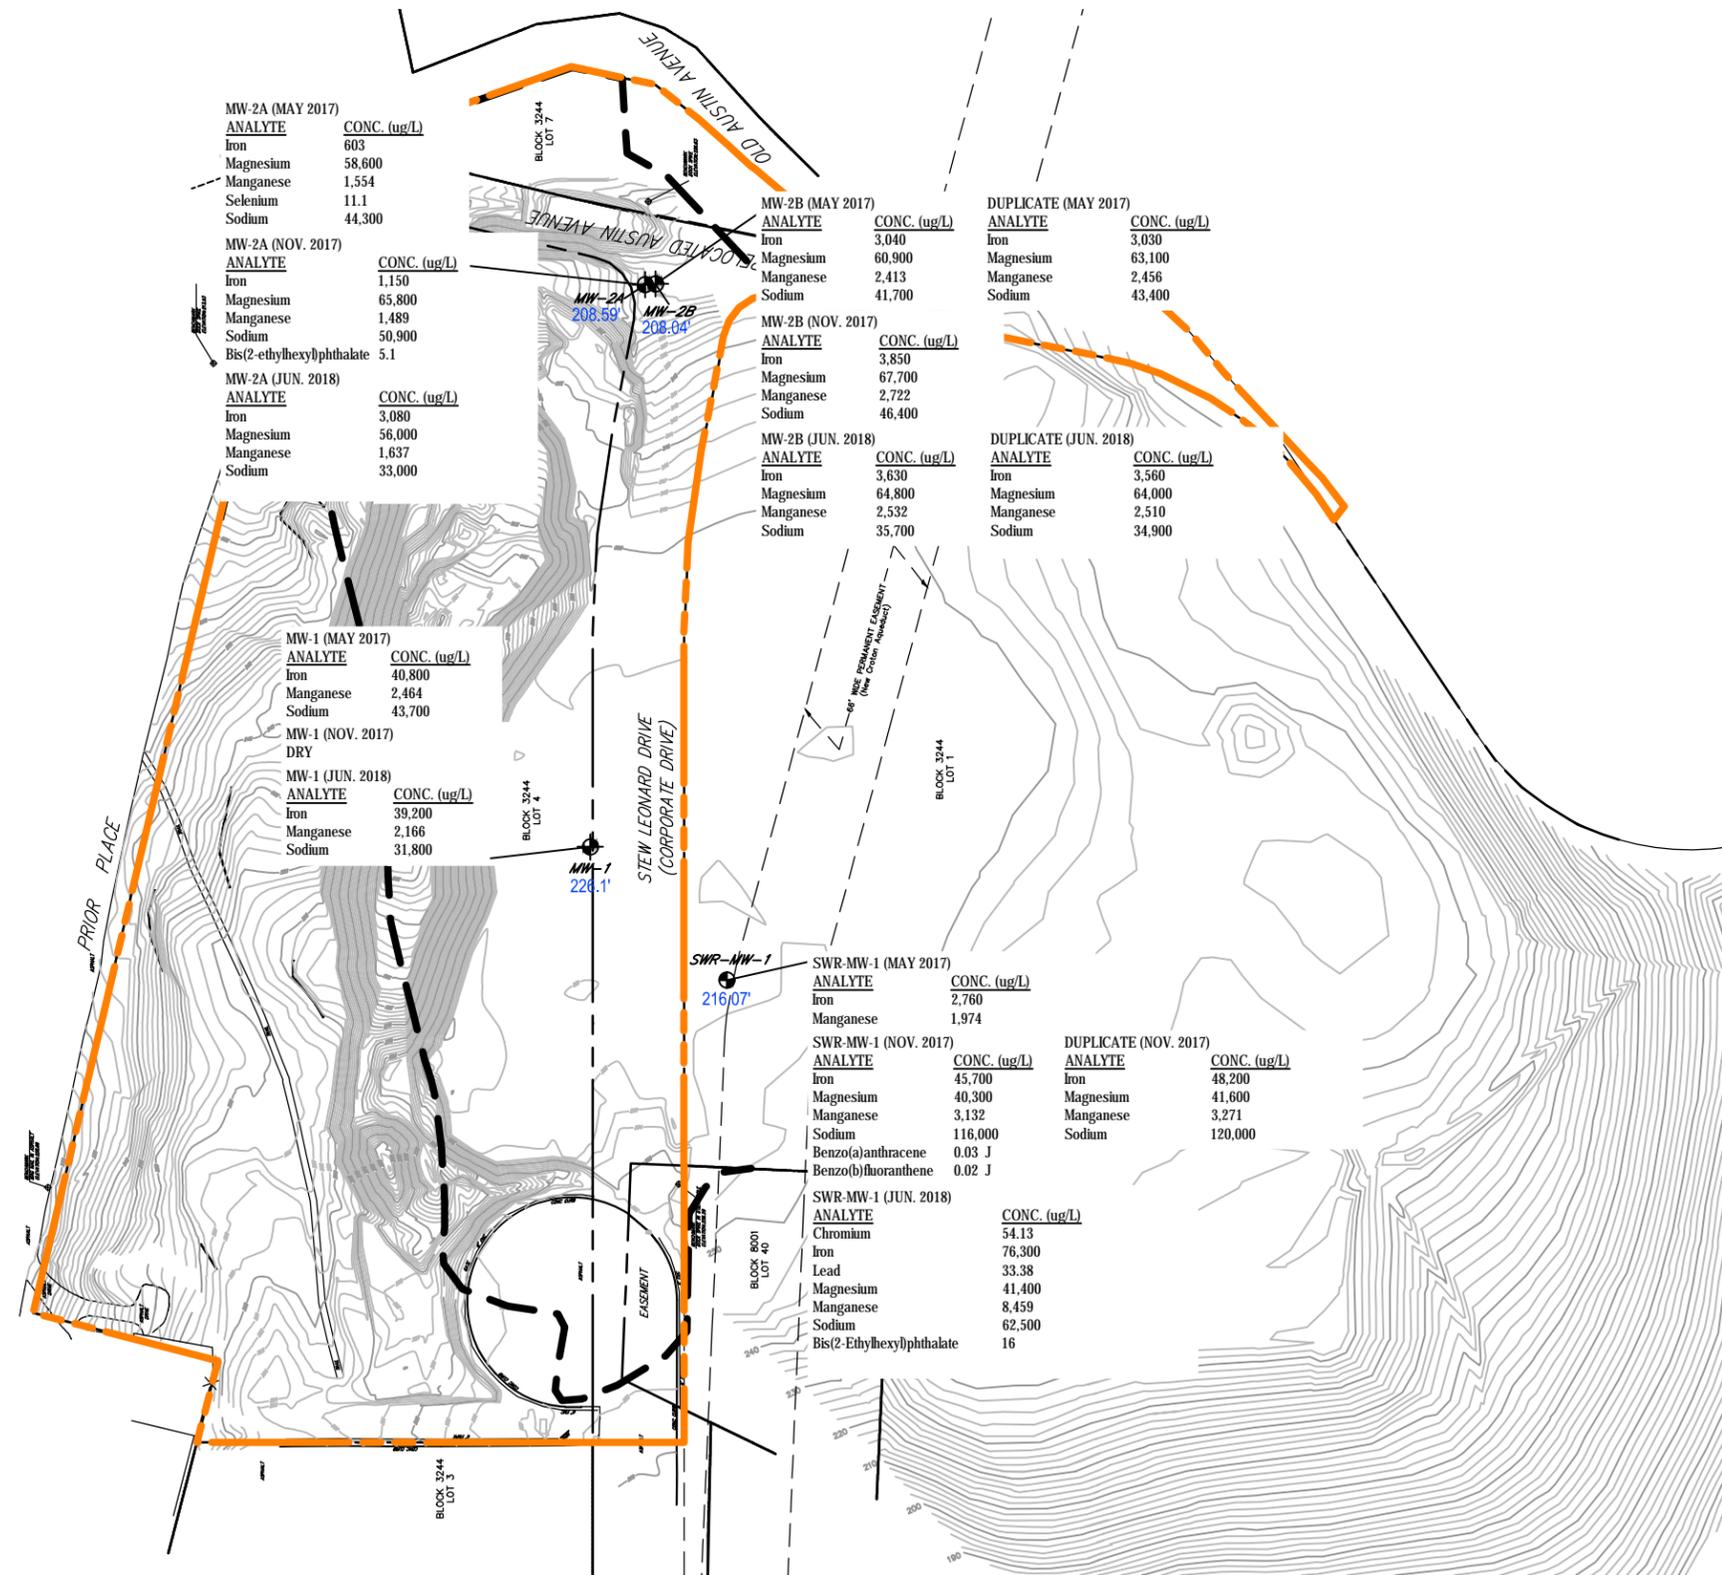
- Chromium – SWR-MW1 (June 2018)
 - Iron – MW-1 (May 2017 and June 2018), MW-2A (May 2017, November 2017, and June 2018), MW-2B (May 2017, November 2017, and June 2018), SWR-MW1 (May 2017, November 2017, and June 2018)

Identified concentrations of metals are highly variable across the Site and over-time, with the most recent round of monitoring (June 2018) generally identifying commonly occurring natural elements in excess of Class GA standards or guidance values on-Site. The exception to this is for a selenium concentration in the sample taken from MW-2A that was identified in excess of the Class GA standard during the May 2017 monitoring event. Concentrations of selenium have been identified in samples taken from MW-2A during each round of sampling; however, the May 2017 monitoring results have been the only ones to exceed Class GA standards to date.

- LOT 4 BCP SITE PROPERTY BOUNDARY (SURVEYED)
- EXTENT OF ASH (APPROXIMATE)
- GROUNDWATER MONITORING WELL LOCATION AND ID (SURVEYED)

1. ONLY ANALYTES THAT EXCEED CLASS GA GROUNDWATER STANDARDS ARE SHOWN HERE. REFER TO TABLES FOR A COMPLETE SUMMARY OF LABORATORY ANALYTICAL RESULTS.
2. LOT 1 BASE MAP FROM A FIELD SURVEY CONDUCTED BY CONTRACTORS LINE AND GRADE SOUTH, LLC, MAY 11, 2011.
3. LOT 4 BASE MAP FROM A FIELD SURVEY CONDUCTED BY JOHN MEYER CONSULTING, P.C. JUNE 30, 2011.
4. EXTENT OF ASH FROM EXISTING CONDITIONS, PLATE 1, MORRIS WESTCHESTER CONSTRUCTION COMPANY, L.L.P. HISTORIC AUSTIN AVENUE LANDFILL CLOSURE PLAN, LEGGETTE, BRASHEARS, & GRAHAM ENGINEERING SERVICES, P.C. MARCH 1988. REVISED BY S&W REDEVELOPMENT OF NORTH AMERICA, LLC, MAY 2011. FURTHER REVISED BY GHD CONSULTING ENGINEERS, LLC, DECEMBER 2012.
