Periodic Review Report

**Lot 4 – Austin Avenue and Prior Place BCP
Site (#C360116) September 27, 2020 to
September 27, 2021 Reporting Period**

Morris Westchester Retail Associates, LLC

November 11, 2021

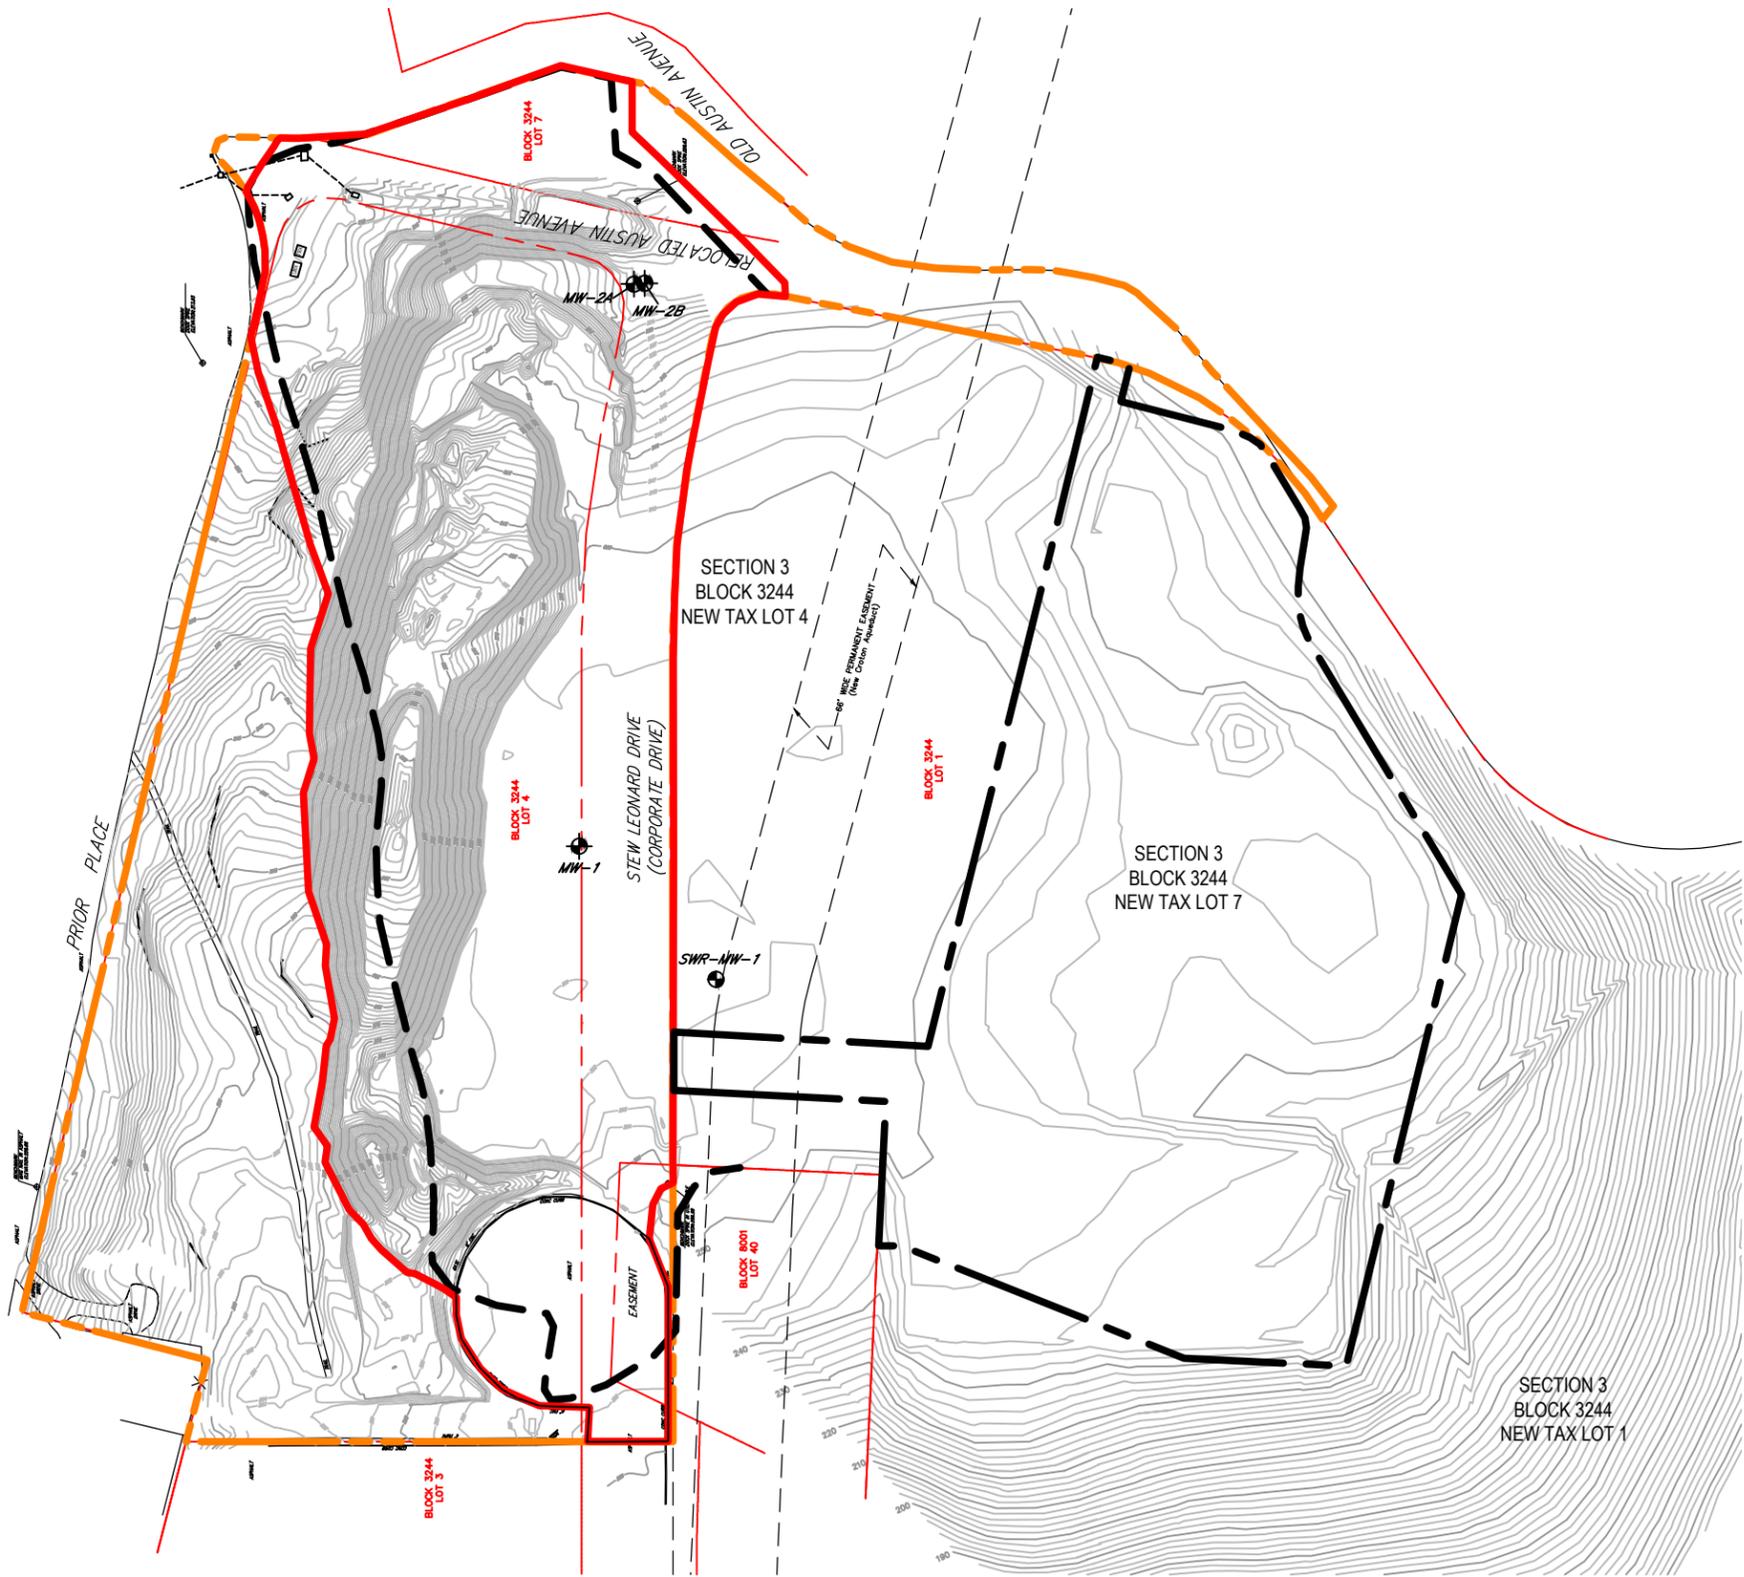
FIGURE 2

The currently undeveloped Site is located in the City of Yonkers, Westchester County, New York and, according to information included on the Certificate of Completion (COC) and the NYSDEC Institutional and Engineering Controls Certification Form, reportedly encompasses three (3) parcels reportedly owned/operated by Morris Westchester Retail Associates, LLC, identified as Parcel 3-3244-4 – 45 Stew Leonard Drive, Parcel 3-3244-7 – 65 Austin Avenue, and a portion of Parcel 3-8001-40 – 40 Stew Leonard Drive. A tax map amendment was applied for by the Site Owner in June 2016, prior to issuance of the COC, which combined the multiple tax parcels of the Site into a single tax parcel (3-3244-4) consisting of approximately 13.17-acres. The Site occupies the majority of this new tax parcel; however, approximately 3.24-acres of the new tax parcel are occupied by a portion of the adjacent Austin Avenue Landfill BCP Site (Site #C360066), which is under common ownership. The Site is bound by Austin Avenue to the north, Stew Leonard's parking lot to the south, an unimproved road and similar vacant land (Lot 1 – Austin Avenue Landfill BCP Site, Site #C360006) to the east, and Prior Place to the west (Figure 2).

SITE LAYOUT

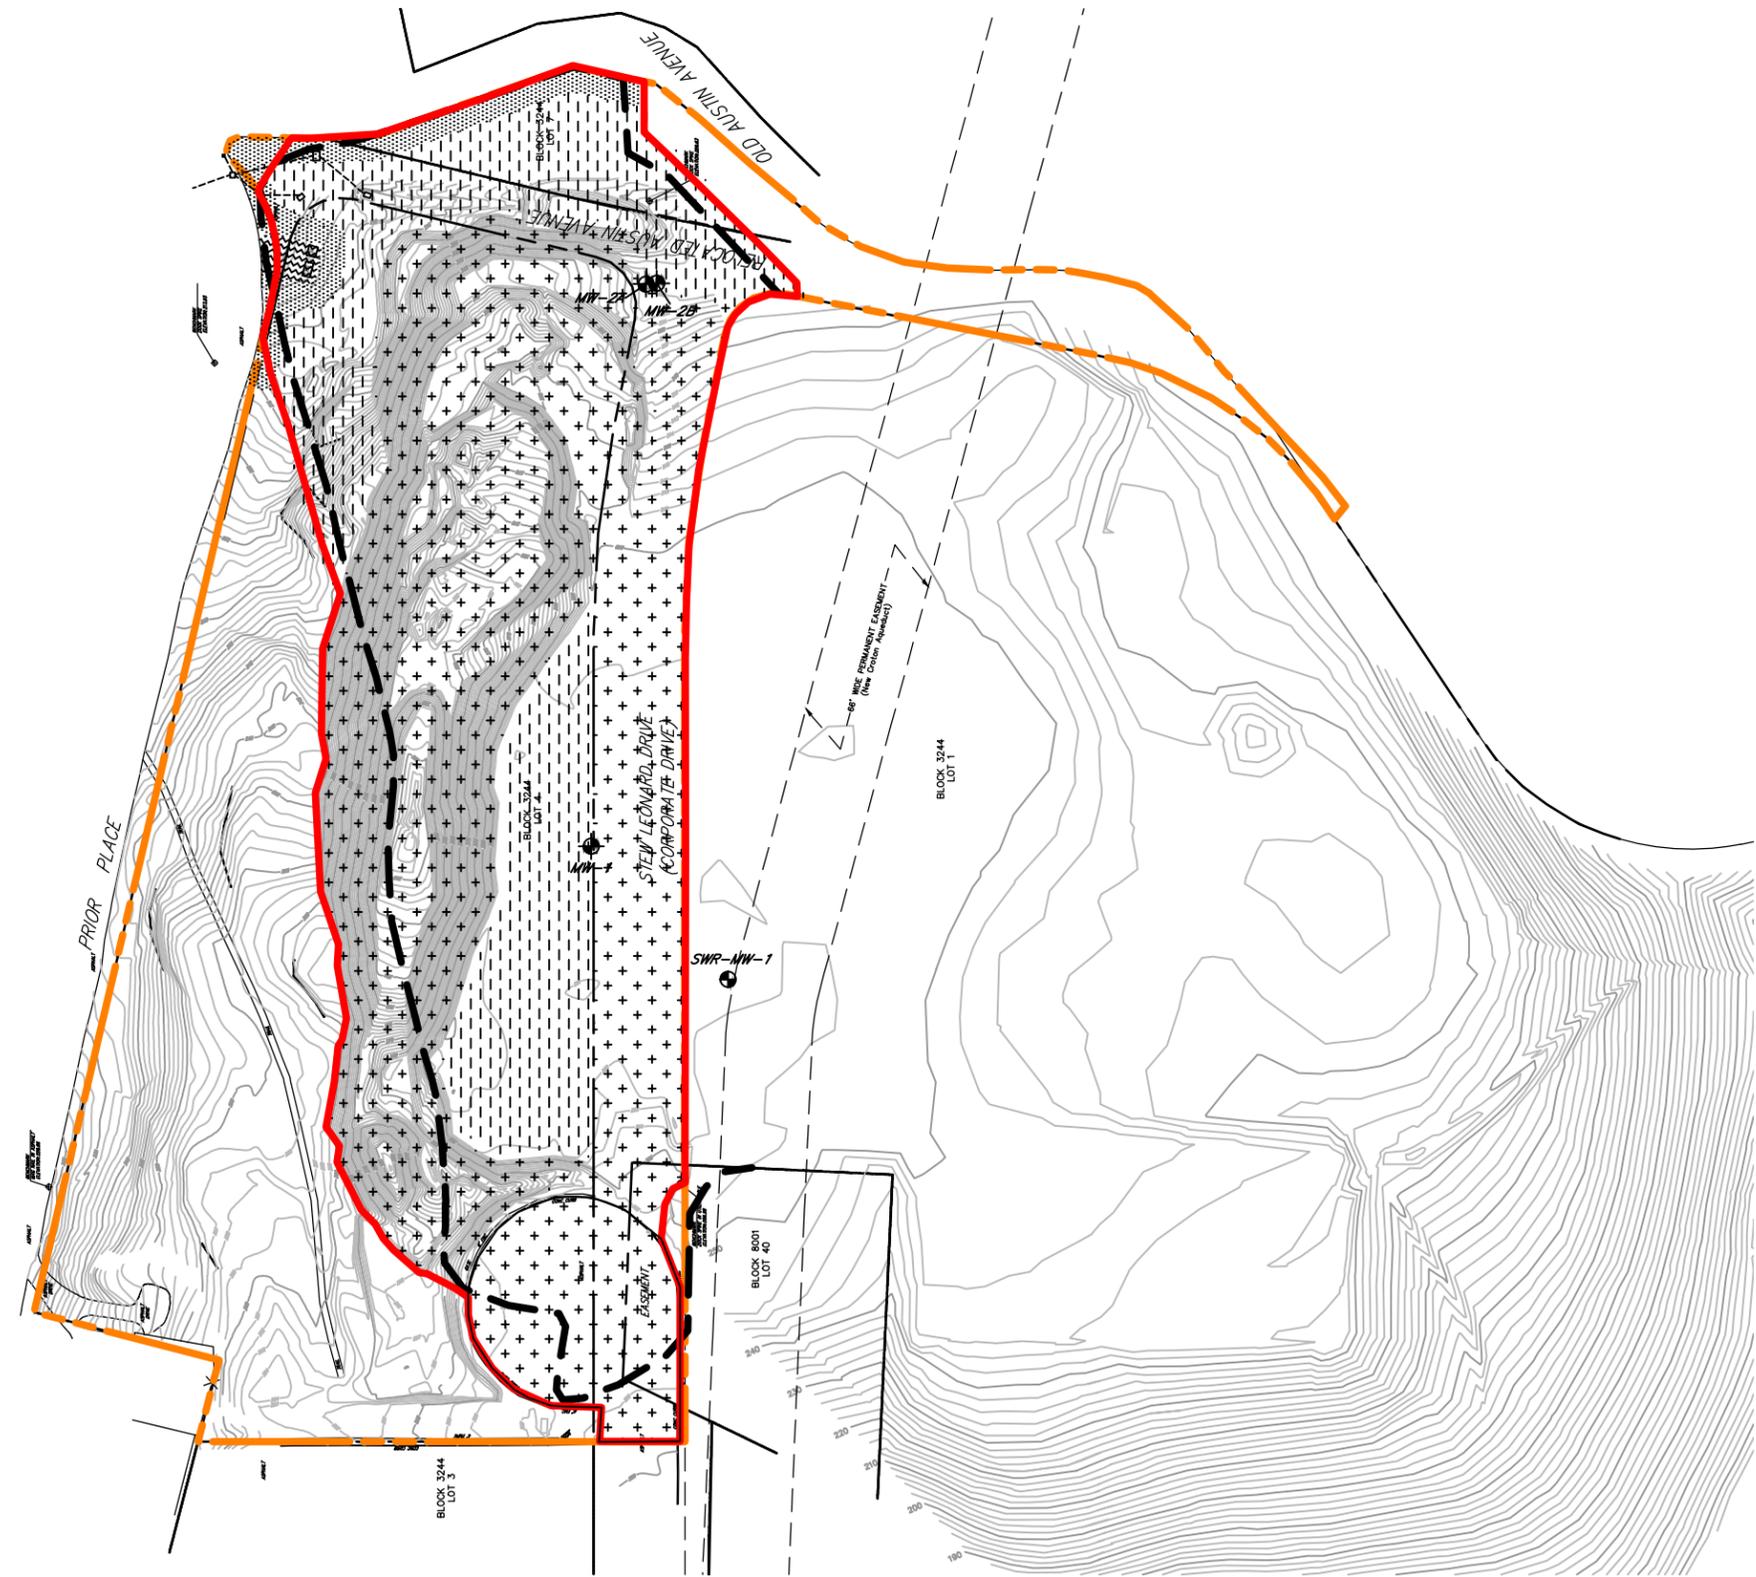
FIGURE 3

SOIL COVER AREAS

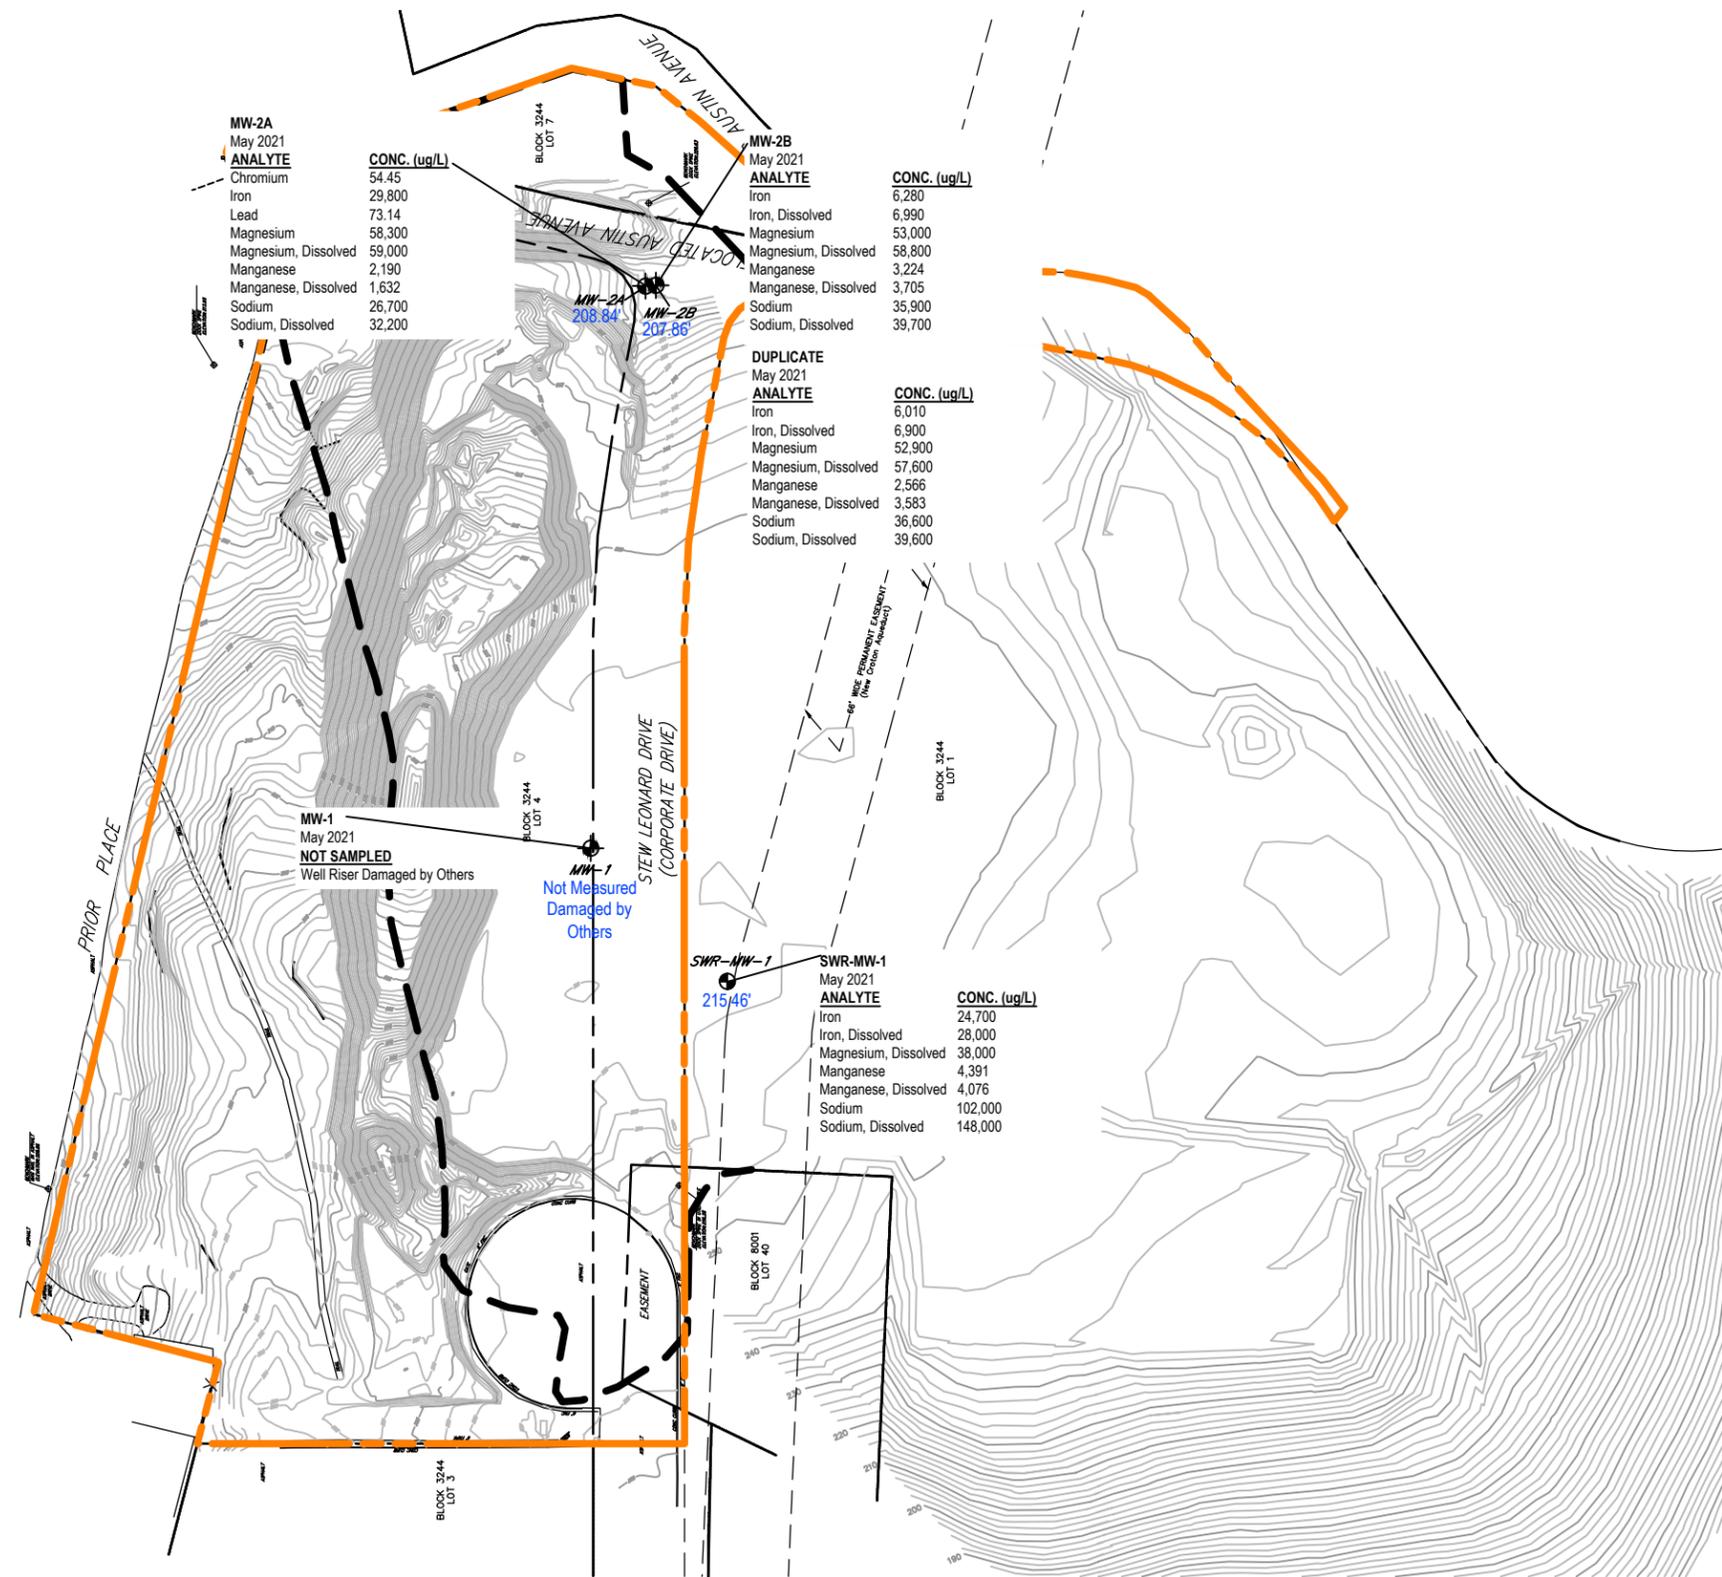
MW-2A
May 2021

ANALYTE	CONC. (ug/L)
Chromium	54.45
Iron	29,800
Lead	73.14
Magnesium	58,300
Magnesium, Dissolved	59,000
Manganese	2,190
Manganese, Dissolved	1,632
Sodium	26,700
Sodium, Dissolved	32,200

1. ONLY ANALYTES THAT EXCEED CLASS GA GROUNDWATER STANDARDS ARE SHOWN HERE. REFER TO TABLES FOR A COMPLETE SUMMARY OF LABORATORY ANALYTICAL RESULTS.
2. LOT 1 BASE MAP FROM A FIELD SURVEY CONDUCTED BY CONTRACTORS LINE AND GRADE SOUTH, LLC, MAY 11, 2011.
3. LOT 4 BASE MAP FROM A FIELD SURVEY CONDUCTED BY JOHN MEYER CONSULTING, P.C. JUNE 30, 2011.
4. EXTENT OF ASH FROM EXISTING CONDITIONS, PLATE 1, MORRIS WESTCHESTER CONSTRUCTION COMPANY, L.L.P. HISTORIC AUSTIN AVENUE LANDFILL CLOSURE PLAN, LEGGETTE, BRASHEARS, & GRAHAM ENGINEERING SERVICES, P.C. MARCH 1988. REVISED BY S&W REDEVELOPMENT OF NORTH AMERICA, LLC, MAY 2011. FURTHER REVISED BY GHD CONSULTING ENGINEERS, LLC, DECEMBER 2012.

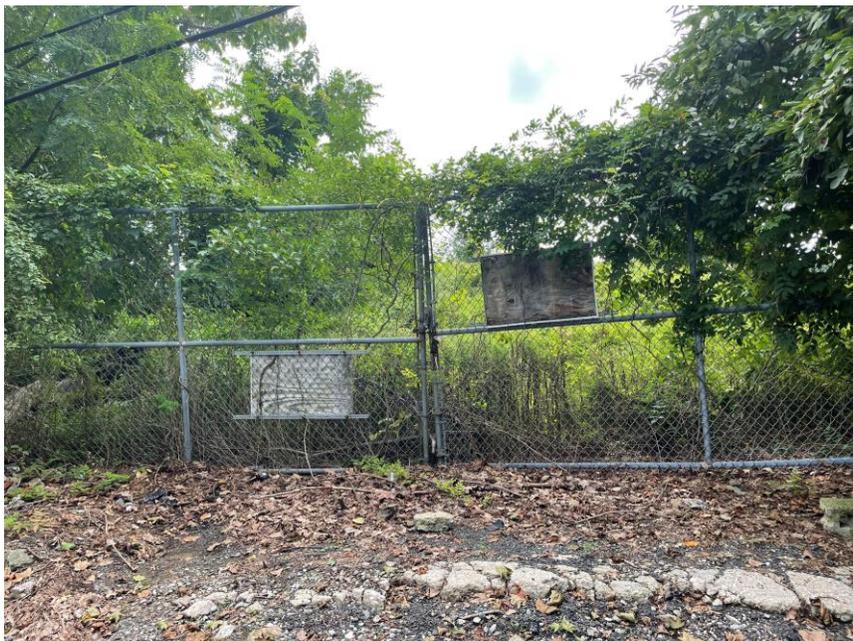
Photo 4 View of locked Austin Avenue gate.

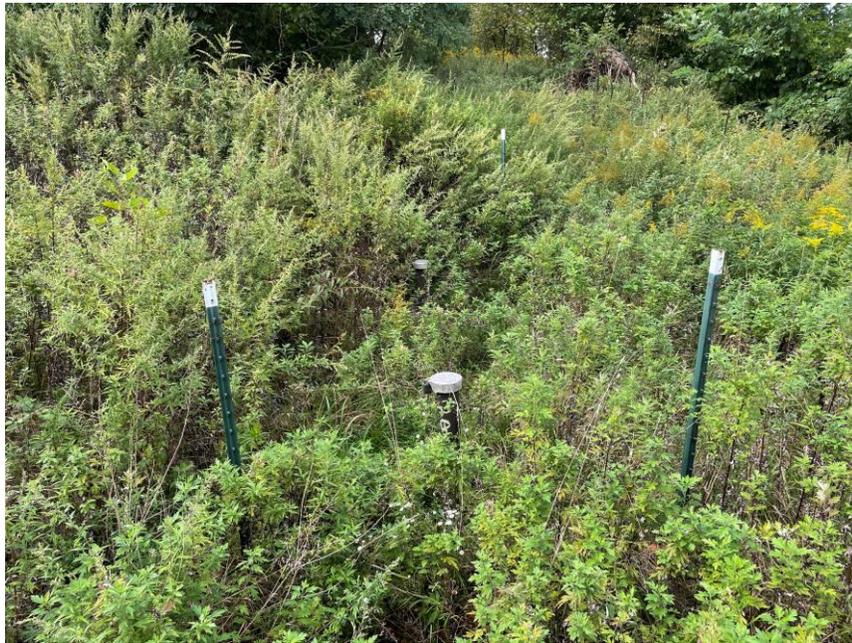
Condition of Monitoring Wells	<u>Lot 4 Monitoring wells MW-2A and MW-2B were intact, covered and locked - MW-1 steel casing and riser was knocked over and crushed (see photo log)</u>
Well Caps In Place	<u>Yes</u>
Locks In Place and Secure	<u>Yes</u>

Photo 5 Typical Site groundwater monitoring wells.

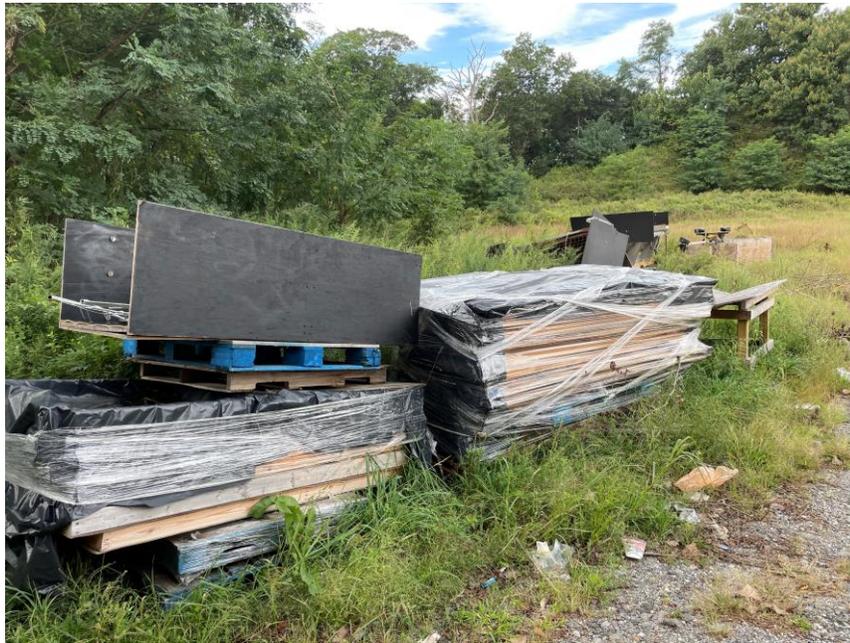
Site Access Control	<u>Access gate at Stew Leonard Drive open. Access at Austin Ave. locked</u>
Change in Use	<u>None. Stew Leonards still uses access road at entrance for equipment staging</u>
Unauthorized Activities	<u>Two plastic ~5 gallon containers found on-site (see below comments)</u>
	<u>Appears that a mowed path from Prior Place has been created and grass mowed along access way towards MW-2A/MW-2B</u>

Photo 7 Typical material staging from adjacent business near Stew Leonard Drive entrance.

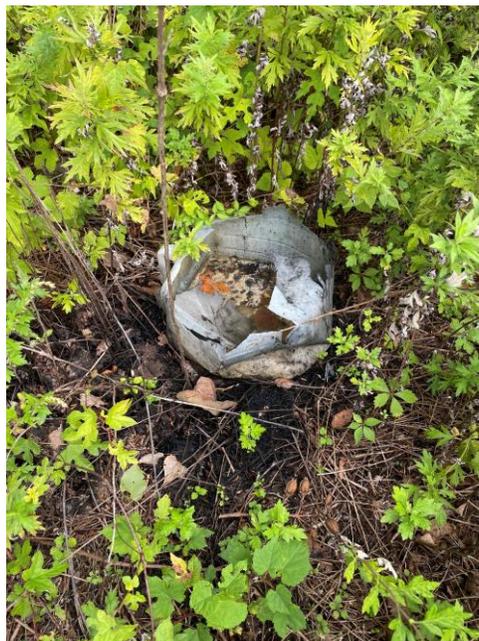
During the annual inspection it was noted that two plastic 5-gallon containers were left on the Site from unknown sources, one near the Stew Leonard Drive containing what appeared to be residual paint and one near the Austin Avenue gate containing what appeared to be a petroleum product. These containers should be removed and properly disposed of off-site.

Found one 5-gallon plastic bucket with residual paint along access road north of MW-1. Second 5 gallon plastic container appeared to have petroleum located in proximity to the Austin Ave gate
Power line was down at Austin Ave - Prior Place intersection. Road closed and access gate at Sprain Rd. open for traffic
Cable/Phone vault on Prior Place open and unlocked

Photo 8 Remnants of 5-gallon bucket containing apparent petroleum product near Austin Avenue gate.

- The two plastic 5-gallon containers observed near the entrance at Stew Leonard Drive and the gate at Austin Avenue should be removed and properly disposed of off-Site.

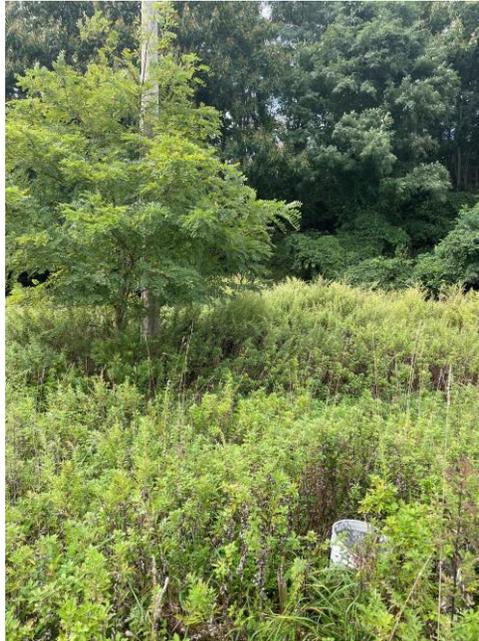
Photo 9 *5-gallon bucket with residual paint near Site entrance from Stew Leonard Drive.*
