Final Engineering Report
Ardsley LLC
Westchester County, New York
Town of Greenburgh, New York
NYSDEC Site No. C360146

May 2024

Project Number: 153292

Brown and Caldwell Associates
500 North Franklin Turnpike, Suite 314
Ramsey, New Jersey 07446

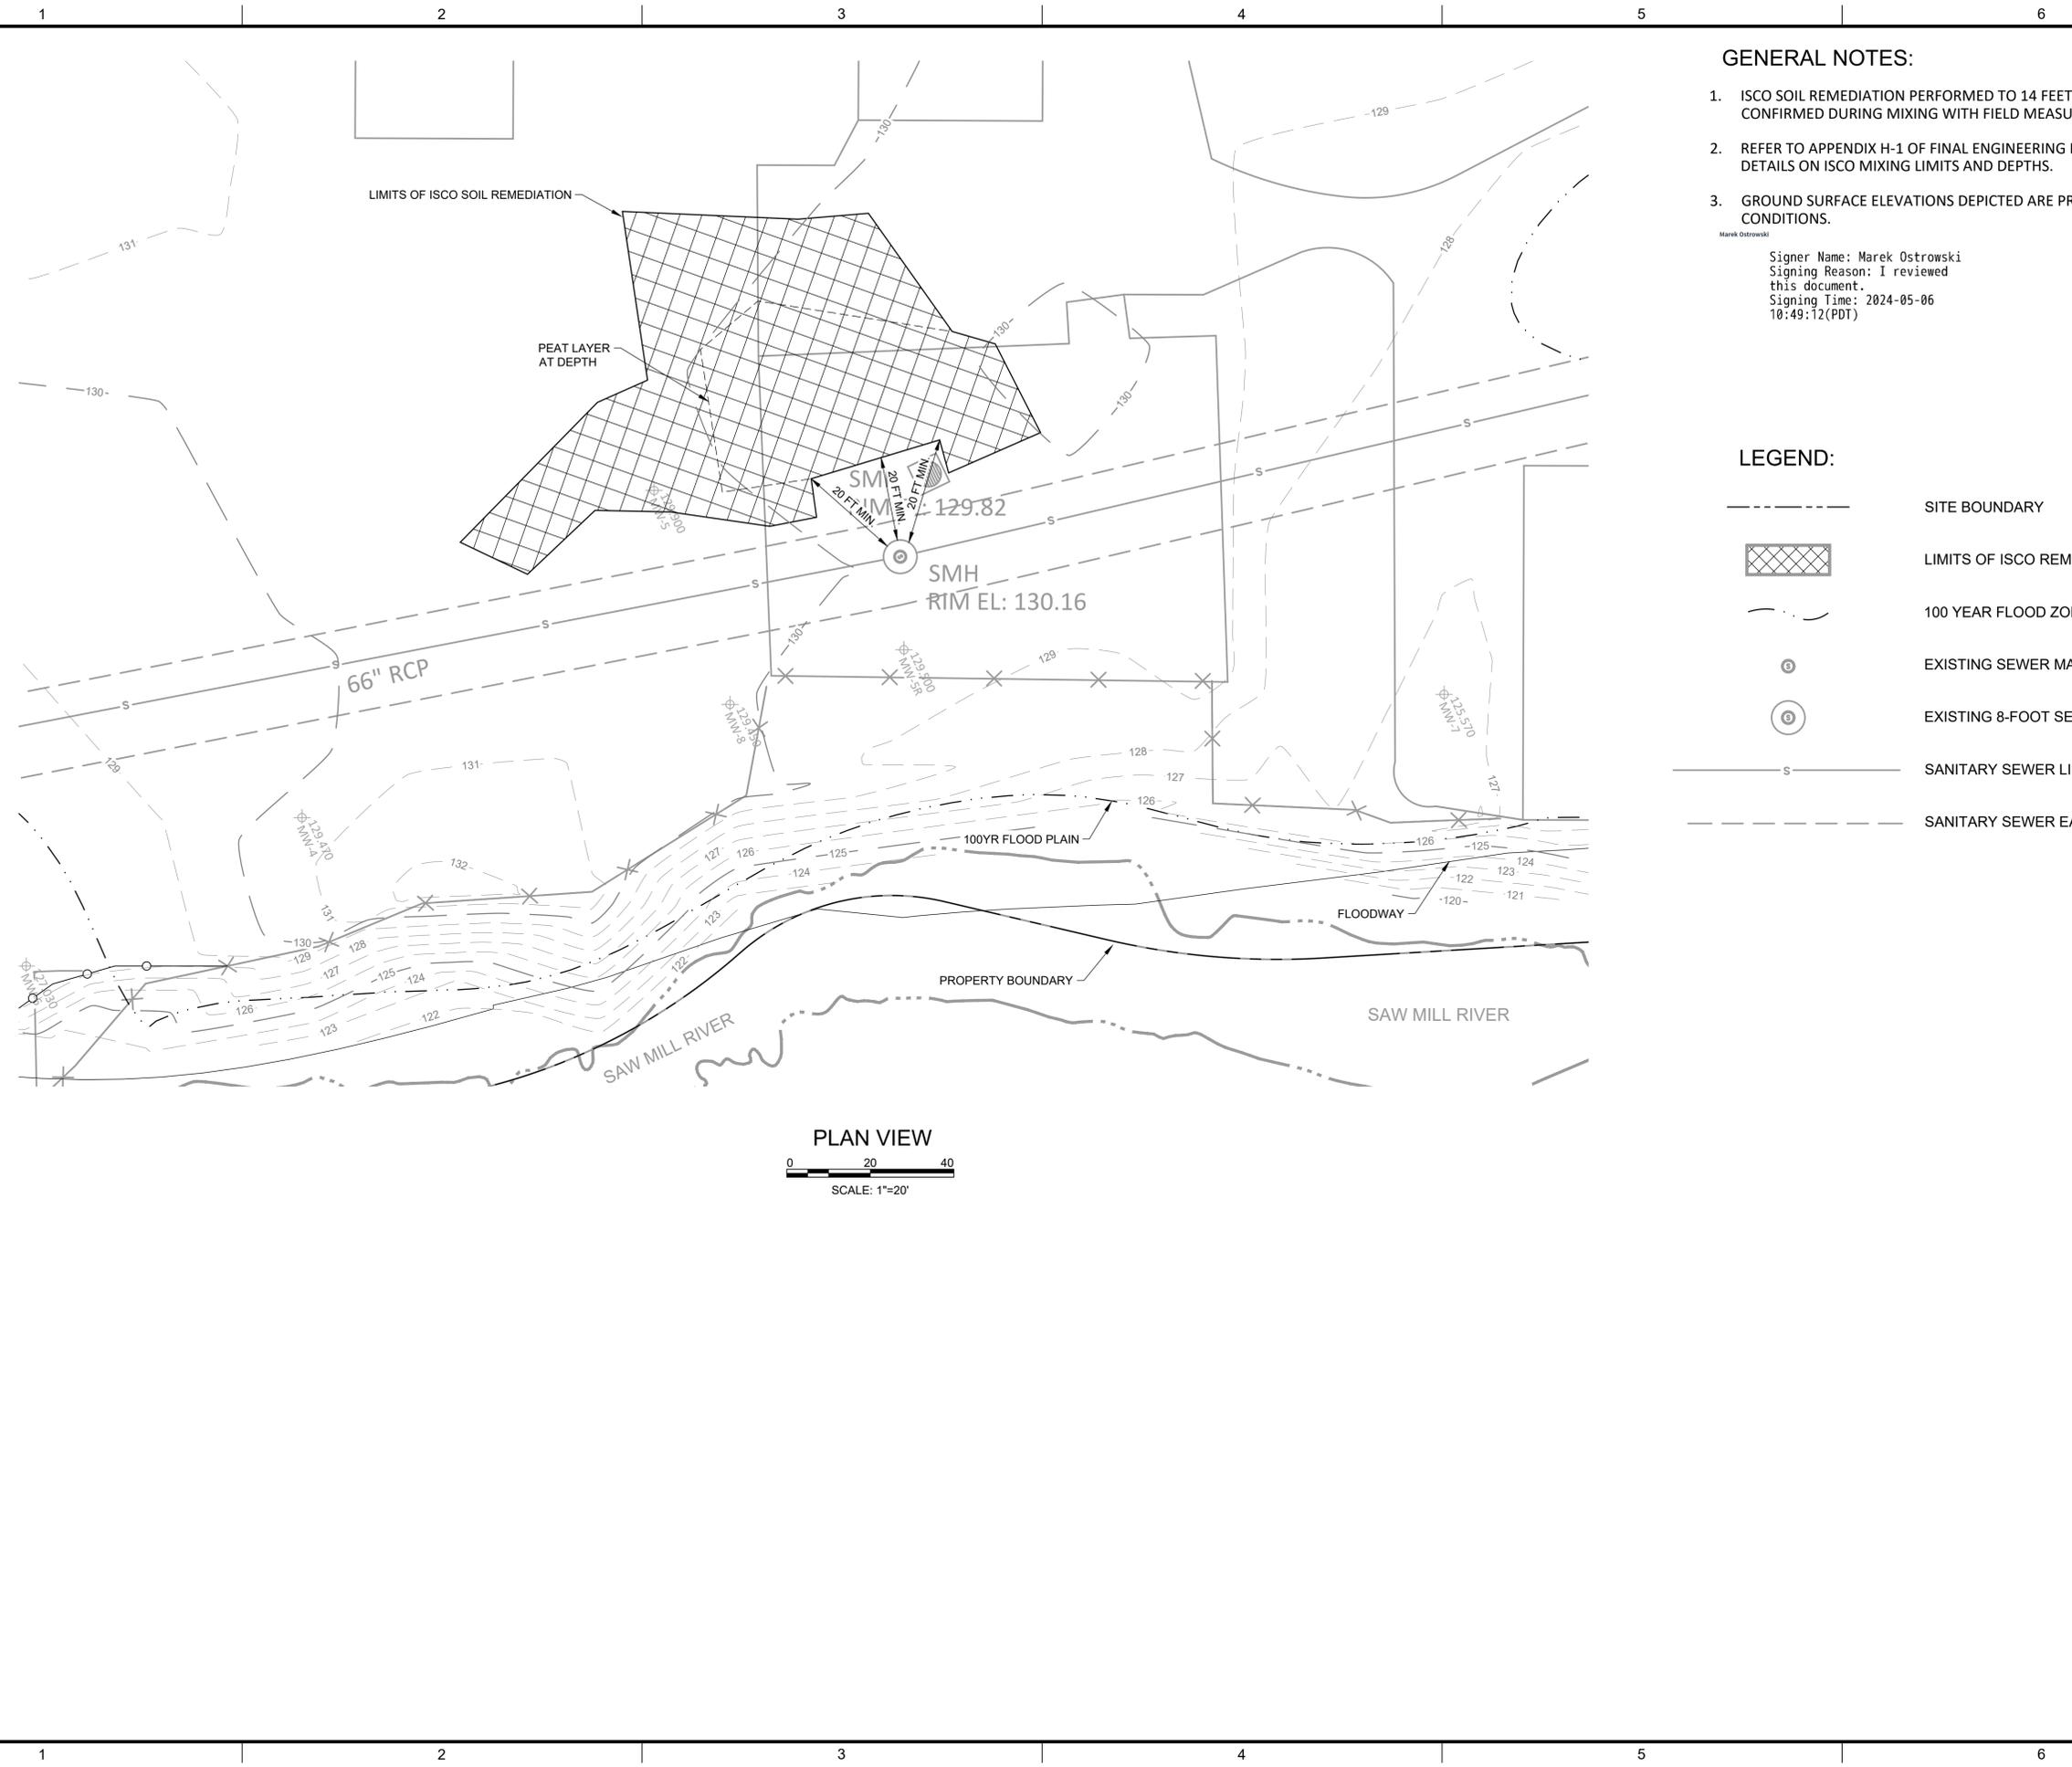
DRAWING NUMBER
FIGURE 3
 SHEET NUMBER OF

1. ISCO SOIL REMEDIATION PERFORMED TO 14 FEET BGS, AS CONFIRMED DURING MIXING WITH FIELD MEASUREMENTS.
2. REFER TO APPENDIX H-1 OF FINAL ENGINEERING REPORT FOR DETAILS ON ISCO MIXING LIMITS AND DEPTHS.
3. GROUND SURFACE ELEVATIONS DEPICTED ARE PRE-REMEDIATION CONDITIONS.

- In-situ chemical oxidation (ISCO) mechanically mixed into soils to a depth of 14 feet below ground surface (bgs) to treat volatile organic compounds (VOCs) including tetrachloroethene (PCE) and trichloroethene (TCE) in the central portion of the Site in the area of the “Former Solvent Shed”.
