Geophysical Investigation Report

**White Plains Mall
200 Hamilton Avenue
White Plains, NY 10601
(AGInc. Job No. 1919933)**

**Geophysical Investigation
and Utility Markout**

SESI Consulting Engineers
03/29/2021
White Plains, NY
AGInc. Job No. 1919933

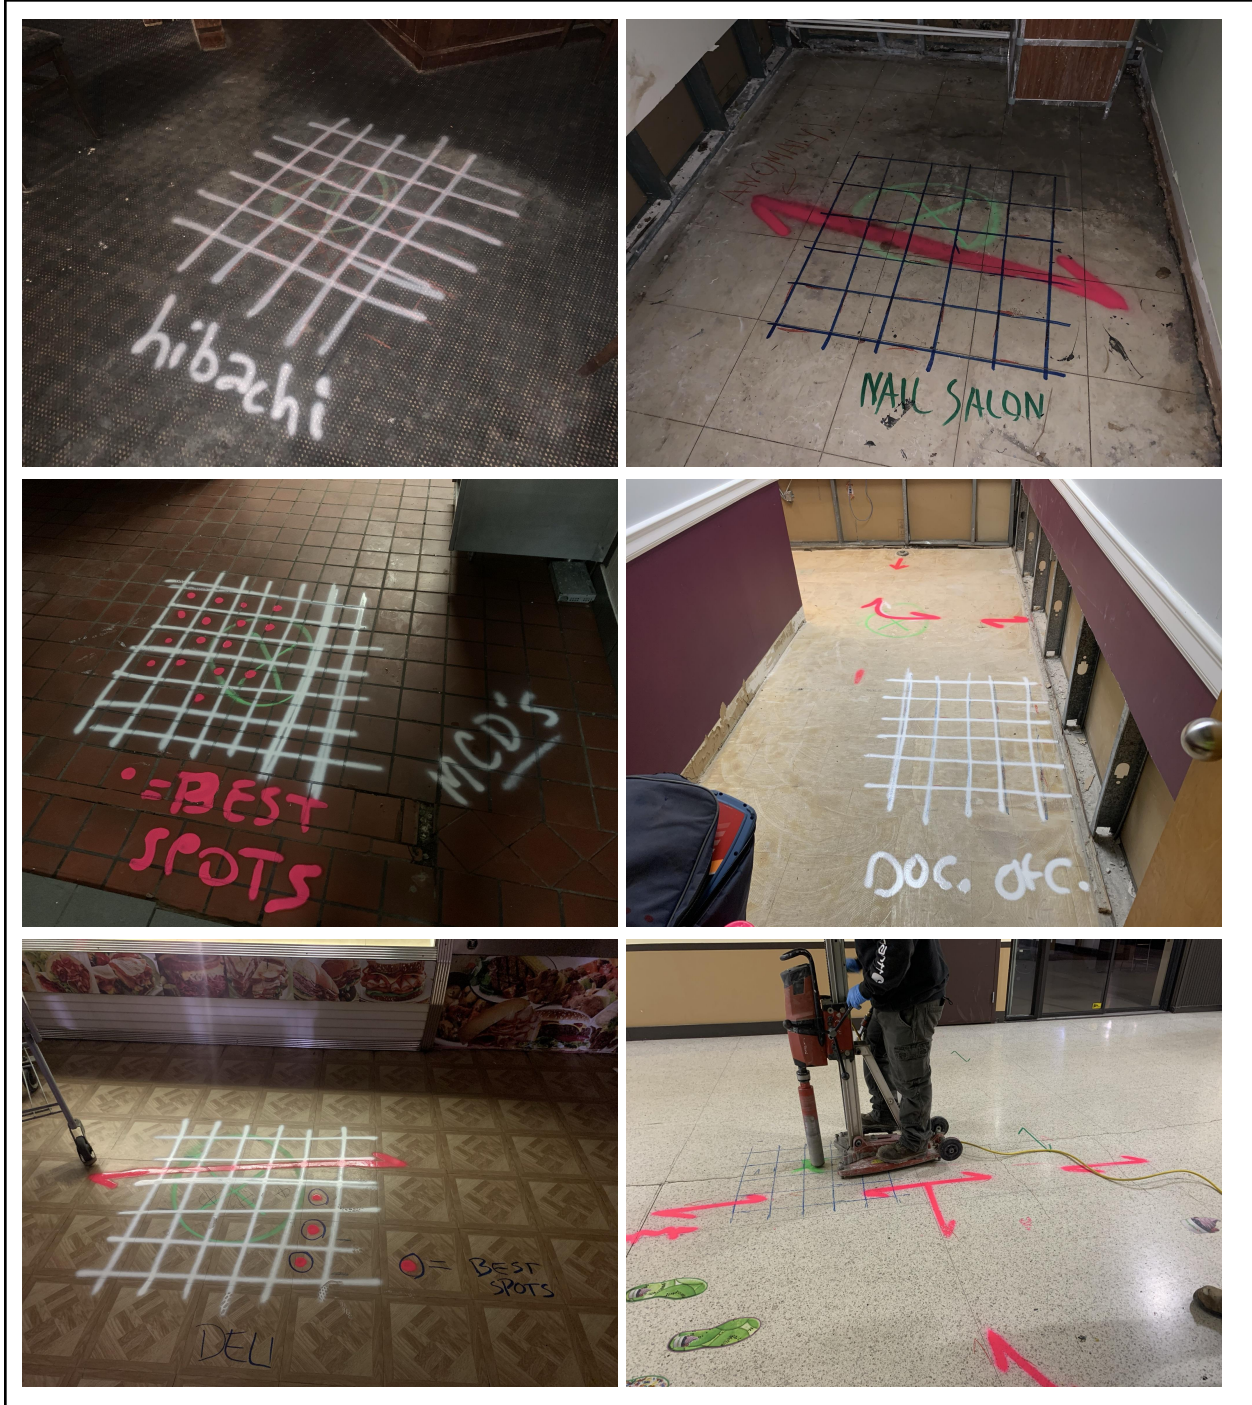
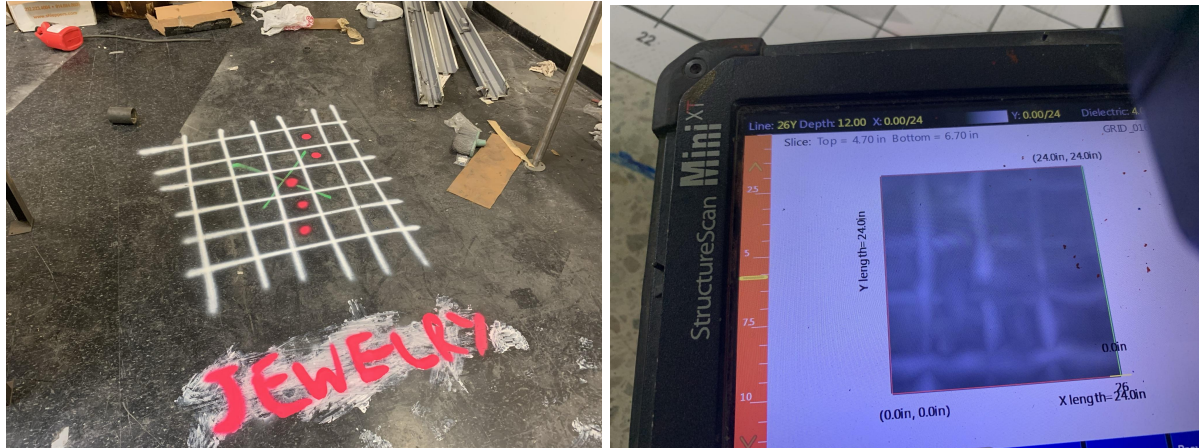
Fig. 1: Images of the interior locations investigated.

- 1) All detected reinforcement in the concrete was marked with white paint or blue crayon. All detected anomalies in the concrete were marked with pink paint.
- 2) The slab thickness estimated ~(6-12 inches) and was slab on grade.

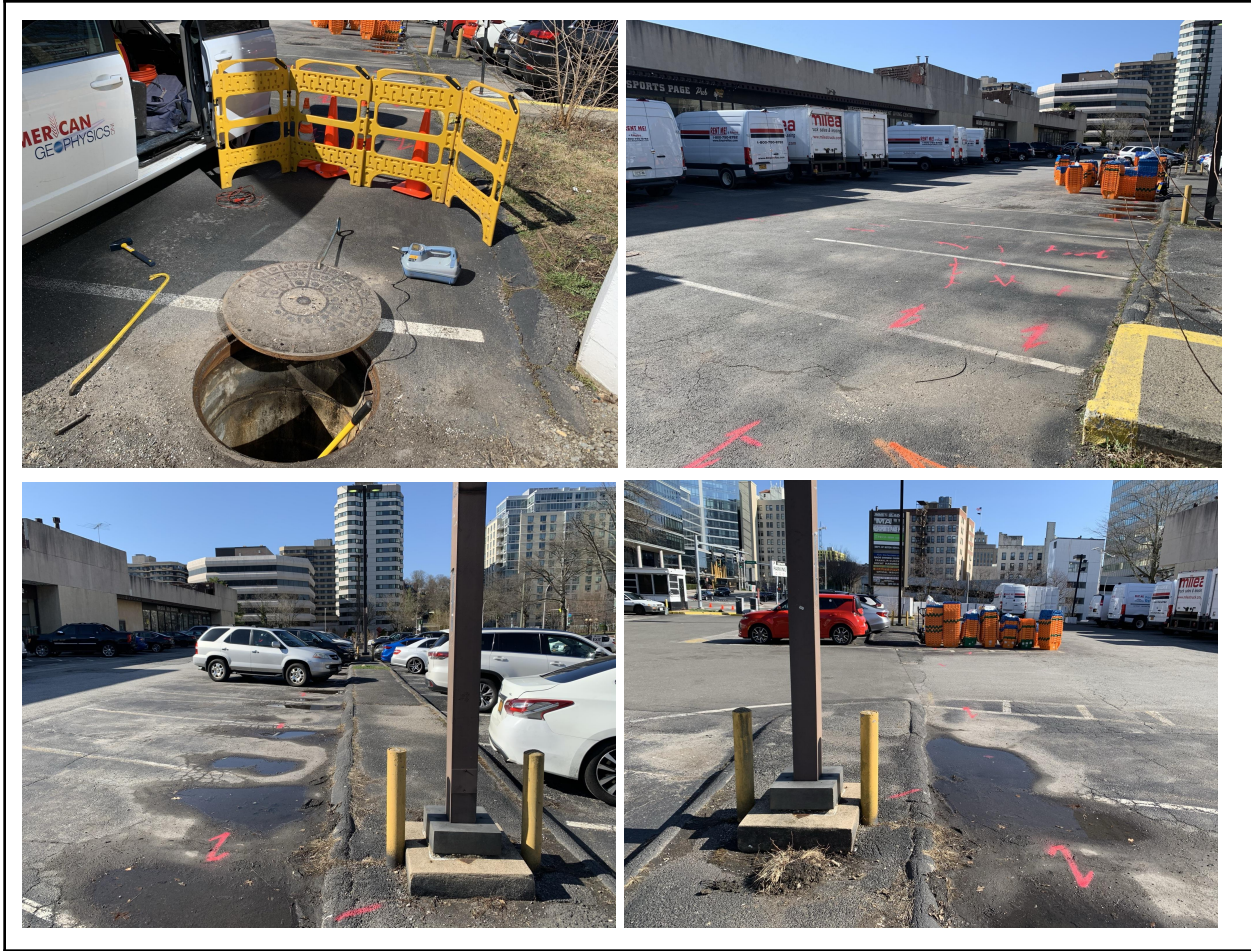
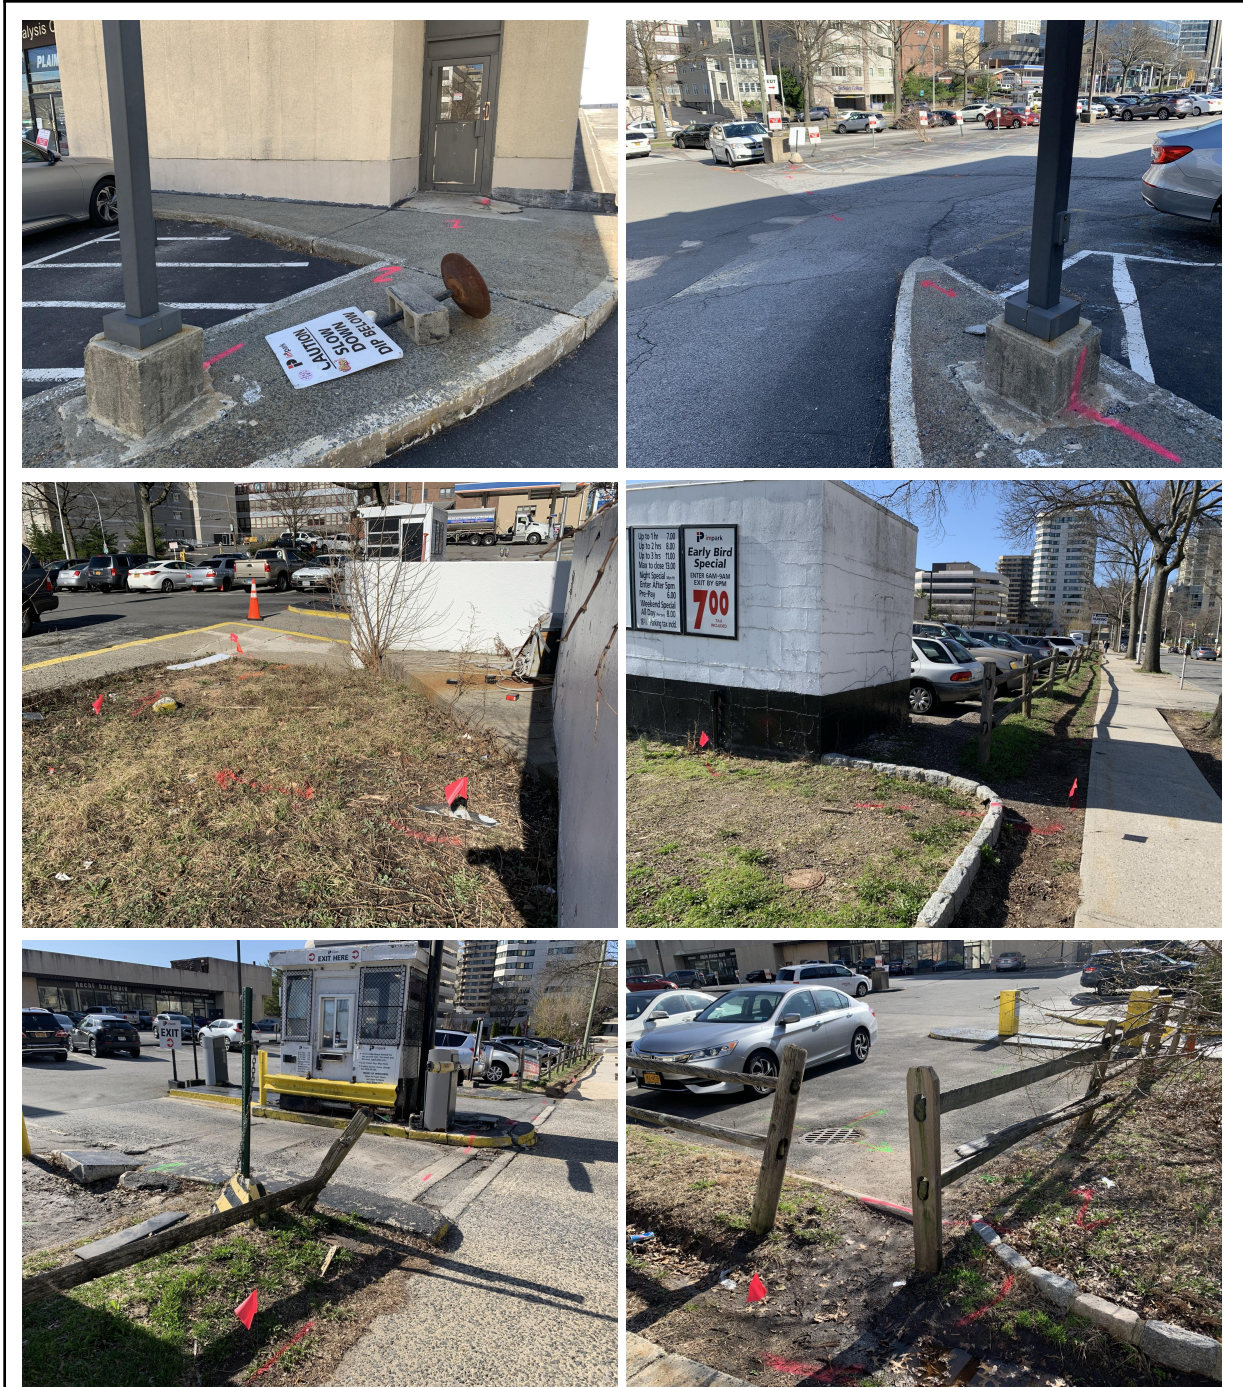
Fig. 2: Images of the electric detected around the parking lot.

- 3) An electric vault on the south side of the parking lot was opened and induced to. All electric was marked with red paint and flags, at depths ~(2-4ft) below ground surface (BGS).

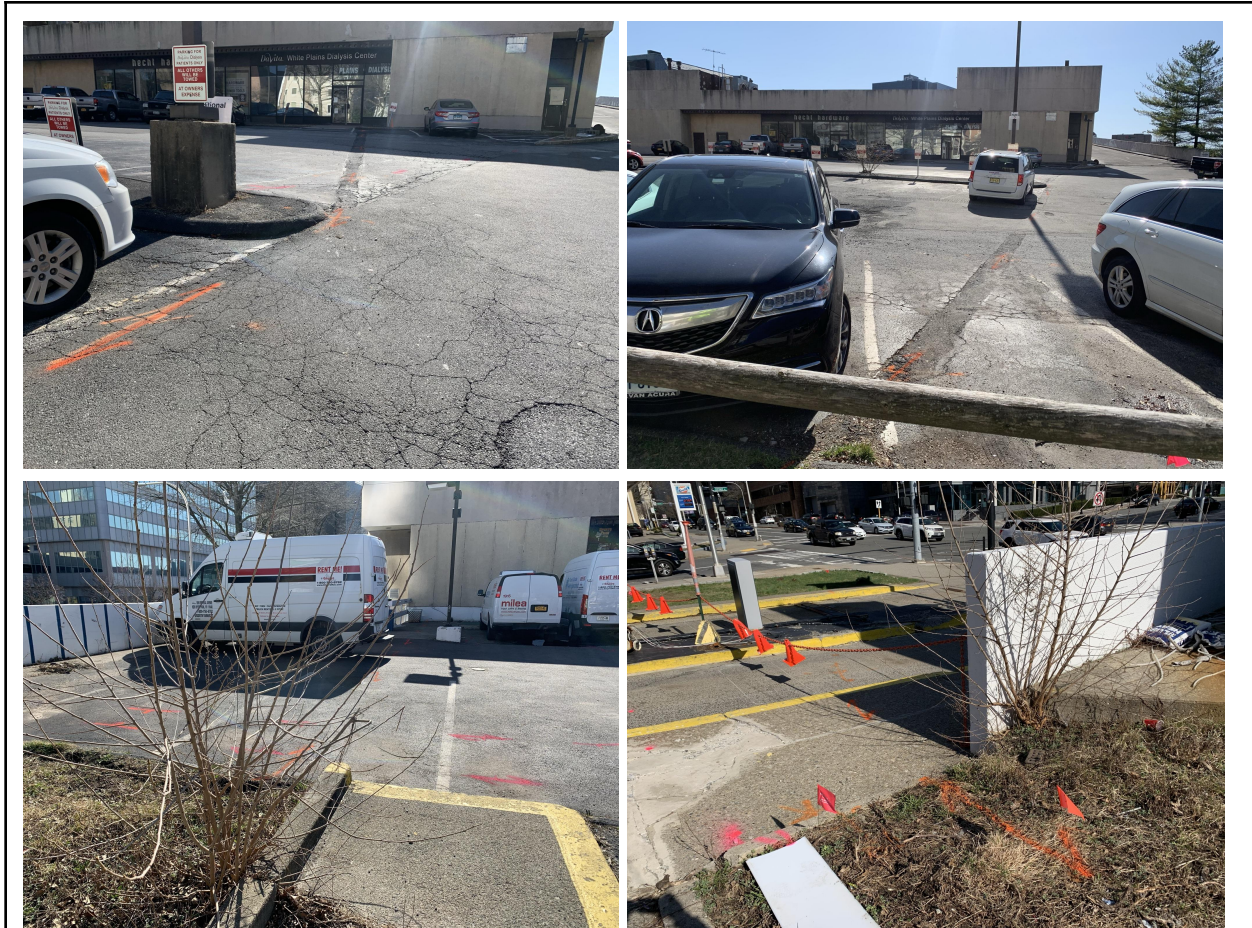
Fig. 3: Images of the two communications trenches detected.

- 4) Two detected communication trenches were detected running east/west from the building to the street, on the south and north sides of the parking lot. They were marked with orange paint and flags.

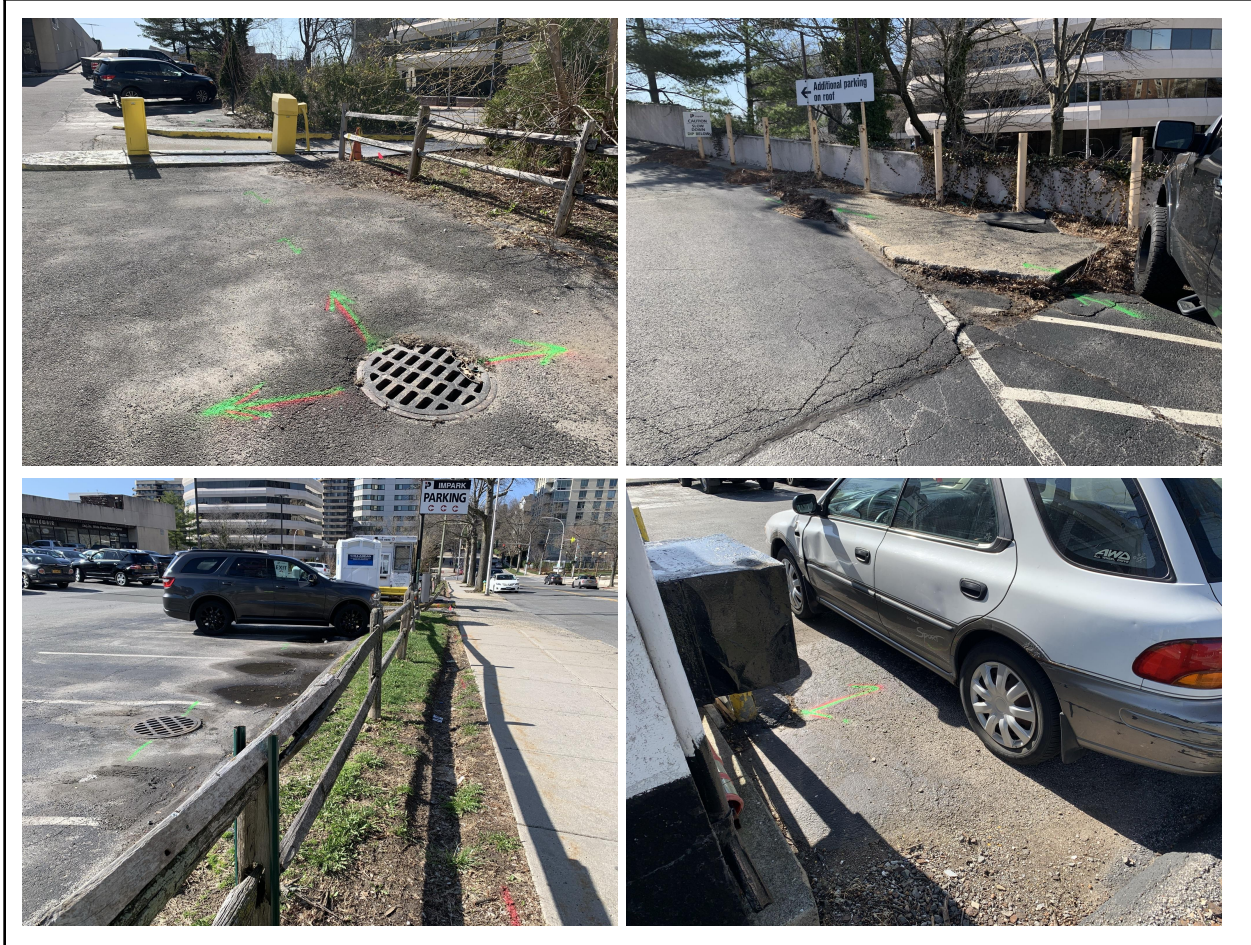
Fig. 4: Images of the storm sewer investigated/detected.

- 5) Storm sewer was detected running parallel to the street along the inside curb of the parking lot. This was marked with green paint.
- 6) An electrical conduit was detected running through the grocery area of the mall at an estimated depth of 6" BGS. This conduit was marked in red paint
