RADIOLOGICAL SURVEY  
FOR  
VILLAGE OF MT. KISCO and RICHARD'S LUMBER  
former Canadian Radium and Uranium Corporation  
MT. KISCO, NEW YORK

JULY 1998

New York State Department of Environmental Conservation  
Division of Solid & Hazardous Materials  
Bureau of Pesticides & Radiation  
50 Wolf Road, Room 402  
Albany, NY 12233-7255

**Radiological Survey  
for  
Village of Mt. Kisco & Richard's Lumber  
Mt. Kisco, New York**

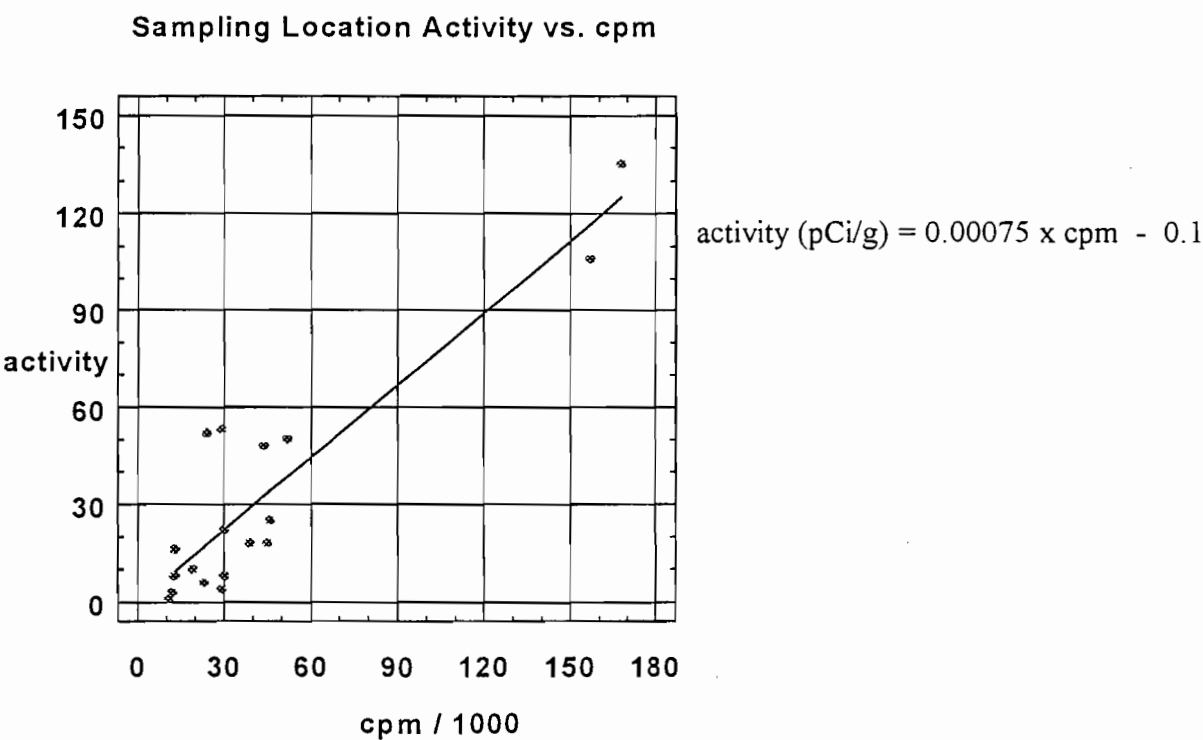
Figure 13

material is within the one large area shown on the survey maps and only some fraction of this area might need to be removed. Calculations to test this procedure have been done and data from both detectors give essentially the same results.

If we use the equations derived for the data in the two Figures 12 and 13 to estimate the average cpm value associated with a given radium concentration, we obtain essentially the same cpm values for both of the approaches described here. The procedure illustrated here makes it possible to determine if, and how much, remediation is necessary. The procedure to be followed is: start with an area average soil activity as a cleanup guidance (see section 4B for a discussion of how this is done), read off the area average cpm, and rerun the software to calculate those areas that exceed that cpm.

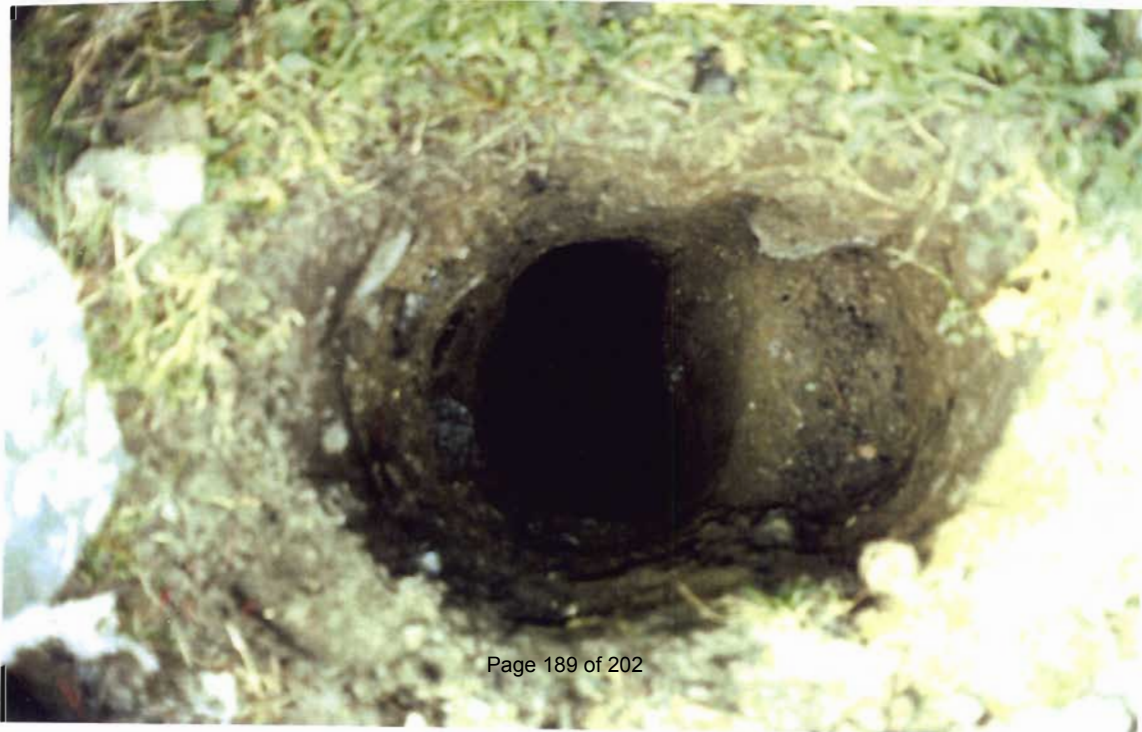
16.

View down hole for sample location MK0302.  
Note large stones & deeper obstruction that appeared to be worked, smooth stones.

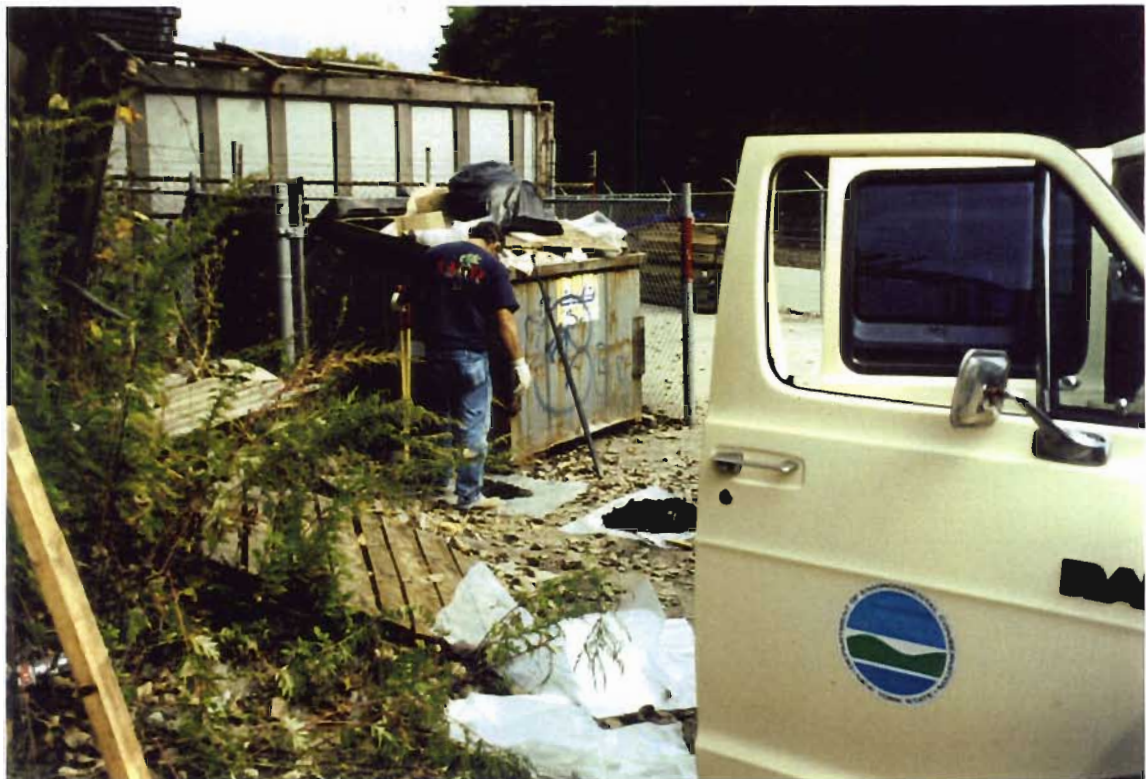
17. Sample location MK0305, "Dumpster Area" E. end of Railroad Ave., soil sample @ location of maximum surface reading with a 2"x 2".

The highest Ra226 activities are found on this part of the site - see particularly MK0305, near the dumpster.

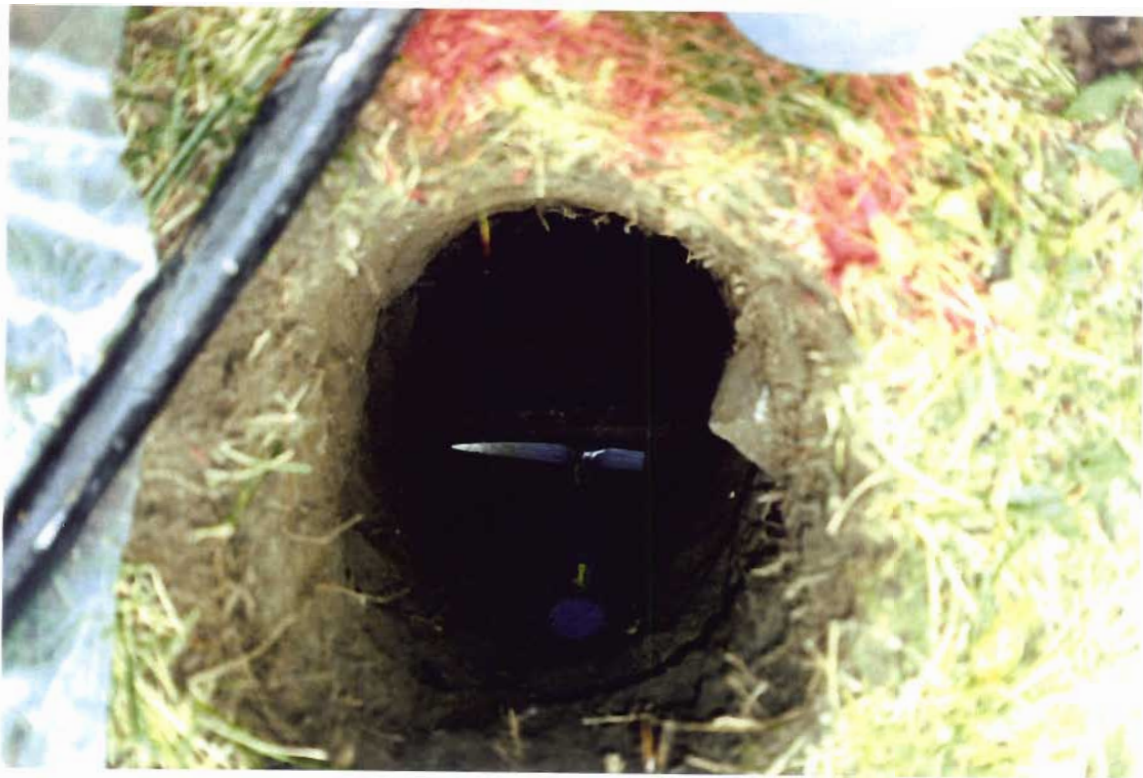
18. Sample location MK0304 - S. side of Railroad Ave., 1/2 way down the street. Note double layer of worked, smooth w/ beveled edges.
