**SUBJECT: PHASE II REMOVAL ASSESSMENT TRIP REPORT – CANADIAN
RADIUM AND URANIUM CORP. SITE, MOUNT KISCO,
WESTCHESTER COUNTY, NEW YORK**

REMOVAL ASSESSMENT TRIP REPORT

SITE NAME: Canadian Radium and Uranium Corp. Site
DC No.: RST3-03-D-0296
TDD No.: 0007-0023
CERCLIS ID: NYD987001468
EPA ID: A23P
EVENT DATES: April 4 through 6, 2016

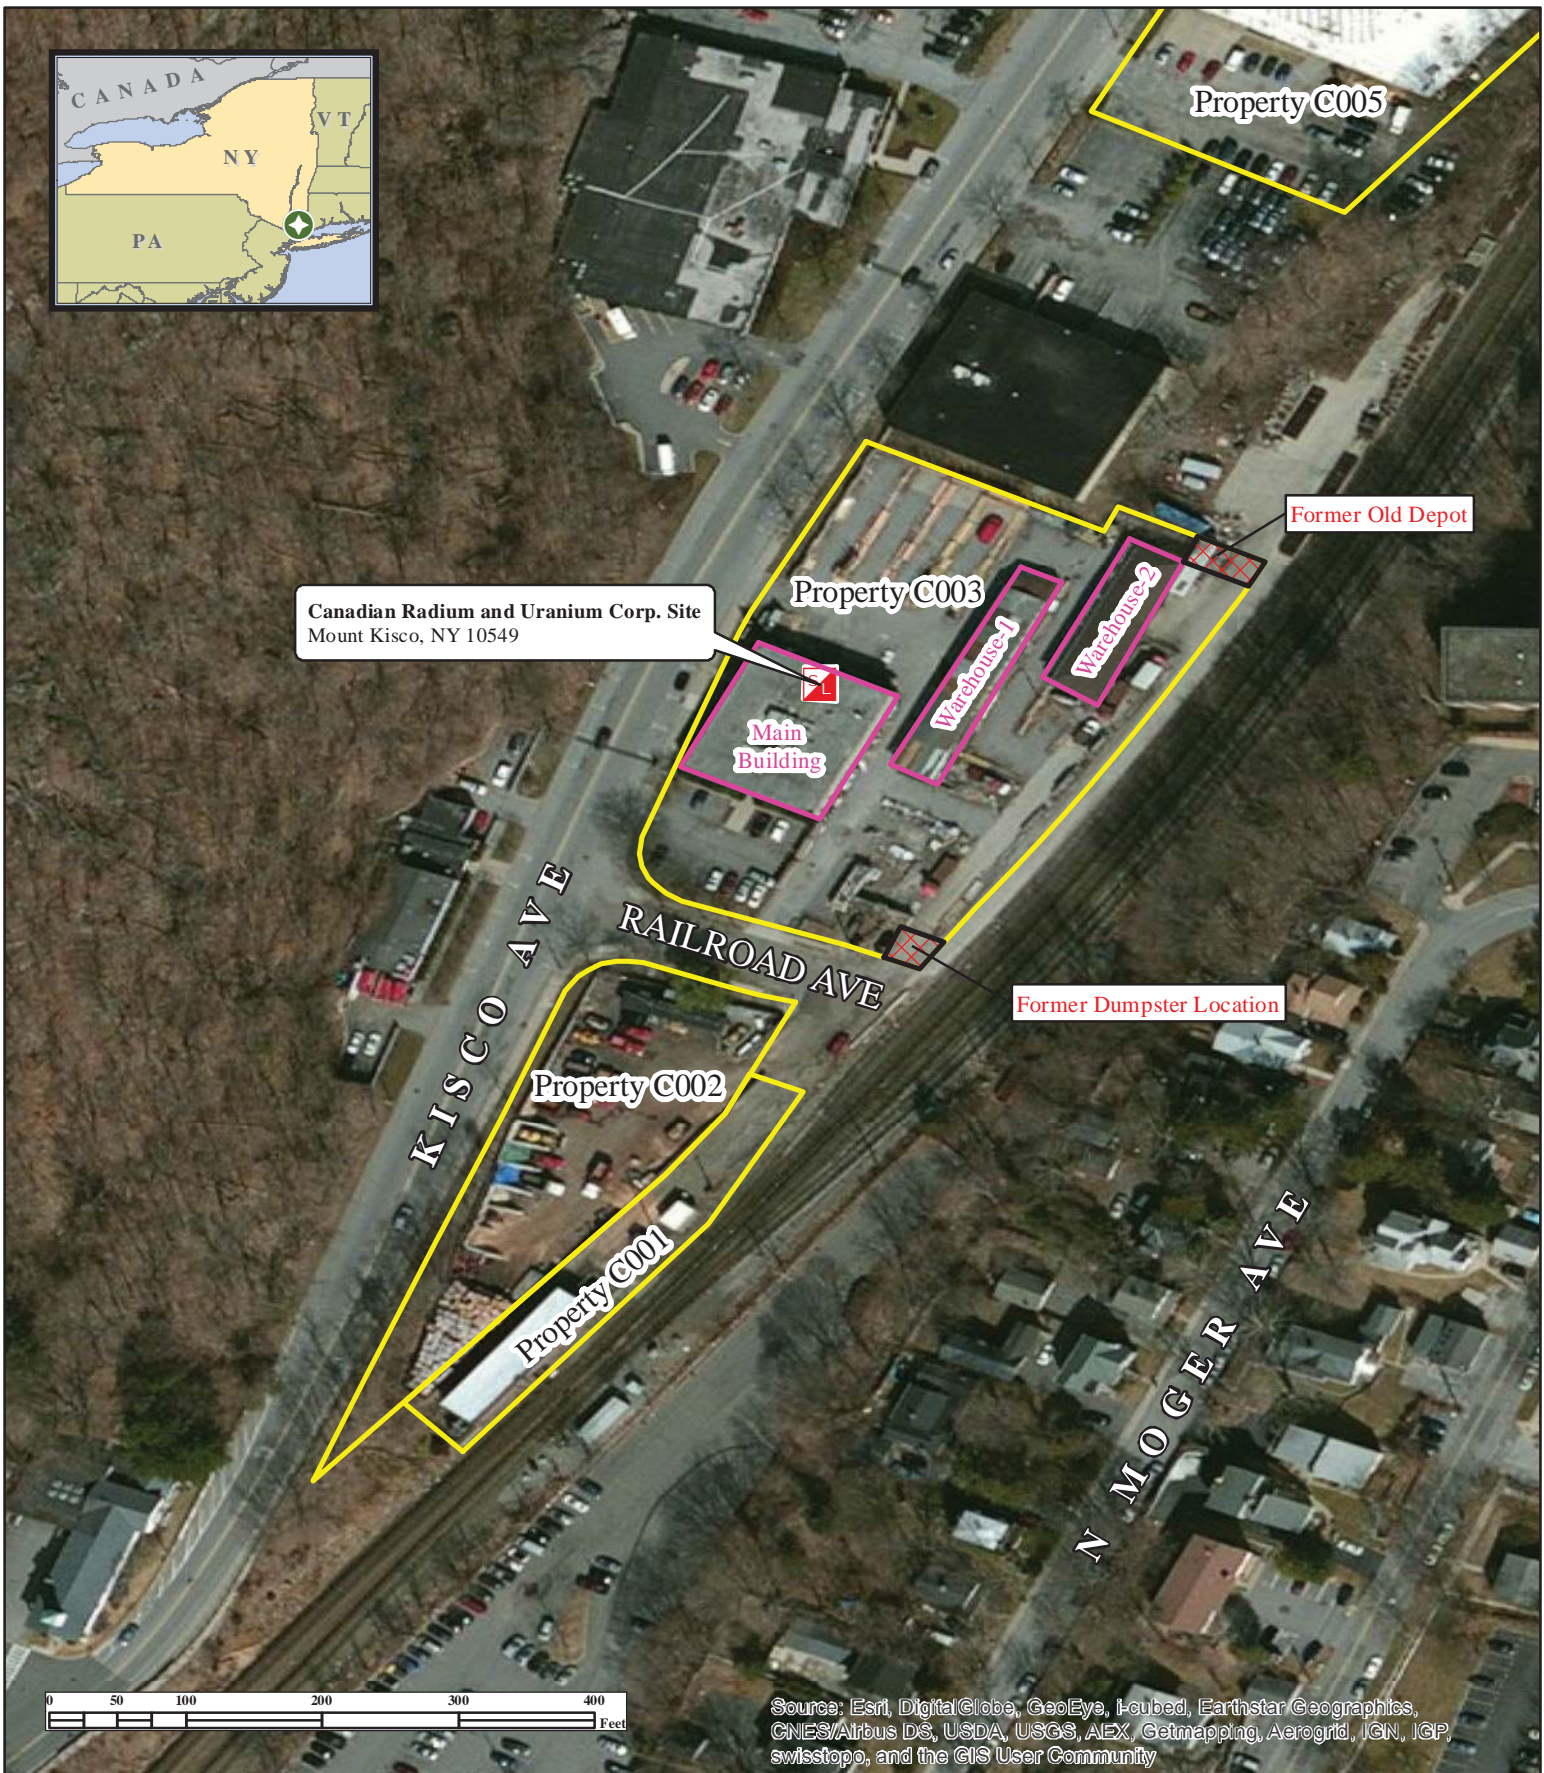
Site Feature

- On-Site Structure
- Former Documented Area

Site Overview Map

Refer to Attachment A, Figure 2: Site Overview Map and Attachment C: Photographic Documentation of Site Activities.

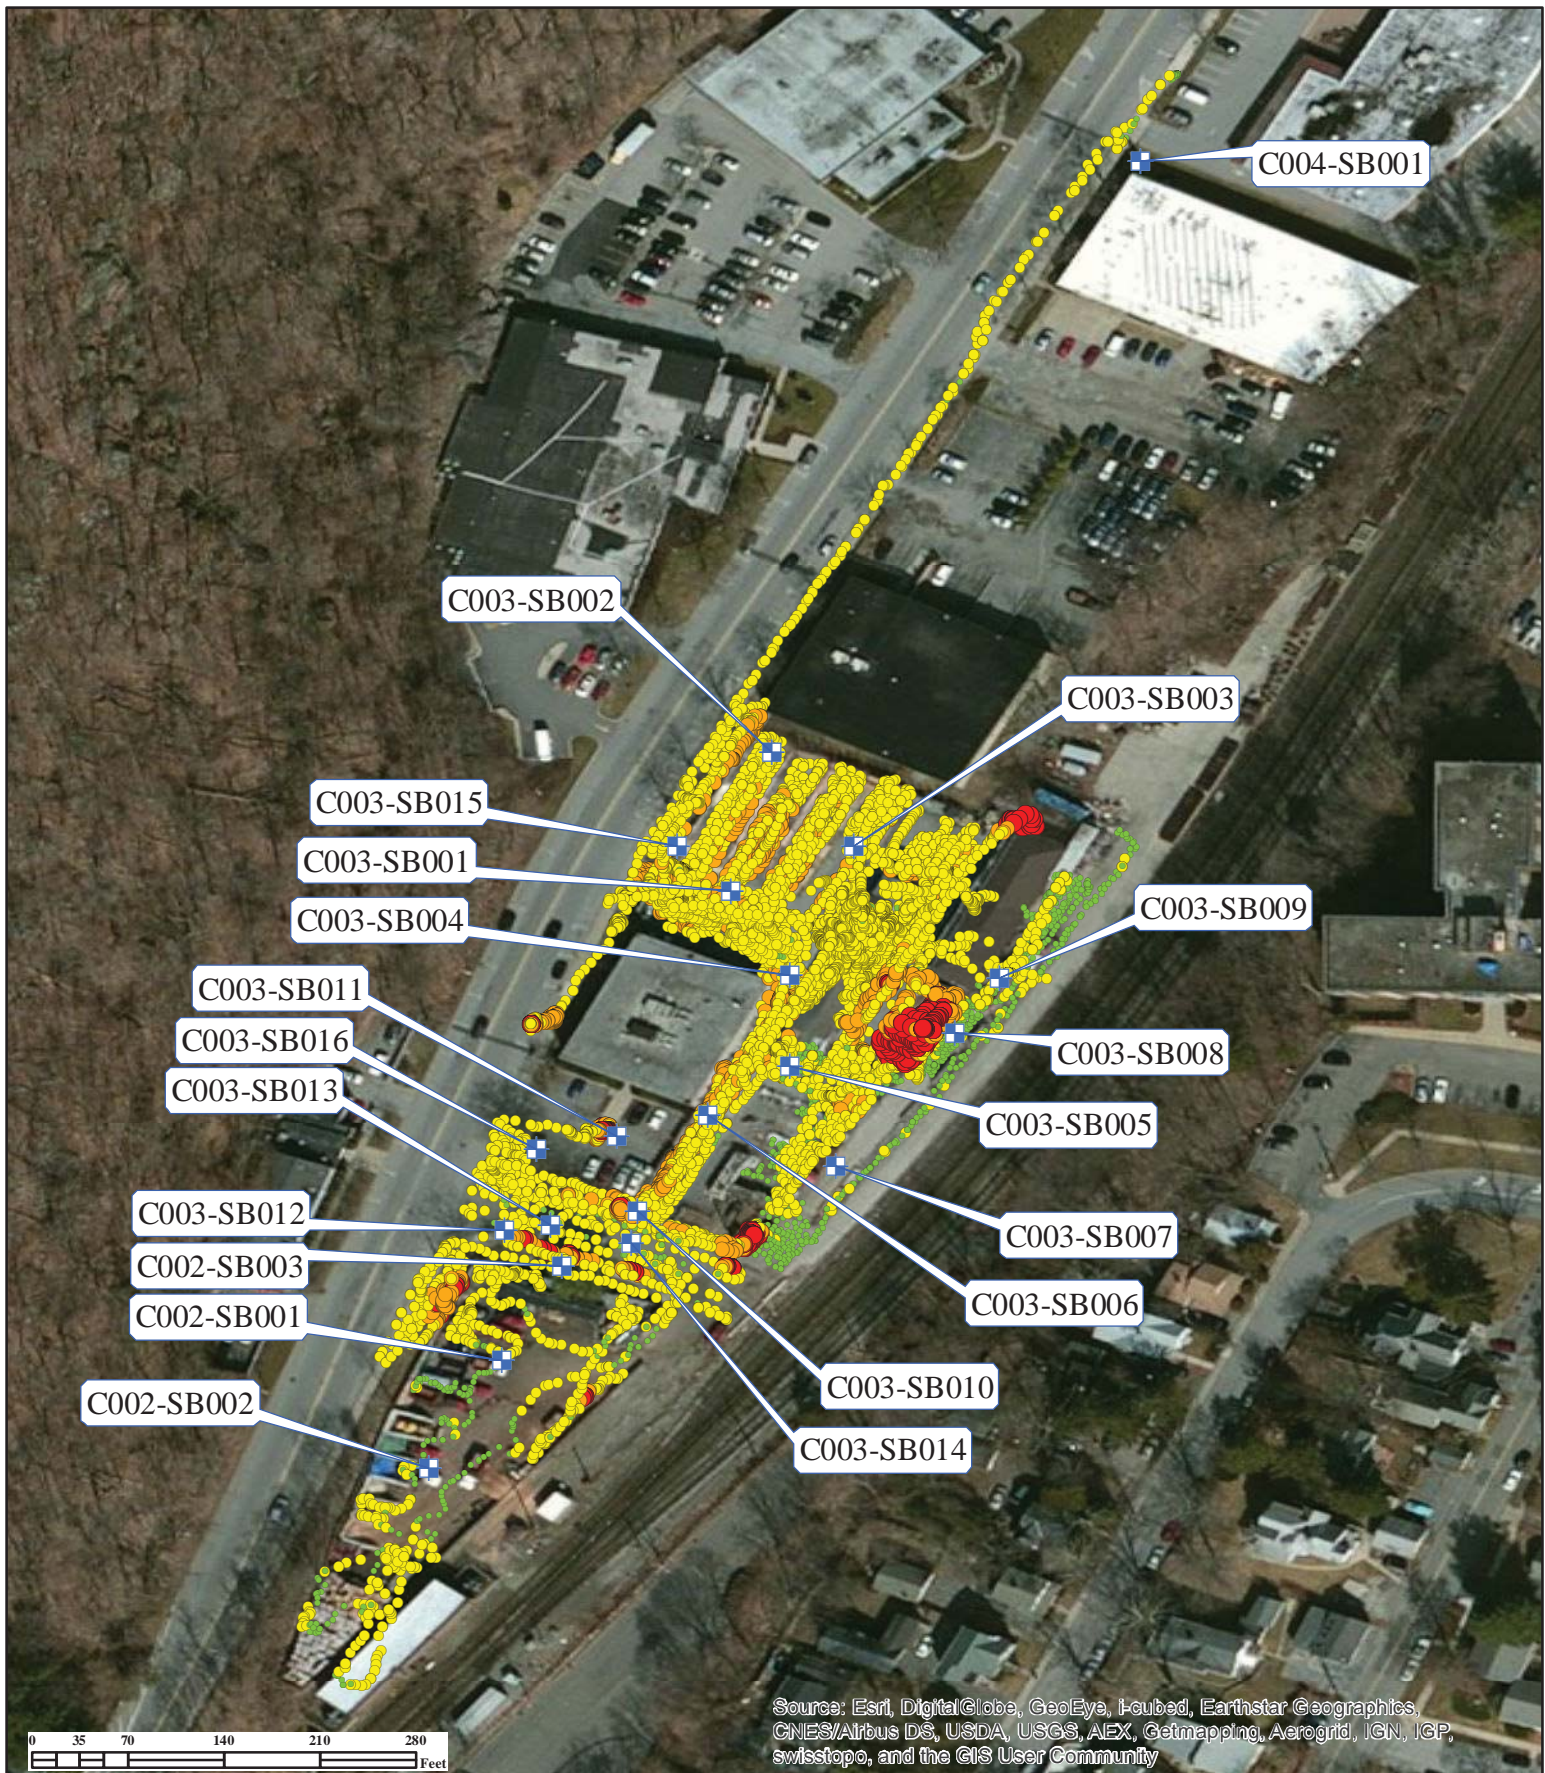
Figure 3: Gamma Survey Results Map

Based upon the radiological survey results, most areas throughout the Site were generally within the background value of 9 µR/hr. However, several on-site locations were identified with gamma

readings exceeding 2x background, 3x background, and more than 3x background. At Property C002, one location along the northeast fence line near the staging location of five bags of contaminated soils which were identified during the Phase I Removal Assessment conducted in August 2015 indicated gamma readings that were greater than 3x background ($>24 \mu\text{R/hr}$). Other areas around Property C002 with elevated gamma readings include a location along the northwest ROW area, the ROW area north of Property C002, and the entire south portion of Railroad Avenue. These areas indicated elevated gamma reading that were 2 to 3 times background ($>16 - 24 \mu\text{R/hr}$). At Property C003, one area around the northwest corner of Warehouse-2 and an asphalt-paved area immediately south of Warehouse-2, indicated gamma readings exceeding 3x background ($>24 \mu\text{R/hr}$). Some northwest locations of Property C003, between merchandise stored outside, indicated gamma readings that were more than 2x background. Other “hotspots” (locations with gamma readings exceeding $24 \mu\text{R/hr}$) identified at Property C003 include, a location by the south access gate to Property C003 next to the customer parking lot, the southeast corner of the perimeter fence by the “former dumpster location” near a utility pole, a location in the center of the customer parking lot, and a location near the west entrance to the main building.

Gamma Survey – Results presented in microrentgens per hour (μR/hr)

Refer to Attachment A, Figure 3: Gamma Survey Results Map.

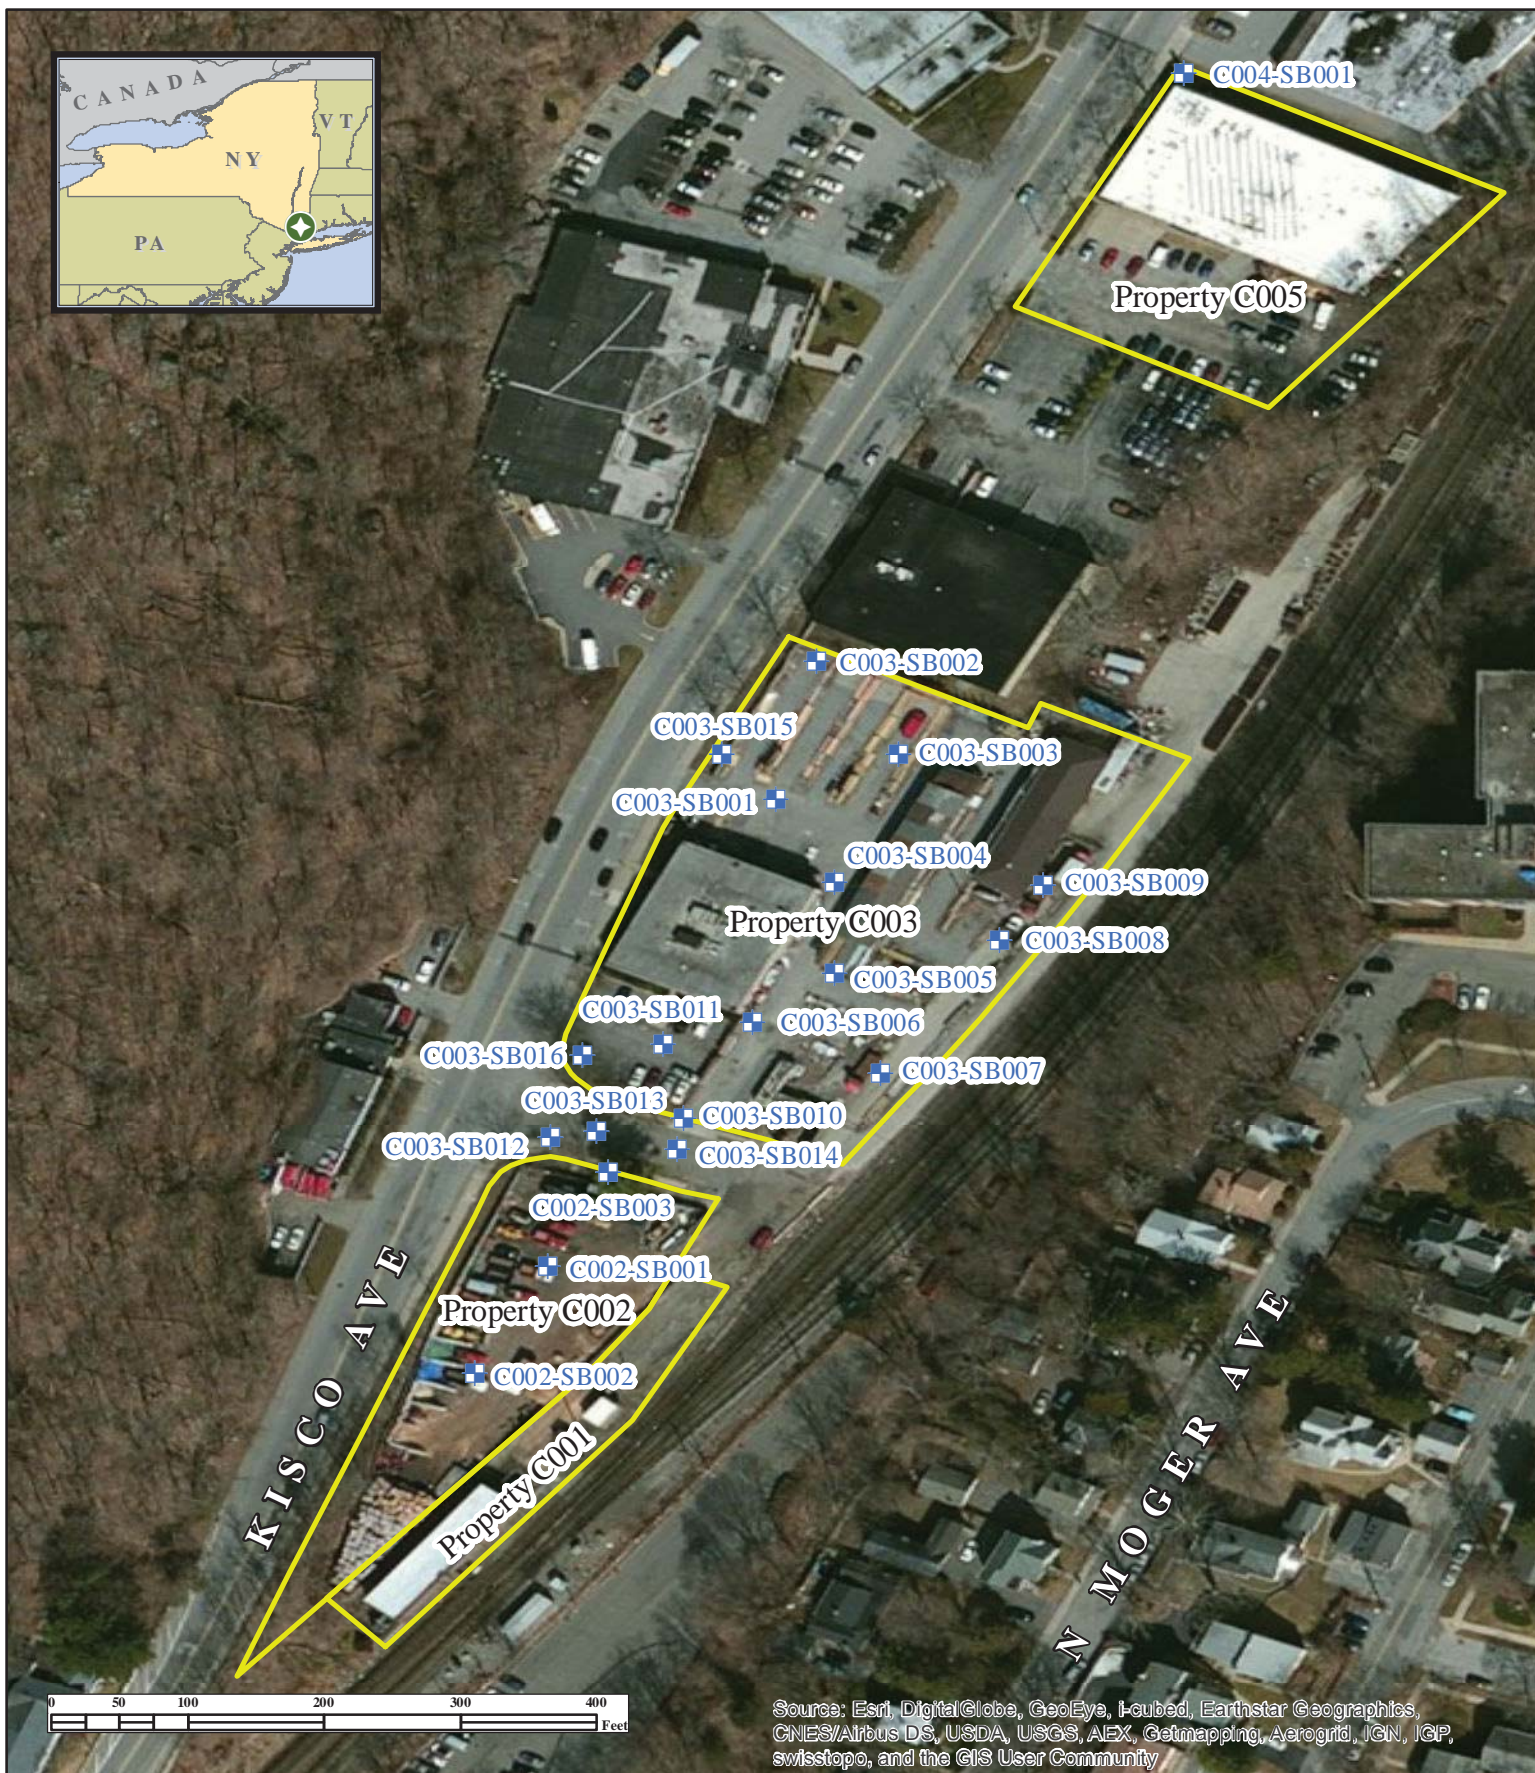
**Figure 4: Soil Boring
Location Map**

On April 5 through 6, 2016, RST 3 collected a total of 71 soil samples, including three field duplicates and three MS/MSD samples from 16 soil boring location at Property C003. On April 6, 2016, RST 3 collected 25 soil samples, including one field duplicate and one MS/MSD sample from three soil boring location at Property C002. On April 6, 2016, RST 3 collected seven soil samples, including one field duplicate and one MS/MSD sample from a background soil boring location at Property C005. One aqueous rinsate blank sample was collected each day of the sampling event.

Refer to Attachment A, Figure 4: Soil Boring Location Map and Attachment B, Table 1: Sample Collection Summary Table.
