August 10, 2023

Re: Monthly Progress Report – July 2023
Former United Hospital – 406 Boston Post Road, Port Chester, New York
NYSDEC BCP Site No. C360202

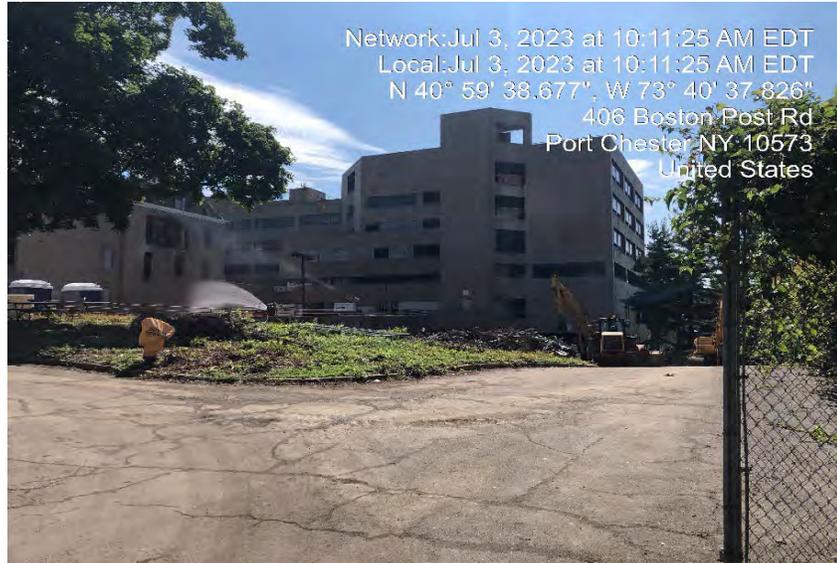
Photograph 1 -
Exterior handling of building materials associated with demolition of interior, non-loadbearing, building elements, view facing east.

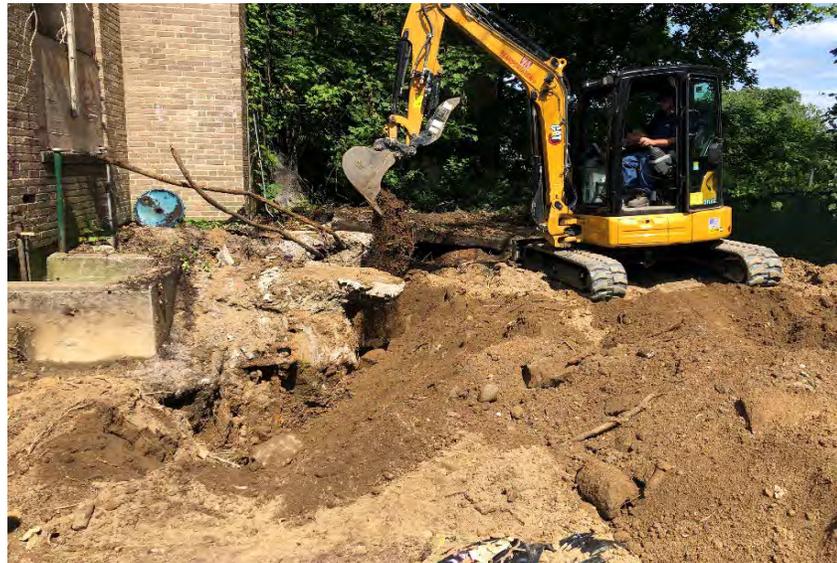
Photograph 2 -
Exploratory excavation work to investigate UST identified adjacent to the northeastern corner of the power/boiler plant building, view facing west.
(Note: UST piping painted green on the building façade; UST located below concrete elements)

- Minor exploratory excavation work to investigate suspected USTs at the Site is expected. All excavated material will be stockpiled on/covered with poly sheeting and will be field screened for evidence of petroleum contamination; any evidence of a petroleum spill/release will be promptly reported to the NYSDEC Project Manager. Unless evidence of gross contamination is identified (e.g., staining, elevated PID readings, odors, etc.), the excavated material will be returned to the location from which it was generated; grossly contaminated material (if any) will be segregated and characterized for off-site disposal. The findings from the exploratory excavation activities will be used to prepare an Interim Remedial Measures (IRM) Work Plan for the removal of all tanks identified at the Site.

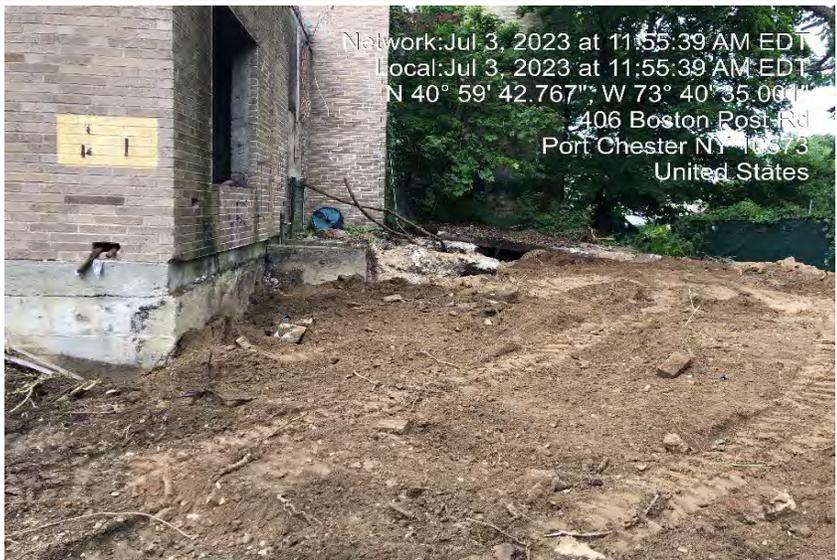
Photograph 3 -
The exploratory excavation area adjacent to the northeastern corner of the power/boiler plant building was backfilled following the investigation work, view facing west.

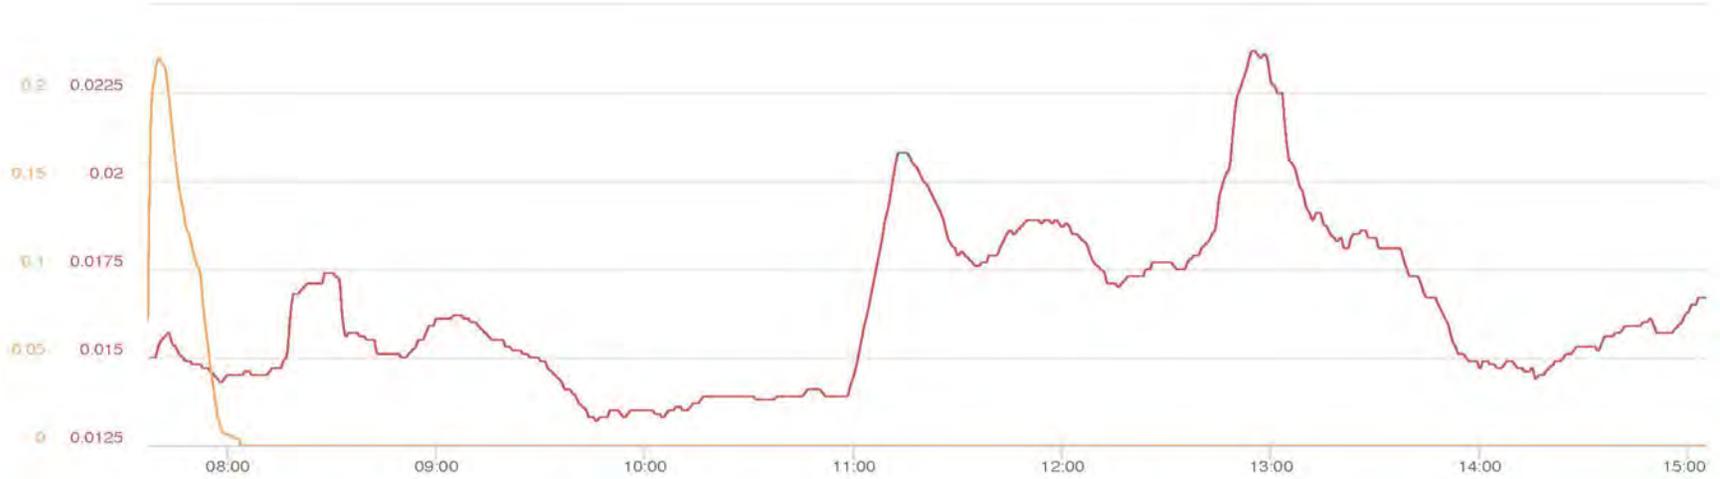
UH - Fixed 1 CAMP Station Graph

Mon, 3rd of Jul 2023, 0:00:00 – 23:59:00
(GMT-05:00) Eastern Time (US & Canada)

Mass Conc. Total mg/m³ AVG 15m

mg/m³
DustTrak-8530
RS232(C)

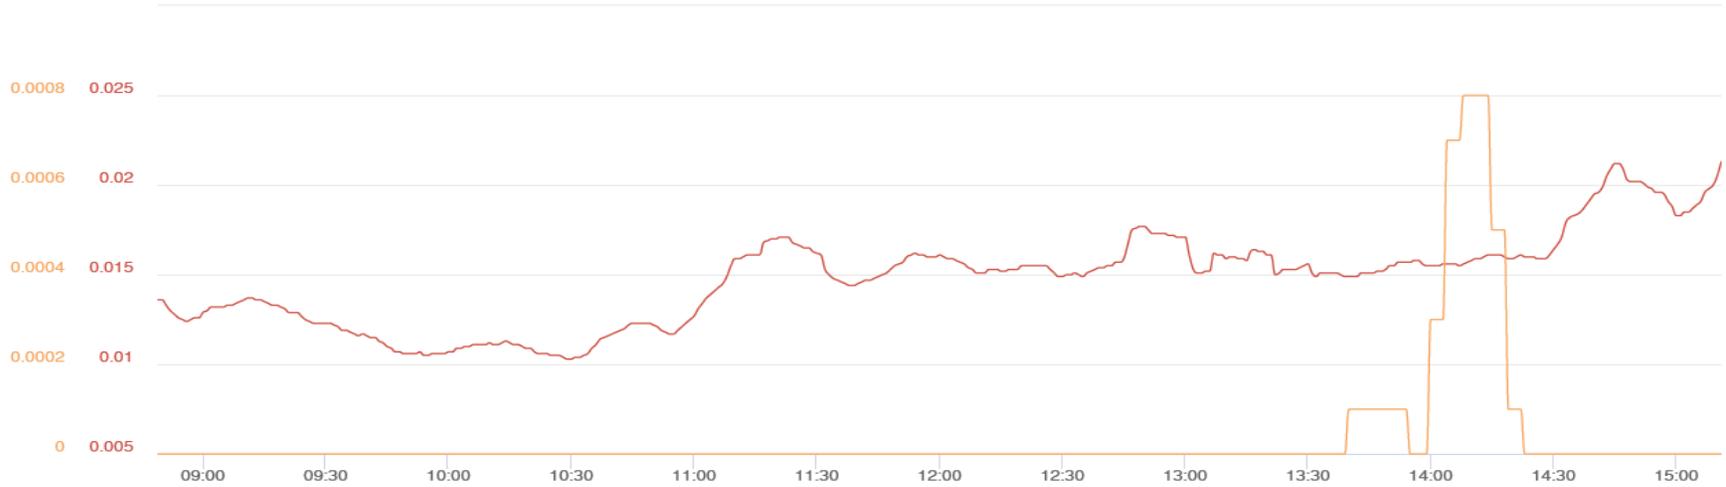
UH - Fixed 2 CAMP Station Graph

Mon, 3rd of Jul 2023, 8:49:00 – 23:59:00
(GMT-05:00) Eastern Time (US & Canada)

Mass Conc. Total mg/m ³ AVG 15m		
mg/m ³		
DustTrak-8530		
RS232(C)		
MIN	AVG	MAX
0.0103	0.0147	0.0212

VOC ppm AVG 15m		
ppm		
miniRAE 3000		
RS232(A)		
MIN	AVG	MAX
0	0	0.0008

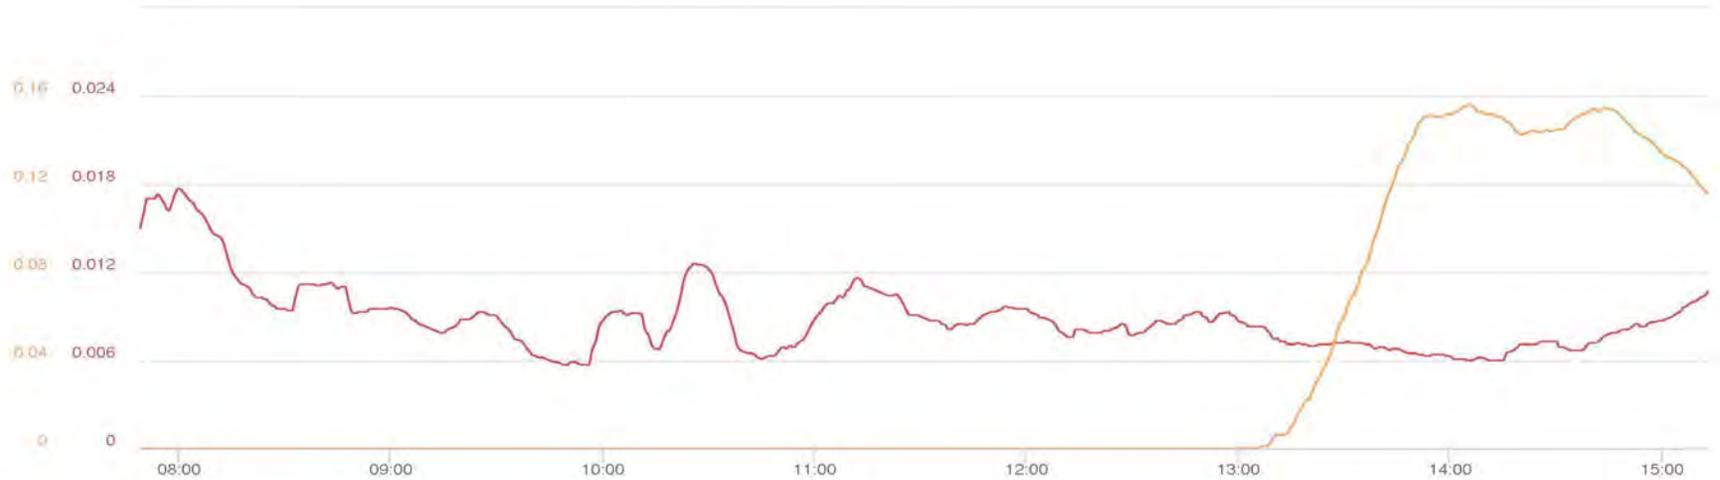
UH - Fixed 3 CAMP Station Graph

Mon, 3rd of Jul 2023, 0:00:00 – 23:59:00
(GMT-05:00) Eastern Time (US & Canada)

Mass Conc. Total mg/m³ AVG 15m
mg/m³
DustTrak-8530
RS232(C)

MIN	AVG	MAX
0.0057	0.0088	0.0177

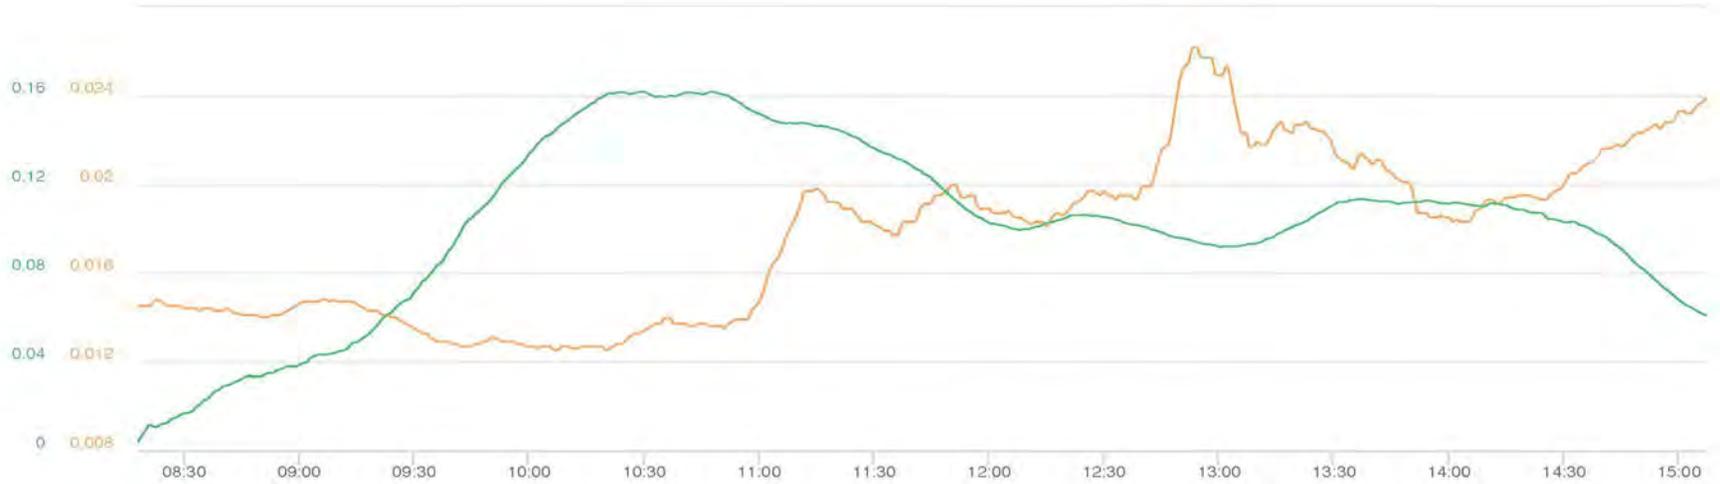
UH - Upwind 1 CAMP Station Graph

Mon, 3rd of Jul 2023, 8:18:00 – 23:59:00
(GMT-05:00) Eastern Time (US & Canada)

Mass Conc. Total mg/m³ AVG 15m
mg/m³
DustTrak-8530
RS232(G)

MIN	AVG	MAX
0.0125	0.0177	0.0262

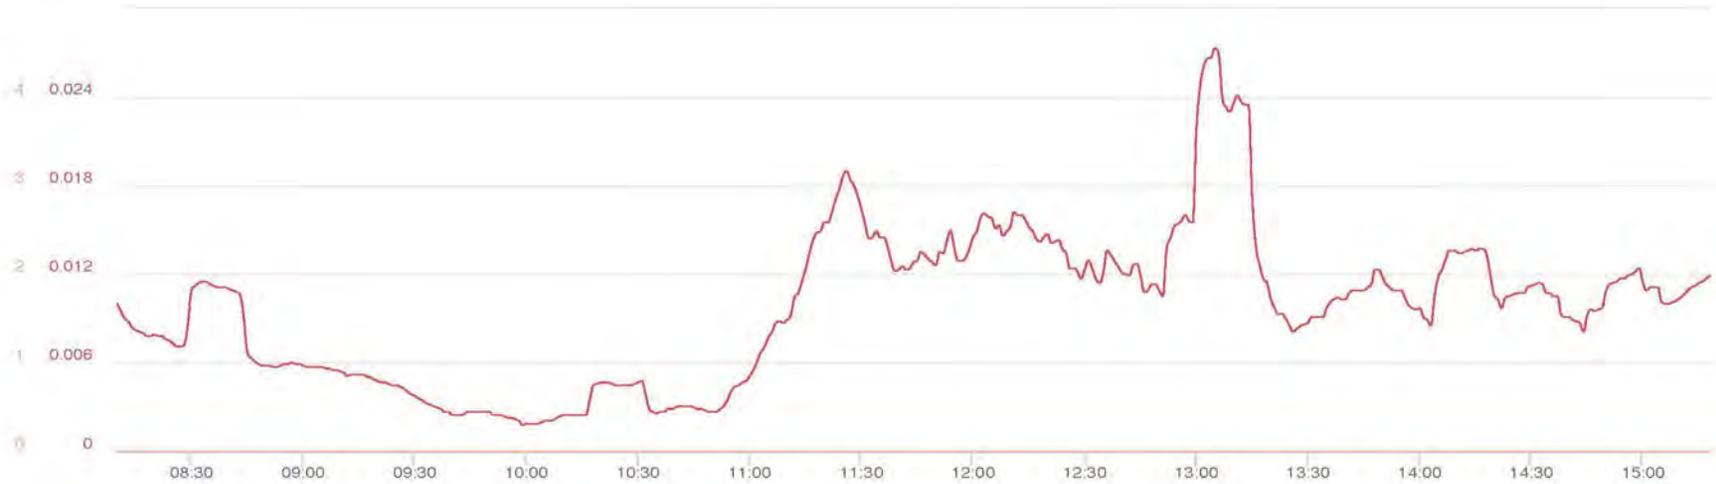
UH - Downwind 1 CAMP Station Graph

Mon, 3rd of Jul 2023, 8:10:00 – 23:59:00
(GMT-05:00) Eastern Time (US & Canada)

Mass Conc. Total mg/m³ AVG 15m
mg/m³
DustTrak-8530
RS232(C)

MIN	AVG	MAX
0.0018	0.0097	0.0273

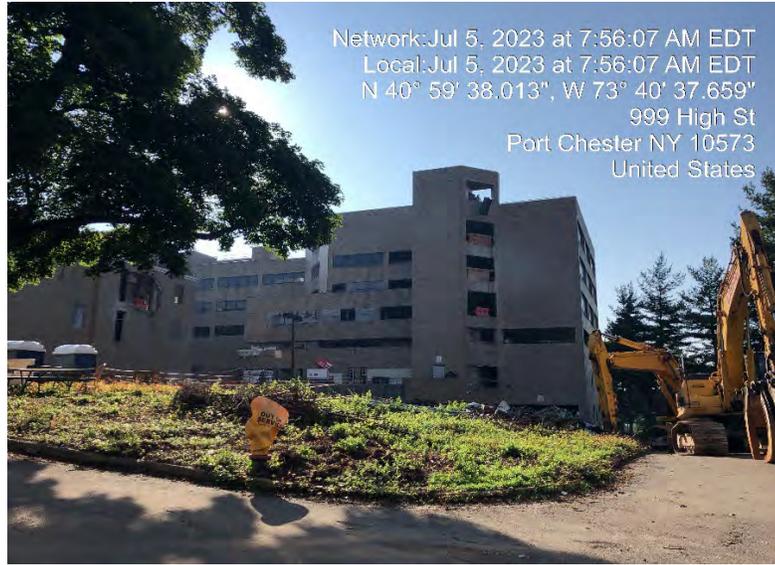
Photograph 1 -
Exterior handling of building materials associated with demolition of interior, non-loadbearing, building elements, view facing east.

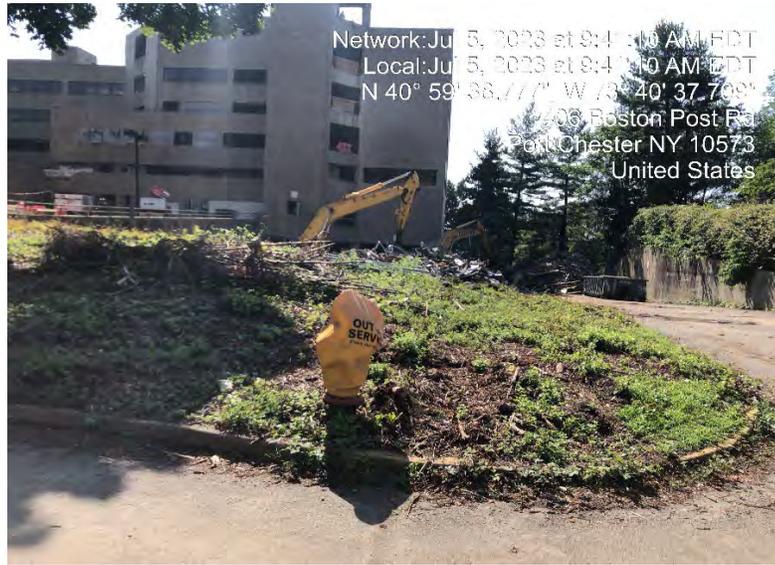
Photograph 2 -
Exterior handling of building materials associated with demolition of interior, non-loadbearing, building elements, view facing east.

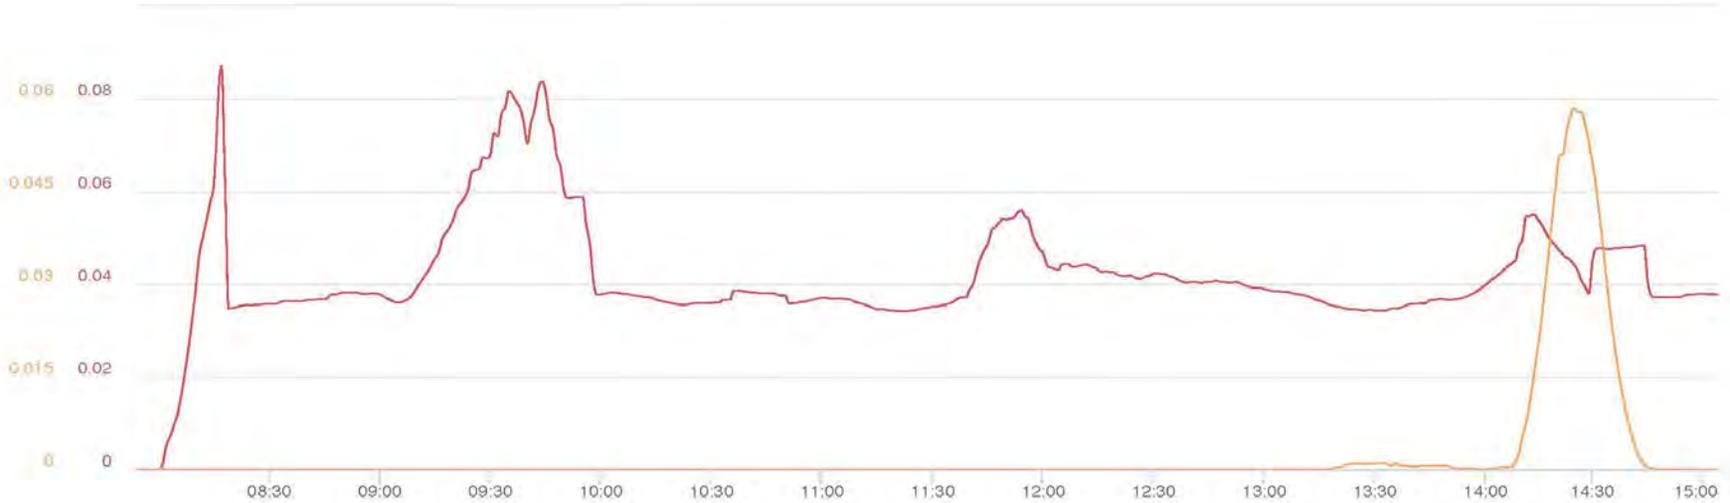
UH - Fixed 2 CAMP Station Graph

07/05/2023 0:00:45 – 07/06/2023 0:00:00
(GMT-05:00) Eastern Time (US & Canada)

Mass Conc. Total mg/m³ AVG 15m
mg/m³
DustTrak-8530
RS232(C)

MIN	AVG	MAX
0	0.0414	0.087

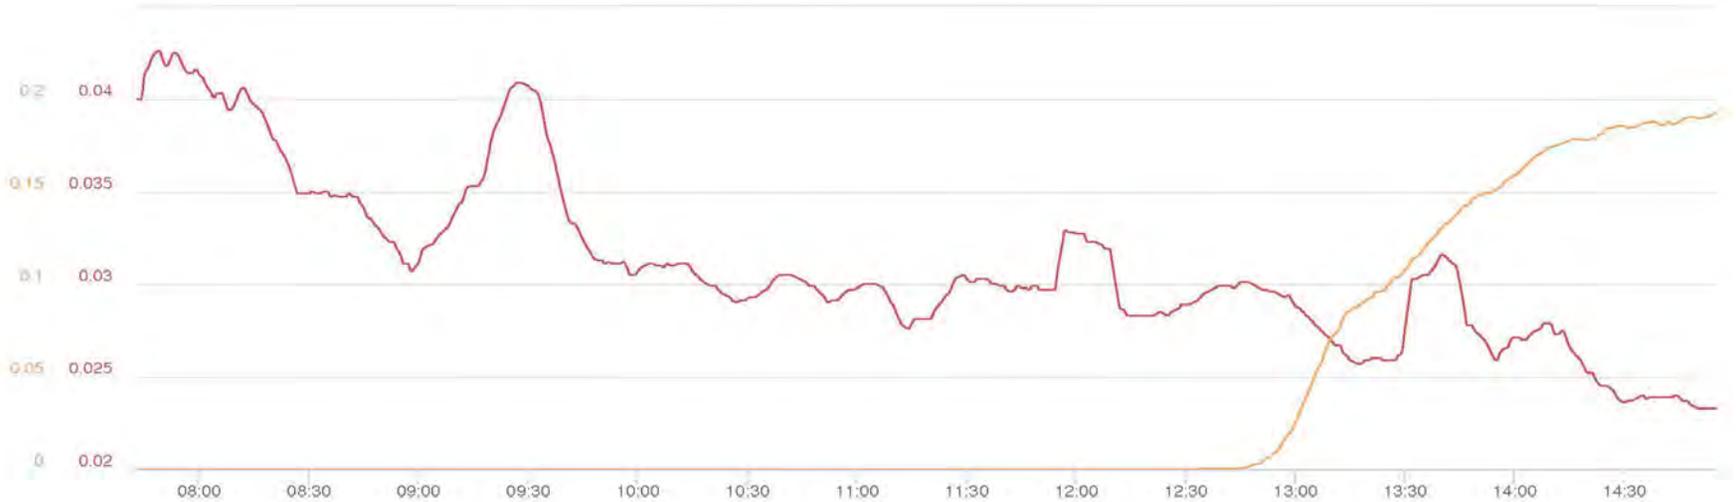
UH - Fixed 3 CAMP Station Graph

07/05/2023 0:00:42 – 07/06/2023 0:00:00
(GMT-05:00) Eastern Time (US & Canada)

Mass Conc. Total mg/m³ AVG 15m
mg/m³
DustTrak-8530
HS2-02(G)

MIN	AVG	MAX
0.0233	0.031	0.0426

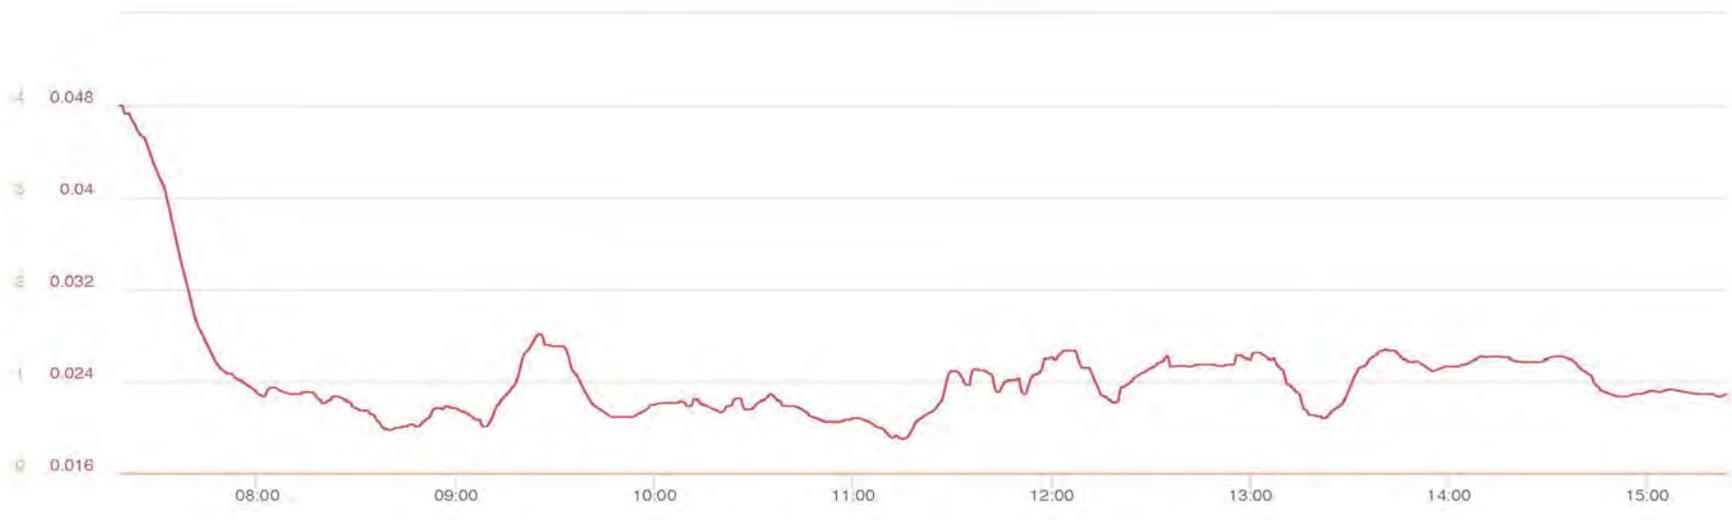
UH - Downwind 1 CAMP Station Graph

07/05/2023 0:00:09 – 07/06/2023 0:00:00
 (GMT-05:00) Eastern Time (US & Canada)

Mass Conc. Total mg/m³ AVG 15m
 mg/m³
 DustTrak-8530
 RS232(C)

MIN	AVG	MAX
0.019	0.0243	0.048

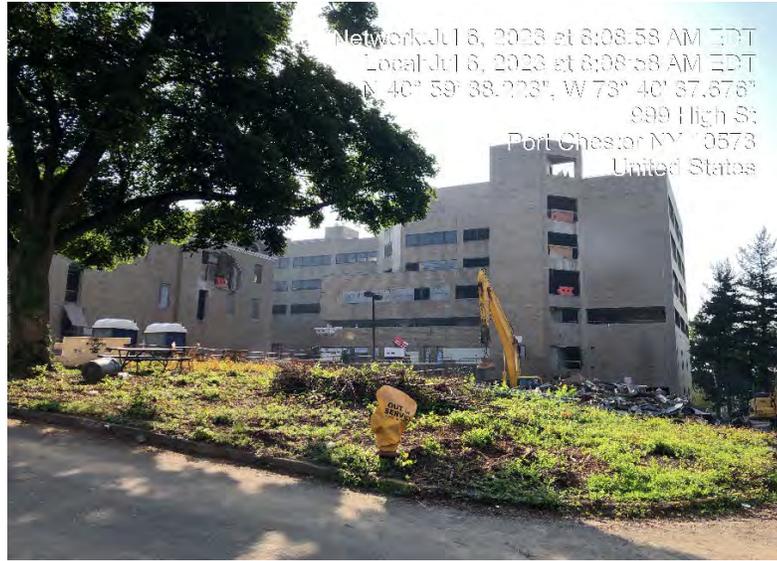
Photograph 1 -
Exterior handling of building materials associated with demolition of interior, non-loadbearing, building elements, view facing east.

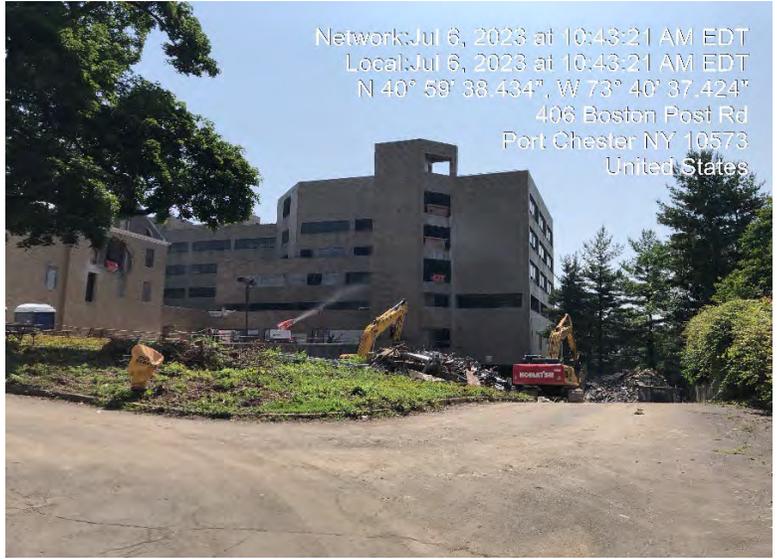
Photograph 2 -
Exterior handling of building materials associated with demolition of interior, non-loadbearing, building elements, view facing east.

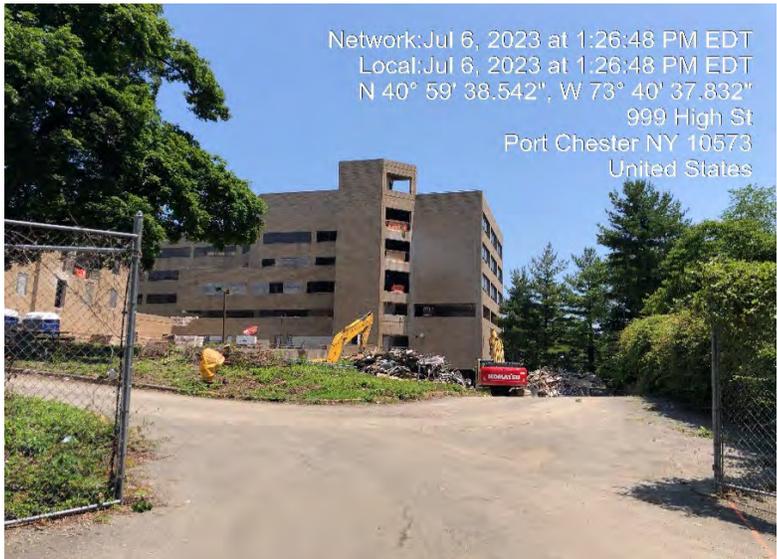
Photograph 3 -
Exterior handling of building materials associated with demolition of interior, non-loadbearing, building elements, view facing east.

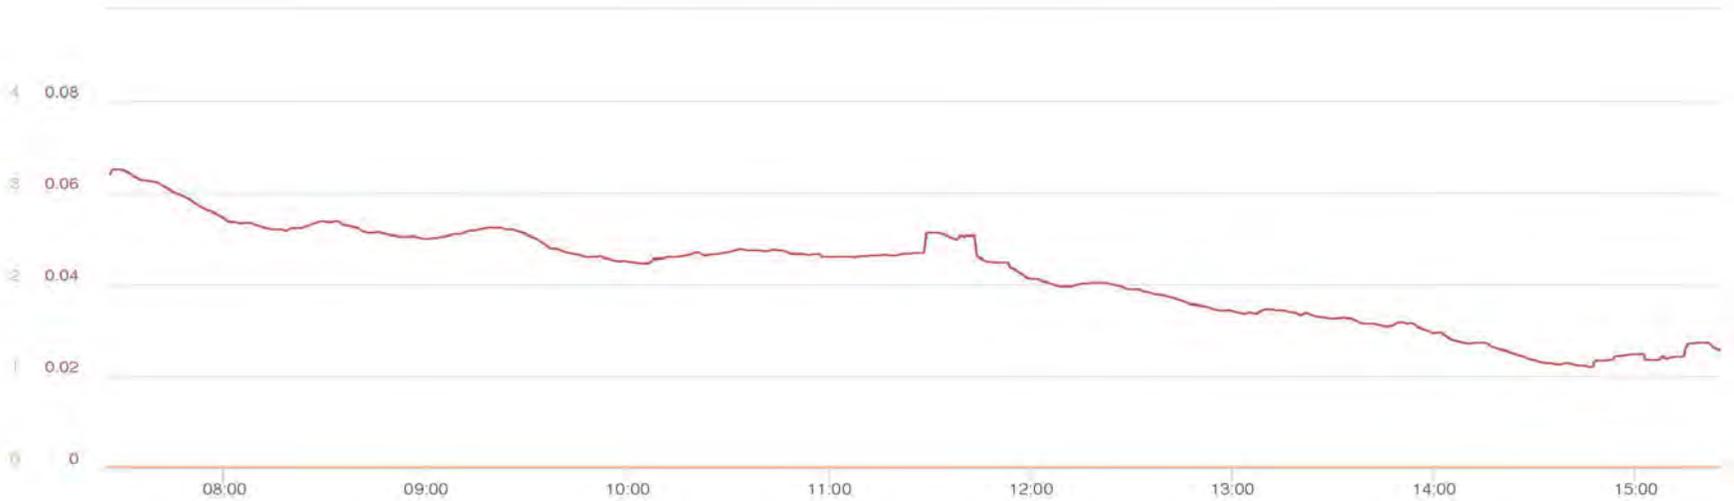
UH - Fixed 1 CAMP Station Graph

07/06/2023 0:00:00 – 07/07/2023 0:00:00
(GMT-05:00) Eastern Time (US & Canada)

Mass Conc. Total mg/m³ AVG 15m
mg/m³
DustTrak-8530
RS232(C)

MIN	AVG	MAX
0.0219	0.0419	0.065

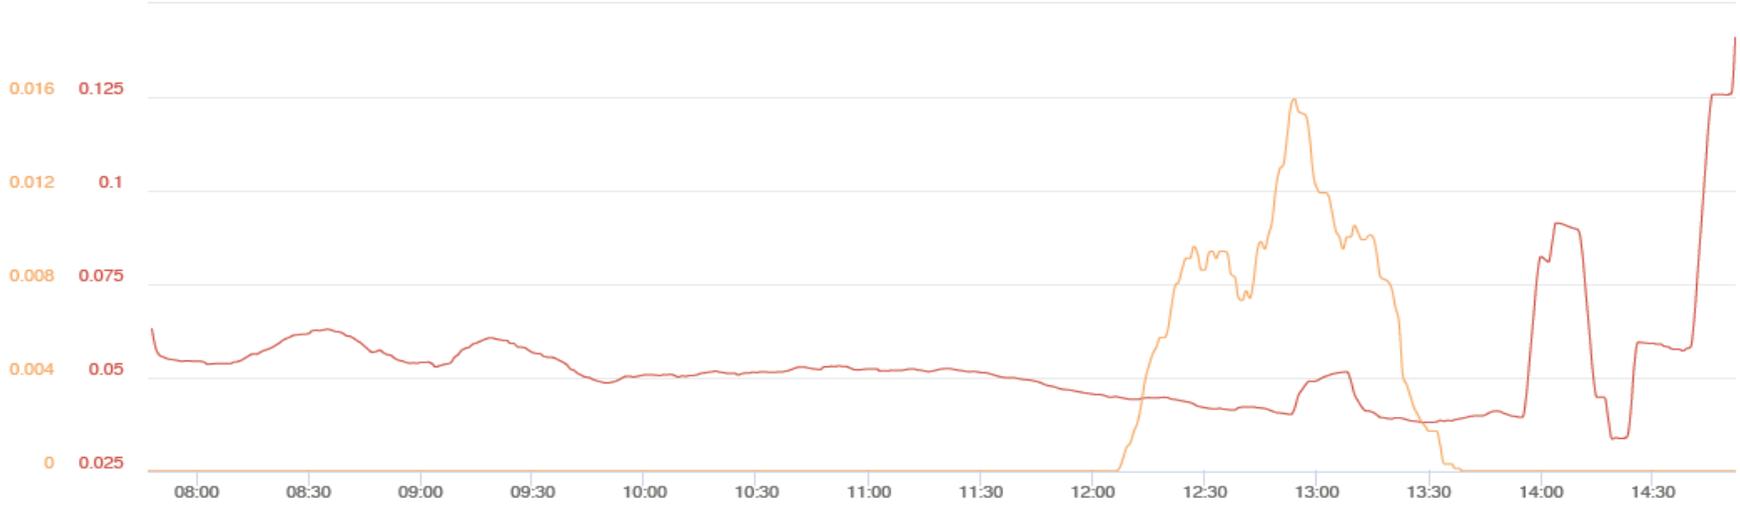
UH - Fixed 2 CAMP Station Graph

07/06/2023 0:00:05 – 07/07/2023 0:00:00
(GMT-05:00) Eastern Time (US & Canada)

Mass Conc. Total mg/m³ AVG 15m <small>mg/m³ DustTrak-8530 RS232(C)</small>			VOC ppm AVG 15m ppm <small>miniRAE 3000 RS232(A)</small>		
MIN	AVG	MAX	MIN	AVG	MAX
0.0335	0.0529	0.126	0	0	0.0159

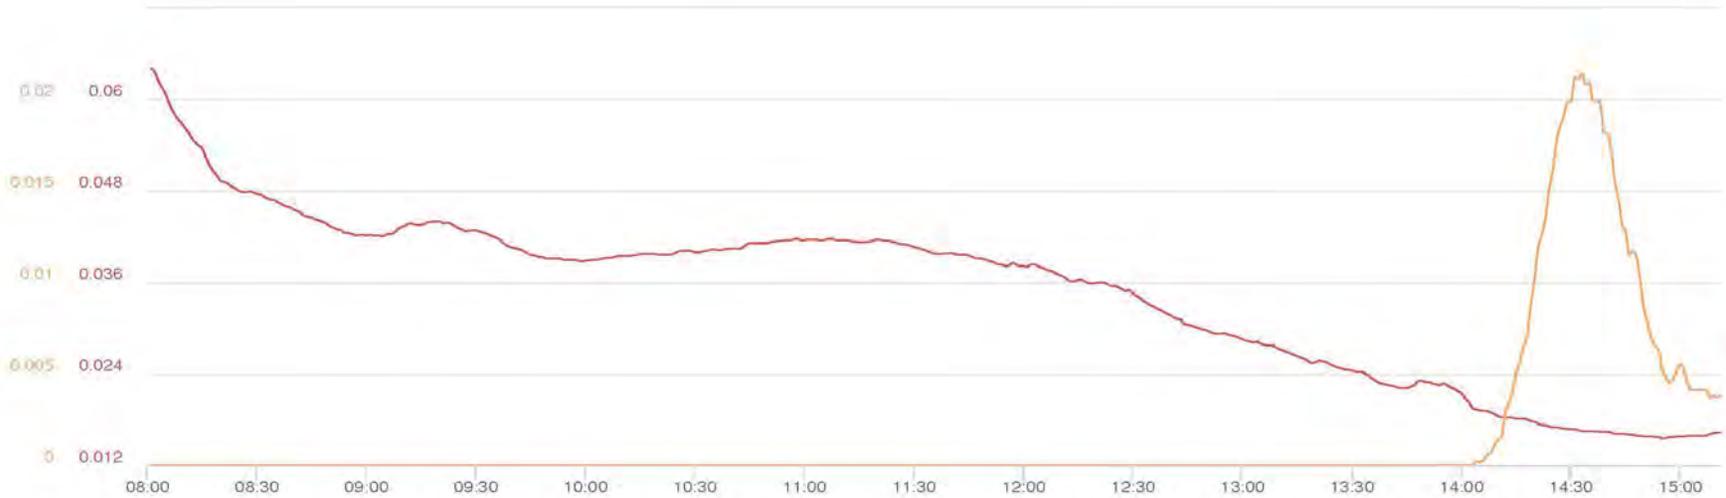
UH - Fixed 3 CAMP Station Graph

07/06/2023 0:00:13 – 07/07/2023 0:00:00
(GMT-05:00) Eastern Time (US & Canada)

Mass Conc. Total mg/m³ AVG 15m
mg/m³
DustTrak-8530
RS232(C)

MIN	AVG	MAX
0.0155	0.0347	0.064

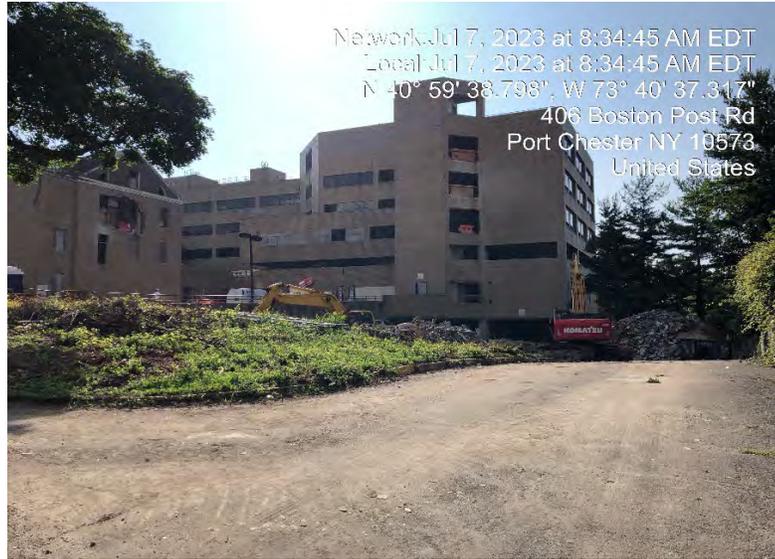
Photograph 1 -
Exterior handling of building materials associated with demolition of interior, non-loadbearing, building elements, view facing east.

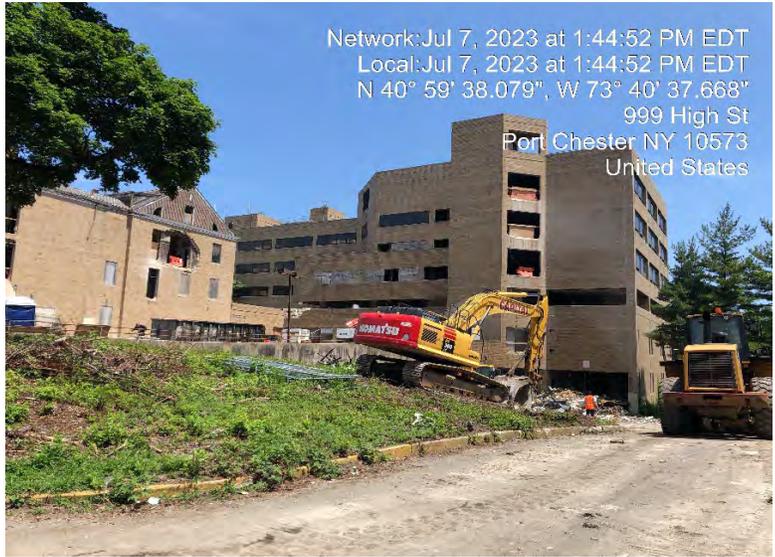
Photograph 2 -
Exterior handling of building materials associated with demolition of interior, non-loadbearing, building elements, view facing east.

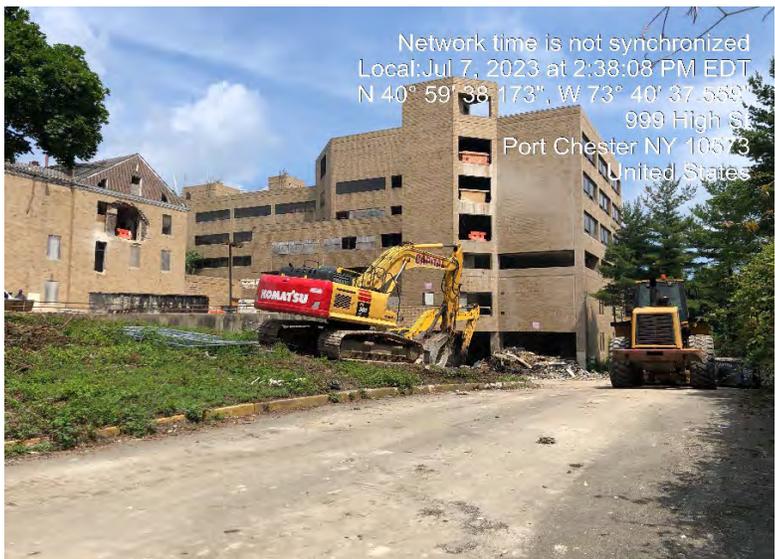
Photograph 3 -
Exterior handling of building materials associated with demolition of interior, non-loadbearing, building elements, view facing east.

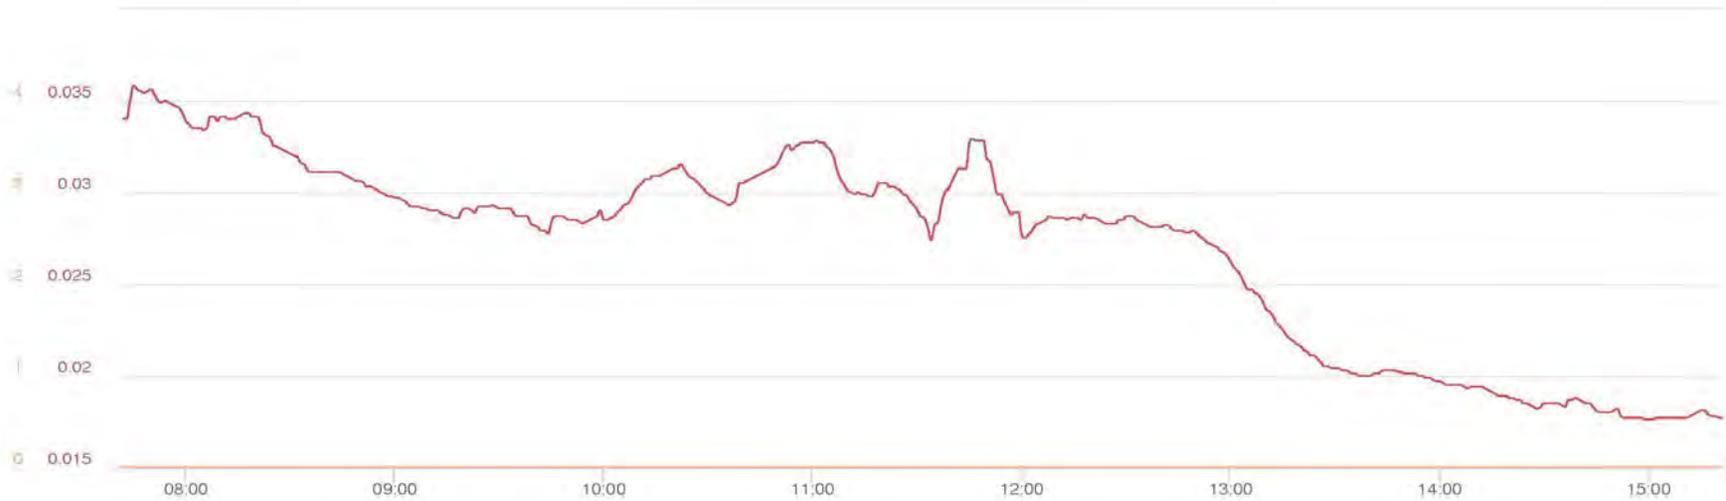
UH - Fixed 1 CAMP Station Graph

Fri, 7th of Jul 2023, 0:00:00 – 23:59:00
(GMT-05:00) Eastern Time (US & Canada)

Mass Conc. Total mg/m³ AVG 15m
mg/m³
DustTrak-8530
RS232(G)

MIN	AVG	MAX
0.0176	0.0271	0.0358

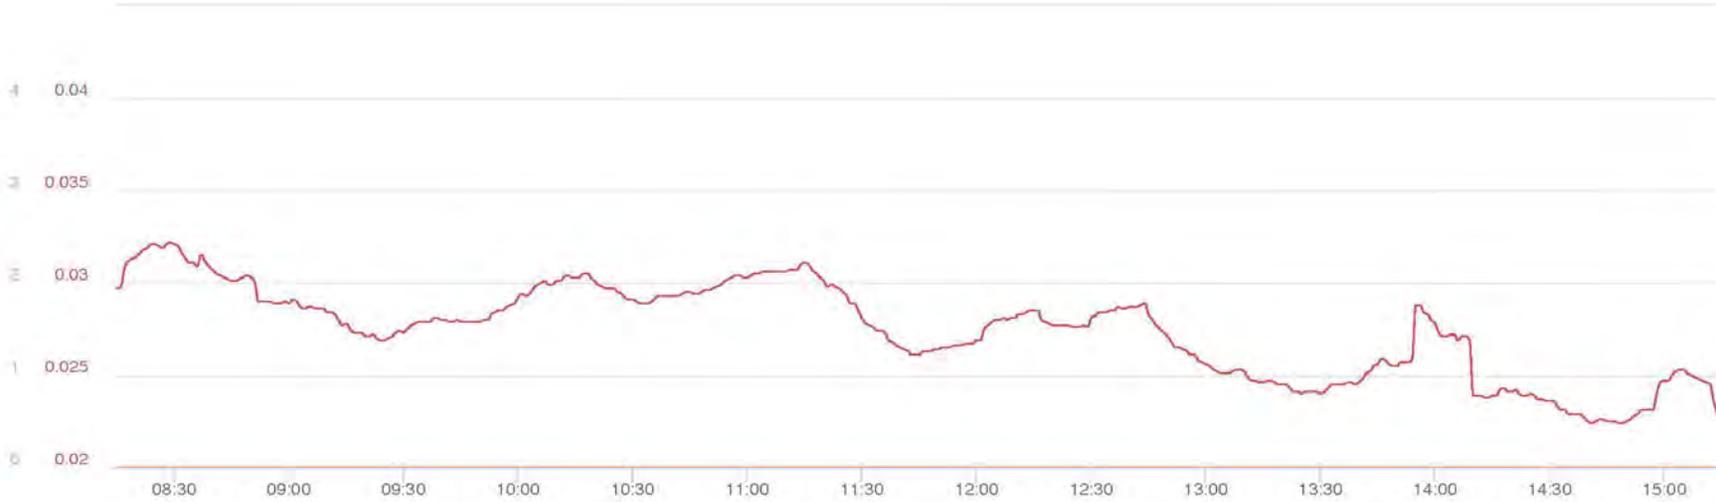
UH - Fixed 2 CAMP Station Graph

Fri, 7th of Jul 2023, 8:15:00 – 23:59:00
(GMT-05:00) Eastern Time (US & Canada)

Mass Conc. Total mg/m³ AVG 15m
mg/m³
DustTrak-8530
RS232(C)

MIN	AVG	MAX
0.0224	0.0275	0.0322

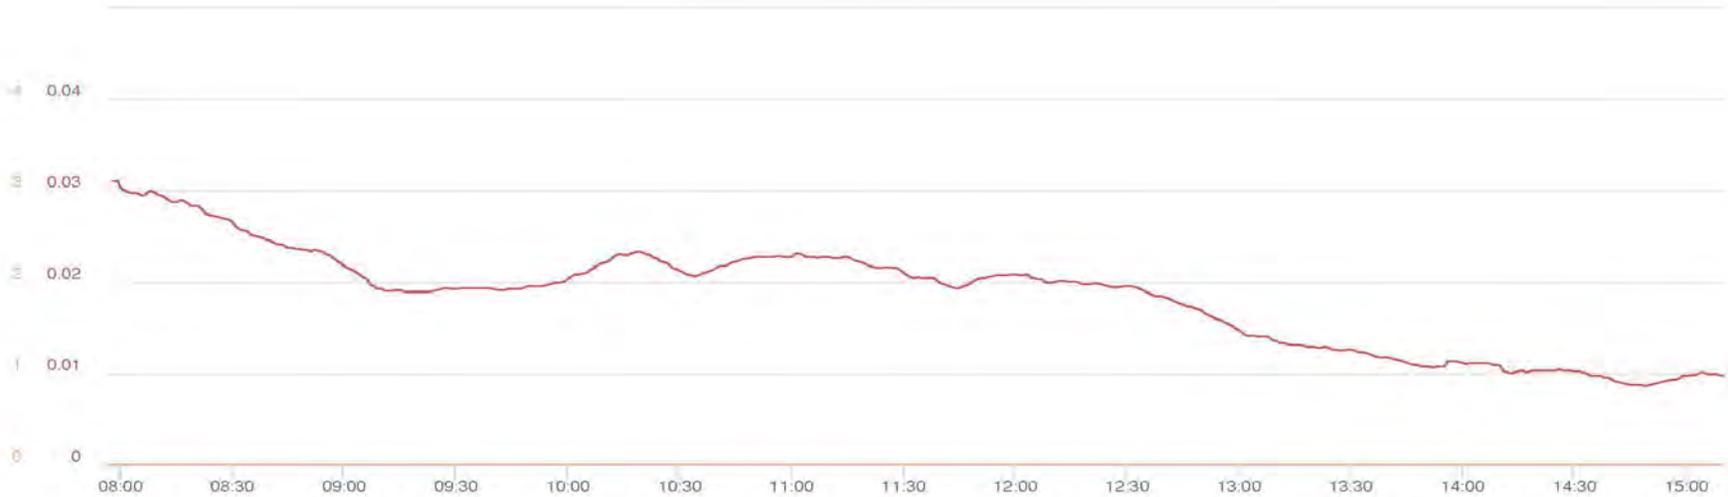
UH - Fixed 3 CAMP Station Graph

Fri, 7th of Jul 2023, 0:00:00 – 23:59:00
(GMT-05:00) Eastern Time (US & Canada)

Mass Conc. Total mg/m³ AVG 15m
mg/m³
DustTrak-8530
RS232(C)

MIN	AVG	MAX
0.0086	0.0184	0.031

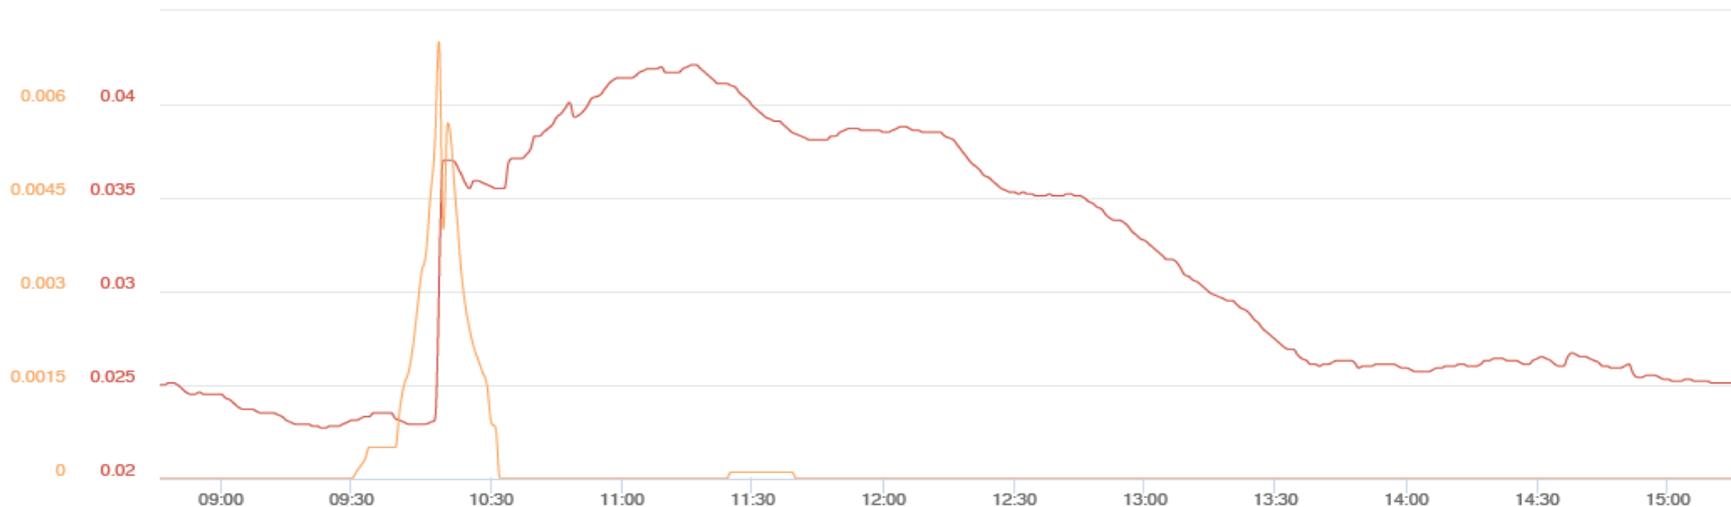
UH - Downwind 2 CAMP Station Graph

Fri, 7th of Jul 2023, 7:00:00 – 17:00:00
(GMT-05:00) Eastern Time (US & Canada)

Mass Conc. Total mg/m ³ AVG 15m		
mg/m ³		
DustTrak-8530		
RS232(C)		
MIN	AVG	MAX
0.0227	0.0313	0.0421

VOC ppm AVG 15m		
ppm		
miniRAE 3000		
RS232(A)		
MIN	AVG	MAX
0	0	0.007

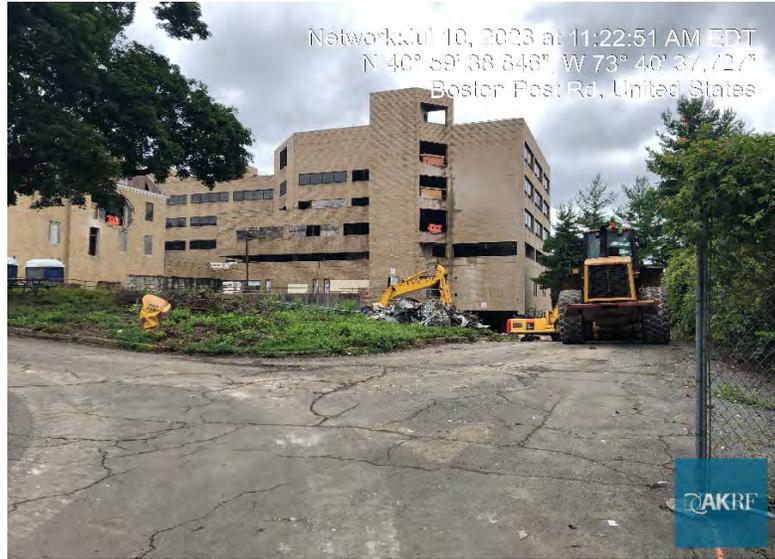
Photograph 1 -
Exterior handling of building materials associated with demolition of interior, non-loadbearing, building elements, view facing east.

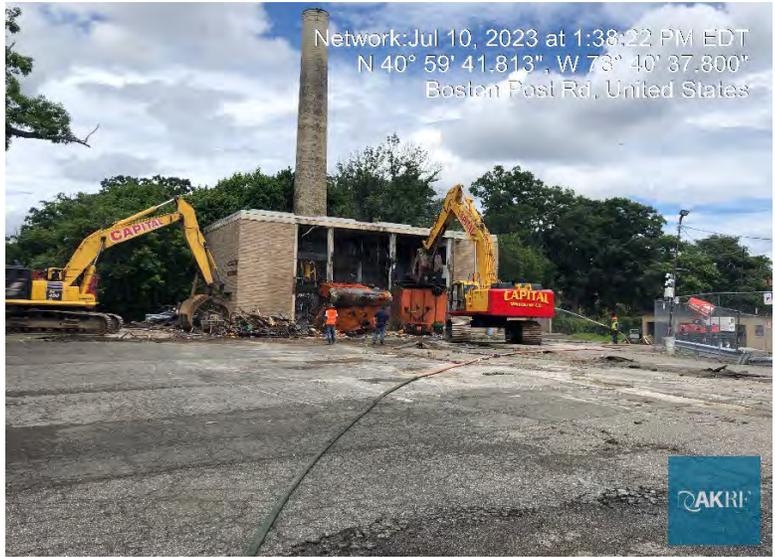
Photograph 2 -
Exterior handling of building materials associated with demolition of boiler building, non-loadbearing, building elements, view facing northeast.

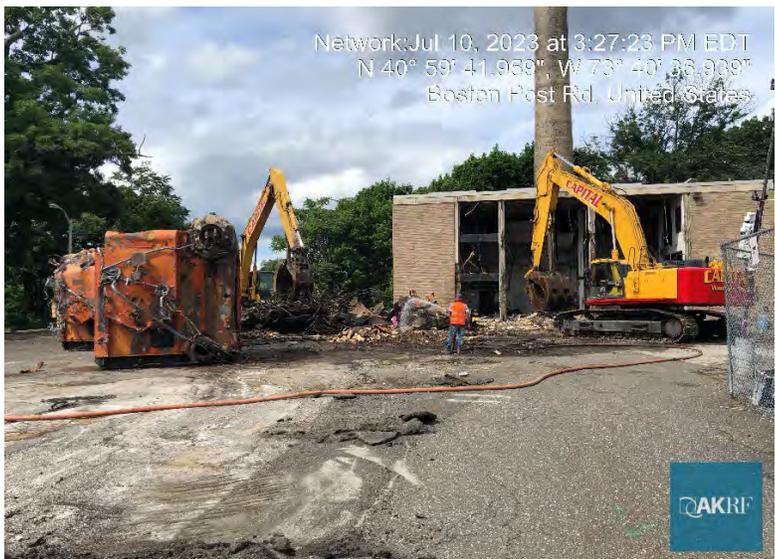
Photograph 3 -
Exterior handling of building materials associated with demolition of boiler building, non-loadbearing, building elements, view facing north.

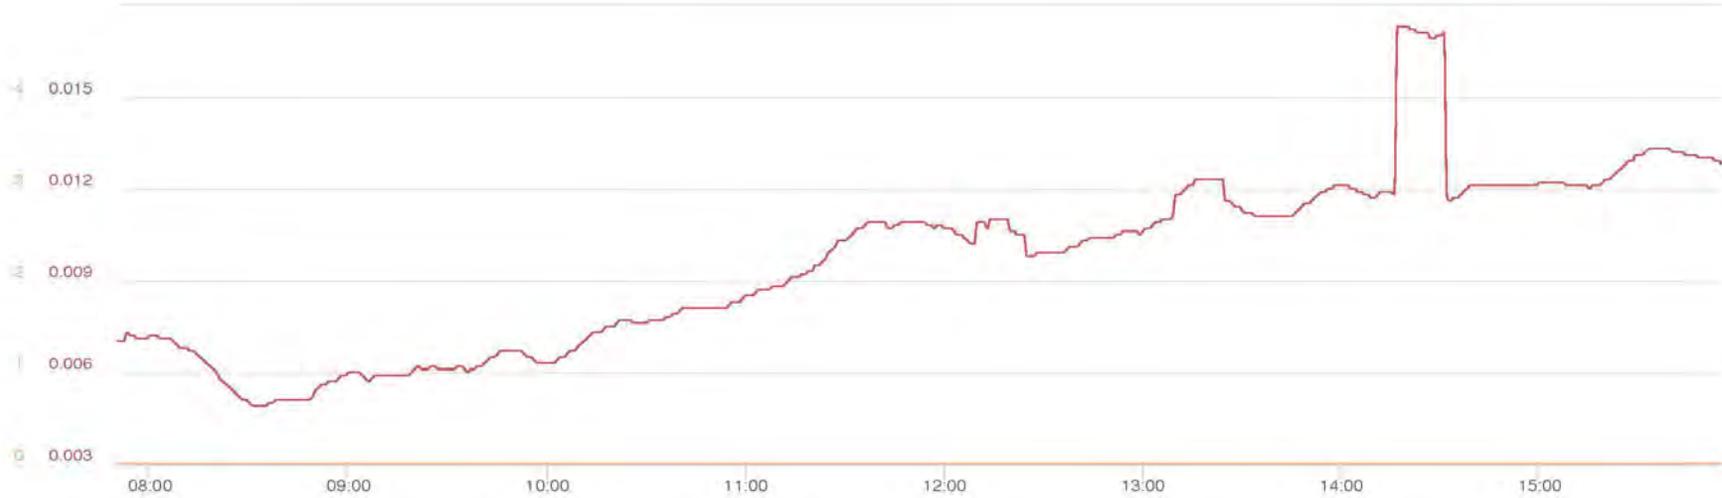
UH - Fixed 1 CAMP Station Graph

07/10/2023 0:00:10 – 07/11/2023 0:00:00
(GMT-05:00) Eastern Time (US & Canada)

Mass Conc. Total mg/m³ AVG 15m
mg/m³
DustTrak-8530
RS232(G)

MIN	AVG	MAX
0.0049	0.01	0.0173

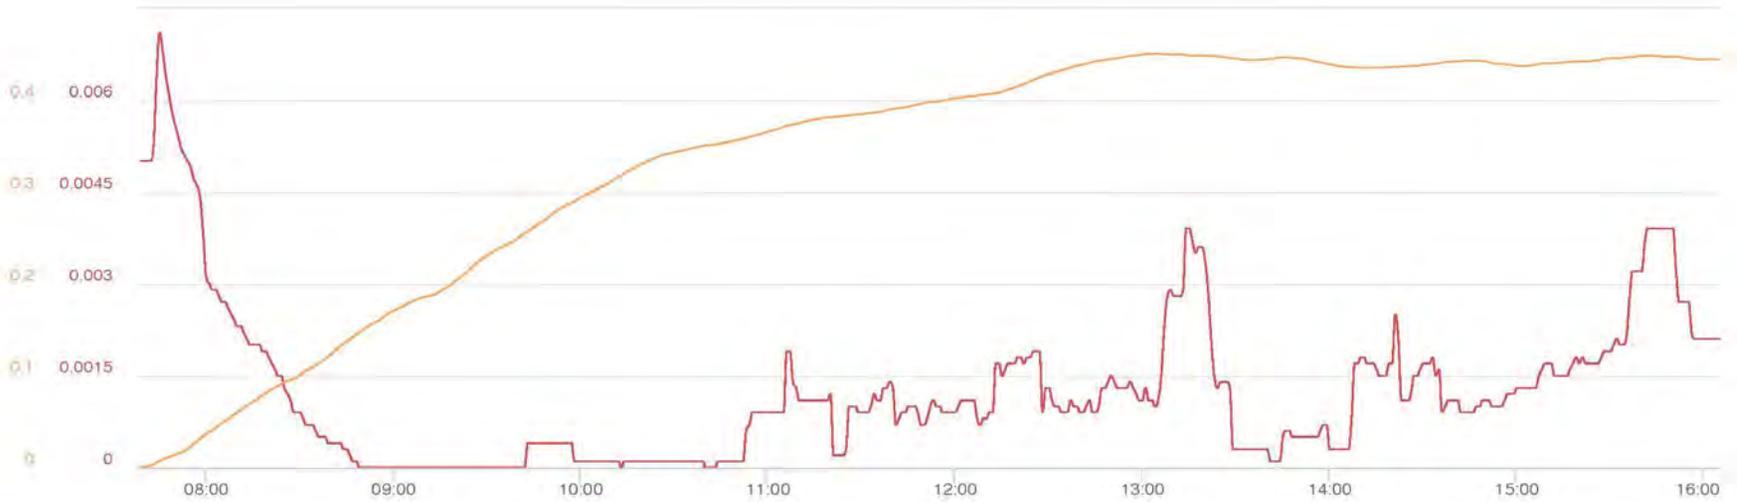
UH - Downwind 1 CAMP Station Graph

07/10/2023 0:00:53 – 07/11/2023 0:00:00
(GMT-05:00) Eastern Time (US & Canada)

Mass Conc. Total mg/m³ AVG 15m
mg/m³
DustTrak-8530
RS232(C)

MIN	AVG	MAX
0	0.0012	0.0071

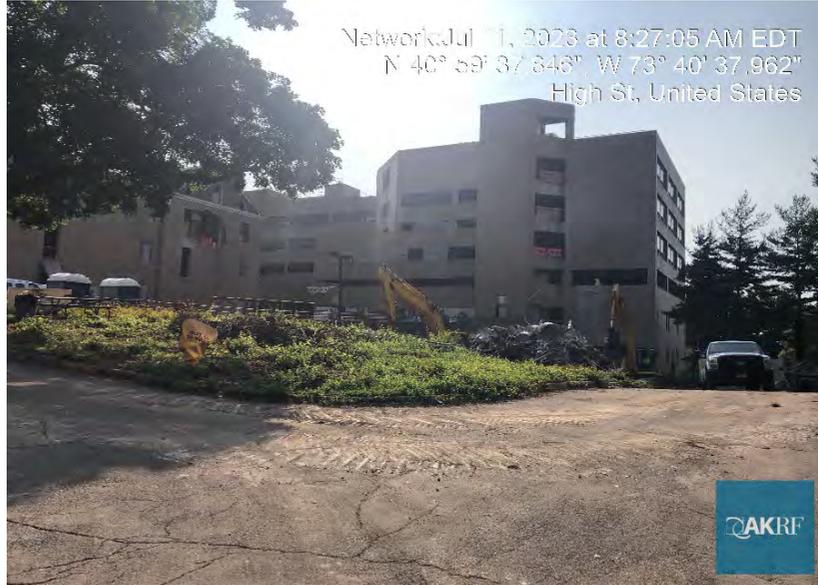
Photograph 1 -
Exterior handling of building materials associated with demolition of interior, non-loadbearing, building elements, view facing east.
