August 10, 2023

Re: Monthly Progress Report – July 2023
Former United Hospital – 406 Boston Post Road, Port Chester, New York
NYSDEC BCP Site No. C360202

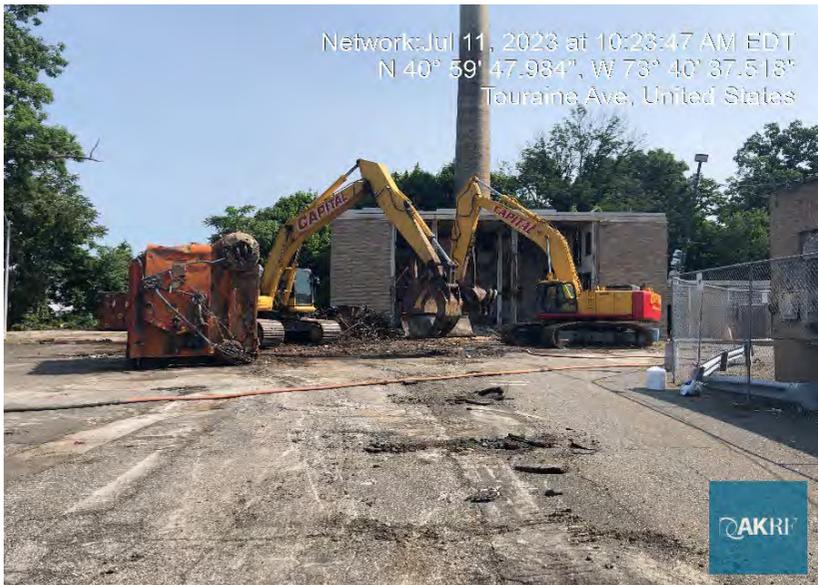
Photograph 2 -
Exterior handling of building materials associated with demolition of boiler building, non-loadbearing, building elements, view facing north.

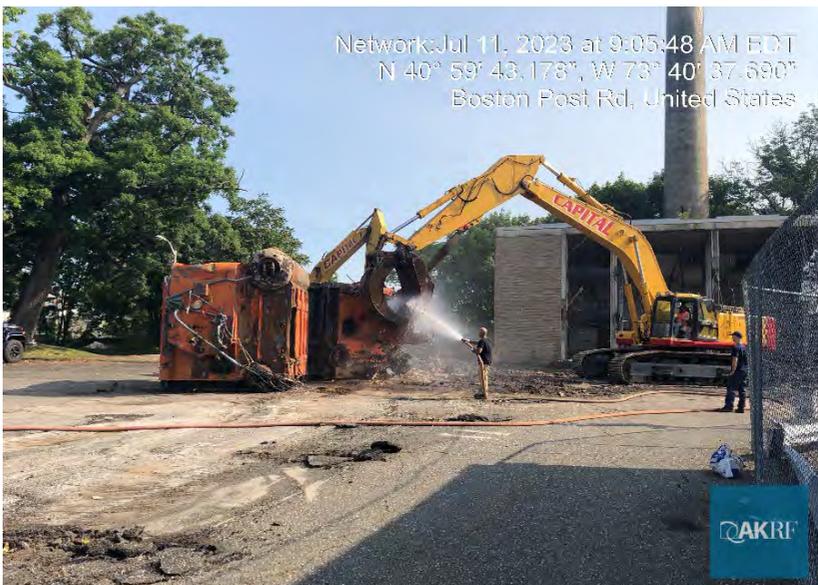
Photograph 3 -
Exterior handling of building materials associated with demolition of boiler building, non-loadbearing, building elements, view facing north.

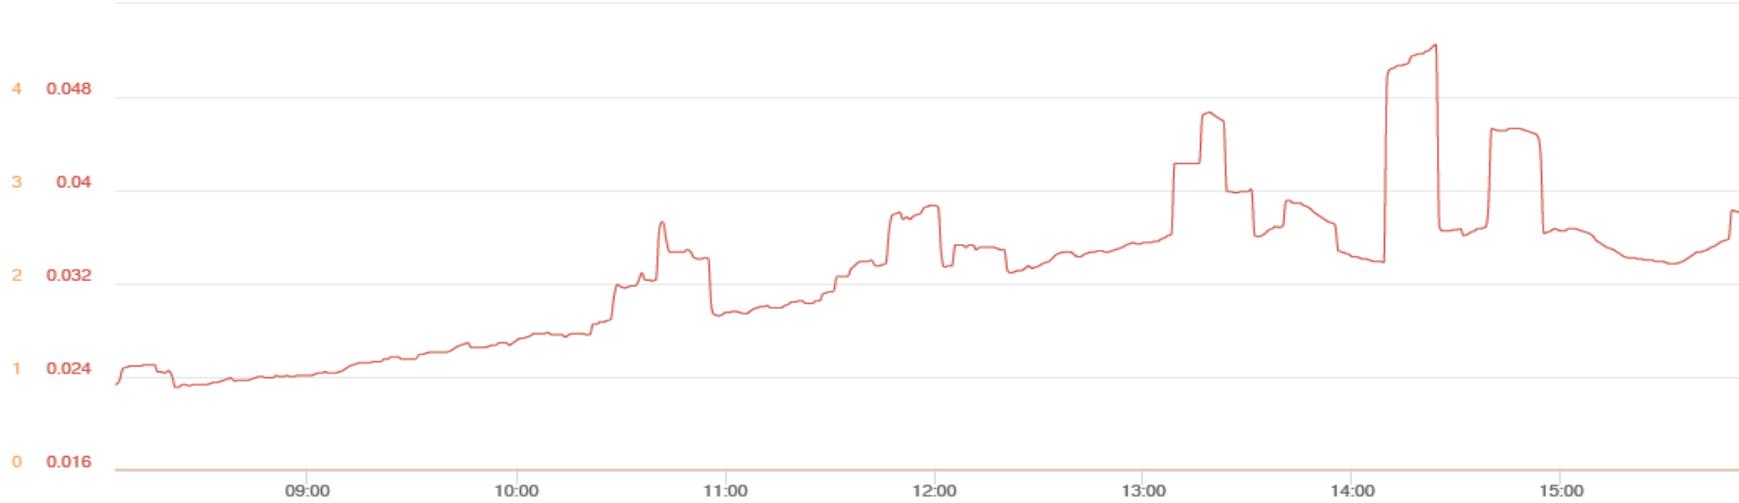
UH - Fixed 1 CAMP Station Graph

07/11/2023 8:05:00 – 07/12/2023 0:00:00
(GMT-05:00) Eastern Time (US & Canada)

Mass Conc. Total mg/m ³ AVG 15m		
mg/m ³ DustTrak-8530 RS232(C)		
MIN	AVG	MAX
0.0231	0.033	0.0525

VOC ppm AVG 15m		
ppm miniRAE 3000 RS232(A)		
MIN	AVG	MAX
0	0	0

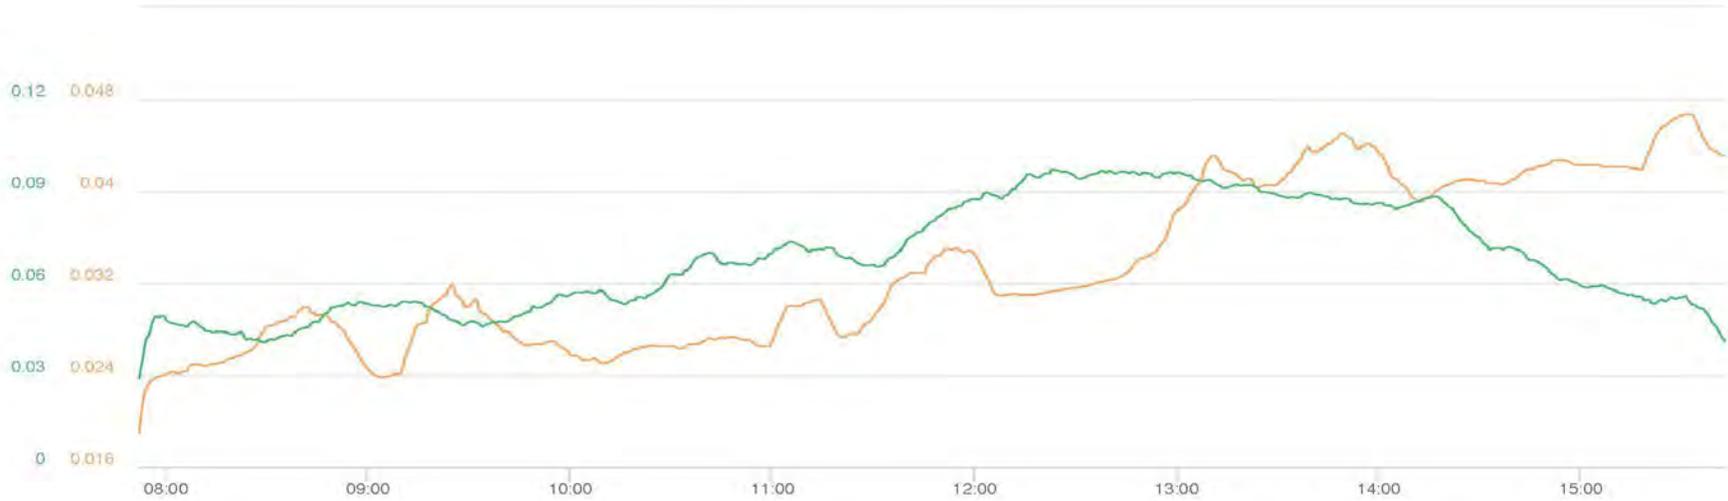
UH - Fixed 2 CAMP Station Graph

07/11/2023 0:00:06 – 07/12/2023 0:00:00
(GMT-05:00) Eastern Time (US & Canada)

Mass Conc. Total mg/m³ AVG 15m
mg/m³
DustTrak-8530
RS232(C)

MIN	AVG	MAX
0.019	0.0334	0.0467

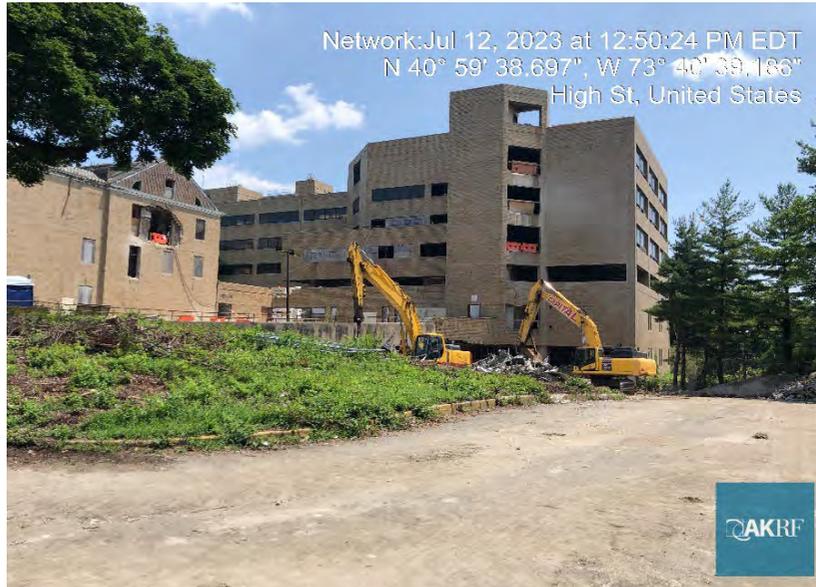
Photograph 1 -
Exterior handling of building materials associated with demolition of interior, non-loadbearing, building elements, view facing east.

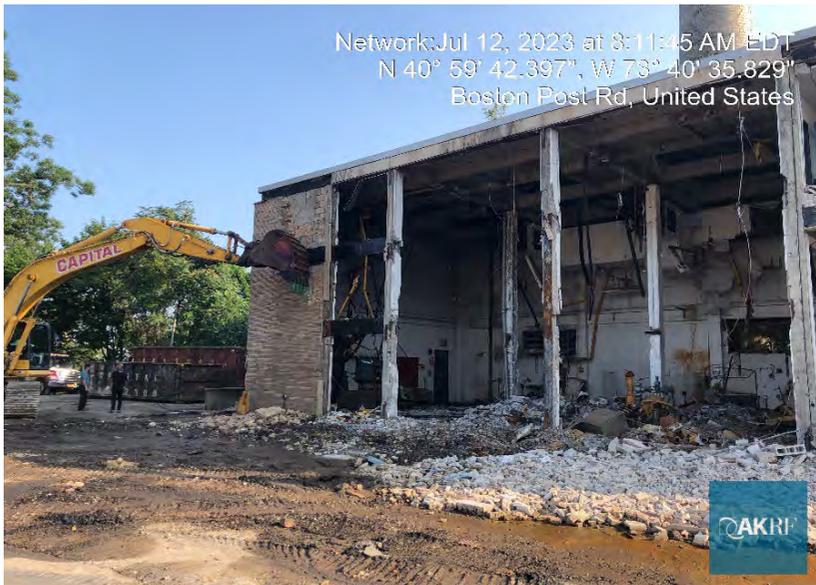
The demolition began Phase III of the demolition work (Structural Demolition) at the former power/boiler plant building in the northern portion of the site. This work involved the removal of the exterior walls on the southern portion of the building to gain access to the building's interior for the removal of mechanical equipment and other loose items (e.g., furniture, garbage, etc.); the demolition debris was loaded into containers for off-site disposal.

Photograph 2 -
Demolition of the former power/ boiler plant building in the northern portion of the site, view facing northwest.

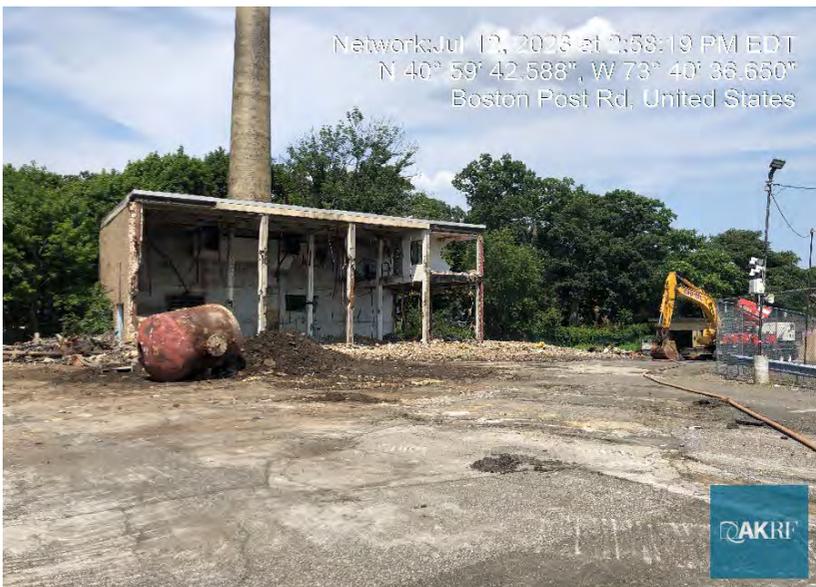
Photograph 3 -
Exterior handling of building materials associated with the demolition of the former power/ boiler plant building in the northern portion of the site, view facing northeast.

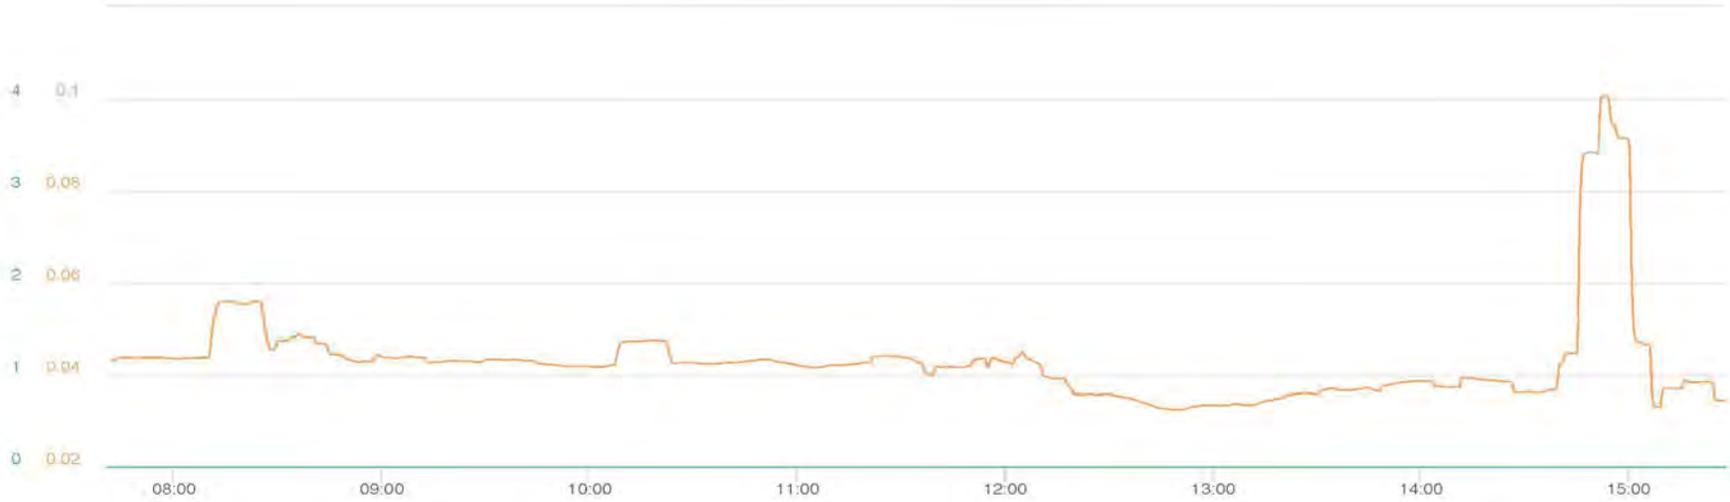
UH - Fixed 1 CAMP Station Graph

07/12/2023 0:00:52 – 07/13/2023 0:00:00
(GMT-05:00) Eastern Time (US & Canada)

Mass Conc. Total mg/m³ AVG 15m
mg/m³
DustTrak-8530
RS232(C)

MIN	AVG	MAX
0.0324	0.0429	0.1006

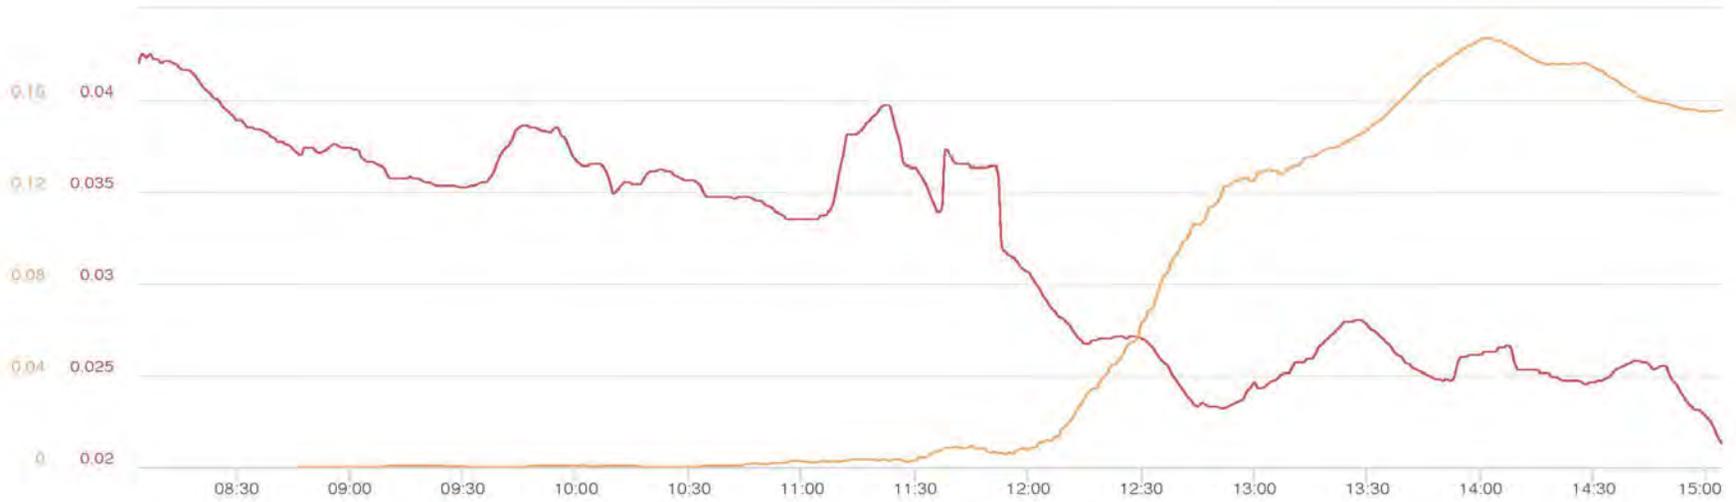
UH - Fixed 3 CAMP Station Graph

Mass Conc. Total mg/m³ AVG 15m
mg/m³
DustTrak-8530
RS232(C)

MIN	AVG	MAX
0.0216	0.0319	0.0425

VOC ppm AVG 15m ppm
miniRAE 3000
RS232(A)

MIN	AVG	MAX
0	0.064	0.1869

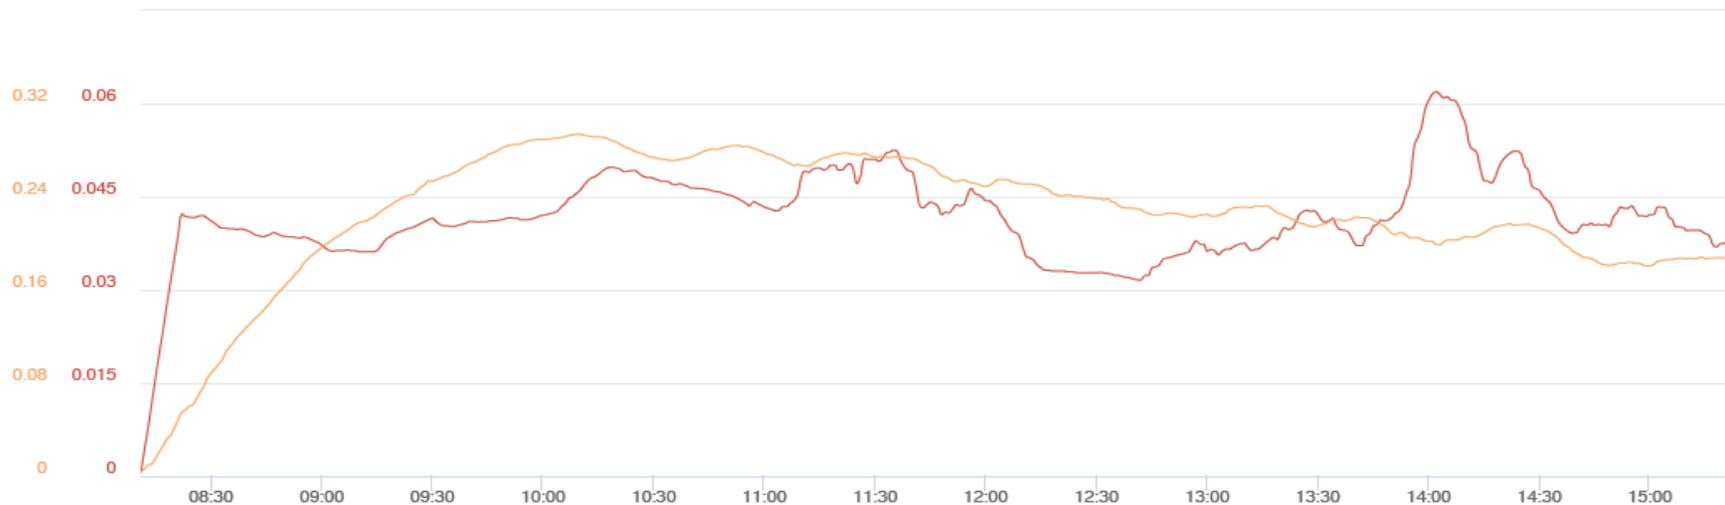
UH - Downwind 2 CAMP Station Graph

Mass Conc. Total mg/m ³ AVG 15m		
mg/m ³ DustTrak-8530 RS232(C)		
MIN	AVG	MAX
0.0006	0.0417	0.0619

VOC ppm AVG 15m		
ppm miniRAE 3000 RS232(A)		
MIN	AVG	MAX
0.0033	0.2241	0.2937

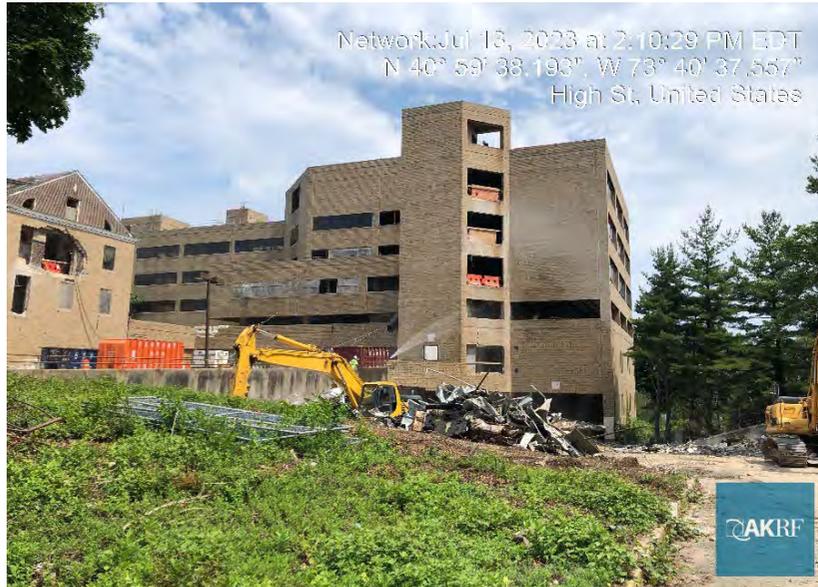
Photograph 1 -
Exterior handling of building materials associated with demolition of interior, non-loadbearing, building elements, view facing east.

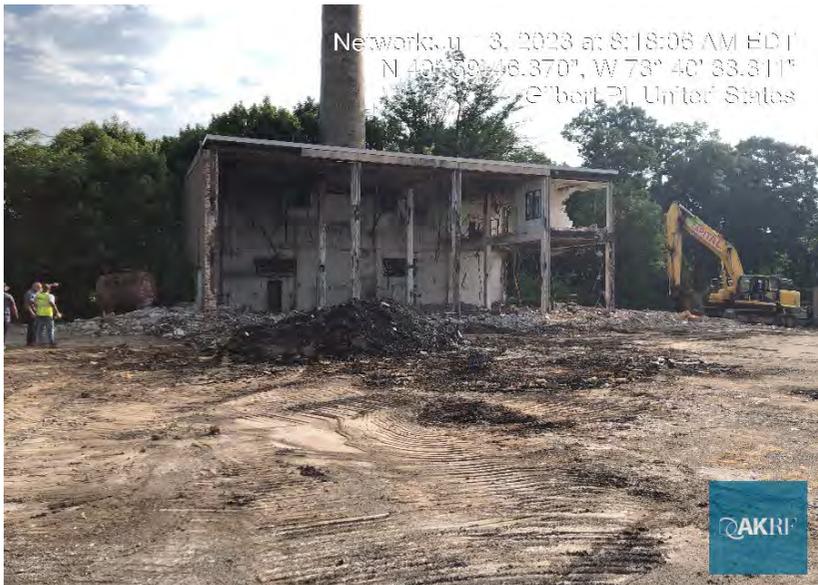
Photograph 2 -
Demolition of the former power/ boiler plant building in the northern portion of the site, view facing northeast.

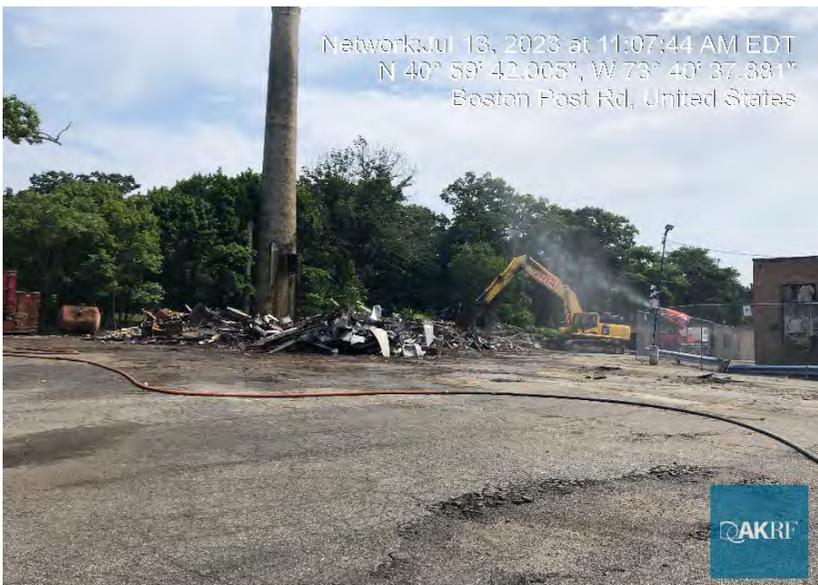
Photograph 3 -
Demolition of the former power/ boiler plant building in the northern portion of the site, view facing northeast.

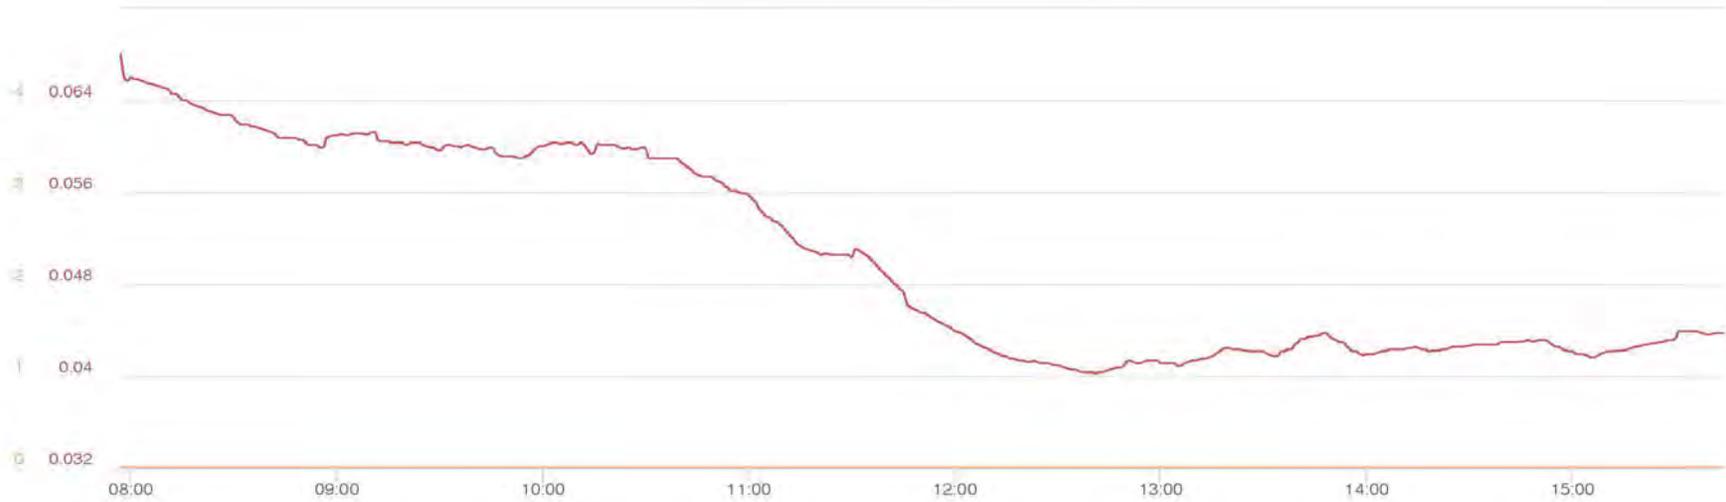
UH - Fixed 2 CAMP Station Graph

Mass Conc. Total mg/m³ AVG 15m
mg/m³
DustTrak-8530
RS232(C)

MIN	AVG	MAX
0.0402	0.0504	0.068

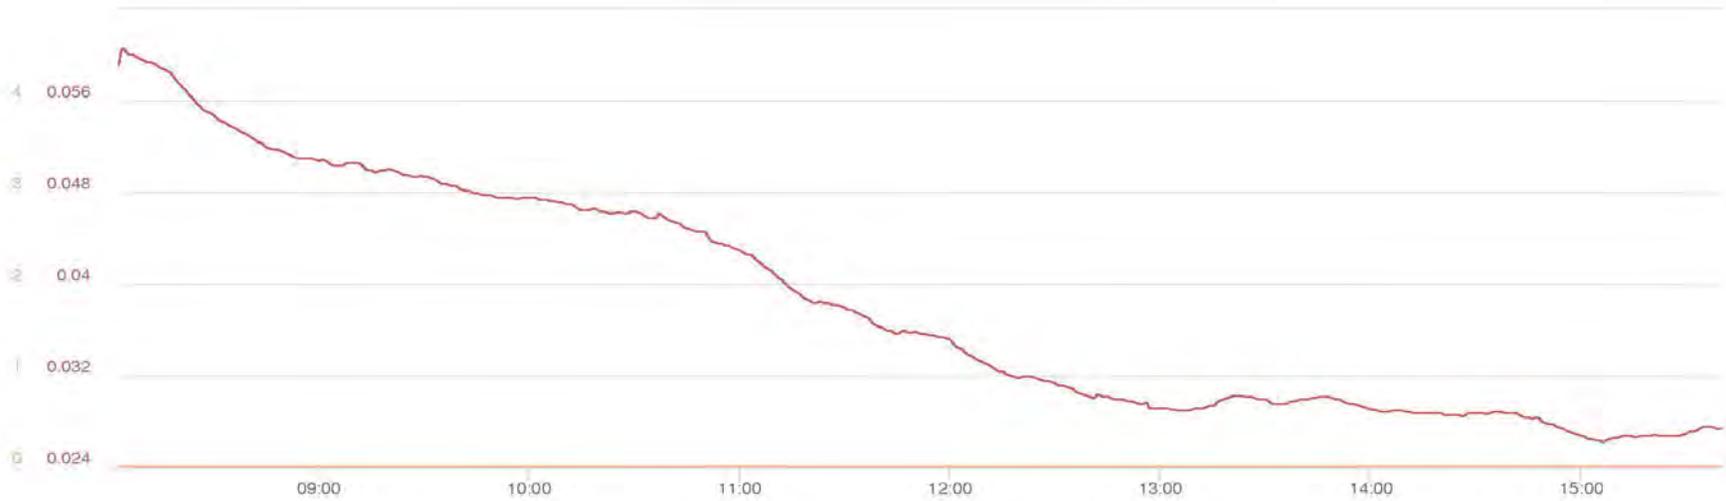
UH - Fixed 3 CAMP Station Graph

Mass Conc. Total mg/m³ AVG 15m
mg/m³
DustTrak-8530
RS232(C)

MIN	AVG	MAX
0.0261	0.0384	0.0605

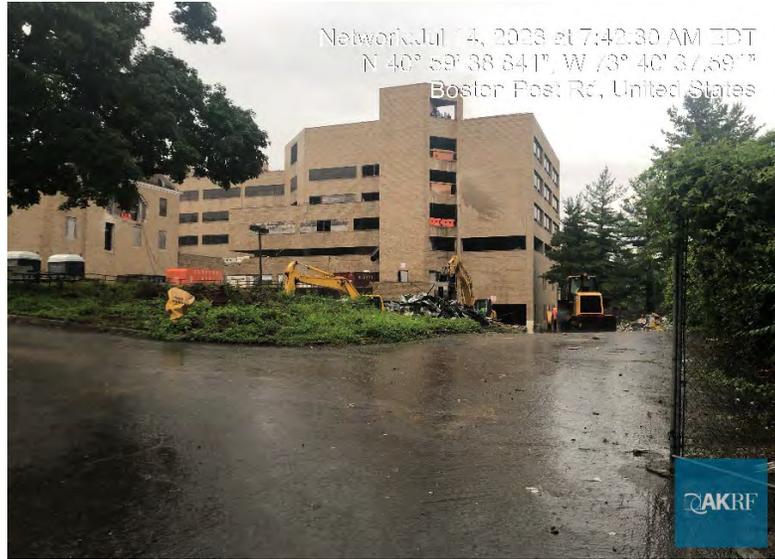
Photograph 1 -
Exterior handling of building materials associated with demolition of interior, non-loadbearing, building elements, view facing east.

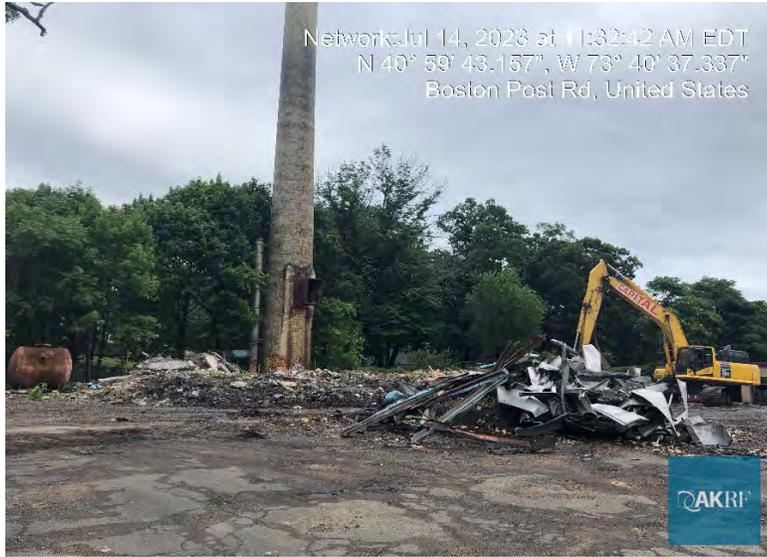
Photograph 2 -
Sorting of demolition debris from the former power/boiler plant building in the northern portion of the site, view facing northeast.

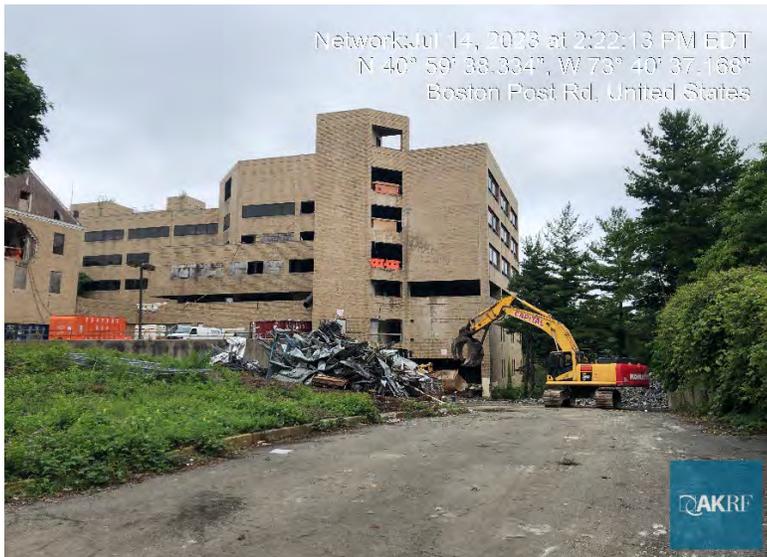
Photograph 3 -
Exterior handling of building materials associated with demolition of interior, non-loadbearing, building elements, view facing east.

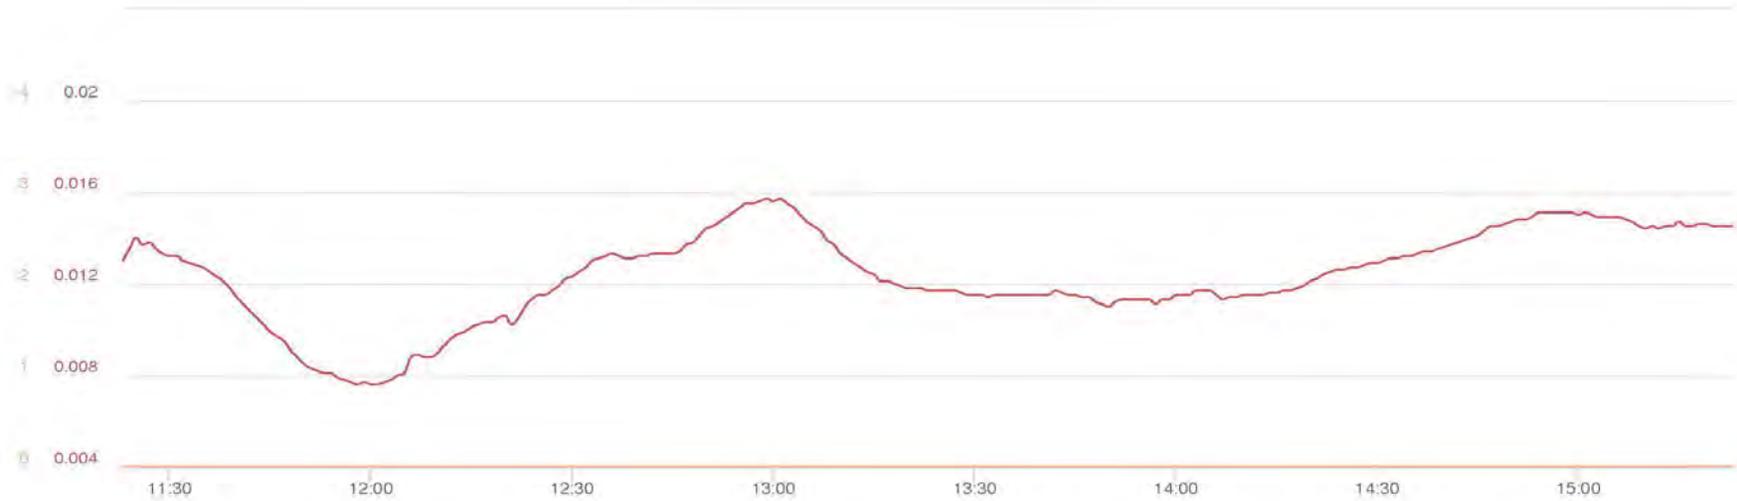
UH - Fixed 3 CAMP Station Graph

Mass Conc. Total mg/m³ AVG 15m
mg/m³
DustTrak-8530
RS232(G)

MIN	AVG	MAX
0.0076	0.0123	0.0157

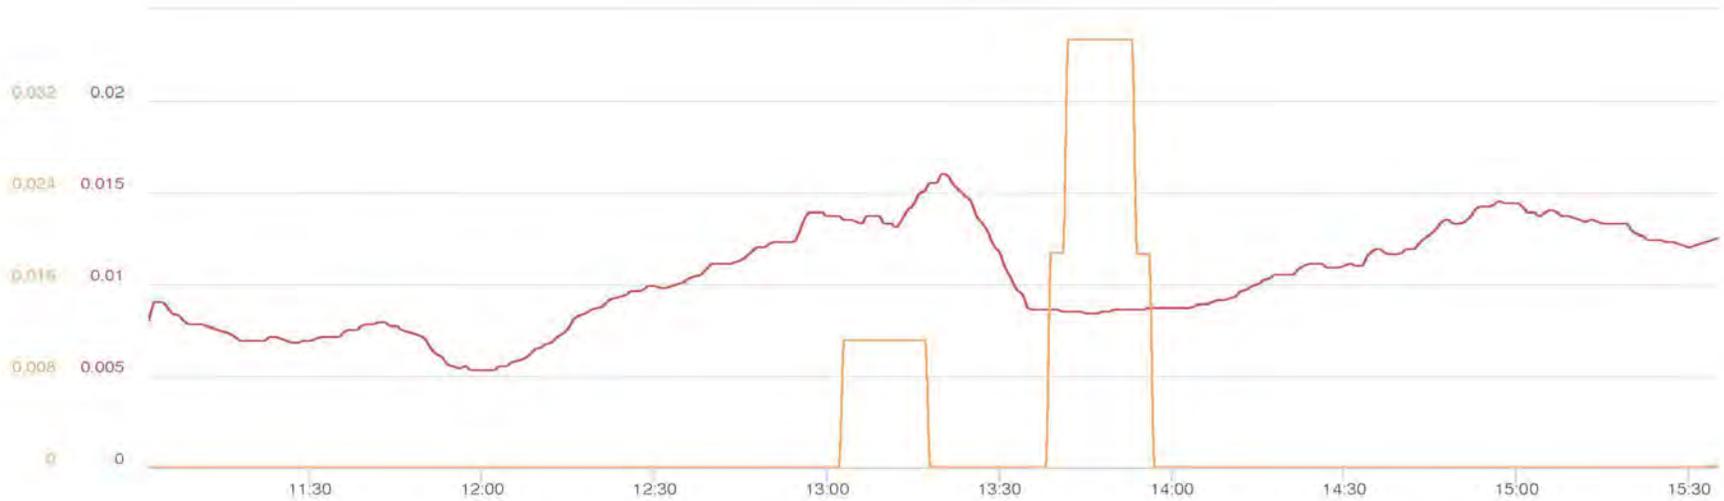
UH - Downwind 1 CAMP Station Graph

Mass Conc. Total mg/m³ AVG 15m
mg/m³
DustTrak-8530
RS232(C)

MIN	AVG	MAX
0.0053	0.0103	0.016

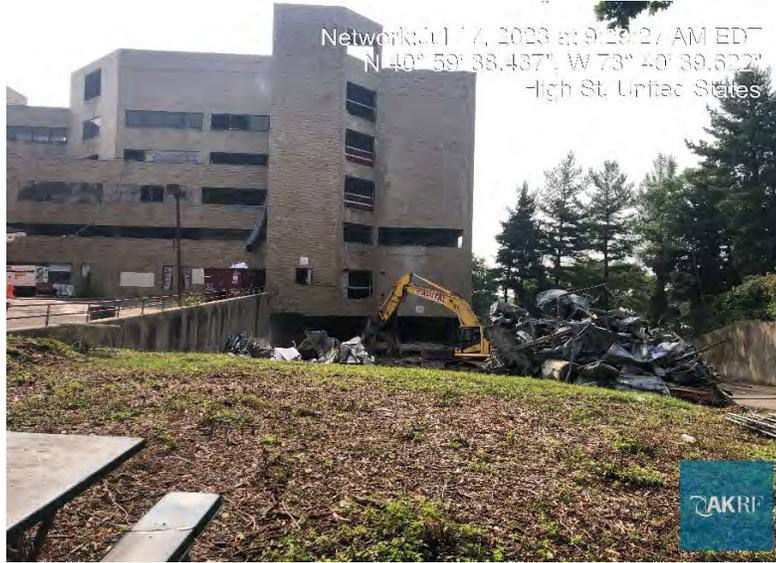
Photograph 1 -
Exterior handling of building materials associated with demolition of interior, non-loadbearing, building elements, view facing east.

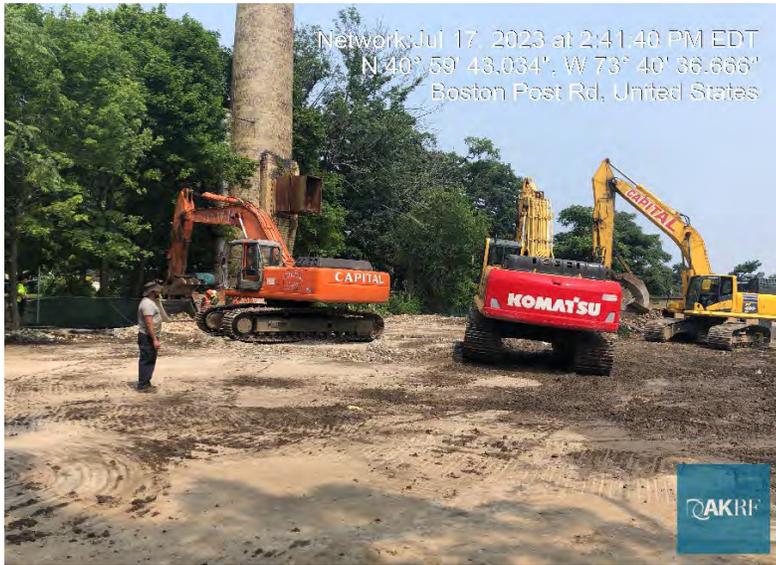
Photograph 2 -
Handling of demolition debris from the former power/boiler plant building in the northern portion of the site, view facing northeast.

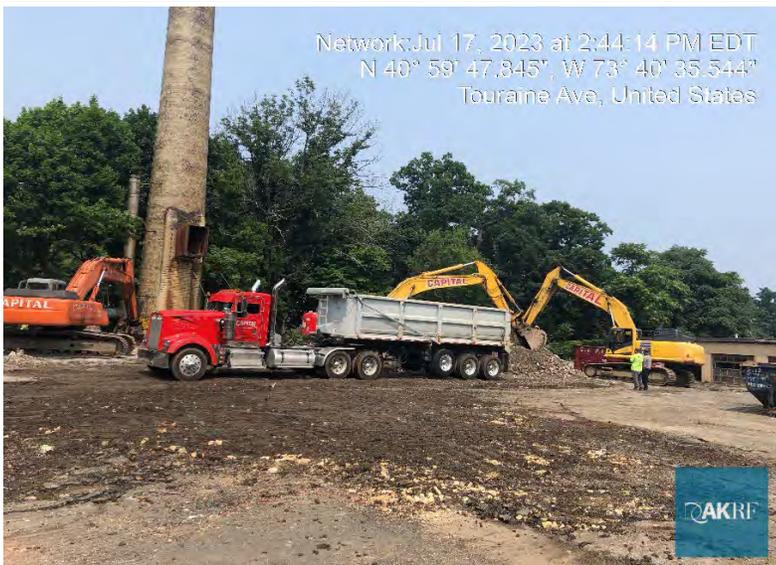
Photograph 3 -
Handling of demolition debris from the former power/boiler plant building in the northern portion of the site, view facing northeast.

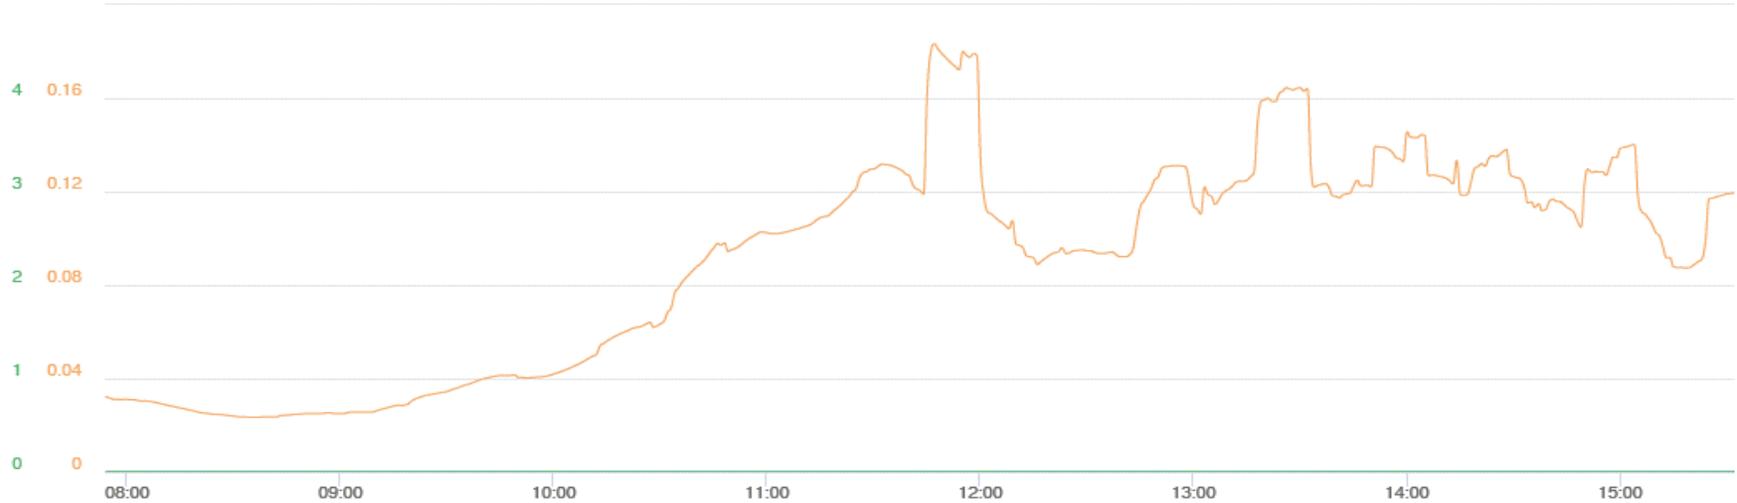
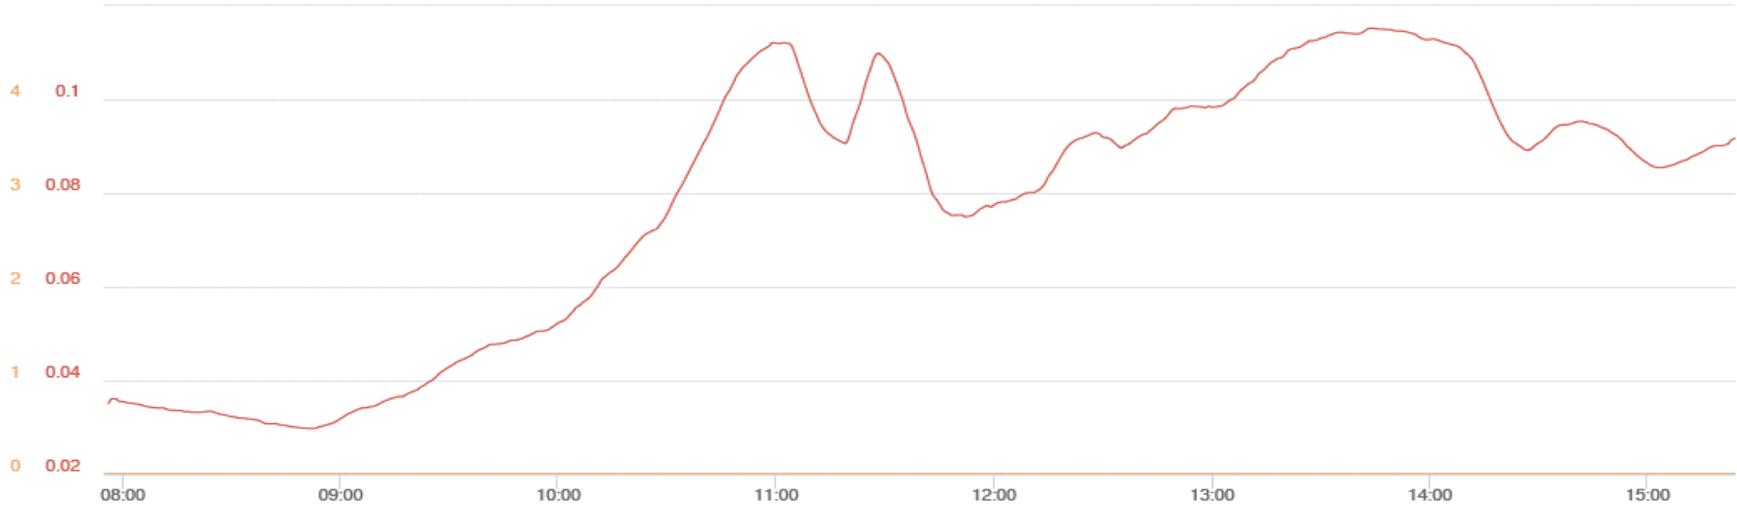
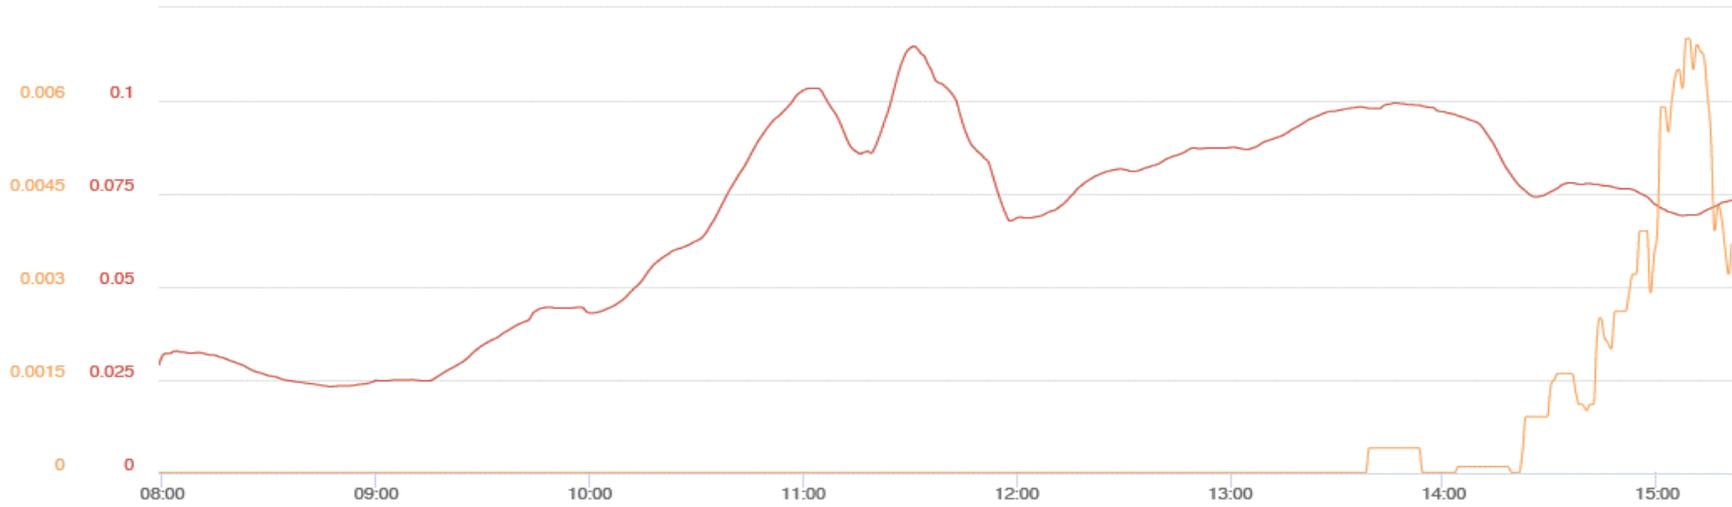
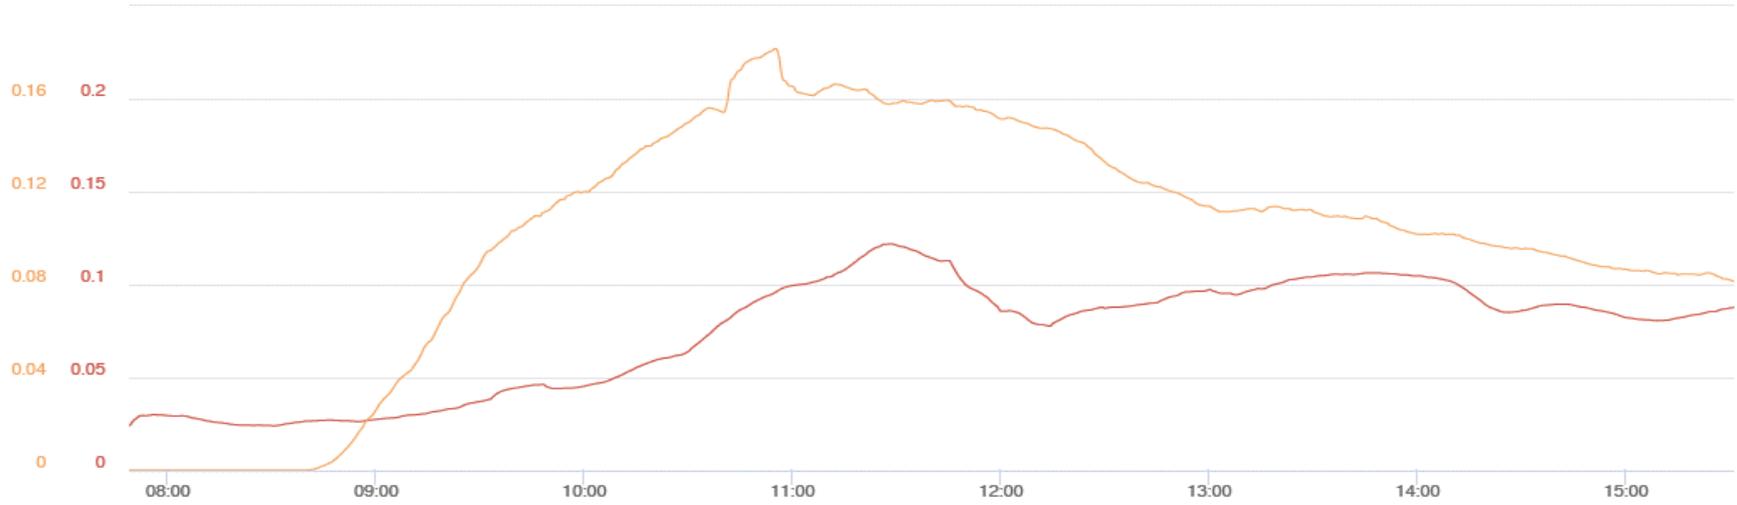
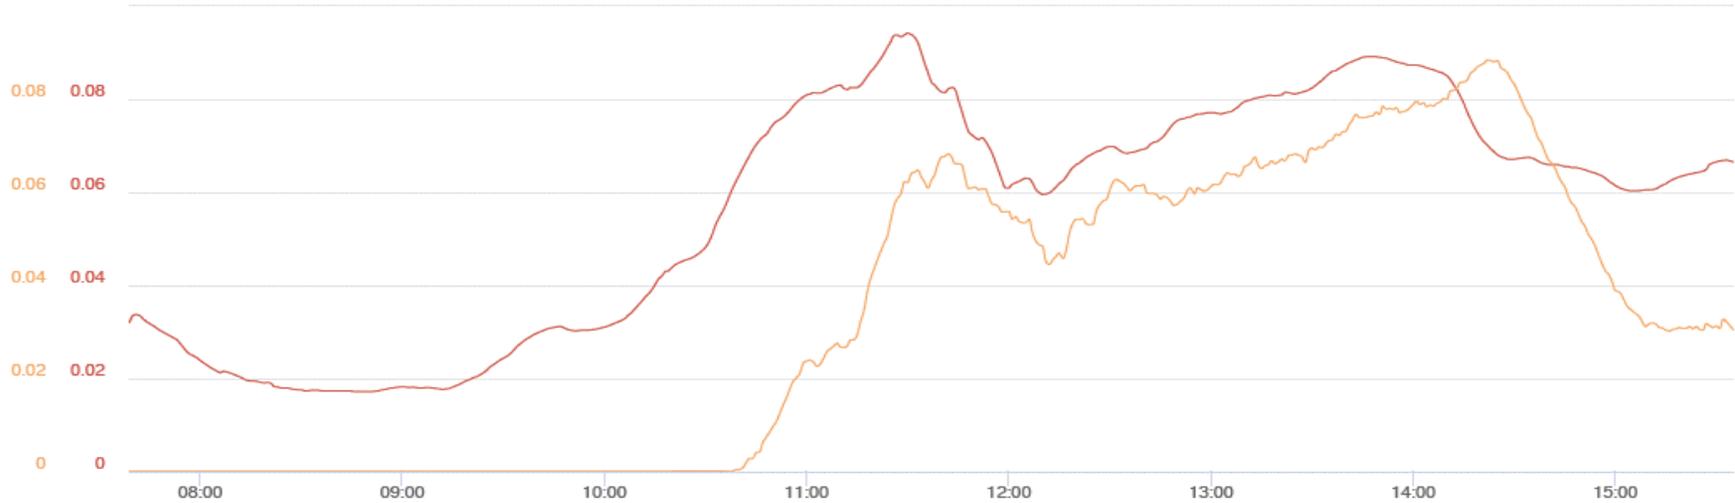
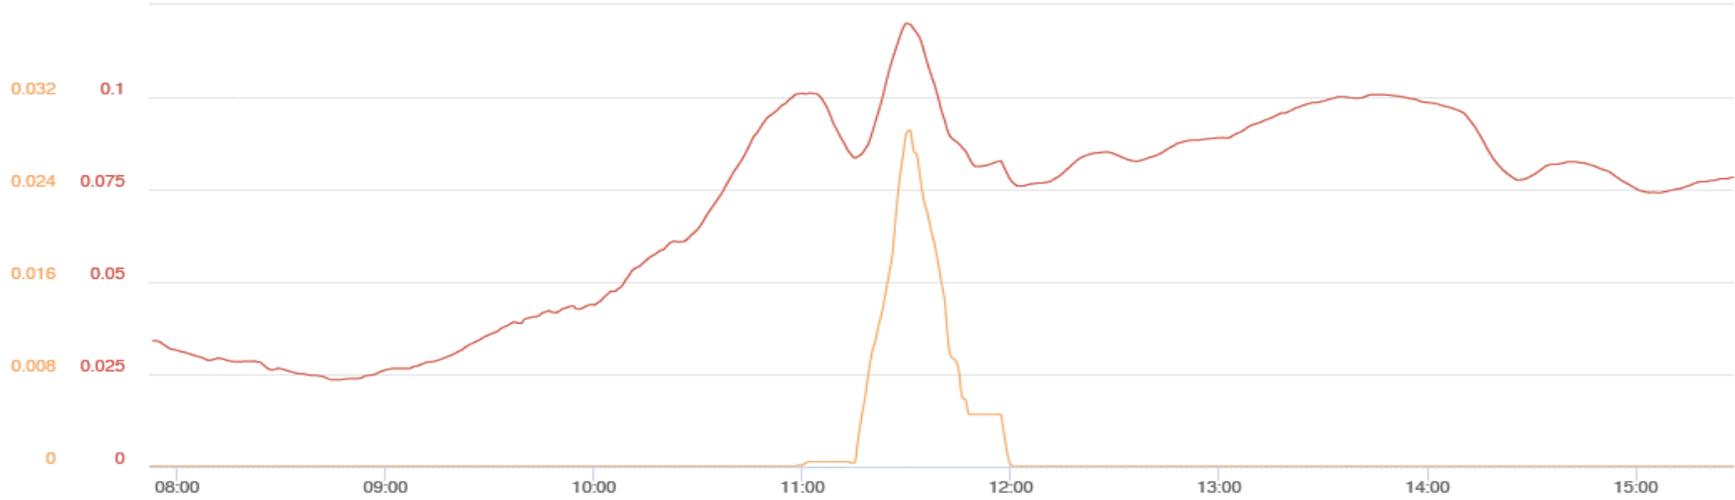
Mass Conc. Total mg/m³ AVG 15m mg/m³ DustTrak-8530 RS232(C)		
MIN	AVG	MAX
0.0233	0.09	0.1832

Mass Conc. Total mg/m³ AVG 15m mg/m³ DustTrak-8530 RS232(C)		
MIN	AVG	MAX
0.0297	0.0779	0.1152

Mass Conc. Total mg/m ³ AVG 15m mg/m ³ DustTrak-8530 RS232(C)			VOC ppm AVG 15m ppm miniRAE 3000 RS232(A)		
MIN	AVG	MAX	MIN	AVG	MAX
0.0231	0.0685	0.1146	0	0.0005	0.007

Mass Conc. Total mg/m³ AVG 15m mg/m³ DustTrak-8530 RS232(C)		
MIN	AVG	MAX
0.0239	0.0739	0.1218

Mass Conc. Total mg/m ³ AVG 15m mg/m ³ DustTrak-8530 RS232(C)			VOC ppm AVG 15m ppm miniRAE 3000 RS232(A)		
MIN	AVG	MAX	MIN	AVG	MAX
0.0171	0.0566	0.0942	0	0.034	0.0884

Mass Conc. Total mg/m ³ AVG 15m mg/m ³ DustTrak-8530 RS232(C)			VOC ppm AVG 15m ppm miniRAE 3000 RS232(A)		
MIN	AVG	MAX	MIN	AVG	MAX
0.0234	0.0699	0.12	0	0	0.0291

Comments:	<p>Elevated particulate levels were detected during implementation of the CAMP program due to ongoing wildfires in Canada (unrelated to on-site work - no visible fugitive dust related to site work was noted); the NYSDEC issued an air quality advisory related to the elevated particulate levels.</p> <p>Elevated levels of particulates (>0.100 mg/m3 above background) were detected at the UH - Fixed 1 CAMP Station from approximately 10:25 to 10:38 due to the exhaust from an idling truck that was parked adjacent to the station (unrelated to on-site work - no visible fugitive dust related to site work was noted); the conditions improved when the vehicle moved away from the station. The demolition contractor was informed that vehicle exhaust can trigger elevated readings on the CAMP equipment and requested that they avoid idling in close proximity to the stations in the future.</p> <p>The use of air monitoring equipment was suspended at approximately 13:15 due to inclement weather (rain); therefore, visual and olfactory monitoring were performed for the remainder of the day. No fugitive dust or odors were detected during the period that the air monitoring equipment was not in use.</p>

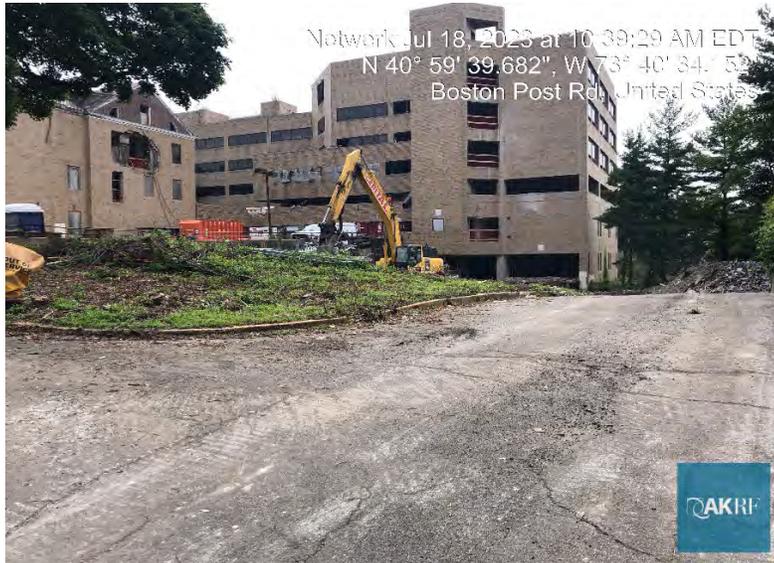
Photograph 1 -
Exterior handling of building materials associated with demolition of interior, non-loadbearing, building elements, view facing east.

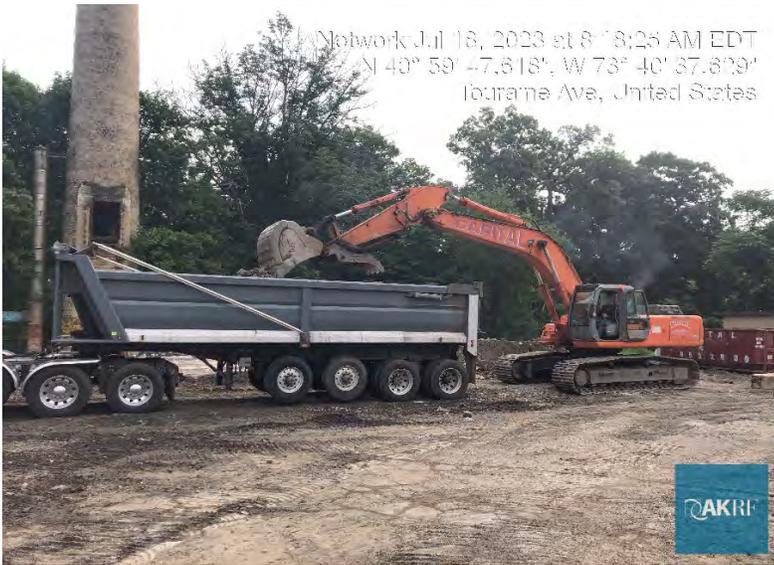
Photograph 2 -
Handling of demolition debris from the former power/boiler plant building in the northern portion of the site, view facing northeast.

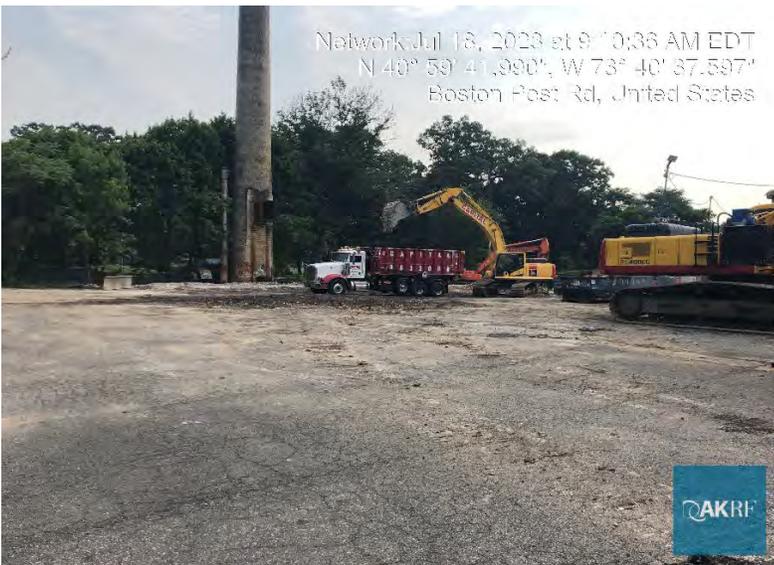
Photograph 3 -
Handling of demolition debris from the former power/boiler plant building in the northern portion of the site, view facing northeast.
