August 10, 2023

Re: Monthly Progress Report – July 2023
Former United Hospital – 406 Boston Post Road, Port Chester, New York
NYSDEC BCP Site No. C360202

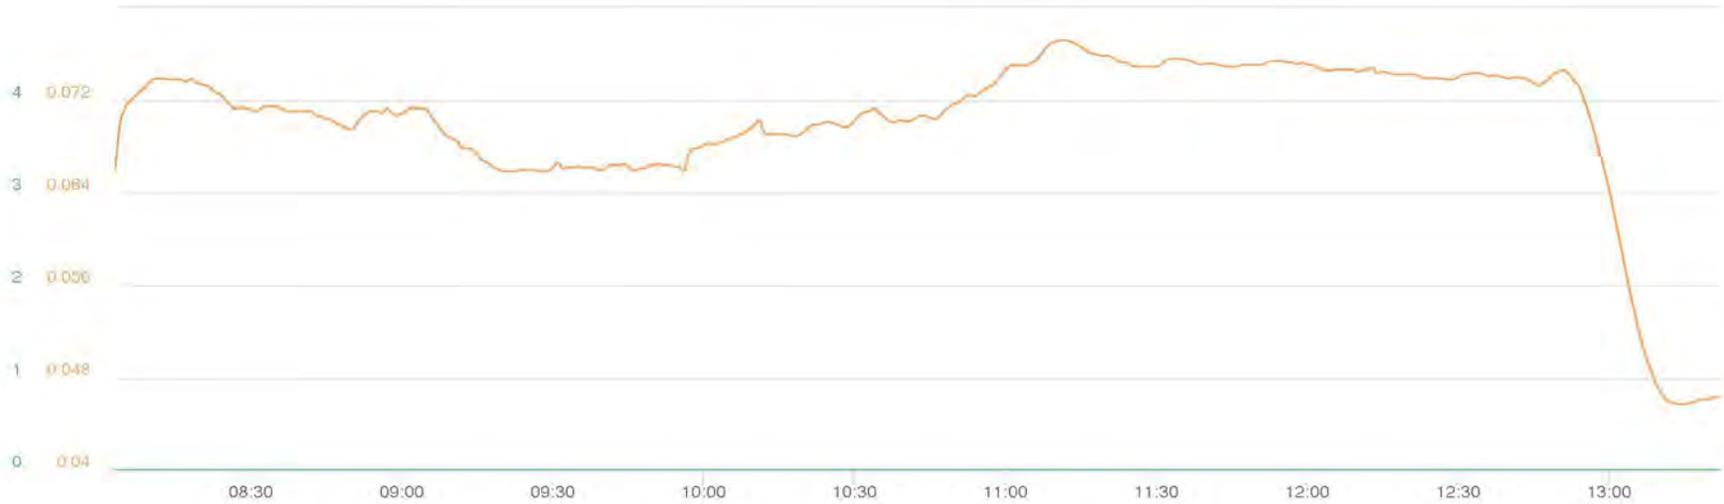
UH - Fixed 2 CAMP Station Graph

Mass Conc. Total mg/m³ AVG 15m
mg/m³
DustTrak-8530
RS232(c)

MIN	AVG	MAX
0.0457	0.0702	0.0772

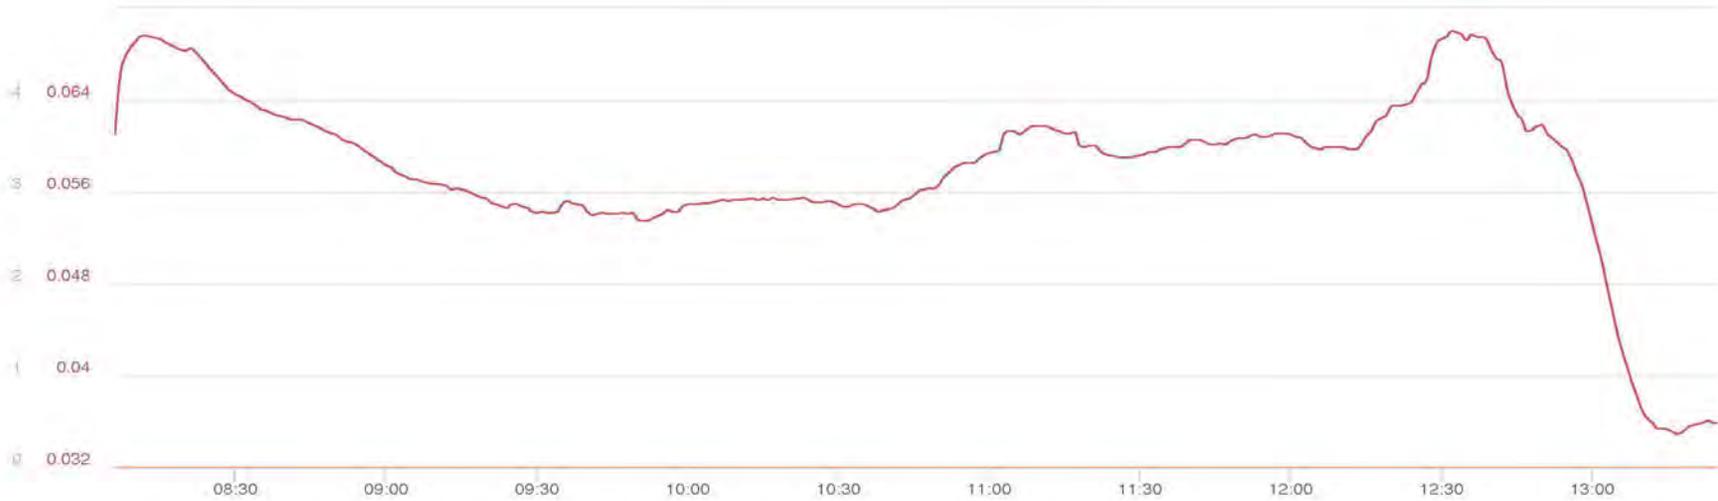
UH - Fixed 3 CAMP Station Graph

Mass Conc. Total mg/m³ AVG 15m
mg/m³
DustTrak-8530
RS232(C)

MIN	AVG	MAX
0.0349	0.0581	0.07

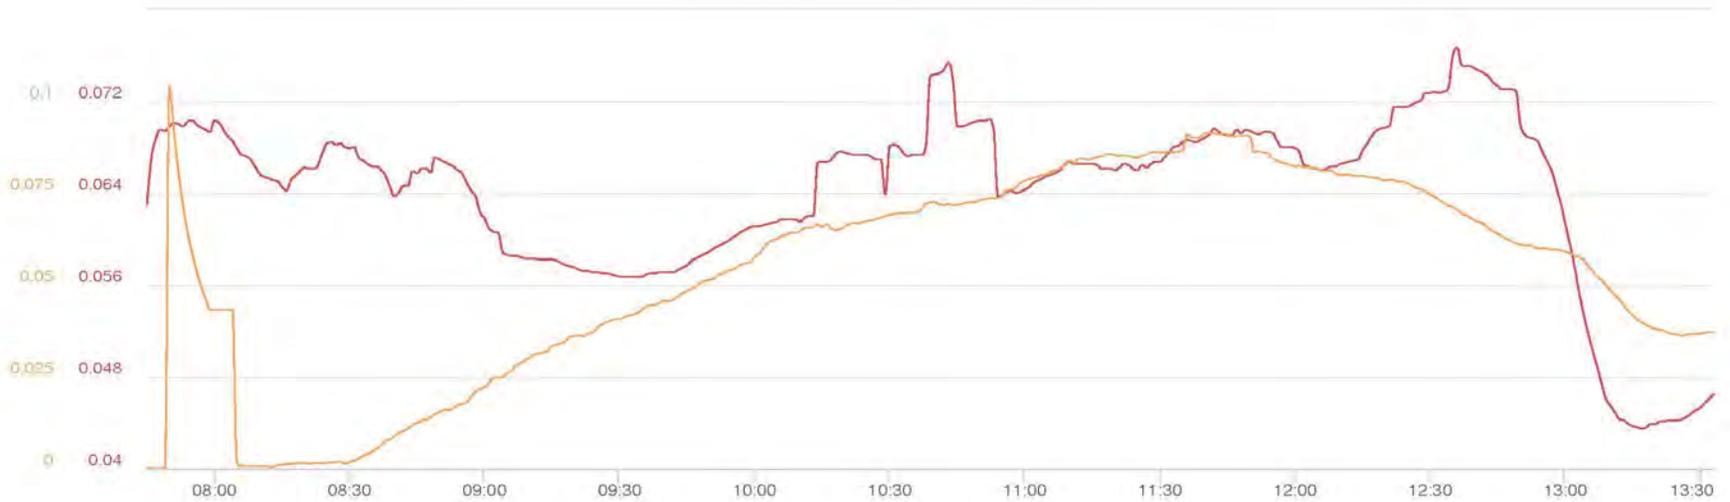
UH - Upwind 1 CAMP Station Graph

Mass Conc. Total mg/m³ AVG 15m
mg/m³
DustTrak-8530
RS232(T)

MIN	AVG	MAX
0.0435	0.0641	0.0766

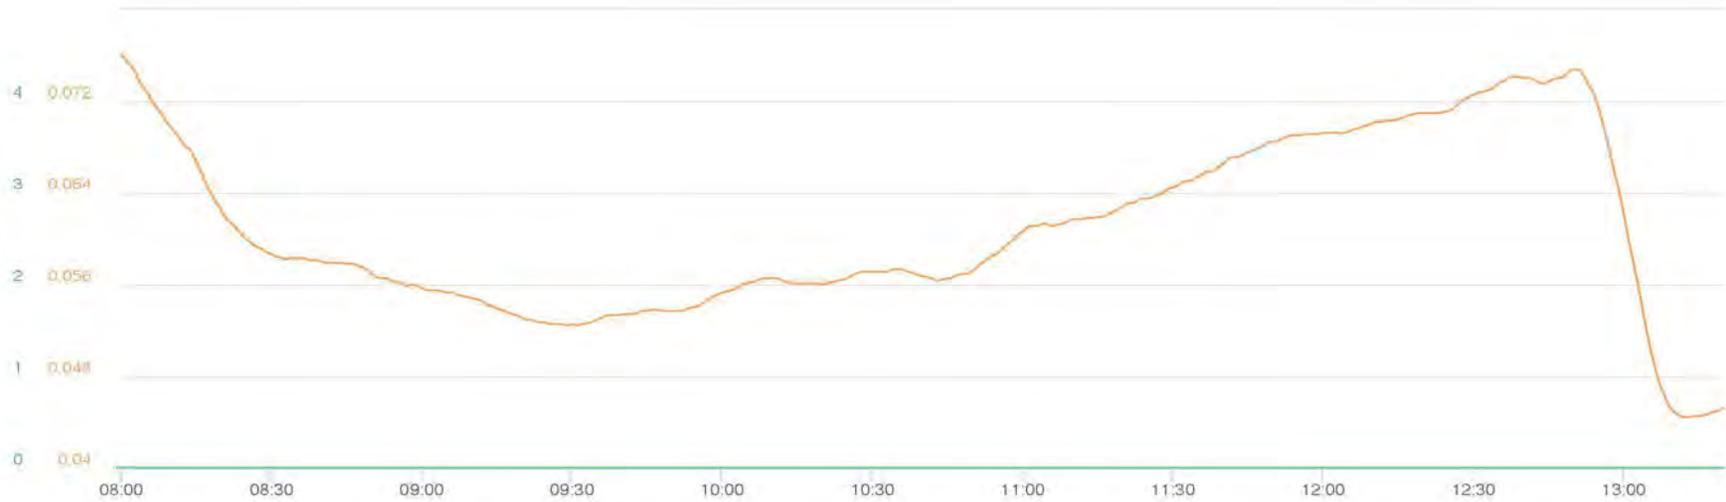
UH - Downwind 2 CAMP Station Graph

Mass Conc. Total mg/m³ AVG 15m
mg/m³
DustTrak-8530
RS232(C)

MIN	AVG	MAX
0.0444	0.061	0.076

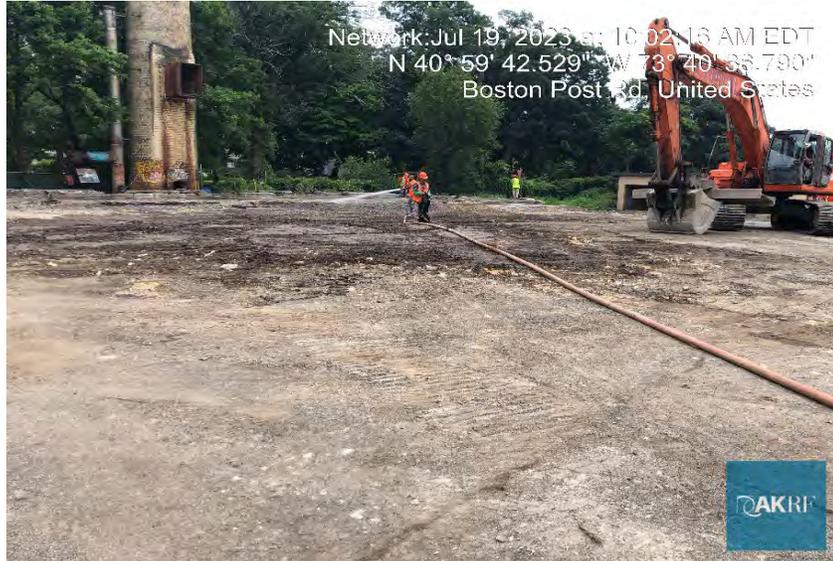
Photograph 1 -
Handling of
demolition debris
from the former
power/boiler plant
building in the
northern portion of
the site, view facing
northeast

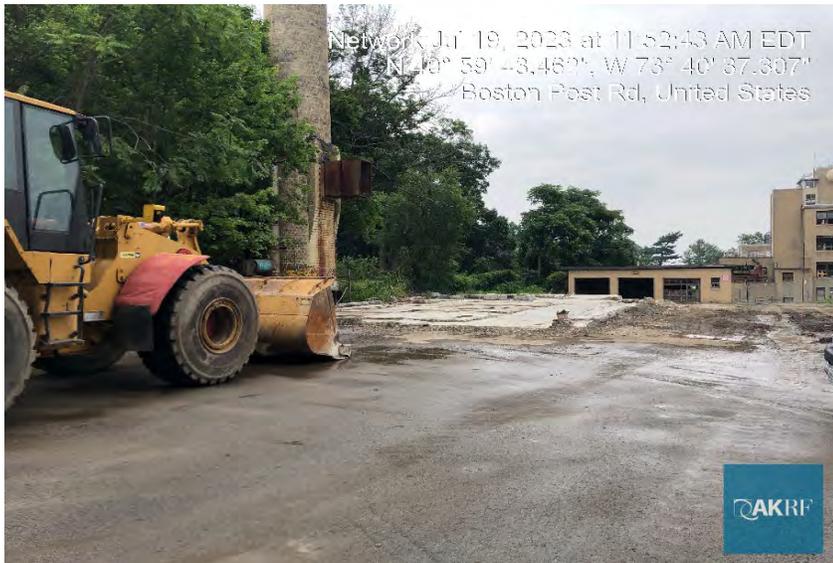
Photograph 2 -
Handling of
demolition debris
from the former
power/boiler plant
building in the
northern portion of
the site, view facing
northeast.

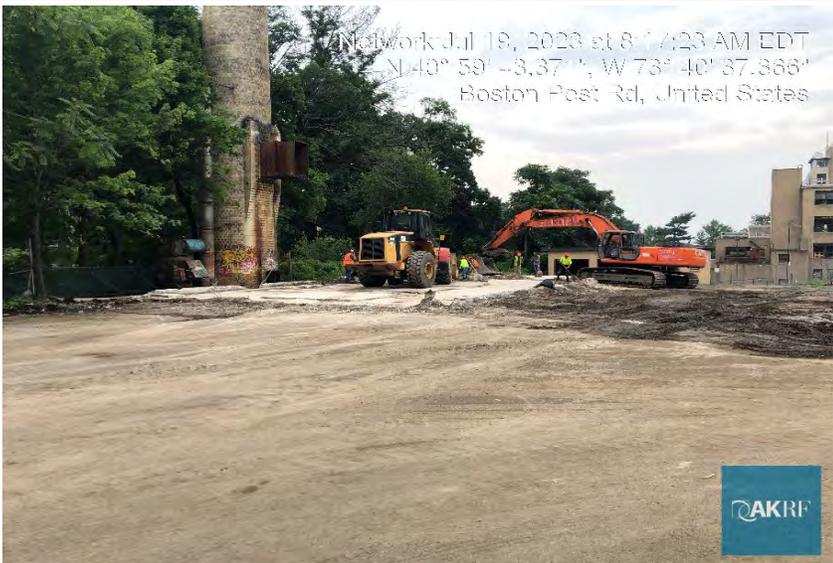
Photograph 3 -
Handling of
demolition debris
from the former
power/boiler plant
building in the
northern portion of
the site, view facing
northeast.

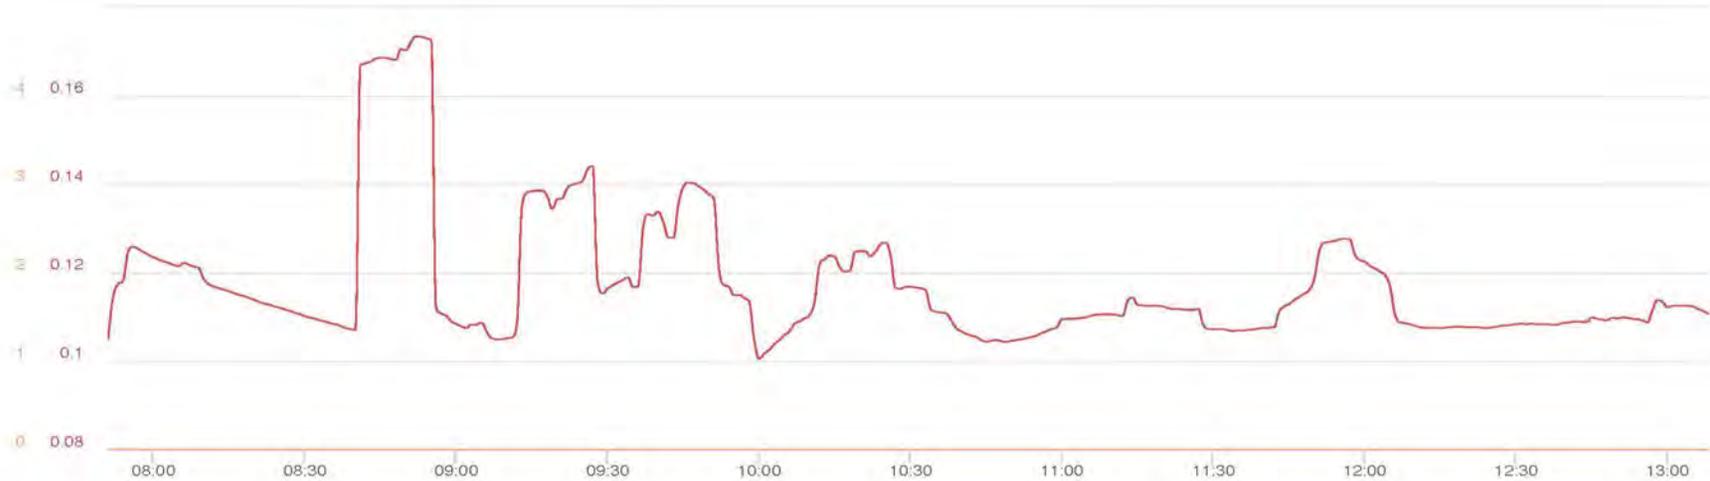
UH - Fixed 1 CAMP Station Graph

Mass Conc. Total mg/m³ AVG 15m
mg/m³
DustTrak-8530
RS232(C)

MIN	AVG	MAX
0.1005	0.1174	0.1734

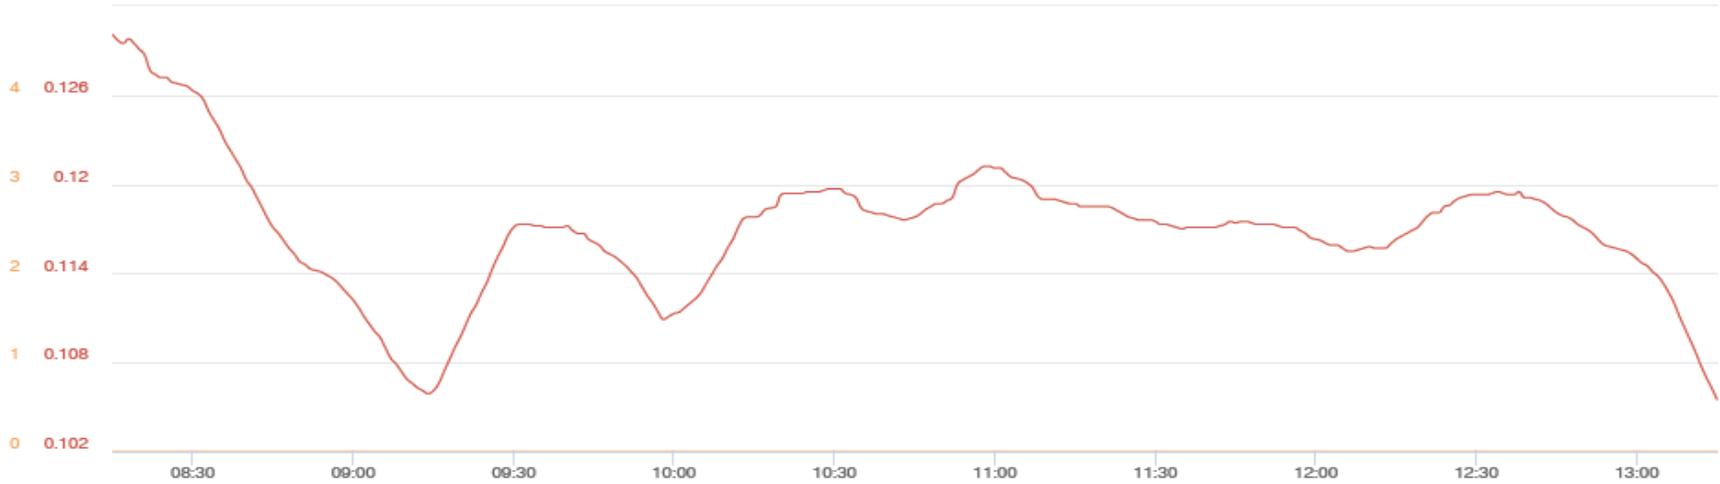
UH - Fixed 2 CAMP Station Graph

Mass Conc. Total mg/m³ AVG 15m
mg/m³
DustTrak-8530
RS232(C)

MIN	AVG	MAX
0.1059	0.117	0.1301

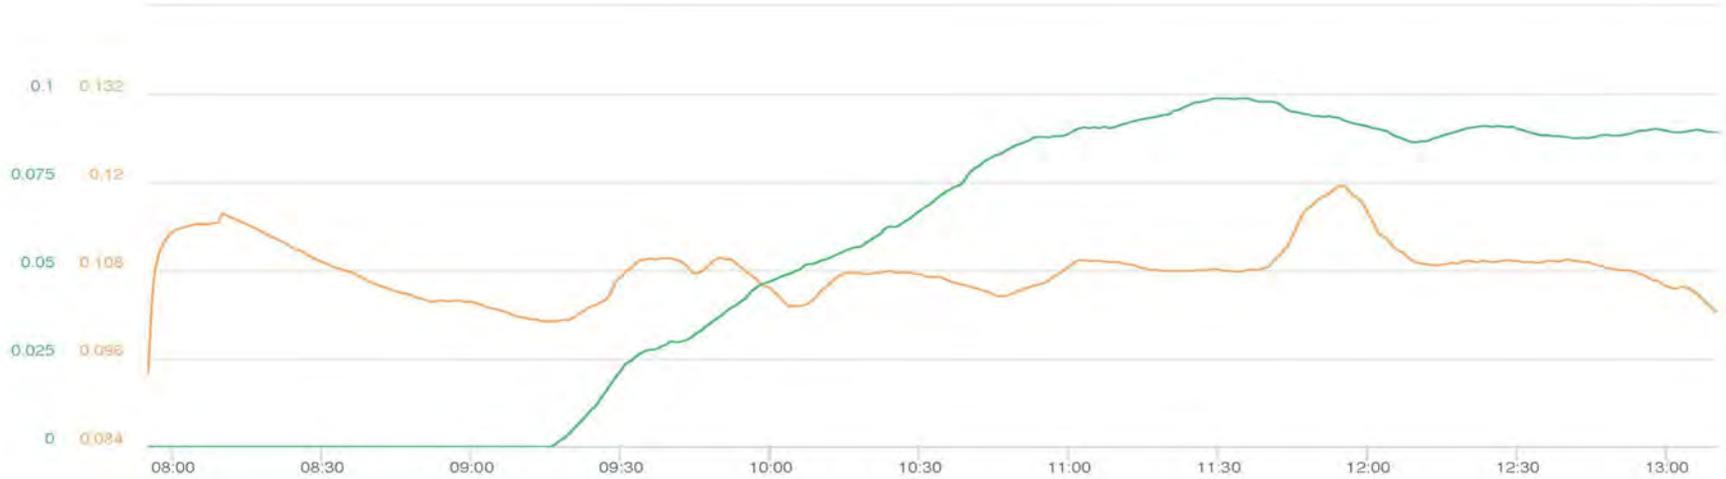
UH - Upwind 1 CAMP Station Graph

Mass Conc. Total mg/m³ AVG 15m
mg/m³
DustTrak-8530
RS232(C)

MIN	AVG	MAX
0.094	0.1081	0.1195

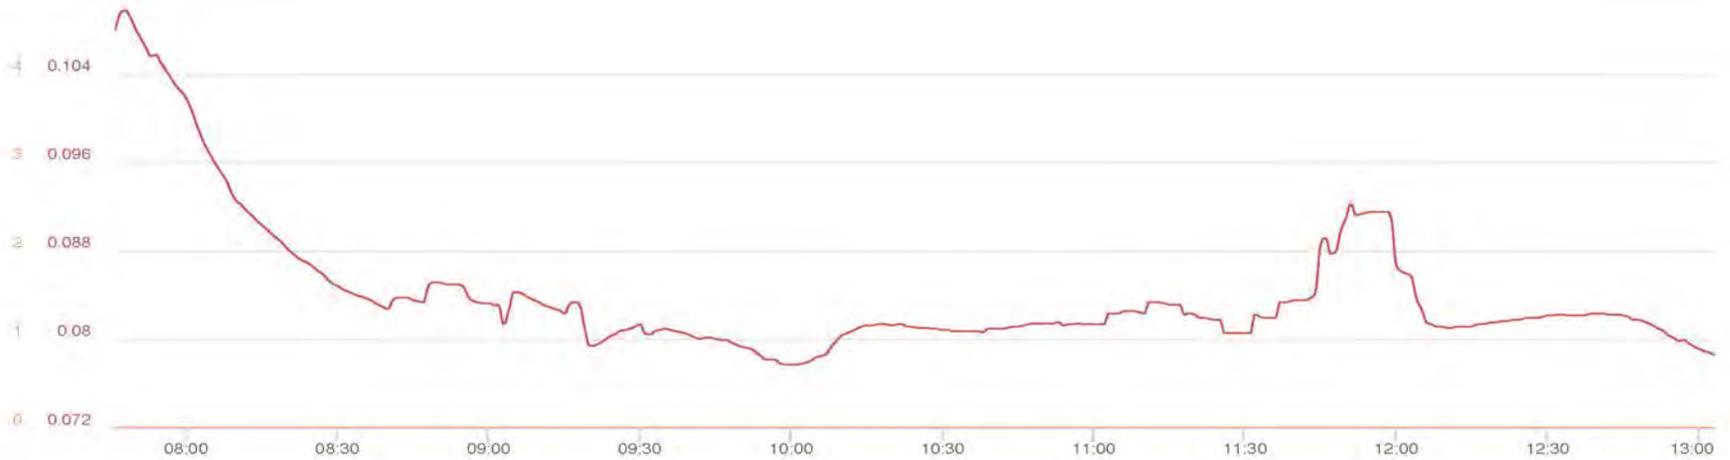
UH - Downwind 1 CAMP Station Graph

Mass Conc. Total mg/m³ AVG 15m
mg/m³

DustTrak-8530
RS232(C)

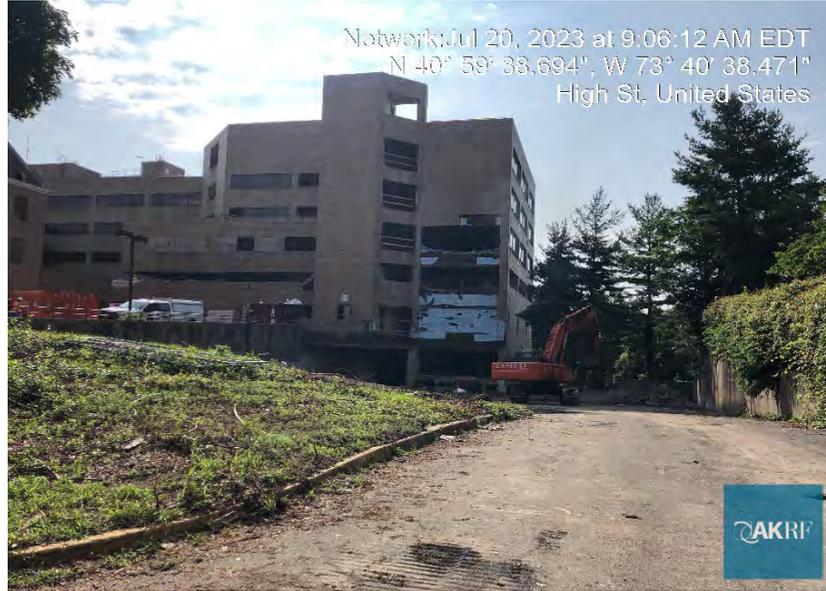
Photograph 1 -
Exterior handling of building materials associated with demolition of interior, non-loadbearing, building elements, view facing east.

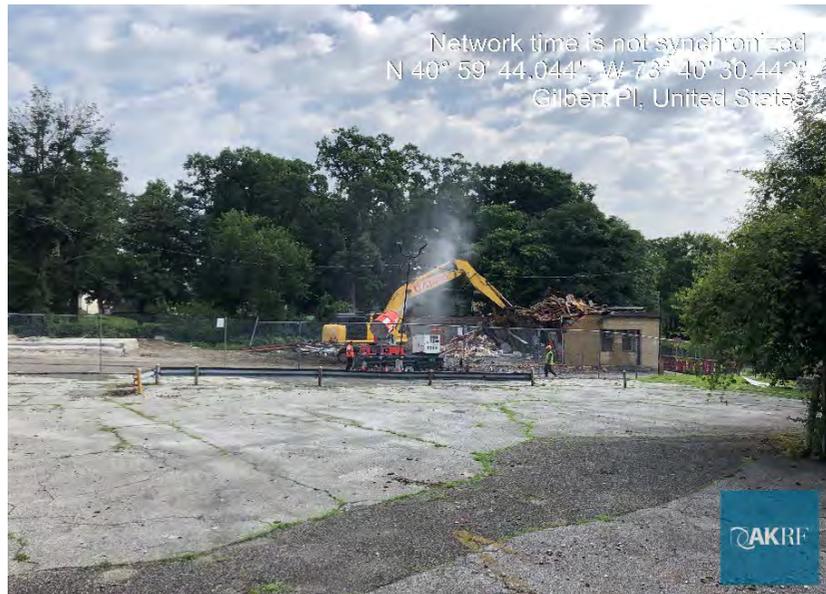
Photograph 2 -
Structural demolition of the former engineering building in the northern portion of the site, view facing northeast.

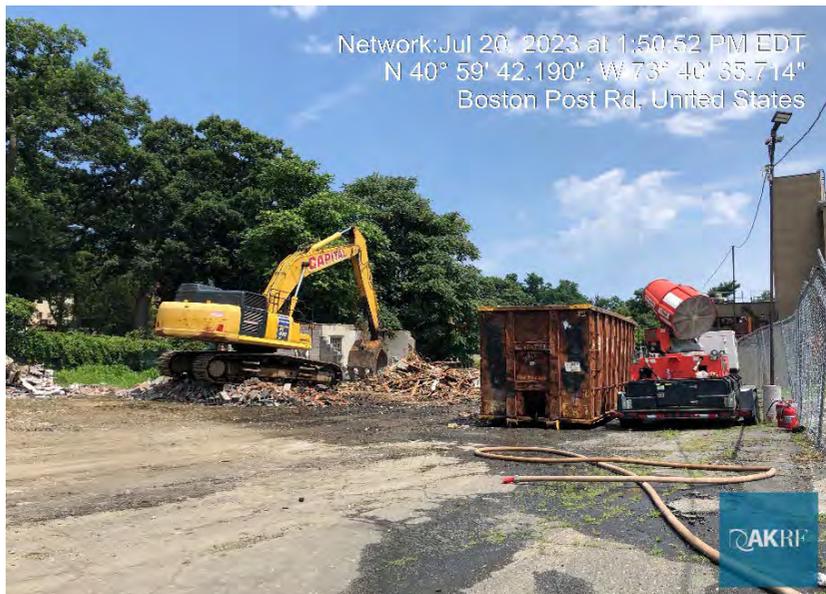
Photograph 3 -
Handling of demolition debris from the former engineering building in the northern portion of the site, view facing northeast.

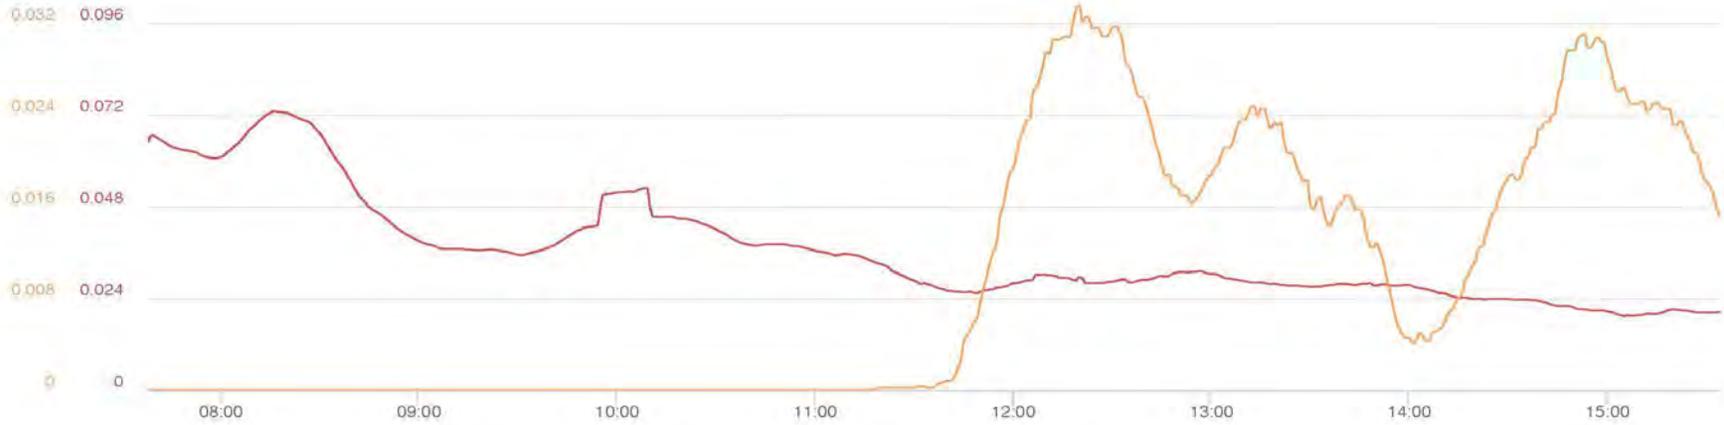
UH - Fixed 2 CAMP Station Graph

Mass Conc. Total mg/m³ AVG 15m
mg/m³
DustTrak-8530
RS232(C)

MIN	AVG	MAX
0.0193	0.0361	0.0729

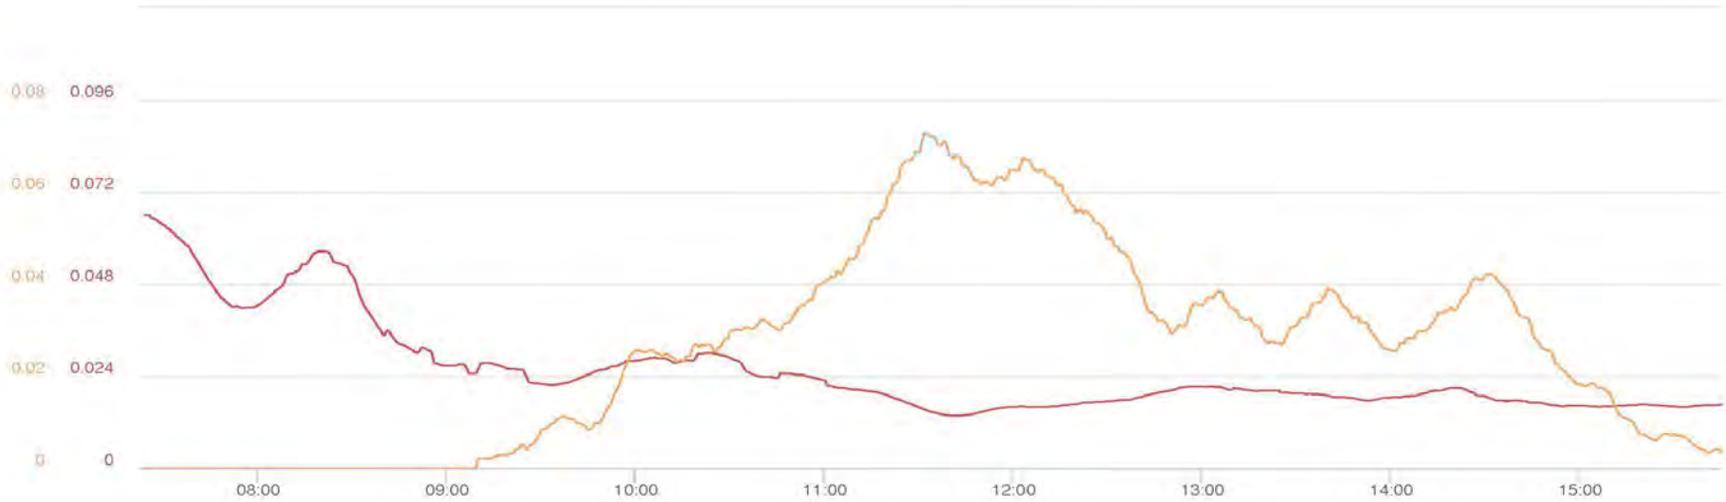
UH - Downwind 1 CAMP Station Graph

Mass Conc. Total mg/m³ AVG 15m
mg/m³
DustTrak-8530
RS232(G)

MIN	AVG	MAX
0.0137	0.0254	0.066

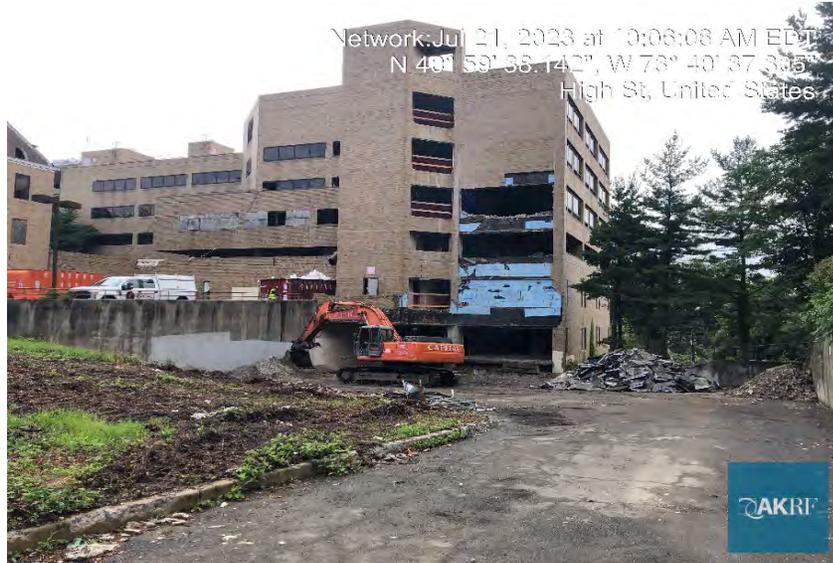
Photograph 1 -
Exterior handling of building materials associated with demolition of interior, non-loadbearing, building elements, view facing east.

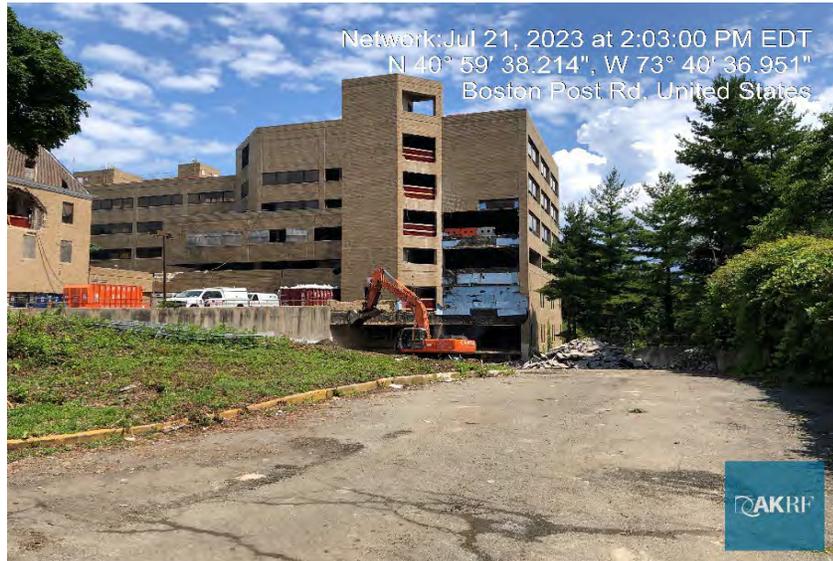
Photograph 2 -
Exterior handling of building materials associated with demolition of interior, non-loadbearing, building elements, view facing east.

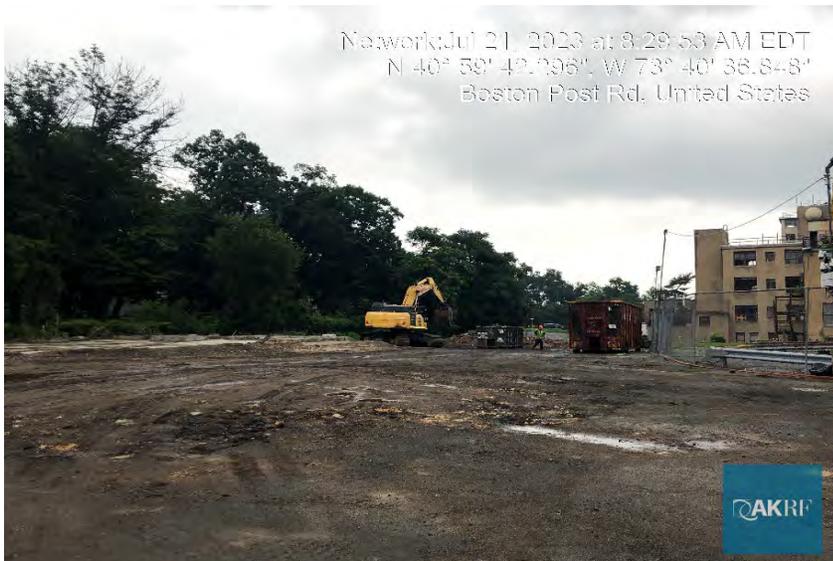
Photograph 3 -
Handling of demolition debris from the former engineering building in the northern portion of the site, view facing northeast.

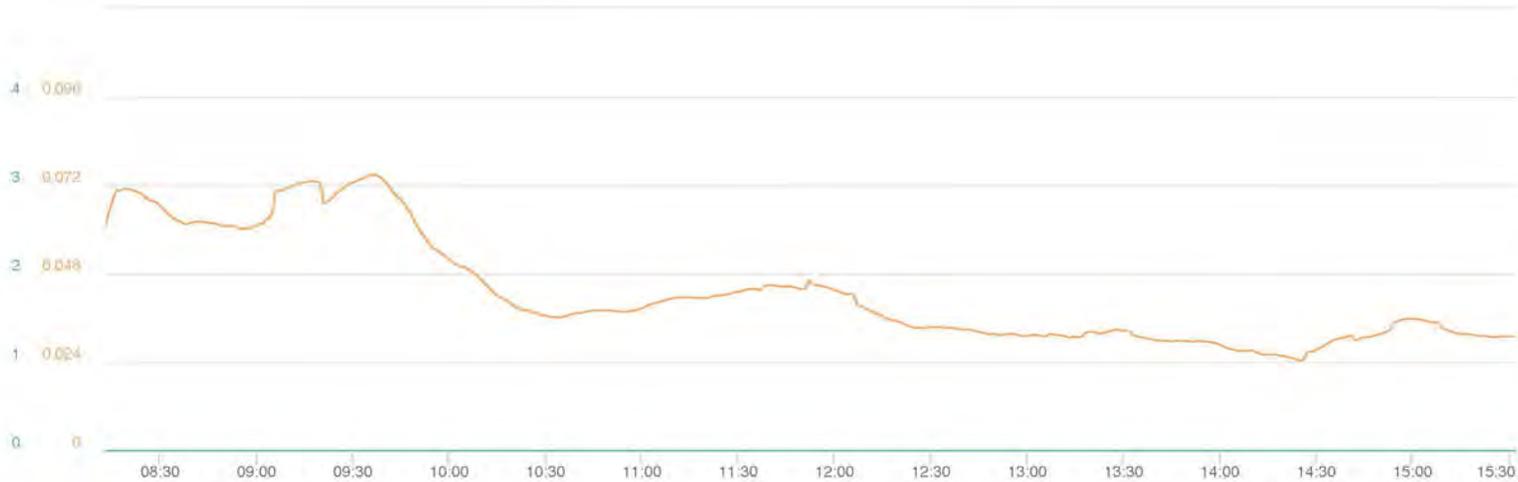
UH - Fixed 1 CAMP Station Graph

Mass Conc. Total mg/m³ AVG 15m
mg/m³
DustTrak-8530
RS232(C)

MIN	AVG	MAX
0.0244	0.0427	0.0747

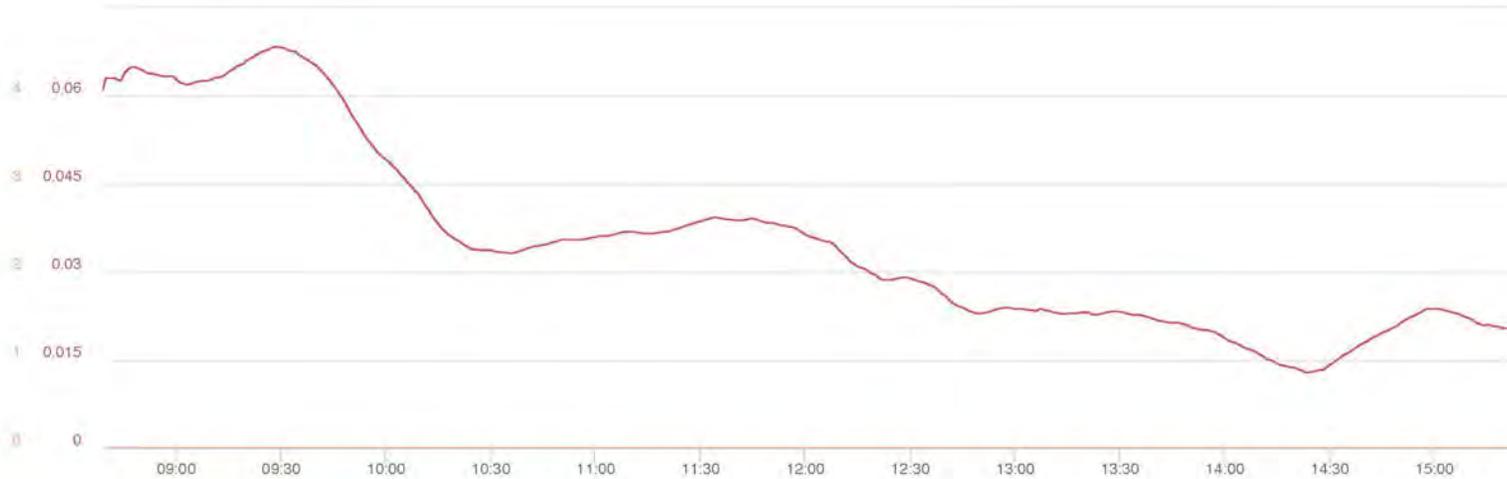
UH - Fixed 3 CAMP Station Graph

Mass Conc. Total mg/m³ AVG 15m
mg/m³
DustTrak-8530
RS232(C)

MIN	AVG	MAX
0.0129	0.0351	0.0683

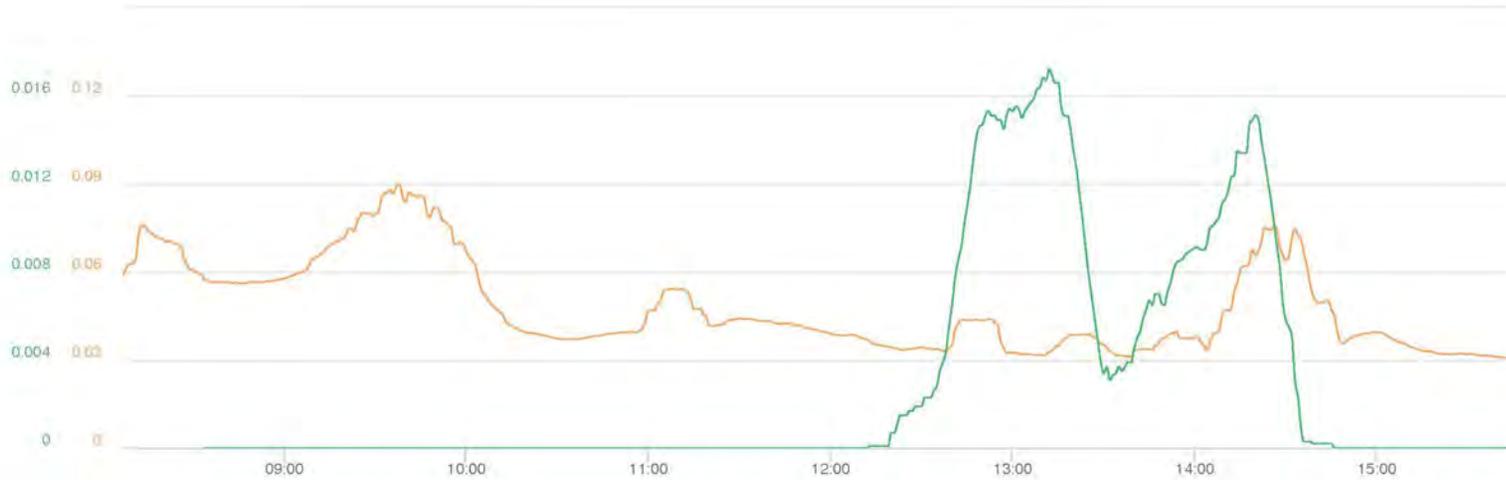
UH - Upwind 1 CAMP Station Graph

Mass Conc. Total mg/m³ AVG 15m
mg/m³
DustTrak-8530
RS232(T)

MIN	AVG	MAX
0.0307	0.0481	0.0899

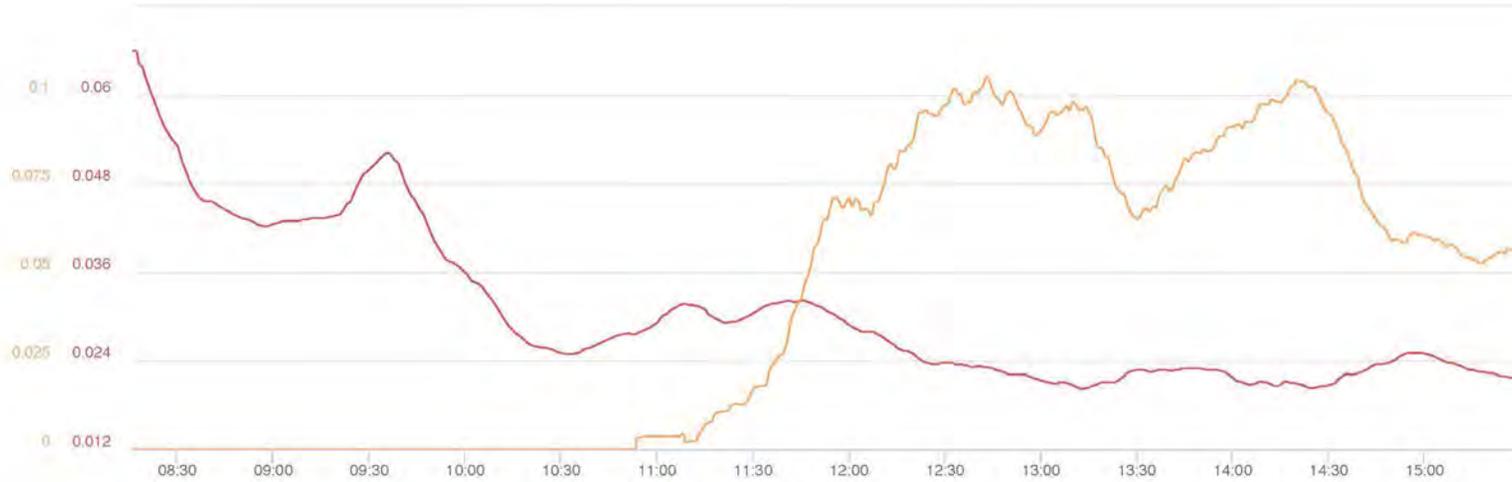
UH - Downwind 1 CAMP Station Graph

Fri, 21st of Jul 2023, 0:17:00 – 23:17:00
(GMT-05:00) Eastern Time (US & Canada)

MIN	AVG	MAX
0.0202	0.0304	0.066

MIN	AVG	MAX
0	0.0428	0.1051

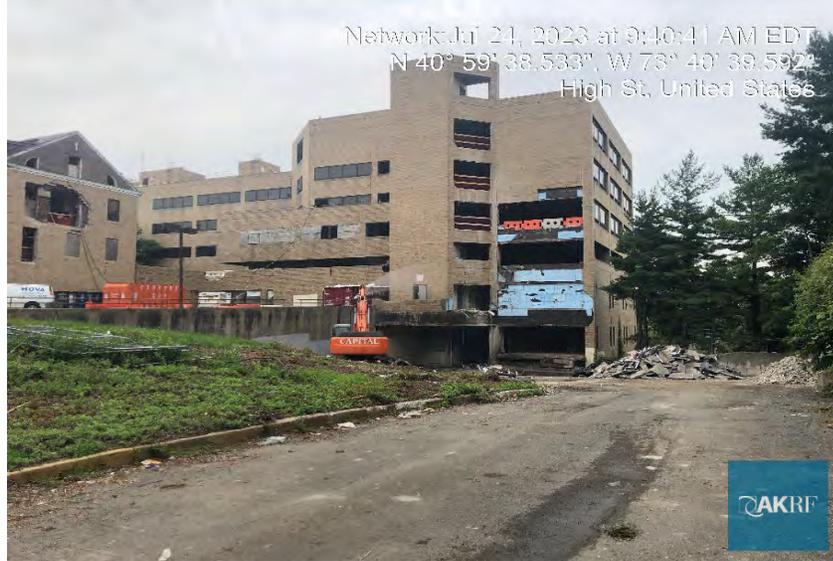
Photograph 1 -
Exterior handling of building materials associated with demolition of interior, non-loadbearing, building elements, view facing East.

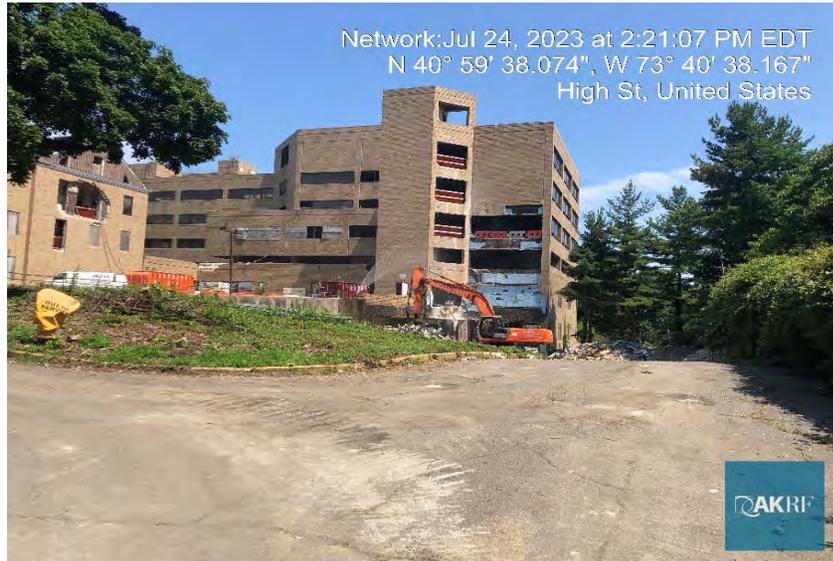
Photograph 2 -
Exterior handling of building materials associated with demolition of interior, non-loadbearing, building elements, view facing East.

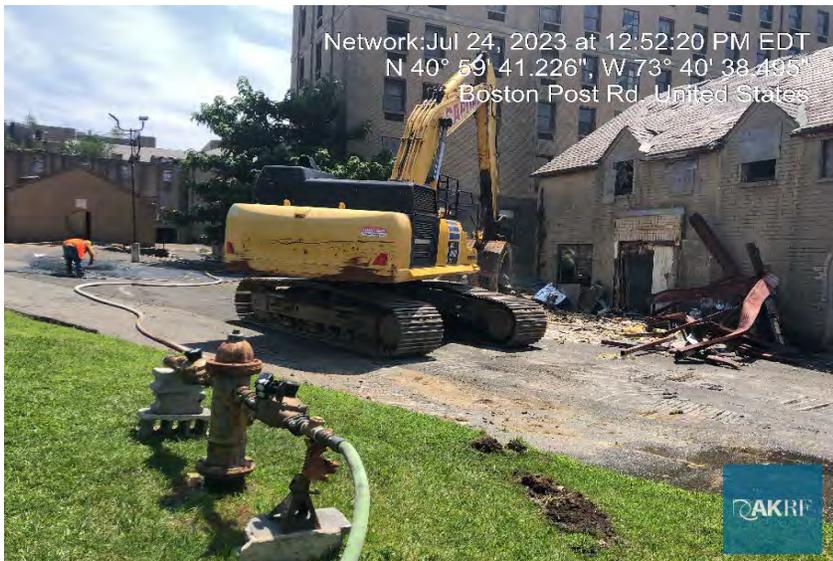
Photograph 3 -
Structural demolition of the corridor connecting the MRI building and Barron Hall in the central portion of the site, view facing East.

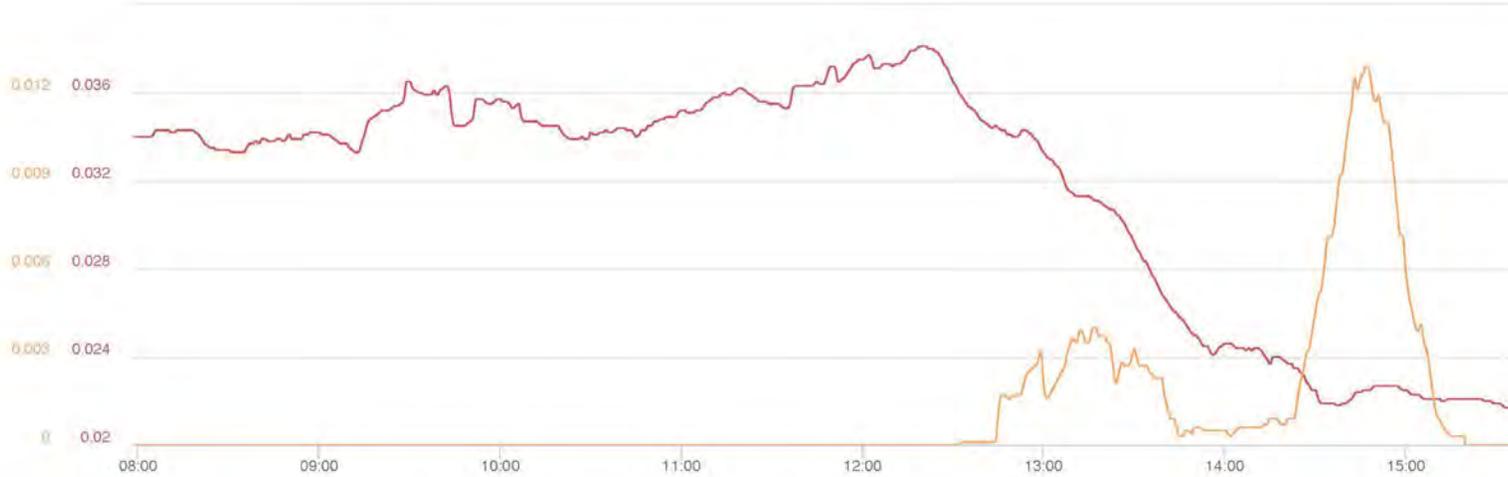
UH - Fixed 2 CAMP Station Graph

07/24/2023 0:00:51 – 07/25/2023 0:00:00
(GMT-05:00) Eastern Time (US & Canada)

MIN	AVG	MAX
0.0217	0.0317	0.0381

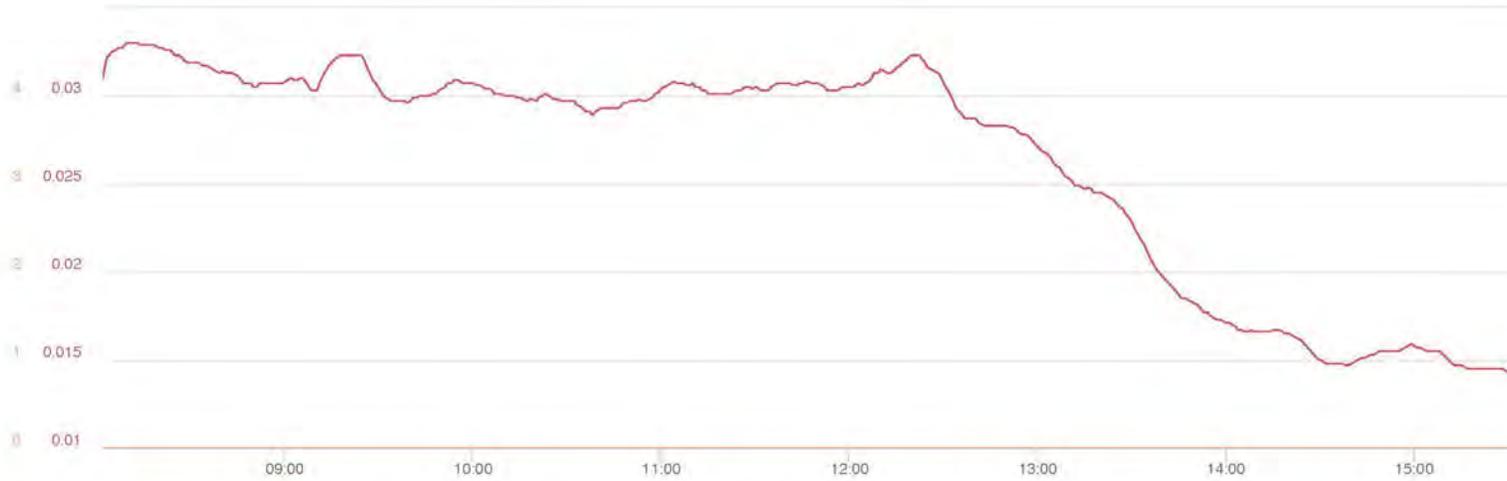
UH - Fixed 3 CAMP Station Graph

07/24/2023 0:00:00 – 07/25/2023 0:00:00
(GMT-05:00) Eastern Time (US & Canada)

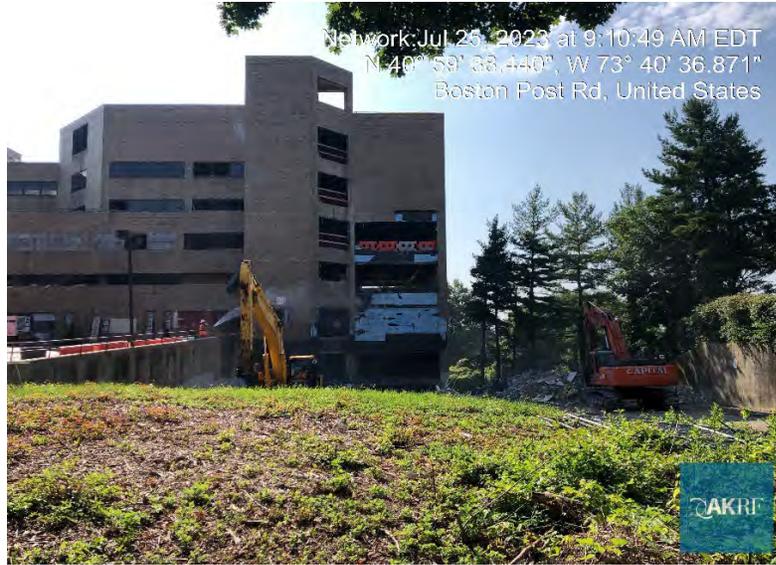
Photograph 1 -
Exterior handling of building materials associated with demolition of interior, non-loadbearing, building elements, view facing East.

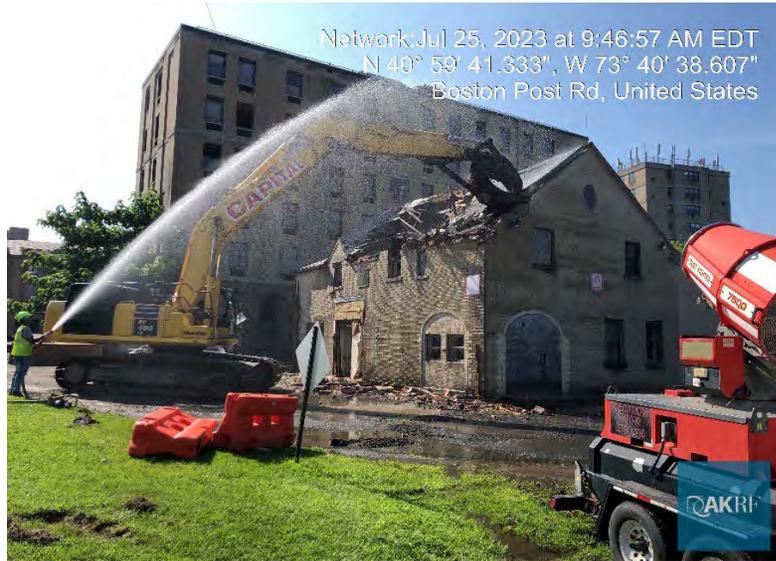
Photograph 2 -
Structural demolition of the MRI building in the central portion of the site, view facing East.

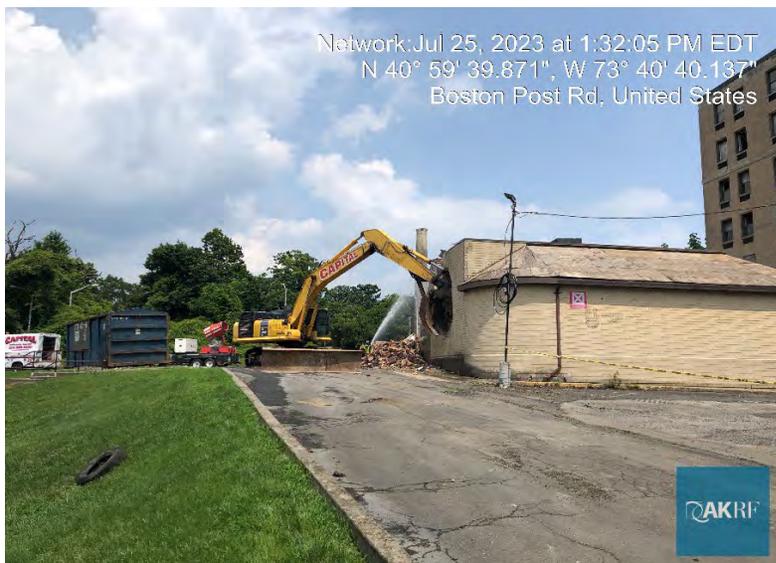
Photograph 3 -
Structural demolition of the MRI building in the central portion of the site, view facing North.

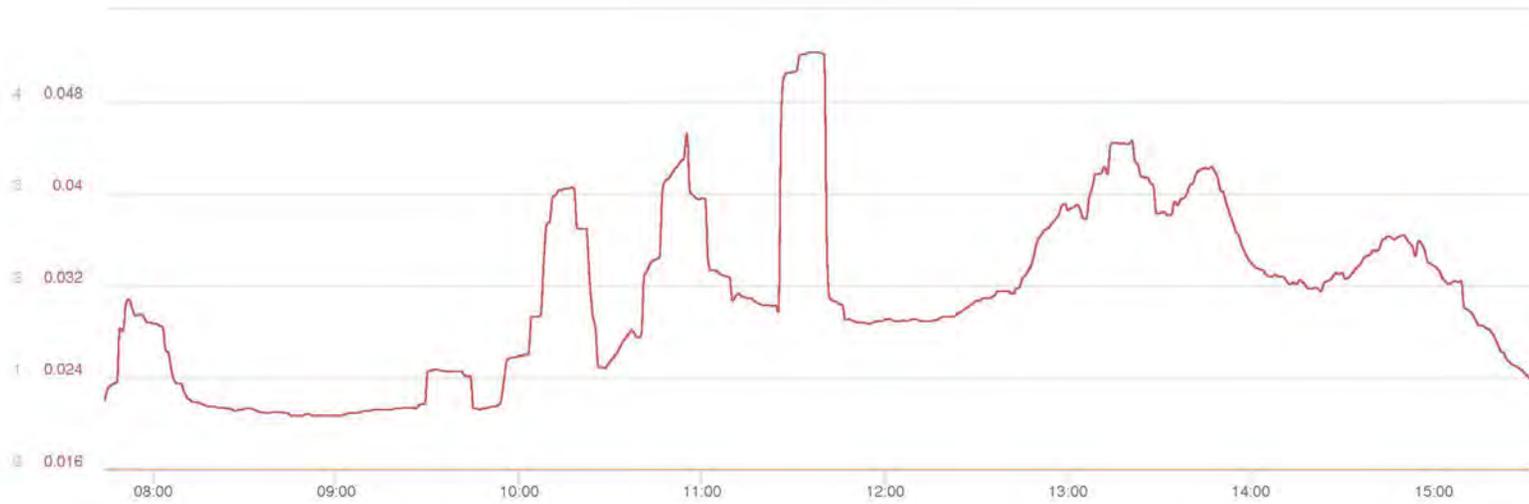
UH - Fixed 1 CAMP Station Graph

07/25/2023 0:00:31 – 07/26/2023 0:00:00
(GMT-05:00) Eastern Time (US & Canada)

MIN	AVG	MAX
0.0207	0.0311	0.0523

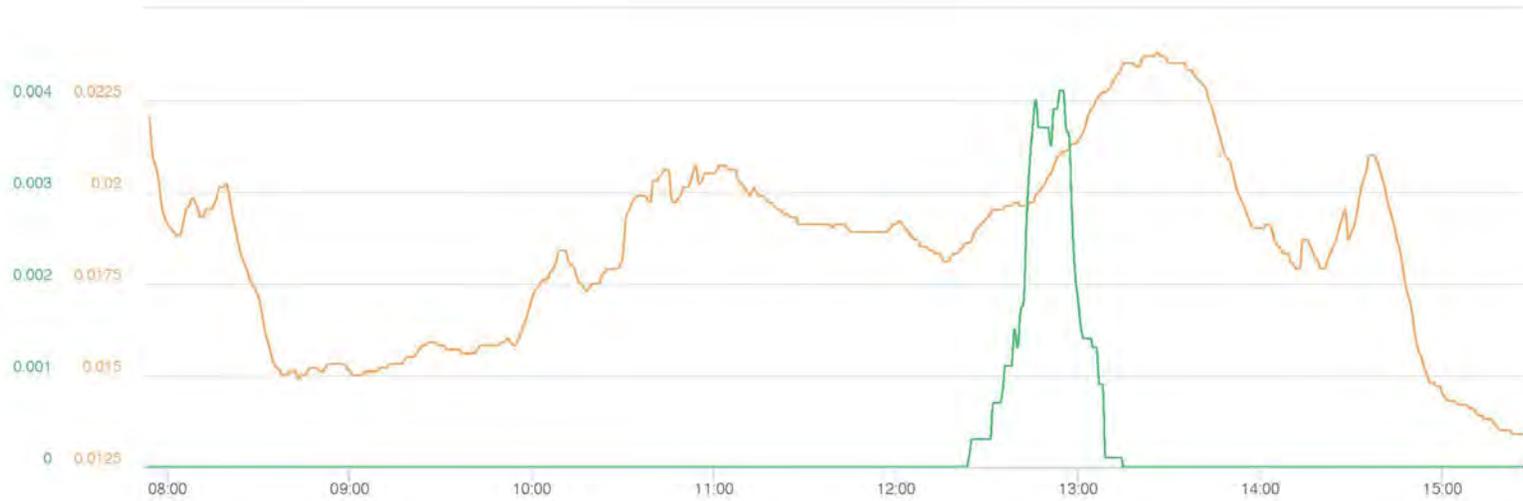
UH - Fixed 2 CAMP Station Graph

07/25/2023 0:00:30 – 07/26/2023 0:00:00
(GMT-05:00) Eastern Time (US & Canada)

MIN	AVG	MAX
0.0134	0.0185	0.0238

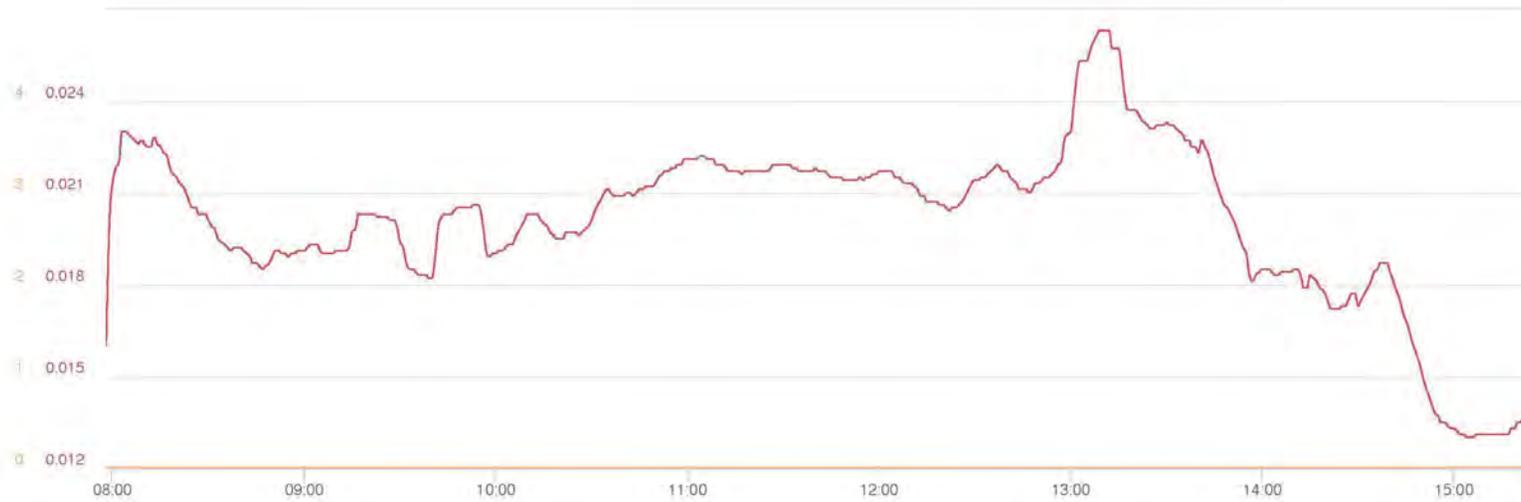
UH - Fixed 3 CAMP Station Graph

07/25/2023 0:00:45 – 07/26/2023 0:00:00
(GMT-05:00) Eastern Time (US & Canada)

MIN	AVG	MAX
0.013	0.0201	0.0263
