August 10, 2023

Re: Monthly Progress Report – July 2023
Former United Hospital – 406 Boston Post Road, Port Chester, New York
NYSDEC BCP Site No. C360202

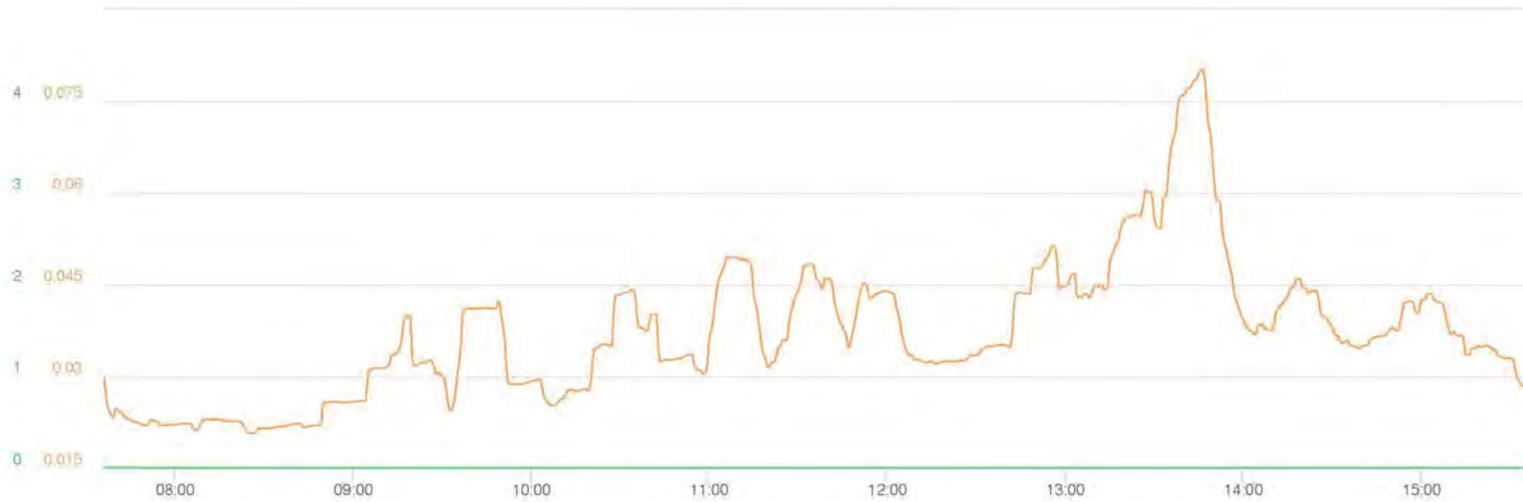
UH - Upwind 1 CAMP Station Graph

07/25/2023 0:00:48 – 07/26/2023 0:00:00
(GMT-05:00) Eastern Time (US & Canada)

MIN	AVG	MAX
0.0207	0.037	0.0801

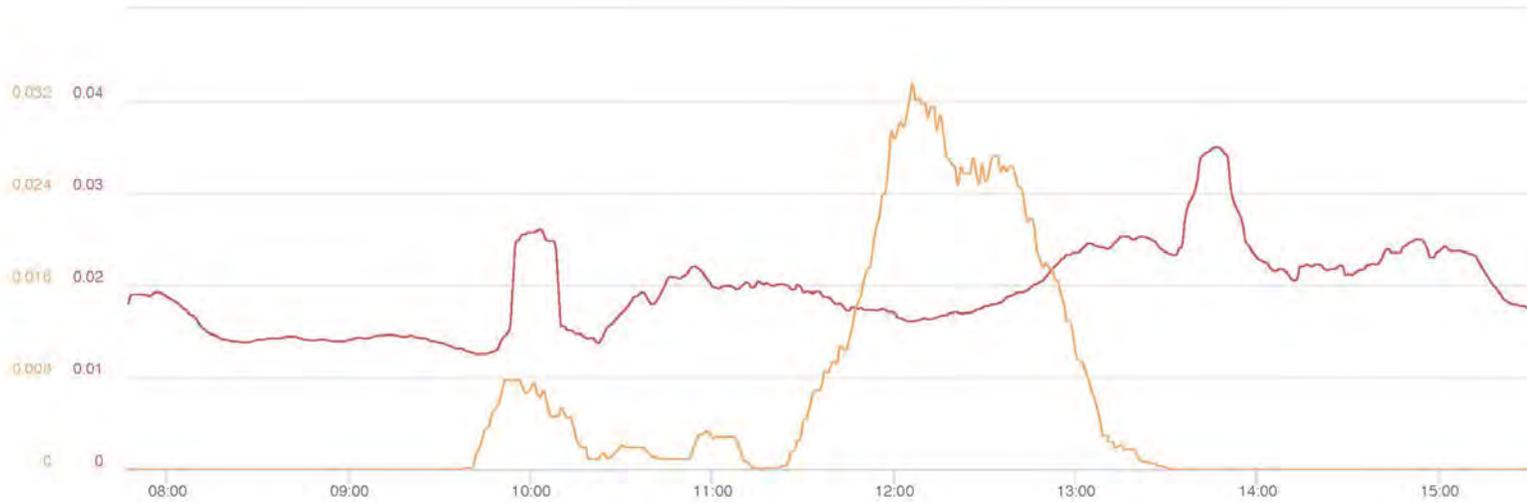
UH - Downwind 1 CAMP Station Graph

07/25/2023 0:00:07 – 07/26/2023 0:00:00
(GMT-05:00) Eastern Time (US & Canada)

MIN	AVG	MAX
0.0125	0.0194	0.0349

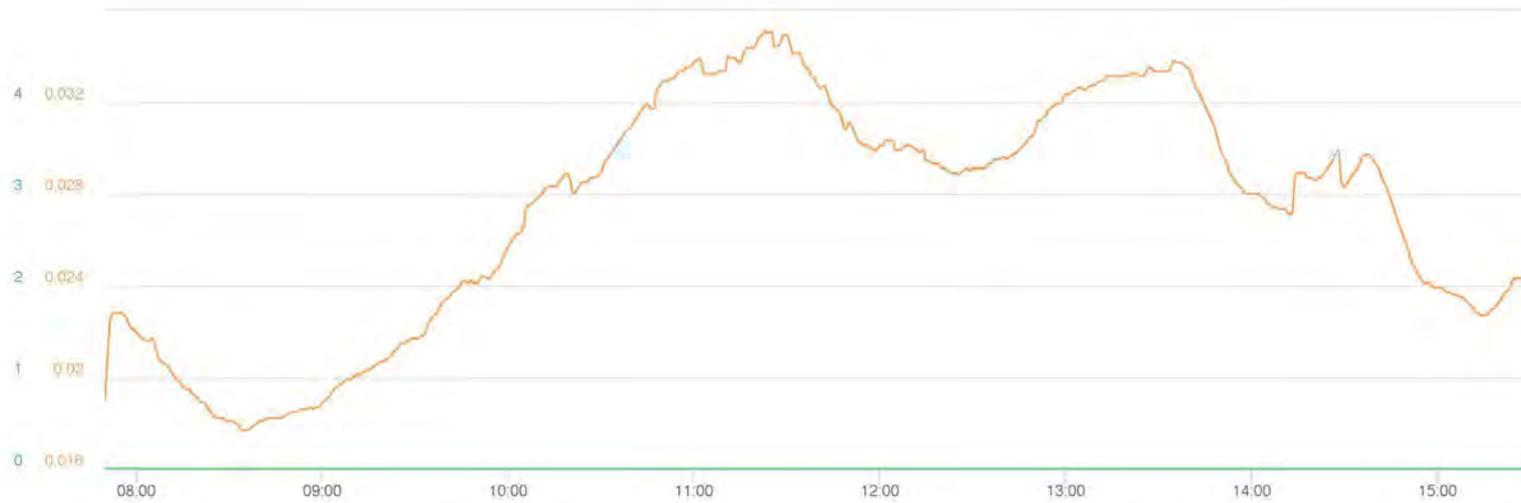
UH - Downwind 2 CAMP Station Graph

07/25/2023 0:00:27 – 07/26/2023 0:00:00
(GMT-05:00) Eastern Time (US & Canada)

MIN	AVG	MAX
0.0177	0.0273	0.0351

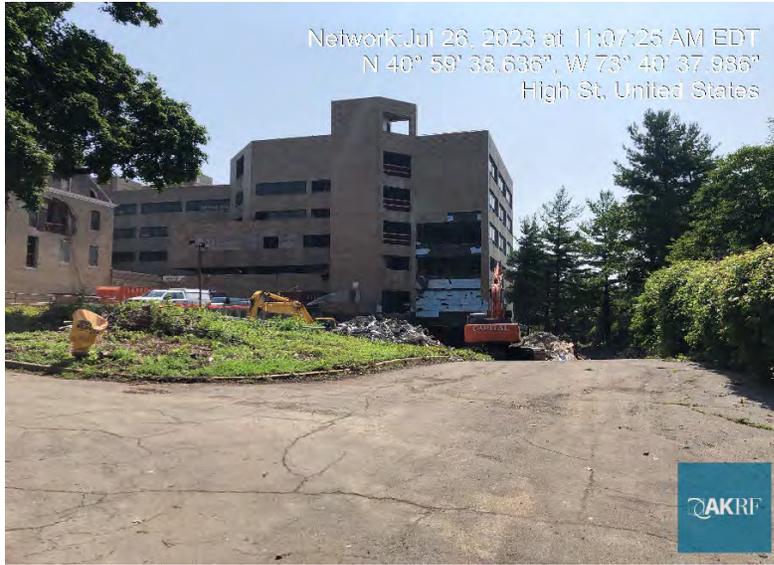
Photograph 1 -
Exterior handling of building materials associated with demolition of interior, non-loadbearing, building elements, view facing East.

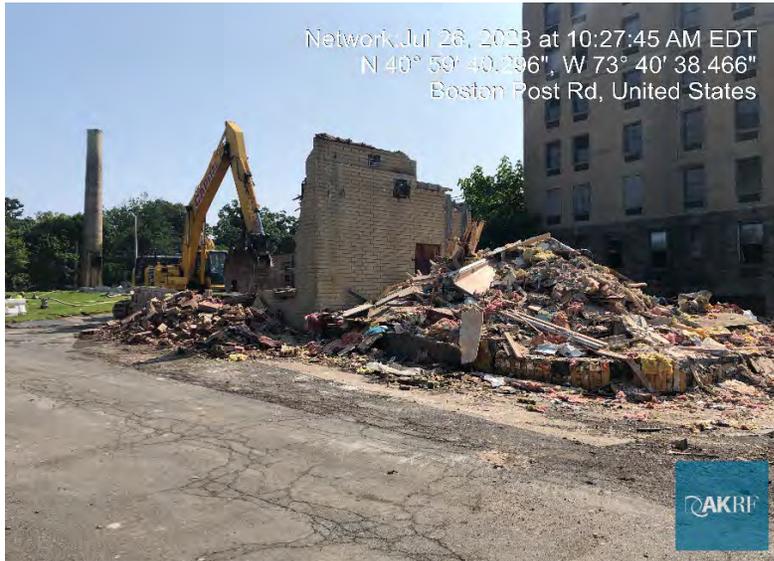
Photograph 2 -
Structural demolition of the MRI building in the central portion of the site, view facing Northeast.

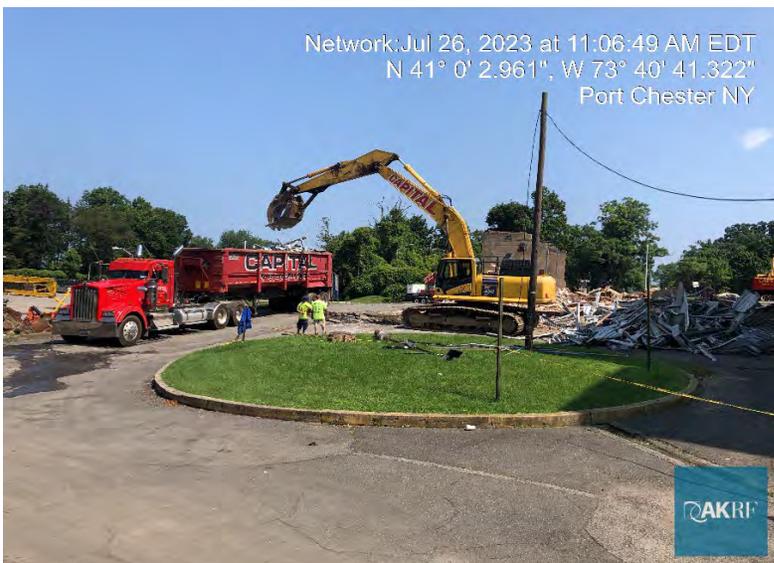
Photograph 3 -
Structural demolition of the MRI building in the central portion of the site, view facing North.

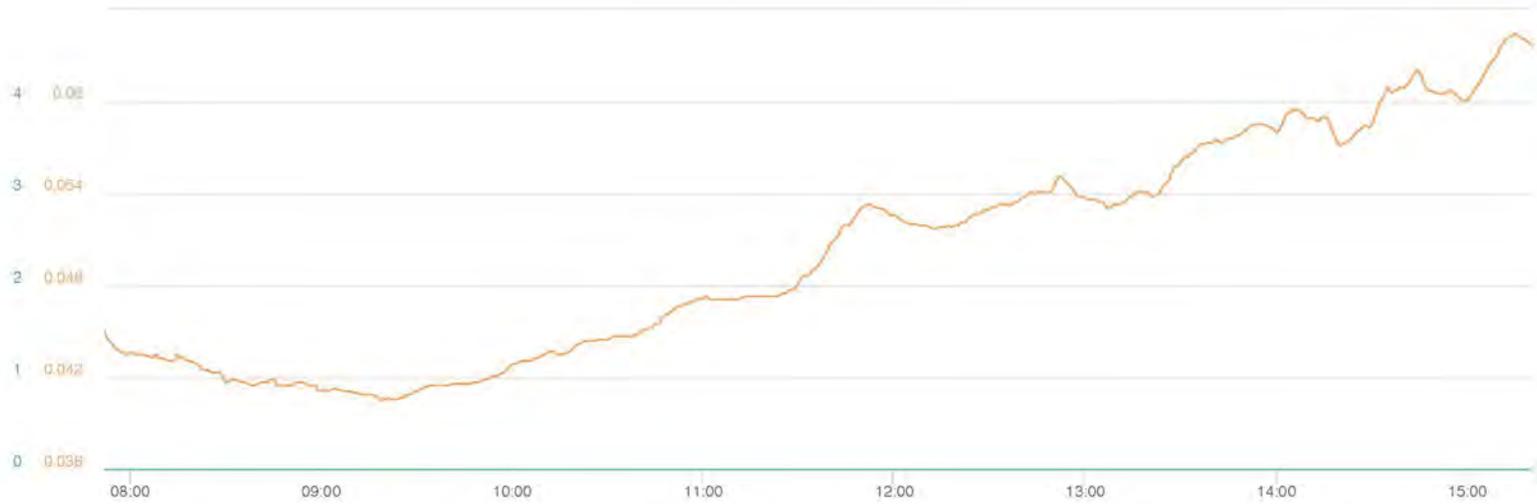
UH - Fixed 1 CAMP Station Graph

07/26/2023 0:00:00 – 07/27/2023 0:00:00
(GMT-05:00) Eastern Time (US & Canada)

MIN	AVG	MAX
0.0405	0.0499	0.0644

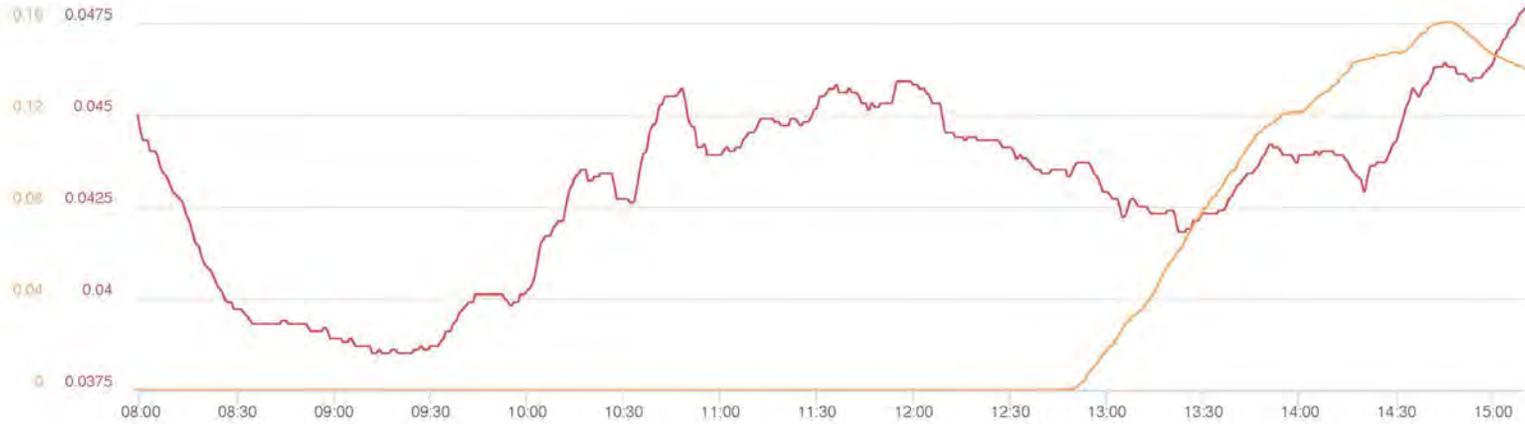
UH - Fixed 3 CAMP Station Graph

07/26/2023 0:00:11 – 07/27/2023 0:00:00
(GMT-05:00) Eastern Time (US & Canada)

MIN	AVG	MAX
0.0395	0.043	0.0478

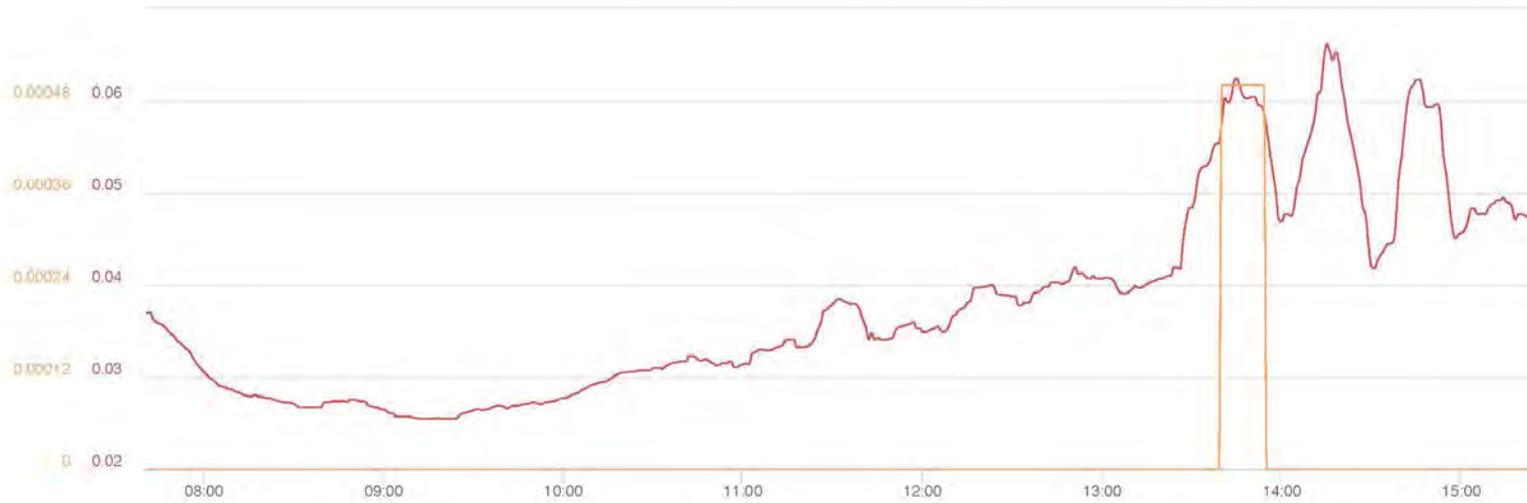
UH - Downwind 1 CAMP Station Graph

07/26/2023 0:00:00 – 07/27/2023 0:00:00
(GMT-05:00) Eastern Time (US & Canada)

MIN	AVG	MAX
0.0255	0.0377	0.0661

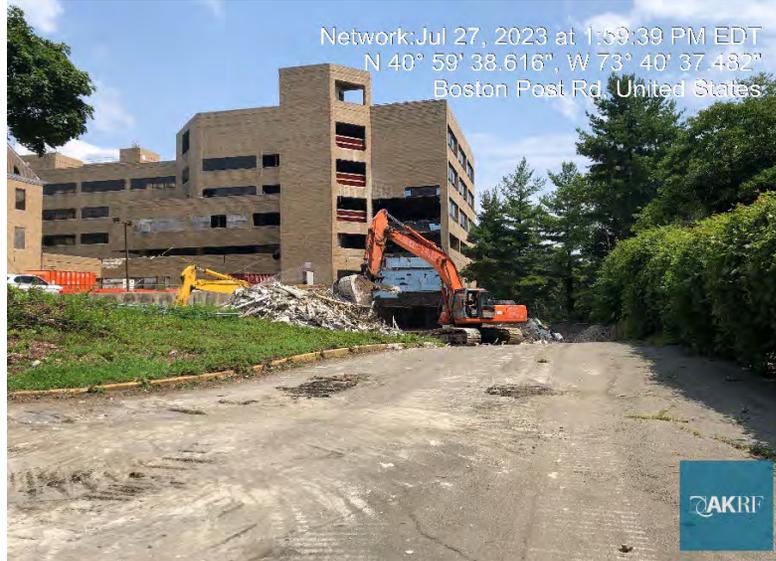
Photograph 1 -
Exterior handling of building materials associated with demolition of interior, non-loadbearing, building elements, view facing East.

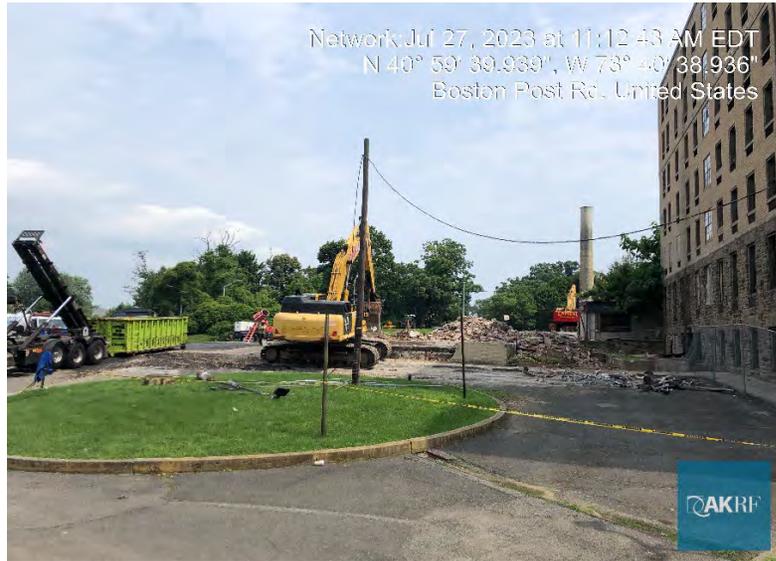
Photograph 2 -
Handling of demolition debris of the MRI building in the central portion of the site, view facing North.

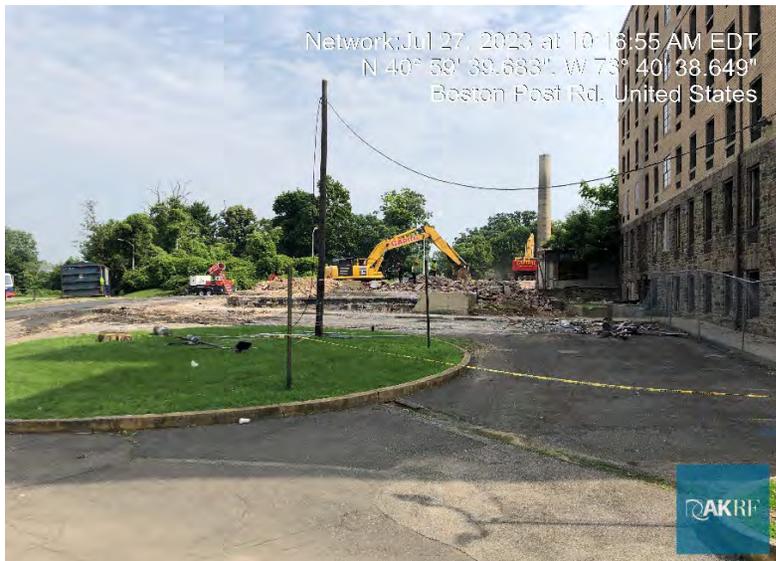
Photograph 3 -
Handling of demolition debris of the MRI building in the central portion of the site, view facing North.

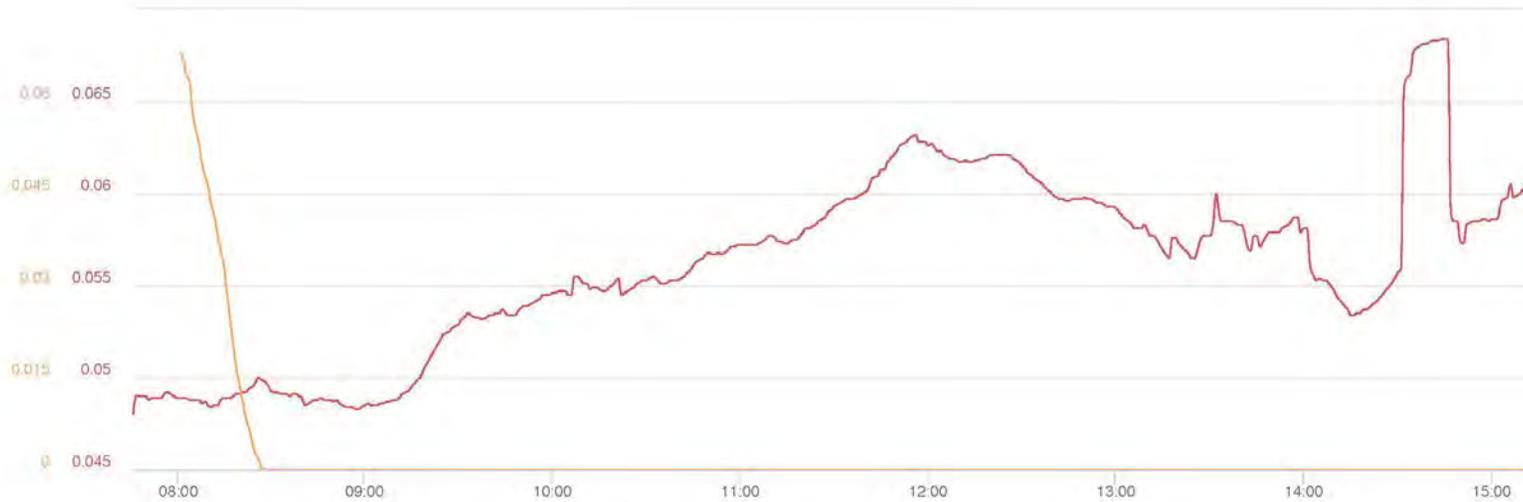
UH - Fixed 1 CAMP Station Graph

07/27/2023 0:00:02 – 07/28/2023 0:00:00
(GMT-05:00) Eastern Time (US & Canada)

MIN	AVG	MAX
0.048	0.0561	0.0684

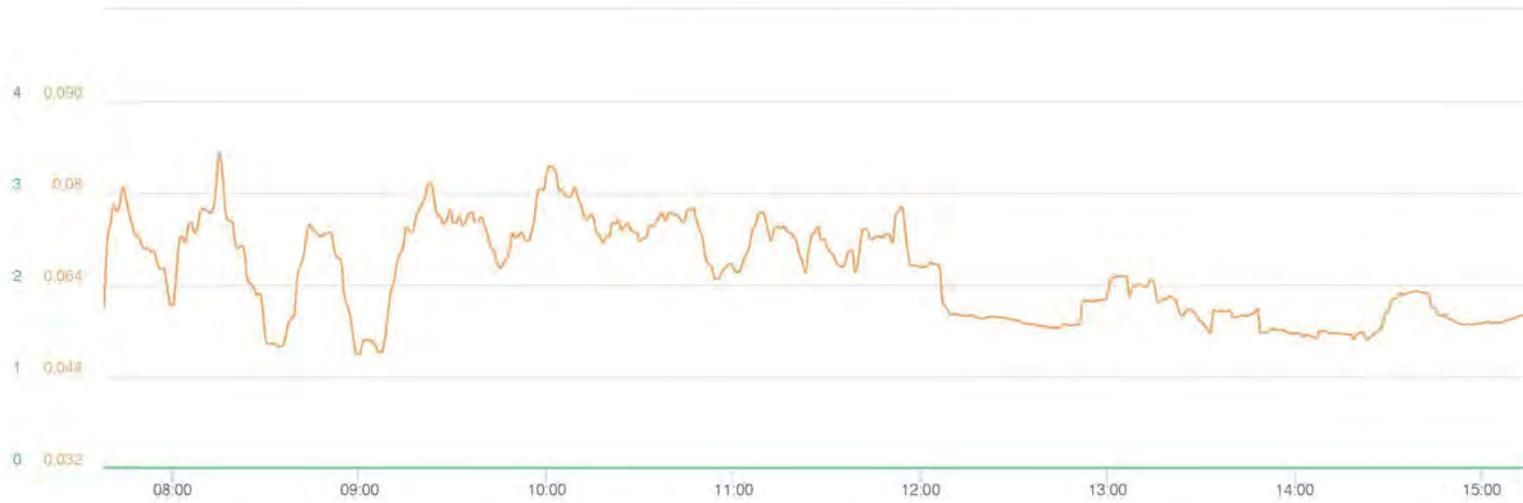
UH - Upwind 1 CAMP Station Graph

07/27/2023 0:00:57 – 07/28/2023 0:00:00
(GMT-05:00) Eastern Time (US & Canada)

MIN	AVG	MAX
0.0519	0.0659	0.0871

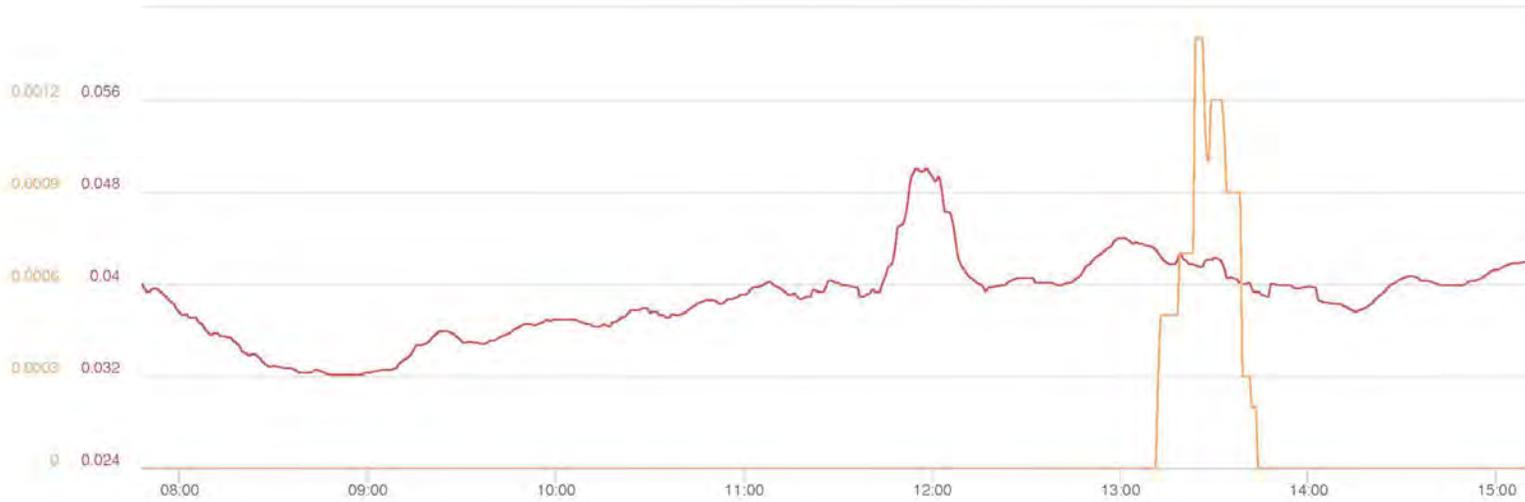
UH - Downwind 1 CAMP Station Graph

07/27/2023 0:00:29 – 07/28/2023 0:00:00
(GMT-05:00) Eastern Time (US & Canada)

MIN	AVG	MAX
0.0321	0.0387	0.05

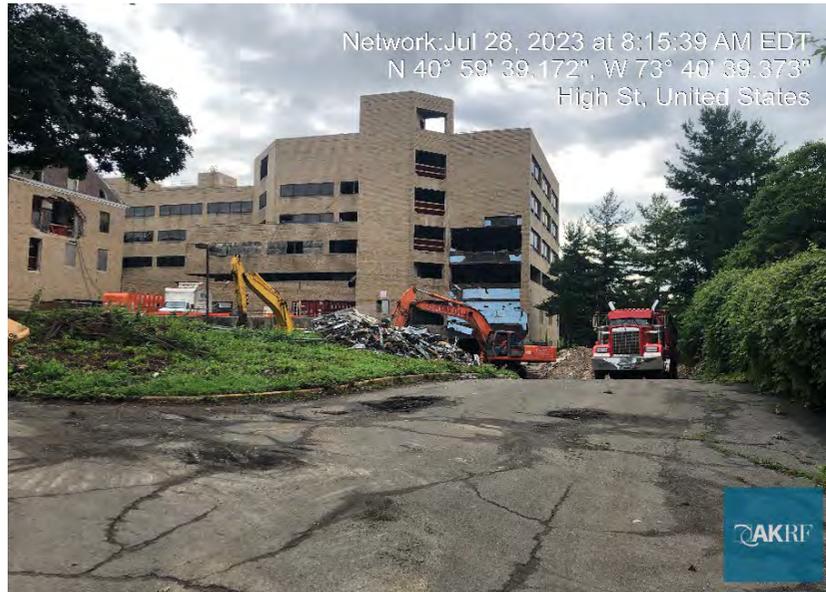
Photograph 1 -
Exterior handling of building materials associated with demolition of interior, non-loadbearing, building elements, view facing east.

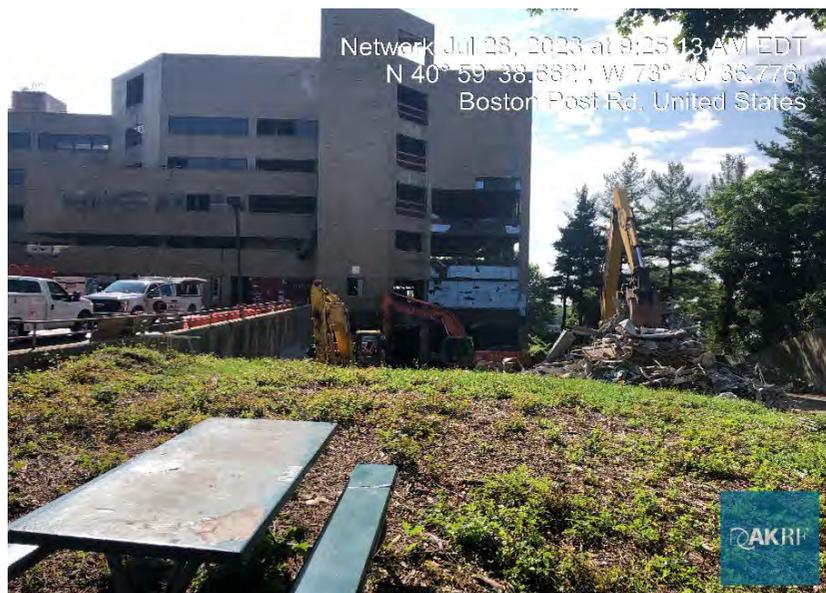
Photograph 2 -
Exterior handling of building materials associated with demolition of interior, non-loadbearing, building elements, view facing east.

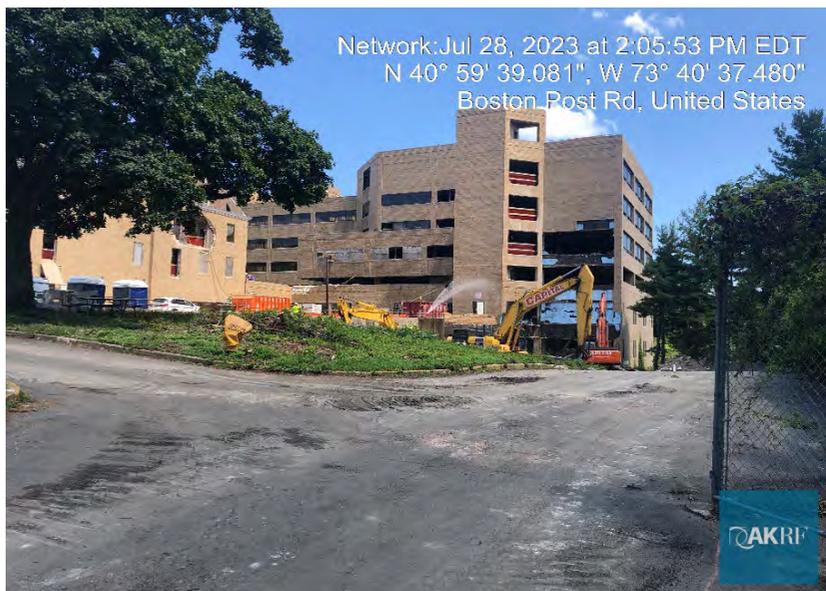
Photograph 3 -
Exterior handling of building materials associated with demolition of interior, non-loadbearing, building elements, view facing east.

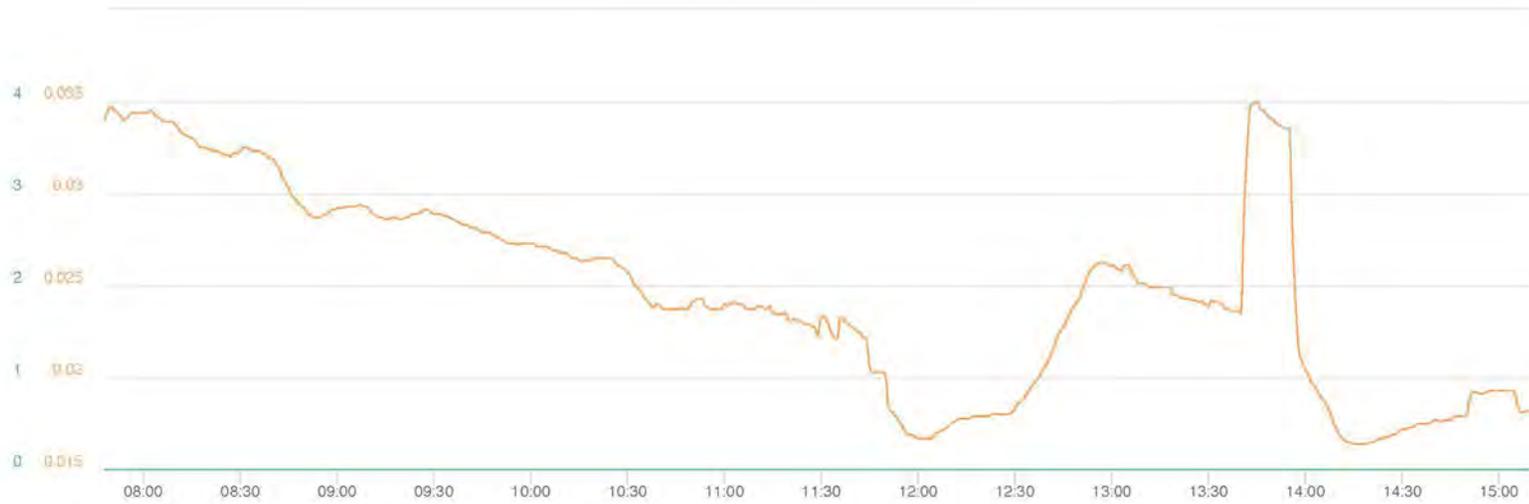
UH - Fixed 1 CAMP Station Graph

Fri, 28th of Jul 2023, 0:00:00 – 23:59:00
(GMT-05:00) Eastern Time (US & Canada)

MIN	AVG	MAX
0.0164	0.0248	0.035

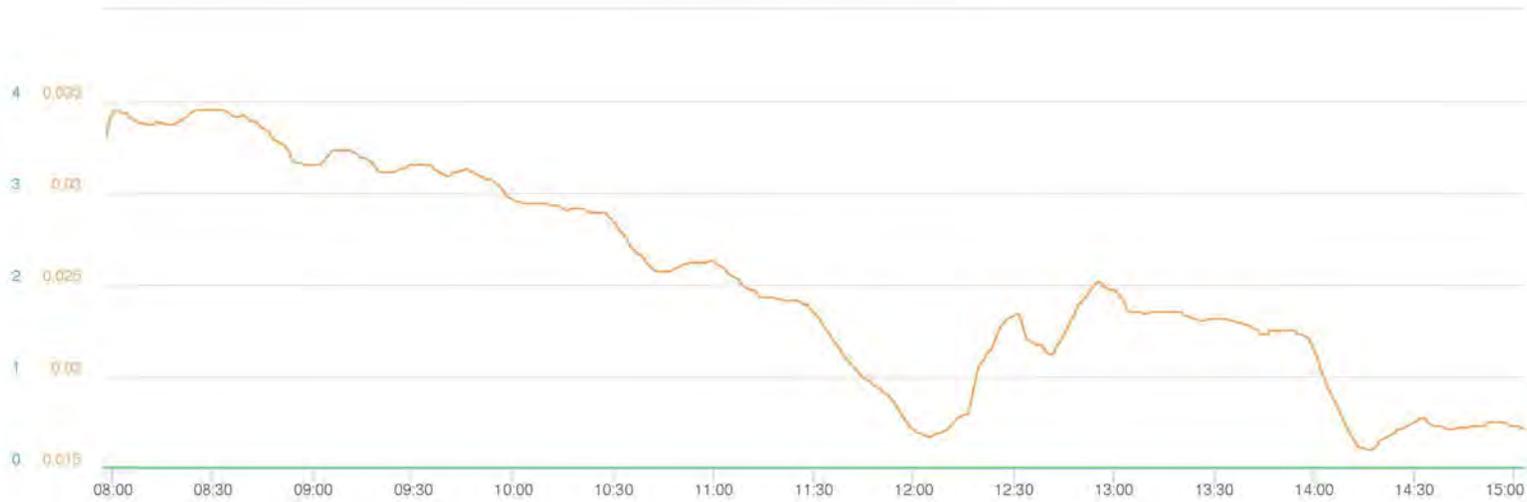
UH - Fixed 2 CAMP Station Graph

Fri, 28th of Jul 2023, 0:00:00 – 23:59:00
(GMT-05:00) Eastern Time (US & Canada)

MIN	AVG	MAX
0.016	0.0252	0.0345

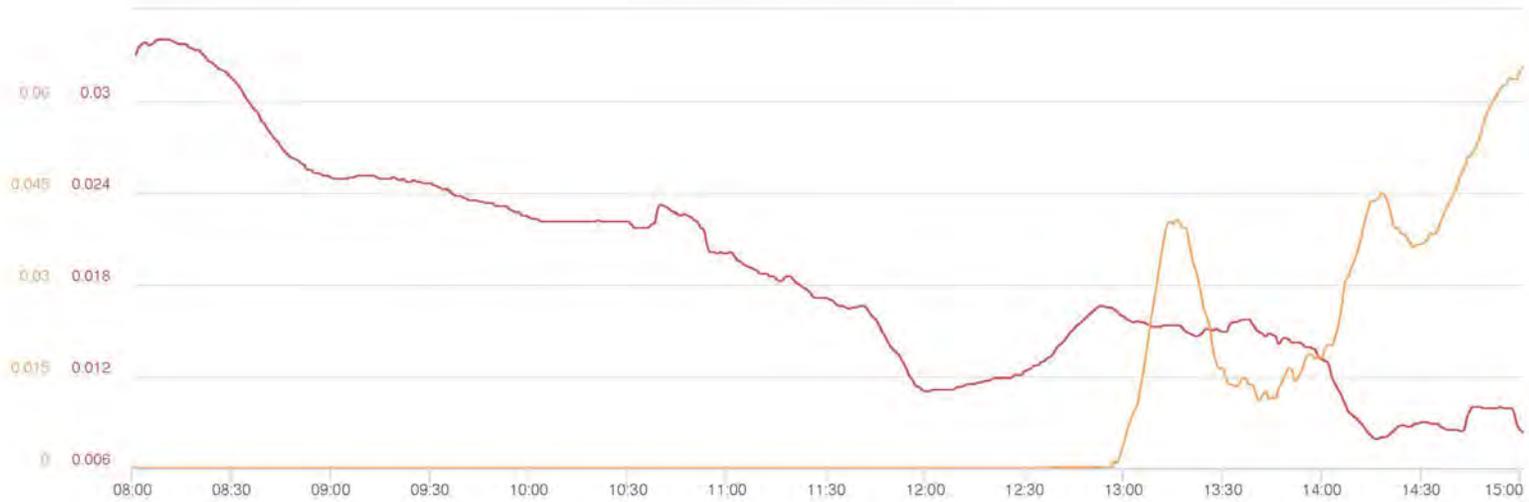
UH - Fixed 3 CAMP Station Graph

Fri, 28th of Jul 2023, 0:00:00 – 23:59:00
(GMT-05:00) Eastern Time (US & Canada)

MIN	AVG	MAX
0.0079	0.0186	0.034

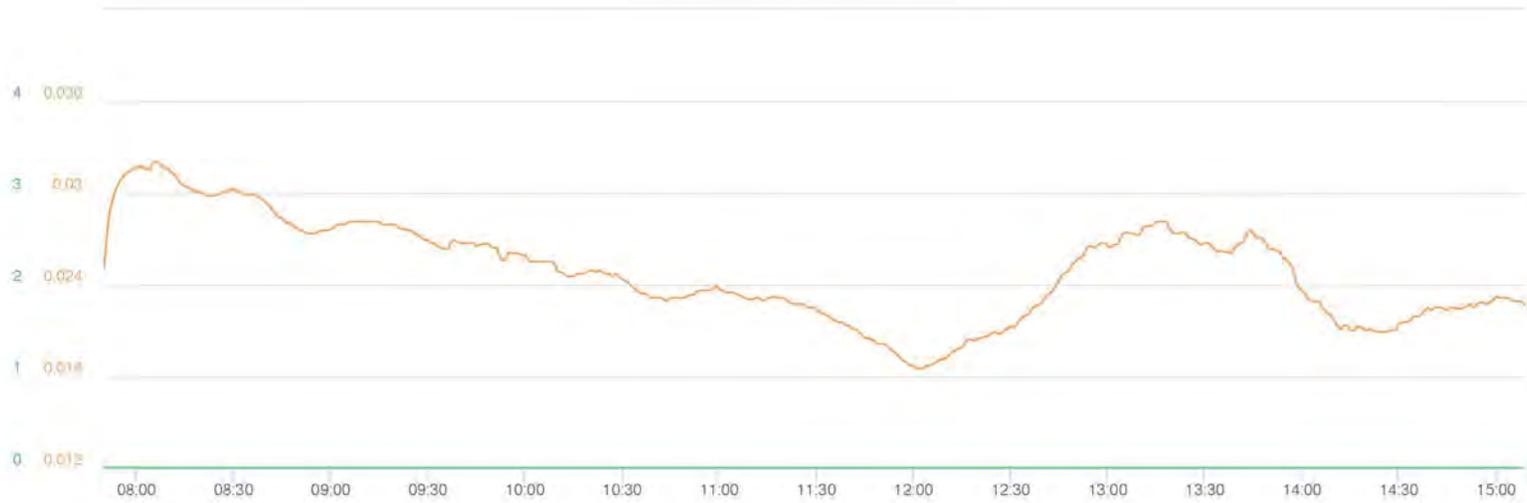
UH - Upwind 1 CAMP Station Graph

Fri, 28th of Jul 2023, 0:00:00 – 23:59:00
(GMT-05:00) Eastern Time (US & Canada)

MIN	AVG	MAX
0.0185	0.0249	0.032

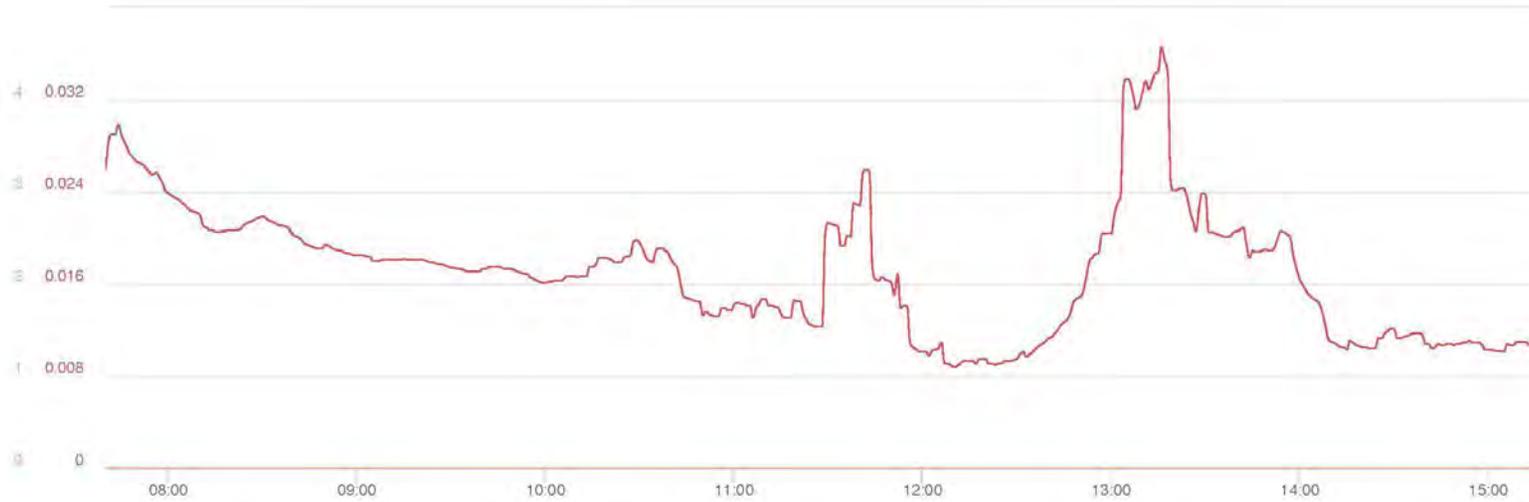
UH - Downwind 1 CAMP Station Graph

Fri, 28th of Jul 2023, 0:00:00 – 23:59:00
(GMT-05:00) Eastern Time (US & Canada)

MIN	AVG	MAX
0.0088	0.017	0.0366

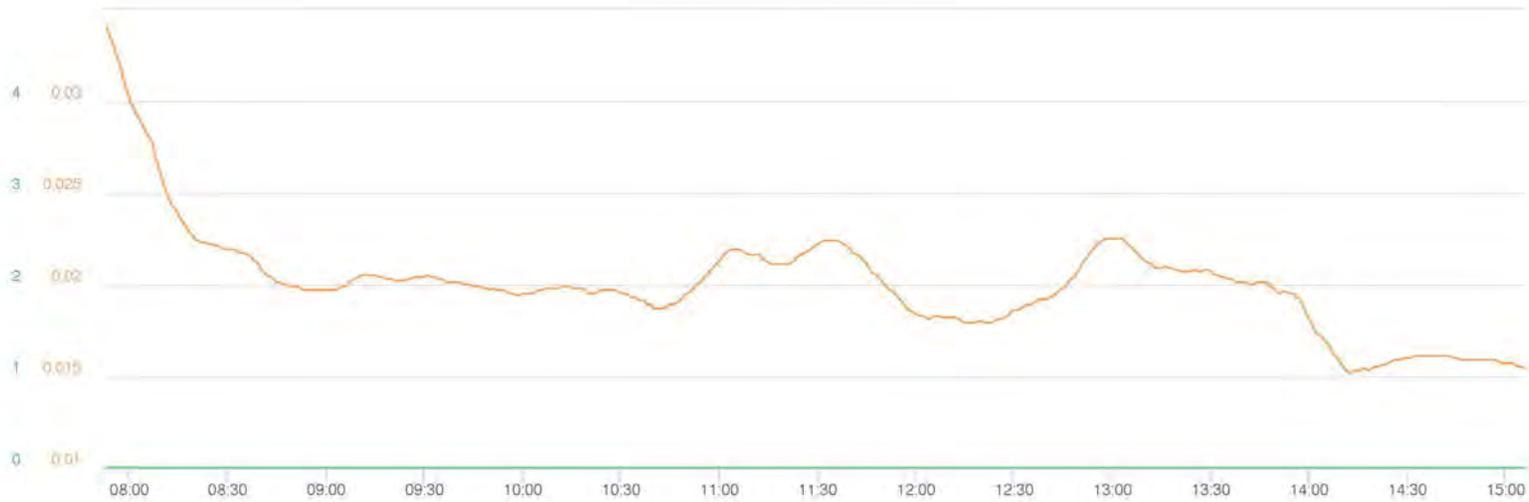
UH - Downwind 2 CAMP Station Graph

Fri, 28th of Jul 2023, 0:00:00 – 23:59:00
(GMT-05:00) Eastern Time (US & Canada)

MIN	AVG	MAX
0.0152	0.02	0.034

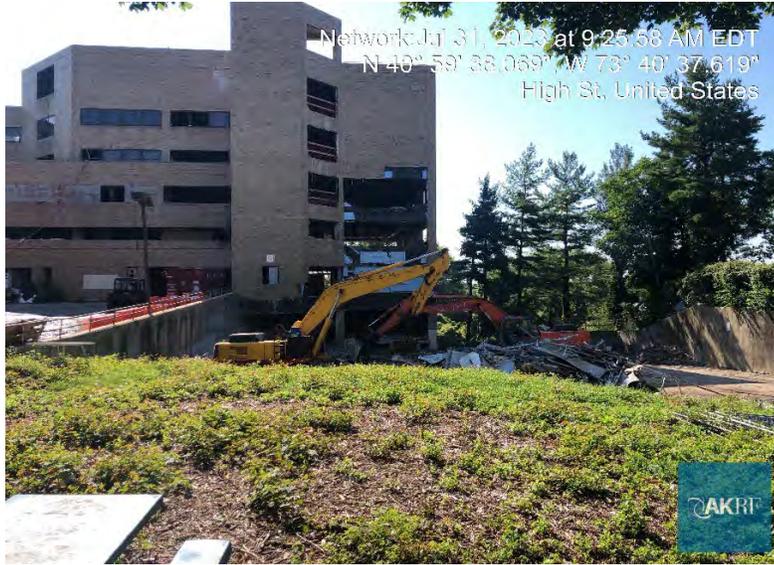
Photograph 1 -
Exterior handling of building materials associated with demolition of interior, non-loadbearing, building elements, view facing east.

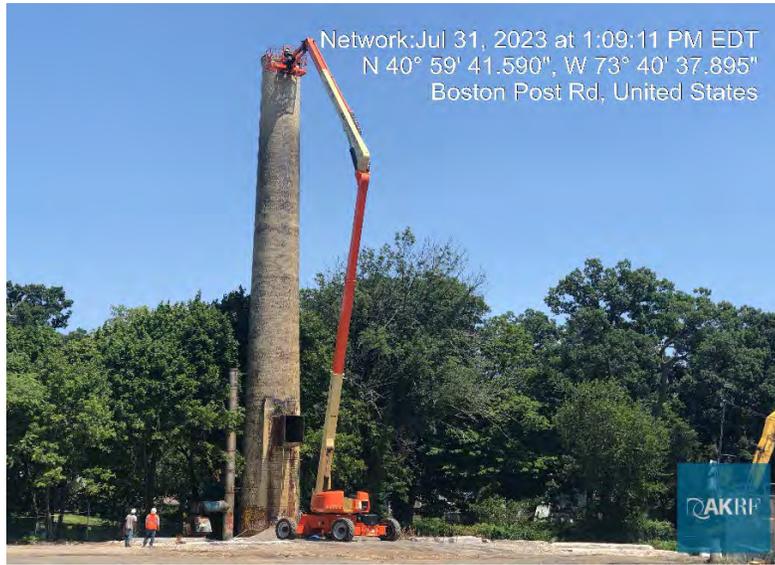
Photograph 2 -
Structural demolition of the chimney associated with the former power/boiler plant building in the northern portion of the site, view facing north.

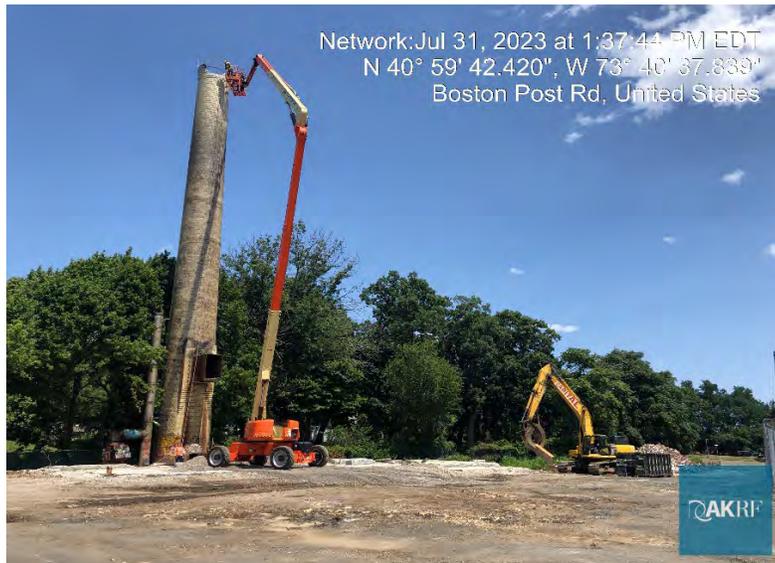
Photograph 3 -
Structural demolition of the chimney associated with the former power/boiler plant building in the northern portion of the site, view facing north.

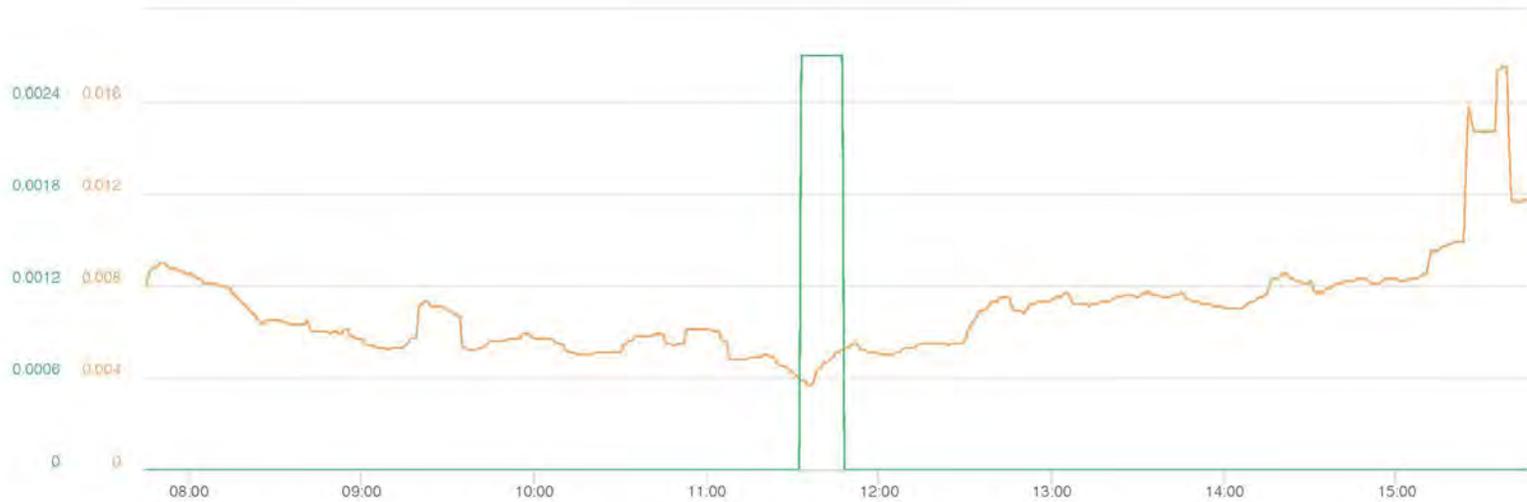
UH - Fixed 1 CAMP Station Graph

07/31/2023 0:00:10 – 08/01/2023 0:00:00
(GMT-05:00) Eastern Time (US & Canada)

MIN	AVG	MAX
0.0037	0.0069	0.0175

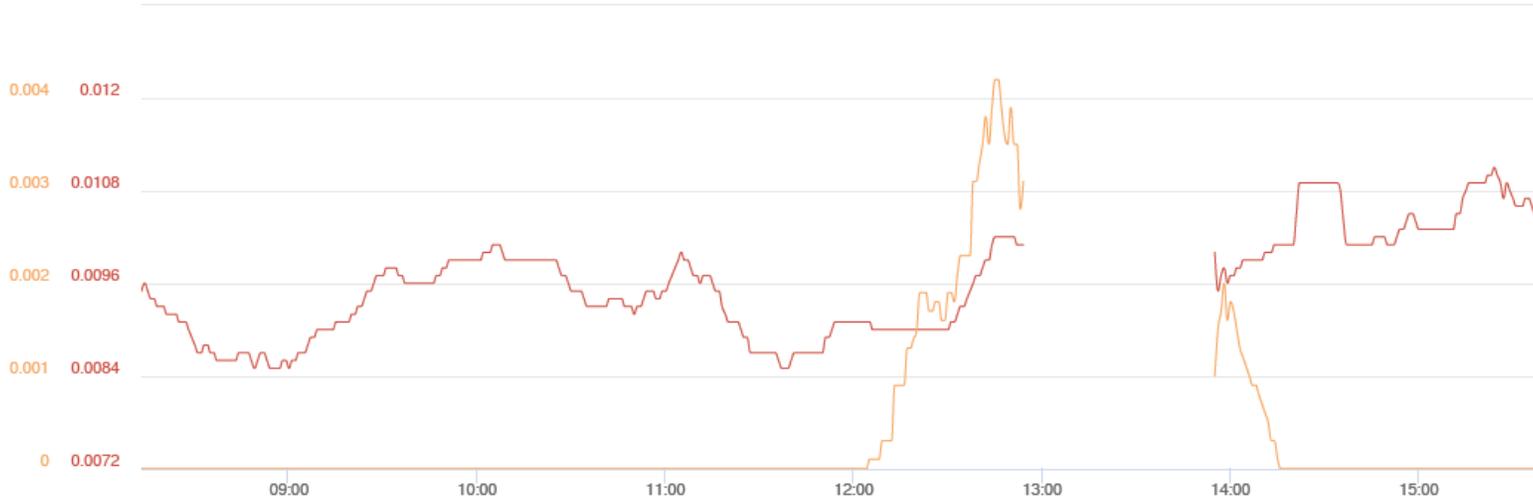
UH - Fixed 2 CAMP Station Graph

07/31/2023 8:13:00 – 08/01/2023 0:00:00
(GMT-05:00) Eastern Time (US & Canada)

Mass Conc. Total mg/m ³ AVG 15m <small>mg/m³</small> DustTrak-8530 <small>RS232(C)</small>			VOC ppm AVG 15m ppm <small>ppm</small> miniRAE 3000 <small>RS232(A)</small>		
MIN	AVG	MAX	MIN	AVG	MAX
0.0085	0.0096	0.0111	0	0	0.0042

Name UH - Fixed 2
S/N 0B380404
Description FA03503
Location 433 Boston Post Rd,
 Port Chester, NY 10573,
 USA

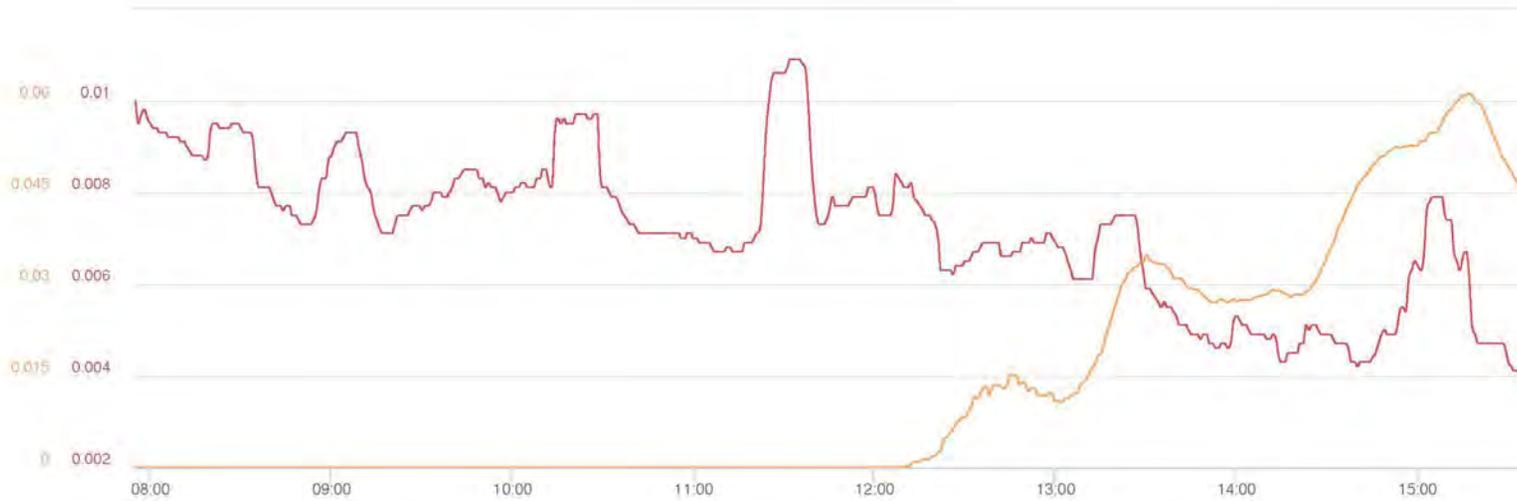
UH - Fixed 3 CAMP Station Graph

07/31/2023 0:00:54 – 08/01/2023 0:00:00
(GMT-05:00) Eastern Time (US & Canada)

Mass Conc. Total mg/m³ AVG 15m
mg/m³
DustTrak-8530
RS232(C)

MIN	AVG	MAX
0.004	0.0072	0.0109

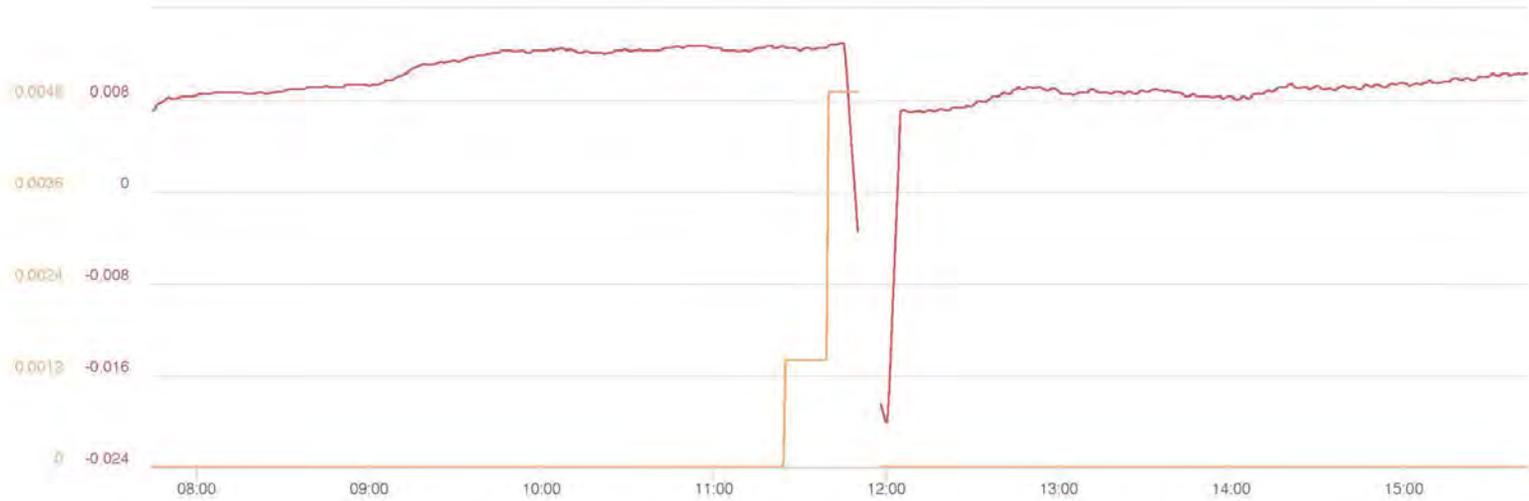
UH - Upwind 1 CAMP Station Graph

07/31/2023 0:00:43 – 08/01/2023 0:00:00
(GMT-05:00) Eastern Time (US & Canada)

Mass Conc. Total mg/m³ AVG 15m
mg/m³
DustTrak-8530
RS232(G)

MIN	AVG	MAX
-0.0201	0.0095	0.0129

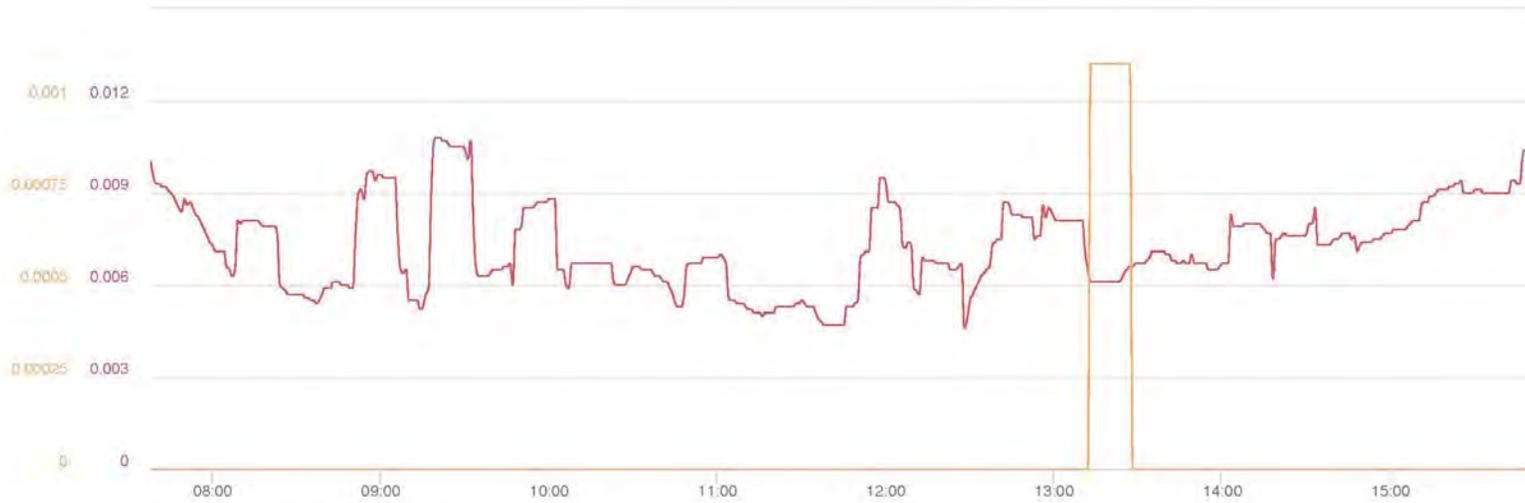
UH - Downwind 1 CAMP Station Graph

07/31/2023 0:00:50 – 08/01/2023 0:00:00
(GMT-05:00) Eastern Time (US & Canada)

Mass Conc. Total mg/m³ AVG 15m
mg/m³
DustTrak-8530
RS232(C)

MIN	AVG	MAX
0.0046	0.0073	0.0108

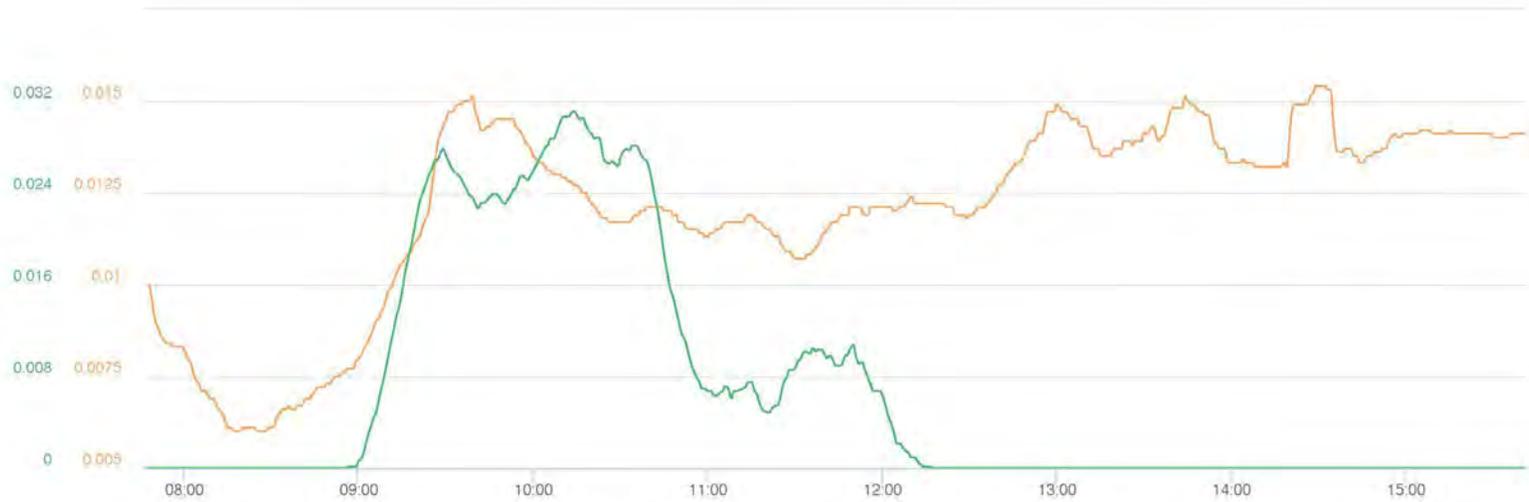
UH - Downwind 2 CAMP Station Graph

07/31/2023 0:00:50 – 08/01/2023 0:00:00
(GMT-05:00) Eastern Time (US & Canada)

Mass Conc. Total mg/m³ AVG 15m
mg/m³
DustTrak-8530
RS232(C)

MIN	AVG	MAX
0.006	0.0121	0.0154
