Re: Monthly Progress Report – August 2023
Former United Hospital – 406 Boston Post Road, Port Chester, New York
NYSDEC BCP Site No. C360202

This Monthly Progress Report has been prepared by AKRF, Inc. (AKRF) to summarize the work performed at the Former United Hospital site located at 406 Boston Post Road in Port Chester, New York [New York State Department of Environmental Conservation (NYSDEC) Brownfield Cleanup Program (BCP) Site No. C360202] (the Site) during the month of August 2023. The following activities were conducted:

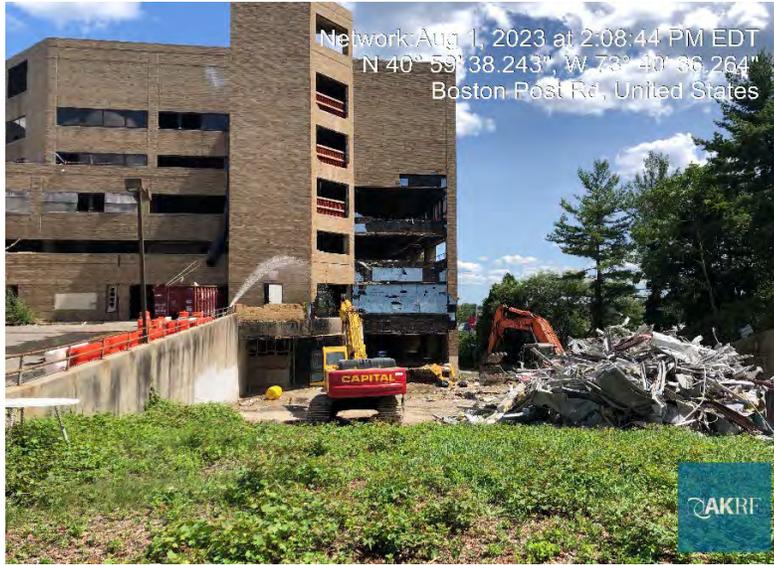
Photograph 1 -
Exterior handling of building materials associated with demolition of interior, non-loadbearing, building elements, view facing east.

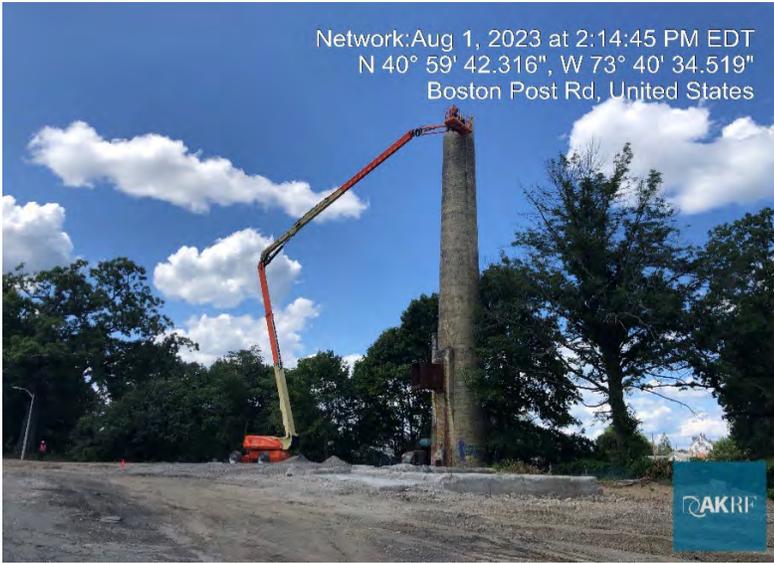
Photograph 2 -
Structural demolition of the chimney associated with the former power/boiler plant building in the northern portion of the site, view facing northwest.

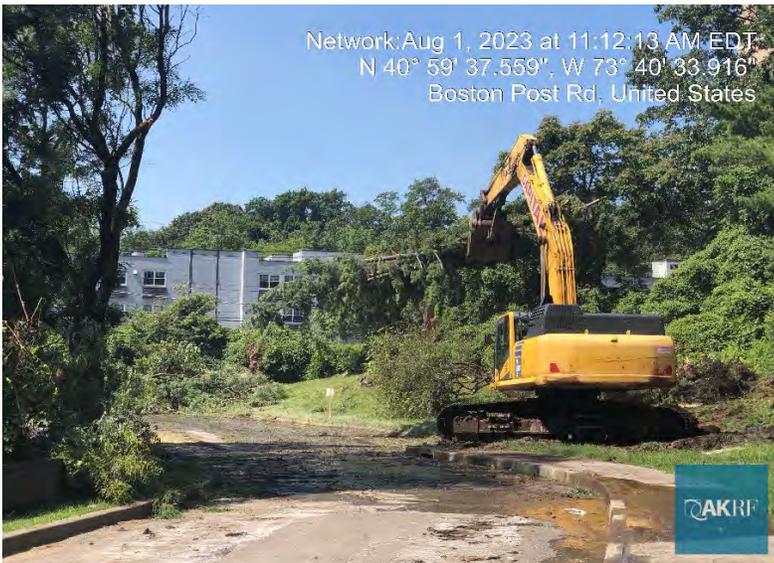
Photograph 3 -
Removal of trees along the hospital building in the southeastern portion of the site to facilitate the future removal of the building's brick facade, view facing south.

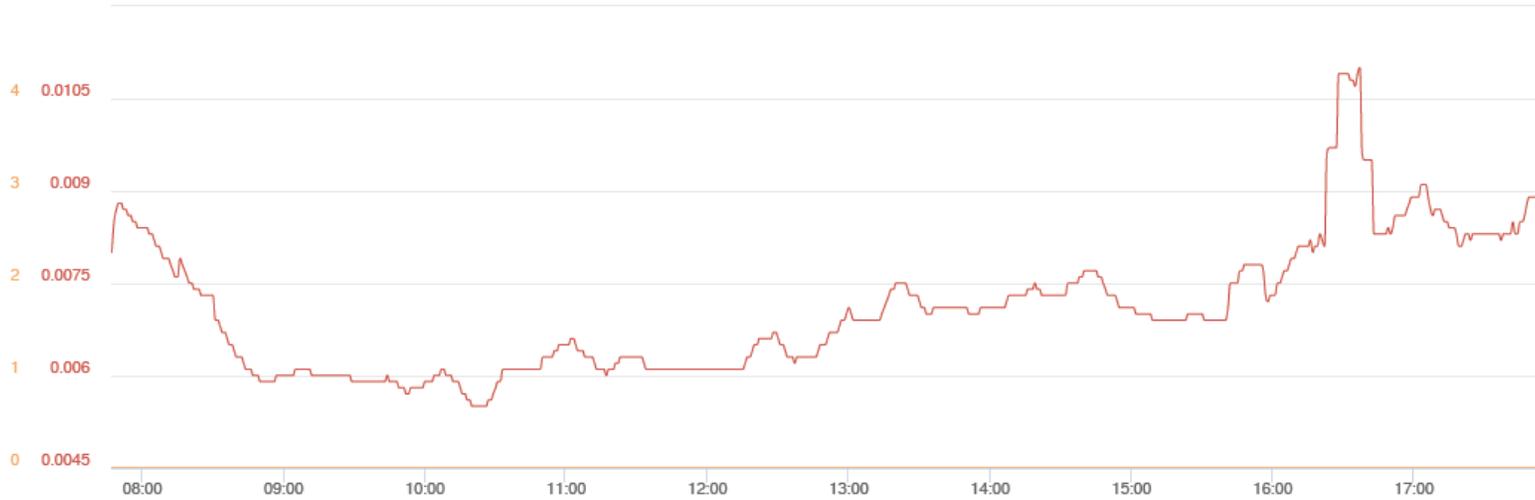
08/01/2023 0:00:26 – 08/02/2023 0:00:00
(GMT-05:00) Eastern Time (US & Canada)

Mass Conc. Total mg/m ³ AVG 15m mg/m ³ DustTrak-8530 RS232(C)			VOC ppm AVG 15m ppm miniRAE 3000 RS232(A)		
MIN	AVG	MAX	MIN	AVG	MAX
0.0055	0.0071	0.011	0	0	0

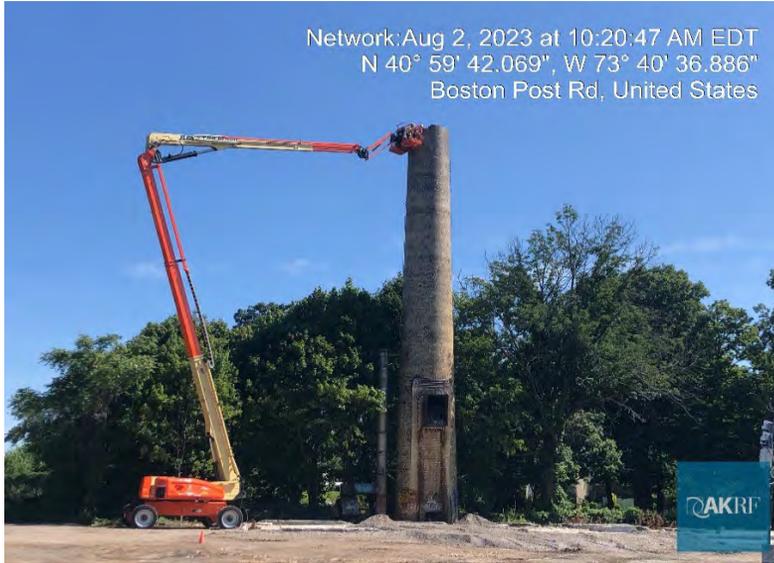
Photograph 2 -
Structural demolition of the chimney associated with the former power/boiler plant building in the northern portion of the site, view facing north.

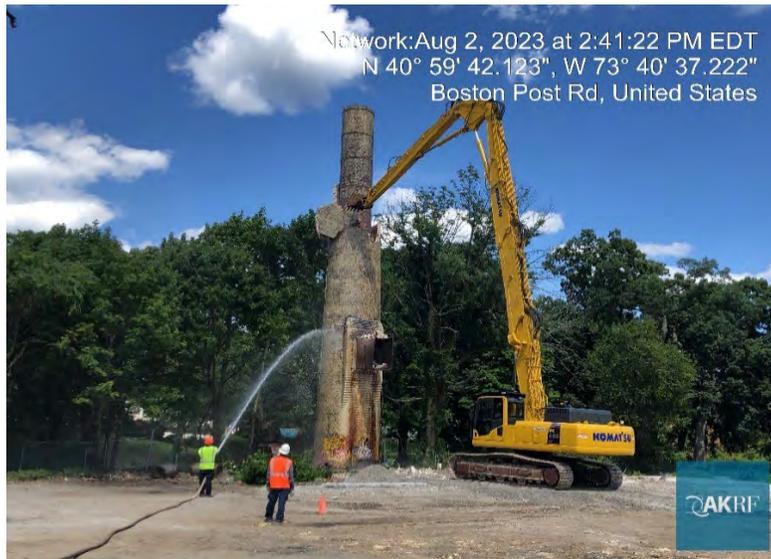
Photograph 3 -
Structural demolition of the chimney associated with the former power/boiler plant building in the northern portion of the site, view facing northwest.

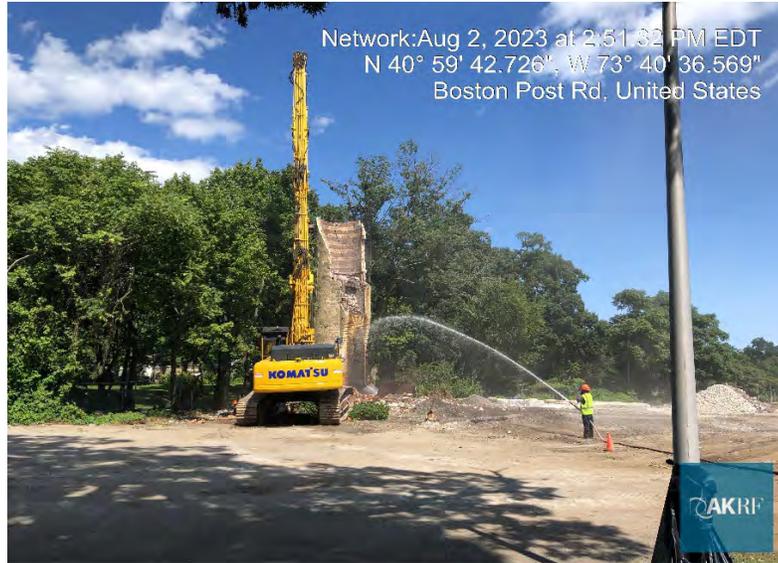
Photograph 4 -
Remaining portion of the chimney after the unstable section was pushed into the exclusion zone in the adjacent public park, view facing northwest.

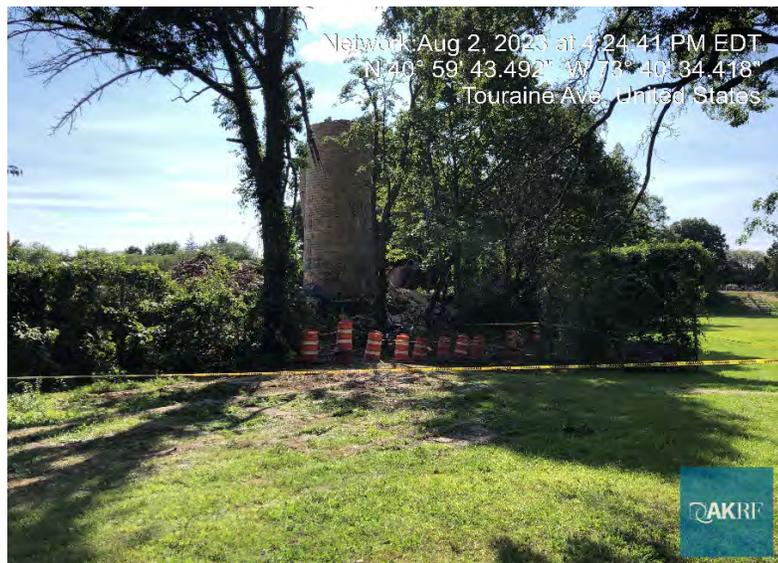
Photograph 6 -
Area where demolition debris landed in the adjacent public park following removal of the bulk of the debris, view facing southwest from the park.

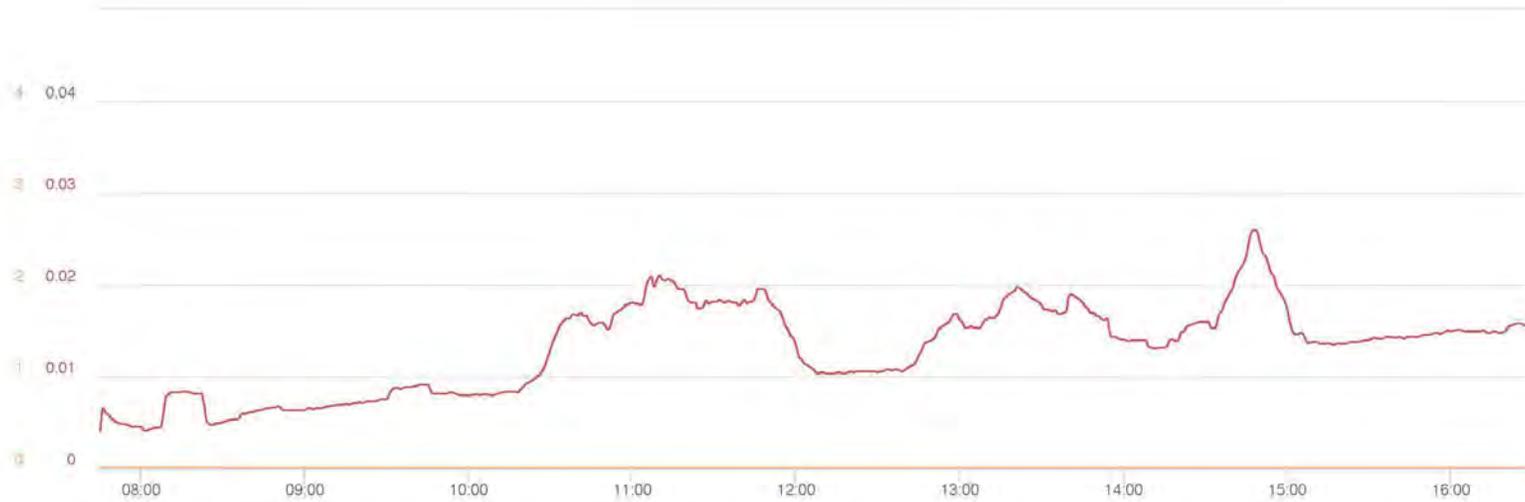
08/02/2023 0:00:26 – 08/03/2023 0:00:00
(GMT-05:00) Eastern Time (US & Canada)

Mass Conc. Total mg/m³ AVG 15m
mg/m³
DustTrak-8530
RS232(G)

MIN	AVG	MAX
0.004	0.013	0.0259

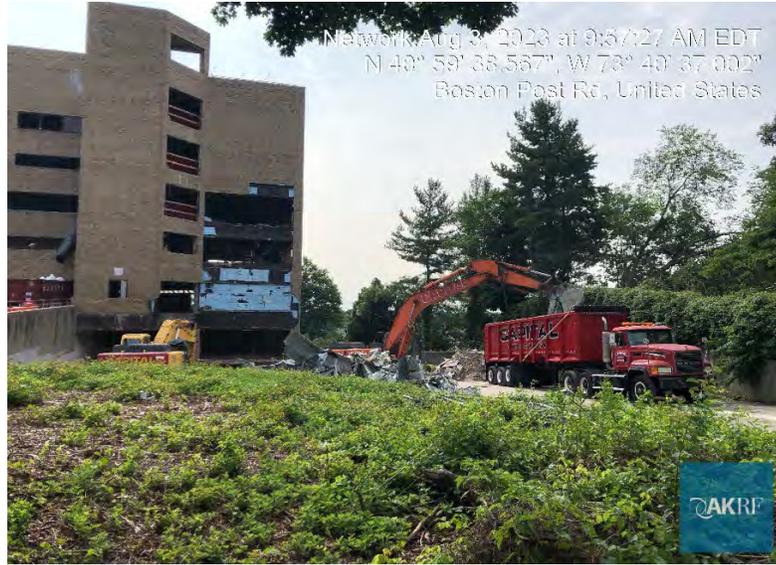
Photograph 1 -
Exterior handling of building materials associated with demolition of interior, non-loadbearing, building elements, view facing east.

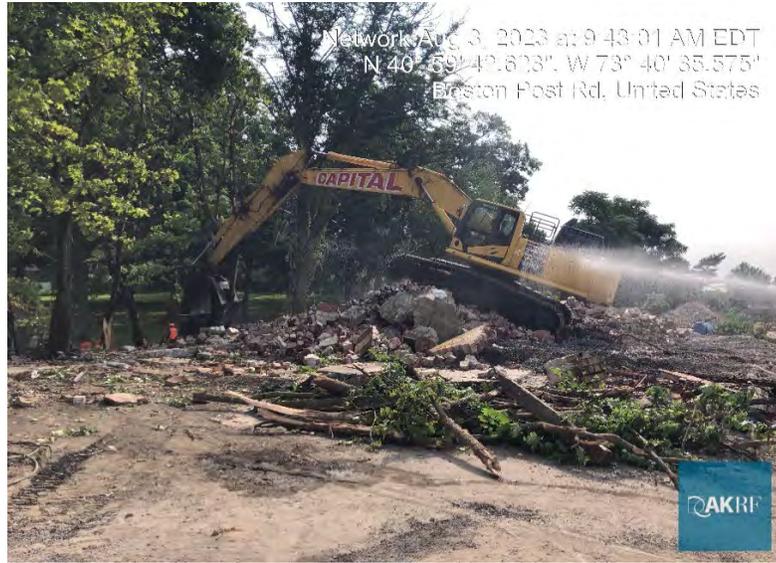
Photograph 2 -
Handling of demolition debris from the chimney associated with the former power/boiler plant building in the northern portion of the site, view facing northeast.

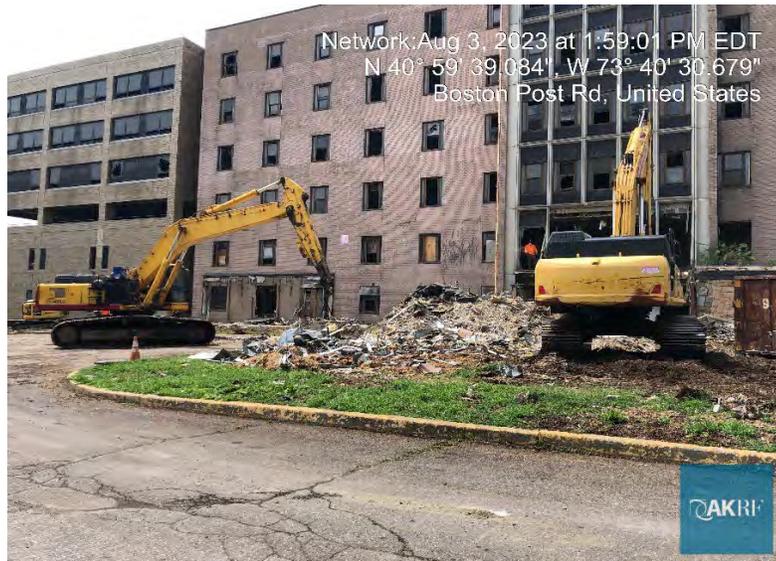
Photograph 3 -
Exterior handling of building materials associated with demolition of interior, non-loadbearing, building elements, view facing west.

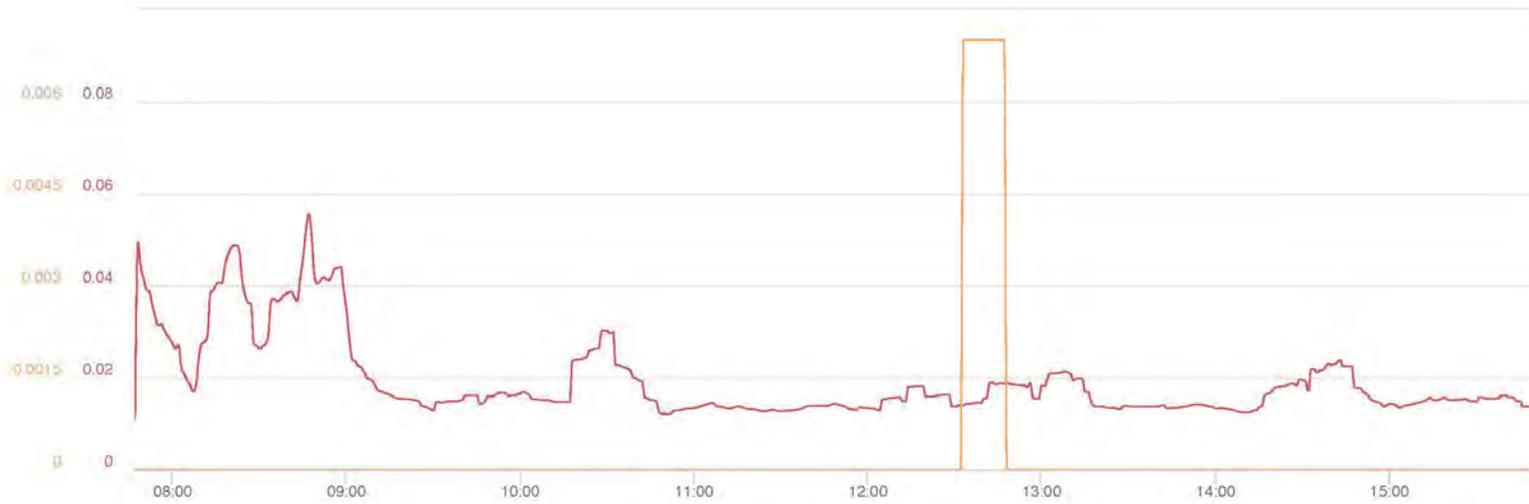
UH - Fixed 1 CAMP Station Graph

Mass Conc. Total mg/m³ AVG 15m
mg/m³
DustTrak-8530
RS232(C)

MIN	AVG	MAX
0.011	0.0191	0.0555

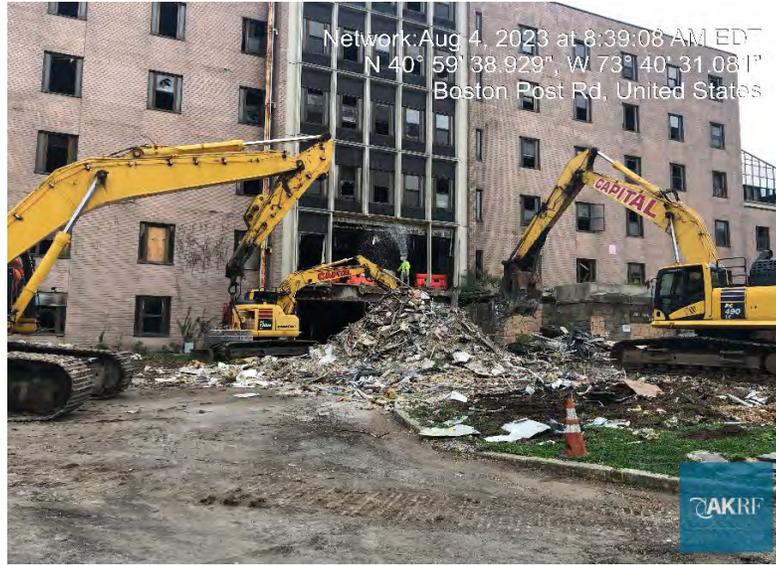
Photograph 1 -
Exterior handling of building materials associated with demolition of interior, non-loadbearing, building elements, view facing northwest.

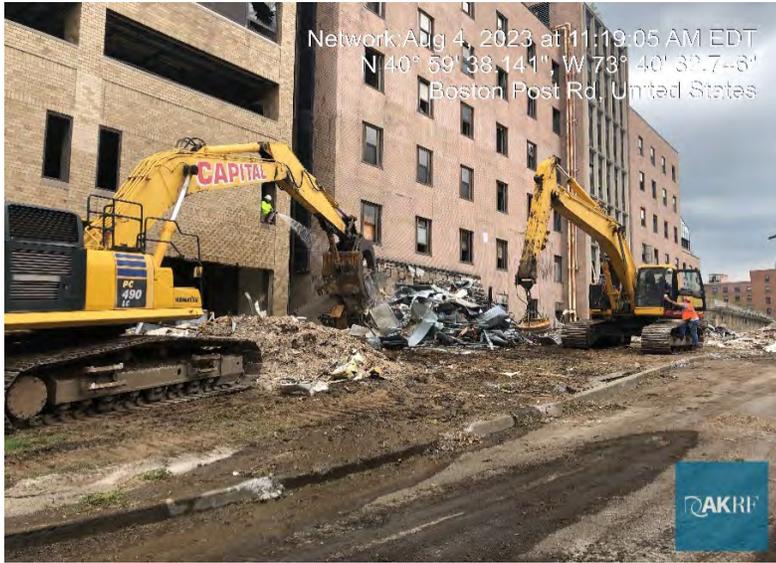
Photograph 2 -
Exterior handling of building materials associated with demolition of interior, non-loadbearing, building elements, view facing north.

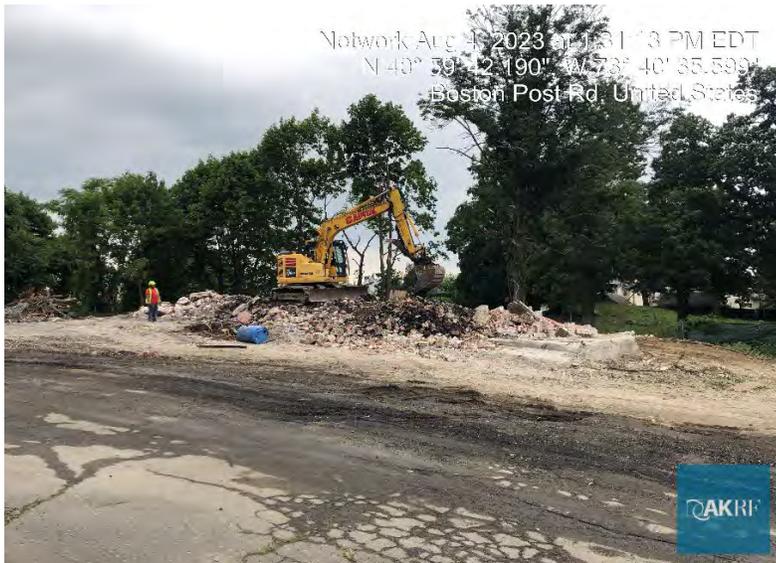
Photograph 3 -
Handling of demolition debris from the chimney associated with the former power/boiler plant building in the northern portion of the site, view facing northwest.

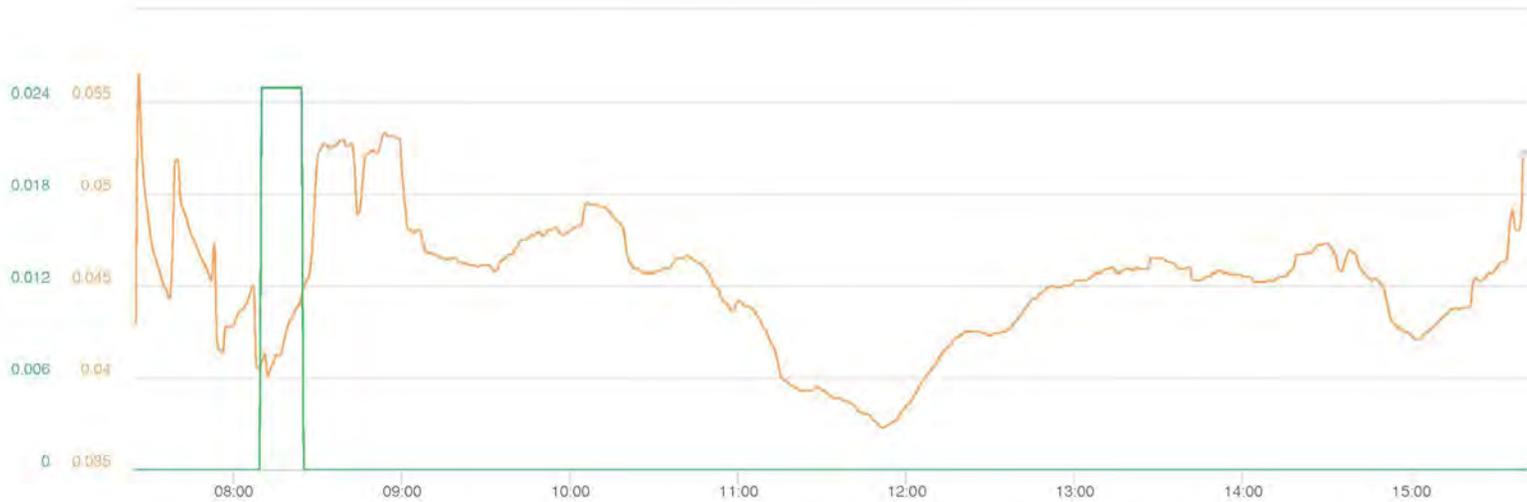
UH - Fixed 1 CAMP Station Graph

Mass Conc. Total mg/m³ AVG 15m
mg/m³
DustTrak-8530
RS232(C)

MIN	AVG	MAX
0.0373	0.0451	0.0565

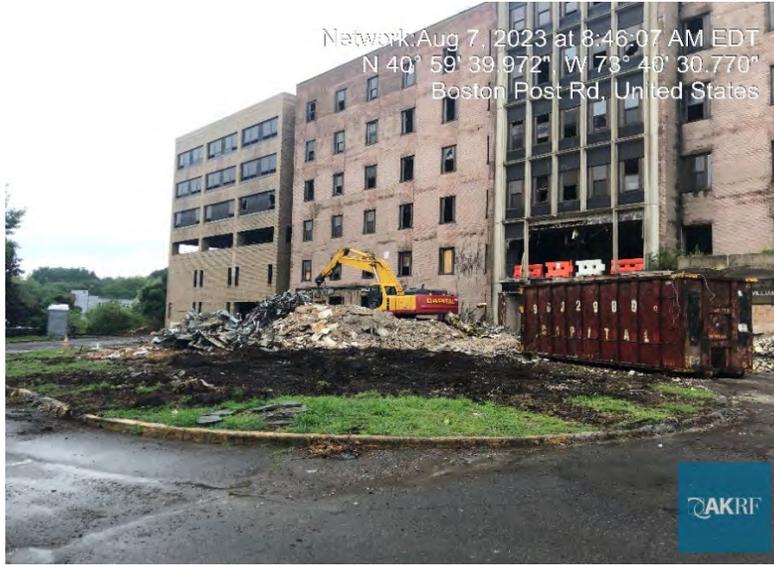
Photograph 1 -
Exterior handling of building materials associated with demolition of interior, non-loadbearing, building elements, view facing southwest.

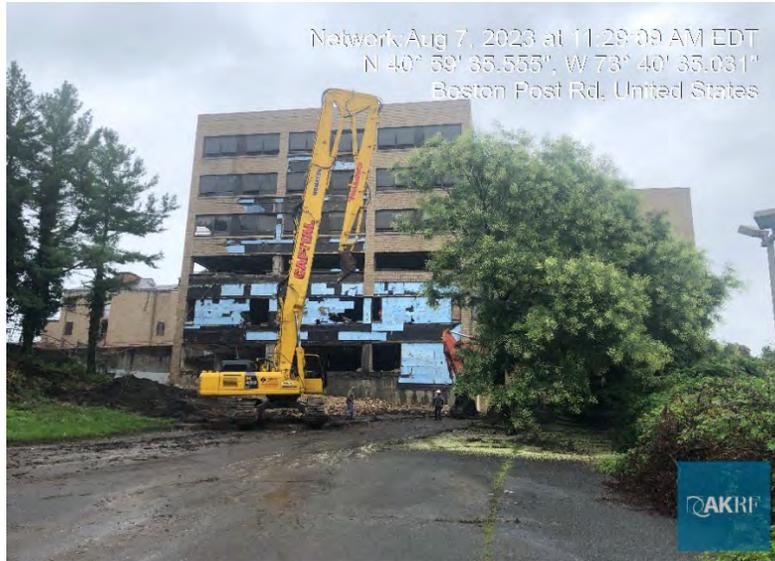
Photograph 2 -
Removal of the brick facade along the southeastern portion of the main hospital building, view facing north.

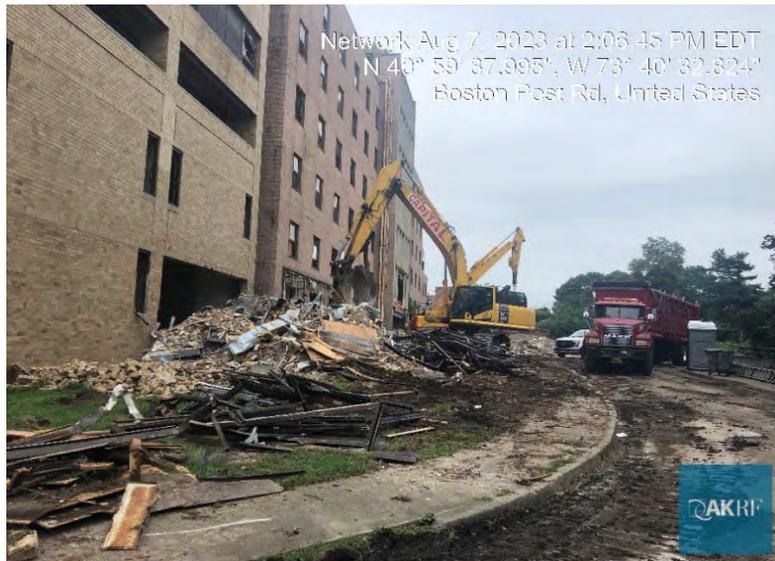
Photograph 3 -
Exterior handling of building materials associated with demolition of interior, non-loadbearing, building elements, view facing north.

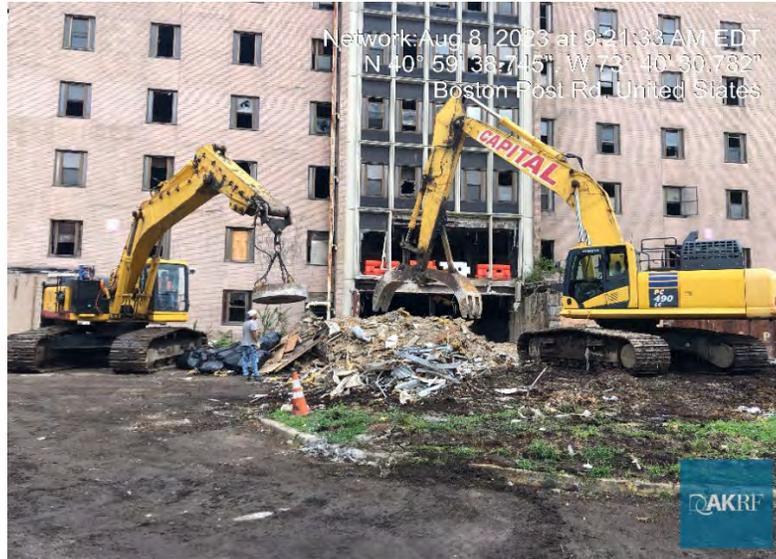
Photograph 1 -
Exterior handling of building materials associated with demolition of interior, non-loadbearing, building elements, view facing west.

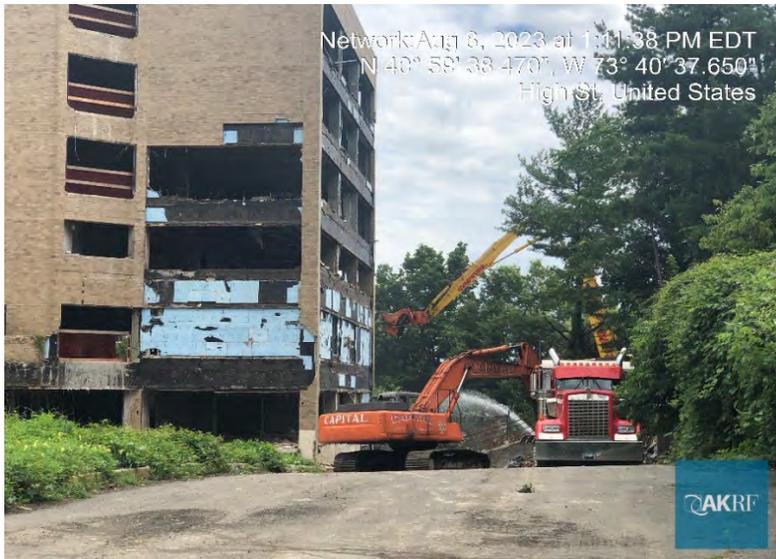
Photograph 2 -
Removal of the brick facade along the southeastern portion of the main hospital building, view facing east.

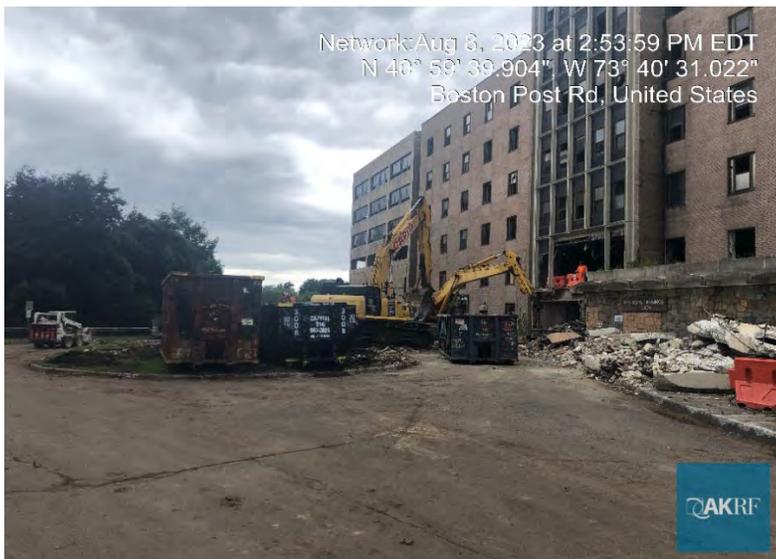
Photograph 3 -
Exterior handling of building materials associated with demolition of interior, non-loadbearing, building elements, view facing south.

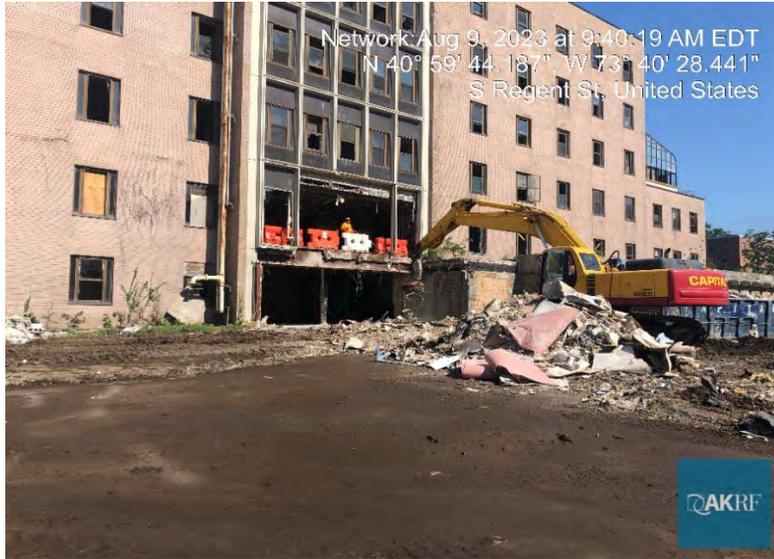
Photograph 1 -
Exterior handling of building materials associated with demolition of interior, non-loadbearing, building elements, view facing northwest.

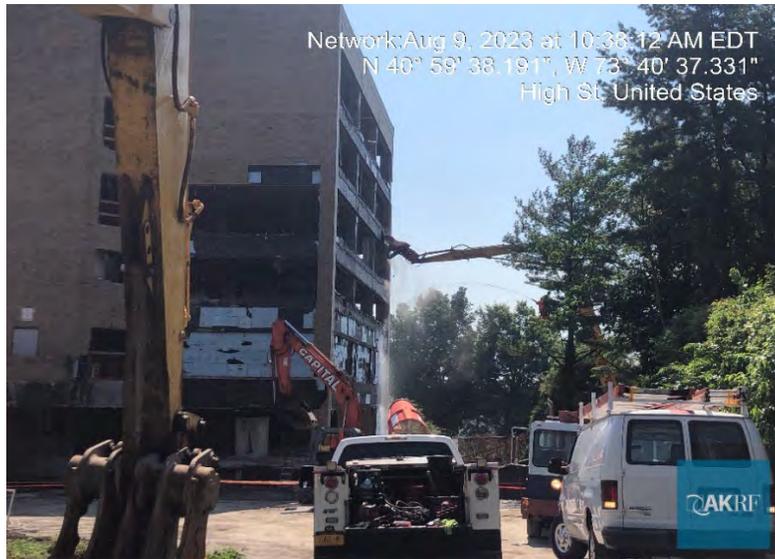
Photograph 2 -
Removal of the brick facade along the southeastern portion of the main hospital building, view facing east.

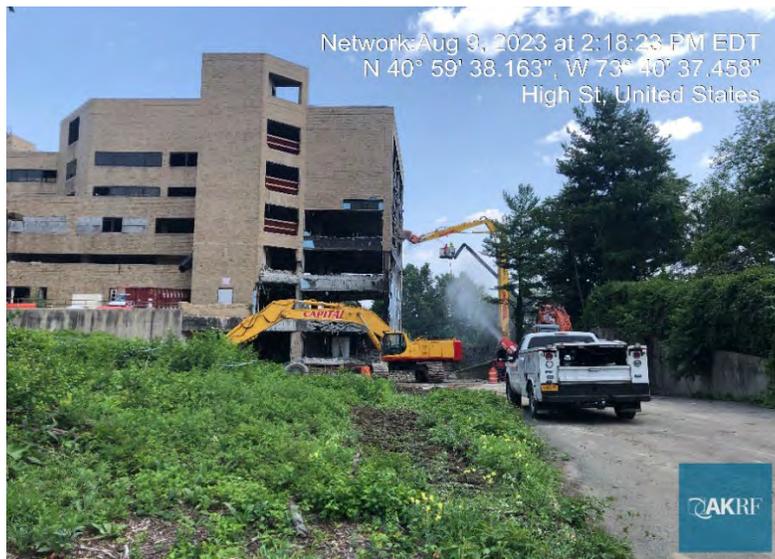
Photograph 3 -
Removal of the brick facade along the southeastern portion of the main hospital building, view facing east.

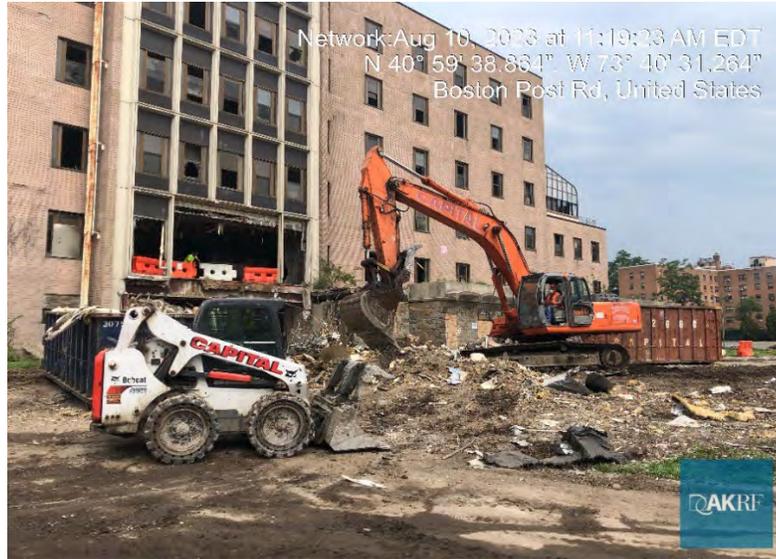
Photograph 1 -
Exterior handling of building materials associated with demolition of interior, non-loadbearing, building elements, view facing northwest.

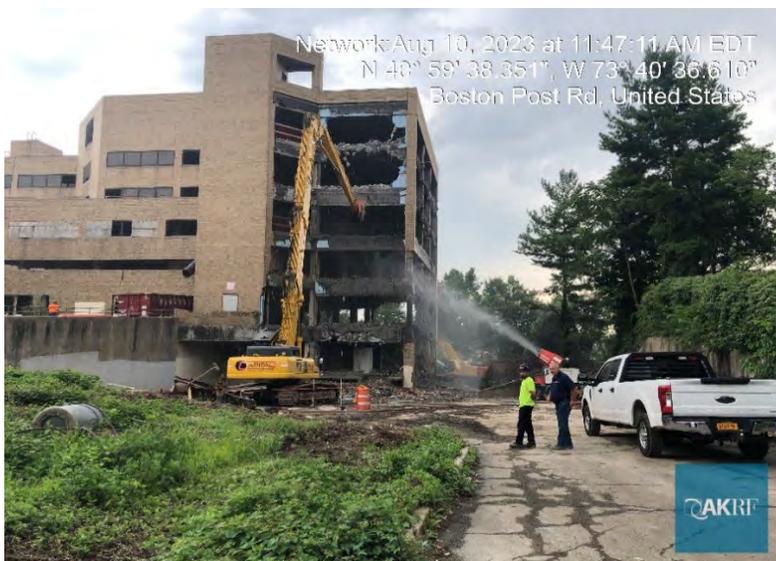
Photograph 2 -
Removal of the brick facade along the southeastern portion of the main hospital building, view facing east.

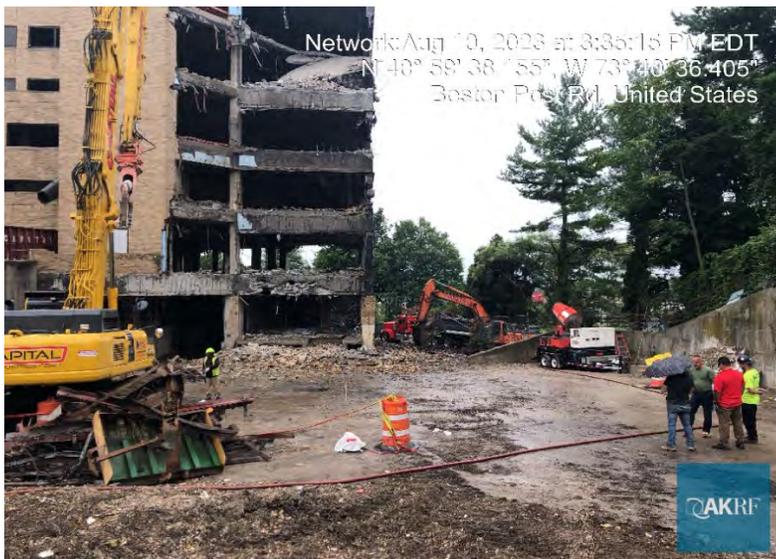
Photograph 3 -
Removal of the brick facade along the southeastern portion of the main hospital building, view facing east.

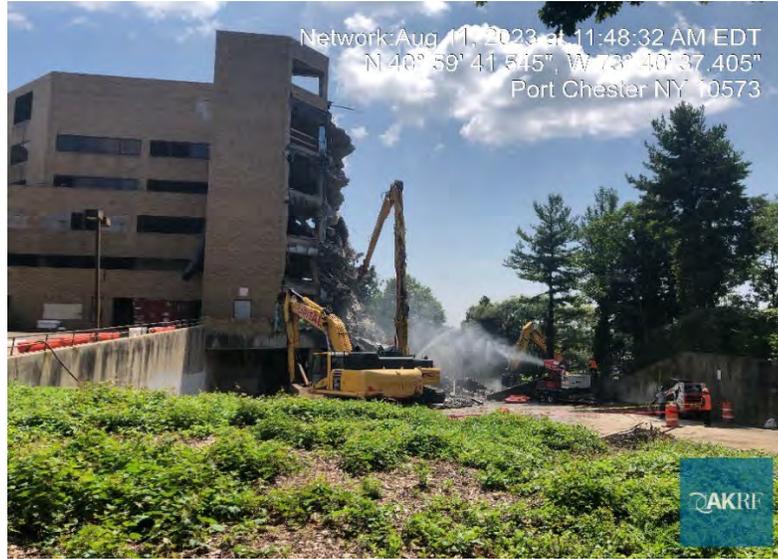
Photograph 2 -
Structural demolition
of the southeastern
portion of the main
hospital building,
view facing east.

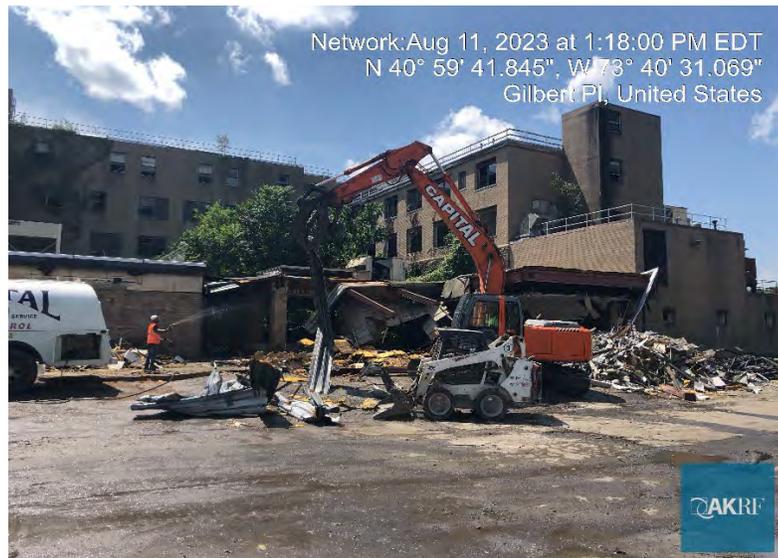
Photograph 3 -
Structural demolition
of the northeastern
portion of the main
hospital building,
view facing
southwest.

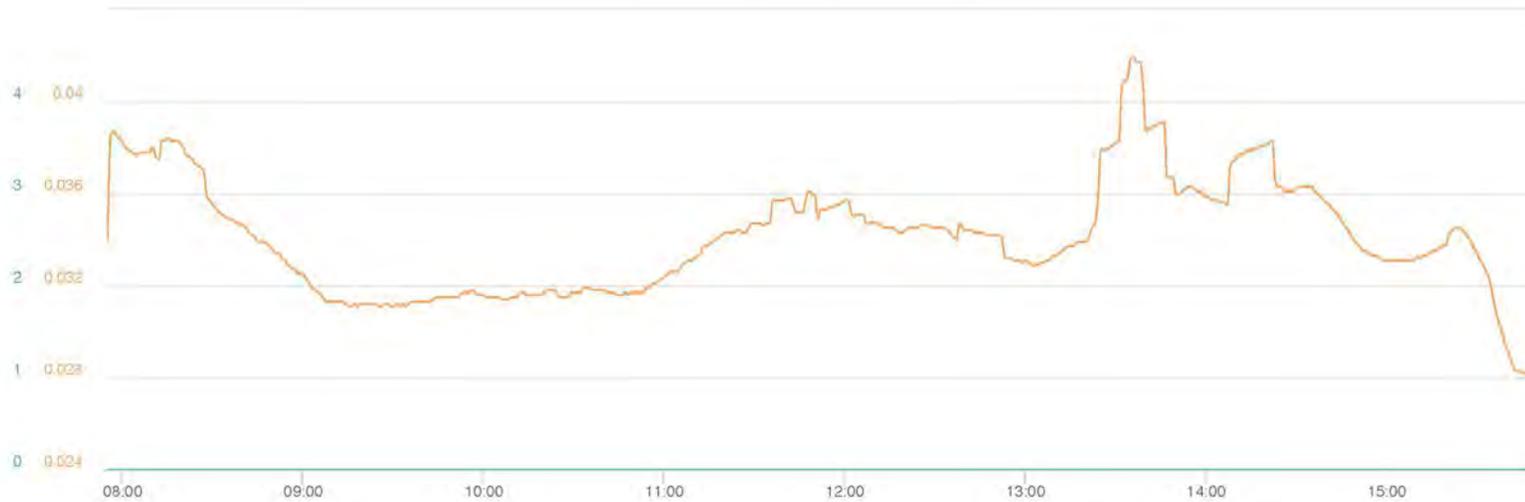
UH - Fixed 1 CAMP Station Graph

Mass Conc. Total mg/m³ AVG 15m
mg/m³
DustTrak-8530
RS232(C)

MIN	AVG	MAX
0.0281	0.0341	0.0419

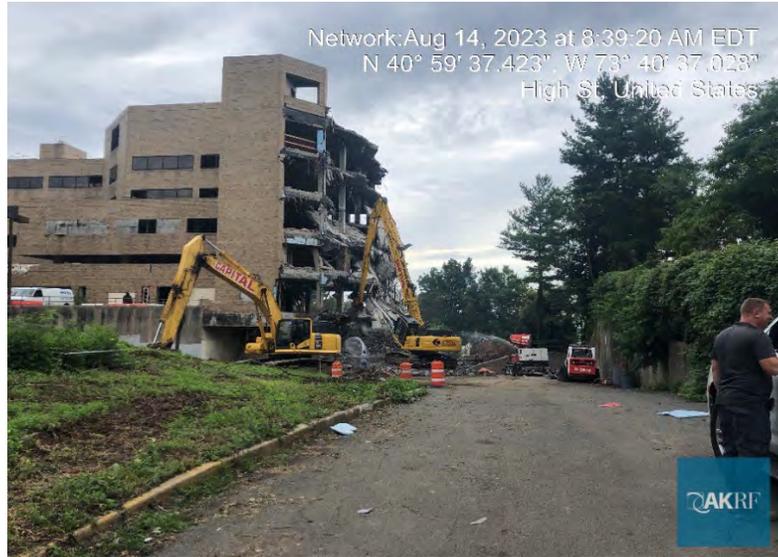
Photograph 1 -
Structural demolition
of the southeastern
portion of the main
hospital building,
view facing east.

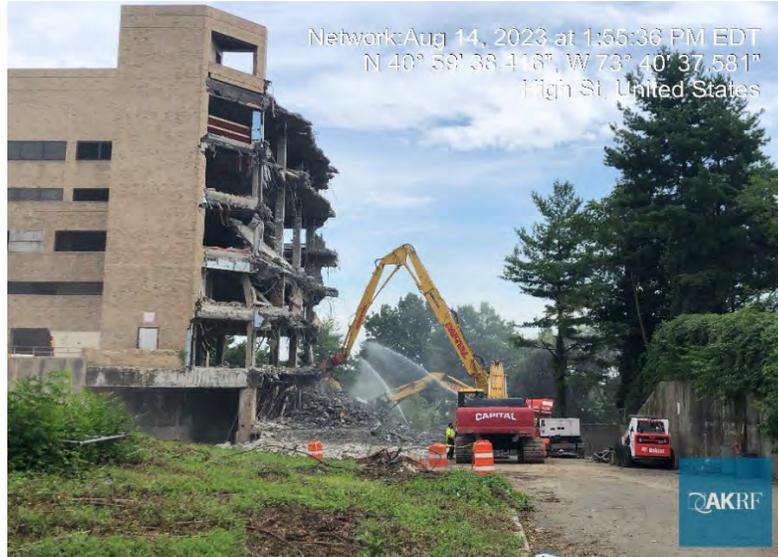
Photograph 2 -
Structural demolition
of the southeastern
portion of the main
hospital building,
view facing east.

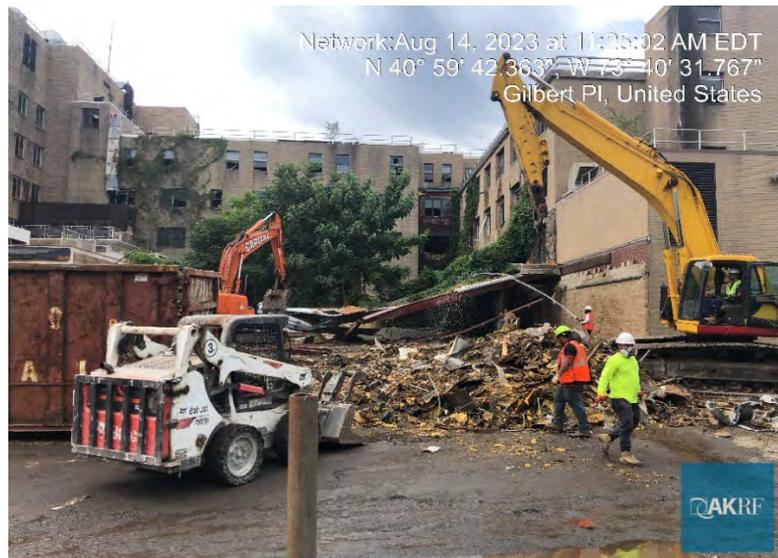
Photograph 3 -
Structural demolition
of the northeastern
portion of the main
hospital building,
view facing
southwest.

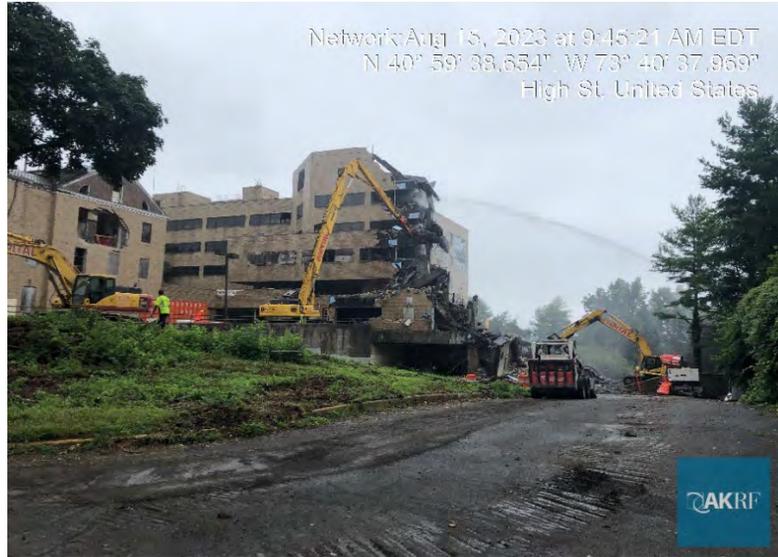
Photograph 1 -
Structural demolition
of the southeastern
portion of the main
hospital building,
view facing east.

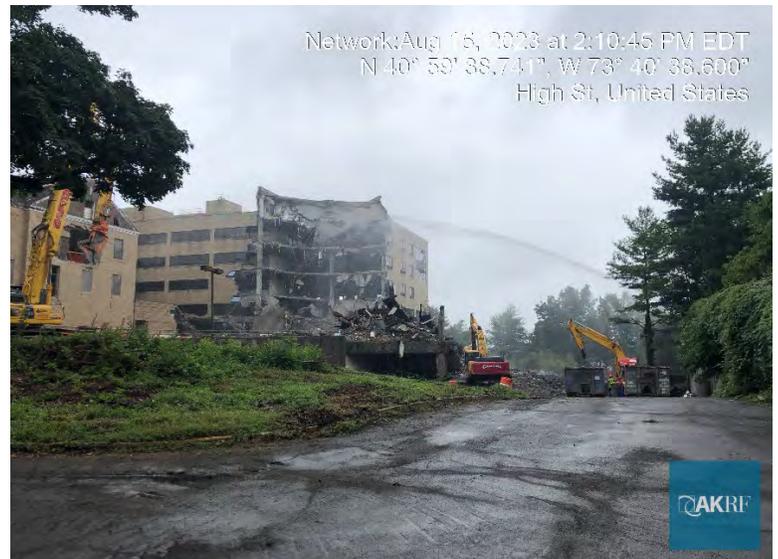
Photograph 2 -
Structural demolition
of the southeastern
portion of the main
hospital building,
view facing east.

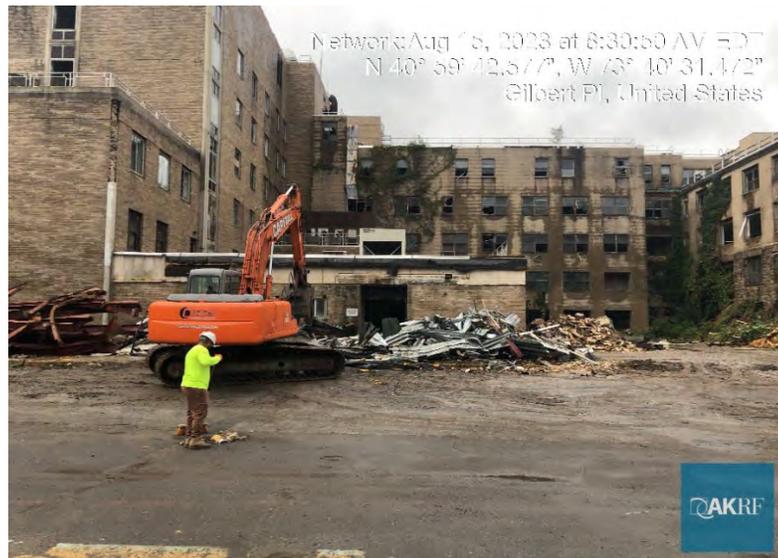
Photograph 3 -
Structural demolition
of the northeastern
portion of the main
hospital building,
view facing south.

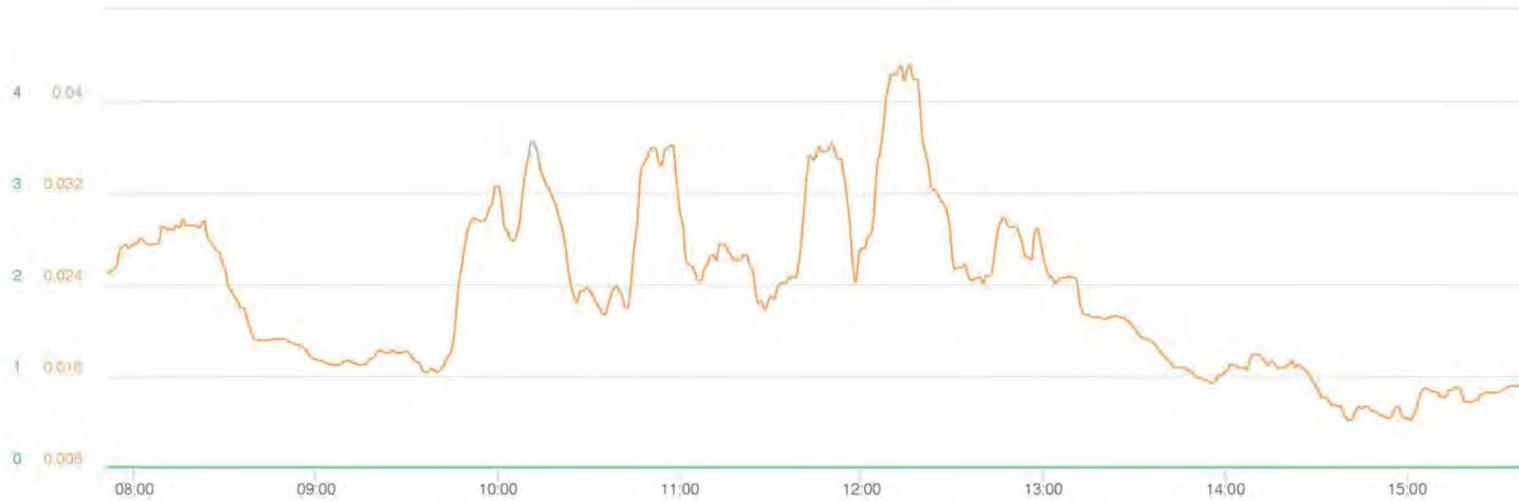
UH - Fixed 3 CAMP Station Graph

MIN	AVG	MAX
0.0121	0.0231	0.043

Comments:	<p>Elevated levels of particulates (>0.100 mg/m3 above background) were detected at the UH - Fixed 3 CAMP station from approximately 07:34 to 08:08 due to a large instantaneous spike from exhaust generated during the startup/movement of equipment that was staged adjacent to the station (unrelated to on-site work - no visible fugitive dust related to site work was noted); the conditions improved when the equipment moved away from the station. The demolition contractor was informed that equipment exhaust can trigger elevated readings on the CAMP equipment and requested that they avoid staging equipment in close proximity to the stations in the future.</p> <p>Elevated levels of particulates (>0.100 mg/m3 above background) were detected at the UH - Fixed 3 CAMP station from approximately 08:34 to 08:48 and from approximately 09:00 to 09:15 due to large instantaneous spikes from dust generated during the take-down of sections of the southeastern portion of the main hospital building. It should be noted that significant dust suppression was being implemented during each take-down, including the use of an out-of-service fire truck, a mister, and multiple fire hoses to apply water to the work area and the debris pile; however, the concrete structures in this area where not reinforced with steel/rebar, resulting in larger than expected take-downs. After each occurrence, work was halted and all dust suppression efforts were focused on the debris pile to control airborne particulate; all visible dust was quickly addressed and the particulate detections at the CAMP station fell below the action level within approximately 15 minutes of each instantaneous spike. AKRF advised the demolition contractor to limit the size of take-downs where possible to prevent similar conditions in the future. According to the demolition contractor, the majority of the remaining portions of the hospital building are reinforced with steel/rebar, which will allow for more controlled demolition (i.e., smaller, more predictable, controlled take-downs).</p>

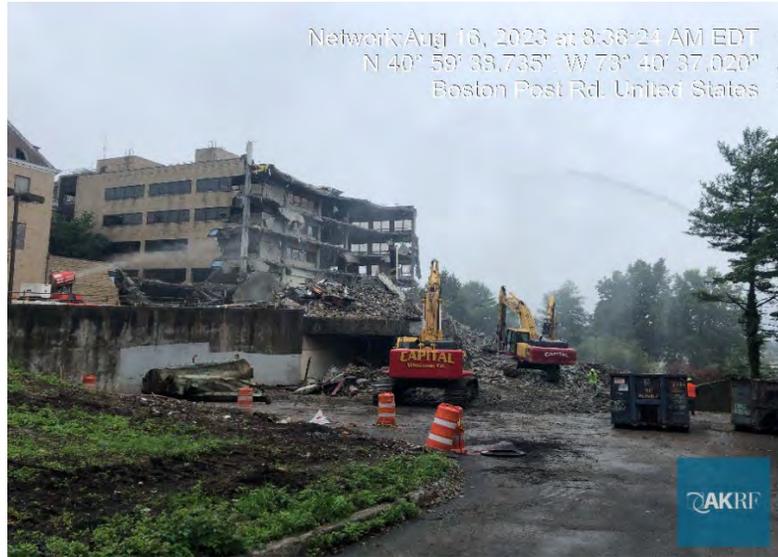
Photograph 1 -
Structural demolition
of the southeastern
portion of the main
hospital building,
view facing east.

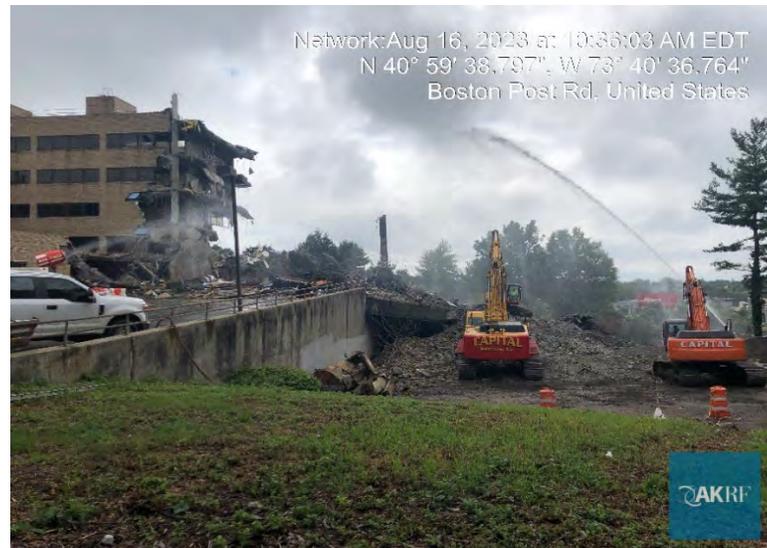
Photograph 2 -
Structural demolition
of the southeastern
portion of the main
hospital building,
view facing east.

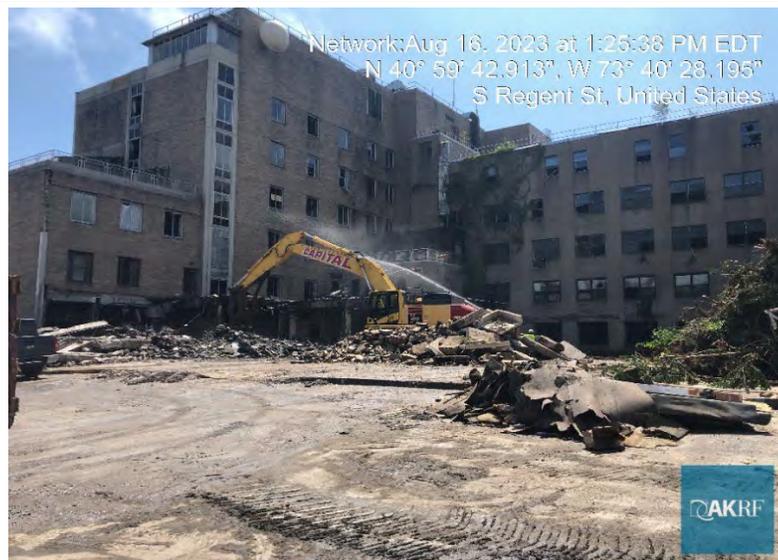
Photograph 3 -
Structural demolition
of the northeastern
portion of the main
hospital building,
view facing
southeast.
