Re: Monthly Progress Report – August 2023
Former United Hospital – 406 Boston Post Road, Port Chester, New York
NYSDEC BCP Site No. C360202

This Monthly Progress Report has been prepared by AKRF, Inc. (AKRF) to summarize the work performed at the Former United Hospital site located at 406 Boston Post Road in Port Chester, New York [New York State Department of Environmental Conservation (NYSDEC) Brownfield Cleanup Program (BCP) Site No. C360202] (the Site) during the month of August 2023. The following activities were conducted:

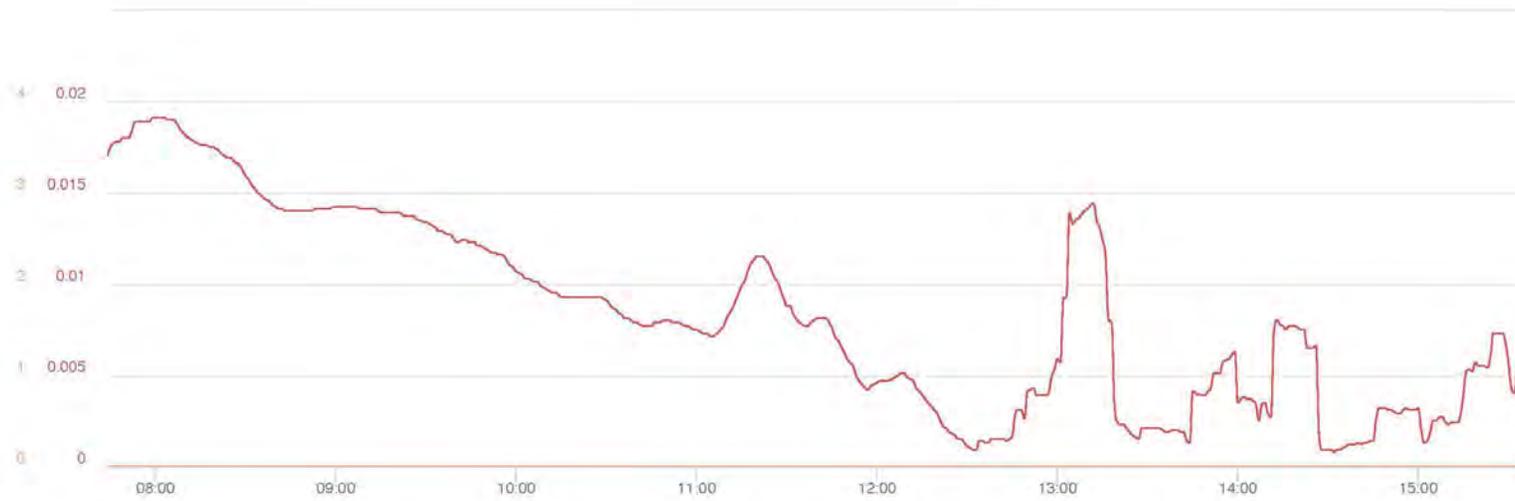
UH - Fixed 1 CAMP Station Graph

08/16/2023 0:00:29 – 08/17/2023 0:00:00
(GMT-05:00) Eastern Time (US & Canada)

MIN	AVG	MAX
0.0008	0.0084	0.0191

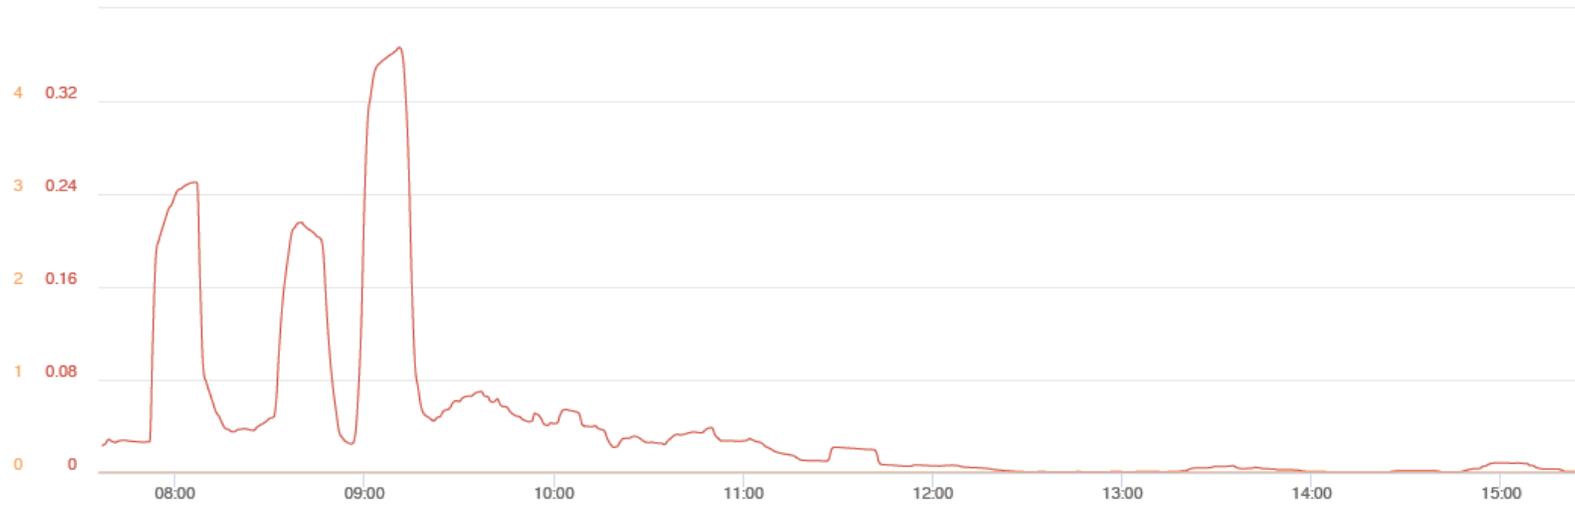
08/16/2023 0:00:31 – 08/17/2023 0:00:00
(GMT-05:00) Eastern Time (US & Canada)

Mass Conc. Total mg/m ³ AVG 15m <small>mg/m³ DustTrak-8530 RS232(C)</small>			VOC ppm AVG 15m ppm <small>miniRAE 3000 RS232(A)</small>		
MIN	AVG	MAX	MIN	AVG	MAX
0.0001	0.0421	0.3661	0	0	0

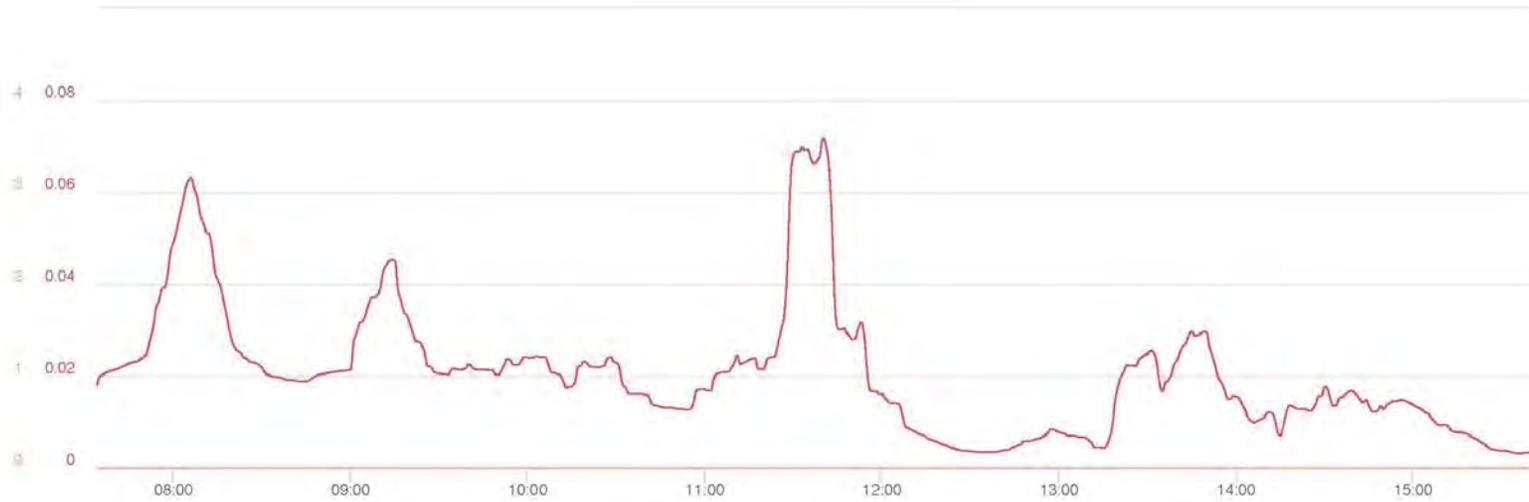
UH - Upwind 1 CAMP Station Graph

08/16/2023 0:00:54 – 08/17/2023 0:00:00
(GMT-05:00) Eastern Time (US & Canada)

MIN	AVG	MAX
0.0031	0.0204	0.0717

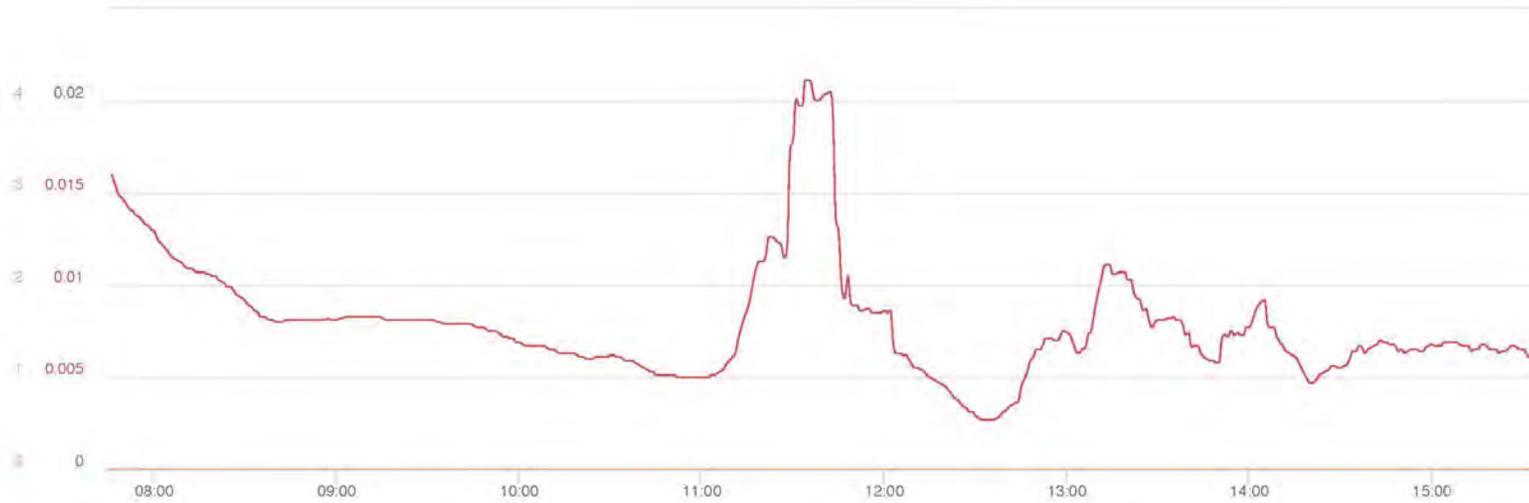
UH - Downwind 1 CAMP Station Graph

08/16/2023 0:00:58 – 08/17/2023 0:00:00
(GMT-05:00) Eastern Time (US & Canada)

MIN	AVG	MAX
0.0027	0.0079	0.0211

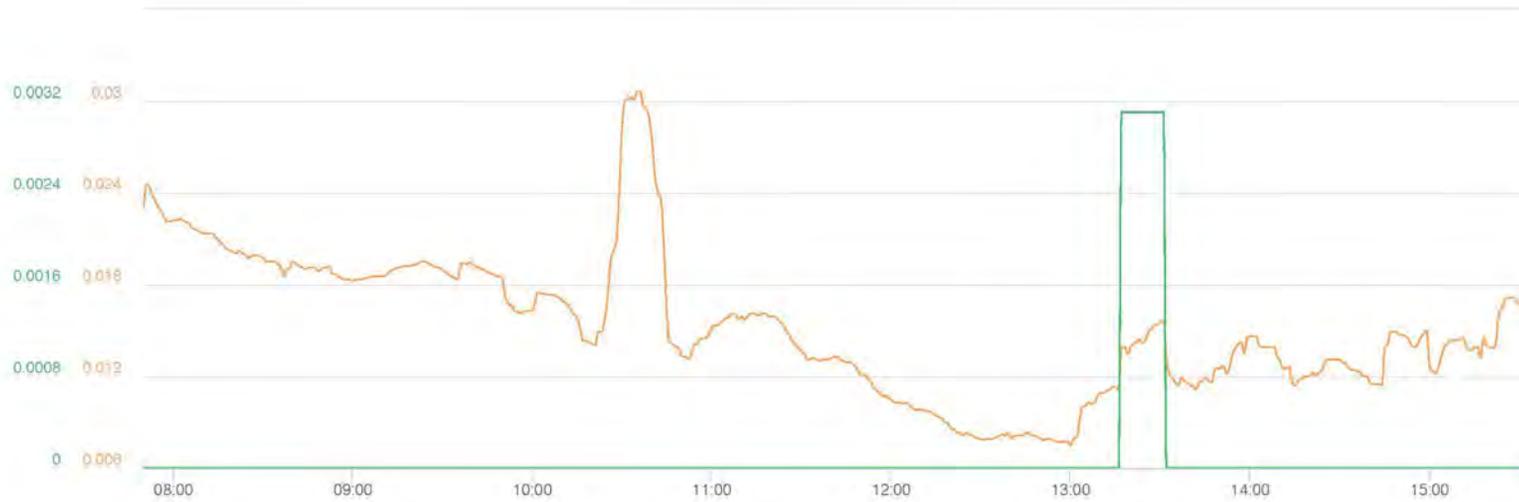
UH - Downwind 2 CAMP Station Graph

08/16/2023 0:00:02 – 08/17/2023 0:00:00
(GMT-05:00) Eastern Time (US & Canada)

MIN	AVG	MAX
0.0075	0.0152	0.0306

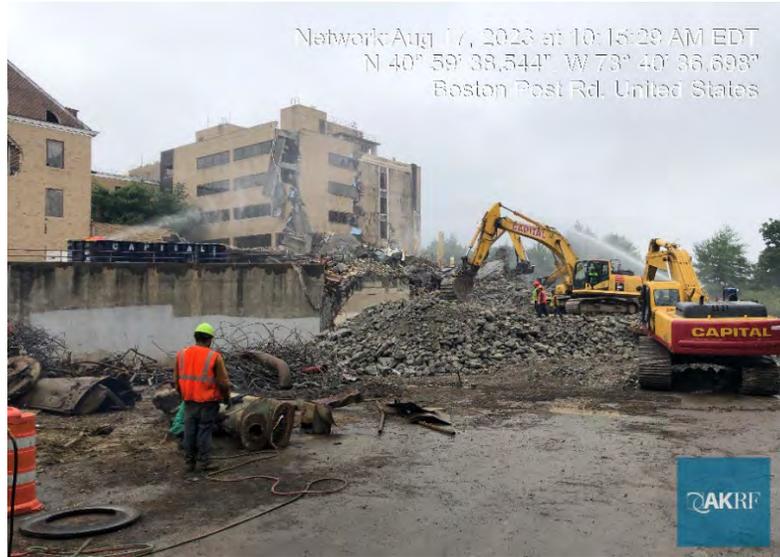
Photograph 1 -
Structural demolition
of the southeastern
portion of the main
hospital building,
view facing east.

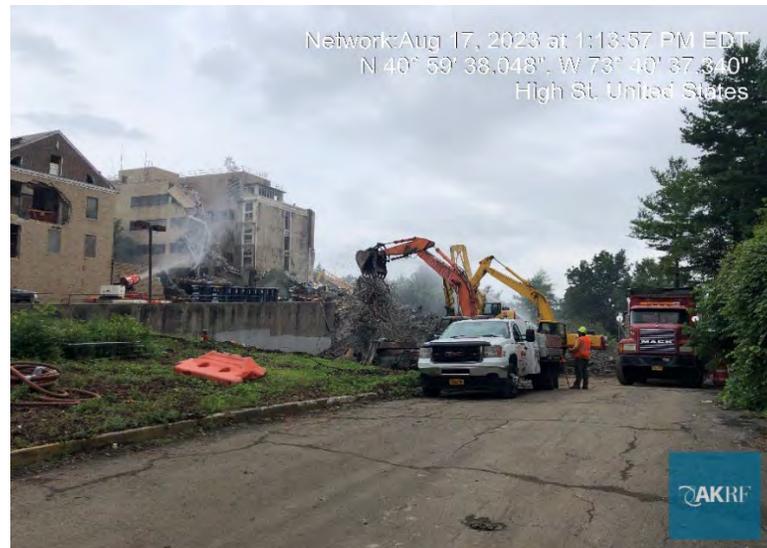
Photograph 2 -
Structural demolition
of the southeastern
portion of the main
hospital building,
view facing east.

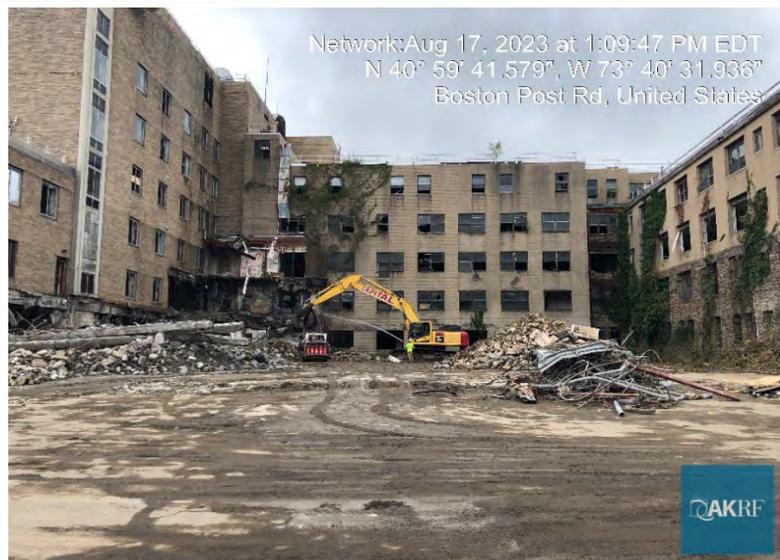
Photograph 3 -
Structural demolition
of the northeastern
portion of the main
hospital building,
view facing south.

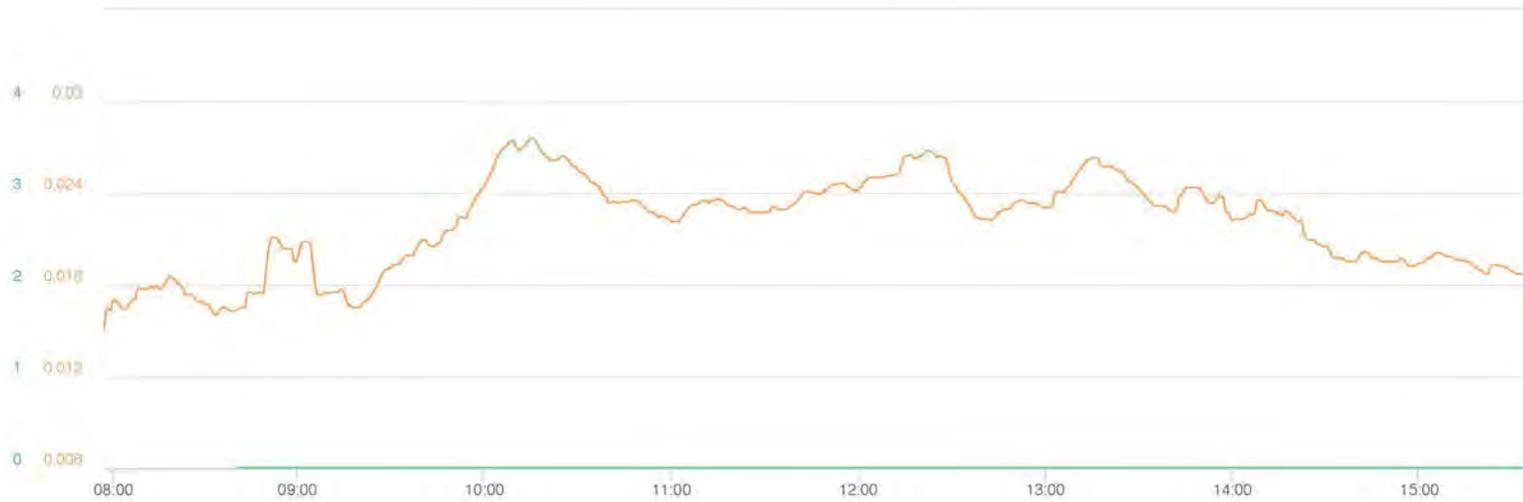
UH - Fixed 2 CAMP Station Graph

08/17/2023 0:00:31 – 08/18/2023 0:00:00
(GMT-05:00) Eastern Time (US & Canada)

MIN	AVG	MAX
0.015	0.0219	0.0275

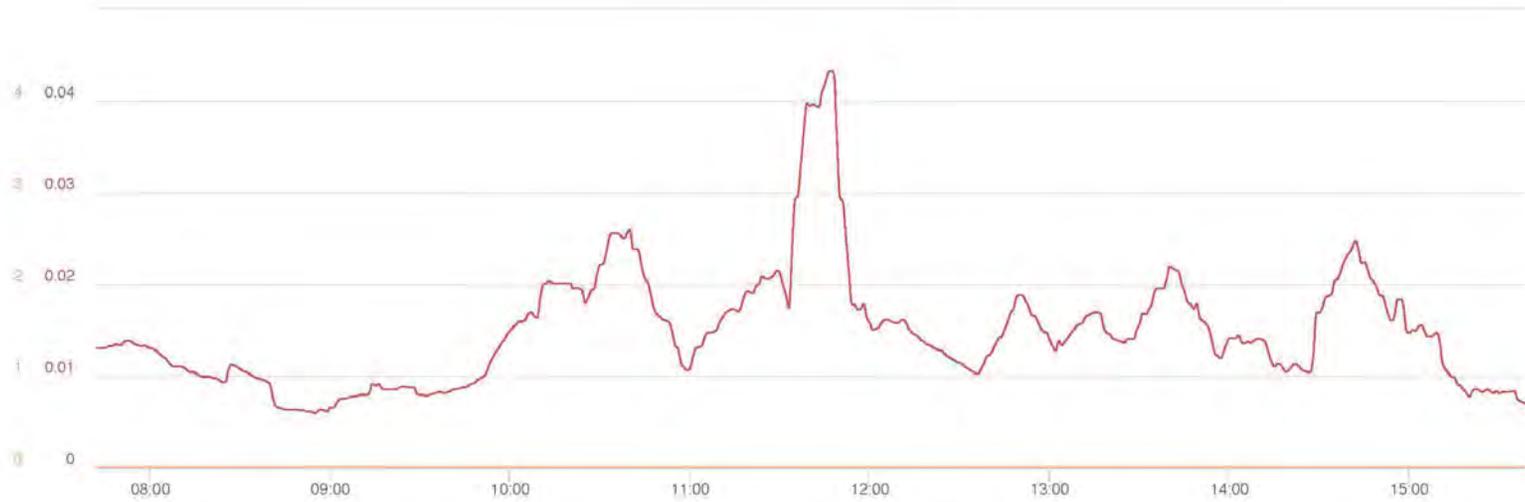
UH - Fixed 3 CAMP Station Graph

08/17/2023 0:00:24 – 08/18/2023 0:00:00
(GMT-05:00) Eastern Time (US & Canada)

MIN	AVG	MAX
0.0059	0.0148	0.0432

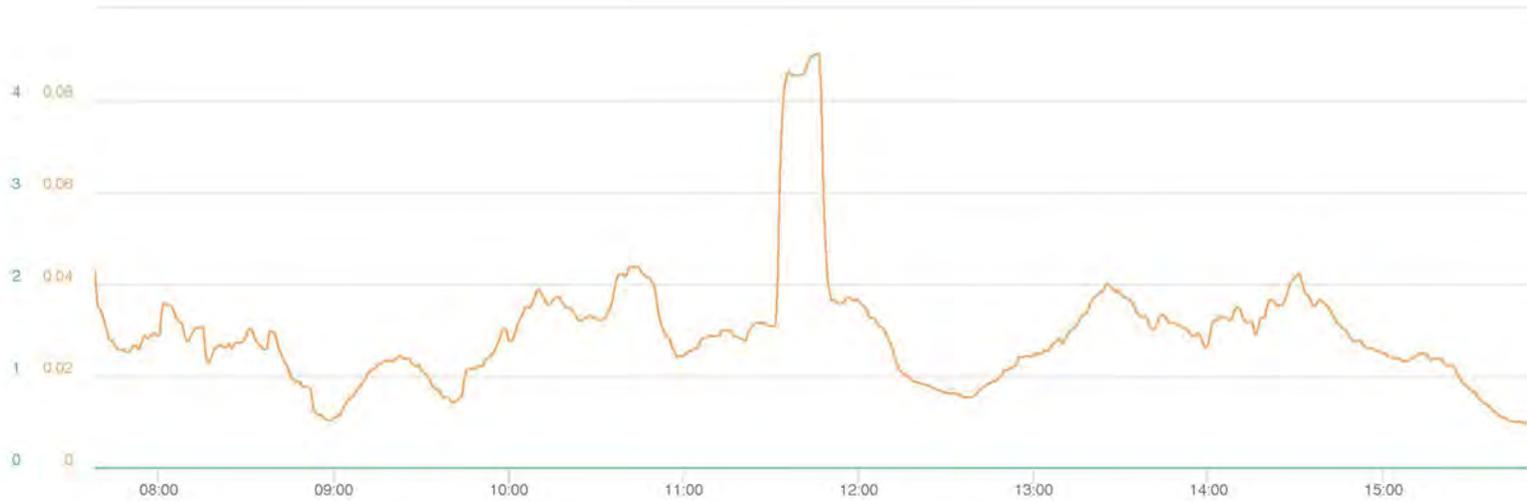
UH - Upwind 1 CAMP Station Graph

08/17/2023 0:00:36 – 08/18/2023 0:00:00
(GMT-05:00) Eastern Time (US & Canada)

MIN	AVG	MAX
0.0097	0.029	0.0901

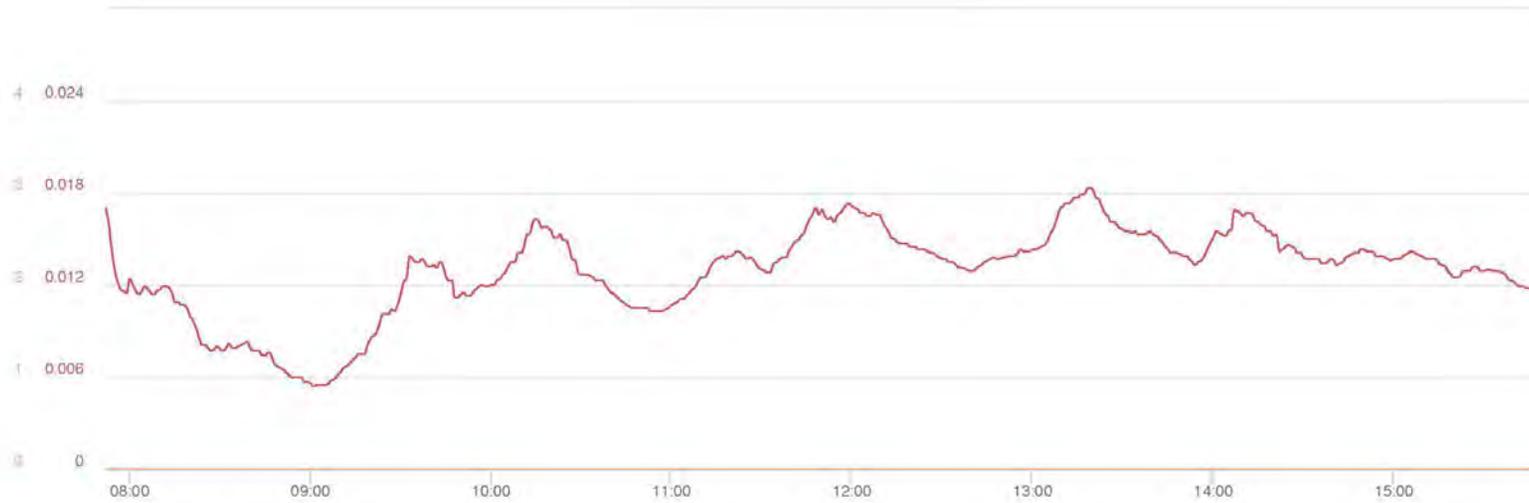
UH - Downwind 1 CAMP Station Graph

08/17/2023 0:00:17 – 08/18/2023 0:00:00
(GMT-05:00) Eastern Time (US & Canada)

MIN	AVG	MAX
0.0054	0.0129	0.0183

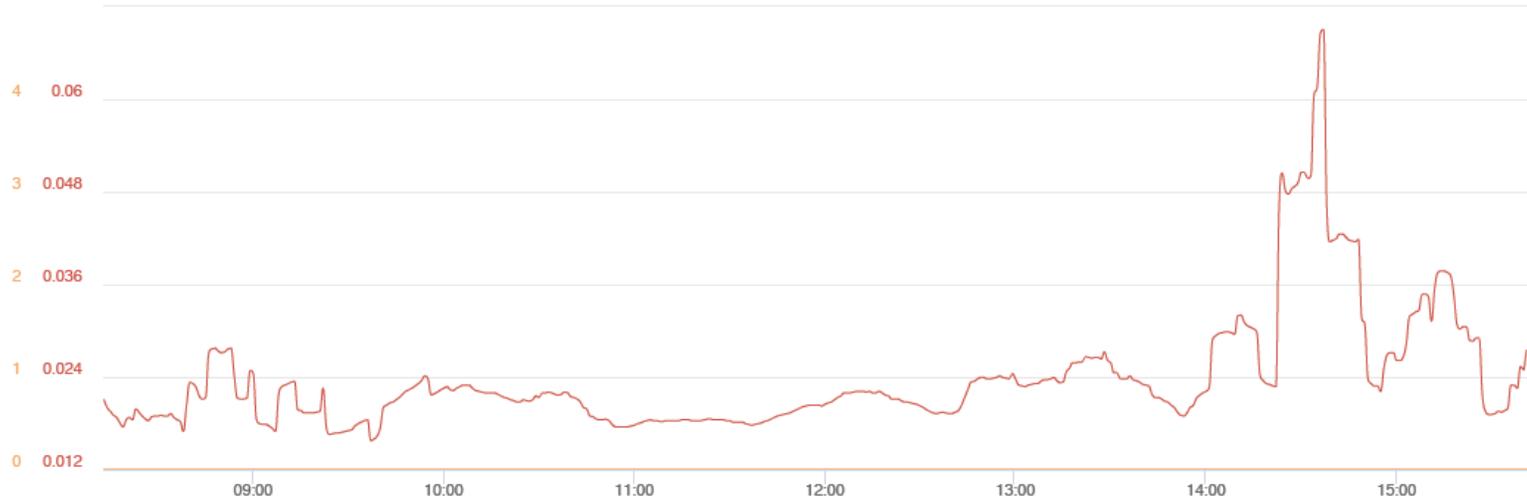
UH - Downwind 2 CAMP Station Graph

08/17/2023 8:12:00 – 08/18/2023 0:00:00
(GMT-05:00) Eastern Time (US & Canada)

Mass Conc. Total mg/m ³ AVG 15m mg/m ³ DustTrak-8530 RS232(C)			VOC ppm AVG 15m ppm miniRAE 3000 RS232(A)		
MIN	AVG	MAX	MIN	AVG	MAX
0.0157	0.0236	0.069	0	0	0

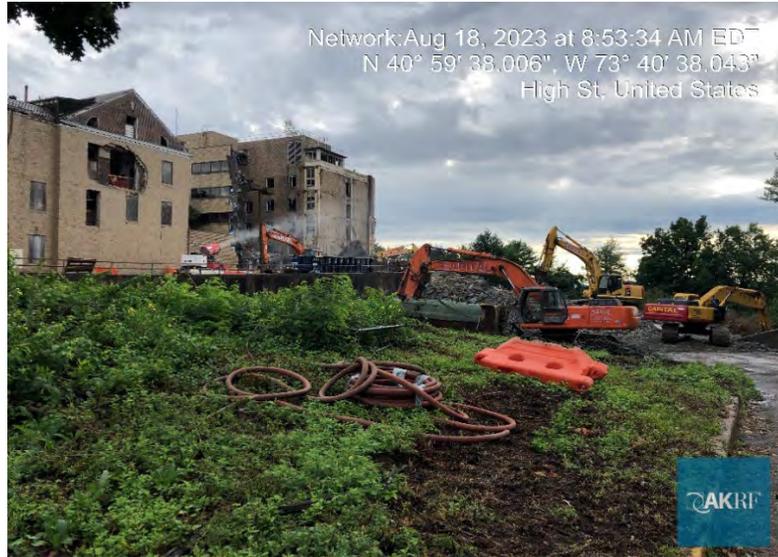
Photograph 1 -
Structural demolition
of the southeastern
portion of the main
hospital building,
view facing east.

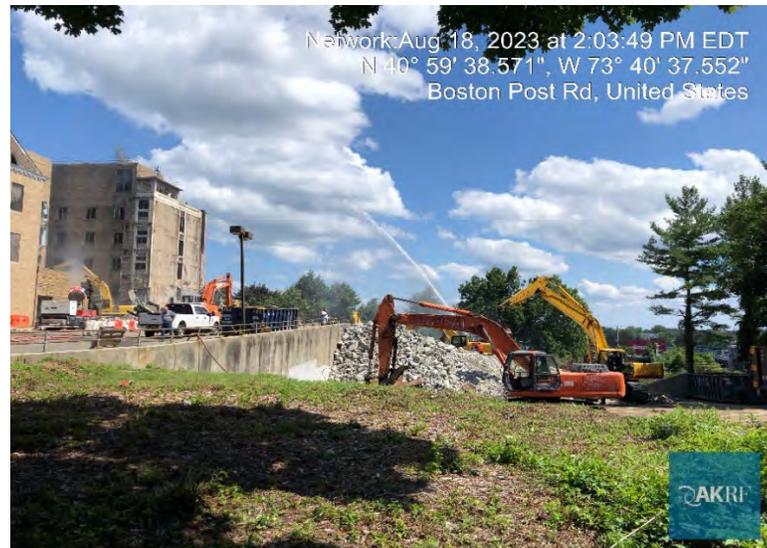
Photograph 2 -
Structural demolition
of the southeastern
portion of the main
hospital building,
view facing east.

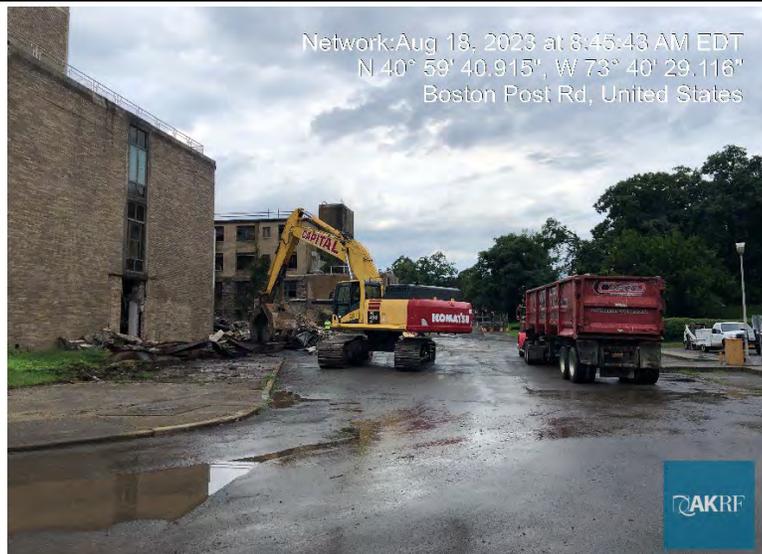
Photograph 3 -
Structural demolition
of the southeastern
portion of the main
hospital building,
view facing west.

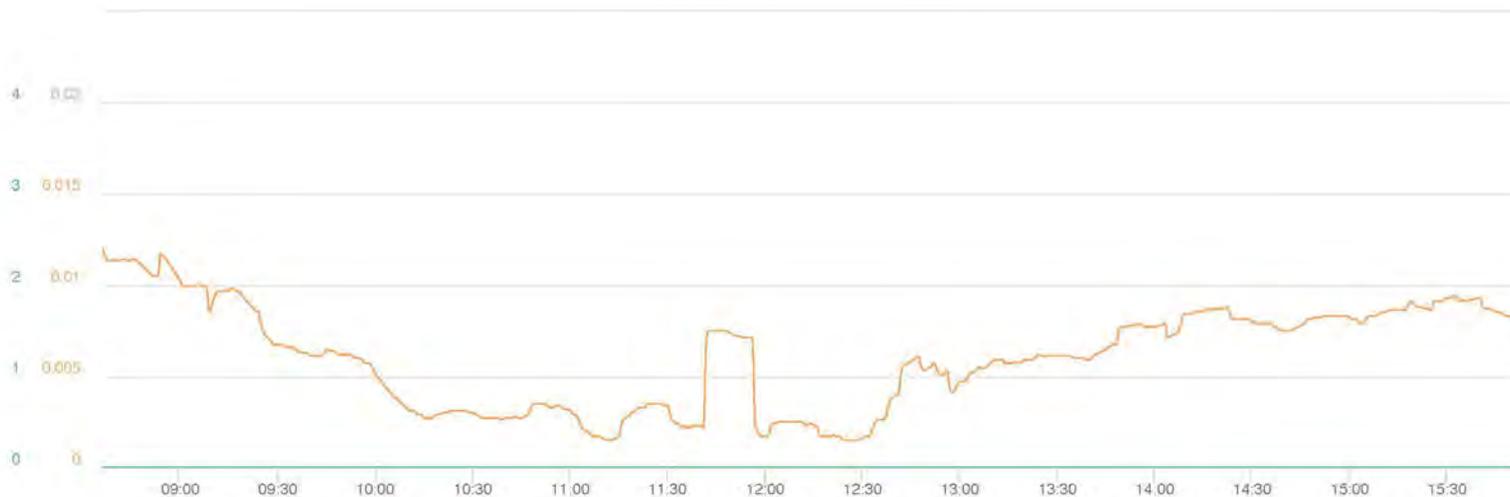
UH - Fixed 1 CAMP Station Graph

Fri, 18th of Aug 2023, 0:00:00 – 23:59:00
(GMT-05:00) Eastern Time (US & Canada)

MIN	AVG	MAX
0.0015	0.006	0.012

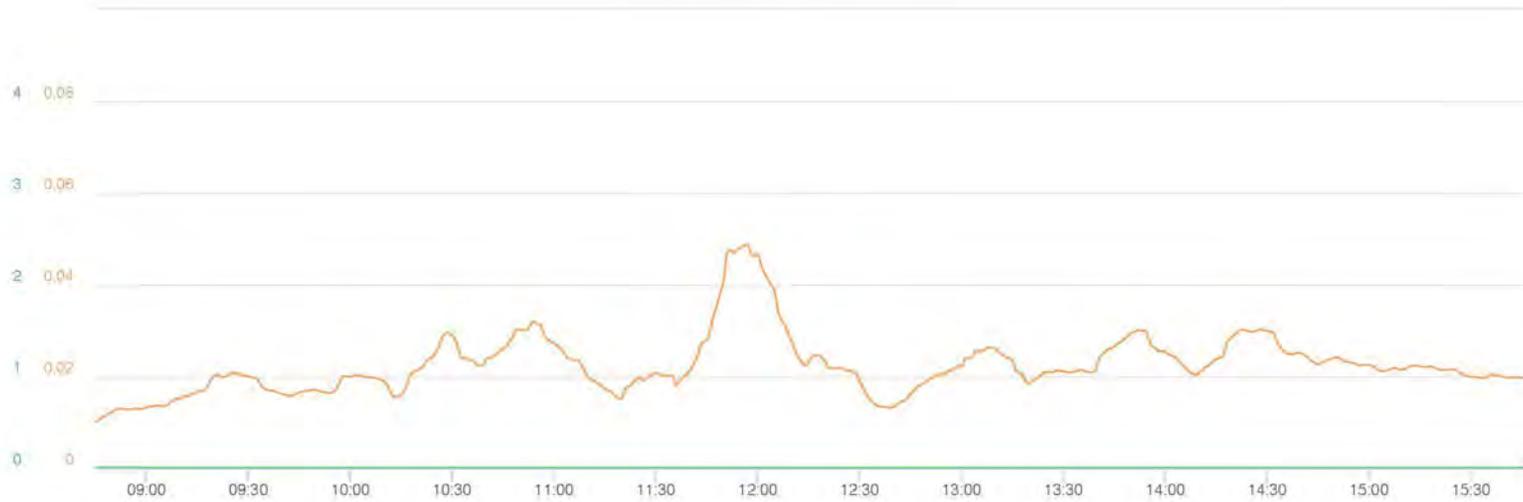
UH - Fixed 2 CAMP Station Graph

Fri, 18th of Aug 2023, 0:00:00 – 23:59:00
(GMT-05:00) Eastern Time (US & Canada)

MIN	AVG	MAX
0.01	0.0224	0.0487

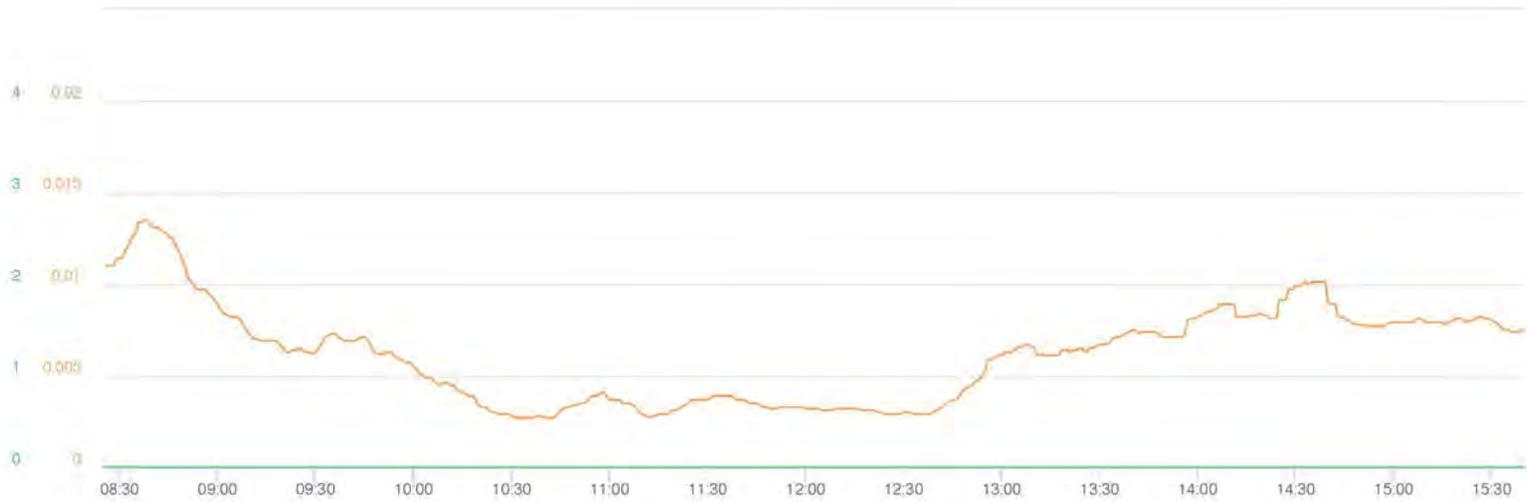
UH - Fixed 3 CAMP Station Graph

Fri, 18th of Aug 2023, 0:00:00 – 23:59:00
(GMT-05:00) Eastern Time (US & Canada)

MIN	AVG	MAX
0.0027	0.0062	0.0135

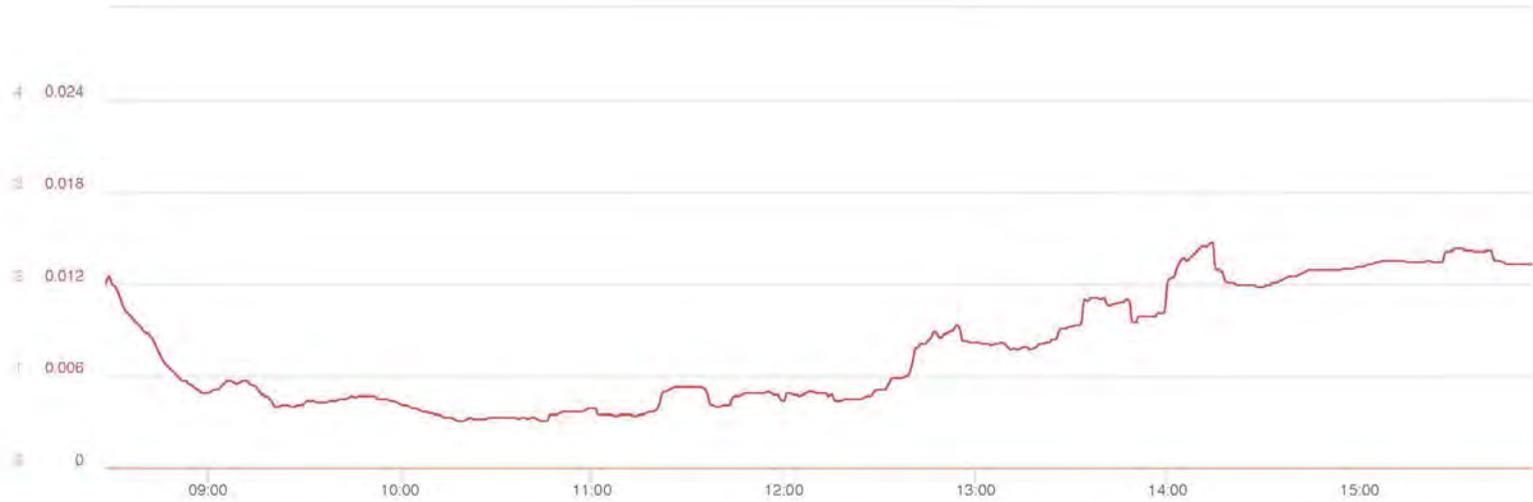
UH - Downwind 1 CAMP Station Graph

Fri, 18th of Aug 2023, 0:00:00 – 23:59:00
(GMT-05:00) Eastern Time (US & Canada)

MIN	AVG	MAX
0.0031	0.0077	0.0147

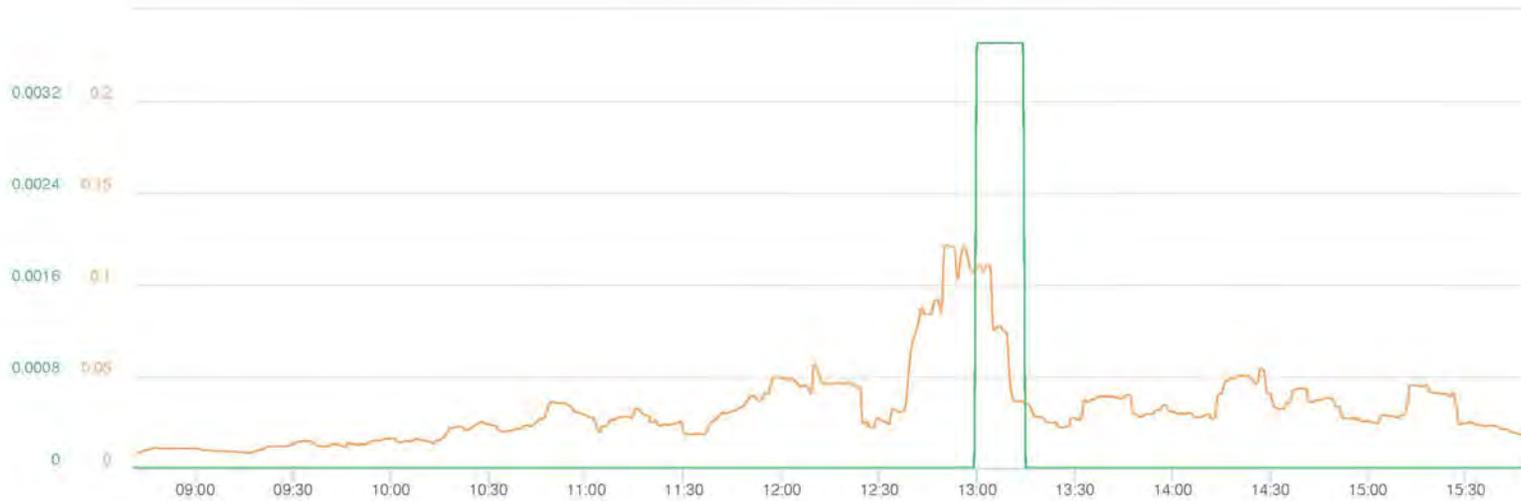
UH - Downwind 2 CAMP Station Graph

Fri, 18th of Aug 2023, 0:57:00 – 23:59:00
(GMT-05:00) Eastern Time (US & Canada)

MIN	AVG	MAX
0.008	0.0322	0.1214

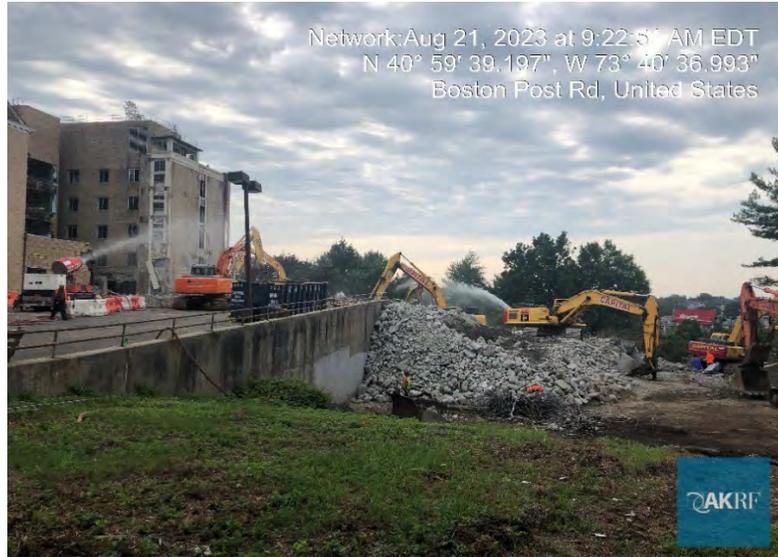
Photograph 1 -
Structural demolition
of the southeastern
portion of the main
hospital building,
view facing east.

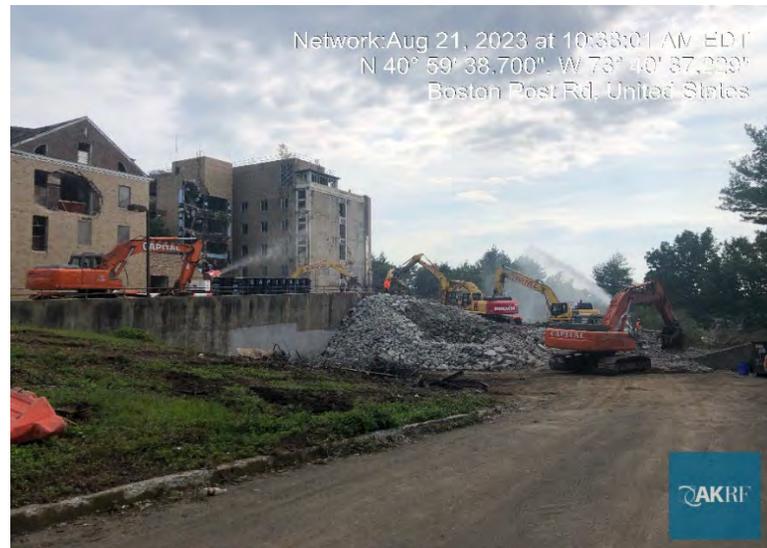
Photograph 2 -
Structural demolition
of the southeastern
portion of the main
hospital building,
view facing east.

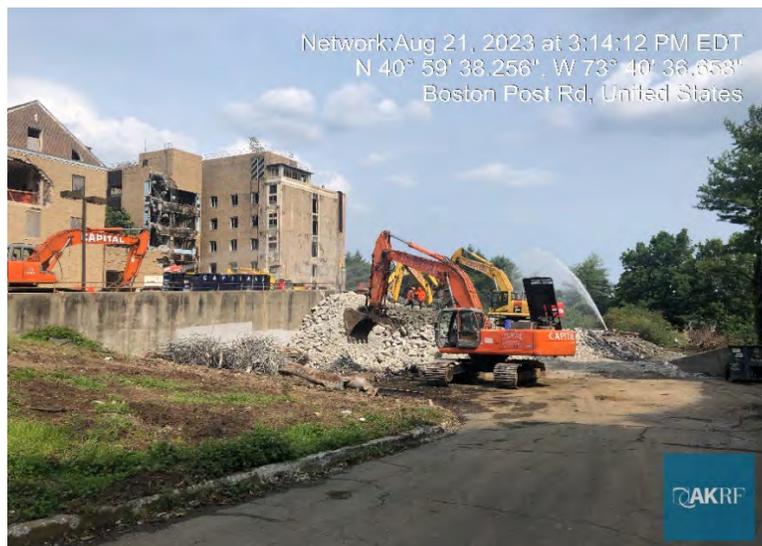
Photograph 3 -
Structural demolition
of the southeastern
portion of the main
hospital building,
view facing east.

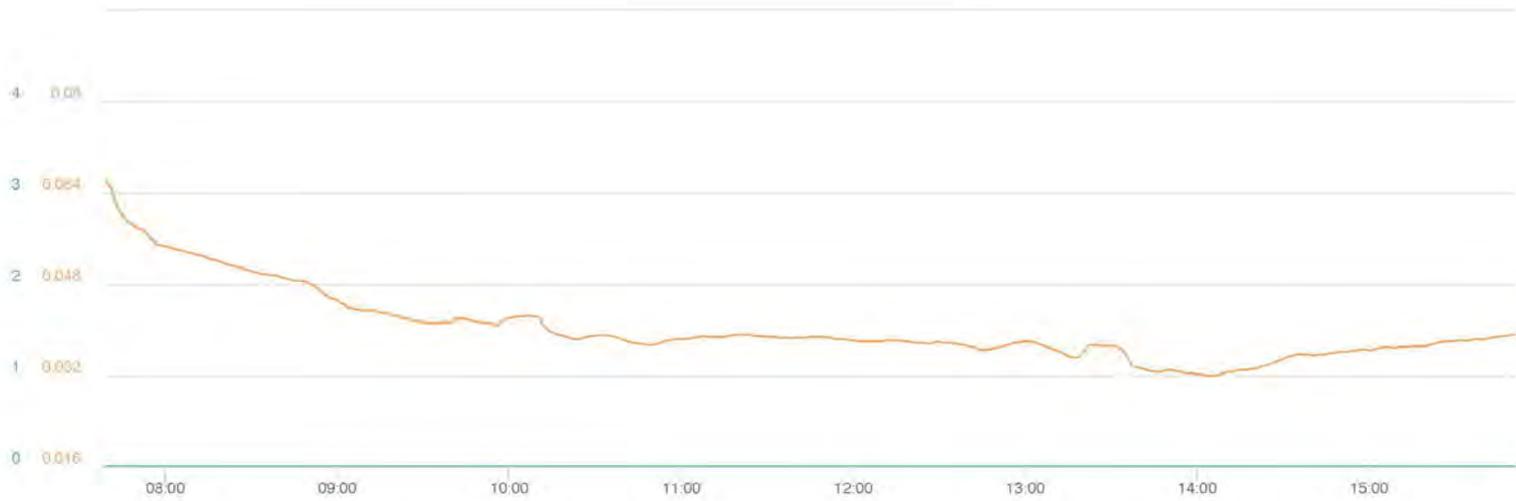
UH - Fixed 1 CAMP Station Graph

08/21/2023 0:00:38 – 08/22/2023 0:00:00
(GMT-05:00) Eastern Time (US & Canada)

MIN	AVG	MAX
0.0319	0.0403	0.066

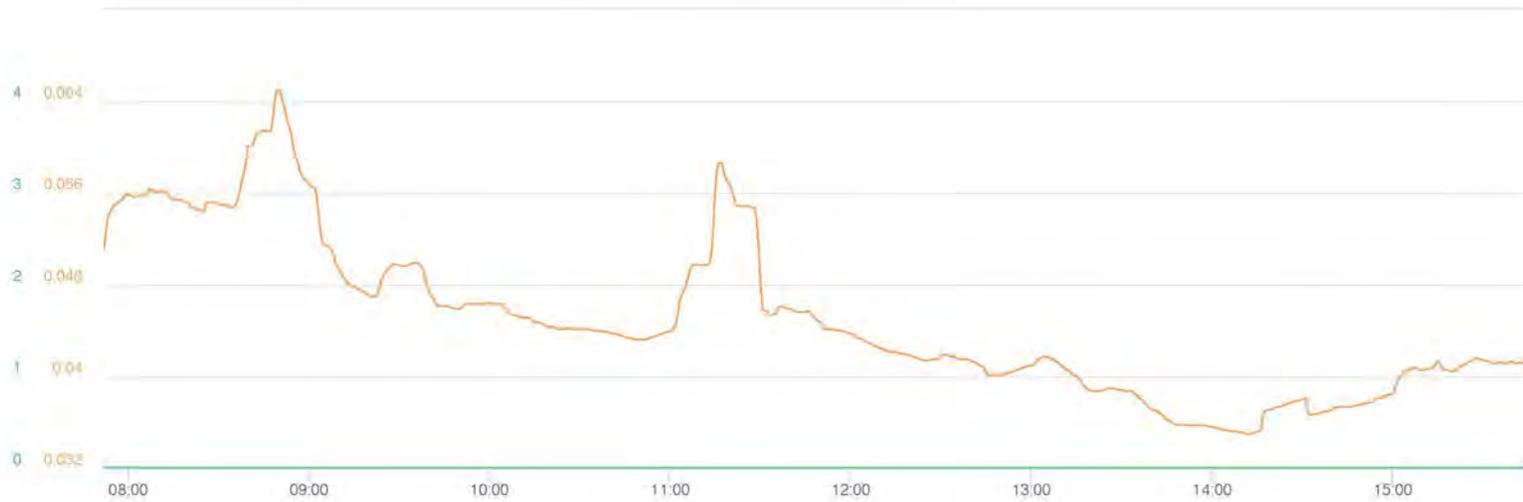
UH - Fixed 2 CAMP Station Graph

08/21/2023 0:00:37 – 08/22/2023 0:00:00
(GMT-05:00) Eastern Time (US & Canada)

MIN	AVG	MAX
0.0349	0.0448	0.0649

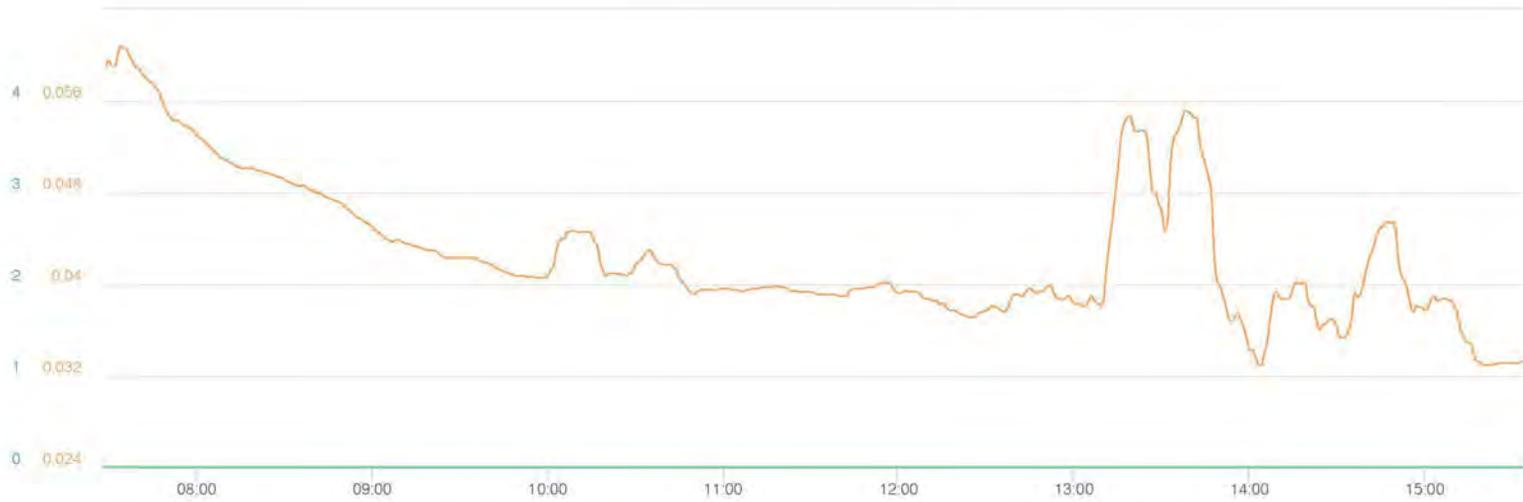
UH - Fixed 3 CAMP Station Graph

08/21/2023 0:00:31 – 08/22/2023 0:00:00
(GMT-05:00) Eastern Time (US & Canada)

MIN	AVG	MAX
0.0329	0.0427	0.0607

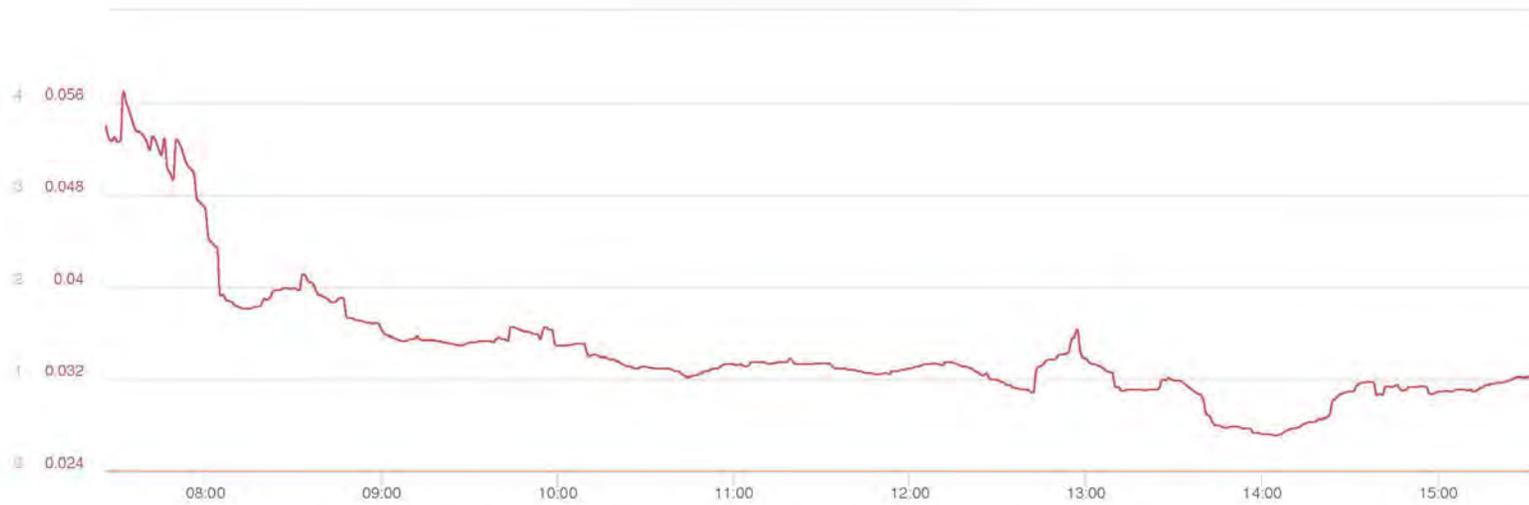
UH - Downwind 1 CAMP Station Graph

08/21/2023 0:00:37 – 08/22/2023 0:00:00
(GMT-05:00) Eastern Time (US & Canada)

MIN	AVG	MAX
0.0271	0.0347	0.057

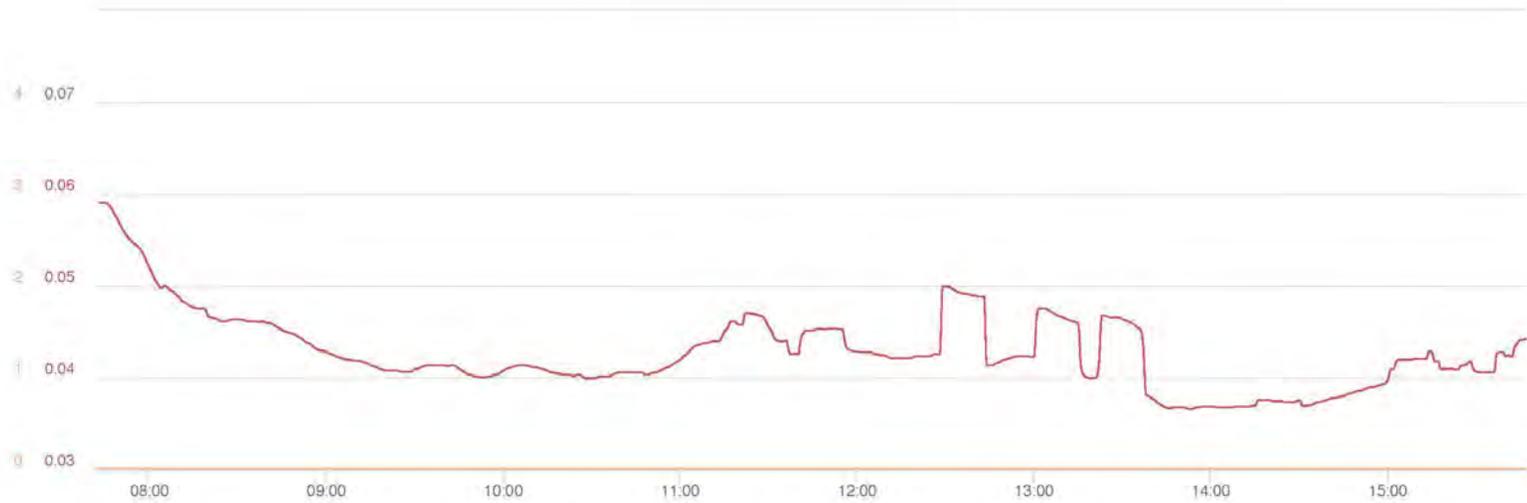
UH - Downwind 2 CAMP Station Graph

08/21/2023 0:00:08 – 08/22/2023 0:00:00
(GMT-05:00) Eastern Time (US & Canada)

MIN	AVG	MAX
0.0365	0.0428	0.059

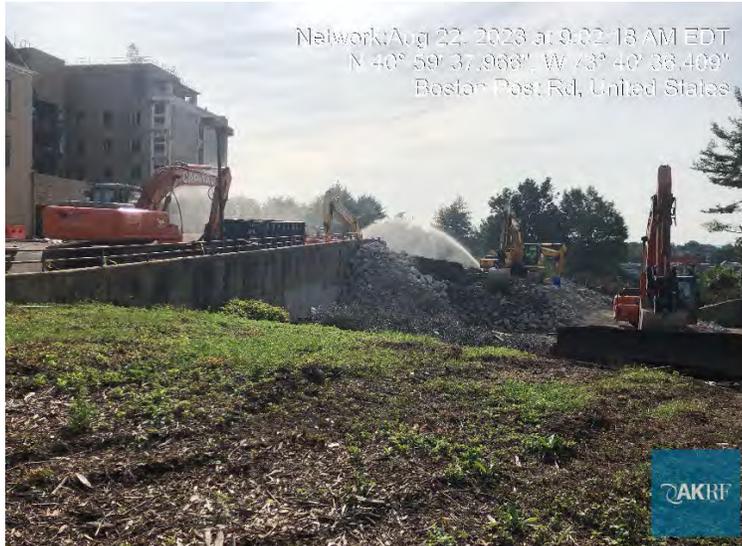
Photograph 1 -
Structural demolition
of the southeastern
portion of the main
hospital building,
view facing east.

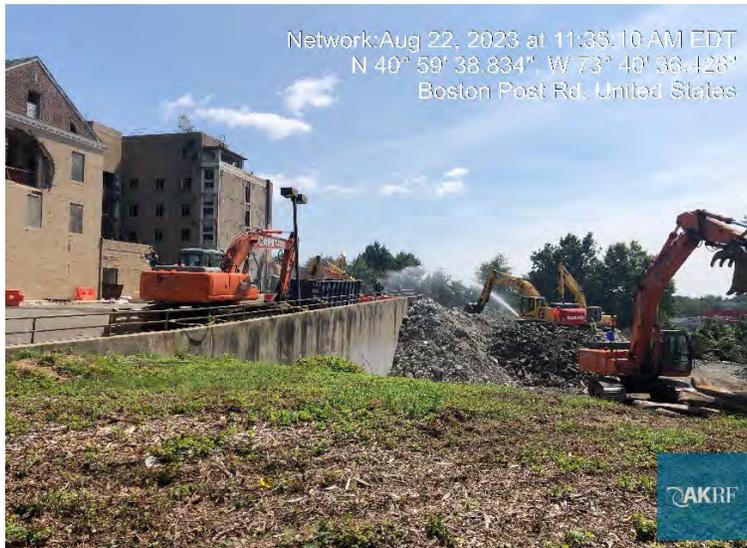
Photograph 2 -
Structural demolition
of the southeastern
portion of the main
hospital building,
view facing east.

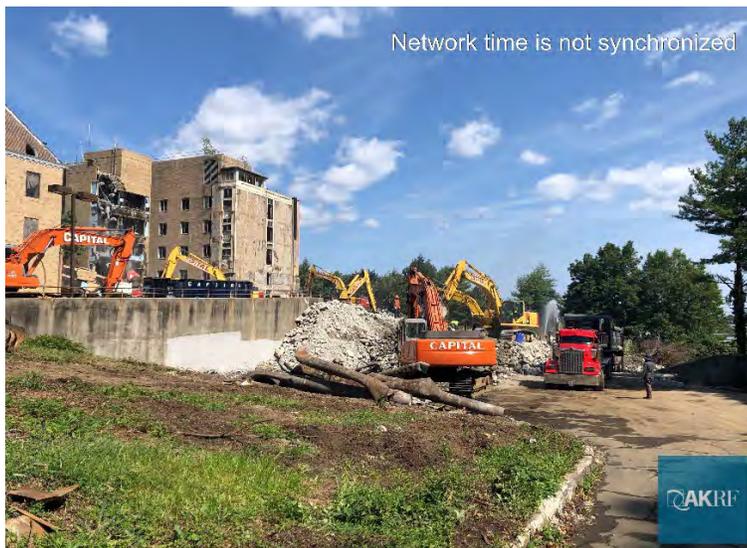
Photograph 3 -
Structural demolition
of the southeastern
portion of the main
hospital building,
view facing east.

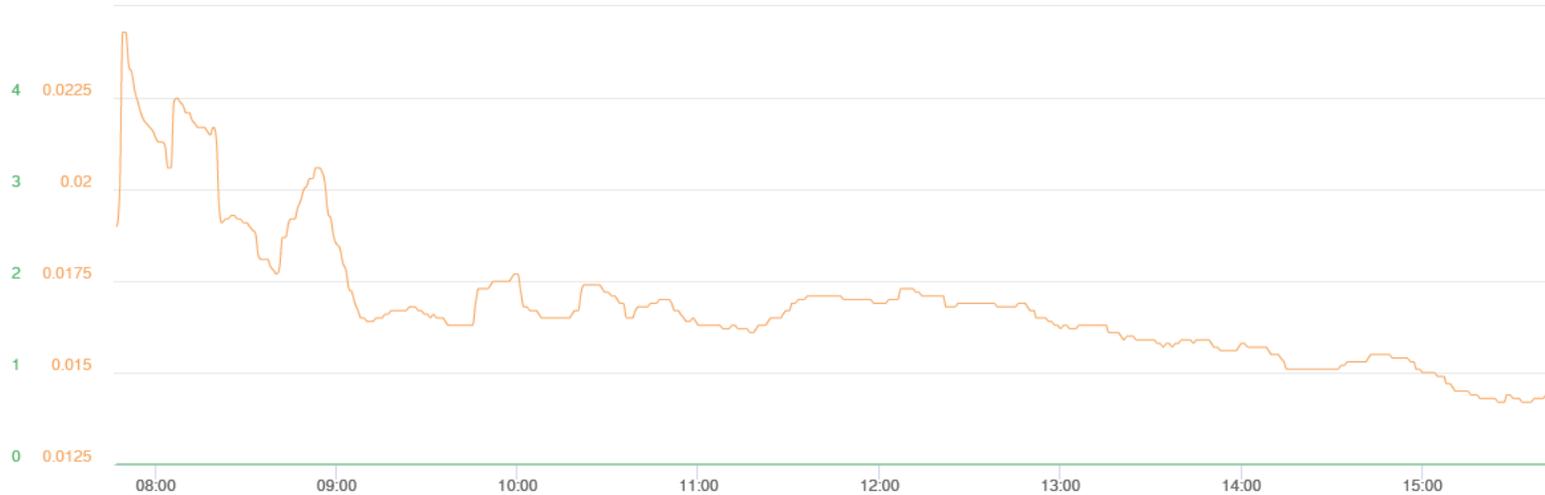
UH - Fixed 1 CAMP Station Graph

08/22/2023 0:00:02 – 08/23/2023 0:00:00
(GMT-05:00) Eastern Time (US & Canada)

Mass Conc. Total mg/m³ AVG 15m mg/m³ DustTrak-8530 RS232(C)			VOC ppm AVG 15m ppm miniRAE 3000 RS232(A)		
MIN	AVG	MAX	MIN	AVG	MAX
0.0142	0.0169	0.0243	0	0	0
