Re: Monthly Progress Report – August 2023
Former United Hospital – 406 Boston Post Road, Port Chester, New York
NYSDEC BCP Site No. C360202

This Monthly Progress Report has been prepared by AKRF, Inc. (AKRF) to summarize the work performed at the Former United Hospital site located at 406 Boston Post Road in Port Chester, New York [New York State Department of Environmental Conservation (NYSDEC) Brownfield Cleanup Program (BCP) Site No. C360202] (the Site) during the month of August 2023. The following activities were conducted:

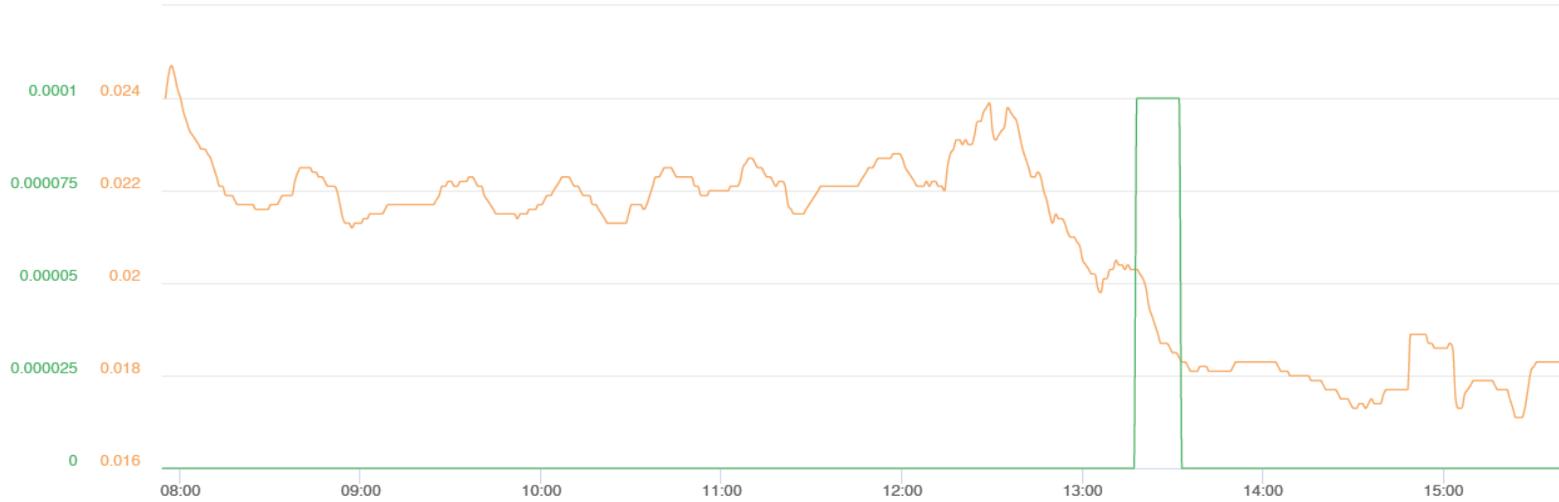
UH - Fixed 2 CAMP Station Graph

08/22/2023 0:00:18 – 08/23/2023 0:00:00
(GMT-05:00) Eastern Time (US & Canada)

Mass Conc. Total mg/m ³ AVG 15m		
mg/m ³ DustTrak-8530 RS232(C)		
MIN	AVG	MAX
0.0171	0.0208	0.0247

VOC ppm AVG 15m		
ppm miniRAE 3000 RS232(A)		
MIN	AVG	MAX
0	0	0.0001

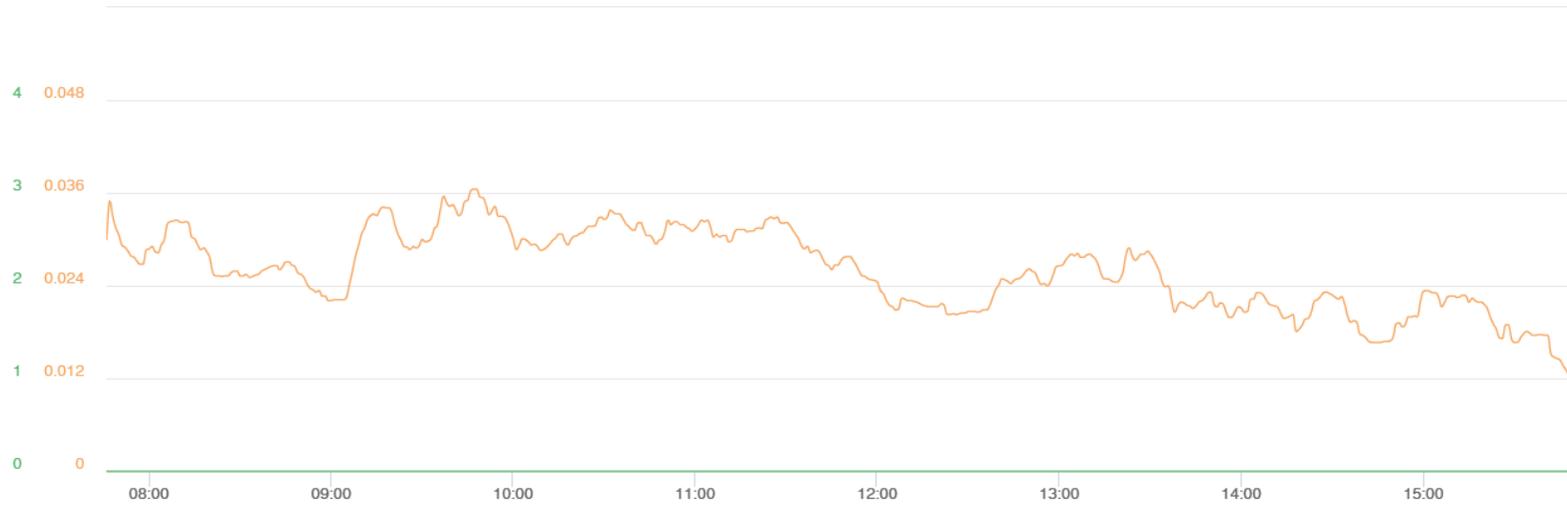
UH - Fixed 3 CAMP Station Graph

08/22/2023 0:00:44 – 08/23/2023 0:00:00
(GMT-05:00) Eastern Time (US & Canada)

Mass Conc. Total mg/m ³ AVG 15m mg/m ³ DustTrak-8530 RS232(C)			VOC ppm AVG 15m ppm miniRAE 3000 RS232(A)		
MIN	AVG	MAX	MIN	AVG	MAX
0.0131	0.026	0.0365	0	0	0

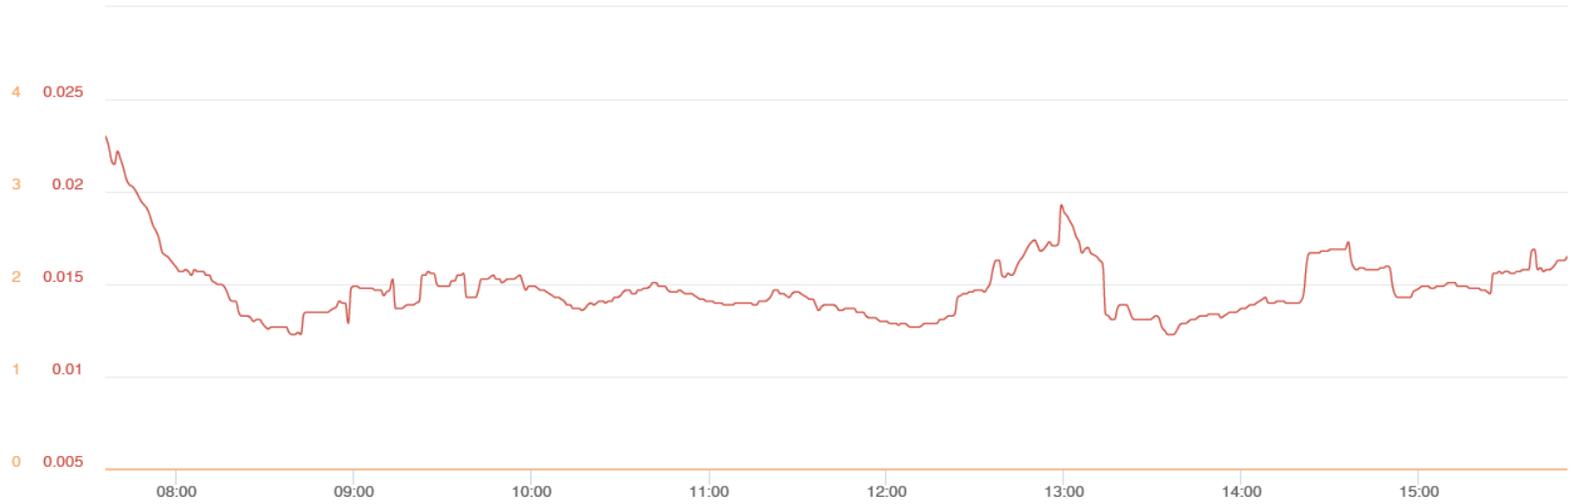
UH - Downwind 1 CAMP Station Graph

08/22/2023 0:00:16 – 08/23/2023 0:00:00
(GMT-05:00) Eastern Time (US & Canada)

Mass Conc. Total mg/m³ AVG 15m mg/m³ DustTrak-8530 RS232(C)			VOC ppm AVG 15m ppm miniRAE 3000 RS232(A)		
MIN	AVG	MAX	MIN	AVG	MAX
0.0123	0.0148	0.023	0	0	0

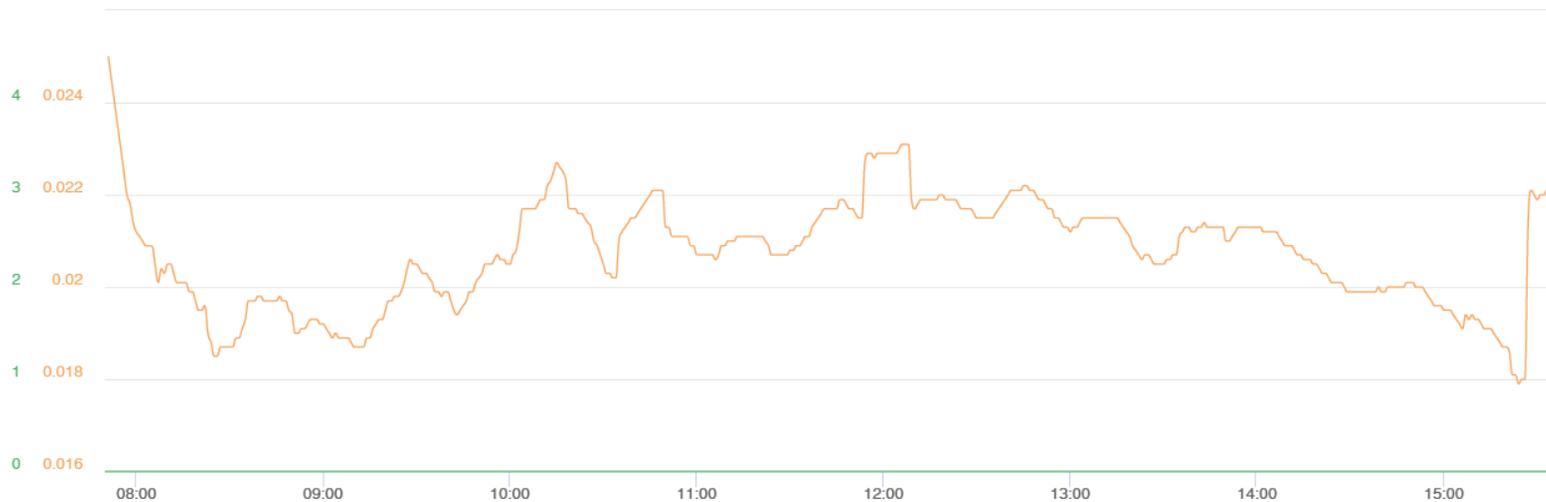
UH - Downwind 2 CAMP Station Graph

08/22/2023 0:00:18 – 08/23/2023 0:00:00
(GMT-05:00) Eastern Time (US & Canada)

Mass Conc. Total mg/m³ AVG 15m

mg/m³
DustTrak-8530
RS232(C)

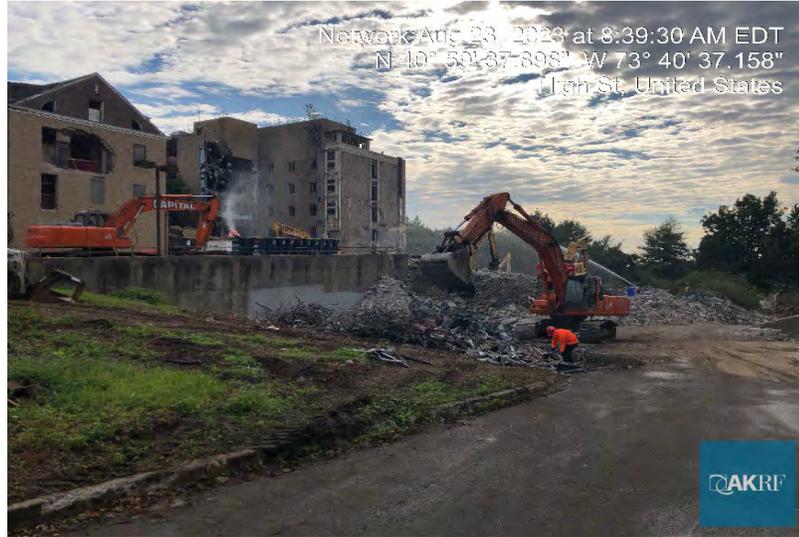
Photograph 1 -
Structural demolition
of the southeastern
portion of the main
hospital building,
view facing east.

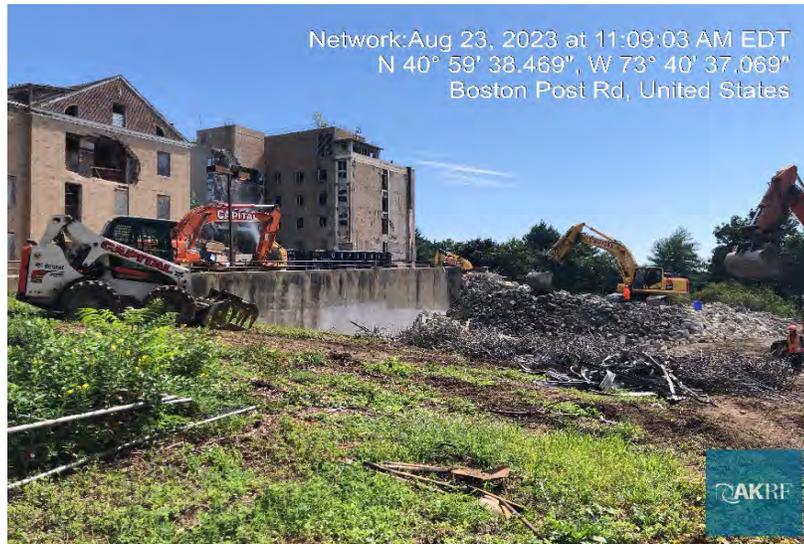
Photograph 3 -
Structural demolition
of the northeastern
portion of the main
hospital building,
view facing west.

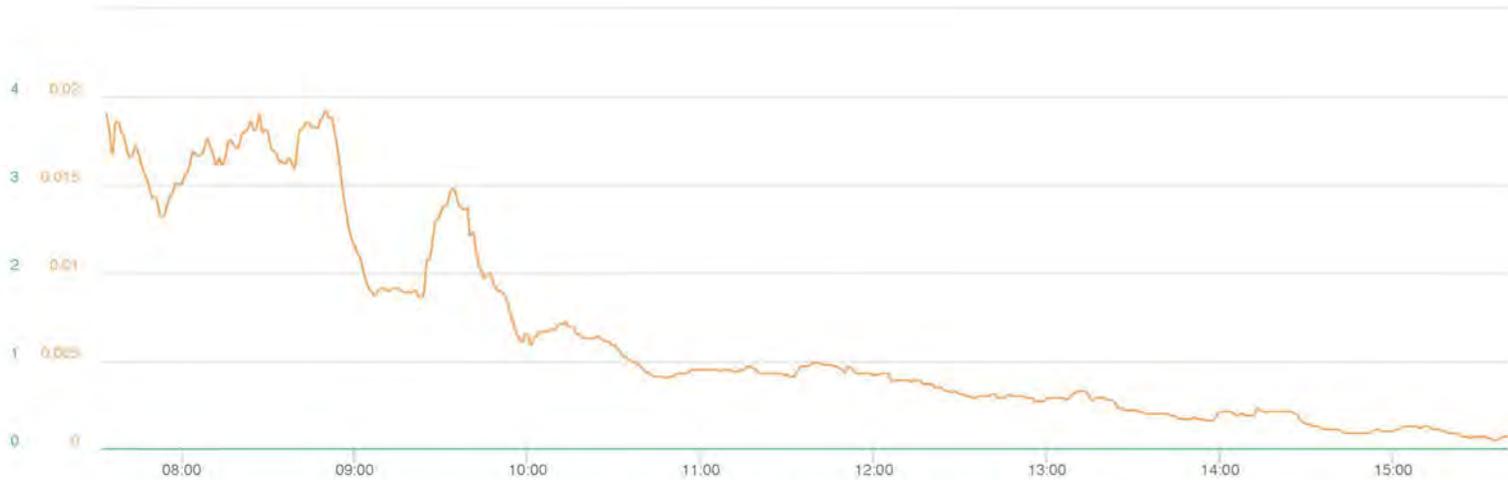
UH - Fixed 3 CAMP Station Graph

MIN	AVG	MAX
0.0005	0.0064	0.0192

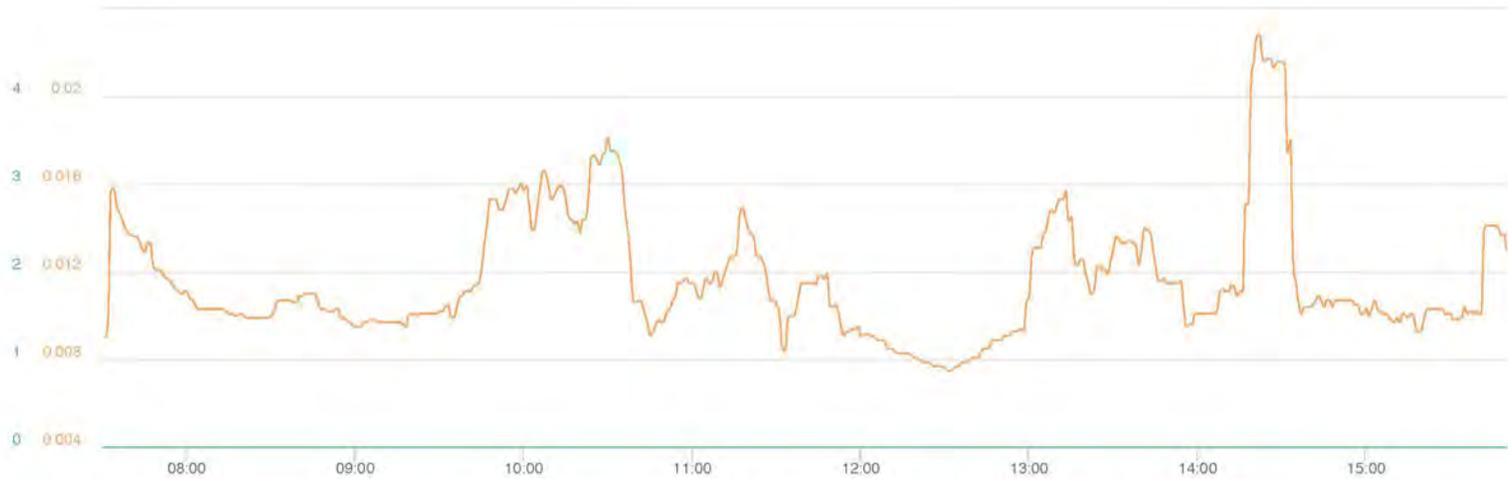
UH - Upwind 1 CAMP Station Graph

MIN	AVG	MAX
0.0075	0.0116	0.0228

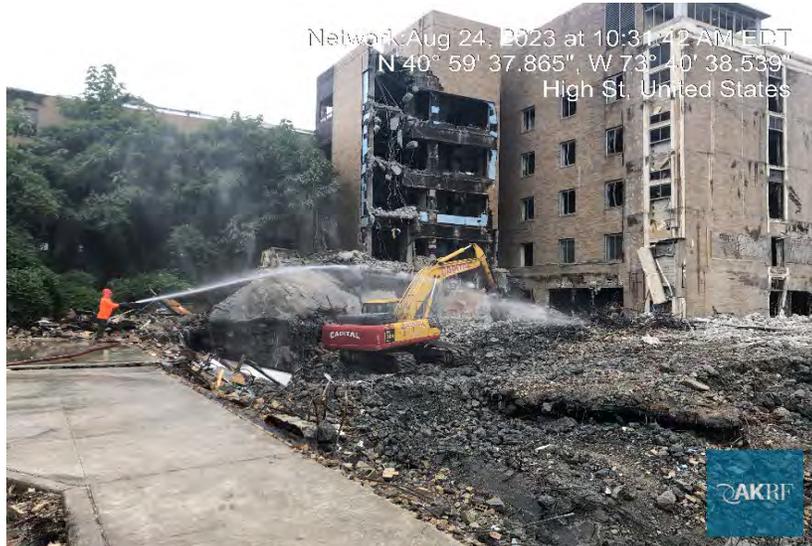
Photograph 1 -
Structural demolition
of the southeastern
portion of the main
hospital building,
view facing northeast.

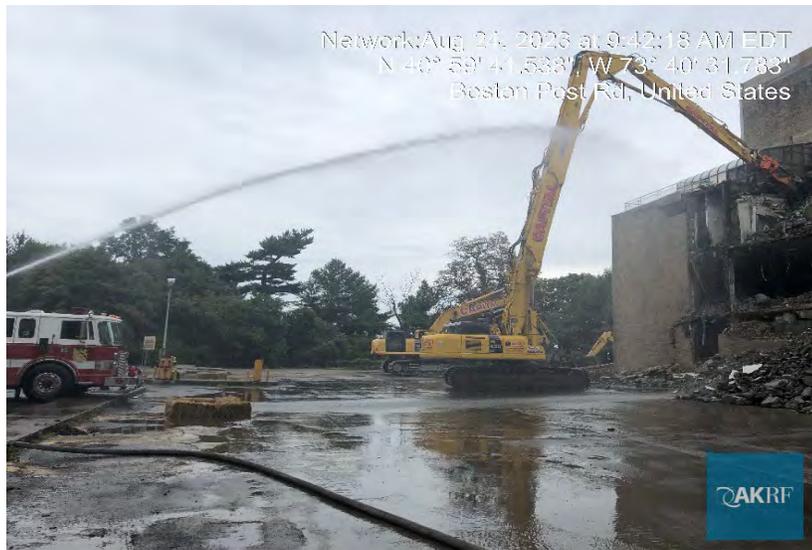
Photograph 2 -
Structural demolition
of the northeastern
portion of the main
hospital building,
view facing east.

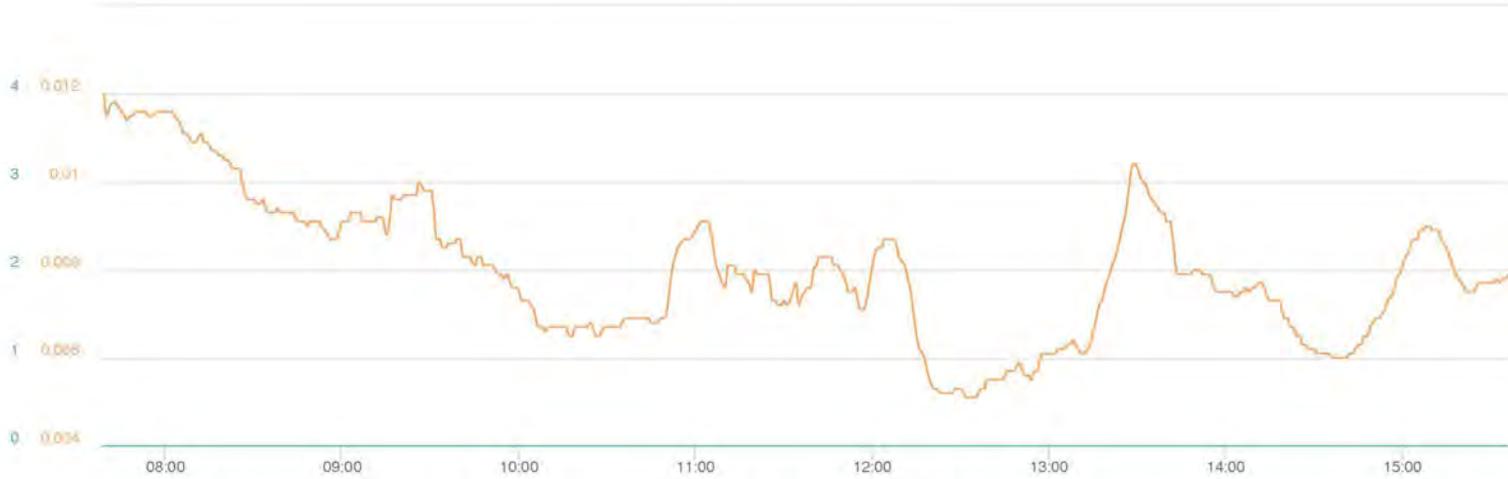
UH - Fixed 3 CAMP Station Graph

MIN	AVG	MAX
0.0051	0.008	0.012

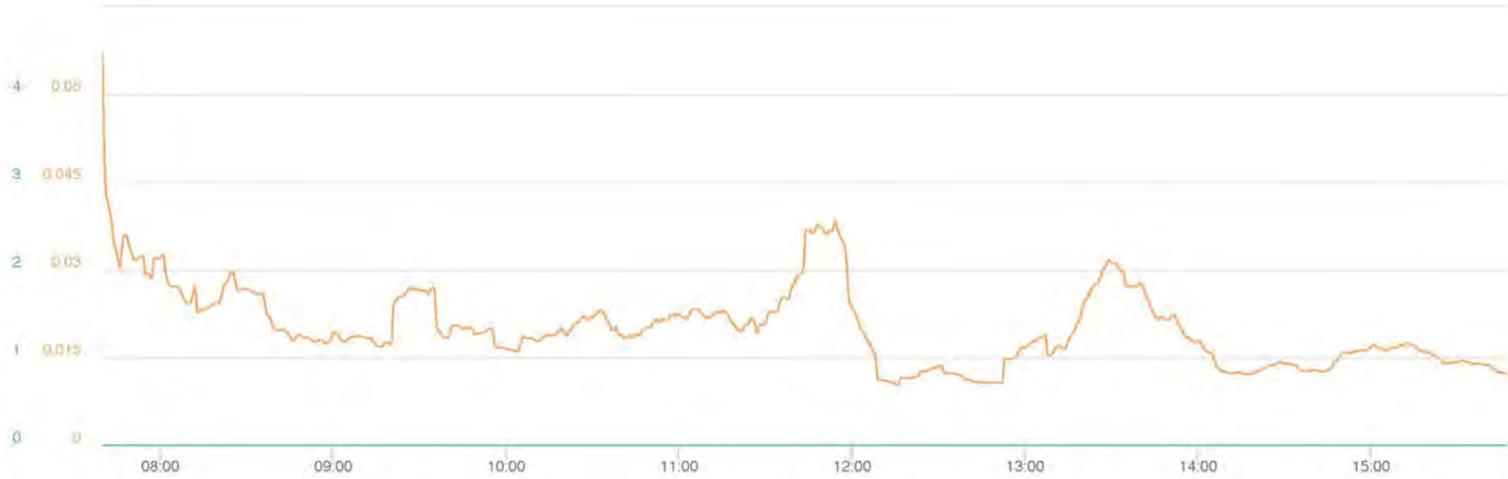
UH - Upwind 1 CAMP Station Graph

MIN	AVG	MAX
0.0103	0.0201	0.067

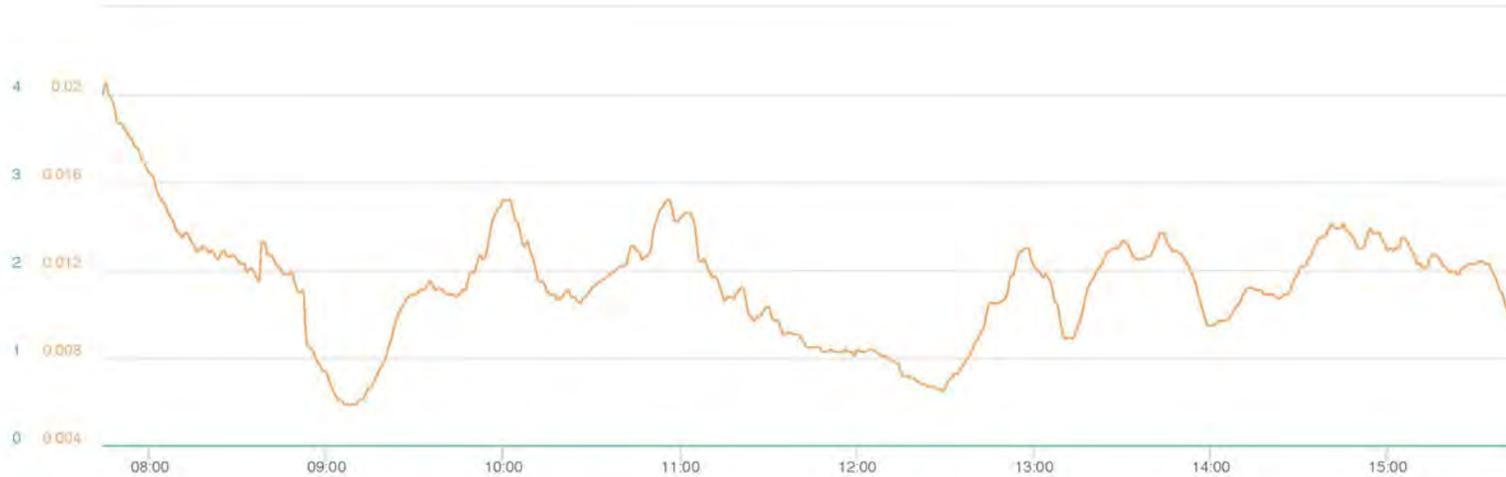
UH - Downwind 1 CAMP Station Graph

MIN	AVG	MAX
0.0059	0.0114	0.0205

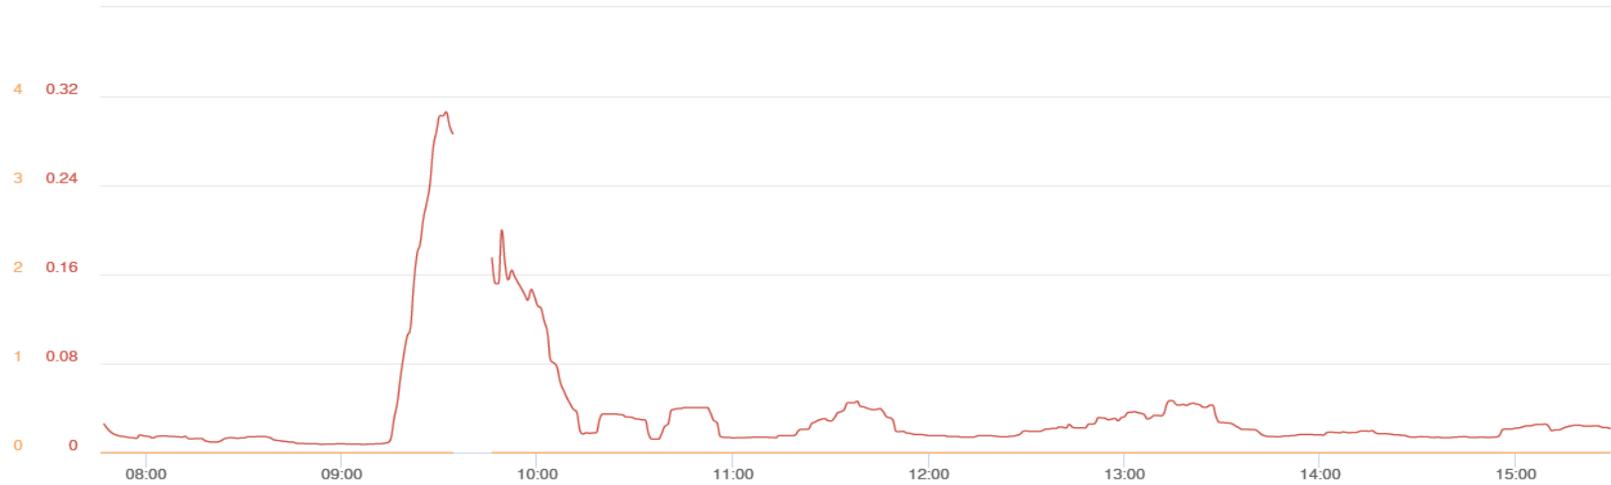
UH - Downwind 2 CAMP Station Graph

MIN	AVG	MAX
0.0077	0.0341	0.3062

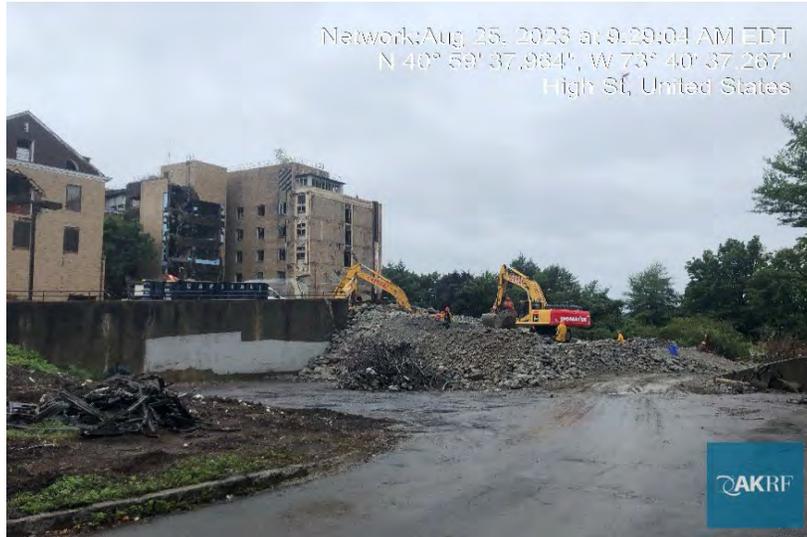
Photograph 1 -
Structural demolition
of the southeastern
portion of the main
hospital building,
view facing east.

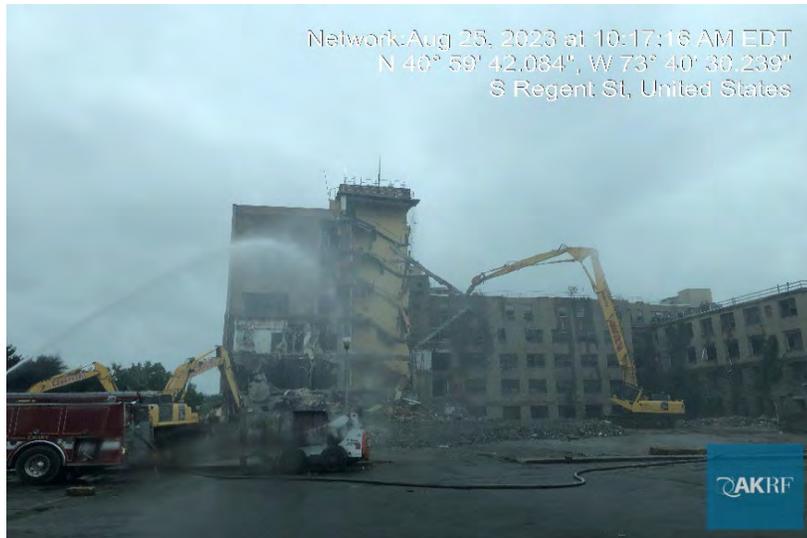
Photograph 2 -
Structural demolition
of the northeastern
portion of the main
hospital building,
view facing South.

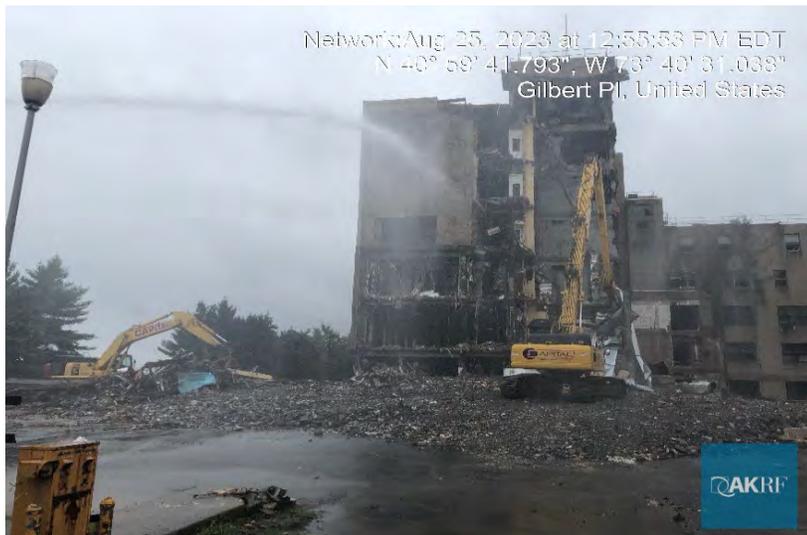
Photograph 3 -
Structural demolition
of the northeastern
portion of the main
hospital building,
view facing south.

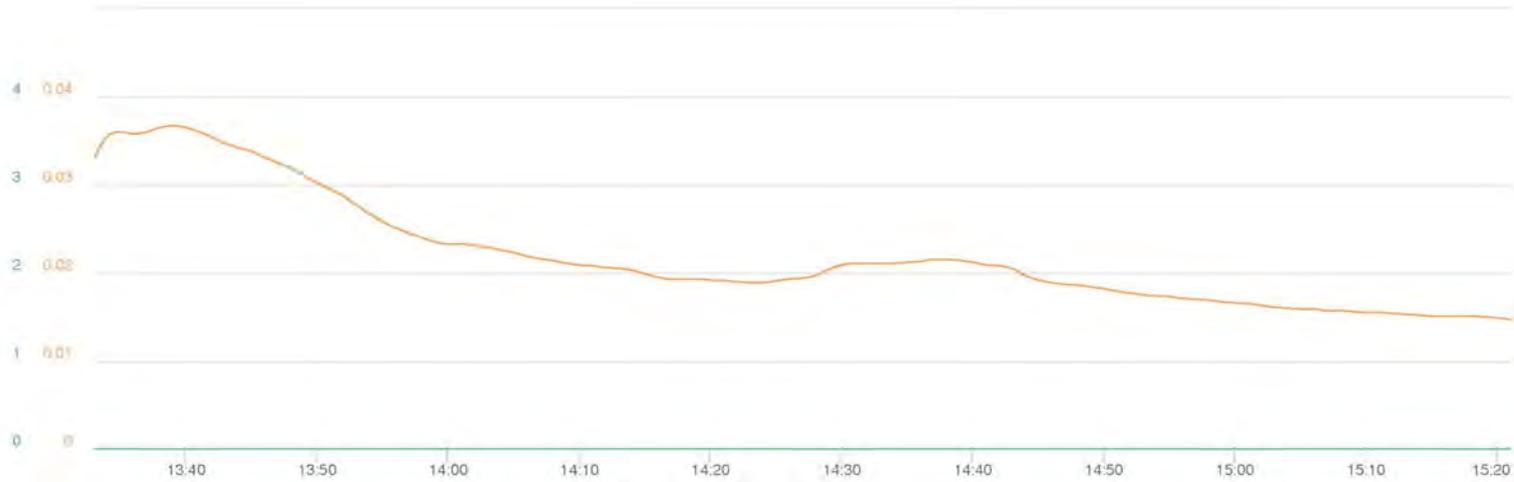
UH - Fixed 3 CAMP Station Graph

MIN	AVG	MAX
0.0149	0.0221	0.0367

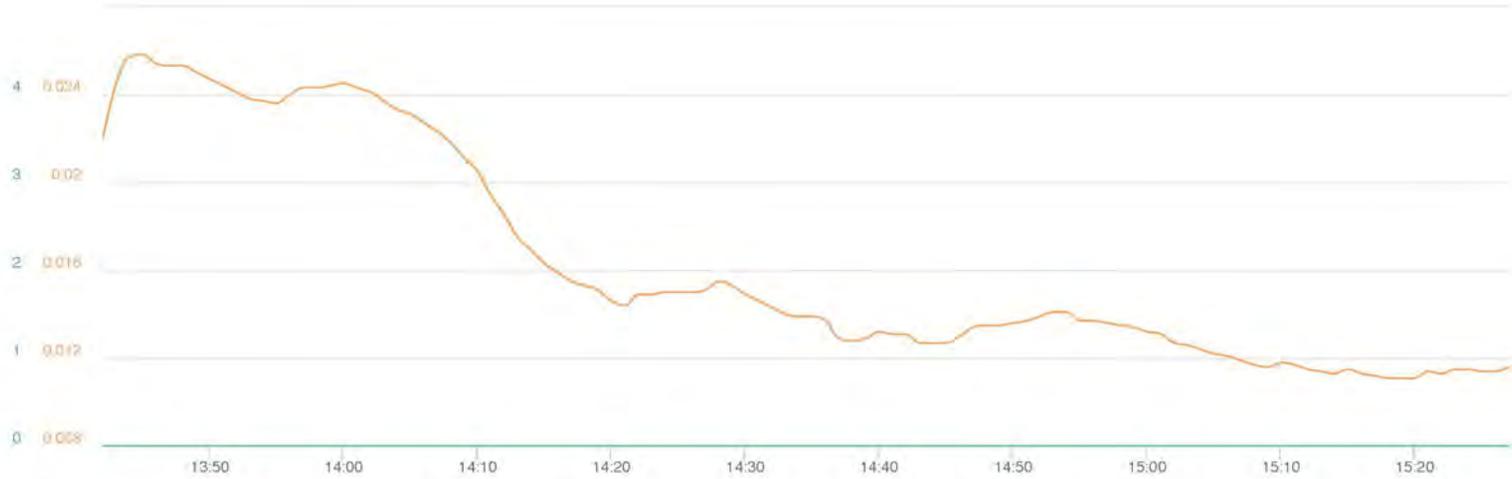
UH - Downwind 1 CAMP Station Graph

MIN	AVG	MAX
0.0111	0.0163	0.0258

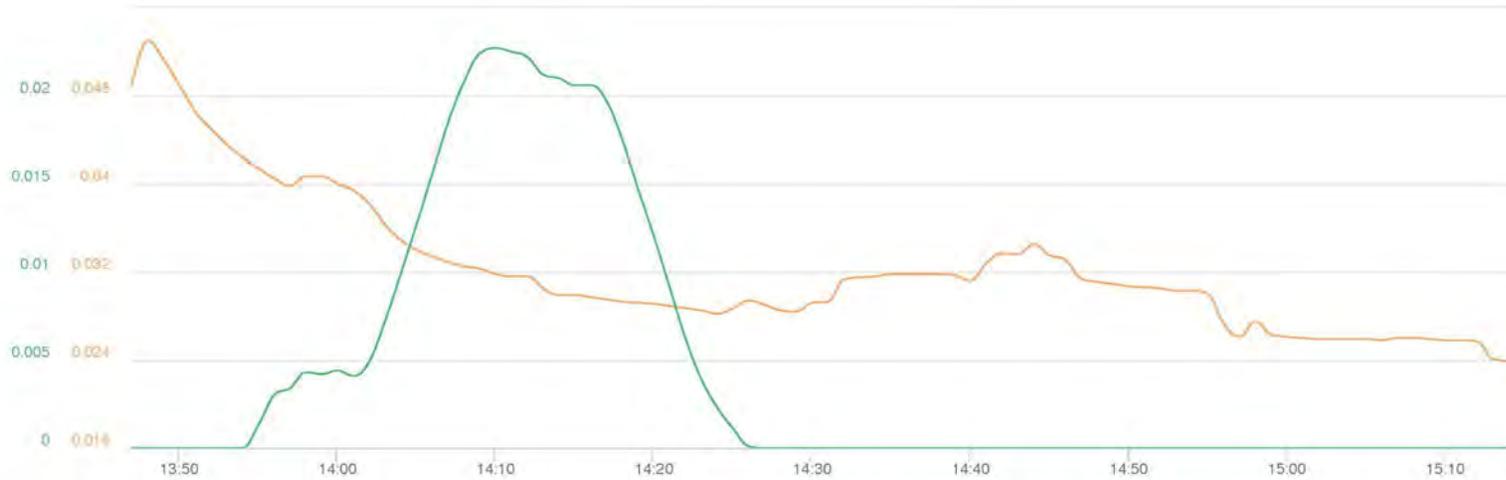
UH - Downwind 2 CAMP Station Graph

MIN	AVG	MAX
0.0241	0.0324	0.053

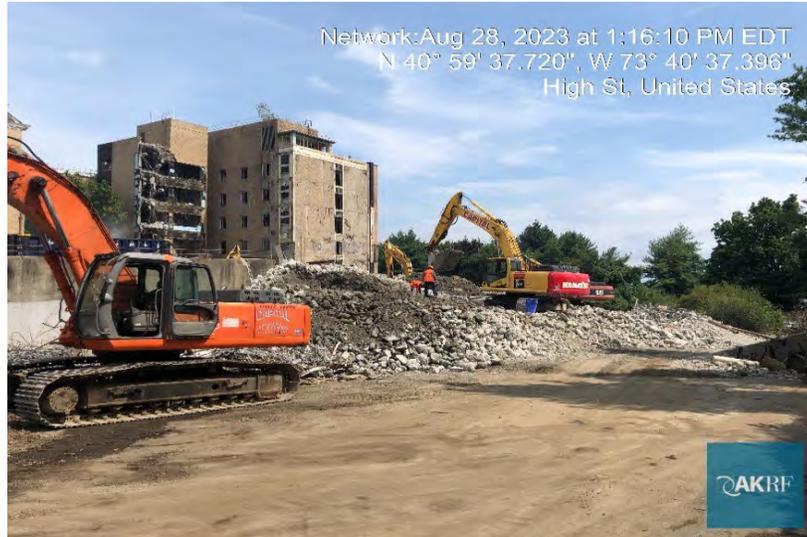
Photograph 1 -
Structural demolition
of the southeastern
portion of the main
hospital building,
view facing east.

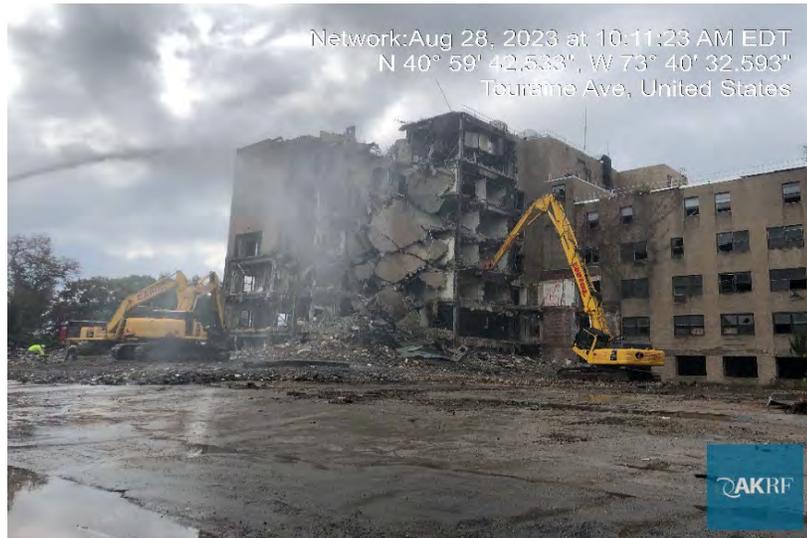
Photograph 2 -
Structural demolition
of the northeastern
portion of the main
hospital building,
view facing southeast.

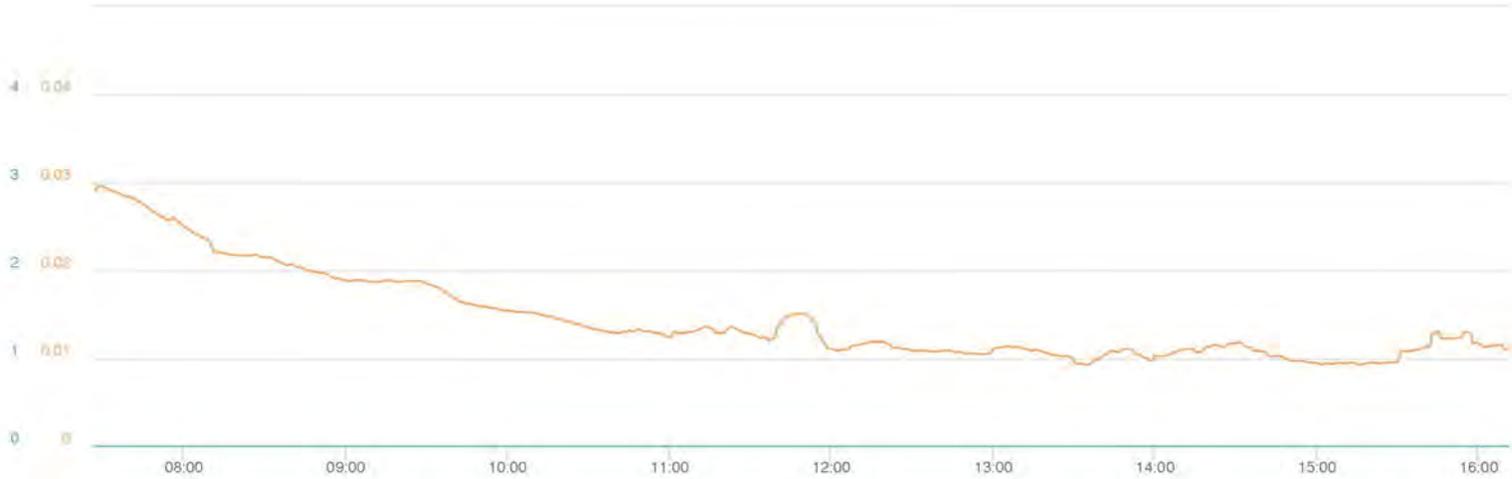
UH - Fixed 3 CAMP Station Graph

MIN	AVG	MAX
0.0093	0.0145	0.0297

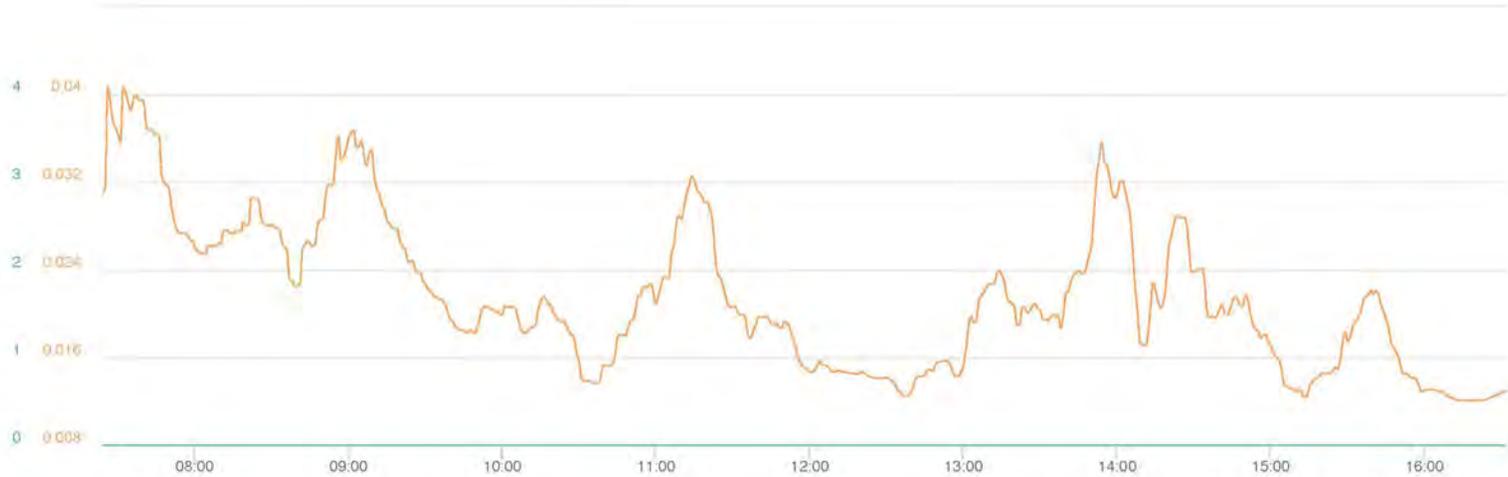
UH - Upwind 1 CAMP Station Graph

MIN	AVG	MAX
0.0121	0.0216	0.0407

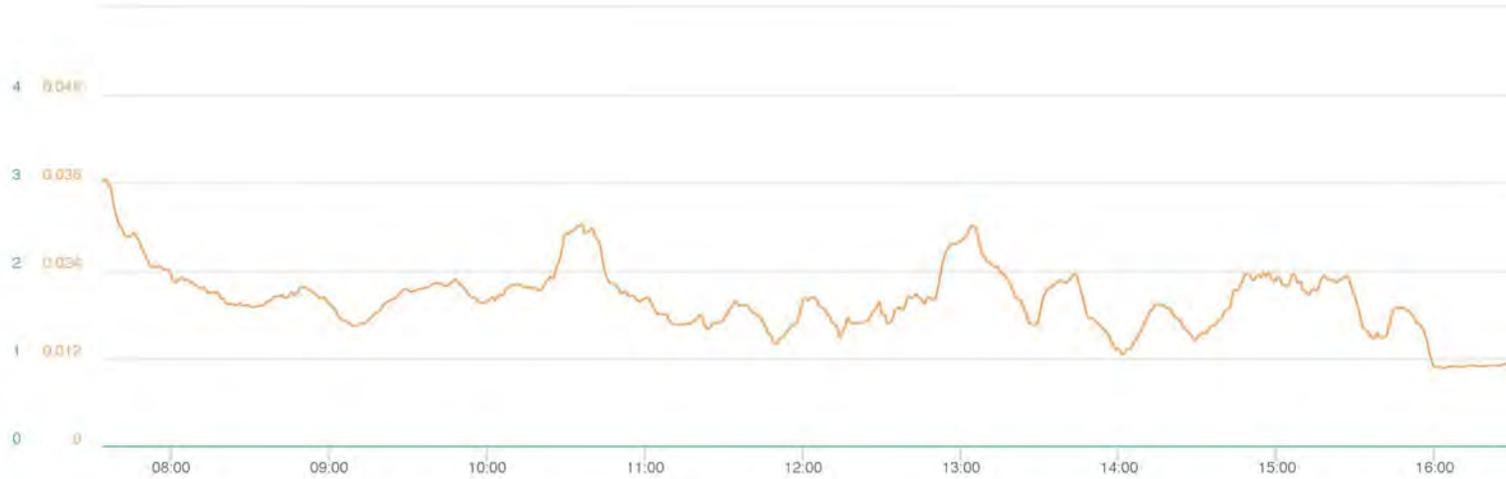
UH - Downwind 1 CAMP Station Graph

MIN	AVG	MAX
0.0107	0.02	0.0365

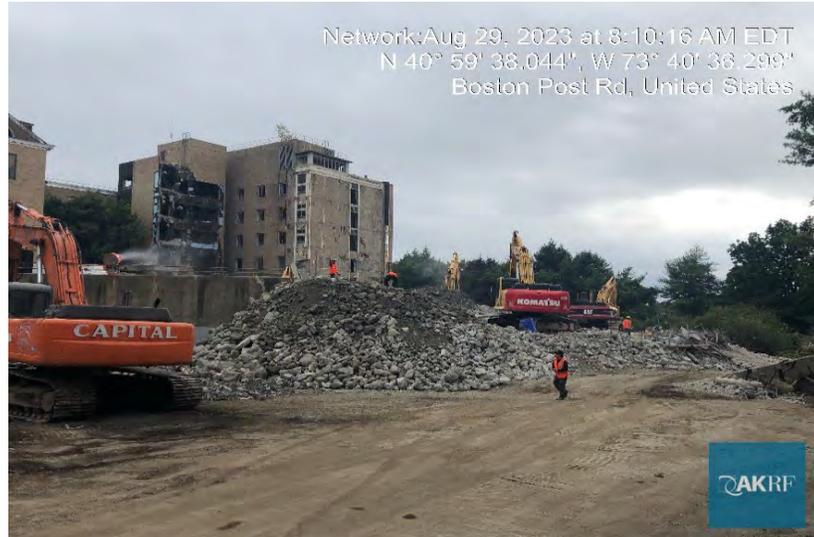
Photograph 1 -
Structural demolition
of the southeastern
portion of the main
hospital building,
view facing east.

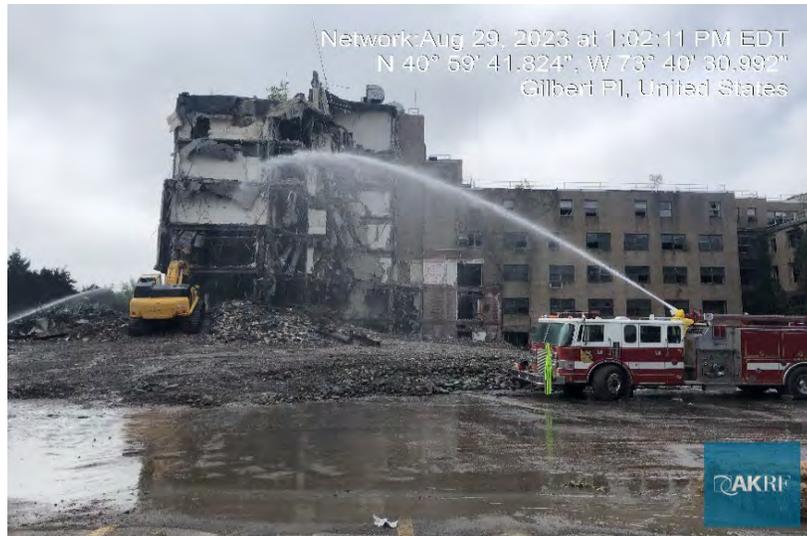
Photograph 2 -
Structural demolition
of the northeastern
portion of the main
hospital building,
view facing south.

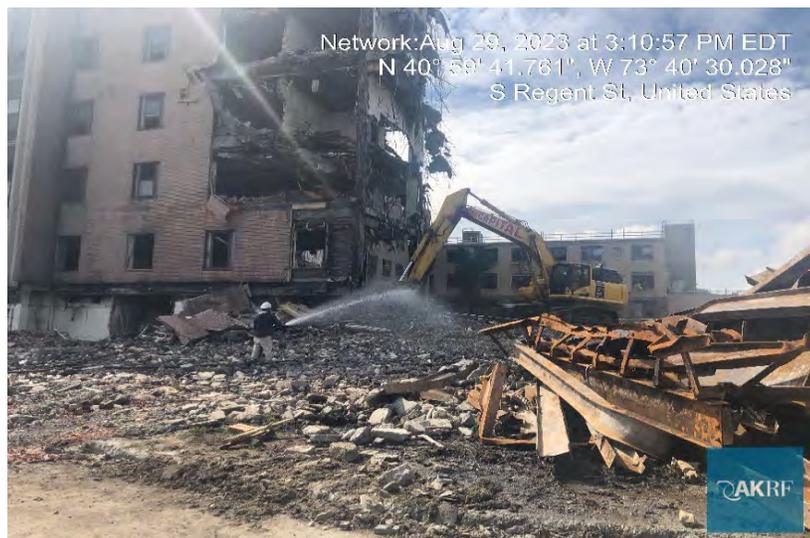
Photograph 3 -
Structural demolition
of the northeastern
portion of the main
hospital building,
view facing
southwest.

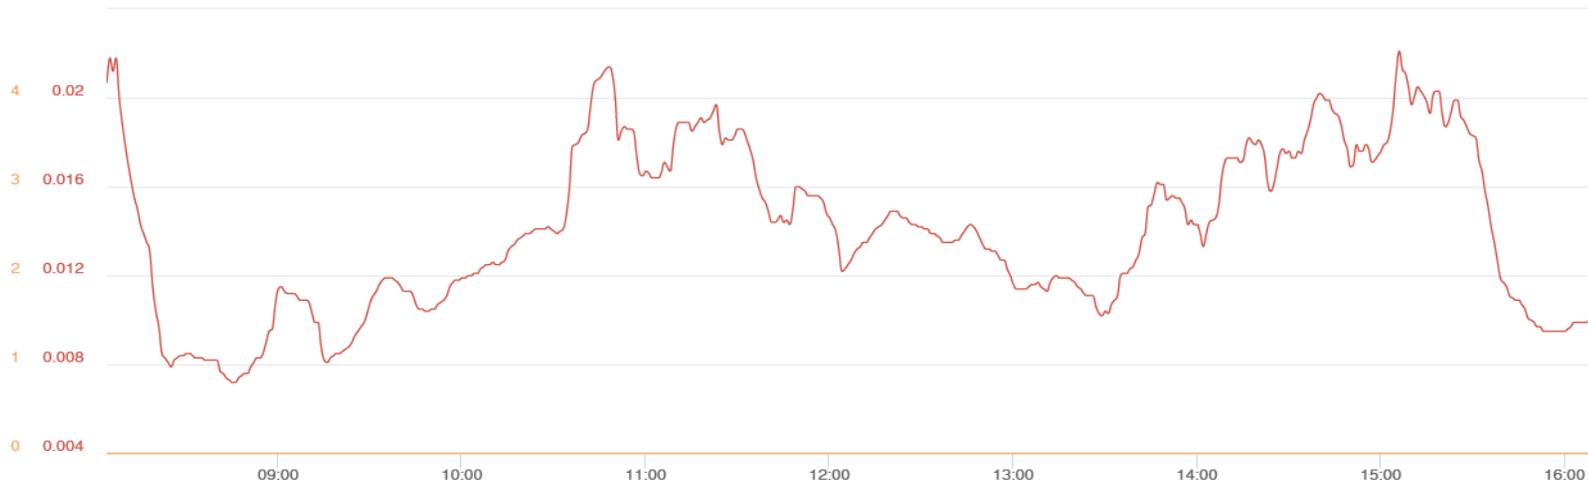
UH - Downwind 1 CAMP Station Graph

Mass Conc. Total mg/m ³ AVG 15m			VOC ppm AVG 15m		
mg/m ³			ppm		
DustTrak-8530			miniRAE 3000		
RS232(C)			RS232(A)		
MIN	AVG	MAX	MIN	AVG	MAX
0.0072	0.0141	0.0221	0	0	0

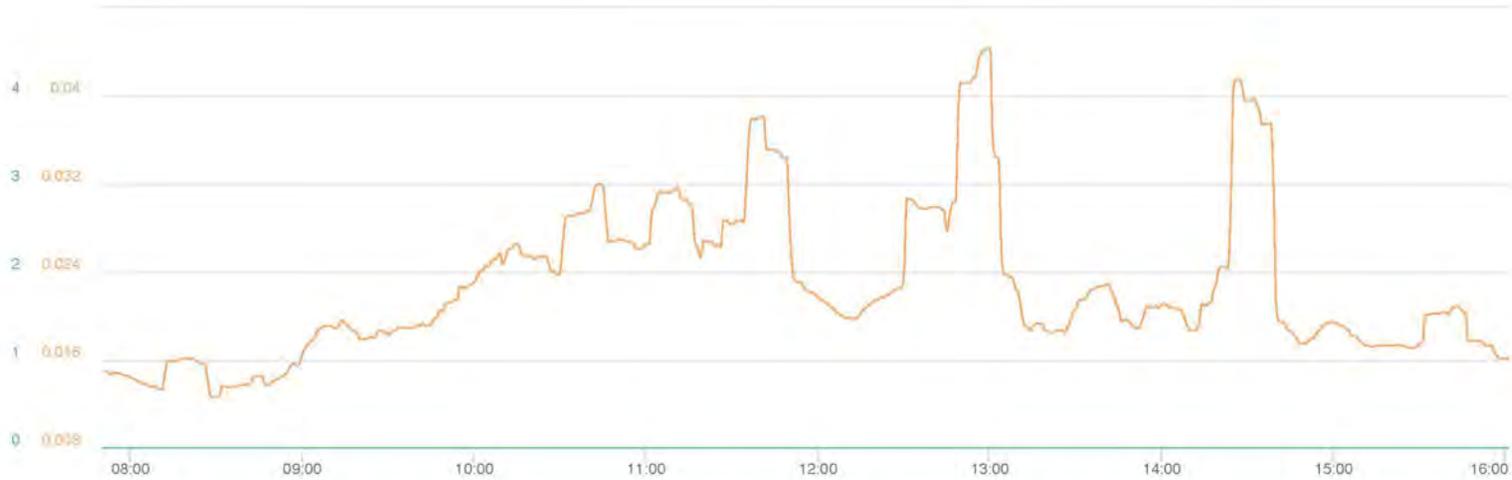
UH - Downwind 2 CAMP Station Graph

MIN	AVG	MAX
0.0126	0.0227	0.0443

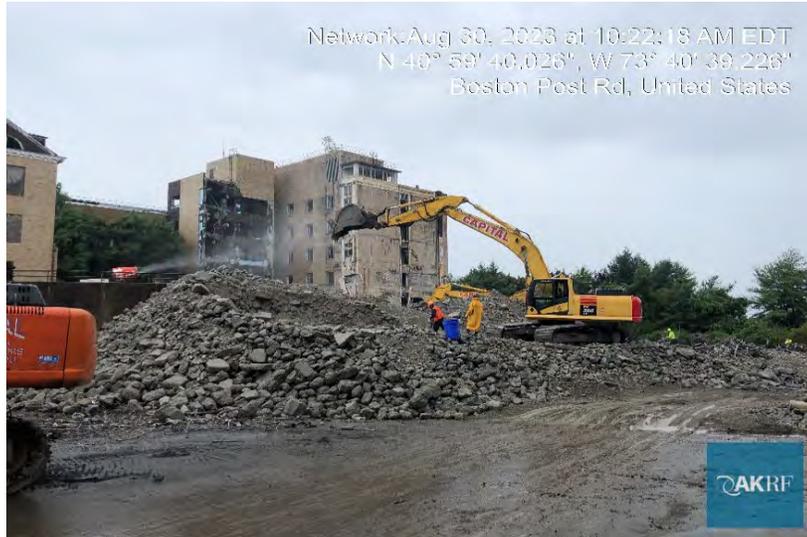
Photograph 1 -
Structural demolition
of the southeastern
portion of the main
hospital building,
view facing east.

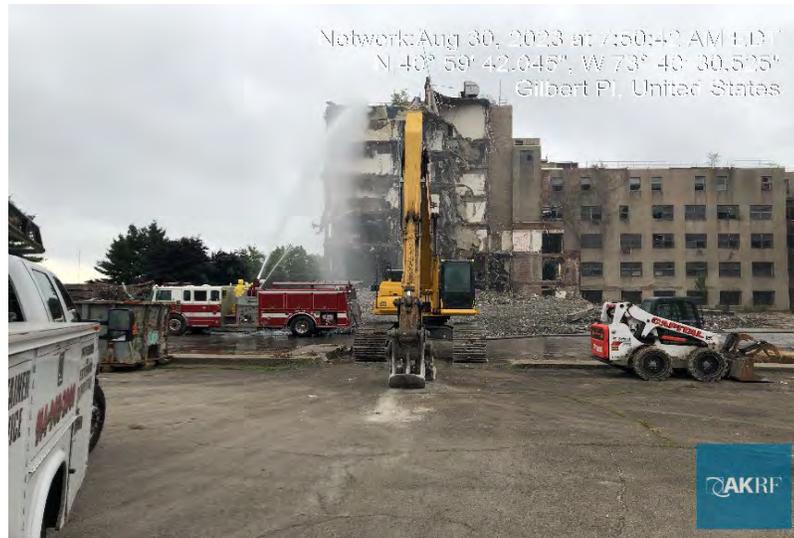
Photograph 2 -
Structural demolition
of the northeastern
portion of the main
hospital building,
view facing south.

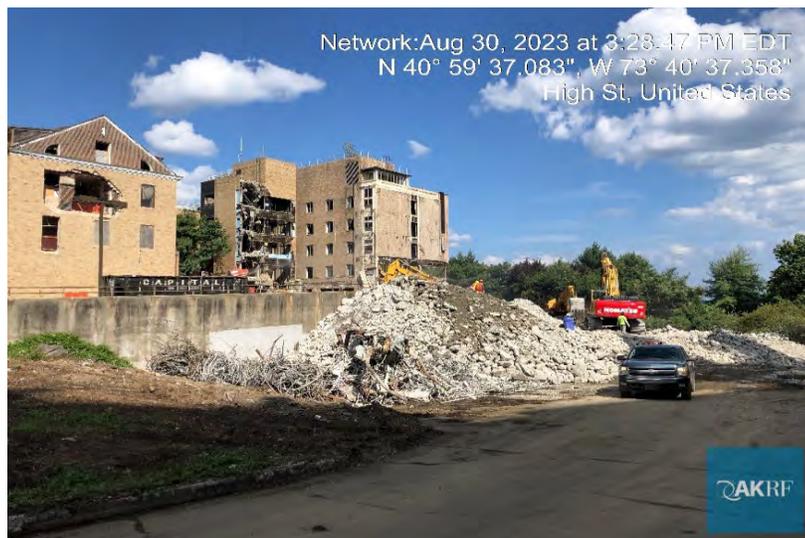
Photograph 3 -
Structural demolition
of the southeastern
portion of the main
hospital building,
view facing east.

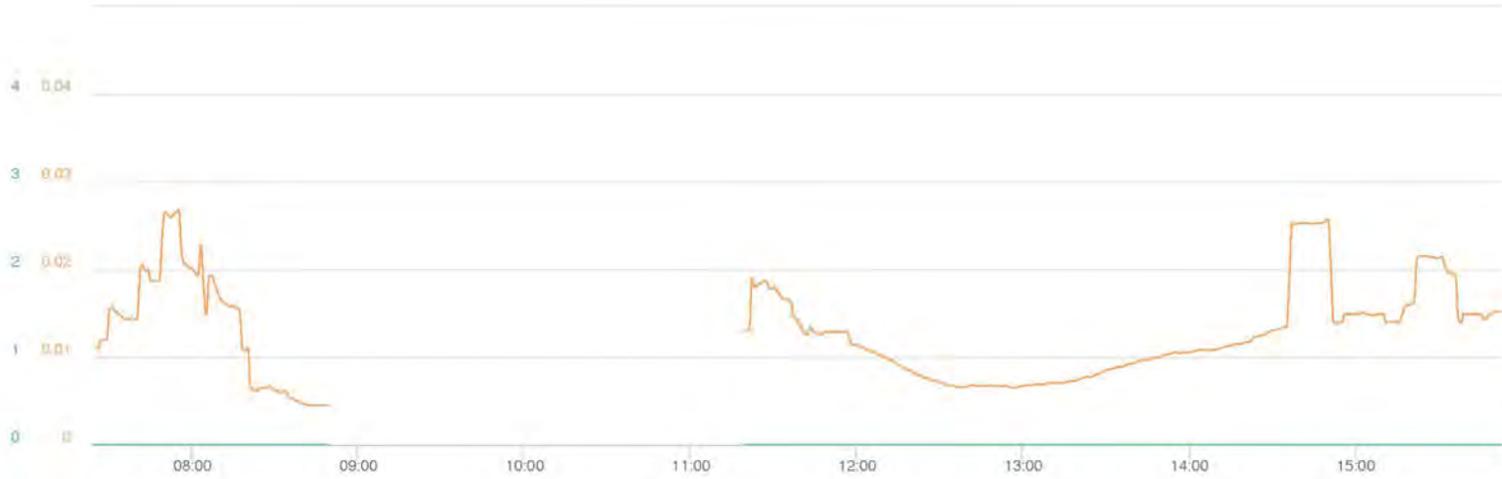
UH - Fixed 1 CAMP Station Graph

08/30/2023 0:00:39 – 08/31/2023 0:00:00
(GMT-05:00) Eastern Time (US & Canada)

Mass Conc. Total mg/m³ AVG 15m
mg/m³

DustTrak-8530
RS232(G)

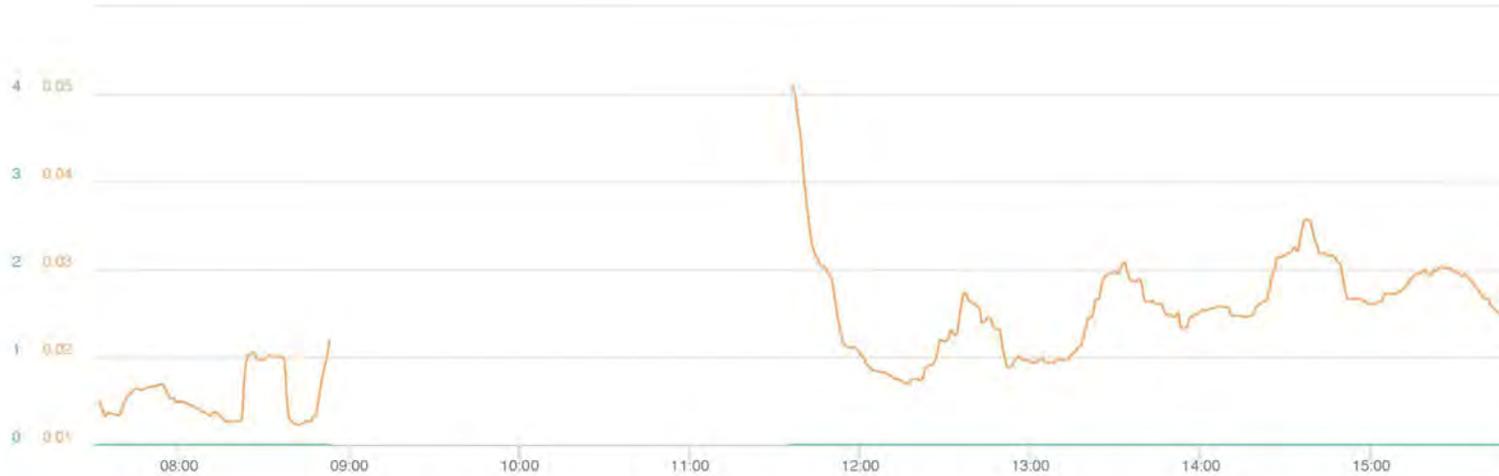
UH - Fixed 2 CAMP Station Graph

08/30/2023 0:00:25 – 08/31/2023 0:00:00
(GMT-05:00) Eastern Time (US & Canada)

Mass Conc. Total mg/m³ AVG 15m
mg/m³

DustTrak-8530
RS232(C)
