Re: Monthly Progress Report – August 2023
Former United Hospital – 406 Boston Post Road, Port Chester, New York
NYSDEC BCP Site No. C360202

This Monthly Progress Report has been prepared by AKRF, Inc. (AKRF) to summarize the work performed at the Former United Hospital site located at 406 Boston Post Road in Port Chester, New York [New York State Department of Environmental Conservation (NYSDEC) Brownfield Cleanup Program (BCP) Site No. C360202] (the Site) during the month of August 2023. The following activities were conducted:

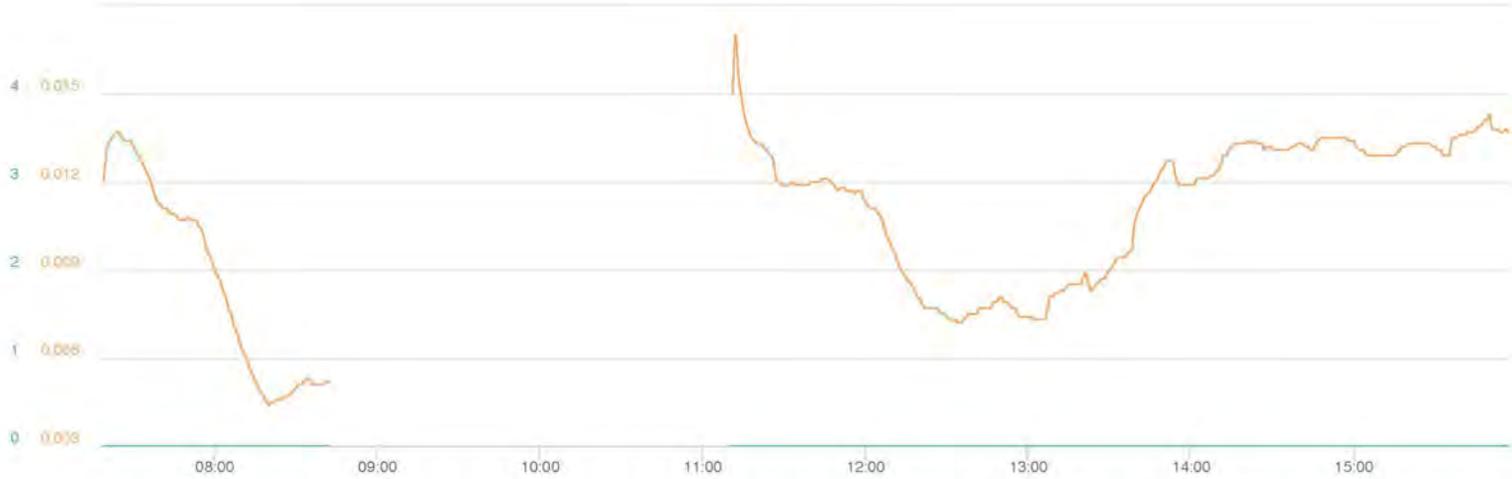
UH - Fixed 3 CAMP Station Graph

08/30/2023 0:00:14 – 08/31/2023 0:00:00
(GMT-05:00) Eastern Time (US & Canada)

Mass Conc. Total mg/m³ AVG 15m
mg/m³
DustTrak-8530
RS232(C)

MIN	AVG	MAX
0.0044	0.0107	0.017

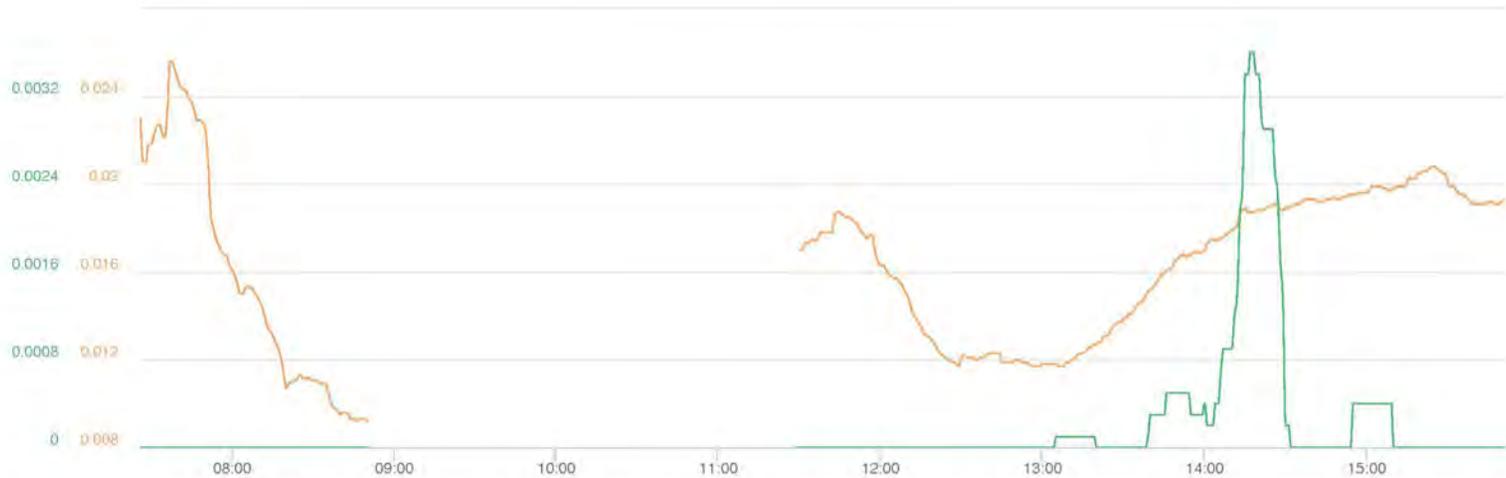
UH - Upwind 1 CAMP Station Graph

08/30/2023 0:00:09 – 08/31/2023 0:00:00
(GMT-05:00) Eastern Time (US & Canada)

Mass Conc. Total mg/m³ AVG 15m
mg/m³
DustTrak-8530
RS232(G)

MIN	AVG	MAX
0.0092	0.0163	0.0256

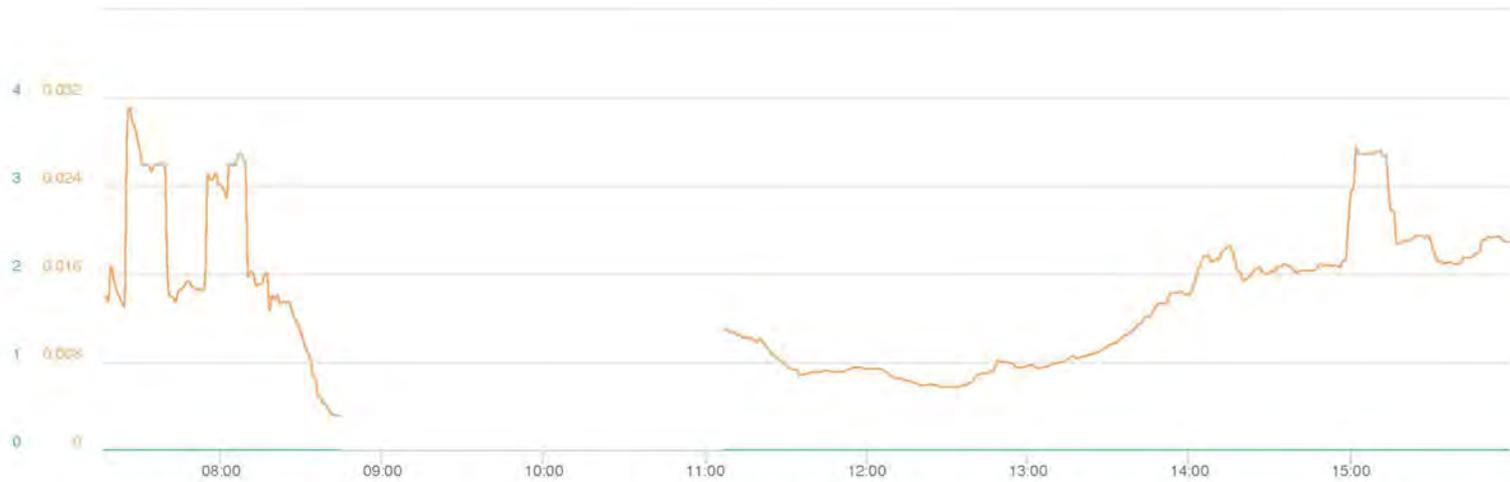
UH - Downwind 1 CAMP Station Graph

08/30/2023 0:00:00 – 08/31/2023 0:00:00
(GMT-05:00) Eastern Time (US & Canada)

Mass Conc. Total mg/m³ AVG 15m
mg/m³

DustTrak-8530
RS232(G)

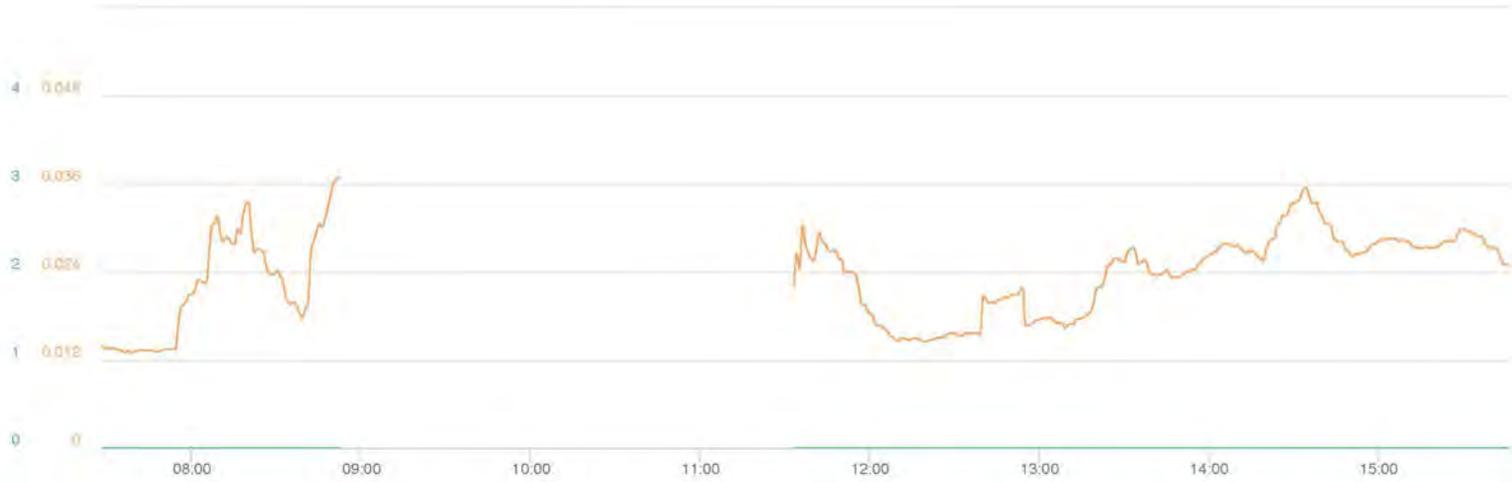
UH - Downwind 2 CAMP Station Graph

08/30/2023 0:00:41 – 08/31/2023 0:00:00
(GMT-05:00) Eastern Time (US & Canada)

Mass Conc. Total mg/m³ AVG 15m
mg/m³
DustTrak-8530
RS232(C)

MIN	AVG	MAX
0.013	0.0234	0.037

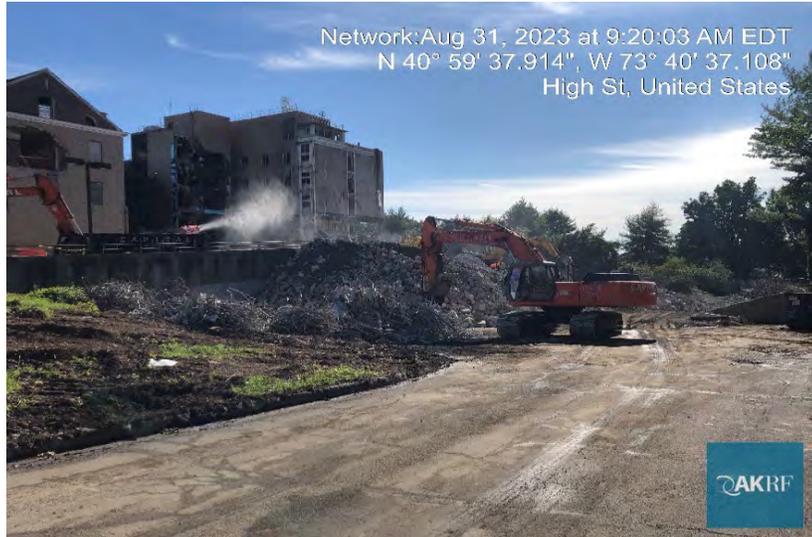
Photograph 1 -
Structural demolition
of the southeastern
portion of the main
hospital building,
view facing east.

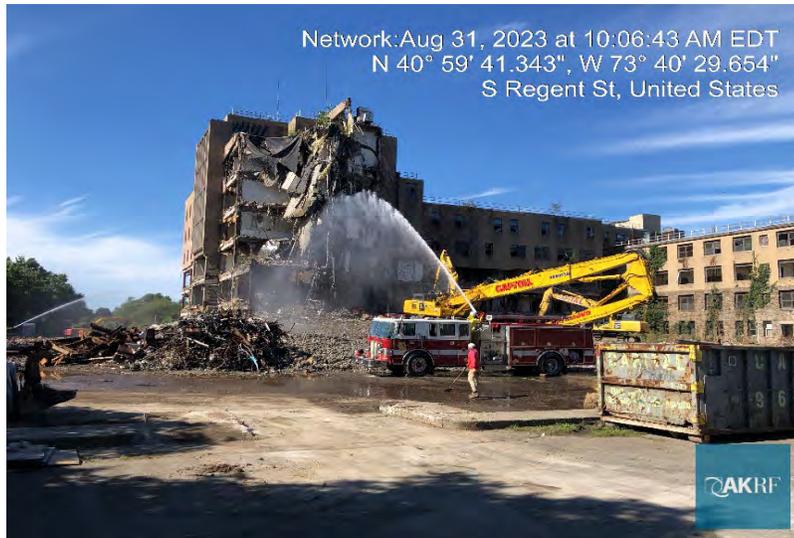
Photograph 2 -
Structural demolition
of the northeastern
portion of the main
hospital building,
view facing south.

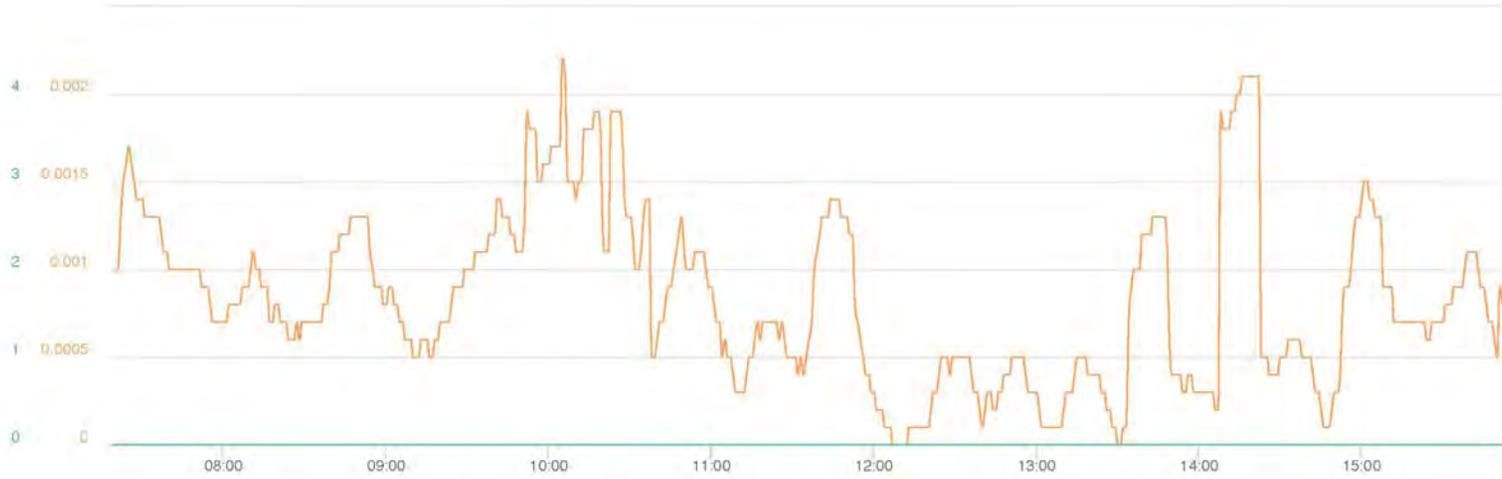
UH - Fixed 1 CAMP Station Graph

08/31/2023 0:00:44 – 09/01/2023 0:00:00
(GMT-05:00) Eastern Time (US & Canada)

Mass Conc. Total mg/m³ AVG 15m
mg/m³

DustTrak-8530
RS232(G)

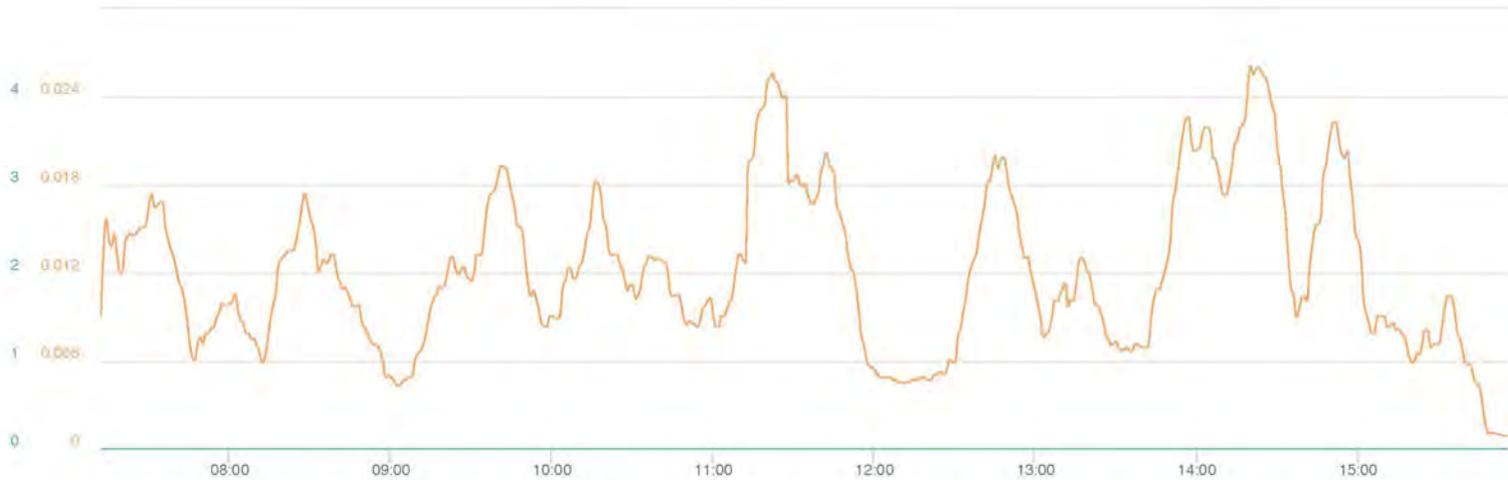
UH - Fixed 3 CAMP Station Graph

08/31/2023 0:00:13 – 09/01/2023 0:00:00
(GMT-05:00) Eastern Time (US & Canada)

Mass Conc. Total mg/m³ AVG 15m
mg/m³
DustTrak-8530
RS232(C)

MIN	AVG	MAX
0.0009	0.0121	0.0261

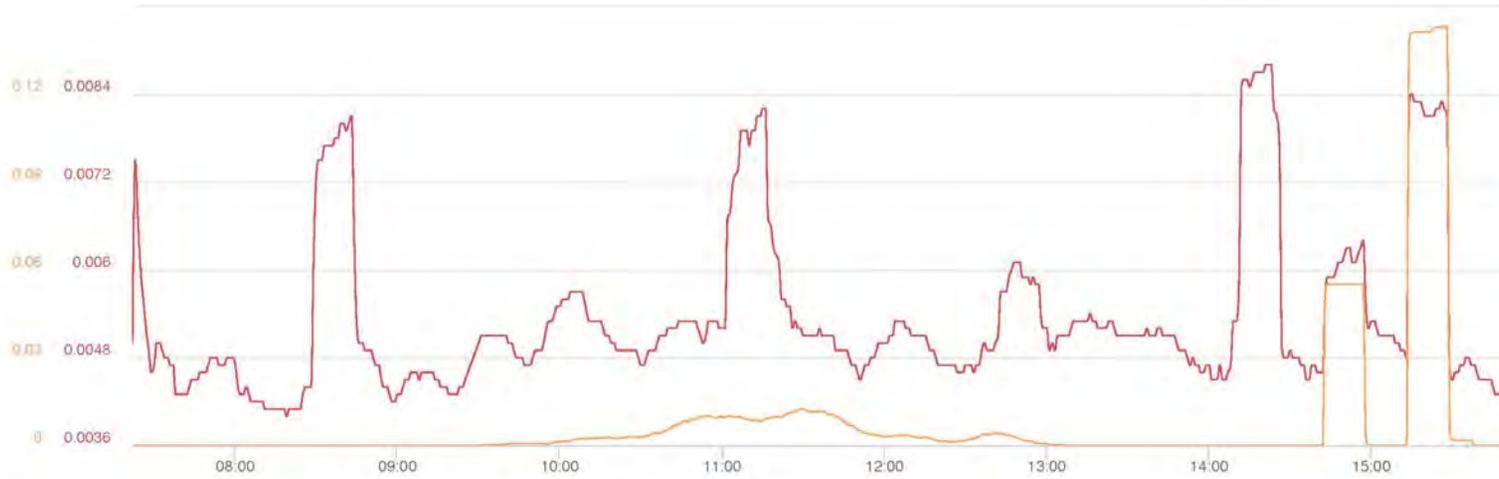
UH - Upwind 1 CAMP Station Graph

08/31/2023 0:00:21 – 09/01/2023 0:00:00
(GMT-05:00) Eastern Time (US & Canada)

Mass Conc. Total mg/m³ AVG 15m
mg/m³
DustTrak-8530
RS232(G)

MIN	AVG	MAX
0.004	0.0053	0.0088

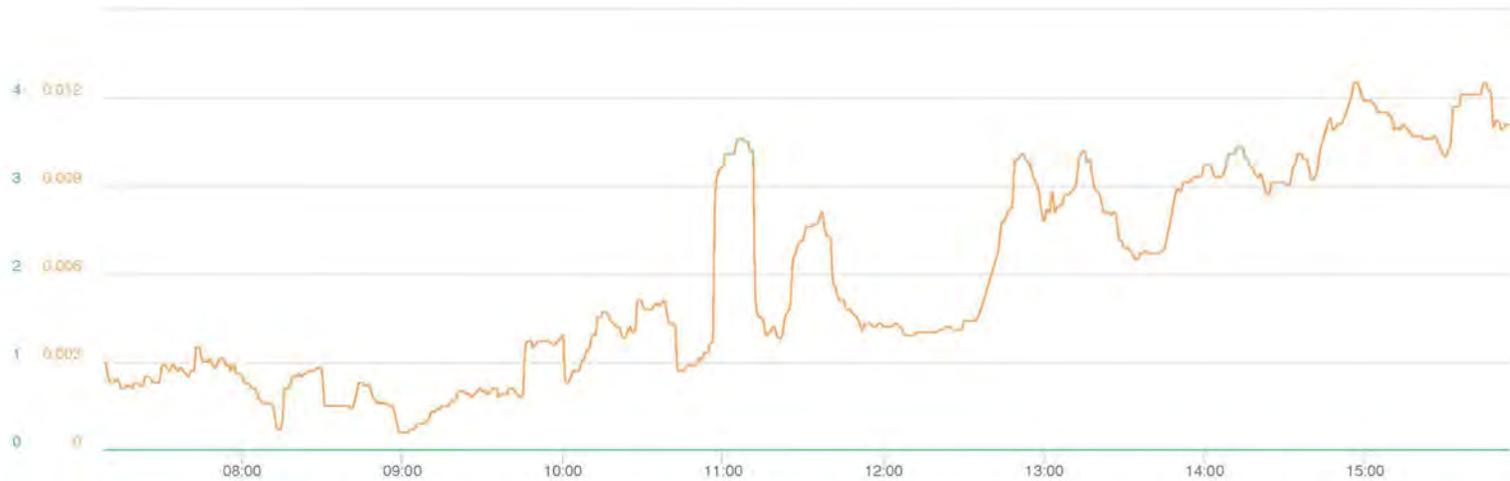
UH - Downwind 1 CAMP Station Graph

08/31/2023 0:00:33 – 09/01/2023 0:00:00
(GMT-05:00) Eastern Time (US & Canada)

Mass Conc. Total mg/m³ AVG 15m

mg/m³
DustTrak-8530
RS232(G)

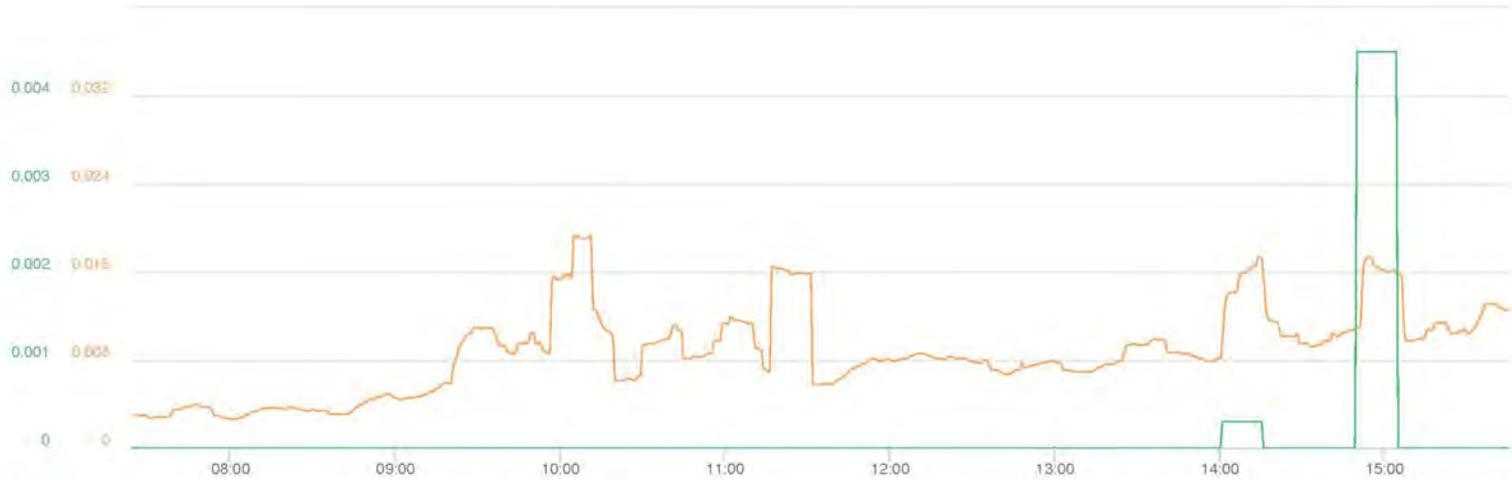
UH - Downwind 2 CAMP Station Graph

08/31/2023 0:00:28 – 09/01/2023 0:00:00
(GMT-05:00) Eastern Time (US & Canada)

Mass Conc. Total mg/m³ AVG 15m

DustTrak-8530
RS232(C)
