# SPILL #9407257

WESTCHESTER CHRYSLER-PLYMOUTH/JEEP-EAGLE
70 WESTCHESTER AVENUE
WHITE PLAINS, NEW YORK

Report No. 94-E-325

November 1994

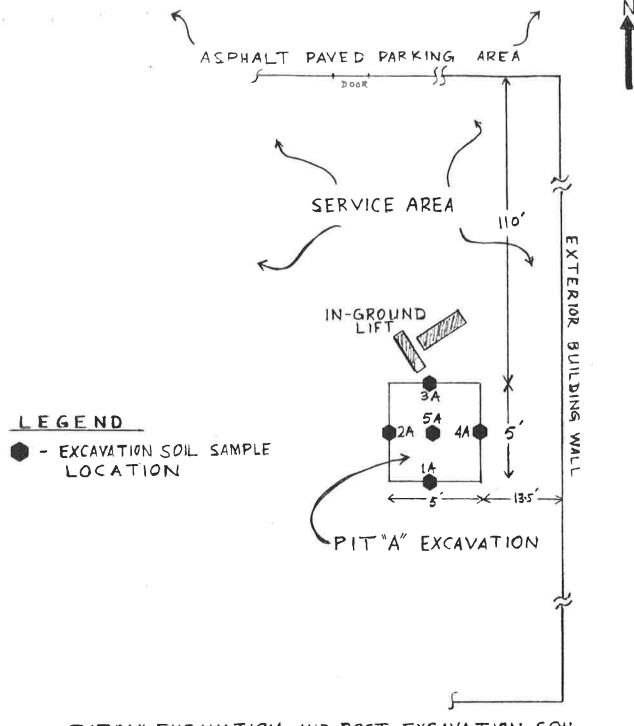
FIGURE - 2

PIT"A" EXCAVATION AND POST EXCAVATION SOIL
SAMPLE LOCATION PLAN

After the removal of all visually contaminated soils, on September 17, 1994, a total of five representative post-excavation soil samples were collected by the SSES representative. Four soil samples were collected from the walls and one sample was taken from the base of the excavation. The soil sampling and testing program is summarized in Tables A-1 and A-2. The post-excavation soil sampling locations are indicated in Figure 2.

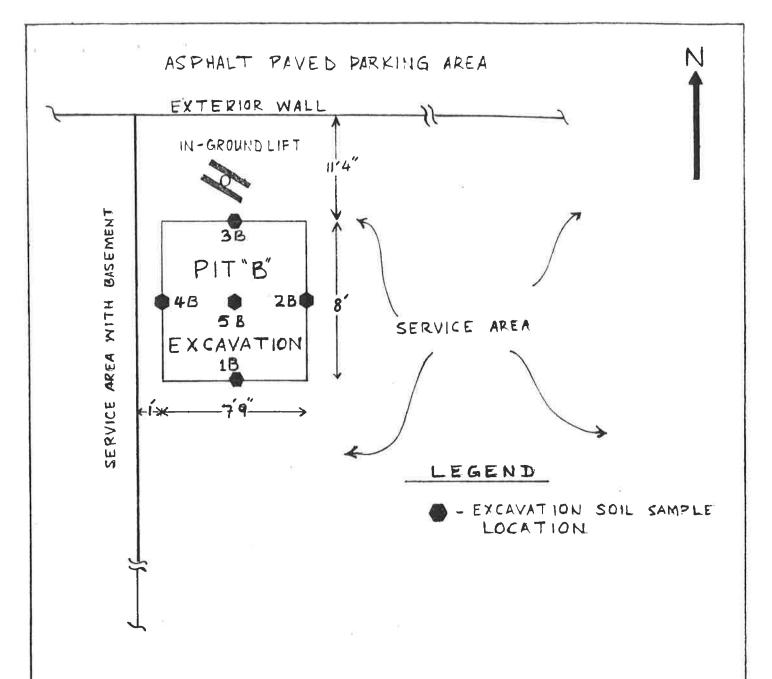
PIT "B" EXCAVATION AND POST EXCAVATION SOIL
SAMPLE LOCATION PLAN

soil sampling and testing program is summarized in Tables B-1 and B-2. The post-excavation soil sampling locations are indicated in Figure 3.

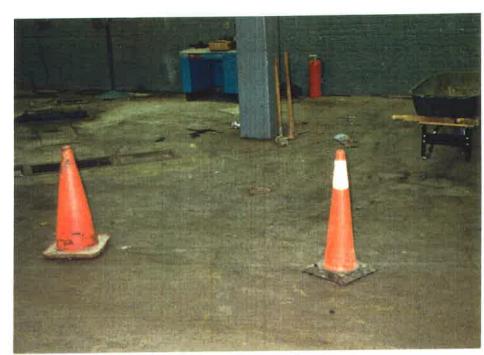
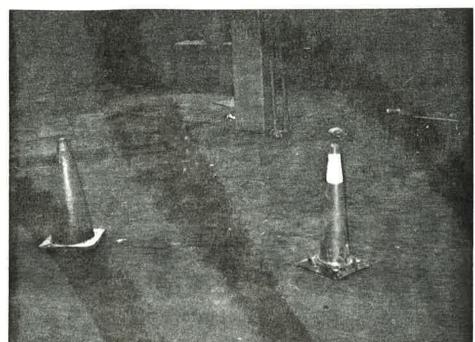
## Photo No. 1

Floor Pit "A" location, looking West to East

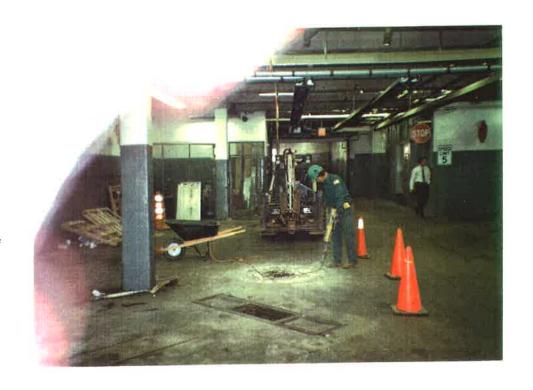
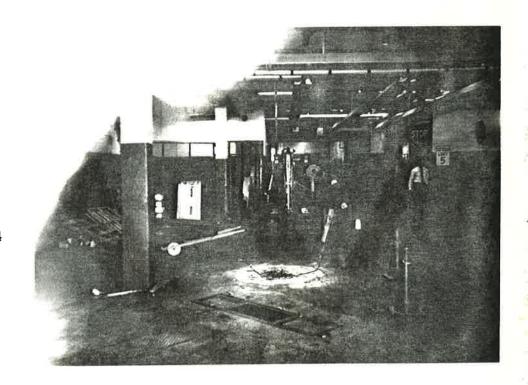
## Photo No. 2

Removing concrete slab at Floor Pit "A" location, looking North to South

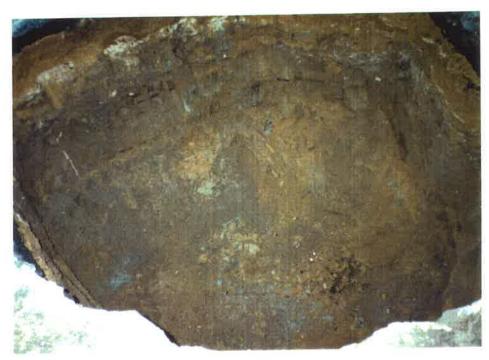
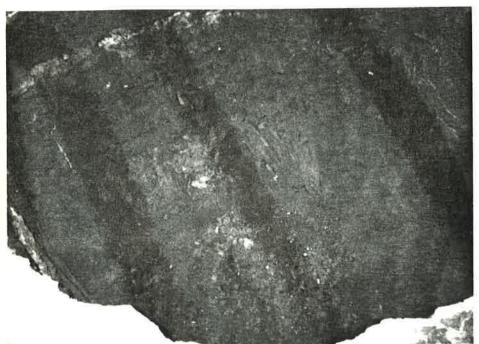
Photo No. 3

Floor Pit "A" excavation, ready for post-excavation soil sampling

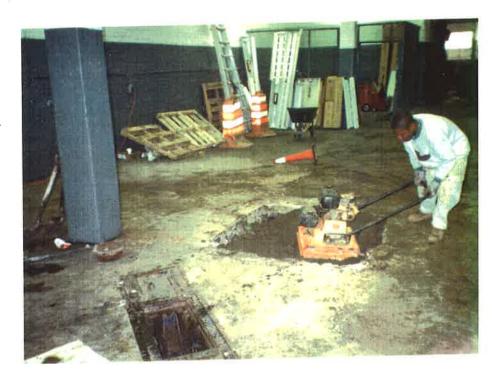
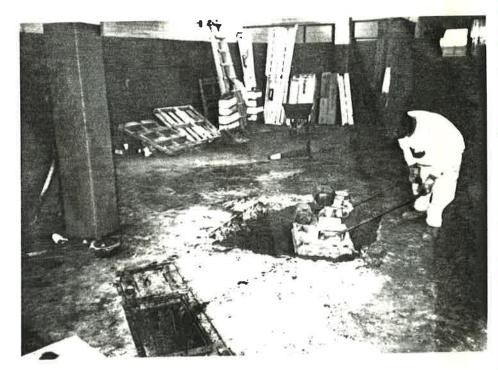
# Photo No. 4

Compacting backfilled (clean soil) material at Floor Pit "A" location

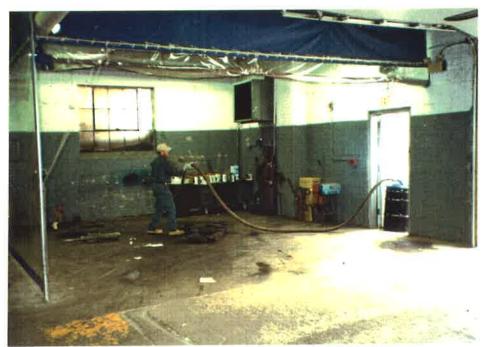
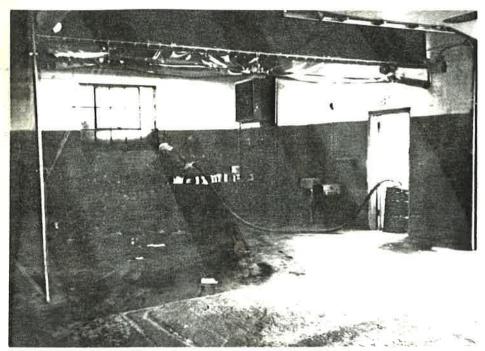
Photo No. 5

Removing
oil/water from
Floor Pit "B",
looking East to
West

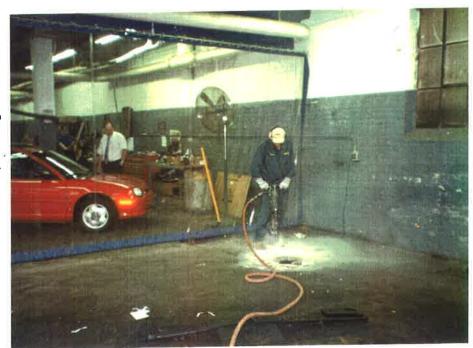
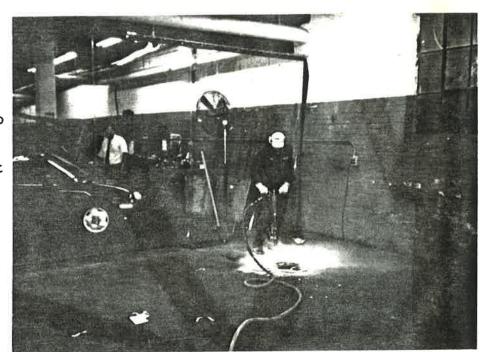
### Photo No. 6

Removing concrete slab at Floor Pit "B" location, looking Northeast to Southwest

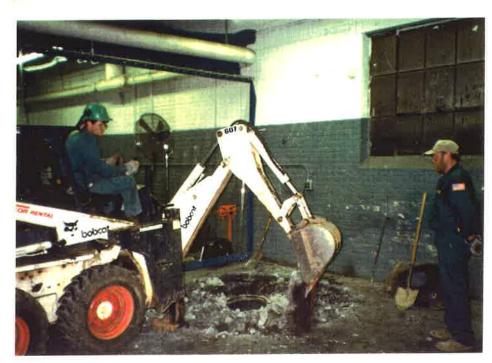
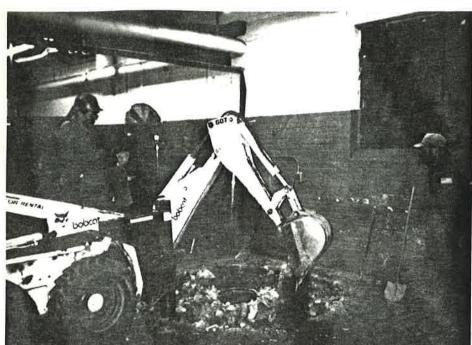
Photo No. 7

Excavating floor Pit "B" area

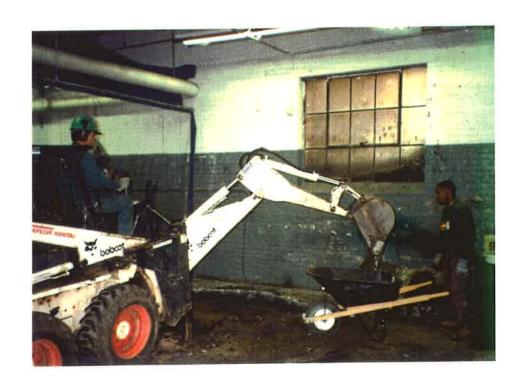
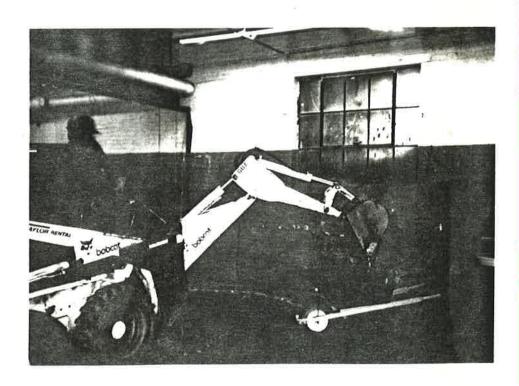
# Photo No. 8

Removing petroleum hydrocarbon contaminated soil from Floor Pit "B" excavation

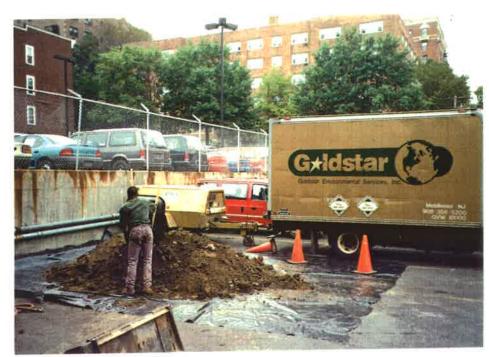
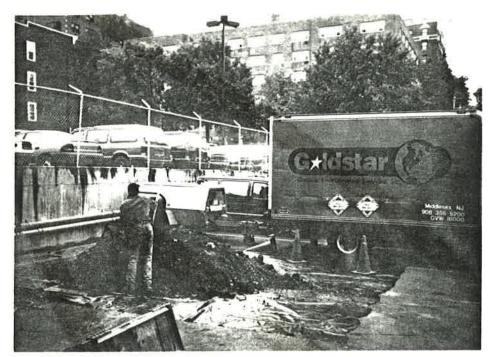
# Photo No. 9

Contaminated soils removed from pits "A" and "B" being stored at the site on plastic sheeting

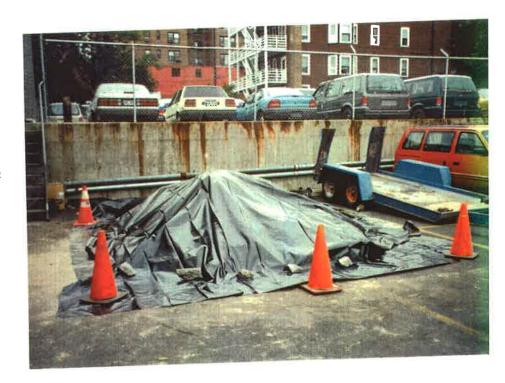
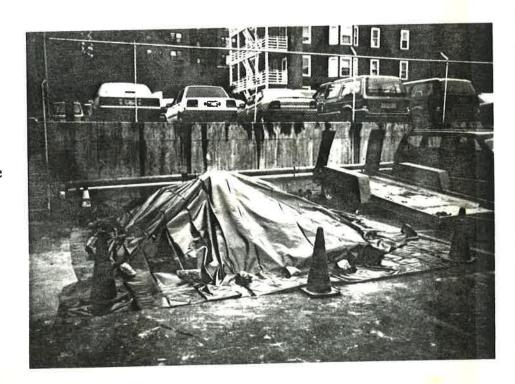
### Photo No. 10

Contaminated soil pile at site covered with plastic
