# 46-70 McLean Avenue Auto Repair Laundry

WESTCHESTER COUNTY, NEW YORK

## Final Engineering Report

NYSDEC Site Number: C360211

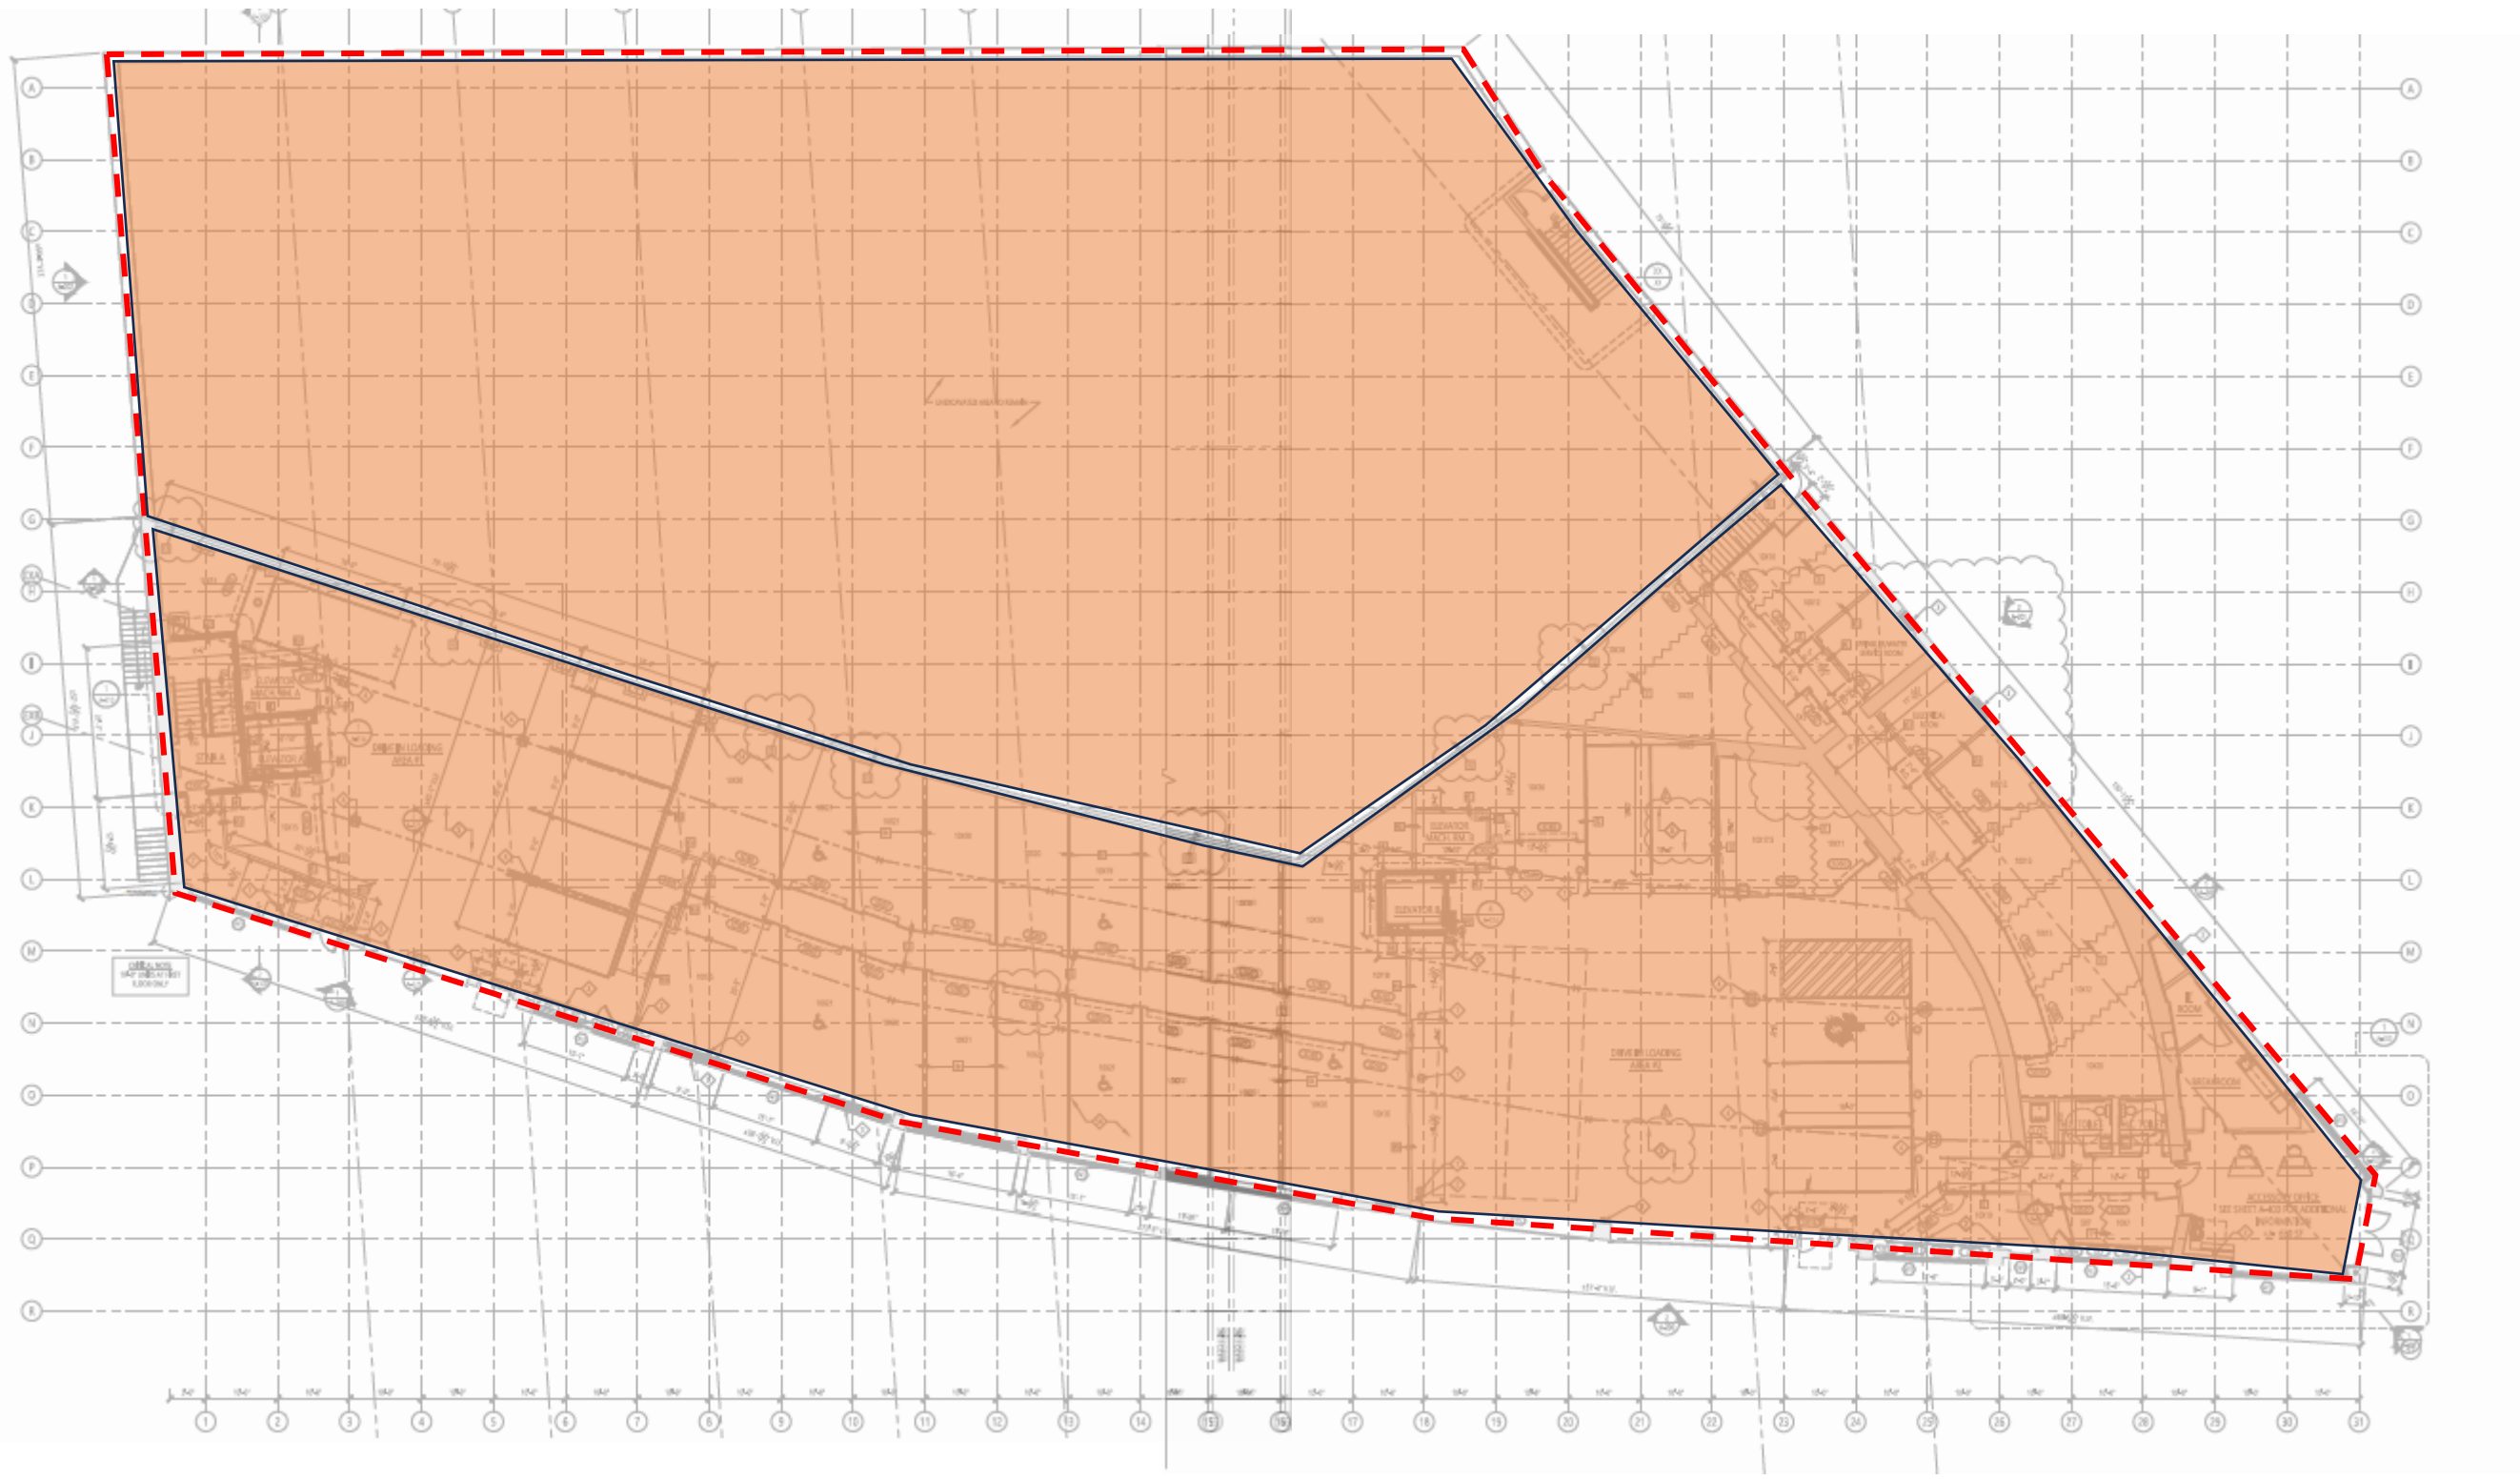
- 6-INCHES OF ¾” VIRGIN QUARRY BLUESTONE, 20-MIL STEGO WRAP VAPOR BARRIER, AND 4- TO 6-INCH CONCRETE BUILDING SLAB
