**PHASE I**  
**ENVIRONMENTAL**  
**SITE ASSESSMENT**

**November 15, 2005**

**Site Identification:** 322 and 330 South Street  
City of Peekskill  
Westchester County, New York

**ESI File: GP04197C**  
**GDC Property IDs: 5 & 8**

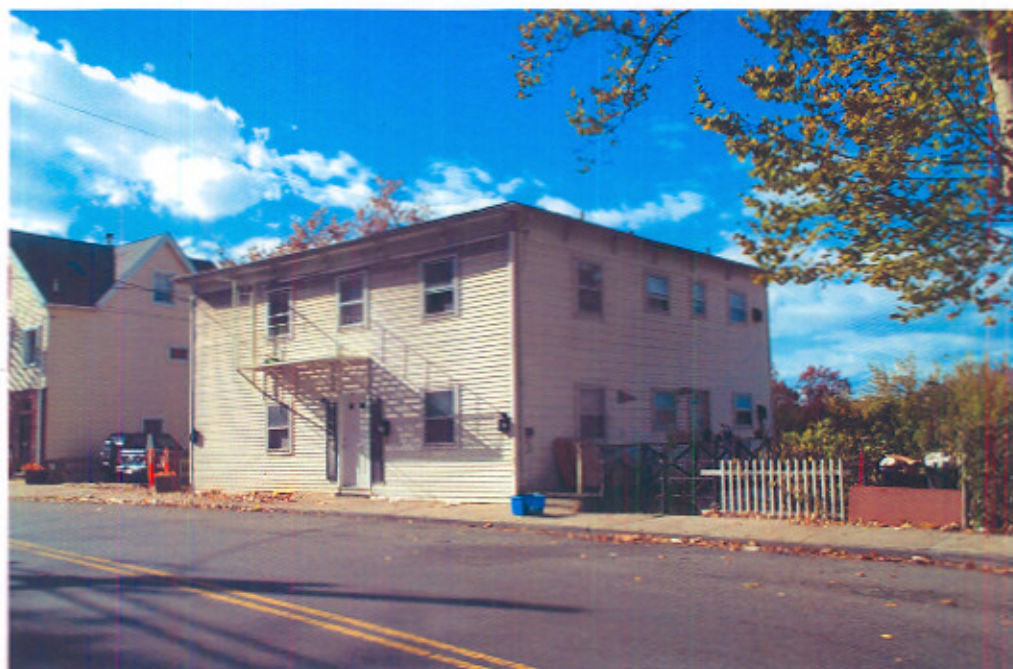
**1. Southern portion of subject property (322 South Street), looking southwest from South Street**

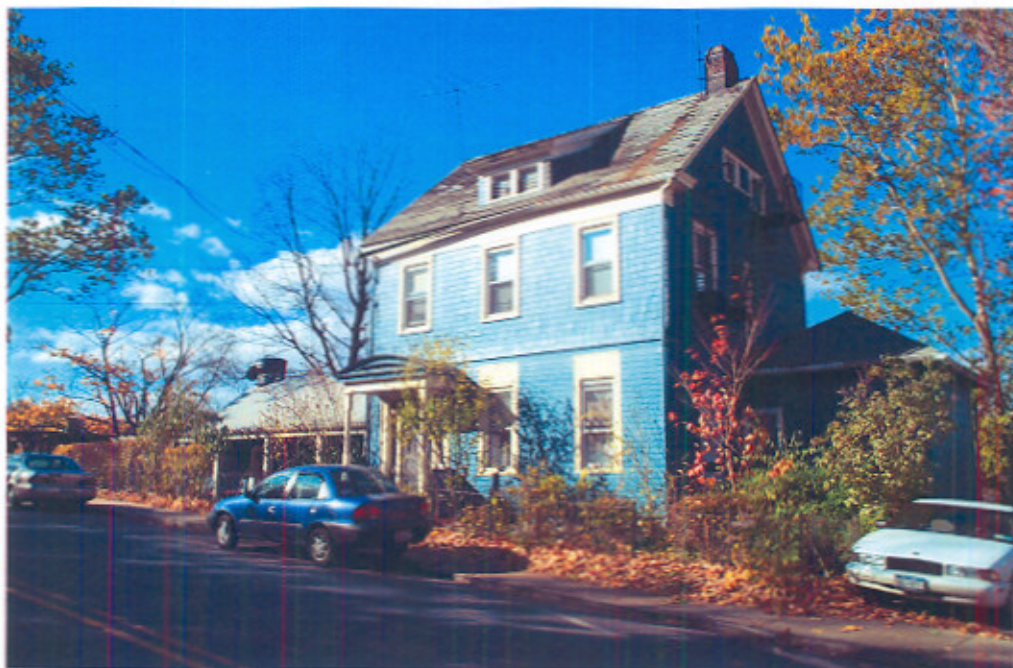
**2. Northern portion of subject property (330 South Street), looking southwest from South Street**

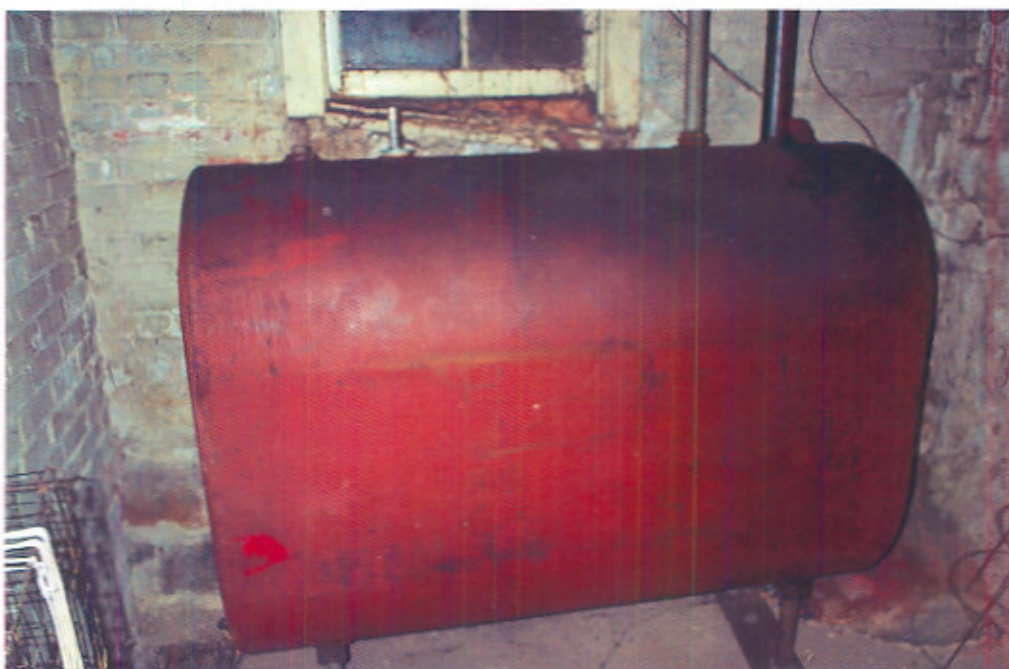
A 275-gallon fuel oil AST is located in the basement of 330 South Street. The tank appeared to be sound and was noted to be free of significant signs of corrosion, staining or leakage. The fill port and vent pipe servicing the AST are located on northern side of the building; no significant staining was noted on or near the fill port and vent pipe. No small quantities of petroleum products, other aboveground storage tanks, or indications of underground petroleum bulk storage tanks (e.g., fill ports or vent pipes) were noted on the subject property.

3. One 275-gallon fuel oil aboveground storage tank is located in the basement of 330 South Street. No evidence of a release was noted at or near the tank; future releases, however, could impact the environmental integrity of the subject property.

**3. 275-gallon fuel oil AST at 330 South Street**

**It is recommended that all PBS tanks be managed in accordance with applicable state and local regulations.**

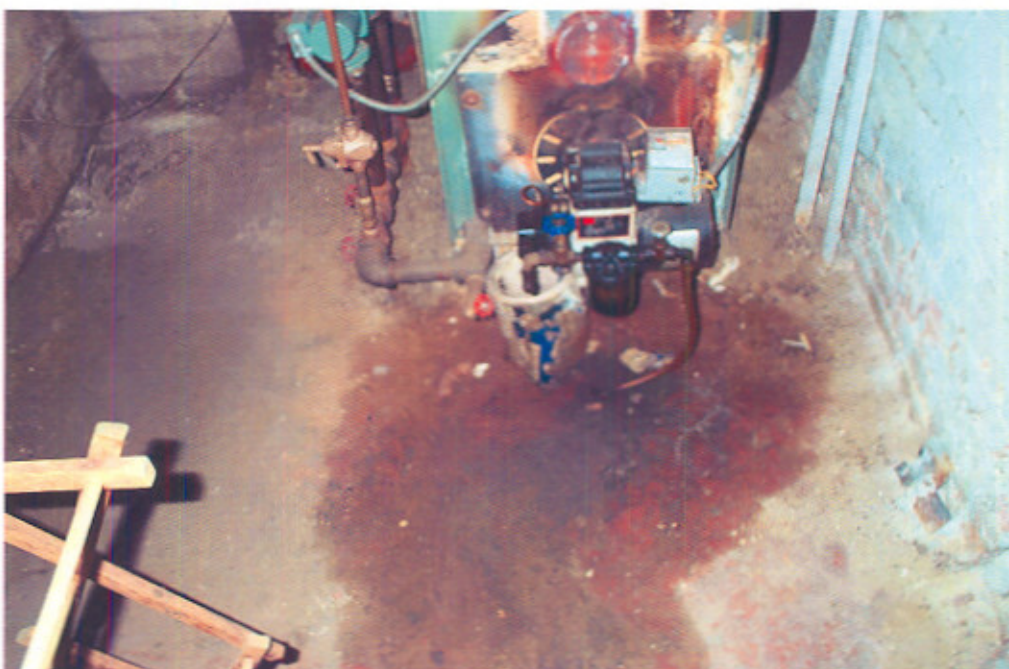
Minor surface staining (contained by the concrete floor) was noted near the boiler at 330 South Street. No other evidence of corrosion, leaks, or staining indicative of an existing release, a past release, or a material threat of a release of any hazardous substances or petroleum products onto the subject property (including on-site structures and paved areas) was observed during the site inspection.

Minor staining is present near the boiler at 330 South Street. This staining is not likely to represent a significant environmental threat.

**4. Minor surface staining near boiler at 330 South Street**

**It is recommended that stained areas be cleaned and that the furnace be inspected for proper operation.**

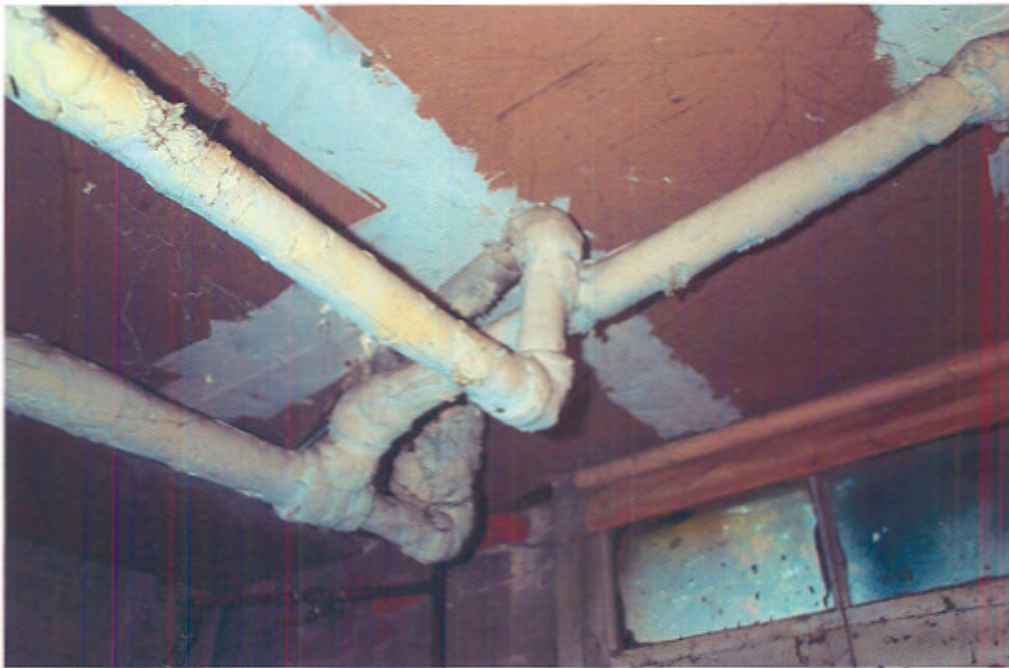
Asbestos-containing materials (ACMs) are those materials that are known to contain over 1% of any type of asbestos. The presence or absence of asbestos within a material can only be determined through the physical analysis of material samples. According to Mr. Cleantis, no asbestos survey of the subject property has been conducted; however, the dates of construction of the on-site buildings (prior to 1900) suggest that asbestos-containing materials could potentially be present on the subject property. Suspect ACMs noted during the site inspection included 12" by 12" vinyl floor tiles, plaster, asphalt roofing, and pipe insulation (at 330 South Street only). Other building construction materials not readily observable during the site inspection (e.g., mastics) could also potentially contain asbestos.

4. According to the property owner, no asbestos or lead-based paint surveys have been conducted; however, given the age of on-site structures, asbestos-containing materials and lead-based paint could potentially be present on the subject property. Suspect ACMs noted during the site inspection included floor tiles, plaster, roofing, and pipe insulation (330 South Street only). Other construction materials not readily observable during the site inspection (e.g., mastics) could also potentially contain asbestos. Paint in poor condition was noted at exterior portions of 330 South Street.

**5. Suspect ACM pipe insulation at 330 South Street**

**No further investigation is recommended. It is recommended that any suspect material encountered during maintenance, renovation, or demolition activities be tested for asbestos or lead, or, in the absence of analytical data, be treated as though it contained asbestos or lead. All maintenance, renovation, or demolition activities should be conducted in accordance with applicable regulations.**

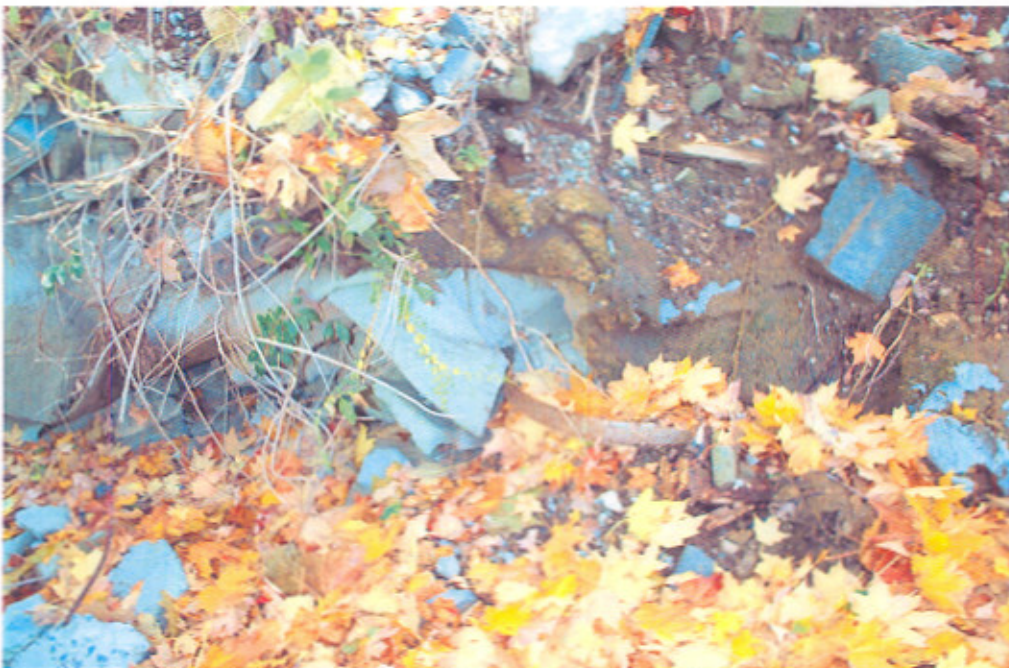
Household trash was noted at exterior portions of both on-site structures. Fill materials used to create terraced outdoor areas at the rear of 330 South Street contain broken masonry and some trash (e.g., carpet and metal).

Terraced areas at the rear of 330 South Street contain fill materials. No other overt topographic irregularities (e.g., sinkholes or berms) indicative of the presence of non-natural materials (including debris) in the subsurface were noted on the subject property.

**6. Exposed subsurface debris in rear yard of 330 South Street**
