# **ELITE ENVIRONMENTAL SERVICES, INC.**

## **Closure Report**

**04-04904**

**Kensico Properties  
275 Kisco Avenue  
Mount Kisco, New York 10549**

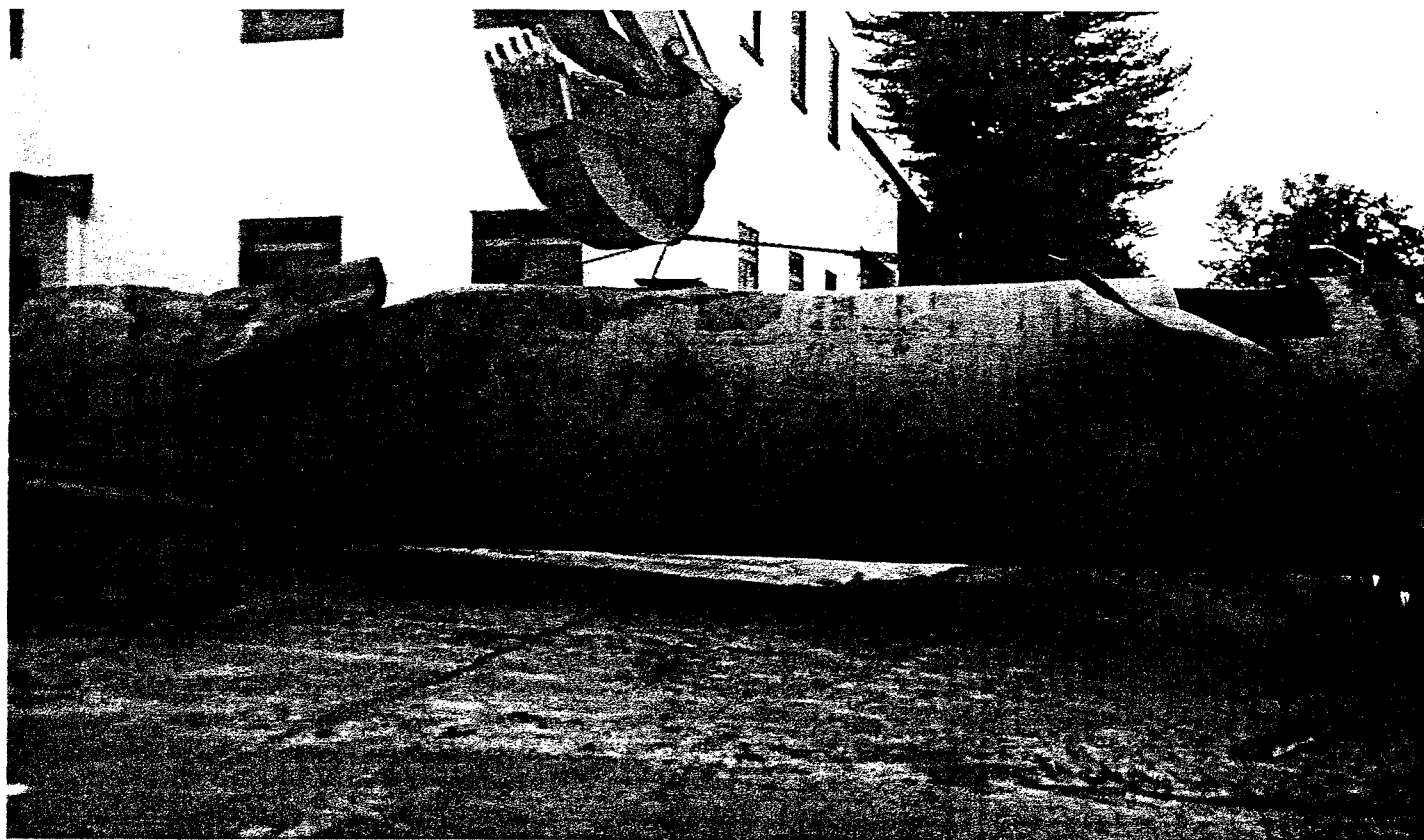
275 Kisco Avenue - Removed 10,000 gallon underground storage tank

The tank was removed from the site property by Elite and brought to Brookfield Scrap Metals, Inc. for recycling. See Appendix E for Tank Recycling Receipt.

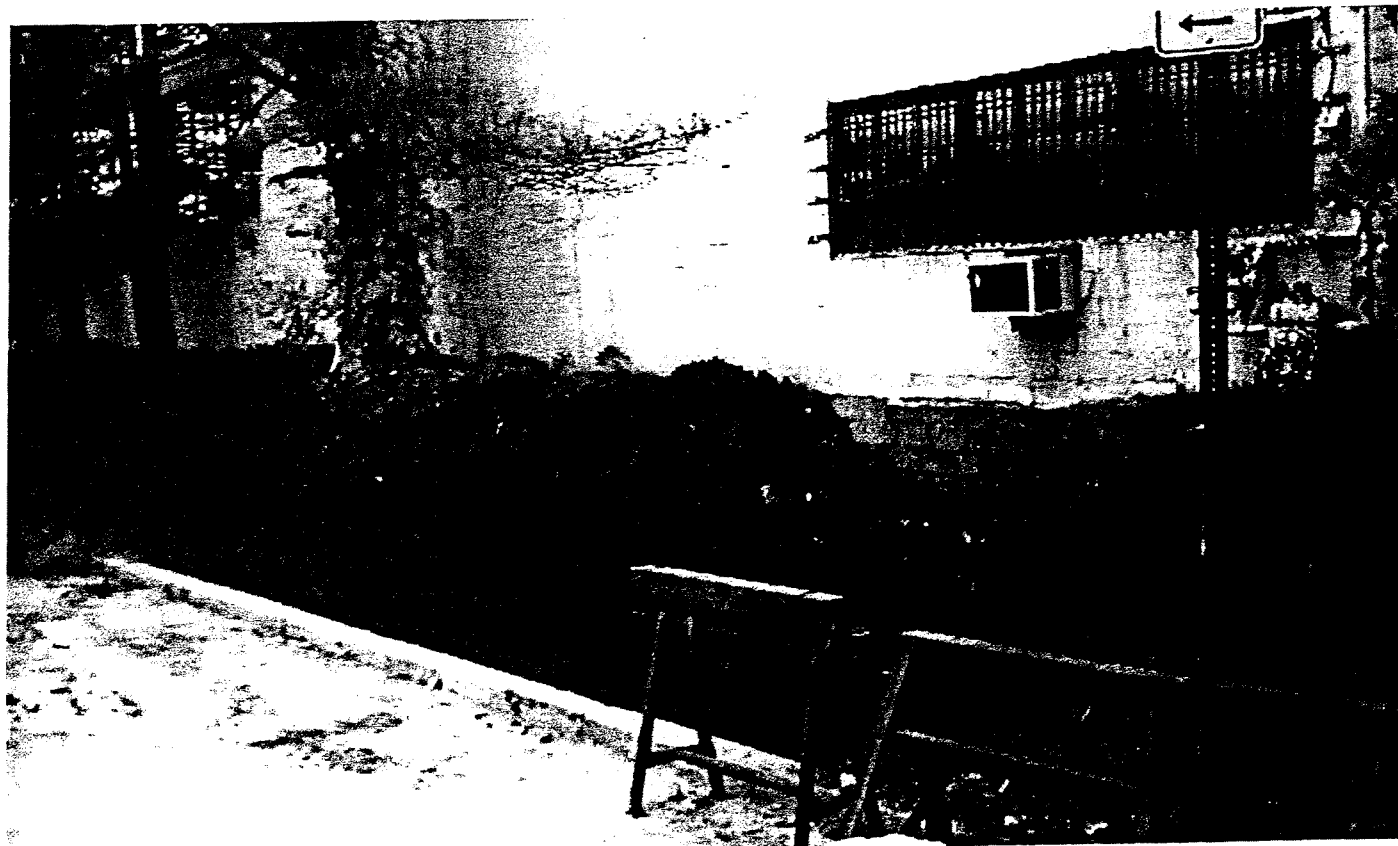
275 Kisco Avenue - Excavation after removal of 10,000 gallon underground storage tank

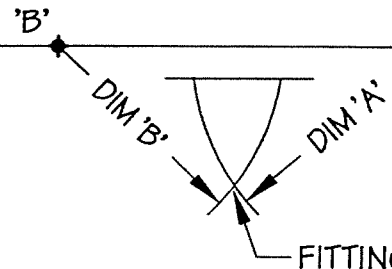
### 3 DETAIL PLAN - NEW TANK

A FILL	NAIL 'B'	NAIL 'A'
B PLUG	254"	83"
C PLUG	242"	78"
D SUPPLY	225"	74"
E SUPPLY	192"	78"
F VENT	128"	123"
G INTERSTITIAL	71"	219"

\* TO LOCATE FITTINGS, CRE FROM THE TWO NAIL POINT DIMENSIONS PROVIDED. TH INTERSECTION OF THE TWO INDICATES THE LOCATION ( FITTING.

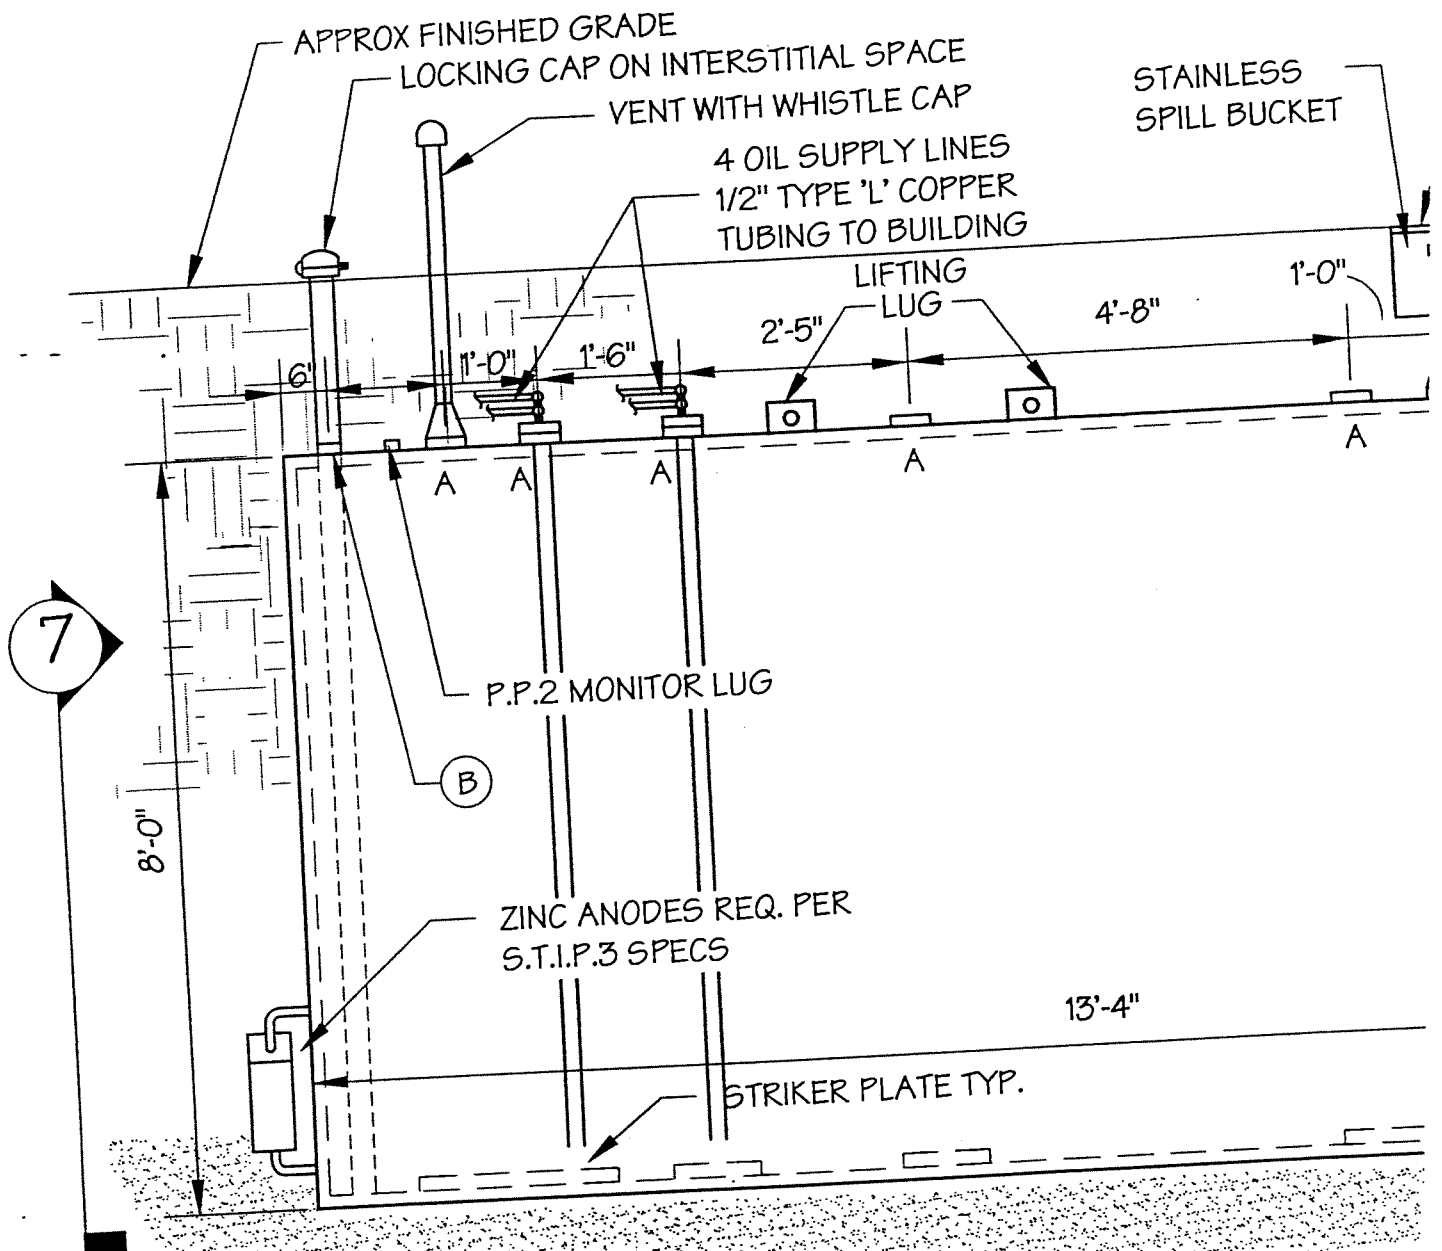
**⑥ NEW TANK ELEVATION DETAIL**  
SCALE: 1/2"=1'-0"

INNERHEADS: 1/4", OUTERHEADS: 1/2"  
INNER SHELL: 7 GA, OUTER SHELL: 1/2"  
PAINT: INTERIOR: NONE  
PAINT: EXTERIOR: SP-6 BLAST, COAT OF CORROCOTE PLUS PER U.L. 58  
CONSTRUCTION: FLAT FLANGED HEAD  
WELD ALL EXTERIOR SEAM  
APPROVED LABELS: U.L. 58, S.T.I.P. 3
