ENVIRONMENTAL

SITE ASSESSMENT

312, 316 and 322 Warburton Avenue
City of Yonkers, Westchester County, New York
Tax ID: Section 2., Block 2151, Lots 29, 31 and 34

GBTS File: 20-0264.01

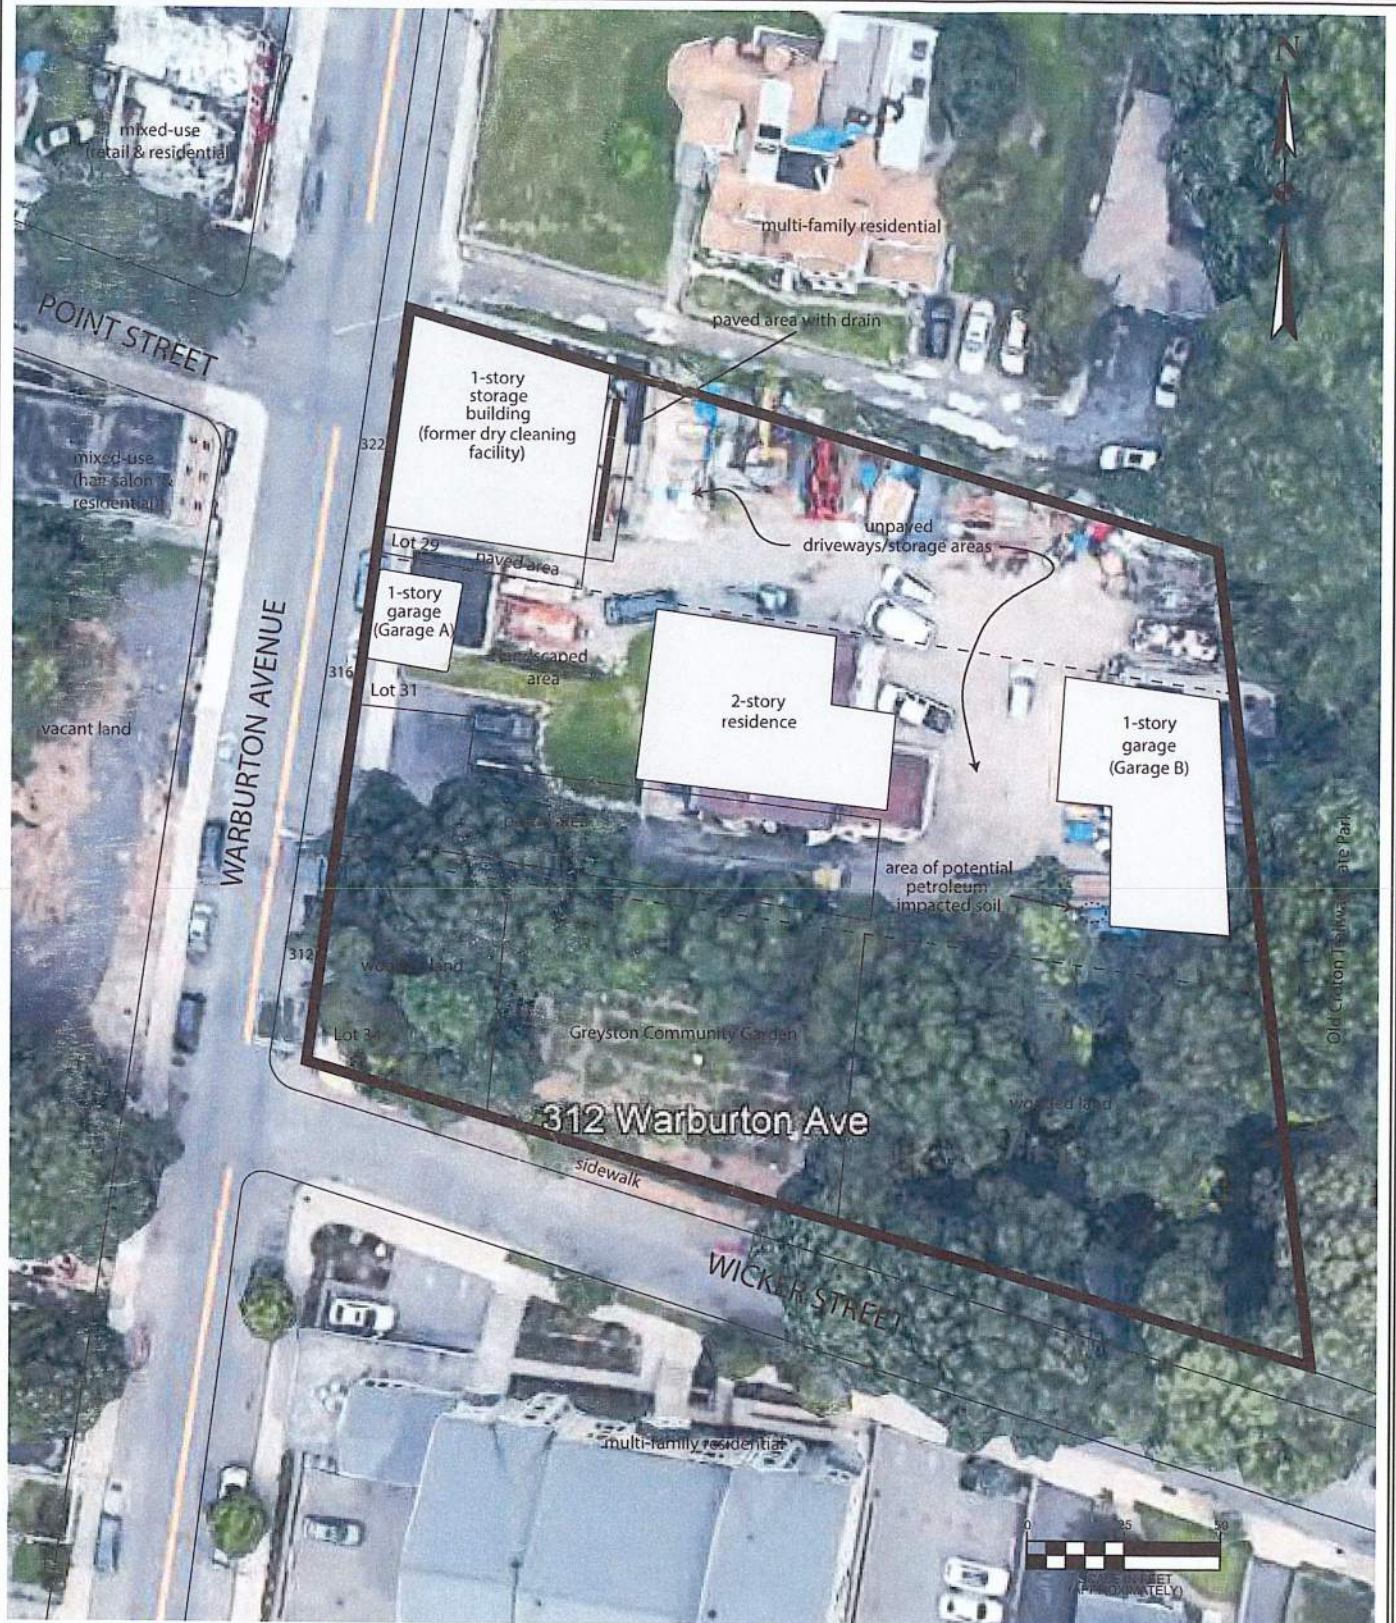
Selected Site Features Map

All feature locations are approximate. This map is intended as a schematic to be used in conjunction with the associated report, and it should not be relied upon as a survey for planning or other activities.

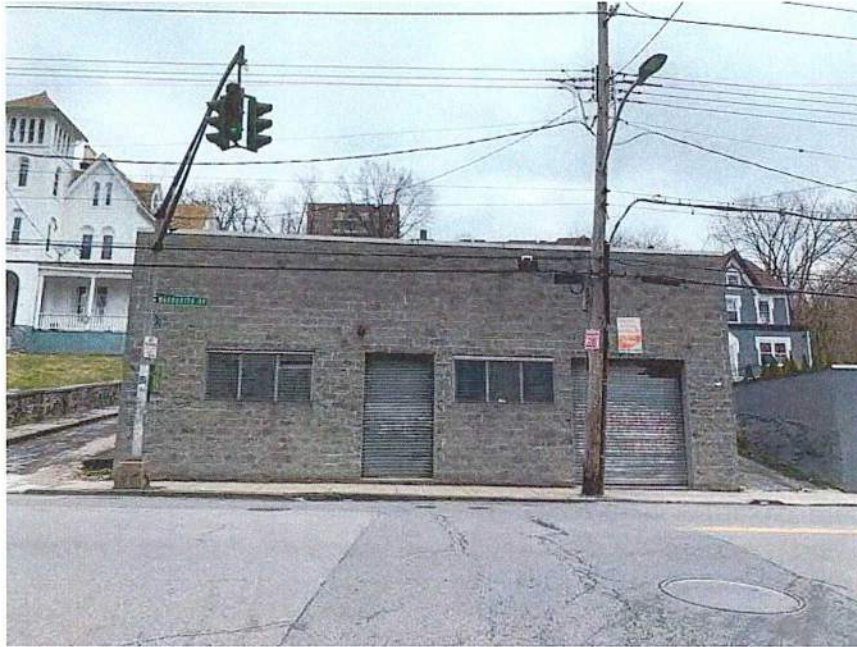
322 Warburton Avenue (Lot 29; Rappaport Cleaners) is registered with the USEPA as a former generator of hazardous waste (EPA ID: NYD030461982). Listed materials include spent chlorinated solvents. Potential solvent releases from this former dry cleaning facility may have impacted the property. The property was not otherwise identified during the review of regulatory agency records. No adjoining or nearby properties were identified that are likely to impact the property.

1. 322 Warburton Avenue (Lot 29; former dry cleaning facility), looking east from Warburton Avenue

No further investigation of historical records is recommended. A Phase II subsurface investigation should be conducted to document the presence or absence of solvent contamination.

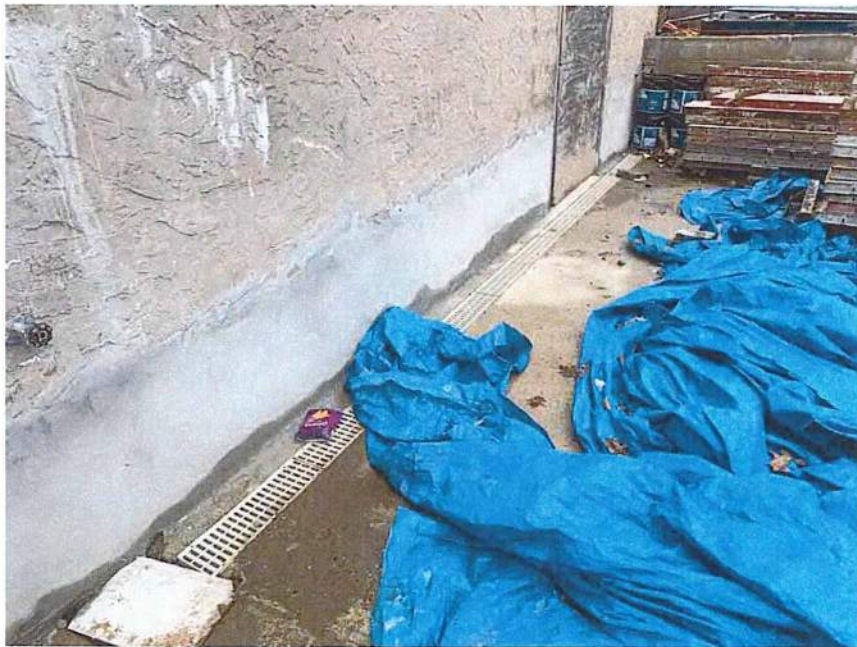
A drain is located near the eastern exterior wall of the building on Lot 29. No staining, odors, or other evidence of contamination was noted in or near the drain. According to Assessor's Office records, all

4. Drain at eastern exterior wall (Lot 29)

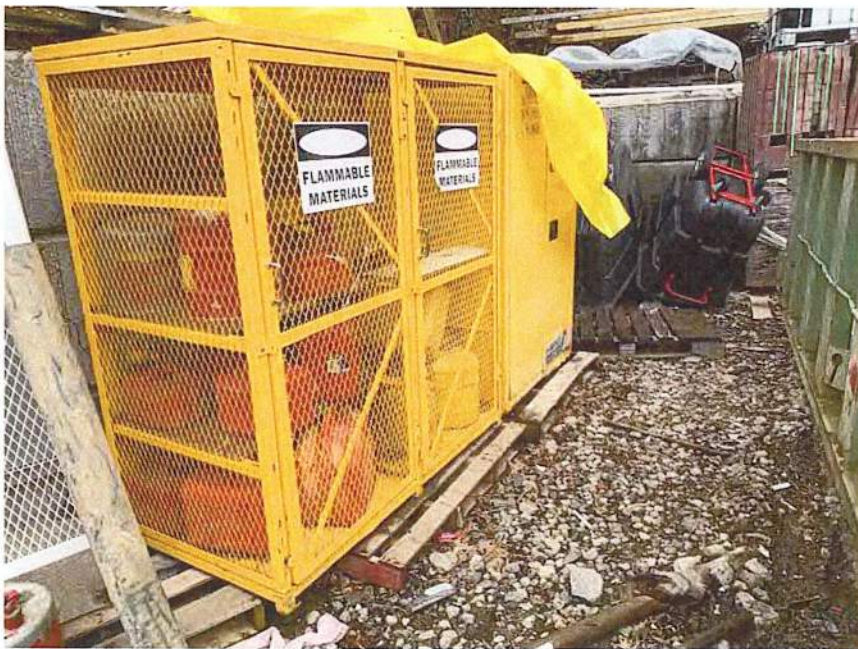
Several small containers of petroleum products (lubricants, etc.) are located throughout Lot 29 (in the building and at unpaved storage areas) and Garage B. No staining or other evidence of a release from these containers was observed. No other small quantities of petroleum products, aboveground storage tanks or indications of underground petroleum storage tanks (e.g., fill ports or vent pipes) were observed on the subject property.

6. Exterior petroleum storage (Lot 29)

It is recommended that all petroleum and chemical products be properly stored and that appropriate absorbent materials be maintained in all areas where releases could potentially occur.

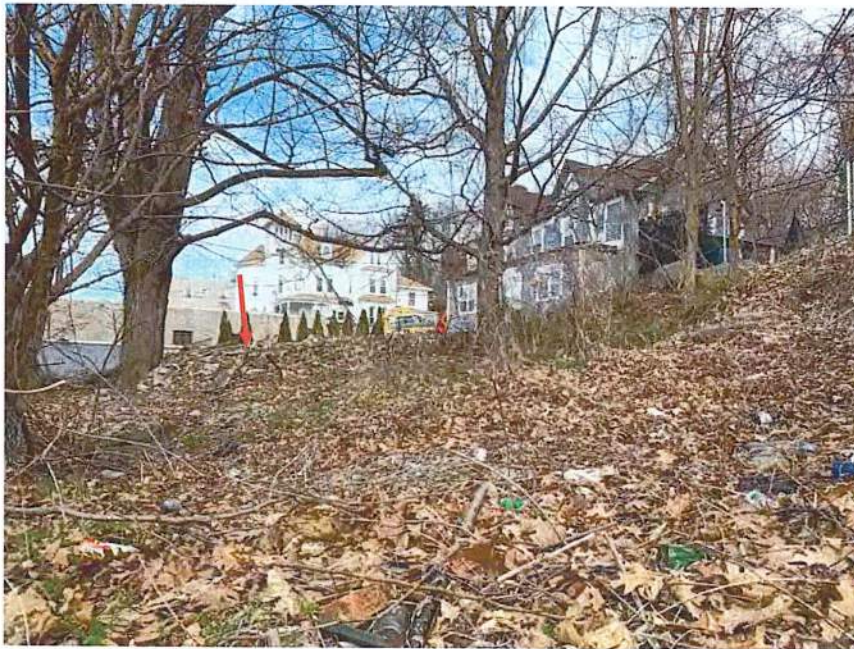
16. Typical debris (western portion of Lot 34), red arrow indicates construction and demolition materials
