2021 Periodic Review Report
136 Fuller Road Site
Brownfield Cleanup Program
NYSDEC Site No. C401055
City of Albany and Town of Guilderland
Albany County, New York

November 2021

Chazen Project No. 90618.00

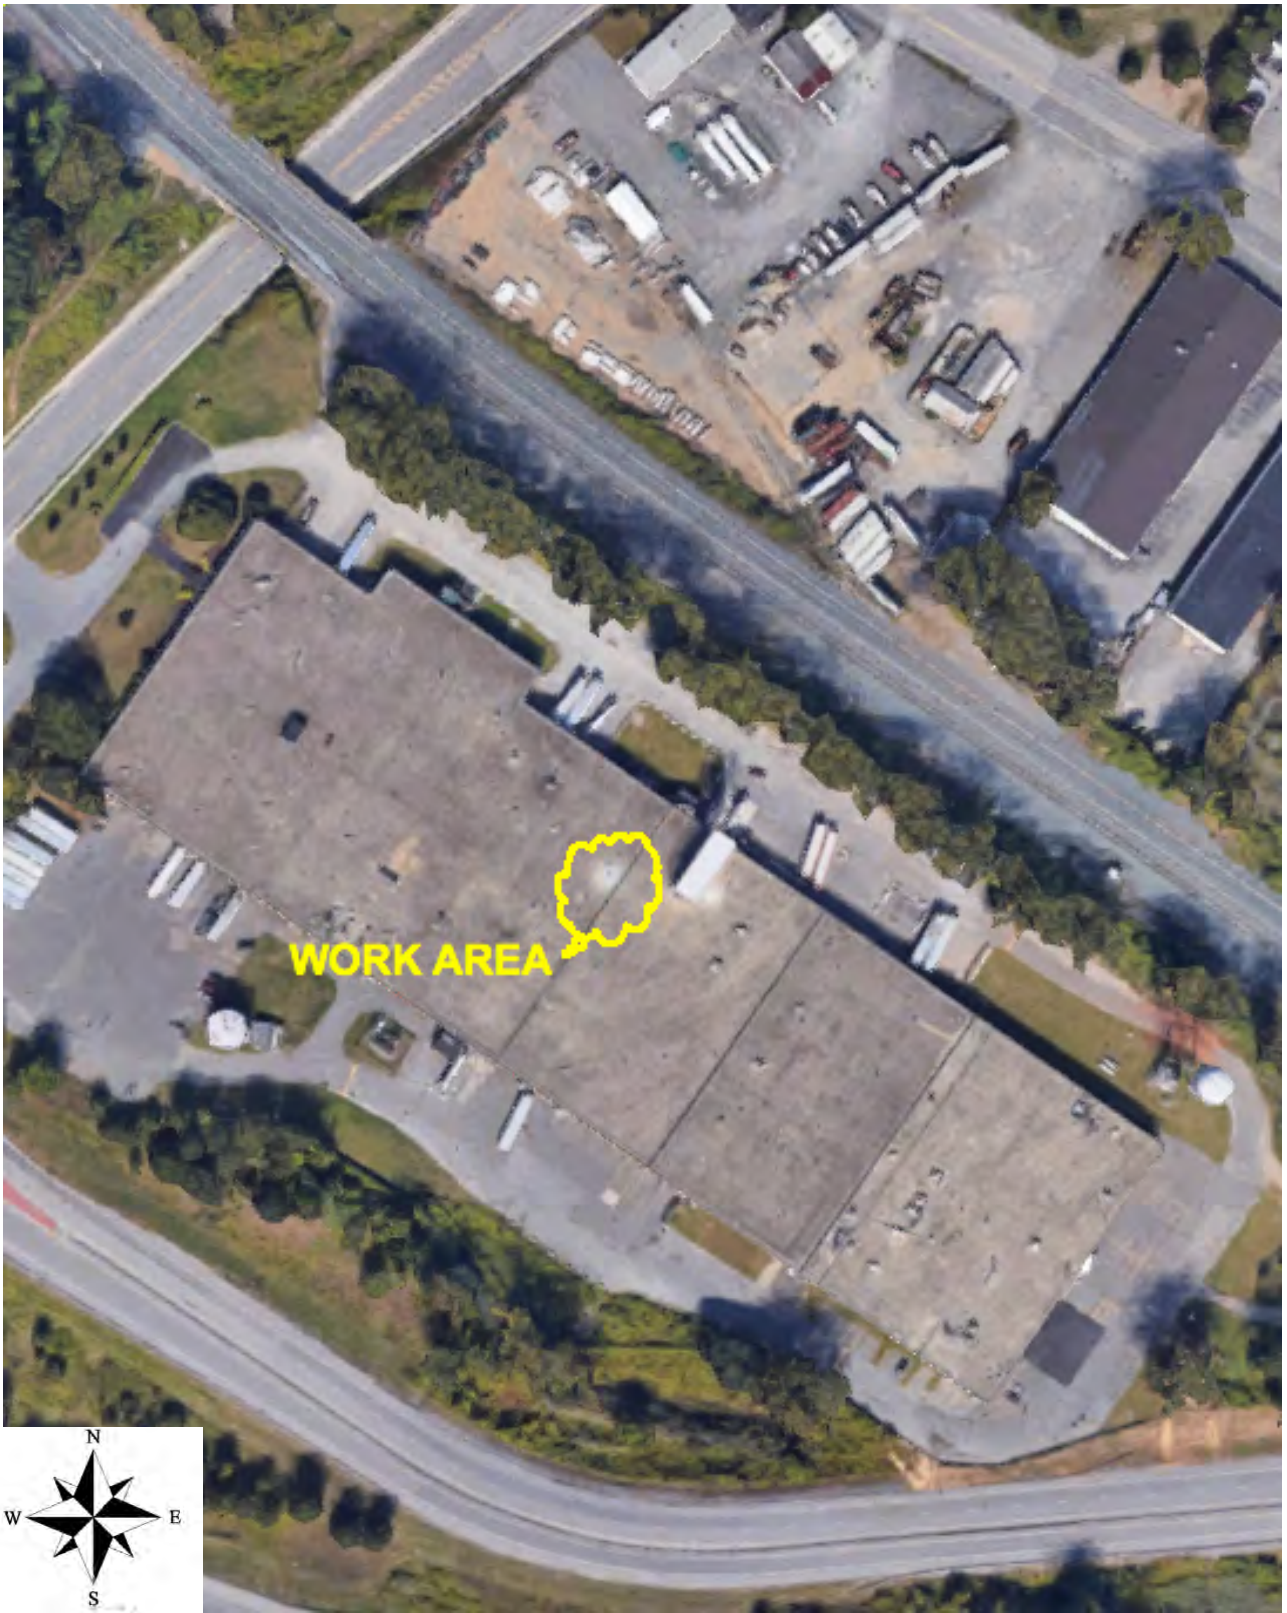
FIGURE – 1 SITE WORK
LOCATION MAP

Project: 136 Fuller Road
DRAWING DATE: July 2018
Date Of Field Activity: May/June 2018
