SITE LOCATION MAP
TROY BELTING AND SUPPLY COMPANY
70 COHOES ROAD

SITE VICINITY & HISTORICAL SAMPLE LOCATION MAP
TROY BELTING AND SUPPLY COMPANY
70 COHOES ROAD

VAPOR MITIGATION SYSTEM
LAYOUT
TROY BELTING & SUPPLY CO.
70 COHOES ROAD
TOWN OF COLONIE ALBANY CO., N.Y.

SOURCE AREA EXCAVATION IRM
AS-BUILT SECTION VIEW
TROY BELTING AND SUPPLY COMPANY
70 COHOES ROAD

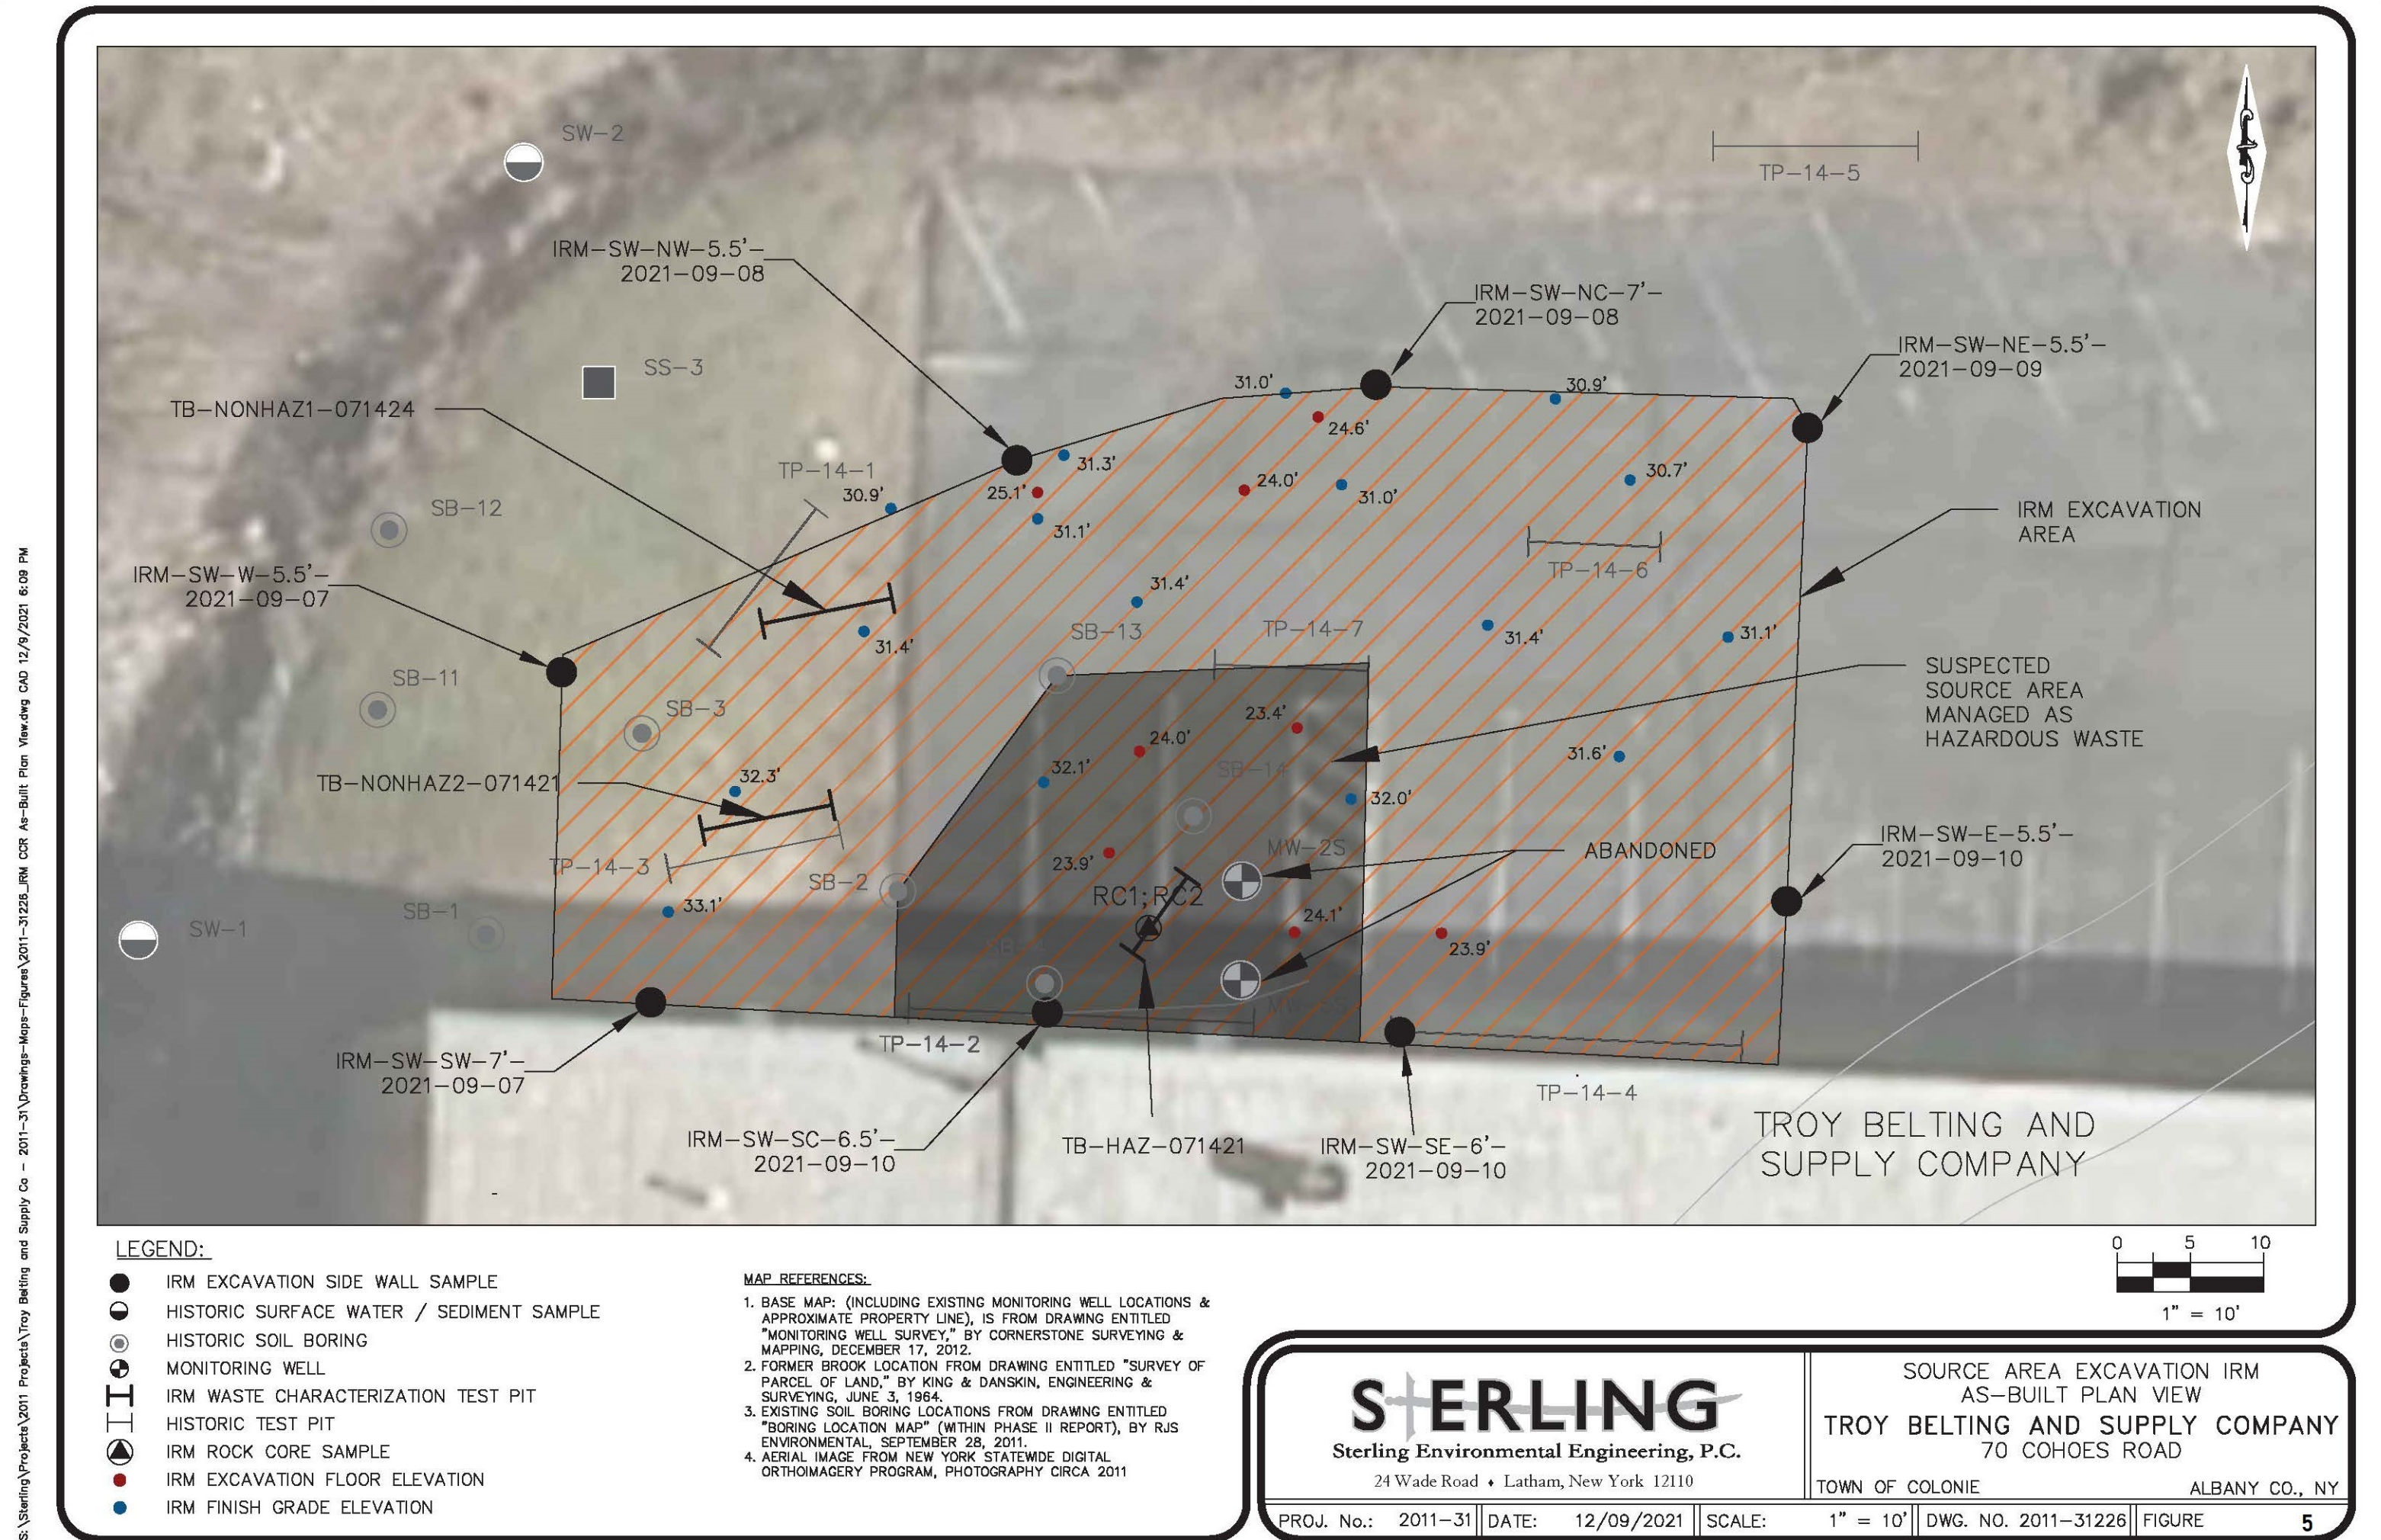
PROJ. No.: 2011-31 | DATE: 12/09/2021 | SCALE: 1" = 20' | DWG. NO. 2011-31227 | FIGURE 4

CONTAMINANT [ppm.]	SOIL CLEANUP OBJECTIVES			SAMPLE ID AND COLLECTION DEPTHS							
	PoG SCO [ppm.]	Commercial SCO [ppm.]	Industrial SCO [ppm.]	IRM-SW-W	IRM-SW-SW	IRM-SW-NW	IRM SW-NC	IRM SW-NE	IRM-SW-SC	IRM-SW-SE	IRM-SW-E
				5.5 ft.	7 ft.	5.5 ft.	7 ft.	5.5 ft.	6.5 ft.	6 ft.	5.5 ft.
Tetrachloroethene	1.3	500	1000	0.017	0.1	0.38	9.3	2.7	17	1	0.00009
Trichloroethene	0.47	200	400	18	6.4	20	57	16	220	6	0.0063
1,1,1-Trichloroethane	0.68	500	1000	1.4	0.16	0.43	0.65	0.17	3.2	0.059	0.00024
cis-1,2-Dichloroethene	0.25	500	1000	0.39	0.67	0.59	16	3.9	4.8	2.6	0.043
1,1-Dichloroethene	0.33	500	1000	0.022	0.015	0.015	0.12	0.023	0.11	0.0064	0.00011
1,1-Dichloroethane	0.27	240	480	0.012	0.031	0.0099	0.063	0.093	0.067	0.019	0.0033
Vinyl Chloride	0.02	13	27	0.029	0.02	0.011	0.21	0.06	0.15	0.086	0.016
