# REMEDIAL INVESTIGATION REPORT

South Island Apartments Site  
1 Osgood Avenue/Center Island,  
Town of Green Island, Albany County, New York  
BCP Site # C401074

November 2017

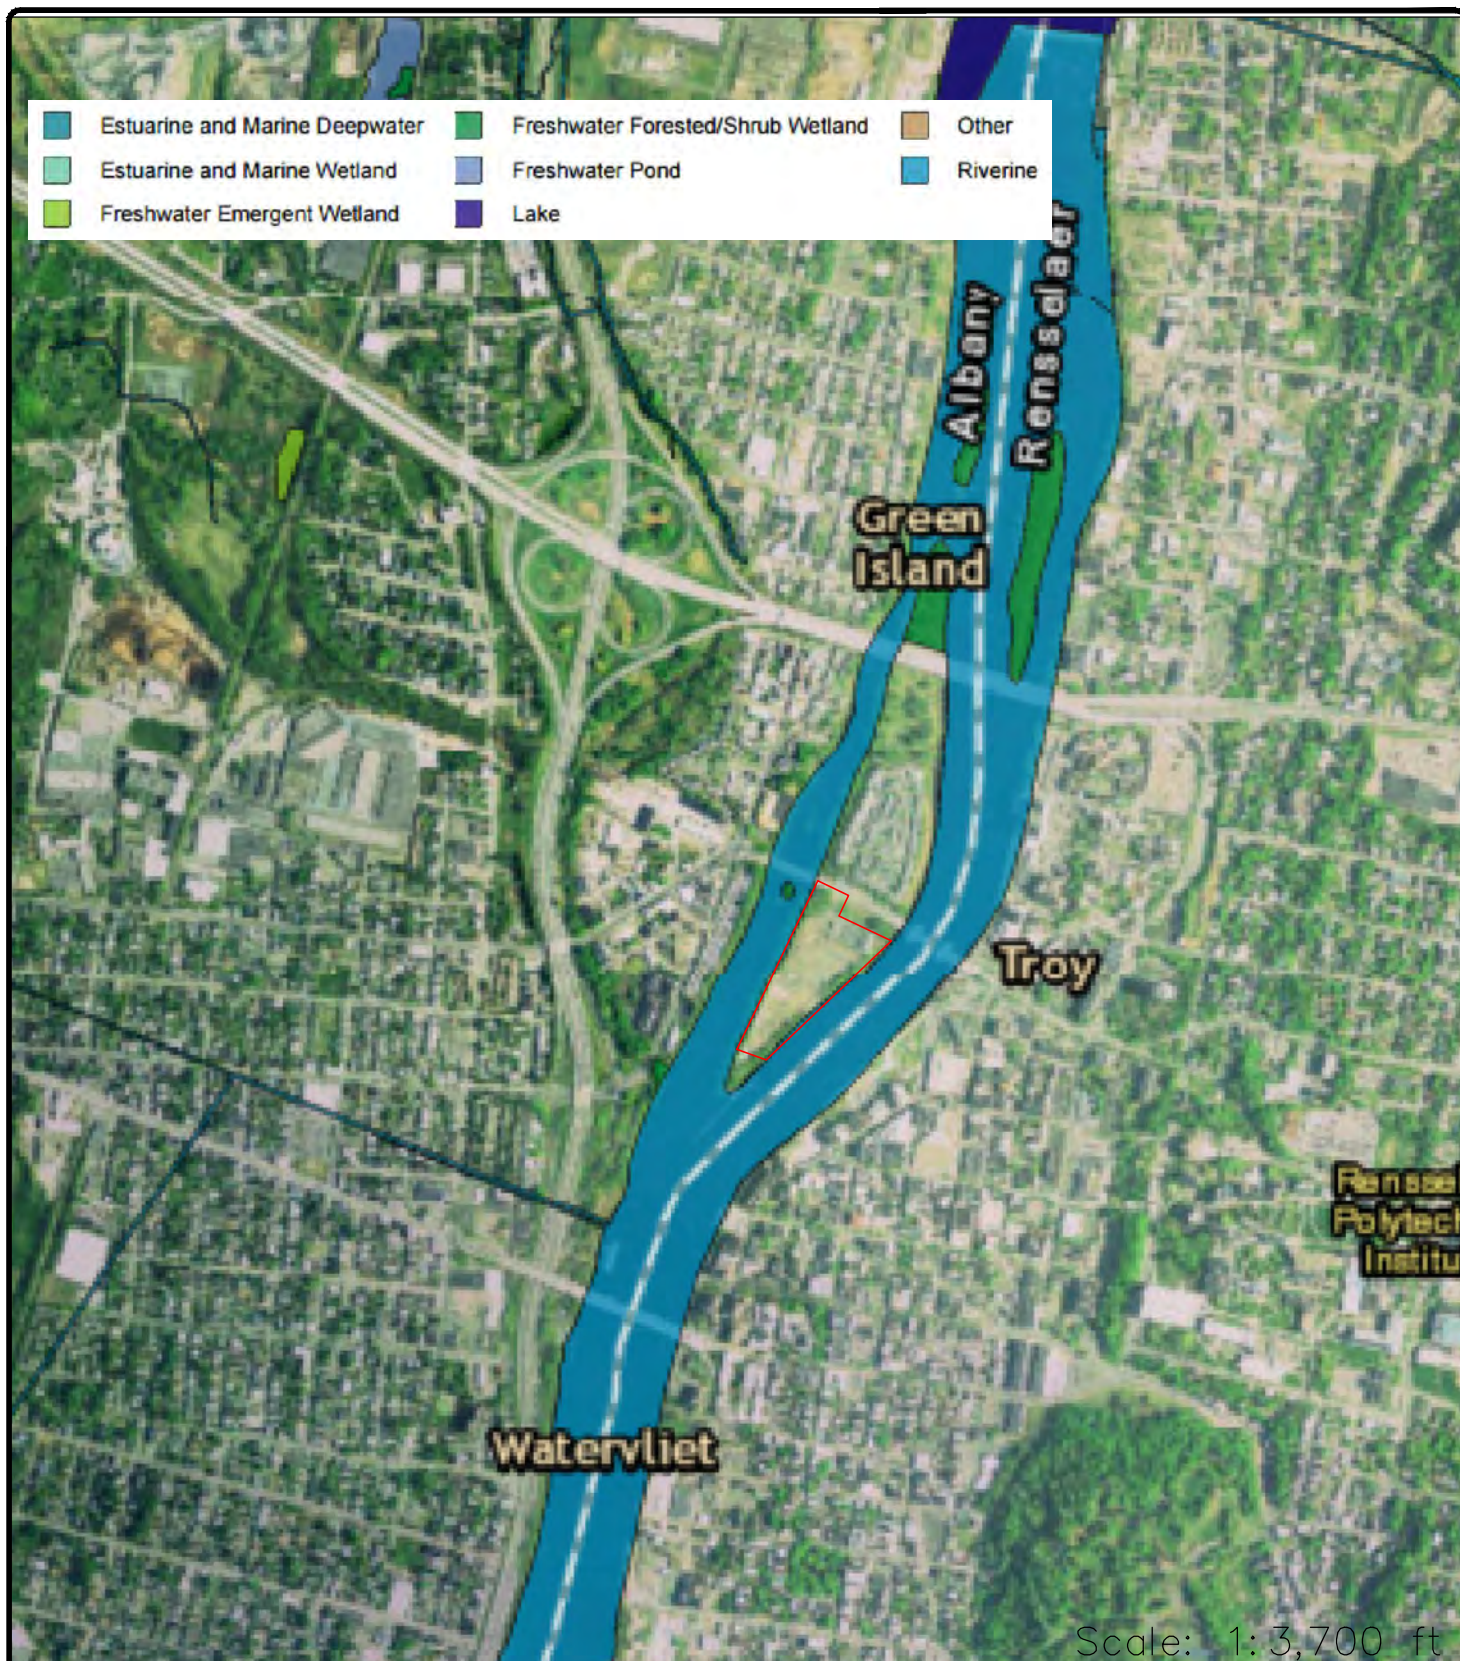
FIGURE 3 – USFWS WETLANDS INVENTORY MAP

According to the NYSDEC Environmental Resource Mapper (Figure 2) and the USFWS National Wetlands Inventory (Figure 3), there are no state or federal designated wetlands located within the Site boundaries. The Hudson River borders the site to the east and west. Refer to Section 2.4.2 for further discussion on the Hudson River.

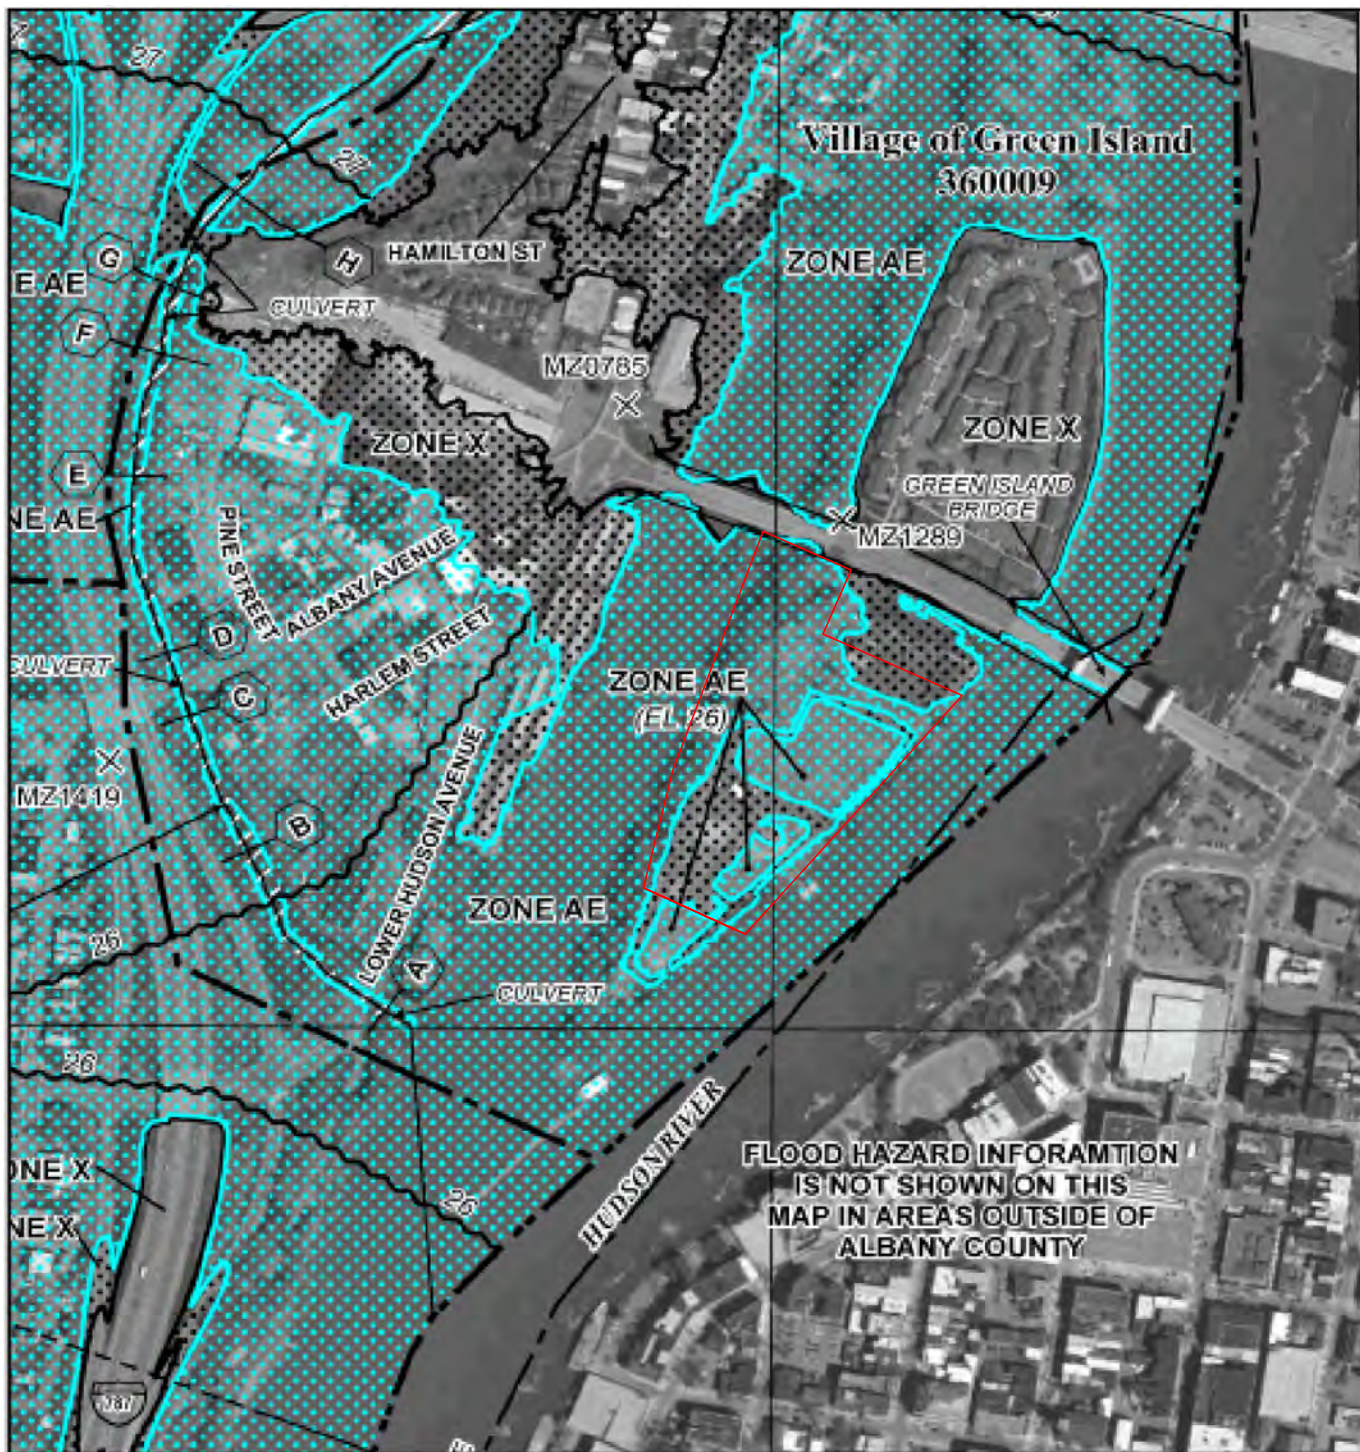
Portions of the Site are located in the 100 year flood plain according to the Flood Insurance Rate Map, map number 36001C0202D, effective date 03/16/2015 (Figure 4). The 100 year flood elevation at the Site is approximately 26 ft AMSL.
