REMEDIAL INVESTIGATION REPORT ADDENDUM

South Island Apartments Northern Parcel
Center Island,
Town of Green Island, Albany County, New York
BCP Site # C401074

August 2018

Envirospec Engineering Project E17-1753

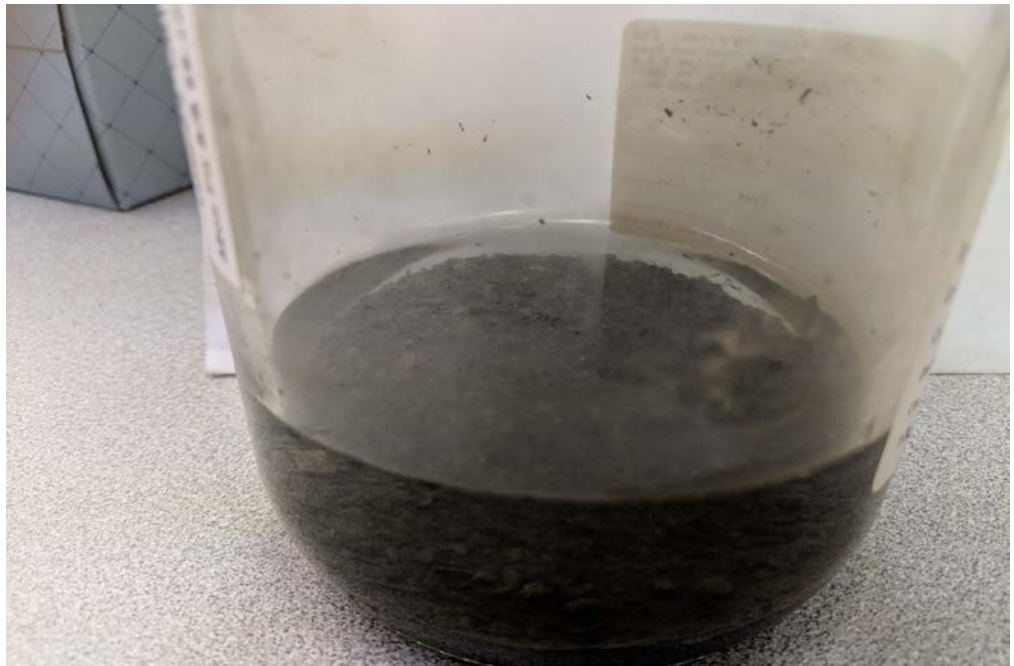
Water sample from
SB-12

A groundwater sample was collected from the area near SB-12 for visual observation to determine if LNAPL was present in this area of the Site. Photos of this groundwater sample are provided in Appendix F. No evidence of free product or a sheen was observed on the groundwater sample. No other analyses were completed for this sample.

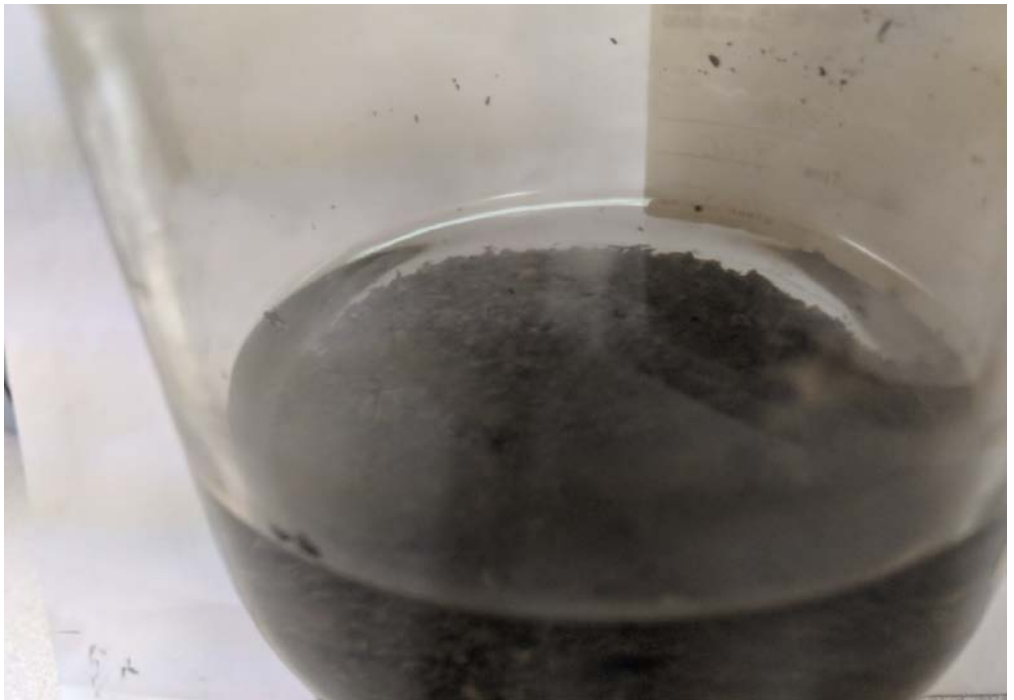
Water sample from
SB-12
