NYSDEC BROWNFIELD CLEANUP PROGRAM REMEDIAL INVESTIGATION WORK PLAN

130 ONTARIO
NYSDEC BCP SITE #C401087
130 ONTARIO STREET, 134 & 154 WEST STREET
CITY OF ALBANY, ALBANY COUNTY, NEW YORK

October 2025
Revised April 2026
PVEDI File #20230102

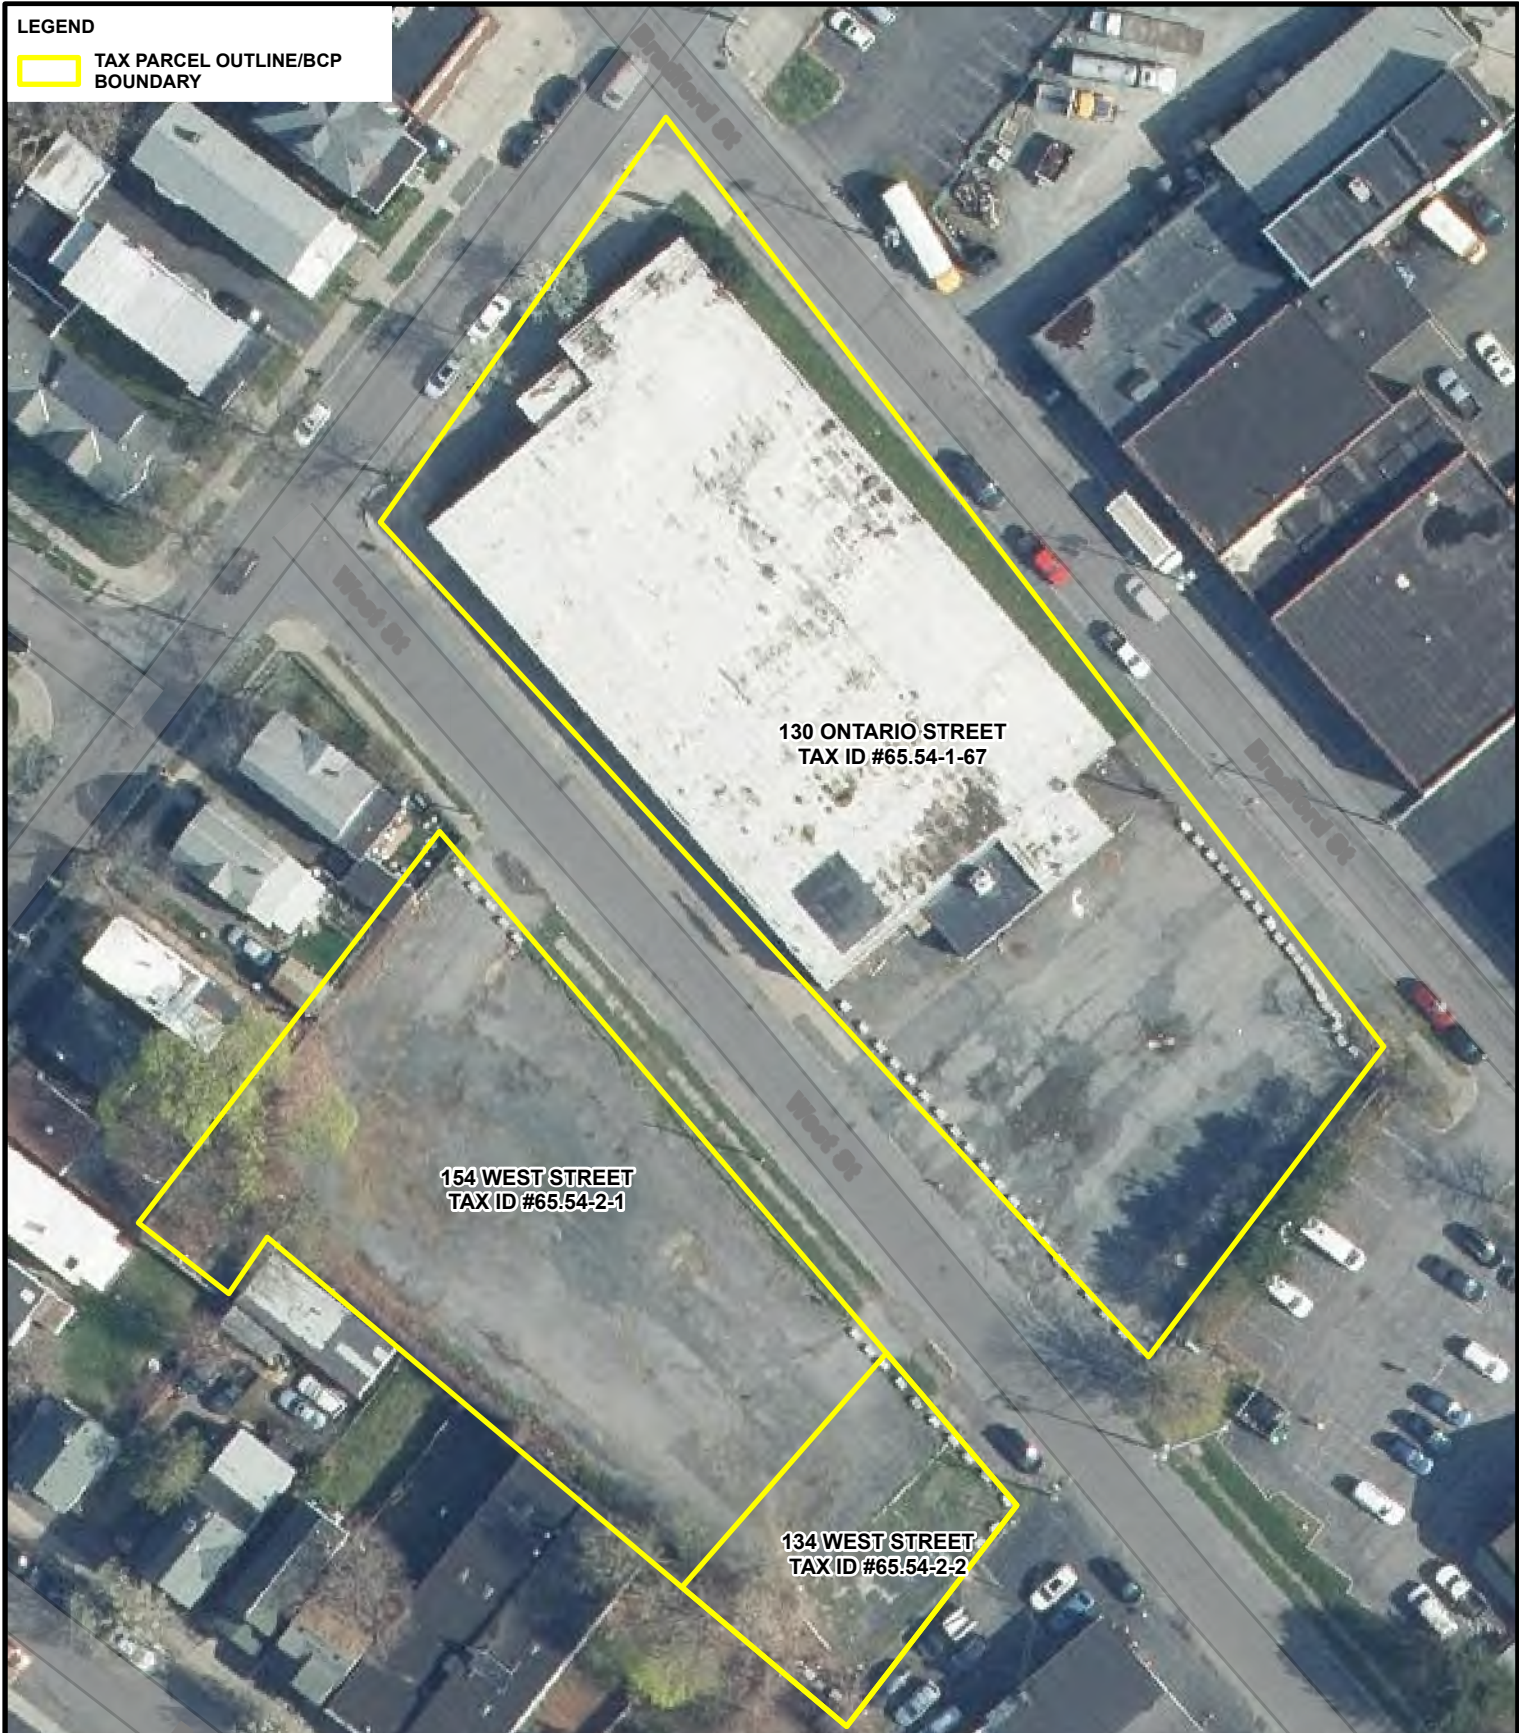
FIGURE 1

**TAX PARCEL OUTLINE/BCP BOUNDARY**

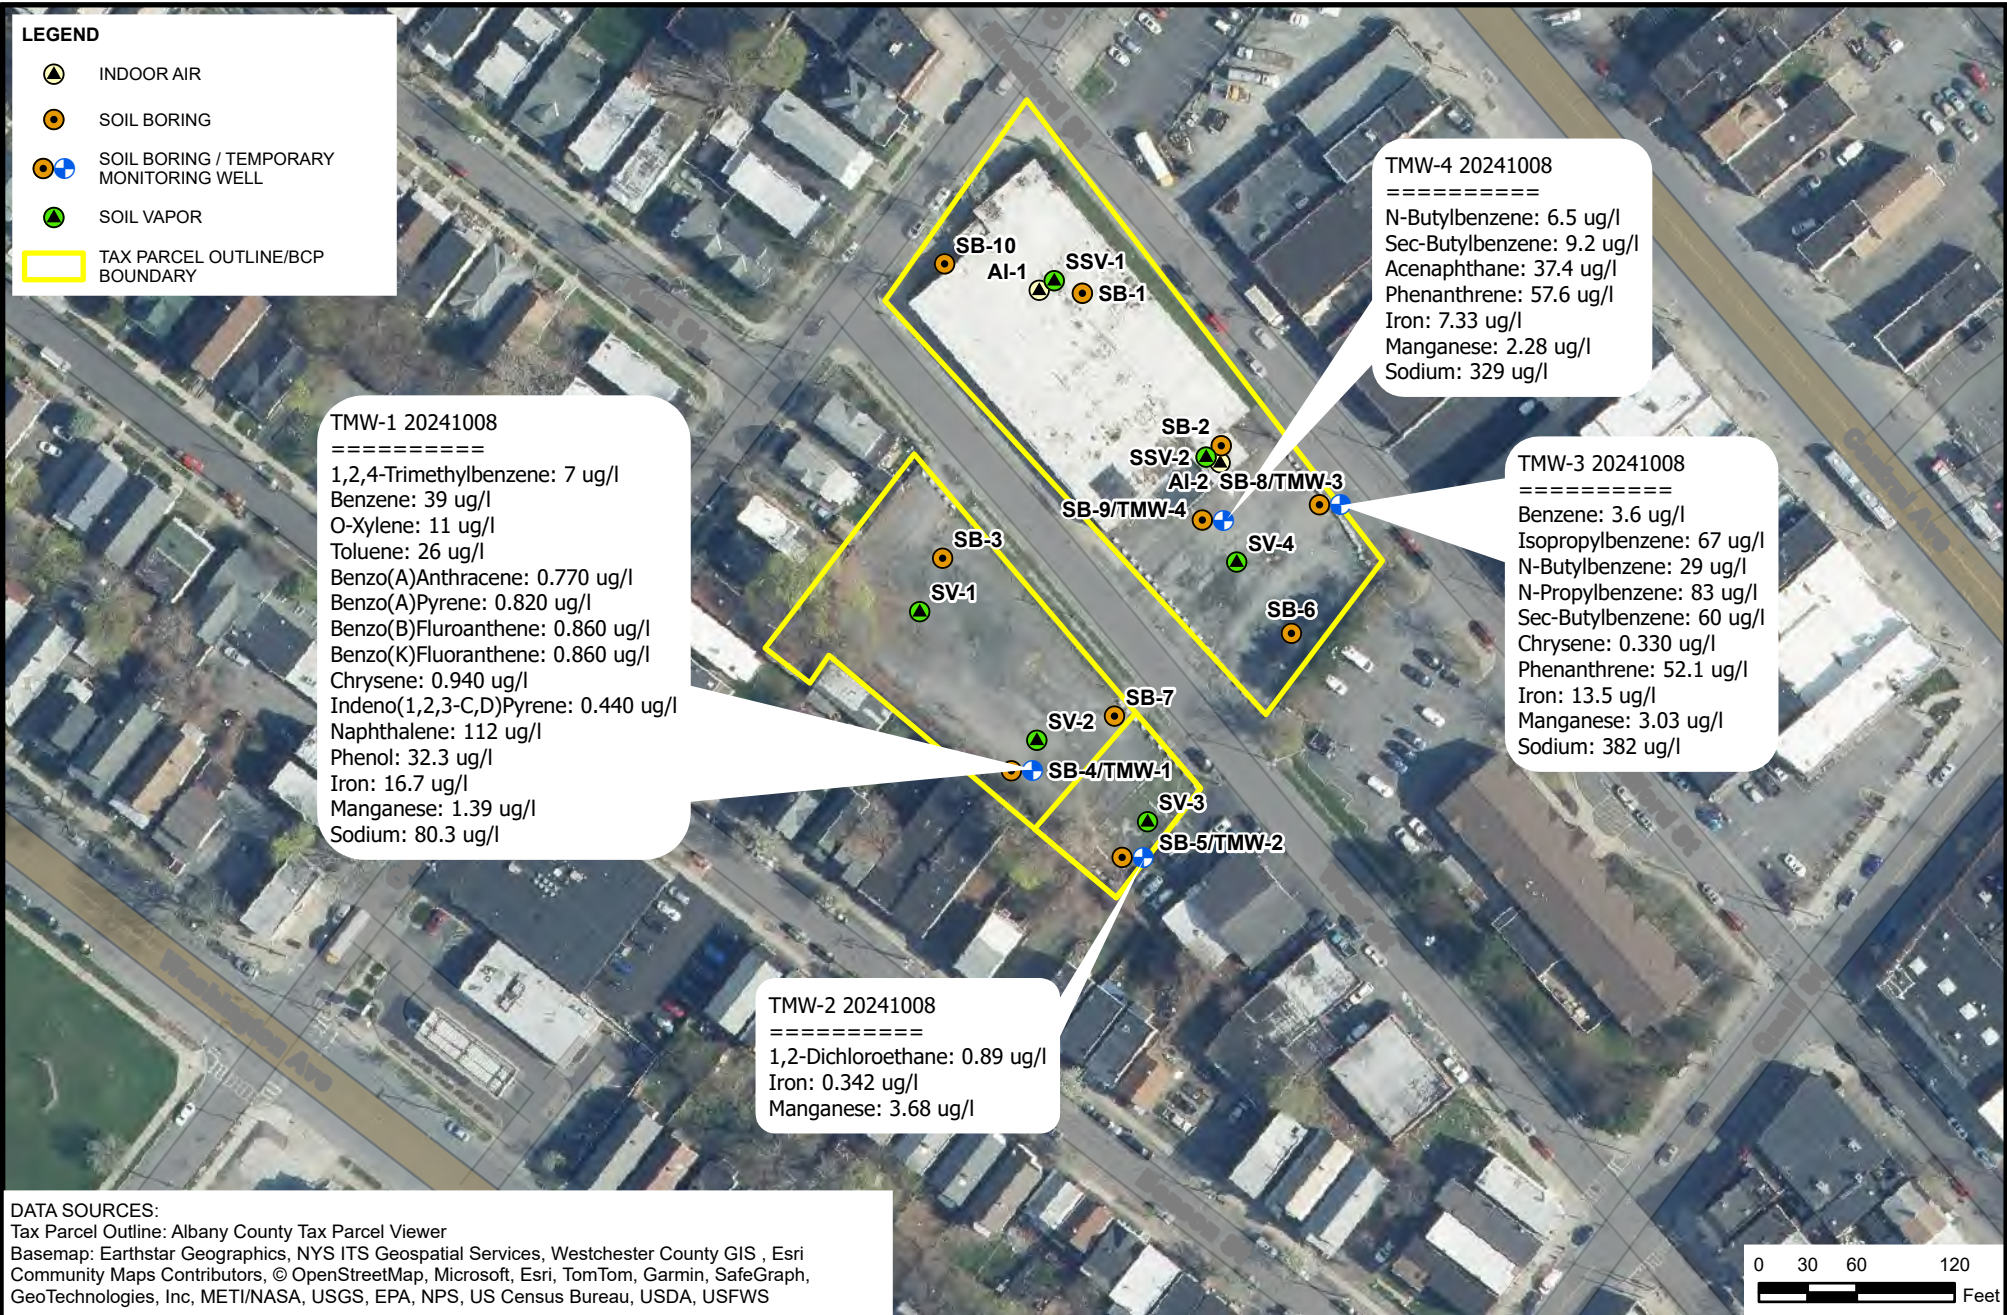
TMW-1 20241008
 =====
 1,2,4-Trimethylbenzene: 7 ug/l
 Benzene: 39 ug/l
 O-Xylene: 11 ug/l
 Toluene: 26 ug/l
 Benzo(A)Anthracene: 0.770 ug/l
 Benzo(A)Pyrene: 0.820 ug/l
 Benzo(B)Fluroanthene: 0.860 ug/l
 Benzo(K)Fluoranthene: 0.860 ug/l
 Chrysene: 0.940 ug/l
 Indeno(1,2,3-C,D)Pyrene: 0.440 ug/l
 Naphthalene: 112 ug/l
 Phenol: 32.3 ug/l
 Iron: 16.7 ug/l
 Manganese: 1.39 ug/l
 Sodium: 80.3 ug/l

TMW-2 20241008
 =====
 1,2-Dichloroethane: 0.89 ug/l
 Iron: 0.342 ug/l
 Manganese: 3.68 ug/l

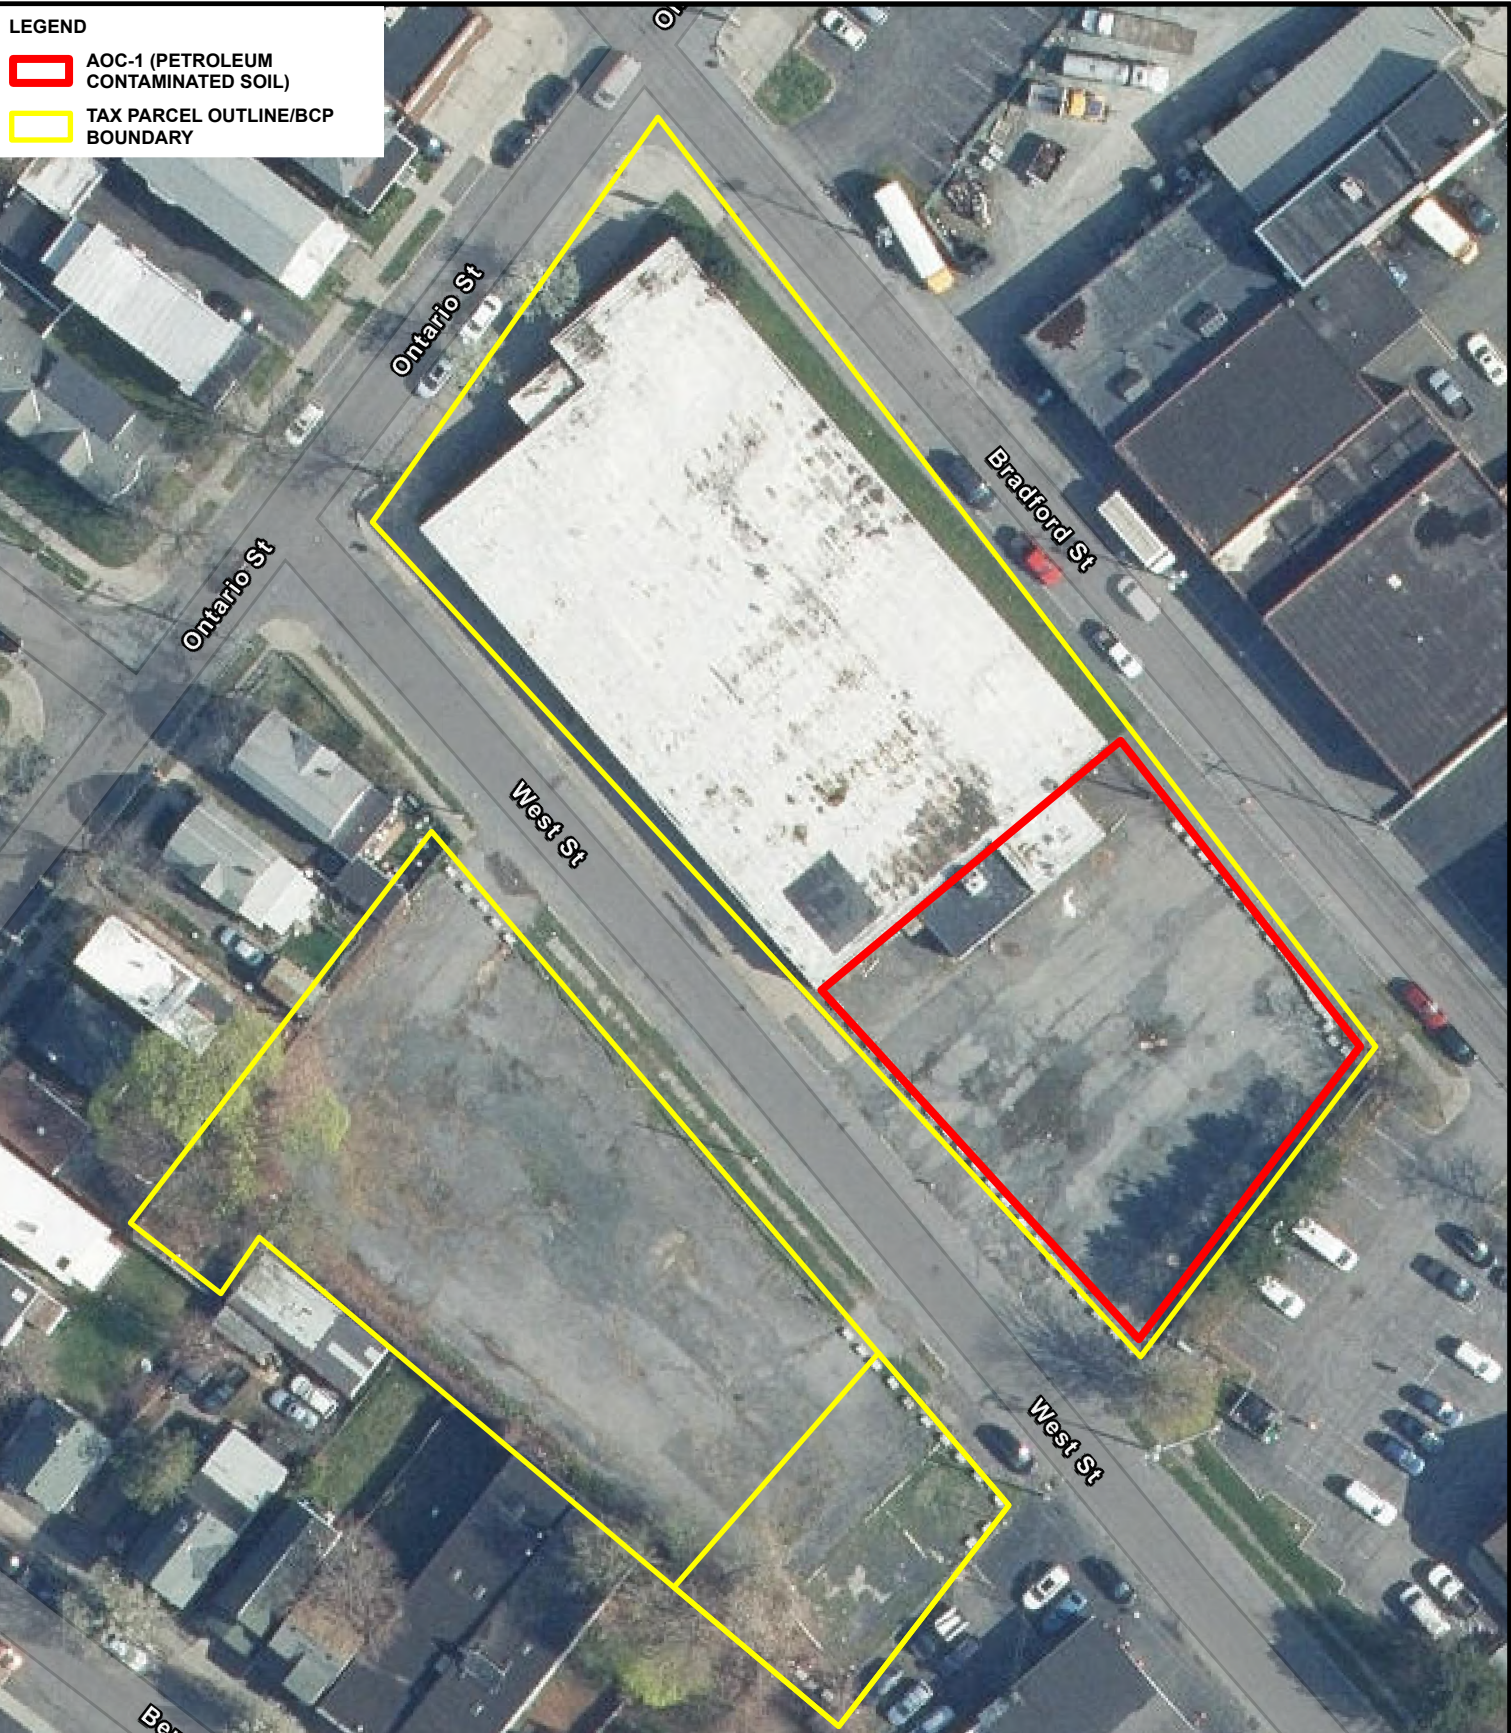
PROJECT NO. 20230102	FIGURE 6
	DATE: 08/14/2025
	SCALE: AS INDICATED
	PROJECTION: STATE PLANE NAD83 NY EAST
	ALL LOCATIONS APPROXIMATE

NYSDOH REGULATED COMPOUND DETECTIONS IN SOIL VAPOR SAMPLES
 130 ONTARIO STREET, 134 & 154 WEST STREET
 CITY OF ALBANY, ALBANY COUNTY, NEW YORK

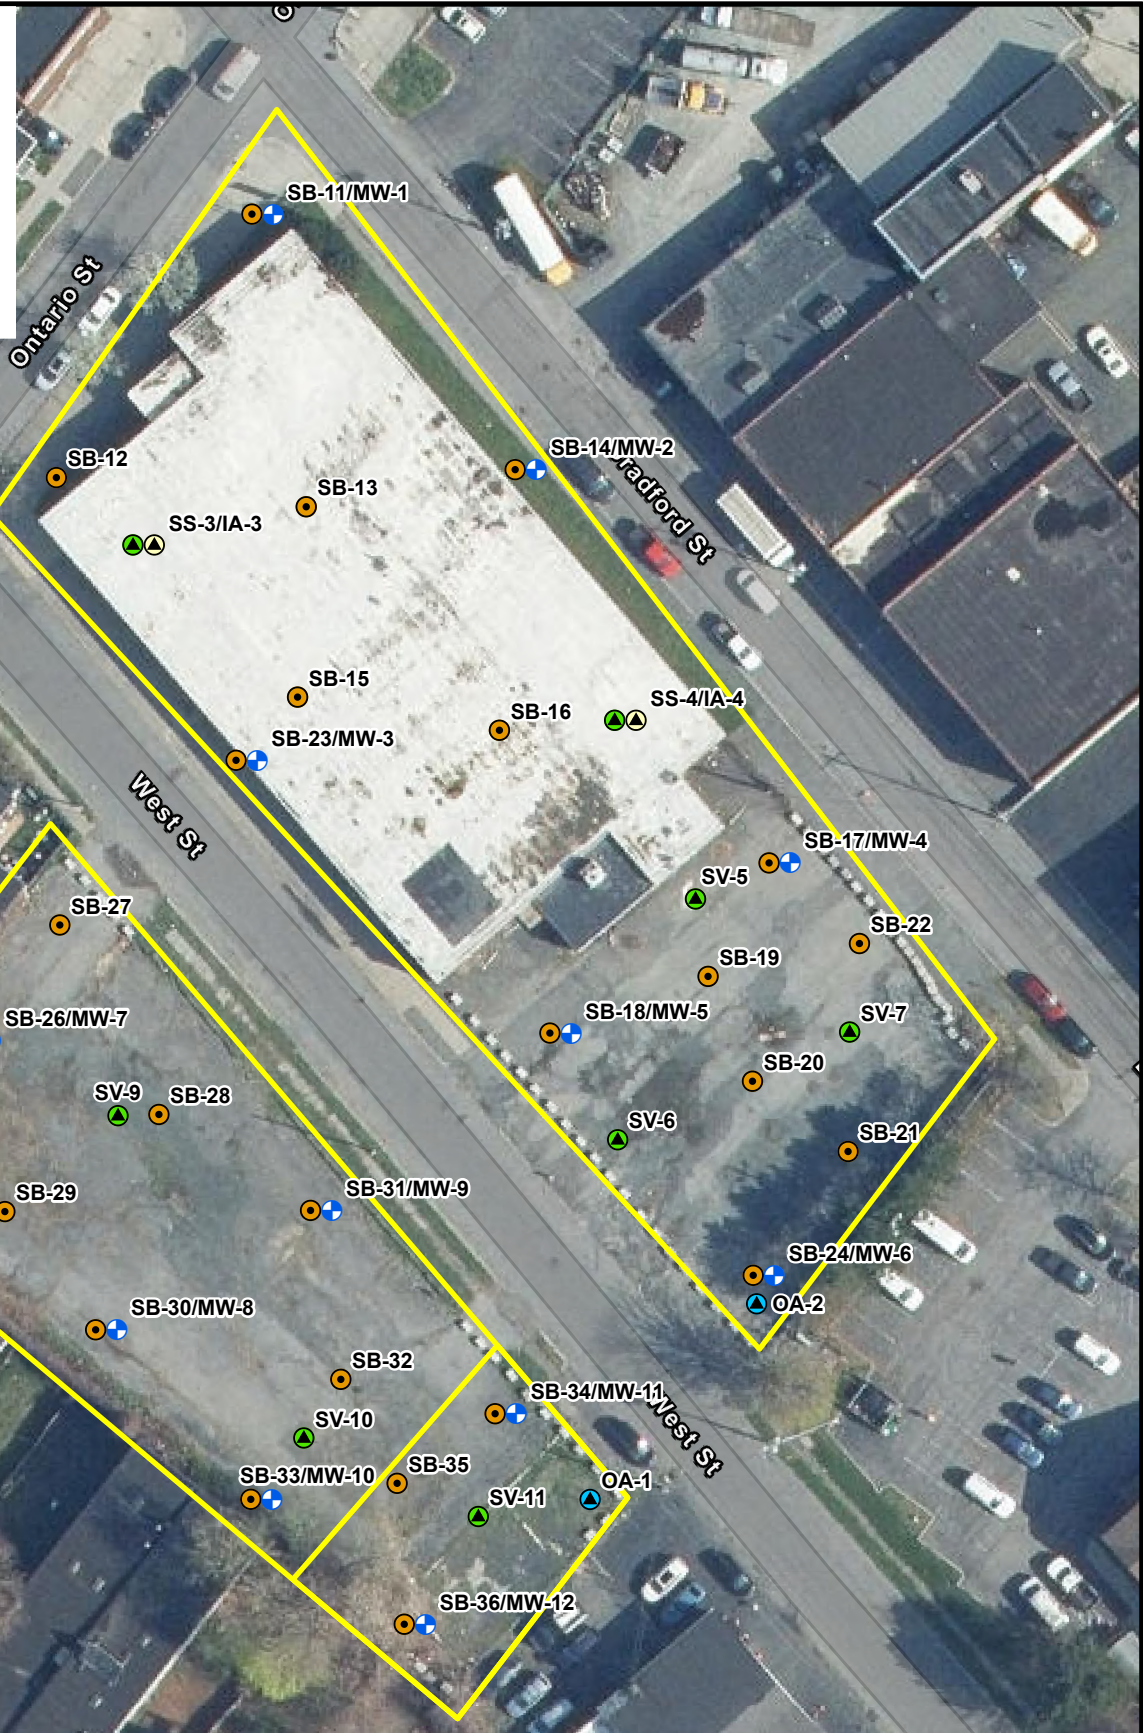
Twenty-six (26) soil borings are proposed across the BCP Site to determine site stratigraphy and collect soil samples for laboratory analysis (See Figure 8). Three (3) from beneath the slab of the on-site structure and twenty-three (23) from exterior locations. Soil borings will be advanced using a direct push track-mounted Geoprobe™ drill rig equipped with 2 ¼-inch diameter stainless steel core barrel (macro-cores) fitted with PVC liners. Soil borings will be sampled continuously from ground surface to a maximum depth of 24-feet bgs, or to refusal, whichever is encountered first. If shallow refusal is encountered, up to three (3) attempts will be made to complete the soil samples to the target depth, as approved by the NYSDEC Project Manager. At each location, field personnel will screen soil samples for VOCs using a photoionization detector (PID), and headspace techniques. The project geologist will keep a detailed log of each core: Lithology, grain size, stratigraphic changes, color, and occurrence of groundwater will be recorded. Observations will be made describing the presence of potential contamination in the soil samples based on odor, visual observations, and/or PID readings.

Twenty-six (26) soil borings are proposed across the BCP Site to determine site stratigraphy and collect soil samples for laboratory analysis (See Figure 8). Three (3) from beneath the slab of the on-site structure and twenty-three (23) from exterior locations. Soil borings will be advanced using a direct push track-mounted Geoprobe™ drill rig equipped with 2 ¼-inch diameter stainless steel core barrel (macro-cores) fitted with PVC liners. Soil borings will be sampled continuously from ground surface to a maximum depth of 24-feet bgs, or to refusal, whichever is encountered first. If shallow refusal is encountered, up to three (3) attempts will be made to complete the soil samples to the target depth, as approved by the NYSDEC
