# NYSDEC BROWNFIELD CLEANUP PROGRAM REMEDIAL INVESTIGATION WORK PLAN

**41 NORTH 2<sup>ND</sup> STREET  
NYSDEC BCP SITE #C411022  
41 NORTH 2<sup>ND</sup> STREET  
CITY OF HUDSON, COLUMBIA COUNTY, NEW YORK**

October 22, 2025  
Revised January 13, 2026  
PVEDI File #20240218

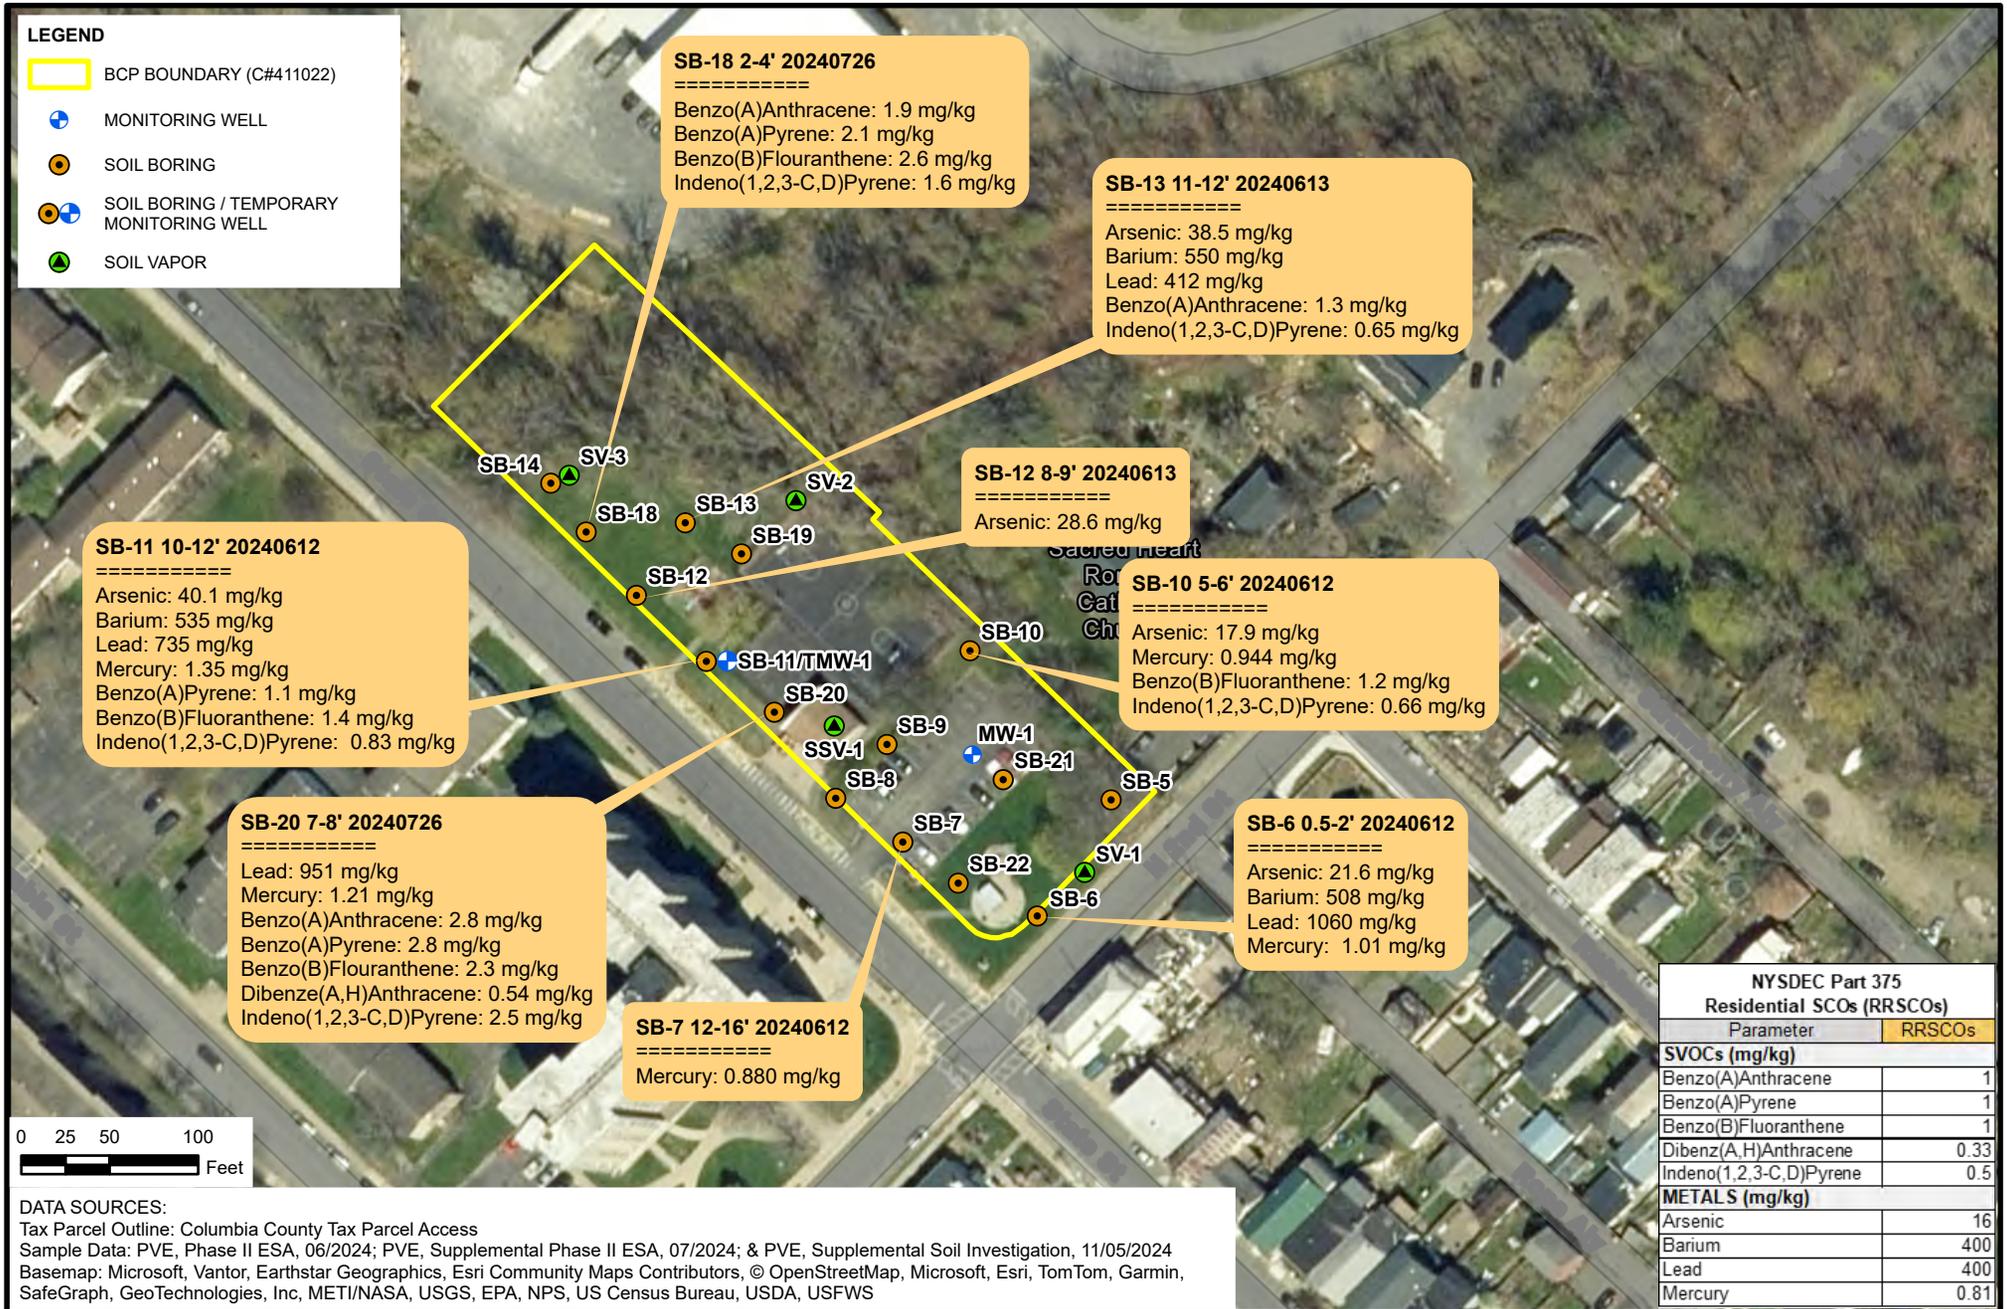
- BCP BOUNDARY (C#411022)
- + MONITORING WELL
- SOIL BORING
- + ● SOIL BORING / TEMPORARY MONITORING WELL
- ▲ SOIL VAPOR

**SB-18 2-4' 20240726**  
 =====  
 Benzo(A)Anthracene: 1.9 mg/kg  
 Benzo(A)Pyrene: 2.1 mg/kg  
 Benzo(B)Flouranthene: 2.6 mg/kg  
 Indeno(1,2,3-C,D)Pyrene: 1.6 mg/kg

**SB-13 11-12' 20240613**  
 =====  
 Arsenic: 38.5 mg/kg  
 Barium: 550 mg/kg  
 Lead: 412 mg/kg  
 Benzo(A)Anthracene: 1.3 mg/kg  
 Indeno(1,2,3-C,D)Pyrene: 0.65 mg/kg

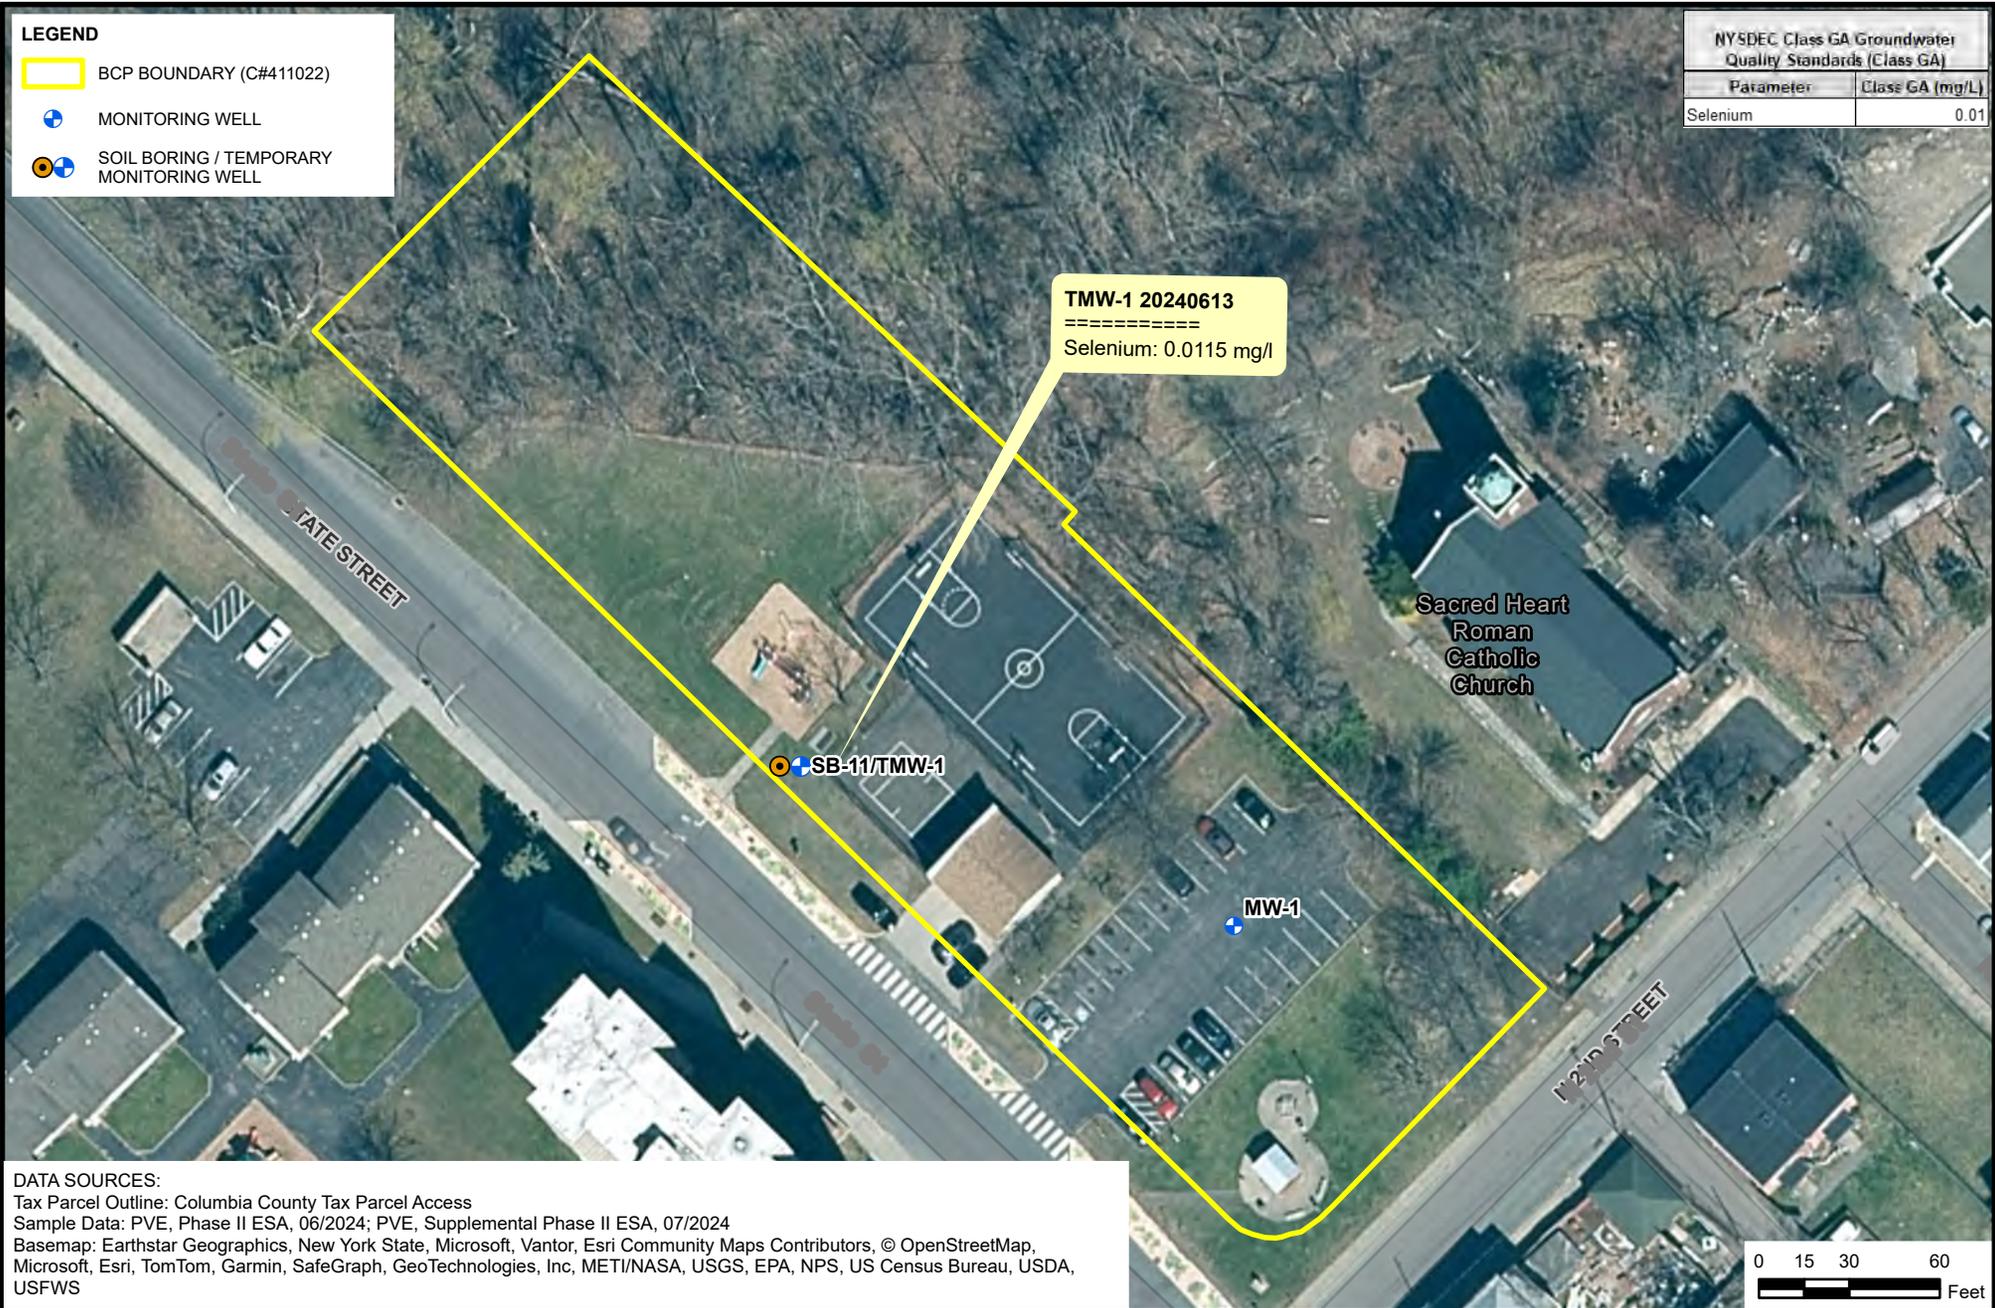
- BCP BOUNDARY (C#411022)
- + MONITORING WELL
- + o SOIL BORING / TEMPORARY MONITORING WELL

NYSDEC Class GA Groundwater Quality Standards (Class GA)	
Parameter	Class GA (mg/L)
Selenium	0.01

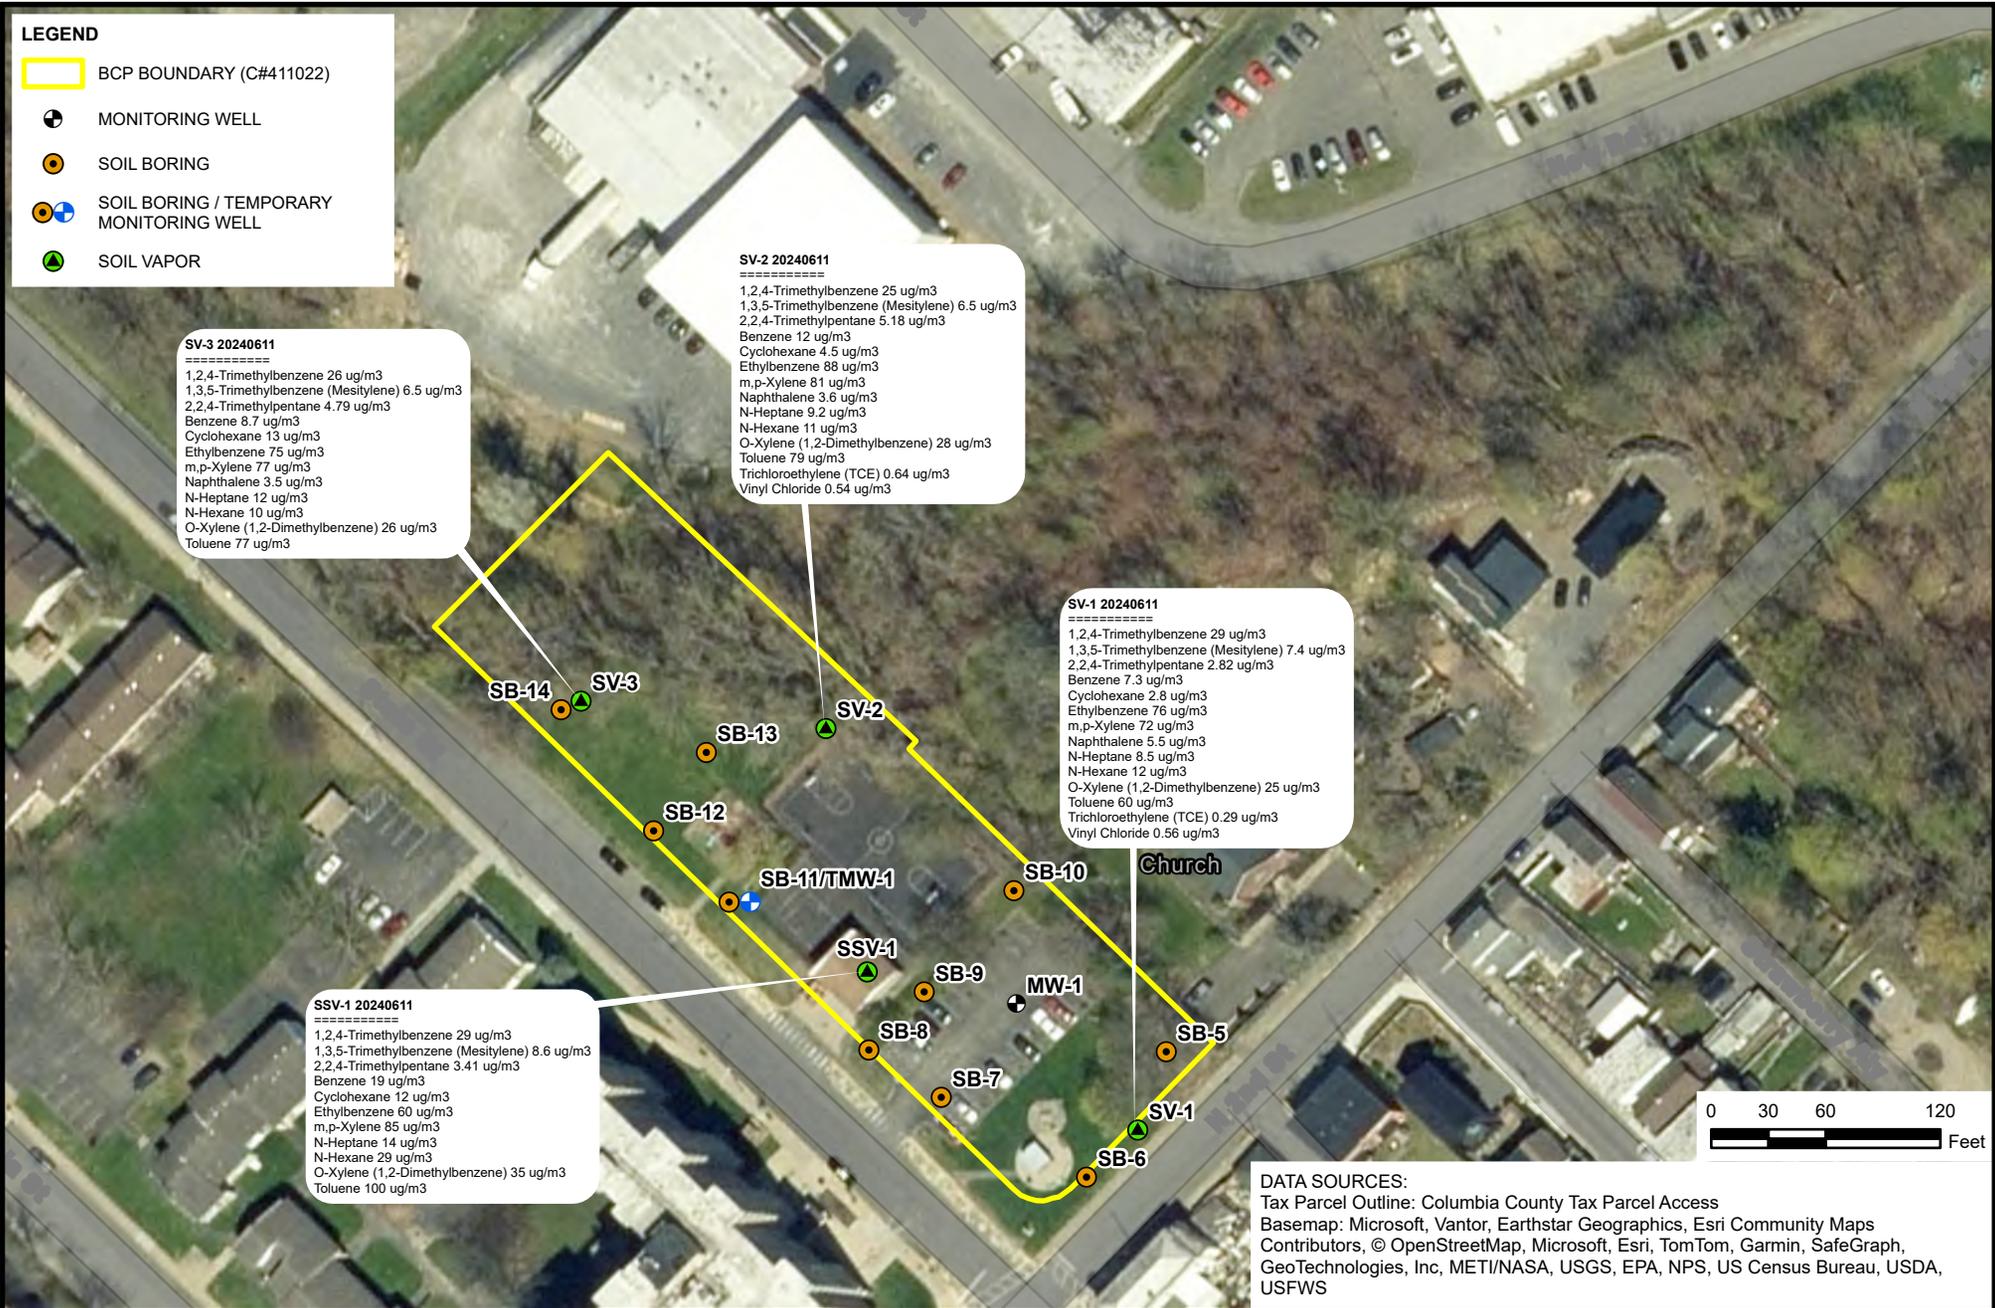
**SV-1 20240611**  
 =====  
 1,2,4-Trimethylbenzene 29 ug/m3  
 1,3,5-Trimethylbenzene (Mesitylene) 7.4 ug/m3  
 2,2,4-Trimethylpentane 2.82 ug/m3  
 Benzene 7.3 ug/m3  
 Cyclohexane 2.8 ug/m3  
 Ethylbenzene 76 ug/m3  
 m,p-Xylene 72 ug/m3  
 Naphthalene 5.5 ug/m3  
 N-Heptane 8.5 ug/m3  
 N-Hexane 12 ug/m3  
 O-Xylene (1,2-Dimethylbenzene) 25 ug/m3  
 Toluene 60 ug/m3  
 Trichloroethylene (TCE) 0.29 ug/m3  
 Vinyl Chloride 0.56 ug/m3

**SSV-1 20240611**  
 =====  
 1,2,4-Trimethylbenzene 29 ug/m3  
 1,3,5-Trimethylbenzene (Mesitylene) 8.6 ug/m3  
 2,2,4-Trimethylpentane 3.41 ug/m3  
 Benzene 19 ug/m3  
 Cyclohexane 12 ug/m3  
 Ethylbenzene 60 ug/m3  
 m,p-Xylene 85 ug/m3  
 N-Heptane 14 ug/m3  
 N-Hexane 29 ug/m3  
 O-Xylene (1,2-Dimethylbenzene) 35 ug/m3  
 Toluene 100 ug/m3

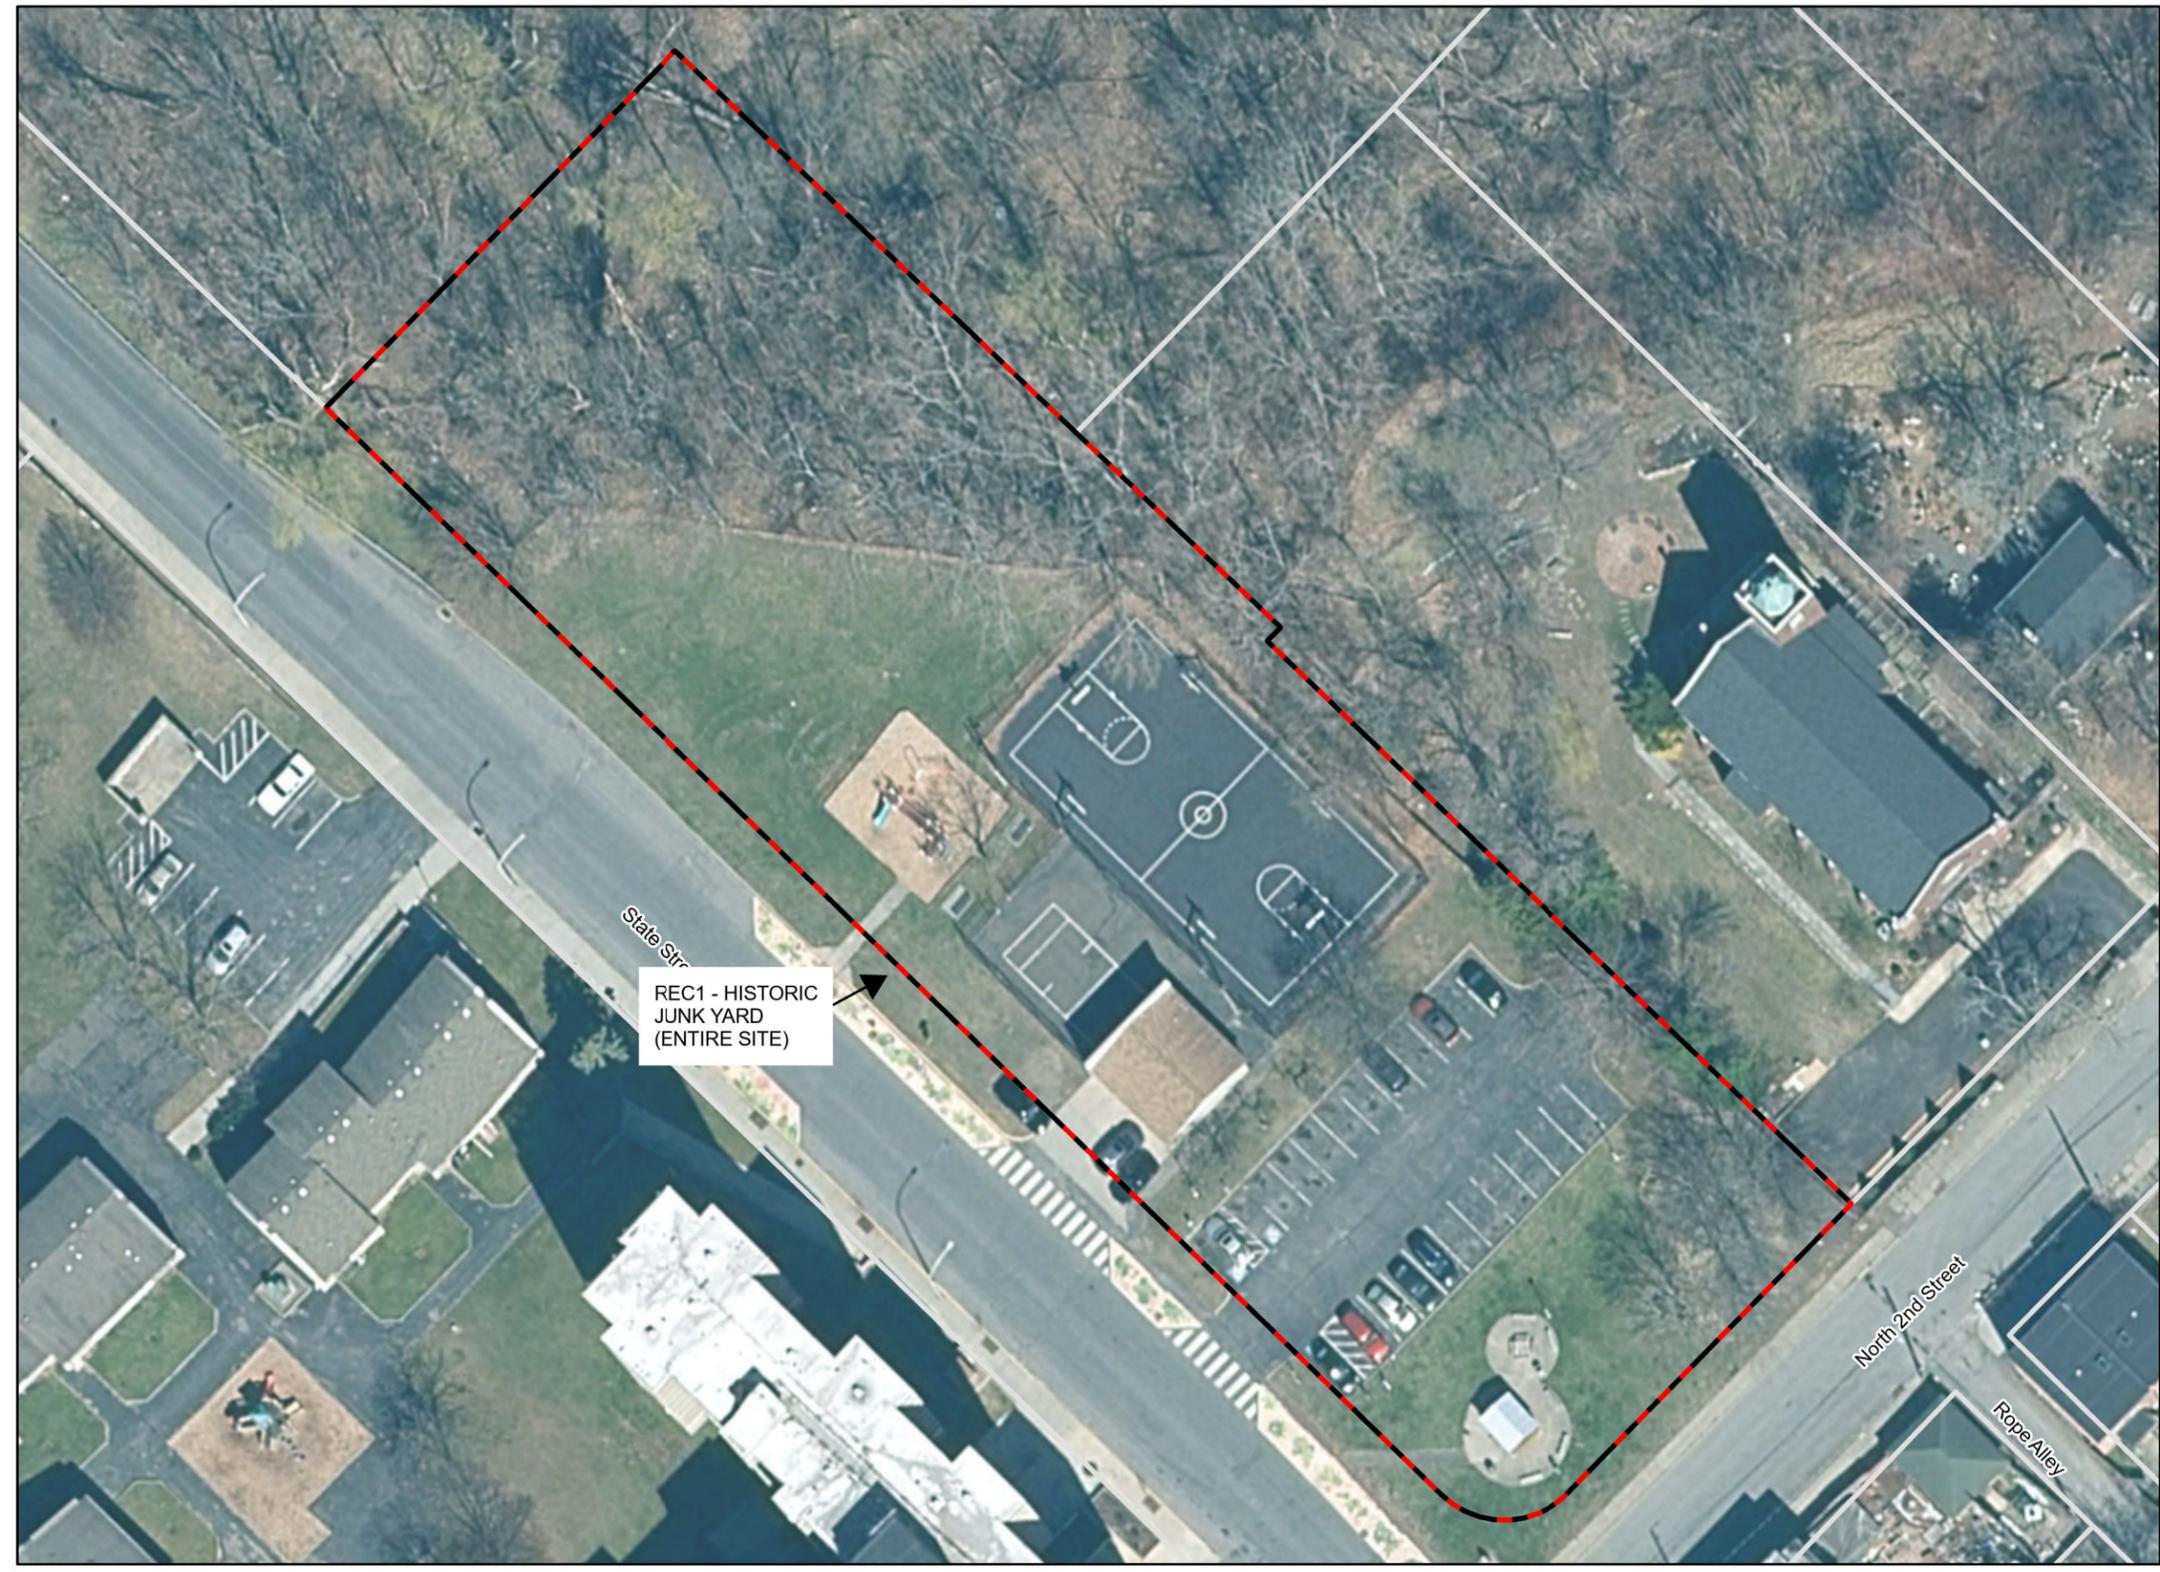
**FIG-10.1**

A figure showing the locations of the RECs identified at this subject property is included as **Figure 10.1**.
