**NORTHEAST TREATERS OF NEW YORK, LLC  
GREENE COUNTY, NEW YORK**

**Periodic Review Report**  
**(September 1, 2021 – September 1, 2022)**

**NYSDEC Site Number: C420029**

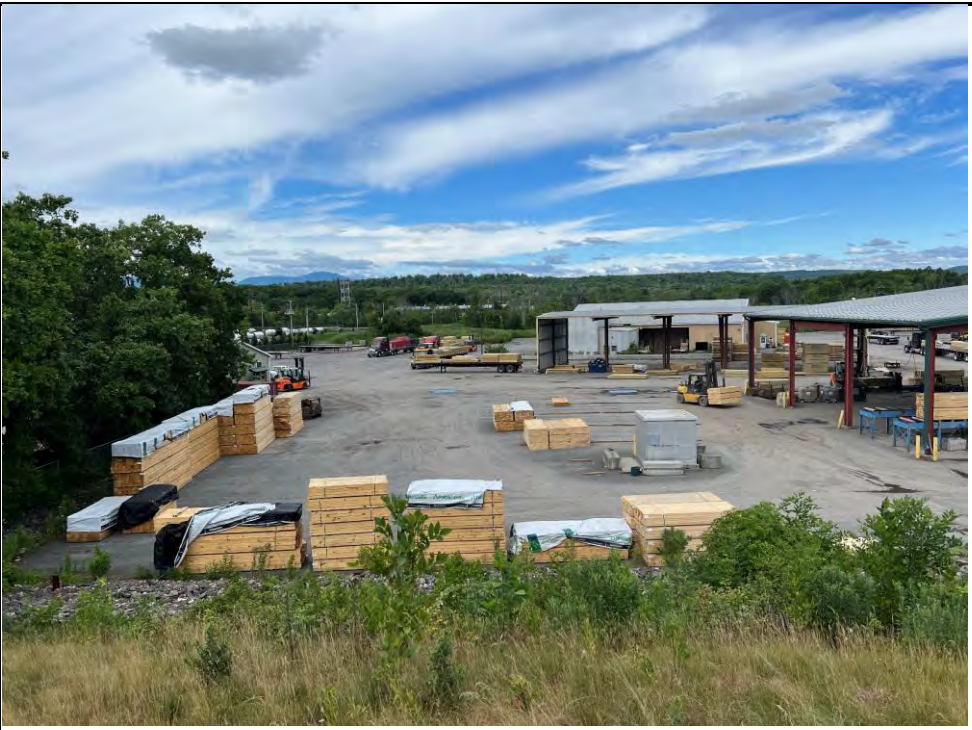
<b>Photo No.</b> 2	<b>Date</b> 7/26/2022	<b>Time</b> 11:14

<b>Direction Looking:</b>	West		
<b>Comments:</b>			
Overview of southwestern portion of protective asphalt cover in acceptable condition

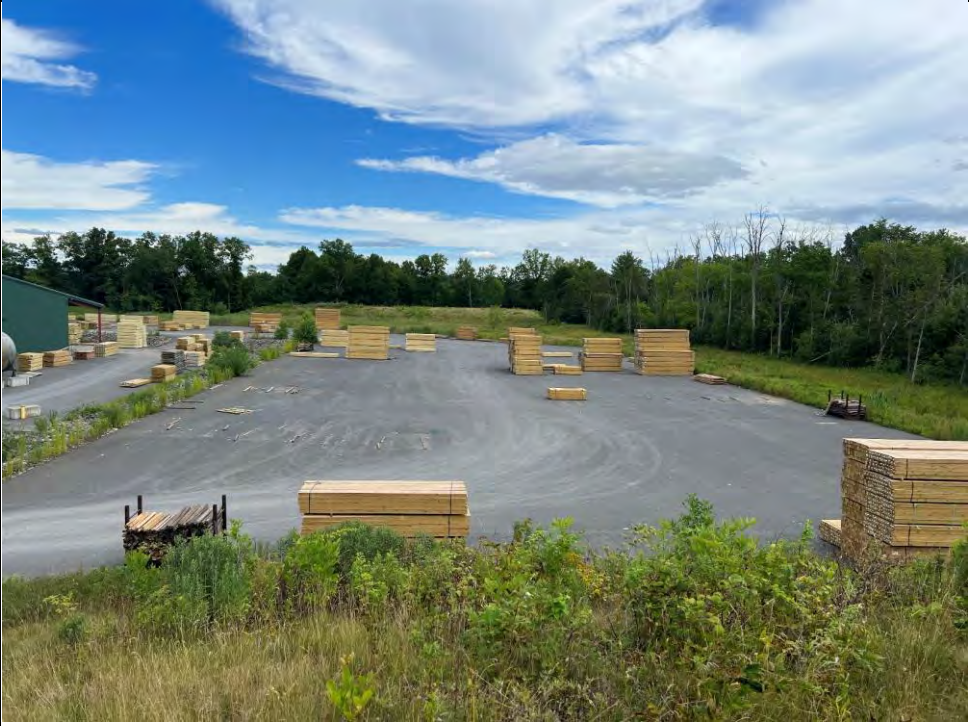
<b>Photo No.</b> 4	<b>Date</b> 7/26/2022	<b>Time</b> 11:17

<b>Direction Looking:</b>	North				
<b>Comments:</b>					
Overview of eastern portion of protective asphalt cover in acceptable condition

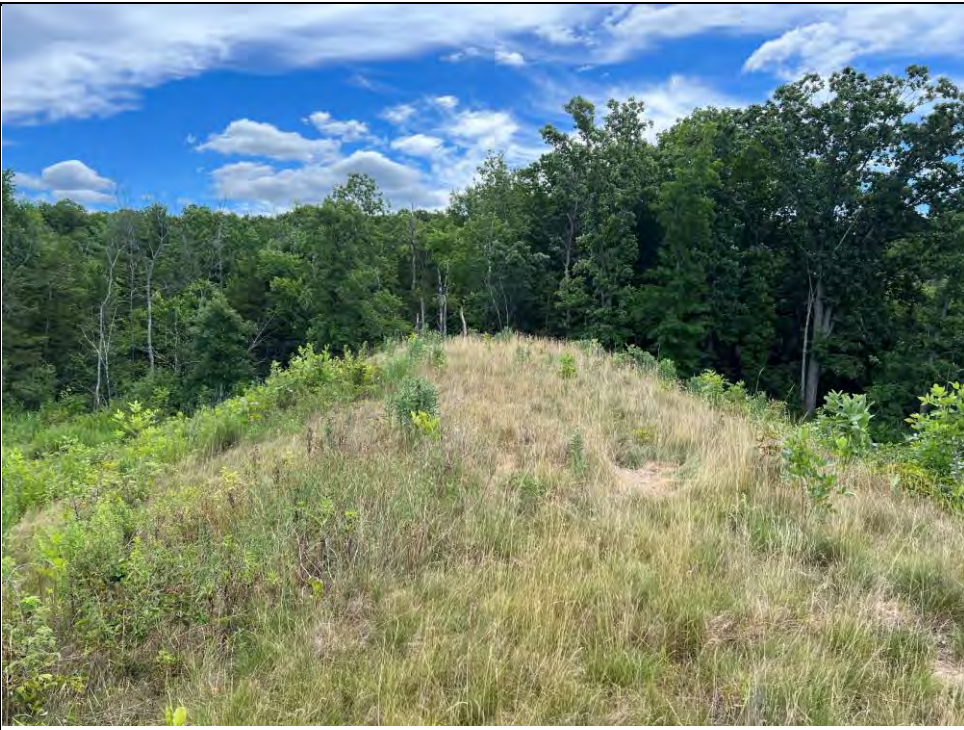
<b>Photo No.</b> 6	<b>Date</b> 7/26/2022	<b>Time</b> 11:13

<b>Direction Looking:</b>	East		
<b>Comments:</b> Southern abatement berm with soil cover in acceptable condition

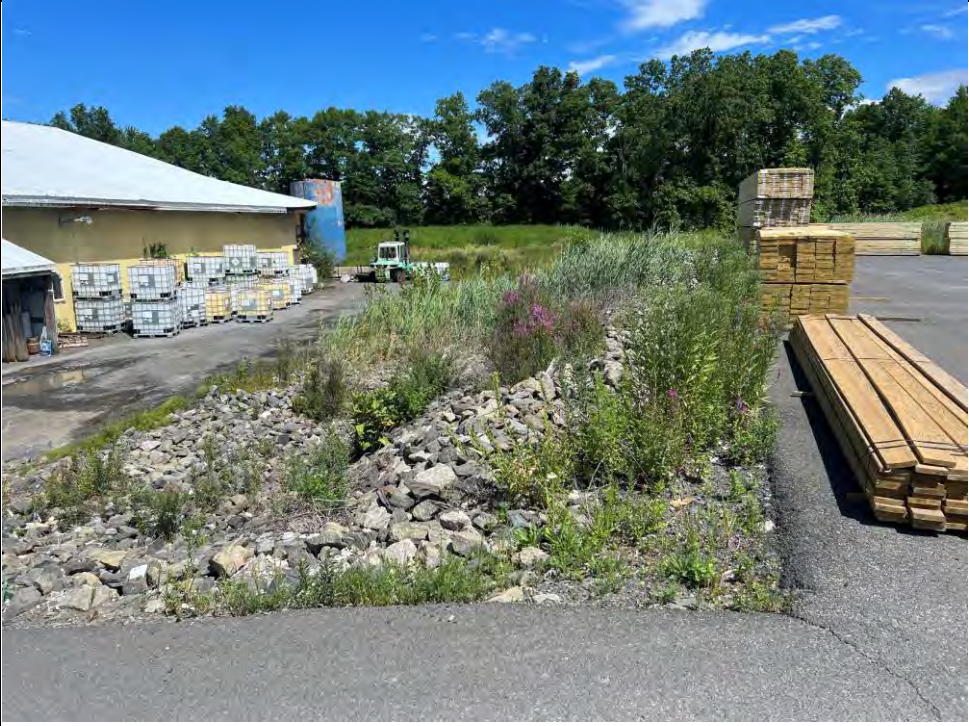
<b>Photo No.</b> 12	<b>Date</b> 7/26/2022	<b>Time</b> 11:37

<b>Direction Looking:</b>	North			
<b>Comments:</b>				
Northern grade transition area in acceptable condition

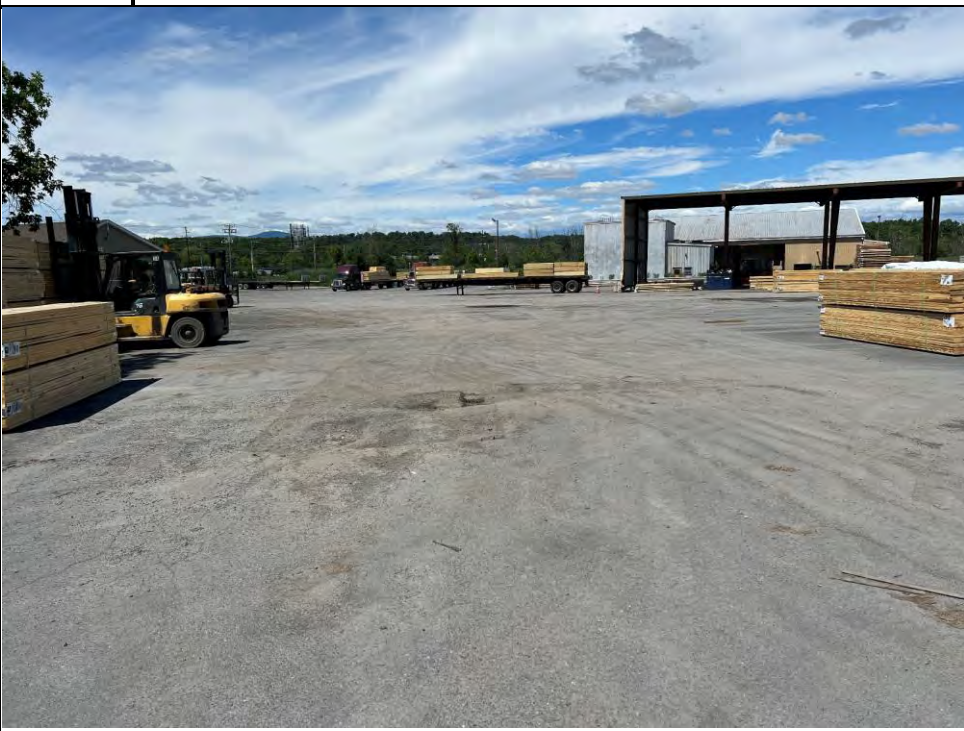
<b>DAILY PHOTOGRAPH LOG</b>	
			<b>Project:</b>	BCP #C420029, Athens, NY. Sterling Project #2014-08
			<b>Photo By:</b>	Paul Scholar
<b>Photo No.</b> 15	<b>Date</b> 7/26/2022	<b>Time</b> 11:56

<b>Direction Looking:</b>	West			
<b>Comments:</b>				
Southern portion of protective asphalt cover in acceptable condition.

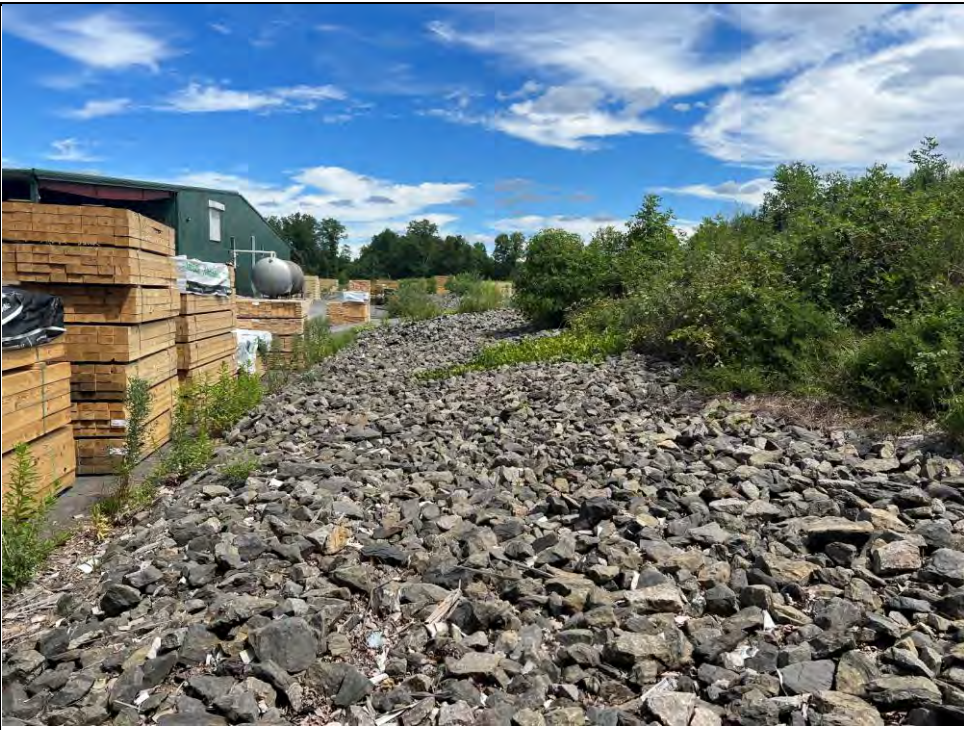
<b>Photo No.</b> 16	<b>Date</b> 7/26/2022	<b>Time</b> 11:31

<b>Direction Looking:</b>	North		
<b>Comments:</b>			
Grade transition area between treatment process building and storage area in acceptable condition

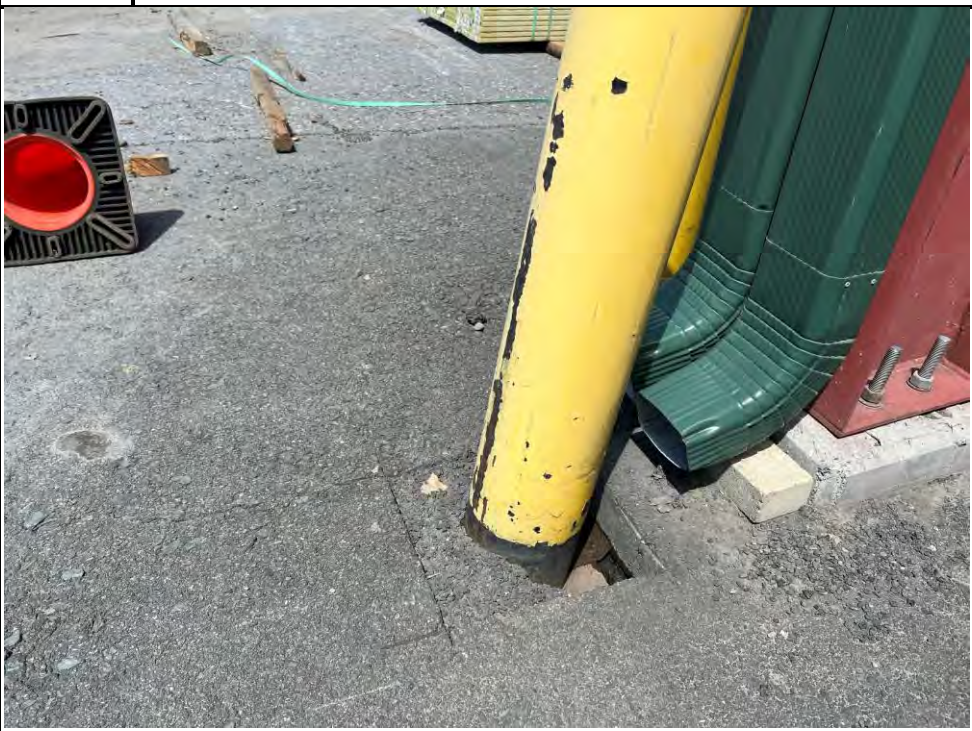
DAILY PHOTOGRAPH LOG	
			<b>Project:</b>	BCP #C420029, Athens, NY. Sterling Project #2014-08
			<b>Photo By:</b>	Paul Scholar
<b>Photo No.</b> 17	<b>Date</b> 7/26/2022	<b>Time</b> 11:50

As documented in the inspection form and photograph log (Appendix B), minor damage was observed to the asphalt cover surrounding a bollard. This area was repaired after the 2021 site inspection; however, the patch is deteriorating and requires repair.

<b>Direction Looking:</b>	Northwest			
<b>Comments:</b>				
View of bollard repair with patched asphalt. Minor washout of asphalt patch observed that should be repaired.

Maintenance of the Site protective cover will be conducted by the property owner as needed based on inspection observations. As documented in the inspection form and photograph log (Appendix B), minor damage was observed to the asphalt cover surrounding a bollard. This area was repaired after the 2021 site inspection; however, the patch is deteriorating and requires repair.

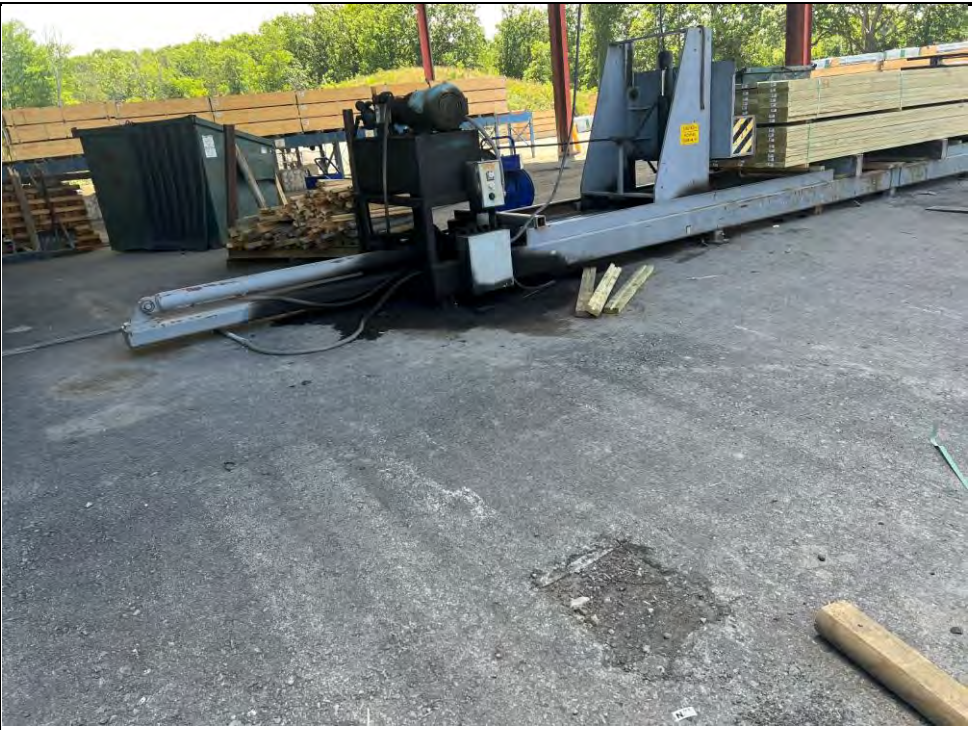
<b>Photo No.</b> 18	<b>Date</b> 7/26/2022	<b>Time</b> 11:44

<b>Direction Looking:</b>	East		
<b>Comments:</b>			
Southwest perimeter of process building

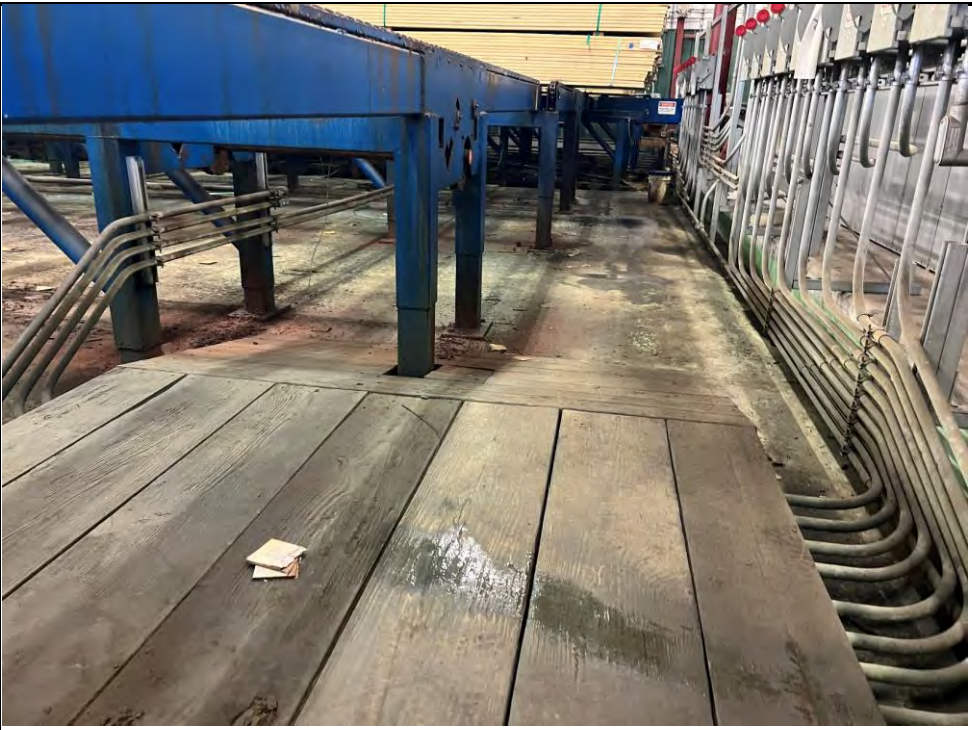
<b>Photo No.</b> 20	<b>Date</b> 7/26/2022	<b>Time</b> 11:48

<b>Direction Looking:</b>		East		
<b>Comments:</b> representative concrete cover in acceptable condition within treatment process building
