**NORTHEAST TREATERS OF NEW YORK, LLC
GREENE COUNTY, NEW YORK**

Periodic Review Report
(September 1, 2022 – September 1, 2023)

NYSDEC Site Number: C420029

**PERIODIC REVIEW REPORT
(September 1, 2022 – September 1, 2023)**

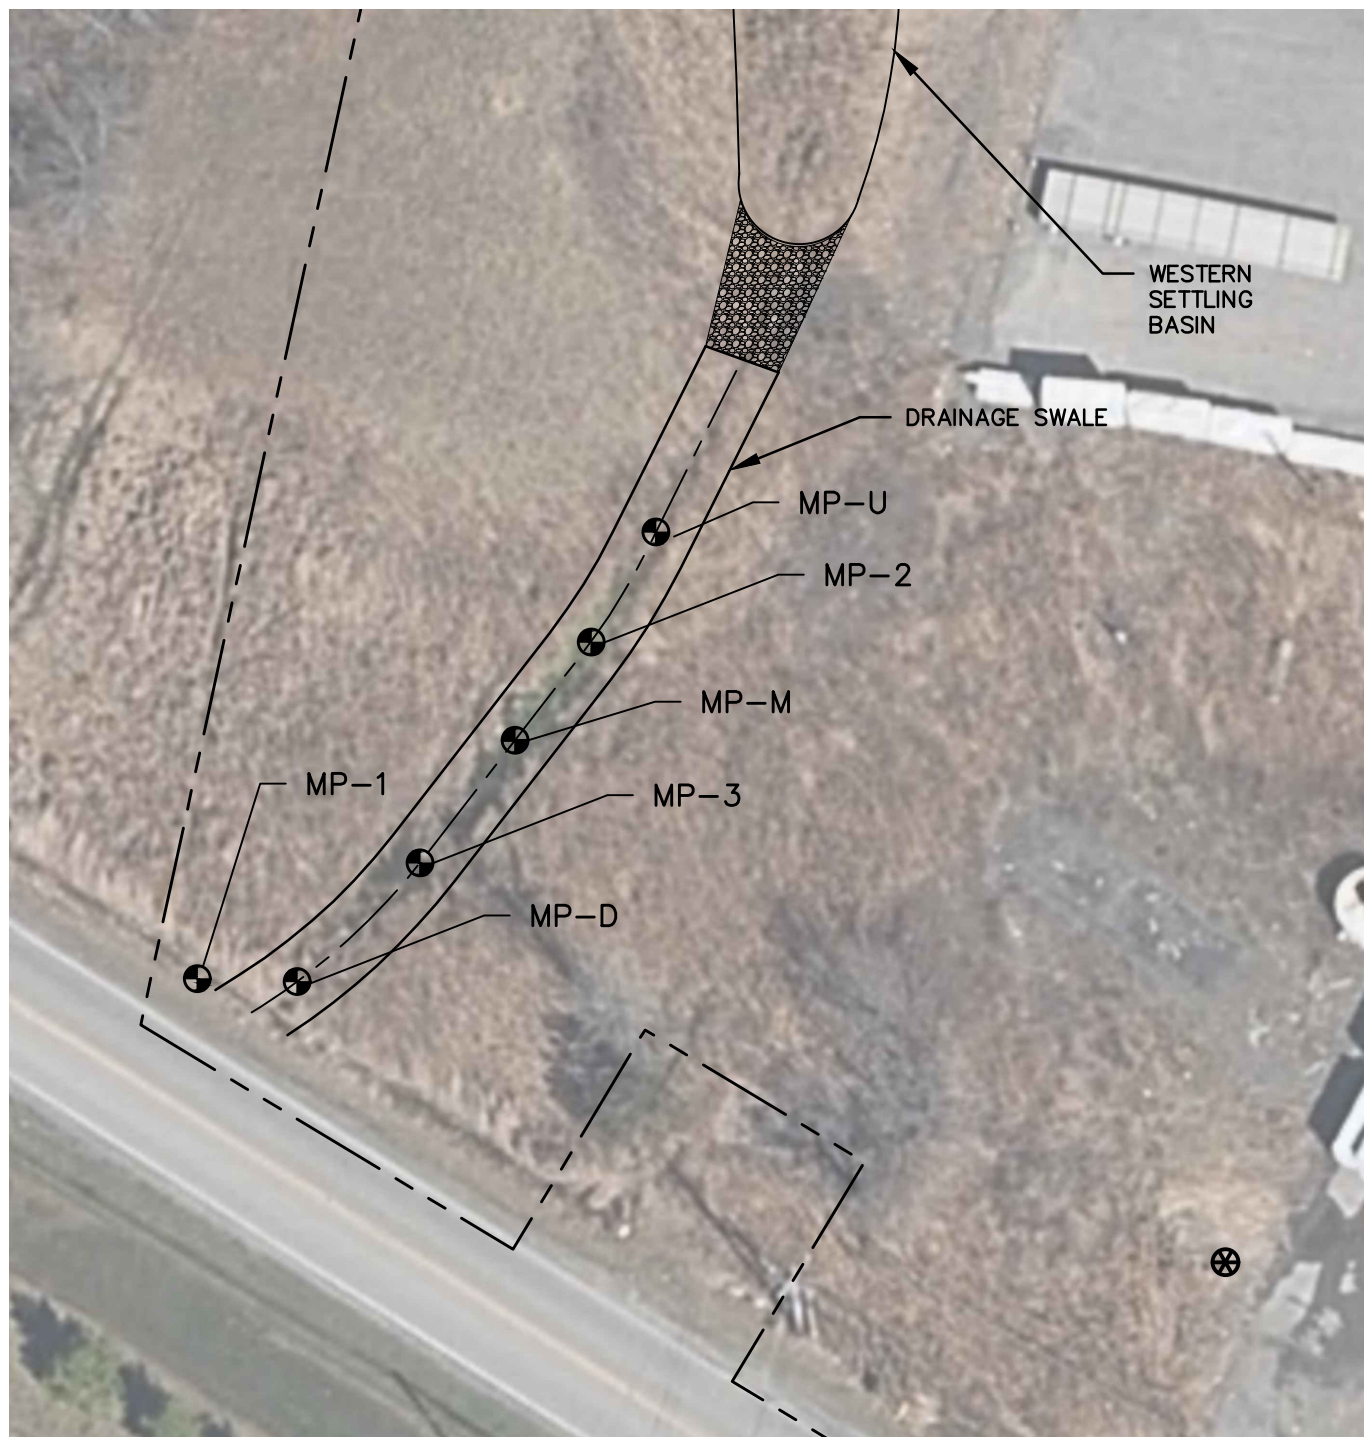
Sediment samples were collected from the following outflow locations of the western settling basin as shown on Figure 3:

The sediment sample locations were designed based on existing and anticipated drainage of the Site. The four (4) sediment samples are located along the western settling basin exit swale at upstream, mid-stream, and downstream sections of the swale and along the downstream property boundary as shown in Figure 3. Surface sediment samples were collected at each location between grade surface and approximately two (2) inches below grade. Samples were analyzed for total arsenic and total chromium via USEPA Method 6010D.

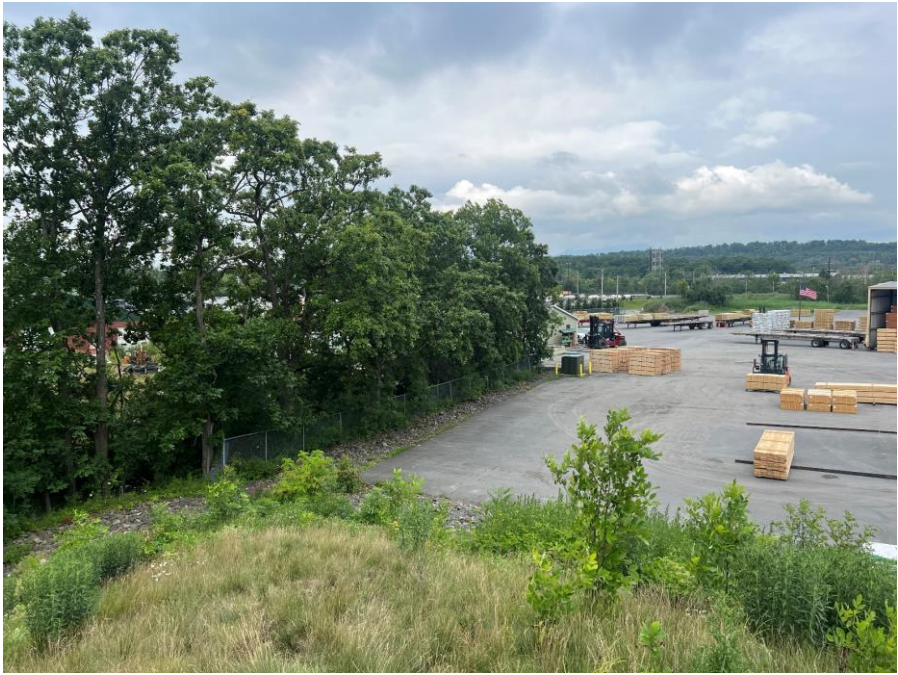
Sterling Environmental Engineering, P.C.			DAILY PHOTOGRAPH LOG		
			Project:	Culpeper Wood Preservers	
			Photo By:	Paul Scholar	
Photo No. 1	Date 2023-08-04	Time 10:17

Direction Looking:	Southwest				
Comments:					
Southwestern portion of protective asphalt cover and southern soil cover berm in acceptable condition.

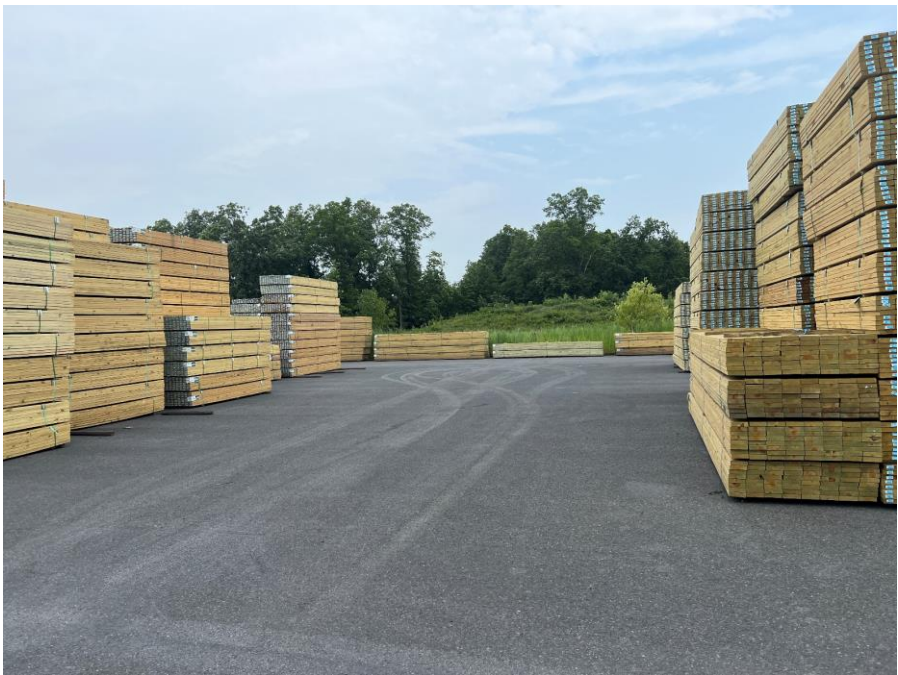
Photo No. 8	Date 2023-08-04	Time 10:27

Direction Looking:	North				
Comments: Northern portion of protective asphalt cover in acceptable condition.

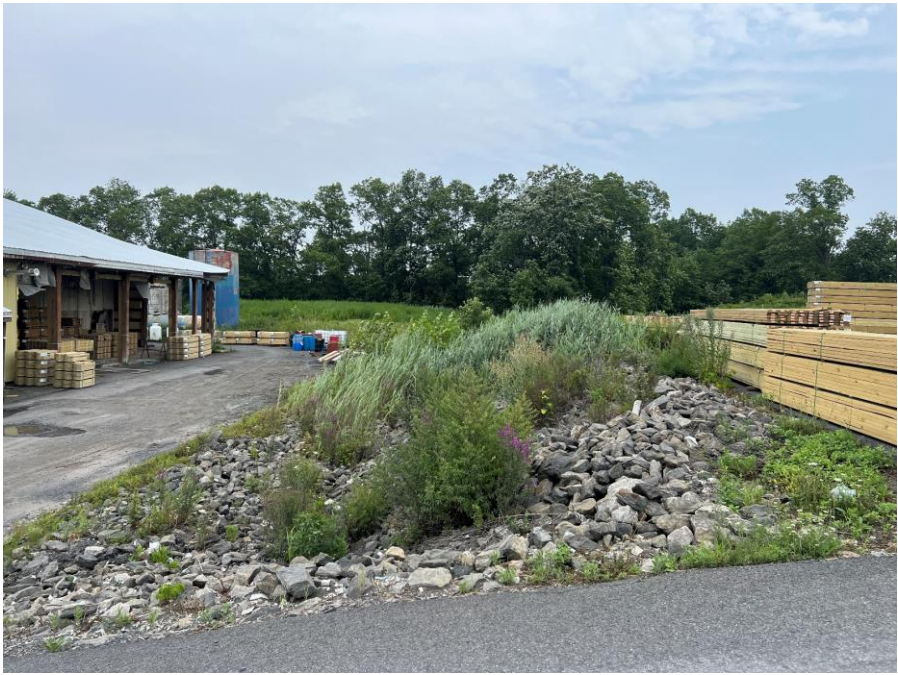
Photo No. 12	Date 2023-08-04	Time 10:30

Direction Looking:	North		
Comments: Northern grade transition area in acceptable condition.

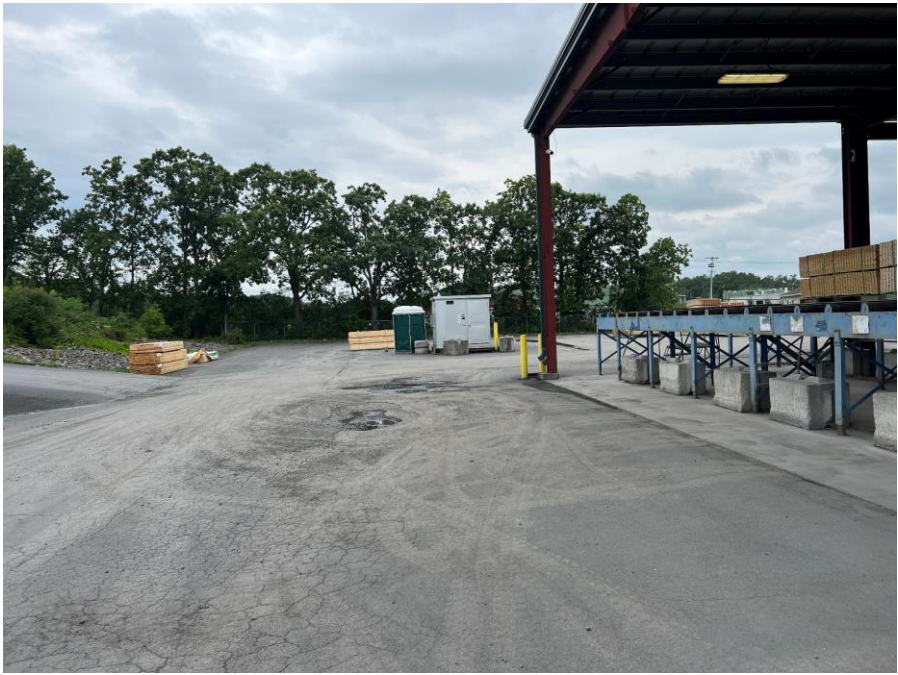
Photo No. 14	Date 2023-08-04	Time 10:34

Direction Looking:	South			
Comments: Southern portion of protective asphalt cover in acceptable condition directly east of the treatment process building. Small pot holes observed to be forming in asphalt along building.

As documented in the inspection form and photograph log (Appendix B), a minor erosional rill was beginning to form within the protective soil cover system on the southern abatement berm. This area was repaired by filling with topsoil and seed to re-establish vegetation. In addition, developing potholes in the asphalt cover system were repaired by filling with concrete to match the surrounding grade.

Items 2 and 3 were noted in the PRR as conditions requiring attention through normal maintenance activities. The conditions were not identified as deficiencies requiring corrective measures because the engineering control was not breached and could readily be addressed through normal operations. Item 2 has been addressed by filling the shallow channel with topsoil and seed to re-establish vegetation. Item 3 has been addressed by filling the potholes with concrete to match the surrounding grade.

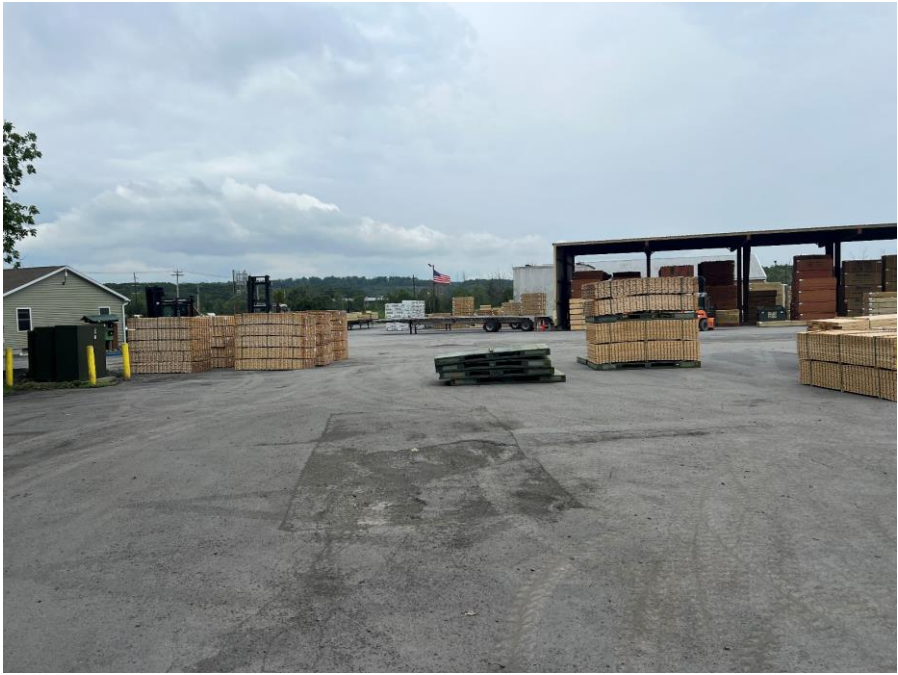
Sterling Environmental Engineering, P.C.			DAILY PHOTOGRAPH LOG	
			<u>Project:</u>	Culpeper Wood Preservers
			<u>Photo By:</u>	Paul Scholar
Photo No. 15	Date 2023-08-04	Time 10:23

Direction Looking:	West			
Comments: Southern portion of protective asphalt cover in acceptable condition.

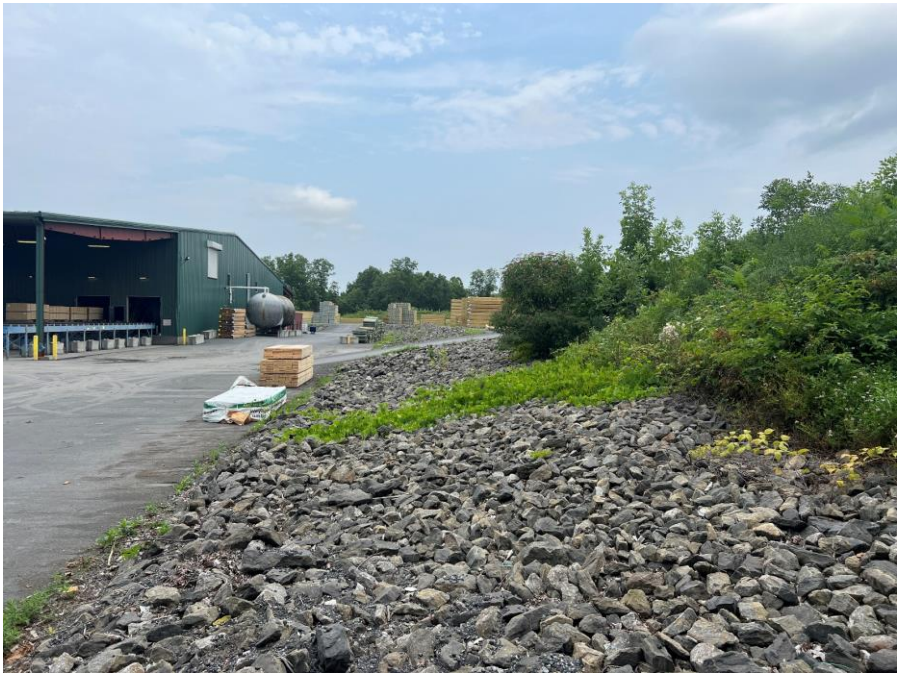
Photo No. 16	Date 2023-08-04	Time 10:23

Direction Looking:	North		
Comments: Grade transition area between treatment process building and storage area in acceptable condition.

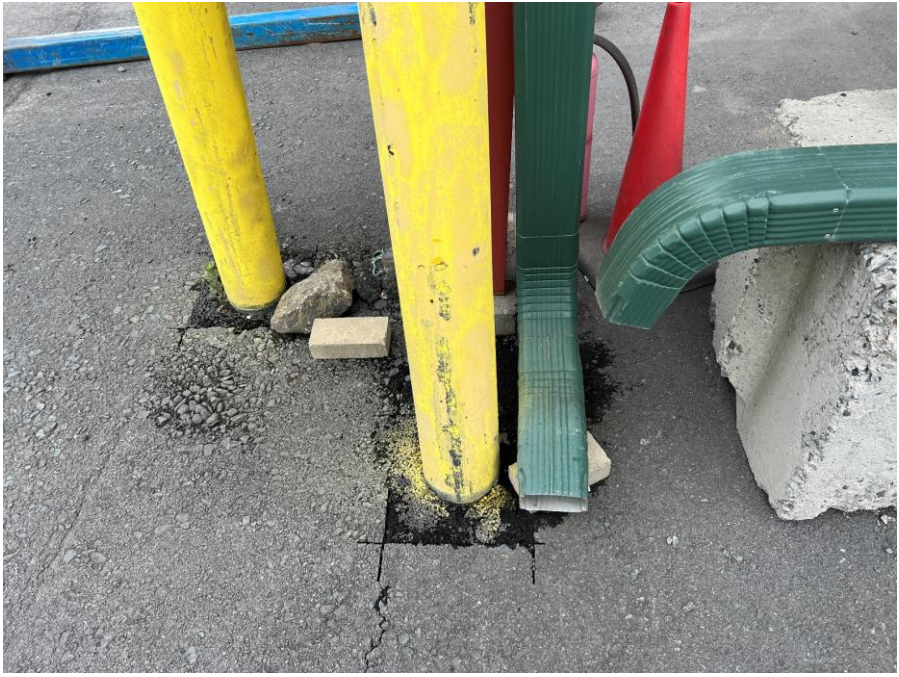
DAILY PHOTOGRAPH LOG		
			Project:	Culpeper Wood Preservers	
			Photo By:	Paul Scholar	
Photo No. 17	Date 2023-08-04	Time 10:33

Direction Looking:	Northwest				
Comments:					
View of bollard repaired with patched asphalt.

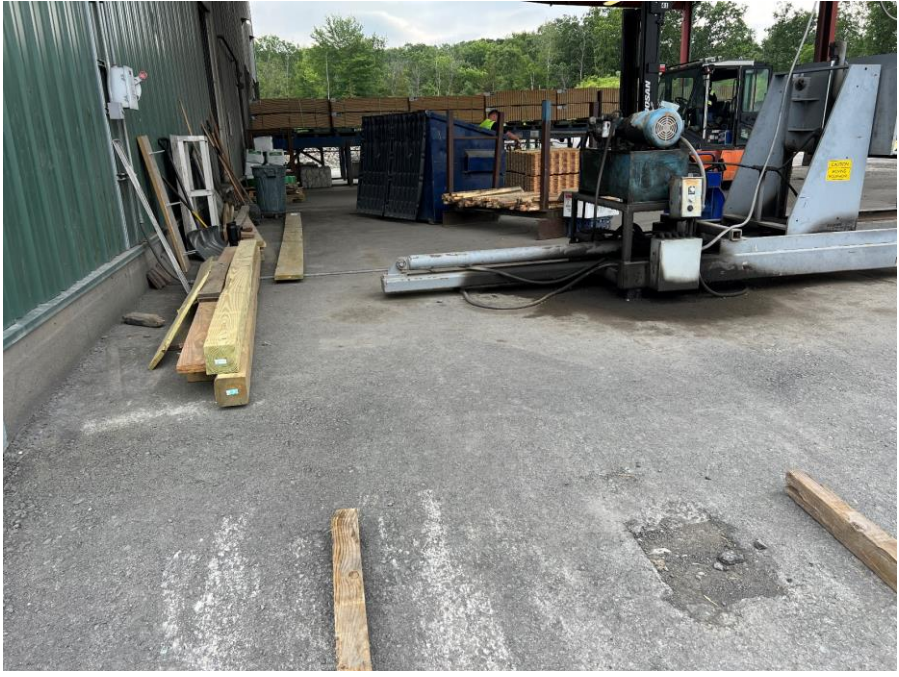
Photo No. 18	Date 2023-08-04	Time 10:32

Direction Looking:	East		
Comments:			
Southwest perimeter of process building.

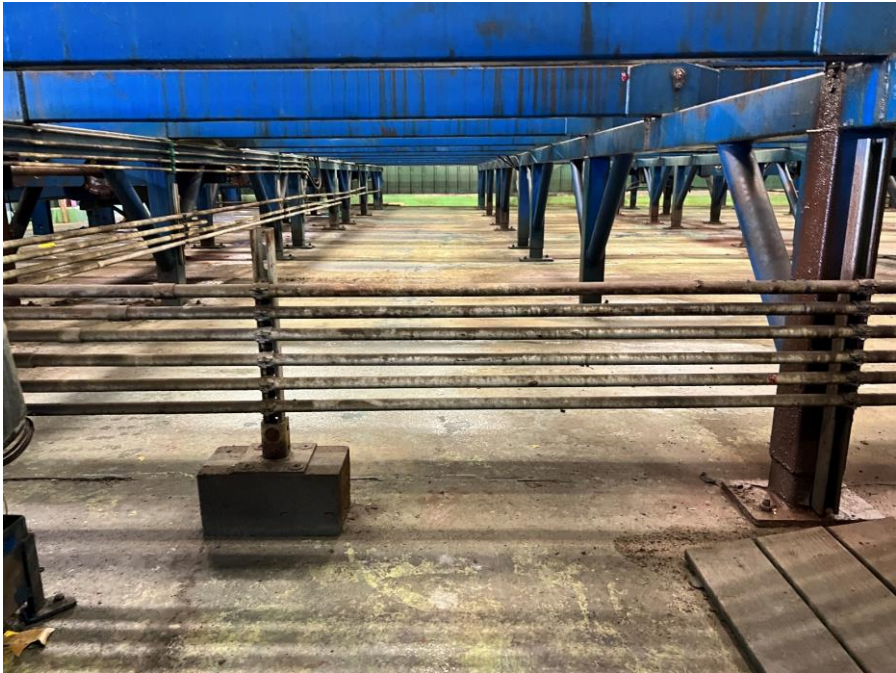
DAILY PHOTOGRAPH LOG	
			<u>Project:</u>	Culpeper Wood Preservers
			<u>Photo By:</u>	Paul Scholar
Photo No. 19	Date 2023-08-04	Time 10:38

Direction Looking:	North			
Comments: Representative concrete cover in acceptable condition within treatment process building.

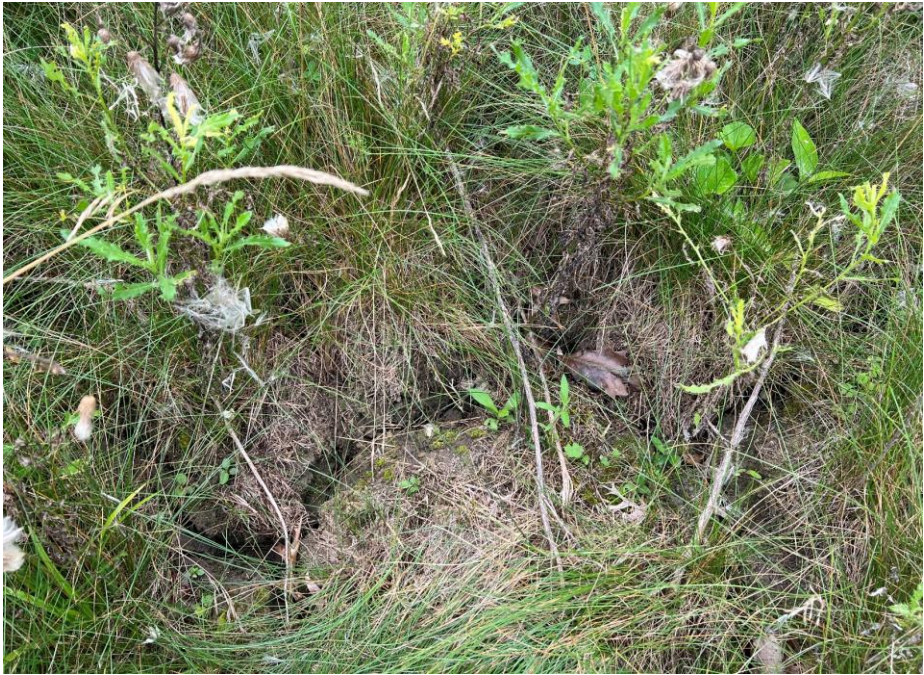
Sterling Environmental Engineering, P.C.			DAILY PHOTOGRAPH LOG		
			Project:	Culpeper Wood Preservers	
			Photo By:	Paul Scholar	
Photo No. 21	Date 2023-08-04	Time 10:19

Direction Looking:	South				
Comments: Minor erosion rill beginning to form within the southern protective soil cover berm.

Maintenance of the Site protective cover will be conducted by the property owner as needed based on inspection observations. As documented in the inspection form and photograph log (Appendix B), a minor erosional rill was beginning to form within the protective soil cover system on the southern abatement berm. This area should be maintained by filling with soil and seeded to prevent further erosion.
