Phase I
Environmental Site Assessment
Former Fort Orange Paper Company Site
1900 River Road
Village of Castleton-on-Hudson
Rensselaer County, New York

C.T. Male Project No: 08.8463

**PHASE I
ENVIRONMENTAL SITE ASSESSMENT REPORT
FORMER FORT ORANGE PAPER COMPANY SITE**

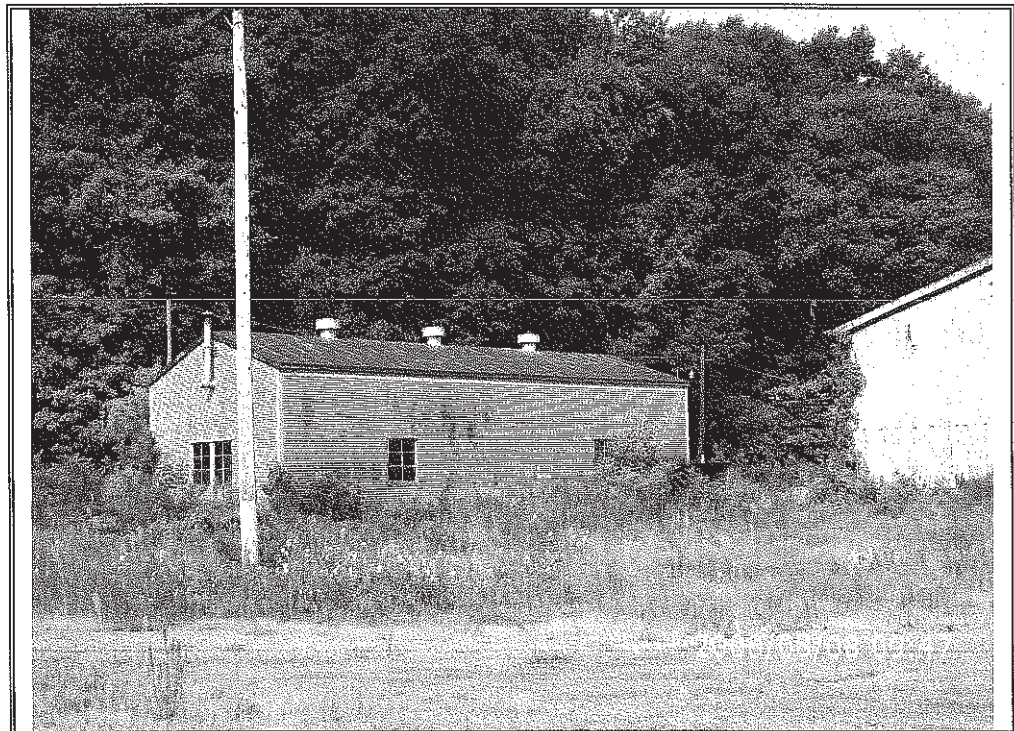
Photograph Number 8

8. Looking west; view of Building #4 (Locomotive House) and wooded land to the west and southwest; southeast end of Building #3 at right in photo.
9. Looking west; interior of Locomotive House; note oil staining on the ground surface.

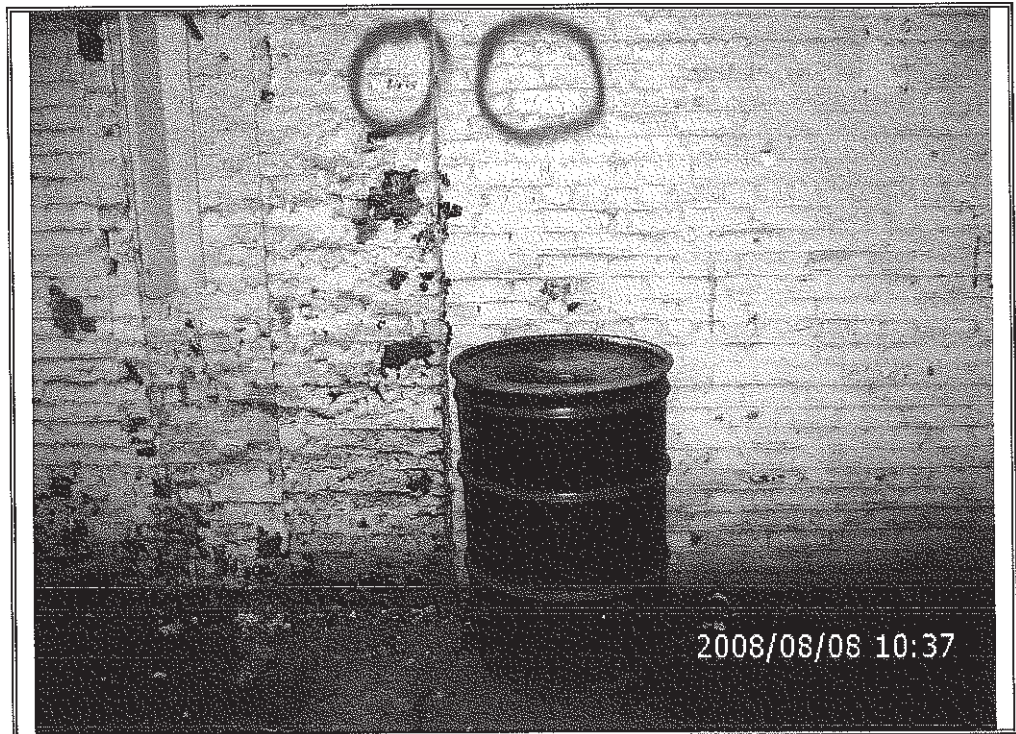
Photograph Number 16

16. View of 55-gallon drum containing unknown liquid within Building #8A (Glue Department).
17. View of interior of Building #8B (Pump Room); sump containing unknown liquid (lower left in photo); 5-gallon bucket containing oil (lower center); significant floor staining.

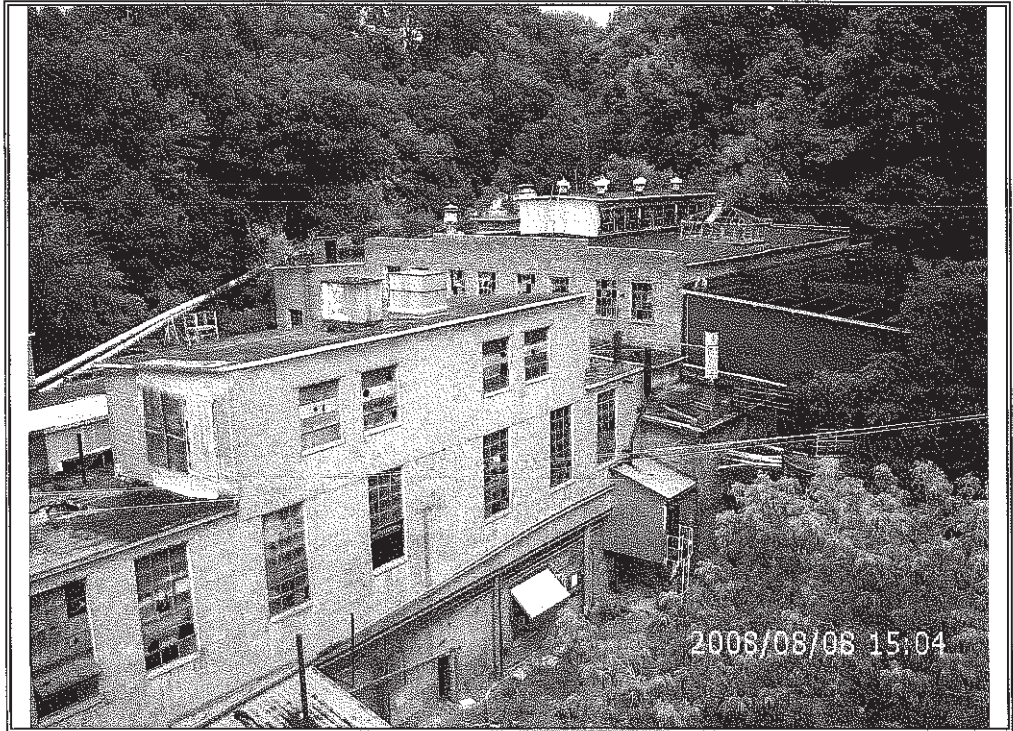
Photograph Number 25

25. Looking northeast; view of eastern portion of the main building complex and wooded land to the east and northeast.
26. View of pad-mounted electrical transformer (non-PCB) adjacent to the Moordener Kill, east-southeast of the main building complex.

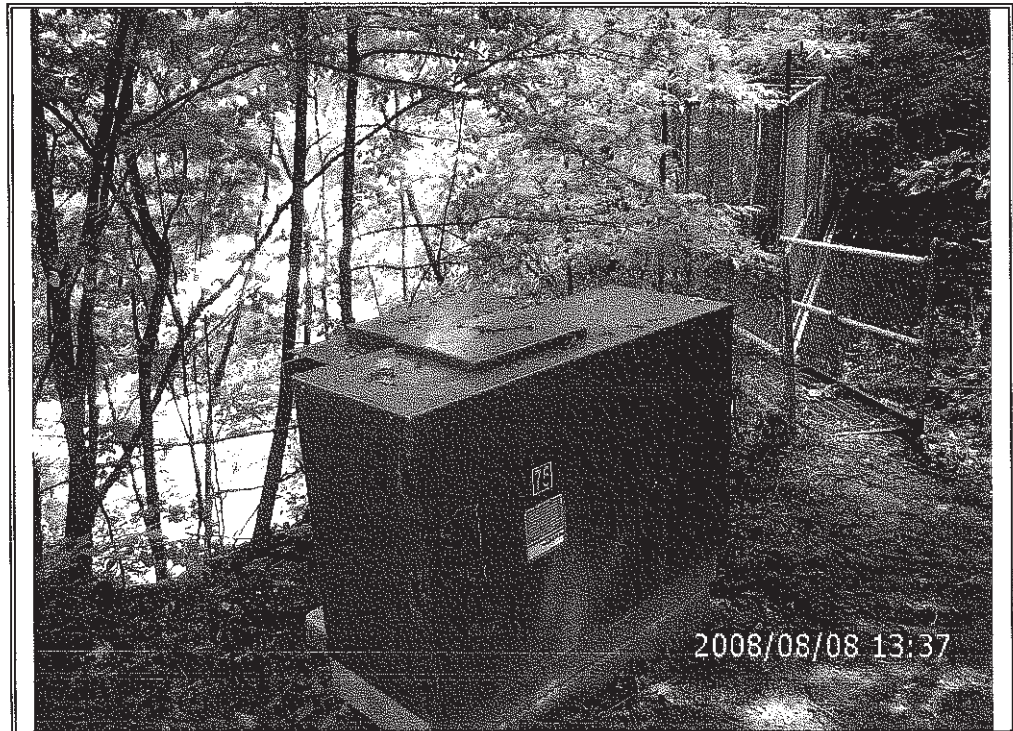
Photograph Number 26

One pad-mounted electrical transformer was identified adjacent to the eastern end of the main building complex. No labels were observed pertaining to its PCB content. No obvious evidence of leakage was observed around the base of the transformer. A second pad-mounted transformer was observed within a wooded portion of the site to the east of the main building complex. According to a label observed on the transformer, it is classified as "Non-PCB" containing.
