**Remedial Investigation &
Tank Closure Program**

MOHAWK HONDA

728-756 STATE STREET
SCHENECTADY, NEW YORK 12307
NETC PROJECT #02.08164

September 22, 2003

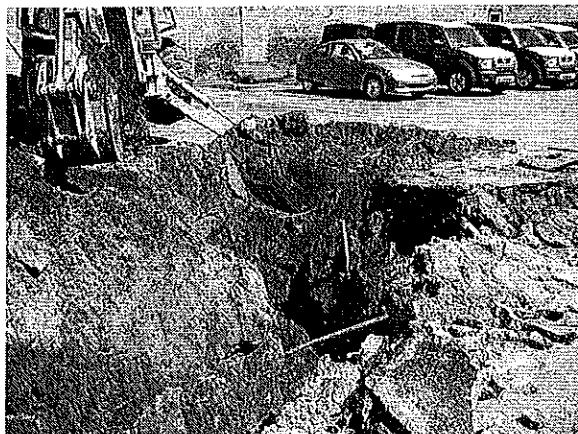
Exposing UST-1 & 2

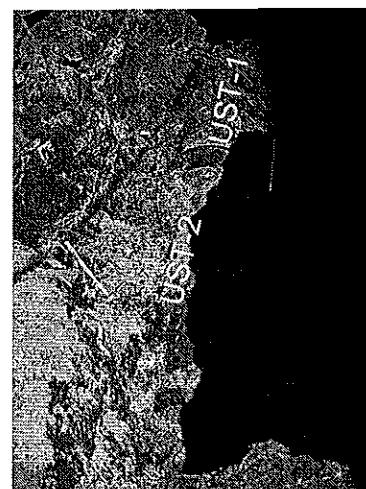
UST-1 and UST-2

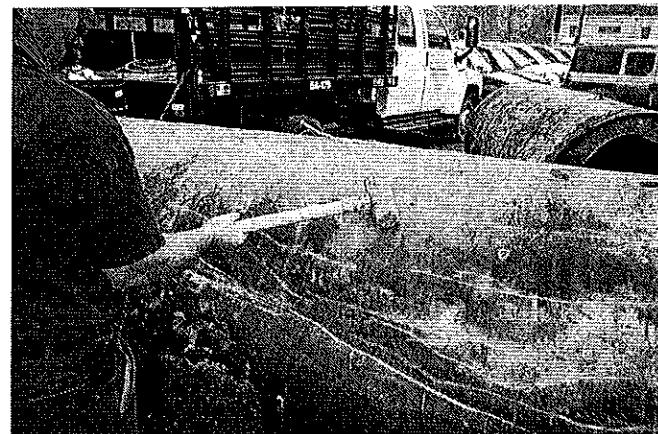
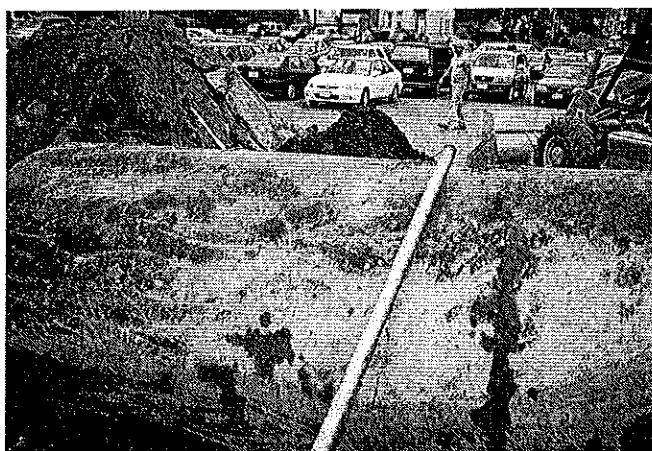
Two 1000 gallon gasoline UST's (i.e., UST # 1 and 2) were decontaminated and removed from exploration Area #1. Visual inspection of the UST's identified pitting and corrosion (i.e., \leq 1 inch diameter) in each USTs. The UST's were installed end to end and manifolded via two 1 inch diameter steel pipes. The UST's were encountered at a depth \pm 7.0 feet below ground surface (bgs) below an asphalt layer. The unconsolidated material encountered above the buried asphalt layer consisted of a sand and gravel cultural fill layer. The unconsolidated deposits encountered below the buried asphalt layer consisted of a brown medium to fine sand, and some silt. Groundwater was observed approximately 10.0 feet bgs.

Holes found in UST-1 & 2

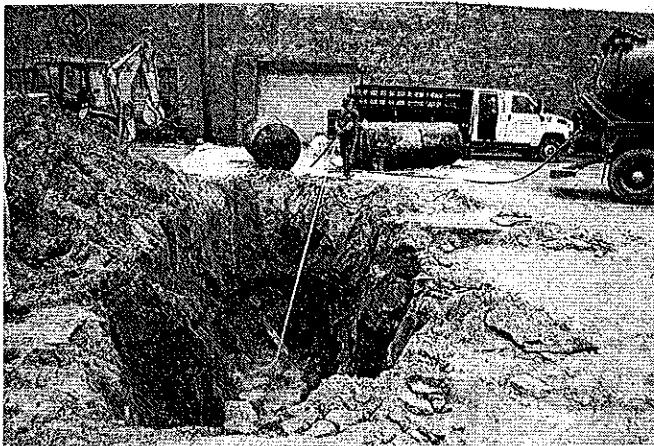
Excavation after UST removal

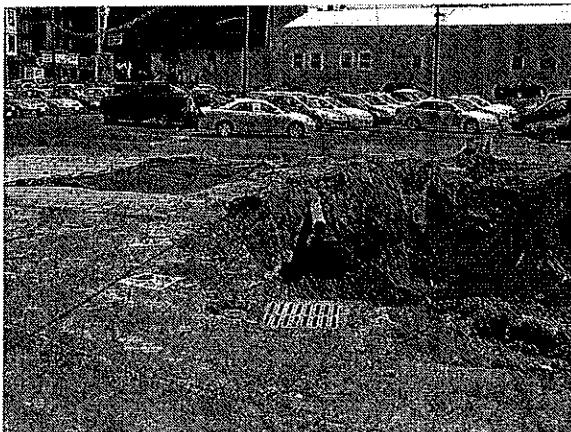
Northern edge of excavation

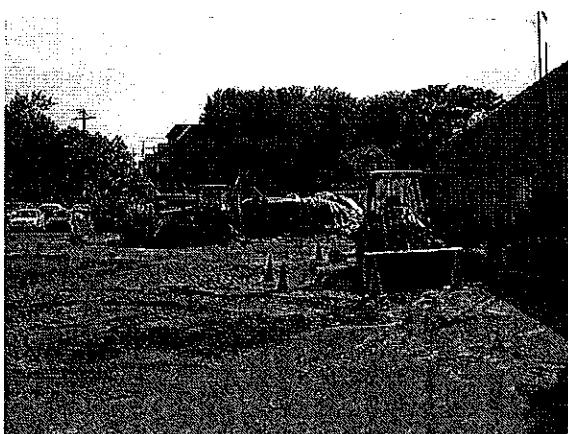
Excavation after completed soil removal and backfilling

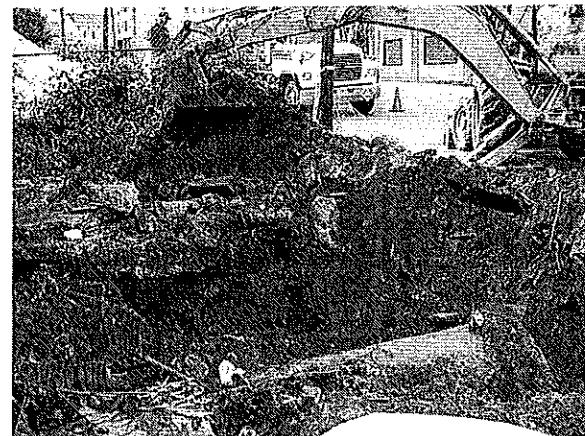
Exposing UST-3

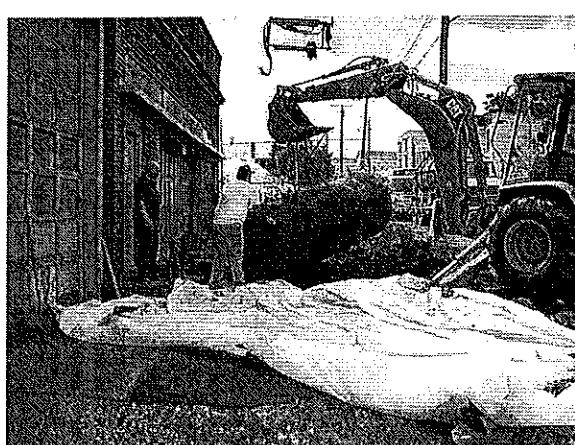
One 1000 gallon waste oil (i.e., UST # 3) was decontaminated and removed from Area #2. Visual inspection identified one structure failure at the base of the UST. The top of the UST was encountered at 2 feet below ground surface (bgs). The upper 7.0 foot of unconsolidated deposits adjacent to the UST consisted of cultural fill (i.e., sand, gravel, brick, shale rock). The unconsolidated deposits below the fill layer consisted of brown medium to fine sand, and some silt. Groundwater was encountered at a depth of \pm 7.0 feet bgs.

UST-3 Removed from Excavation

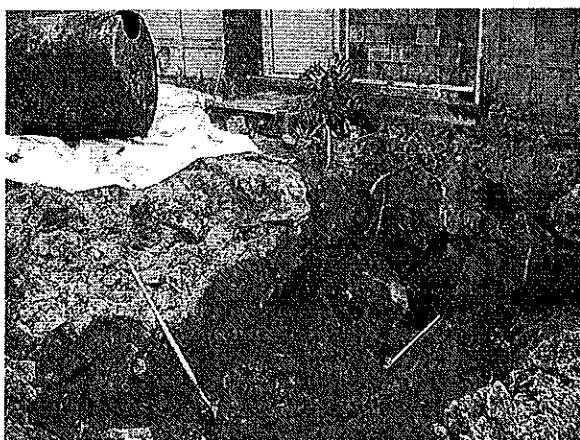
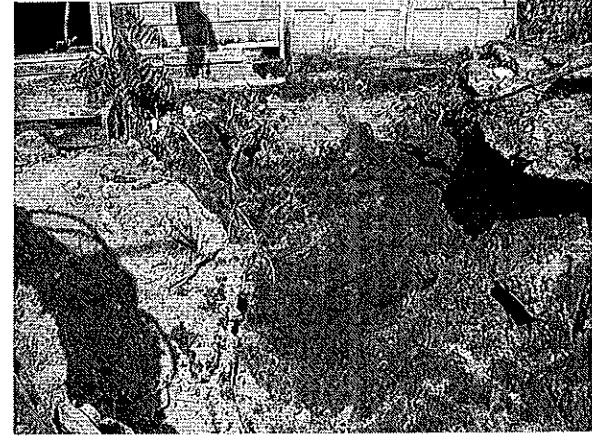
Excavation after UST-3 removal

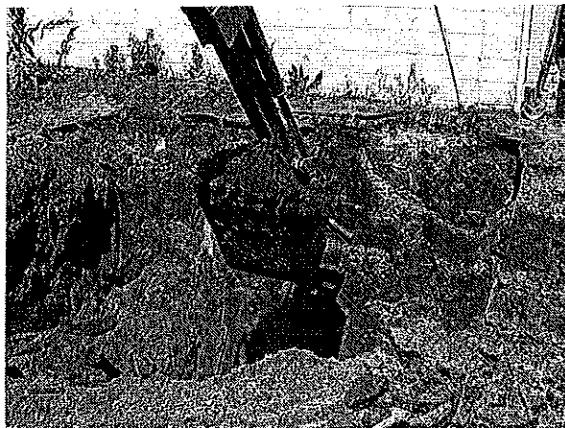
Excavation of Area 3 - west side

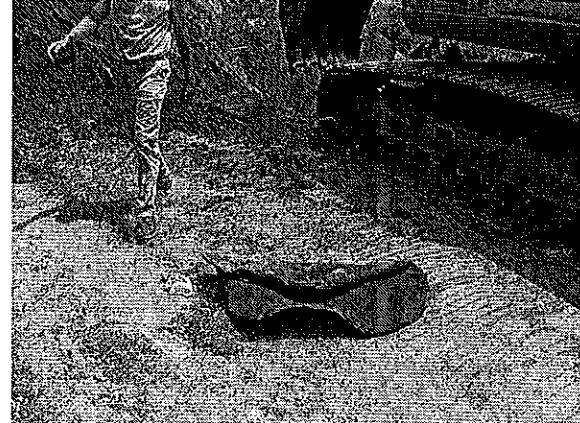
End of UST found in excavation

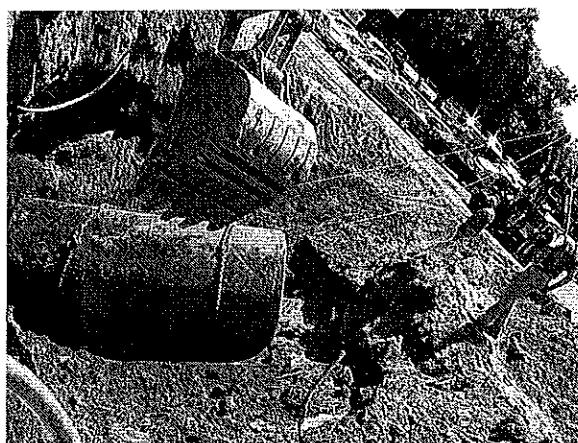
UST-4 Being removed from excavation

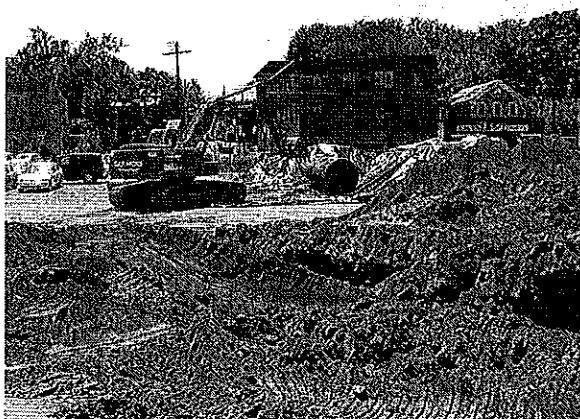
UST-4 removed from excavation and placed on plastic

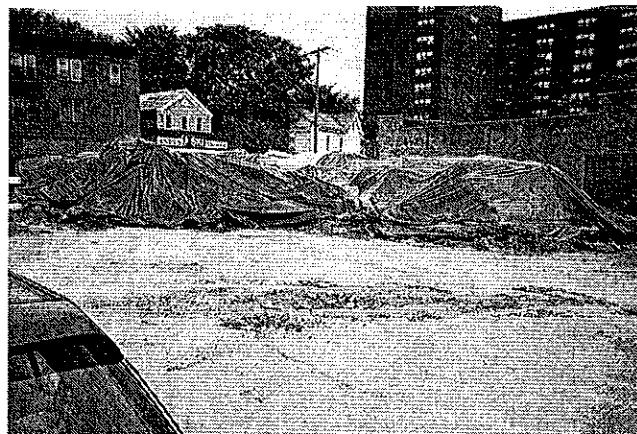
Stockpiled petroleum contaminated soil
