**INTERIM REMEDIAL MEASURE #1
(Excavation Pit #1, EP1)
CONSTRUCTION COMPLETION REPORT
For**

**FORMER HAIGHT /AMERICAN HIDE TANNERY SITE
125 Bath Street
Ballston Spa, New York, Saratoga County**

NYSDEC BCP Site No. C546055-10-12

May 2014

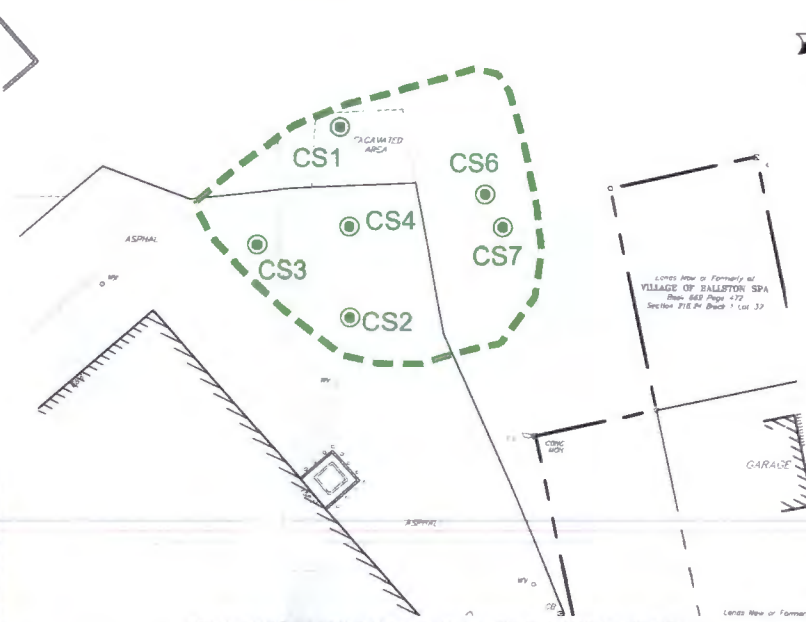
CONFIRMATORY EP1 SAMPLE LOCATIONS
SCALE: 1" = 30'

The above confirmatory sample results indicate that OU1/EP1 was remediated to Restricted Use Industrial SCOs (*see* Appendix C). Appendix B contains the EP1 Confirmatory Sampling Maps, which depicts the location and depth of the confirmatory samples. In addition, the wastewater sample results for the disposal of the water removed from EP1 during excavation is included in Appendix C.

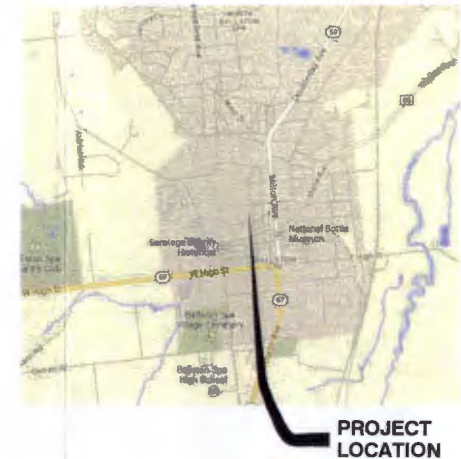
STATE OF NEW YORK SARATOGA COUNTY		VILLAGE OF BALLSTON SPA BATH STREET EPI CONFIRMATORY SAMPLING MAP OF THE LANDS OF LINEN SYSTEM HOSPITAL, INC.		SHEET REFERENCE NUMBER: 1 SHEET 1 OF 1	
KHEOPS ARCHITECTURE, ENGINEERING & SURVEY, DPC 300 Pearl Street, Suite 100 Buffalo, New York 14202 P: 716.851.0800 F: 716.851.0801 WWW.KHEOPSDPC.COM		Designed by:	Date:	05/2014	Job No.
		Drawn by:	TAP		
		Checked by:	MLB		
		Dwg. Scale:	HORIZ. AS SHOWN VERT. AS SHOWN		
<small>© COPYRIGHT 2014 KHEOPS ARCHITECTURE, ENGINEERING & SURVEY, DPC. ALL RIGHTS RESERVED. UNAUTHORIZED DUPLICATION IS A VIOLATION OF FEDERAL AND STATE LAWS. THIS REPORT IS A VIOLATION OF SECTION 1705 OF THE NEW YORK STATE EDUCATION LAW. THESE PLANS ARE NOT SUITABLE FOR MACHINE GUIDANCE USE OR PURPOSES.</small>

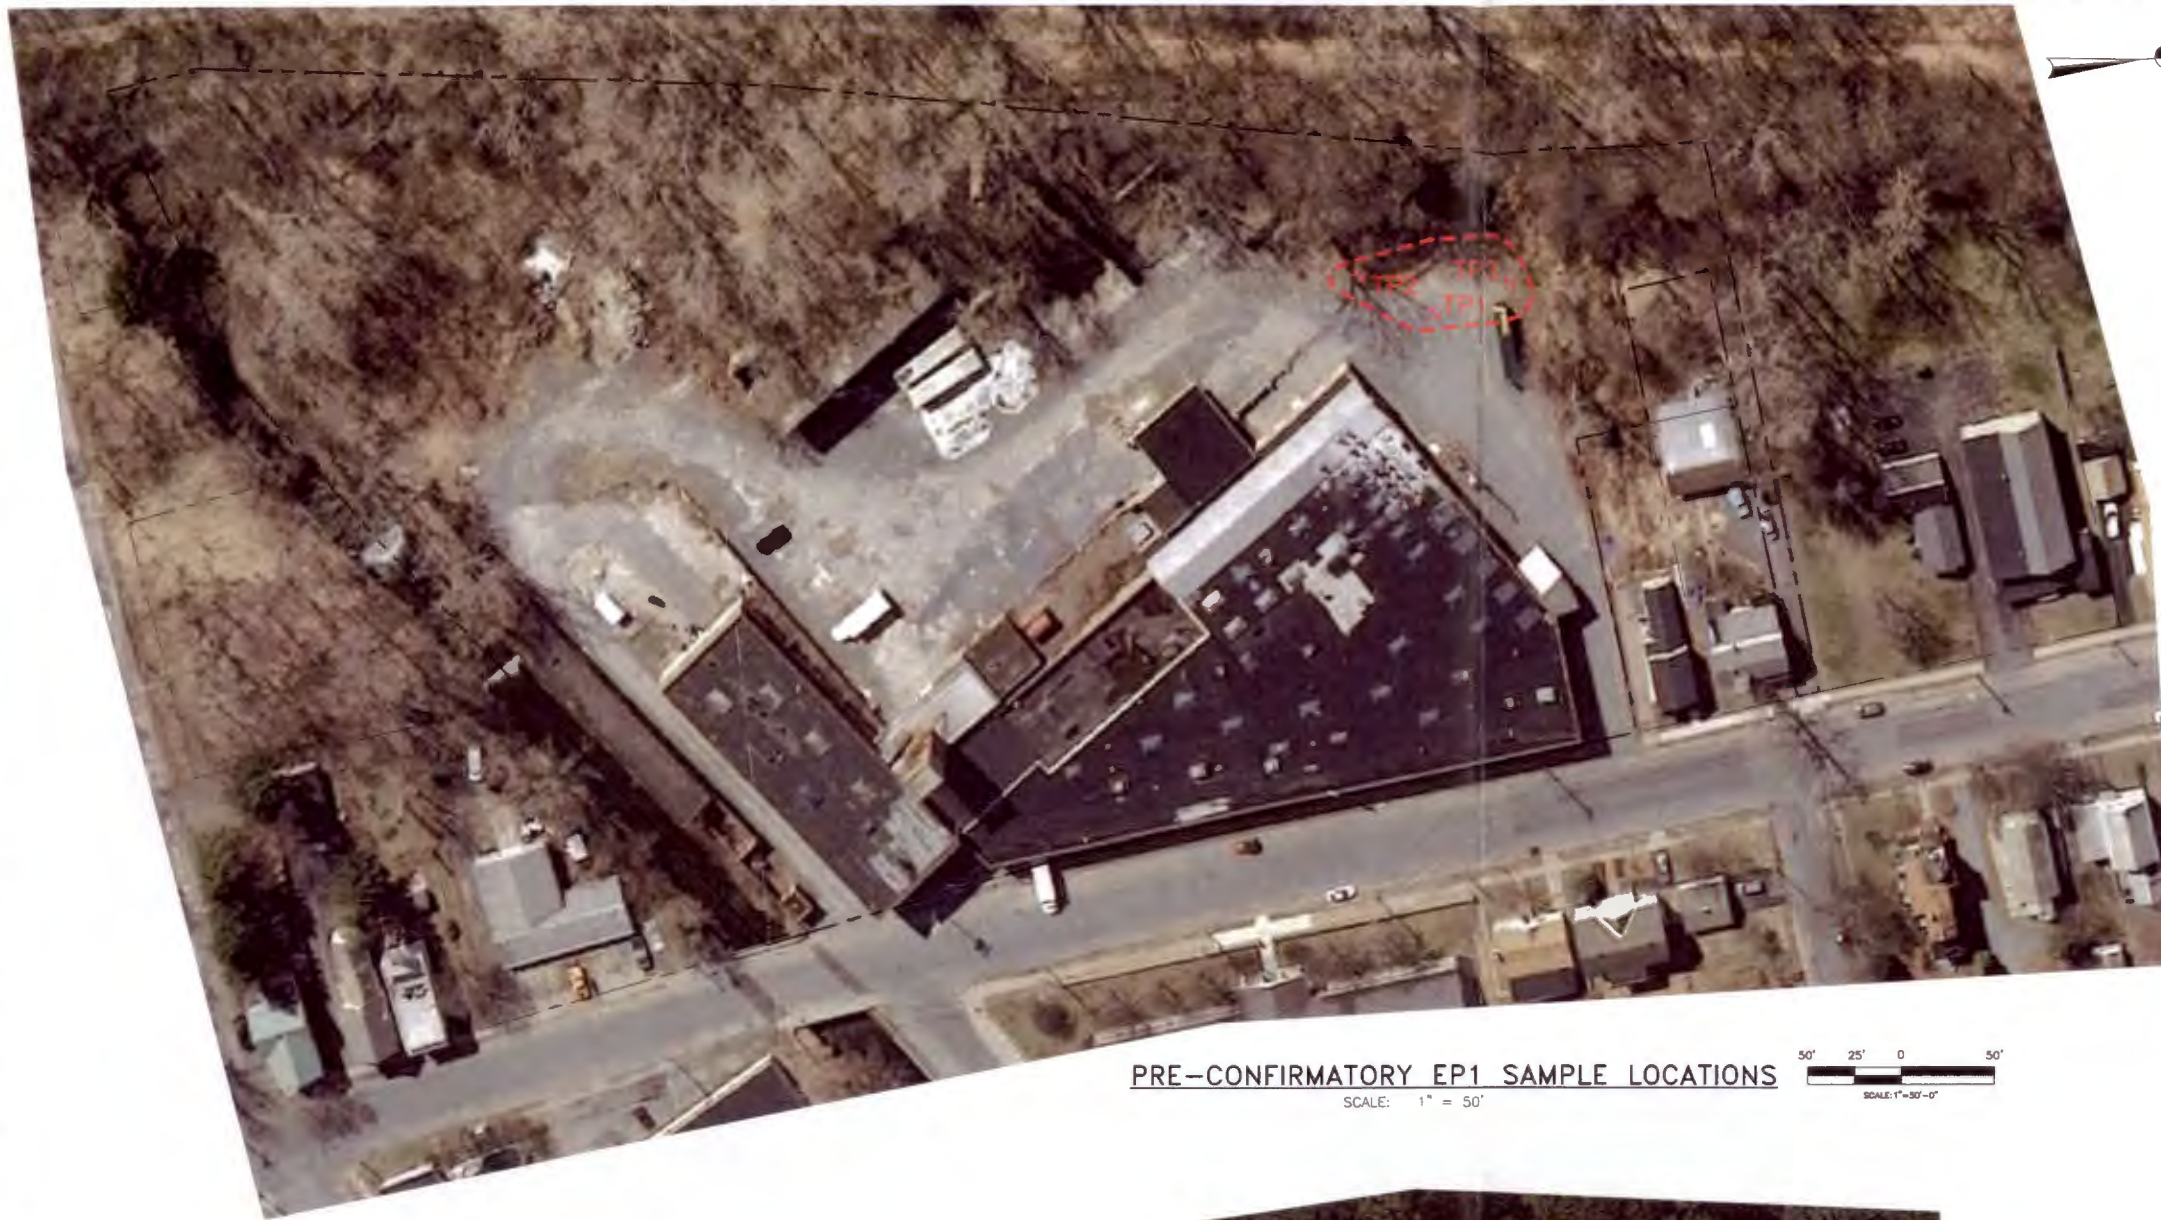
PRE-CONFIRMATORY EP1 SAMPLE LOCATIONS
SCALE: 1" = 50'
