AOC #1
REMEDIAL ACTION WORK PLAN
for the
BROWNFIELD CLEANUP PROGRAM
at the
FORMER ONEIDA KNIFE PLANT
LOT 1
Kenwood Avenue
City of Sherrill, Oneida County, New York
NYSDEC Site No. C633077

8232 Loop Road
Baldwinsville, New York 13027
(315) 638-8587
Project No. 2015025

September 2017
Revised December 2017

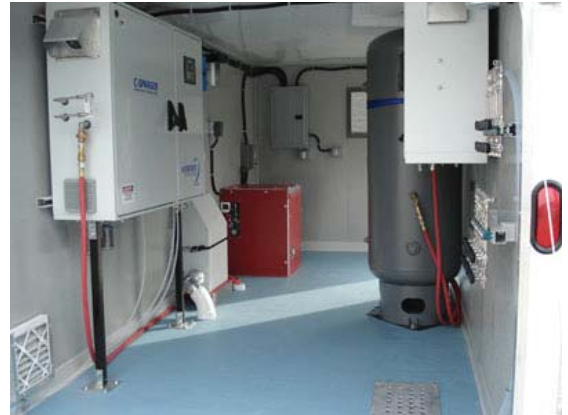
MODEL 8100 (WALL-MOUNT)

- Low capital equipment/operating costs
- Ease of installation and setup
- Requires standard 120VAC household current
- Minimal installation site disturbance
- Variety of systems: wall-mount, modular, trailer
- Ozone/peroxide matched to site requirement (from 0.5-8.0 lbs/day ozone)
- Hydroxyl radical formation dramatically boosts reaction potential
- Pulsed microbubble oxidant injection ensures maximum contaminant contact
- Clean in-situ destruction of contaminants – no hazardous byproducts
- No vapor control necessary Does not form hexavalent chromium
