Re: Periodic Review Report and IC/EC Certification Submittal
IBM Gun Club, Former Burn Pit Area
Robinson Hill Road, Union, NY 13760
NYSDEC Site # C704044

Re: 2017 Periodic Review Report
IBM Gun Club – Former Burn Pit Area
Union, New York
BCP Agreement #C704044

2017 PERIODIC REVIEW REPORT FORMER BURN PIT AREA

IBM Gun Club - Former Burn Pit Area
Union, New York

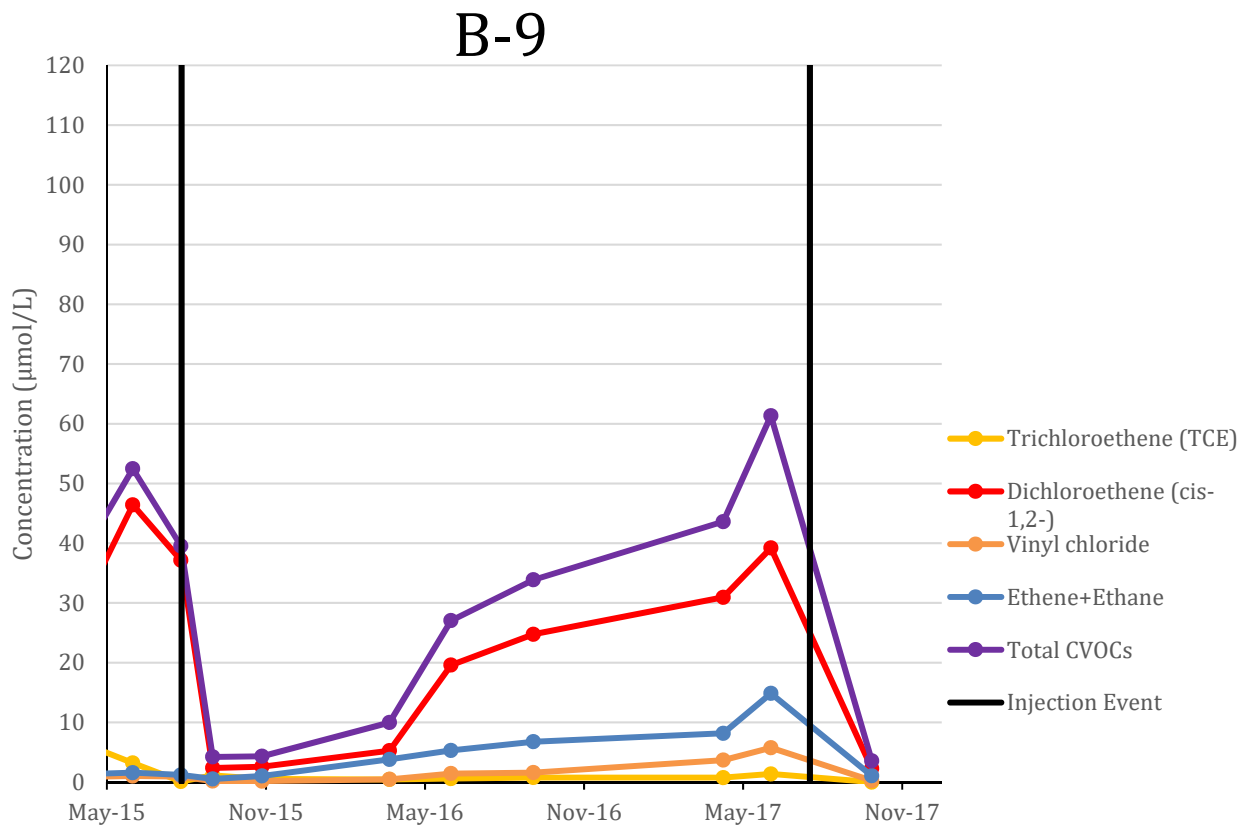
Exhibit 3.5 – Molar Concentrations of TCE and Breakdown Products for Injection Borehole B-9- a location in the B-line IDZ exhibiting about the median transmissivity for the B-series boreholes.

Injection borehole B-9 exhibits high transmissivity in comparison to what is observed in the B-series boreholes. TCE has represented less than 30% of the molar mass at this location since the first B-series injection in July 2014, down from 90%. This well responds quickly to injection events with steeply declining VOC concentrations, while the effects are transported downgradient relatively quickly compared to other, less transmissive injection boreholes.

As reflected in selected time-series line plots to follow (Exhibits 3.4-3.7), concentrations of the principal parent compound, TCE, continue to decline consistent with the objectives of the long-term remedy. The plots below represent a selection of representative monitoring locations and show molar concentrations of TCE, primary, and terminal breakdown products over the period spanning the last two injection events through October 2017.

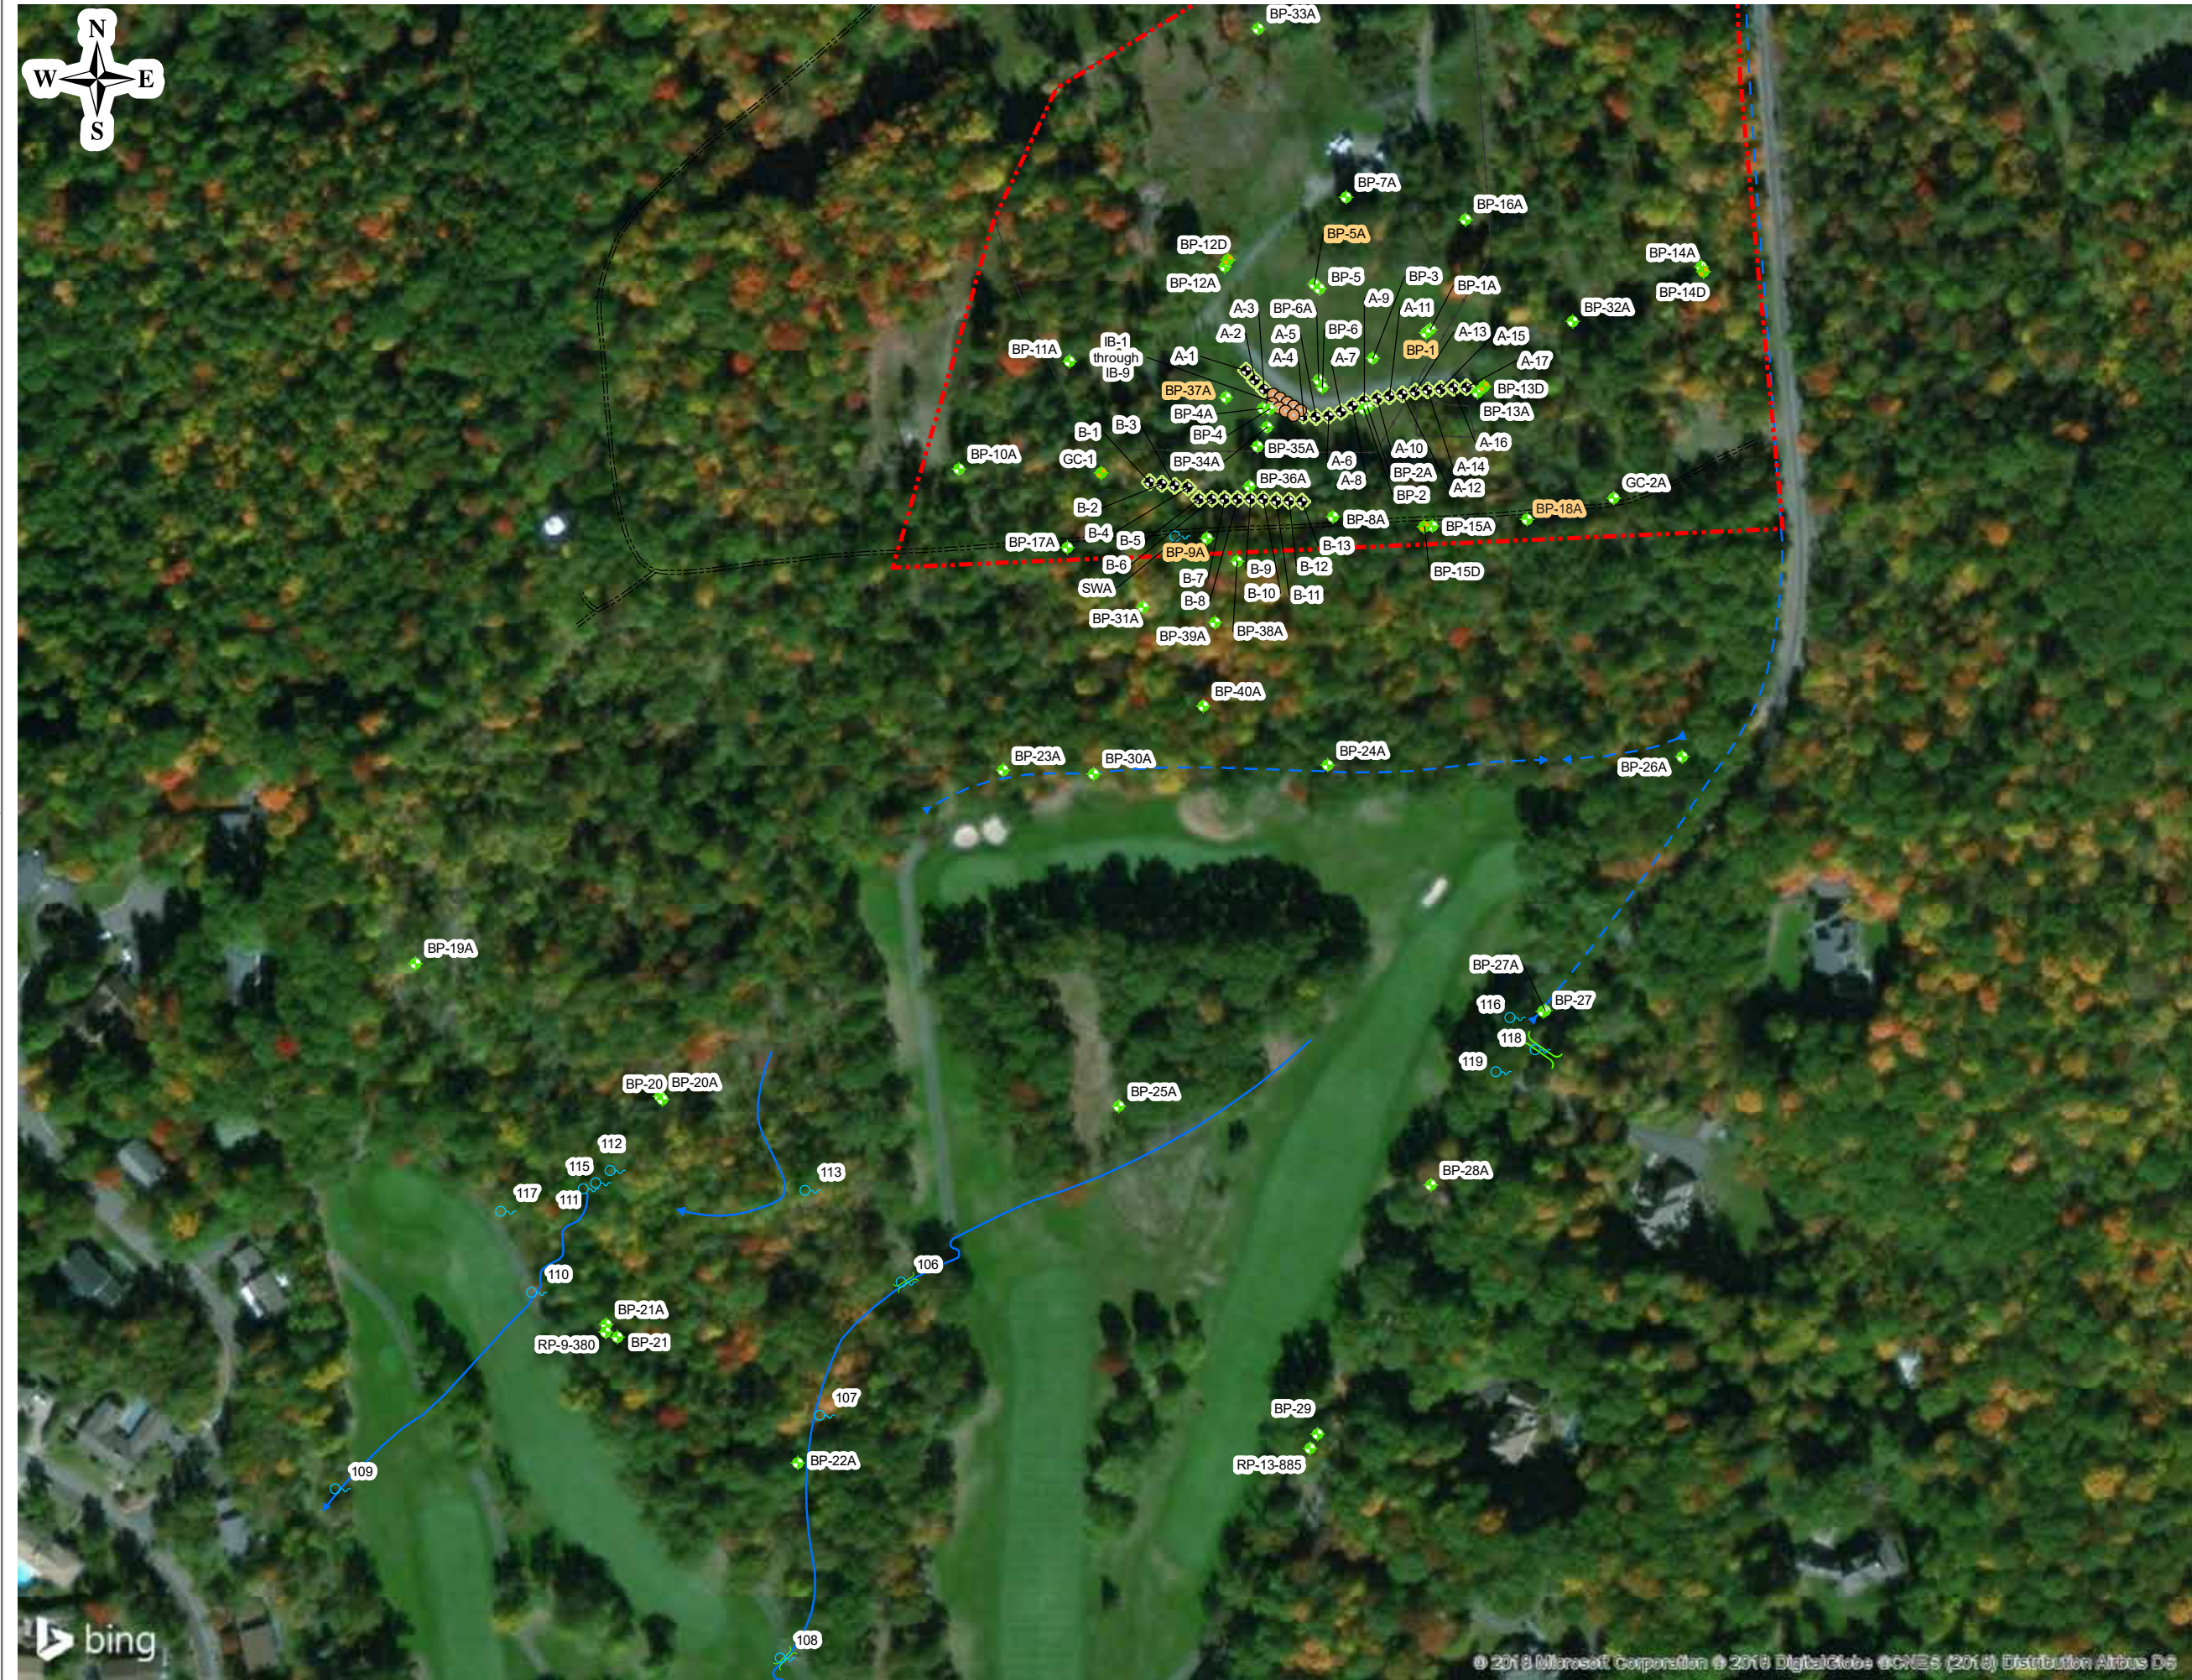
The principal contaminants driving the need for remediation at this Site are chlorinated ethenes, primarily trichloroethene (TCE) and its biochemical breakdown products, cis-1,2 dichloroethene (cDCE) and vinyl chloride (VC). Other VOCs were found in soil, rock, and groundwater during remedial investigation work at the Site, but less frequently and at lower concentrations relative to applicable standards. They included chlorinated methanes, chlorinated ethanes, ketones, and petroleum hydrocarbons. VOCs were the only contaminants identified as contaminants of concern (COCs) for groundwater, soil, and rock media, and are the subject of remedy performance monitoring². Figure 3 provides a plan view of the monitoring network.

Monitoring Location Plan

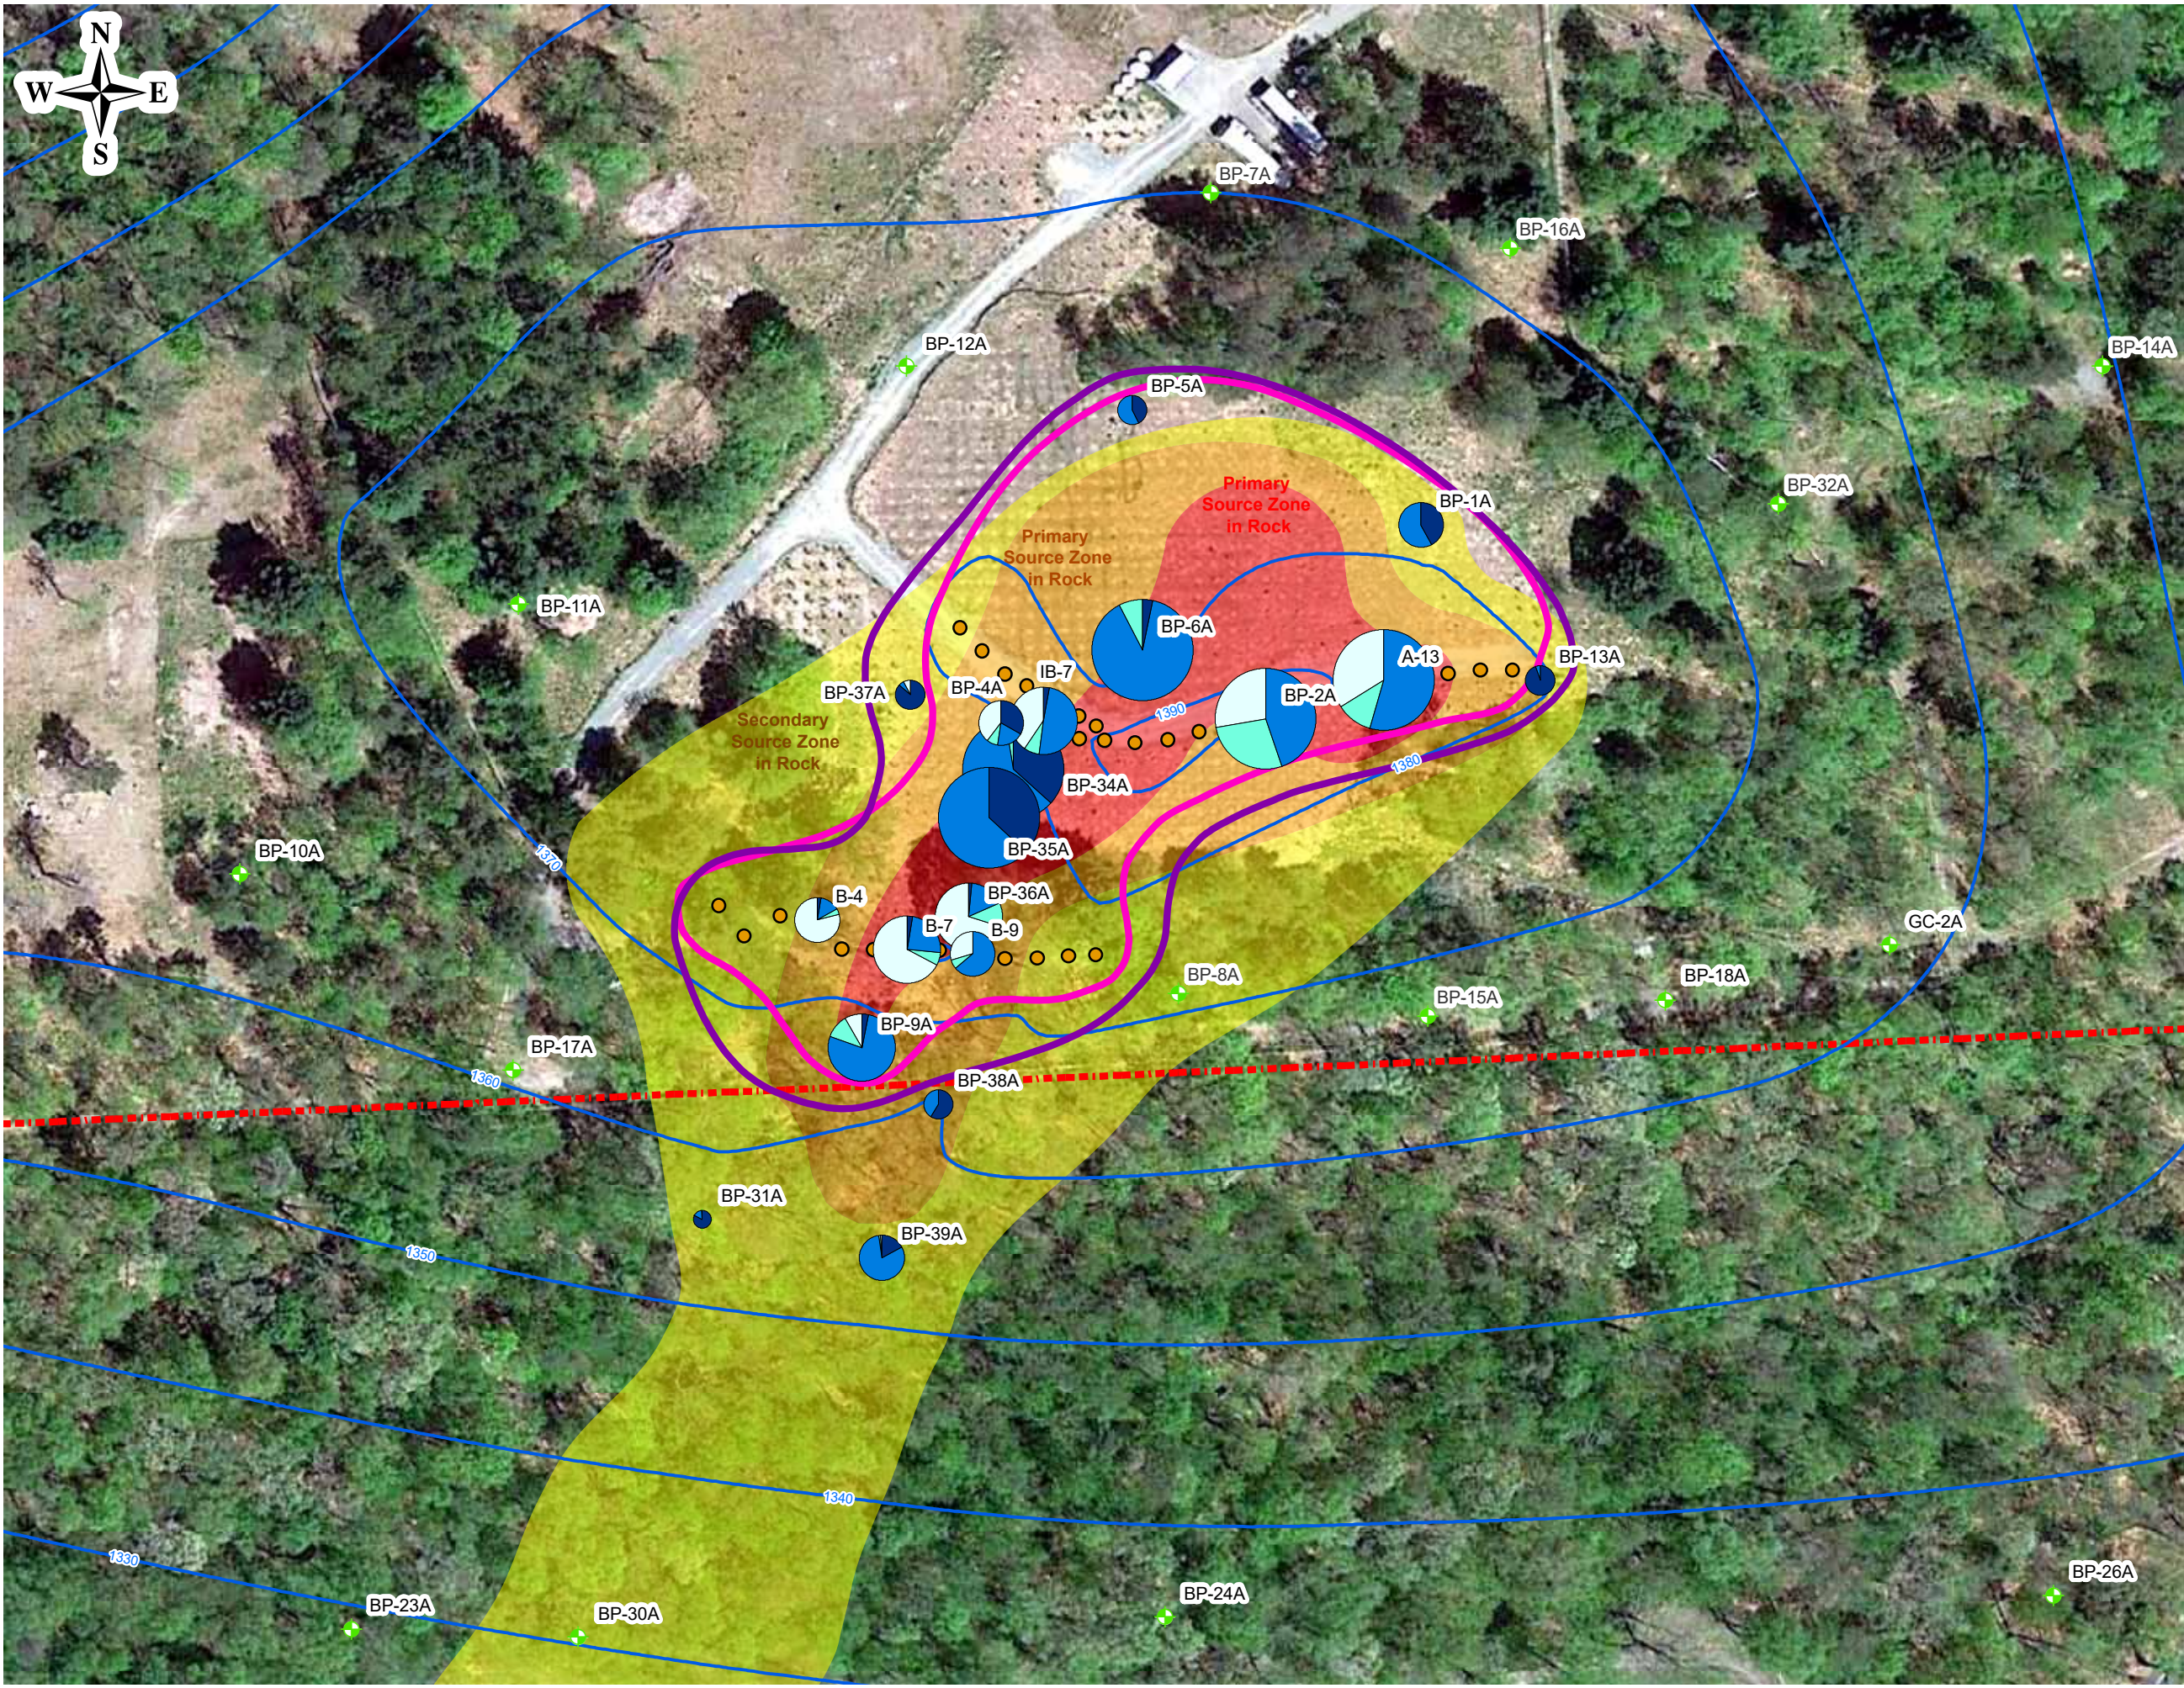
Figure 4

As shown by the October 2017 pie charts on Figure 4, TCE is no longer the most prevalent chlorinated ethene found in groundwater samples collected from most locations within the primary source rock, with TCE molar fractions generally less than 50%. As previously reported, prior to the initiation of the remedy, TCE made up most of the chlorinated ethane mass, representing 85% to over 90% of the mass within the plume, with small amounts of cDCE and only traces of the terminal breakdown products.

Summary of Geochemical Conditions - Sulfate-Reducing

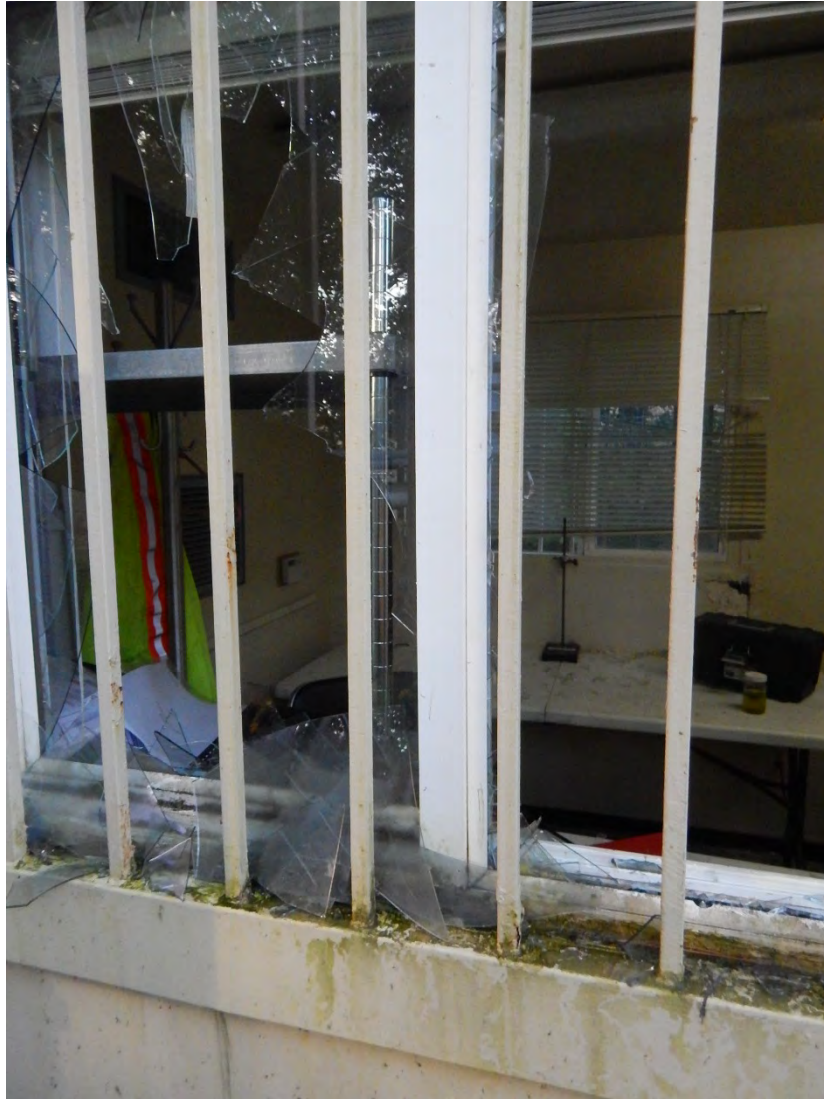
Two occurrences of vandalism to the field office were observed upon arrival for the September 26, 2017 Site inspection and the October 2017 sampling event. Interior damage was observed to windows and equipment, with a few materials stolen, including the wireless internet router. The east gate entrance lock on Robinson Hill road was also observed to have been broken, but no damage was observed to the perimeter fence. GSC completed repairs to the trailer, including installation of a ¼" aluminum plate with tamper-proof screws over the windows and door handle on the field office.

Photo 15: Window broken through steel bars at the site trailer.

- Upon arrival for the inspection, the office trailer portion of the on-site storage container was found have been vandalized. Upon arrival for sampling approximately two weeks later, it was found vandalized again. It is unclear how entry was gained through the perimeter fence as no damage was observed, but trailer repairs have been completed and enhancements to security are underway.
