Re: 2018 Periodic Review Report and IC/EC Certification Submittal
IBM Gun Club, Former Burn Pit Area
Robinson Hill Road, Union, NY 13760
NYSDEC Site # C704044

Re: 2018 Periodic Review Report
IBM Gun Club – Former Burn Pit Area
Union, New York
BCP Agreement #C704044

Attachment A – Institutional and Engineering Controls Certification Form
Attachment B – Remedy Performance Testing Reports of April, June, and September 2018
Attachment C – Site-Wide Inspection Report for September 2018
Attachment D – Maintenance Reports for 2018

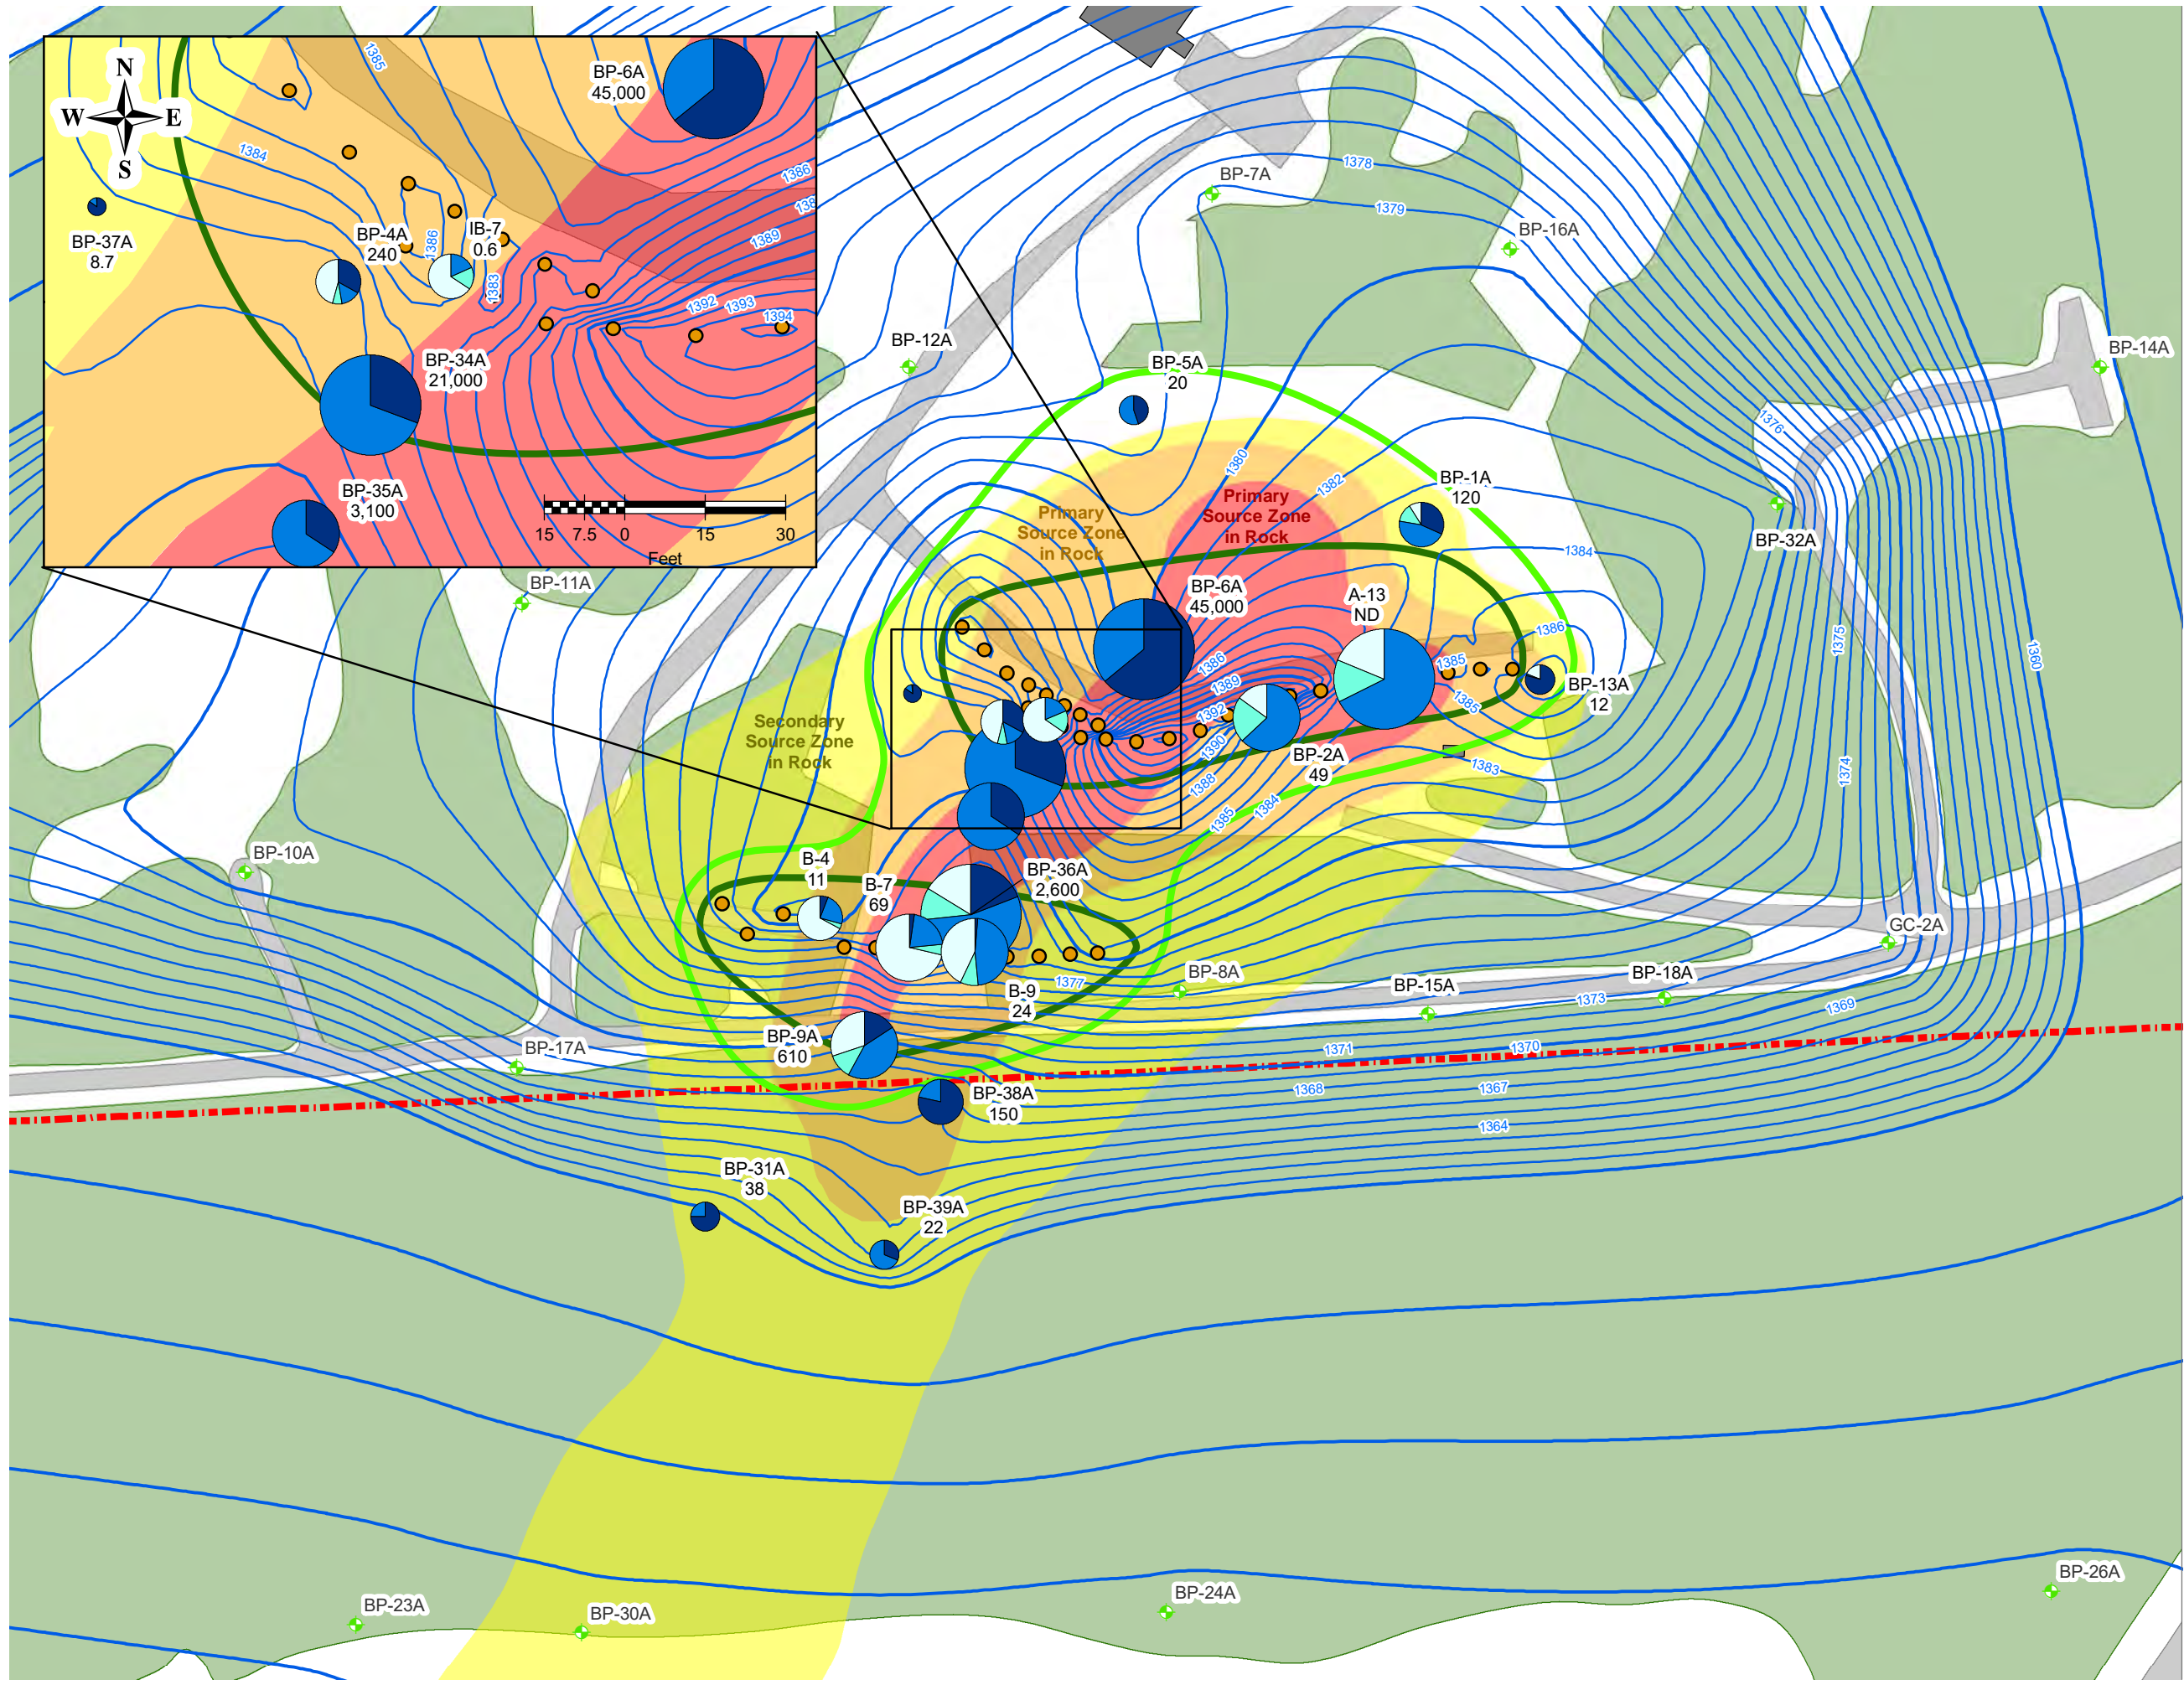
Figure 1 Summary of April 2018 Groundwater Quality Conditions

The inferred geochemical (REDOX) conditions are based on observations of oxidation-reduction potential (ORP), methane, sulfide, ferrous and total iron, and nitrate. Methanogenic conditions are characterized by methane concentrations ≥ 20 $\mu\text{g/L}$, sulfate reducing by sulfide ≥ 50 $\mu\text{g/L}$, iron reducing by $\text{Fe(II)/Fe(tot)} \geq 0.7$ mg/L , and nitrate reduction by nitrate < 1 mg/L . ORP is generally expected to be less than 200 for iron reduction, less than 100 for sulfate reduction, and less than 0 for methanogenic conditions.

A summary of the groundwater quality data and inferences is presented on Figure 1. Figure 2 is an interactive PDF figure presenting the geochemical data used to infer the geochemical conditions shown on Figure 1. Field sampling records and analytical laboratory reports are kept on file and available upon request.

The field and laboratory data for April 2018 indicate remedy performance generally consistent with project performance goals established in the SMP. Geochemical conditions generally remain within ranges that are favorable for reductive dehalogenation over most of the source area. An injection of edible oil amendment was conducted in August 2017; thus, the April 2018 data reflects conditions about 8 months later. As shown on Figure 1, the overall area of sulfate-reducing conditions, which are marginally conducive to reductive dehalogenation, is consistent with previous monitoring in October 2017. The area under methanogenic conditions that is most conducive to reductive dehalogenation is inferred to be slightly larger than that observed at the end of 2017, encompassing BP-34A and BP-9A, downgradient of the A-line and B-line of injection boreholes, respectively. Figure 2 (an interactive PDF) presents the geochemical data used to infer the geochemical conditions shown on Figure 1.

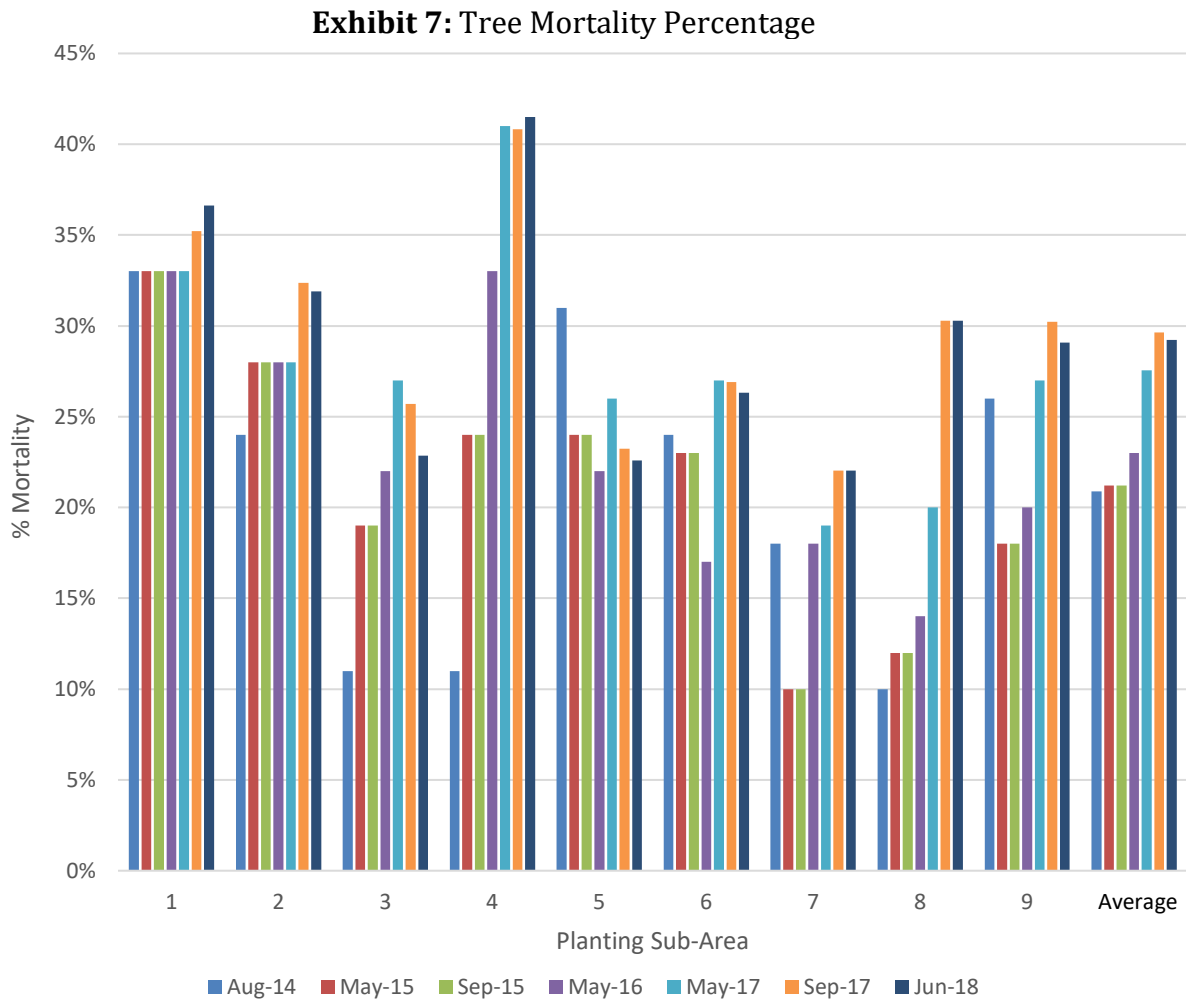
Exhibit 7 below shows the tree mortality percentages for each tree planting sub-area since inspections began in August 2014. Mortality rates ranged from 41% (Area 1) to 22% (Area 7), with an overall mortality of 30%. In general, mortality in each area is stable or improved since the October 2017 inspection.

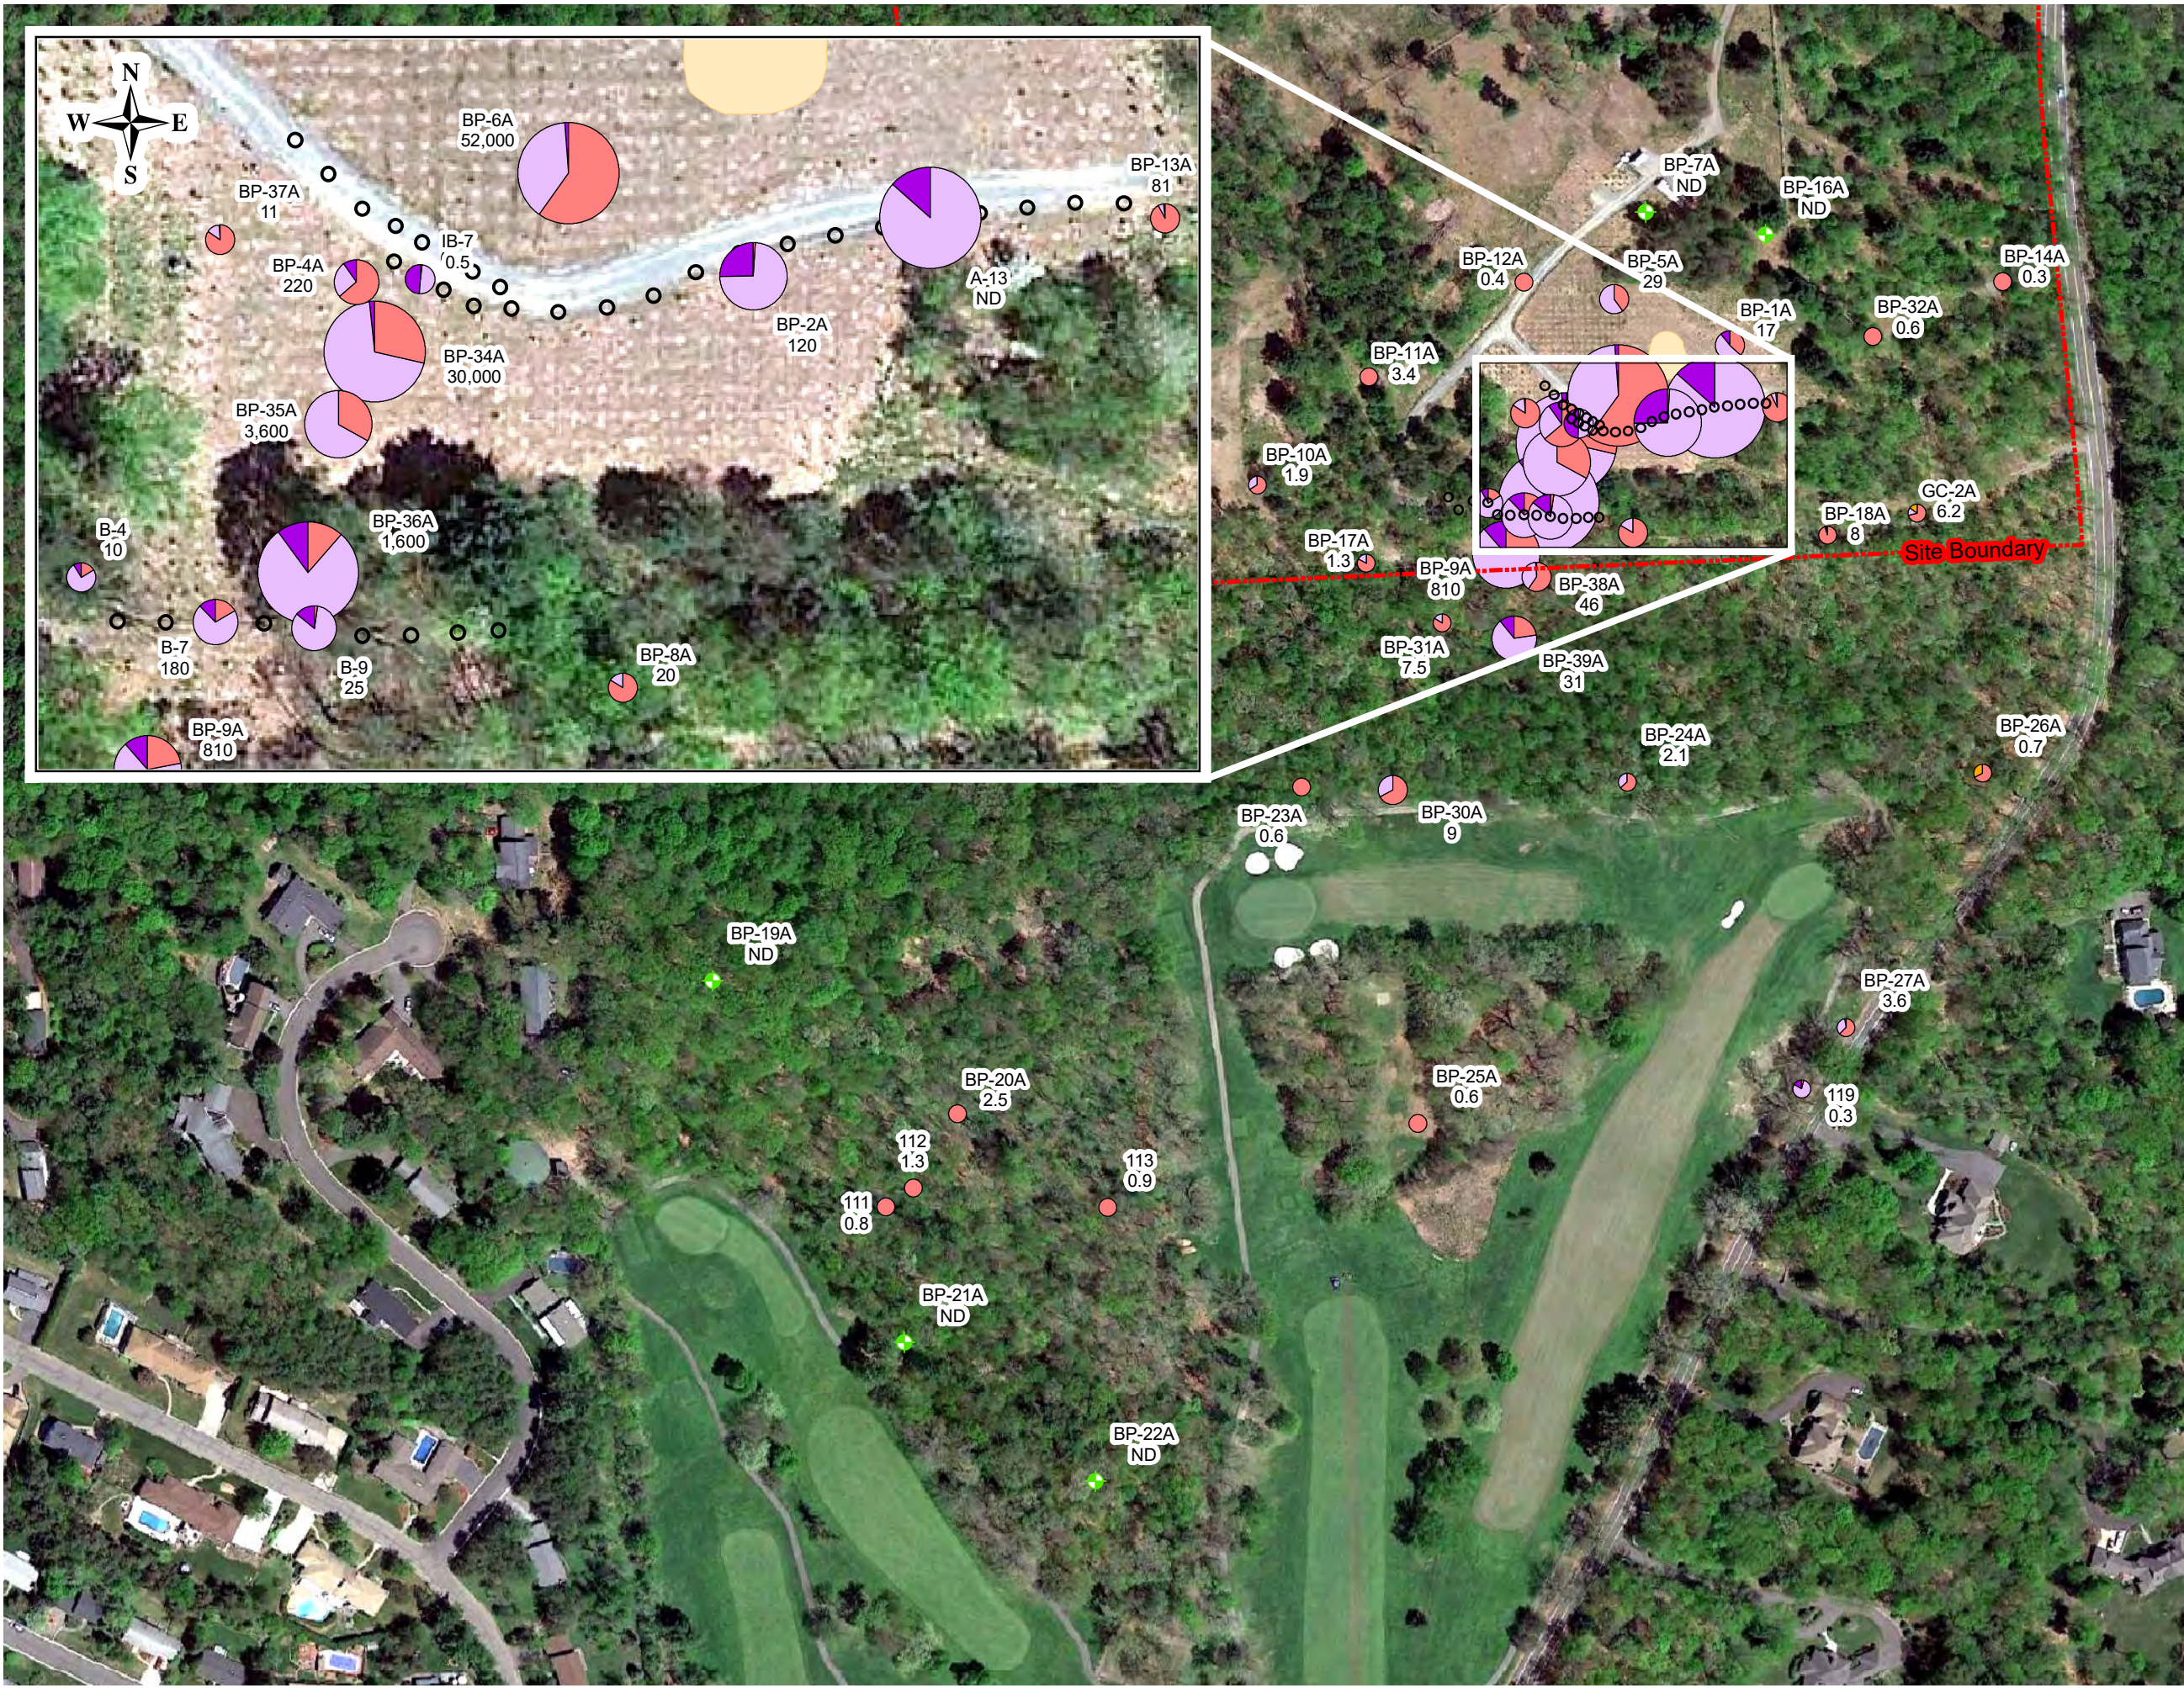
Figure 3

Groundwater Quality Conditions for Key Site VOCs - June 2018

- Injection Boring
- BP-34A 30,000 Well Name and June 2018 TCE Concentrations in Groundwater (µg/L).
- Trichloroethene (TCE)
- cis*-1,2 Dichloroethene (*cis*-1,2 DCE)
- Vinyl Chloride (VC)
- Carbon Tetrachloride (CCl4)
- Total Chlorinated Ethenes and Carbon Tetrachloride in Groundwater (µg/L)
- <10
- >10 to 100
- >100 to 1,000
- >1,000 to 10,000
- >10,000
- Not detected above lab reporting limits

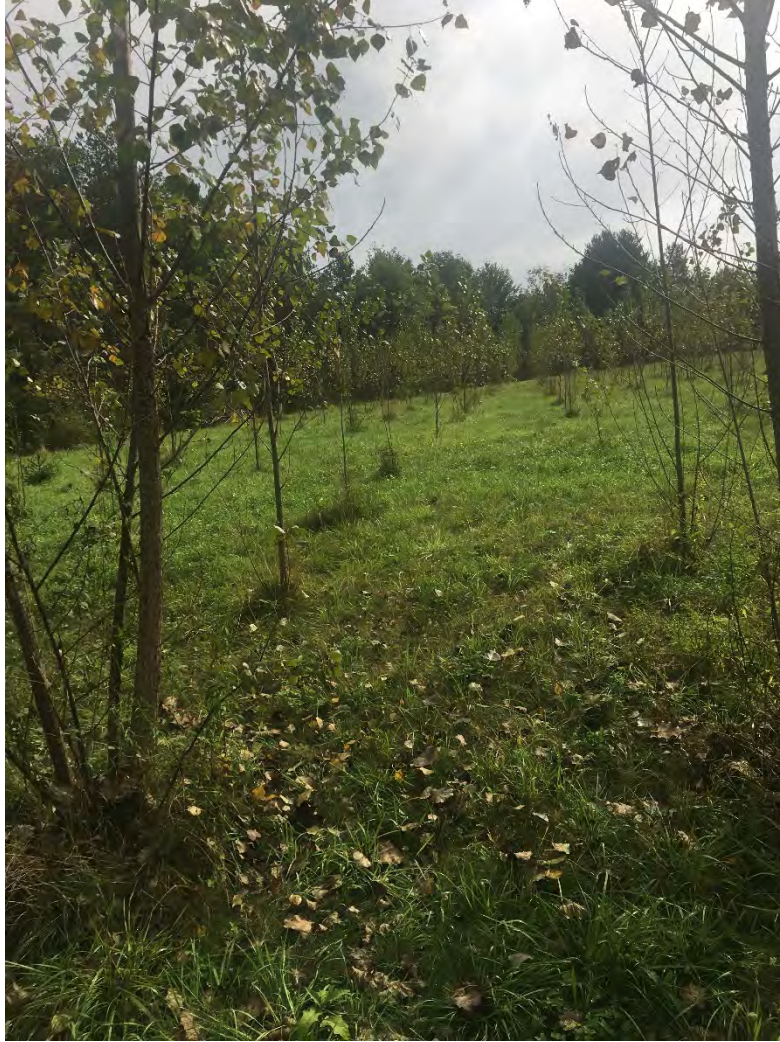
Photo 1: Tree and grass cover looking east across Phytoremediation Areas 1, 2, and 3.

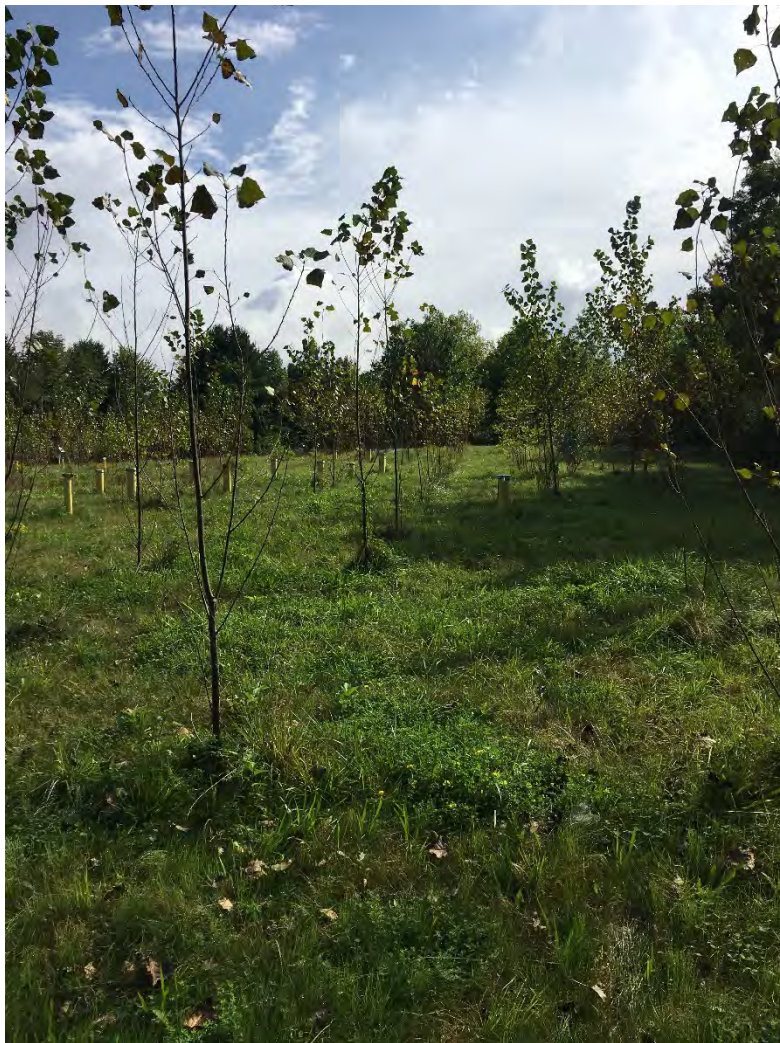
Photo 2: Tree and grass cover looking east from Phytoremediation Area 6 across Areas 5 and 4. A- and IB-series injection boreholes are visible at the center left.

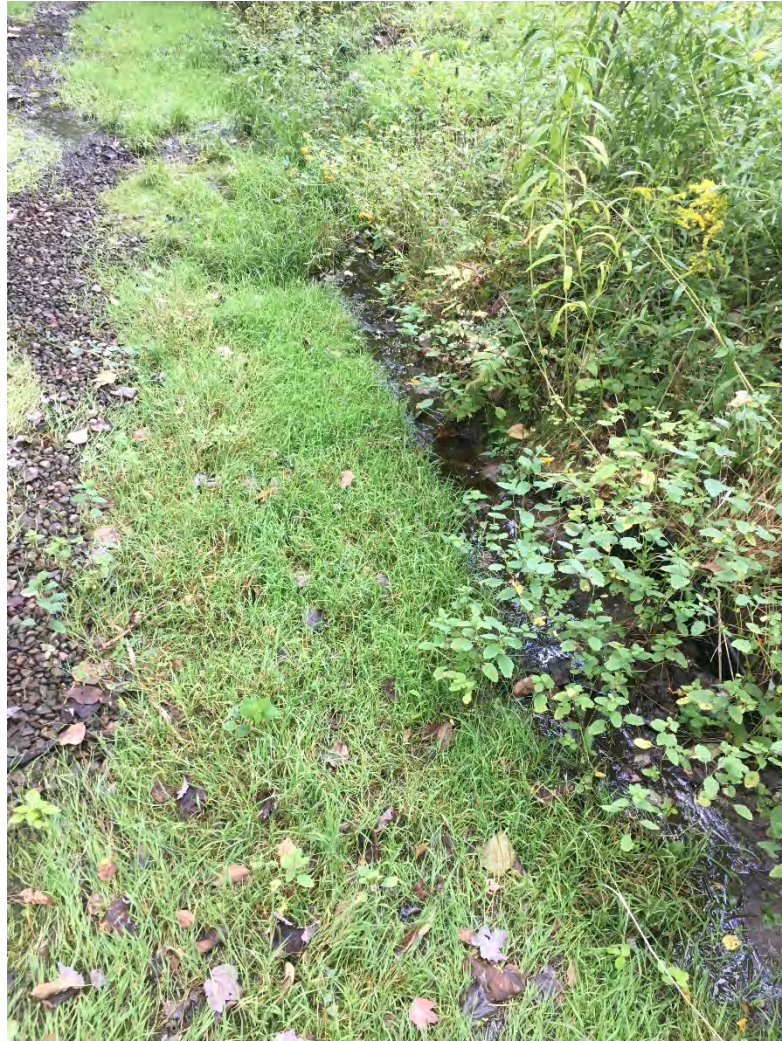
Photo 5: Looking west along the southern access road. The toe of the seep area with water breaking out along the length is to the right in the photo. Black fabric of the partially covered silt fence is faintly visible in the lower right.

- There is some evidence that a portion of the soil fill in the seep area is creeping downhill towards the southern access road at the toe of the fill slope. A silt fence present at the base of the slope has been partially covered by soil material from above. There is no evidence of slope failure, and the tree and grass coverage are still well established. We will continue to monitor the slope;
- Evidence remains that the bonfire gathering spot near outside the site fence and near monitoring well BP-10A is being utilized, but there was less debris present compared to previous inspections.

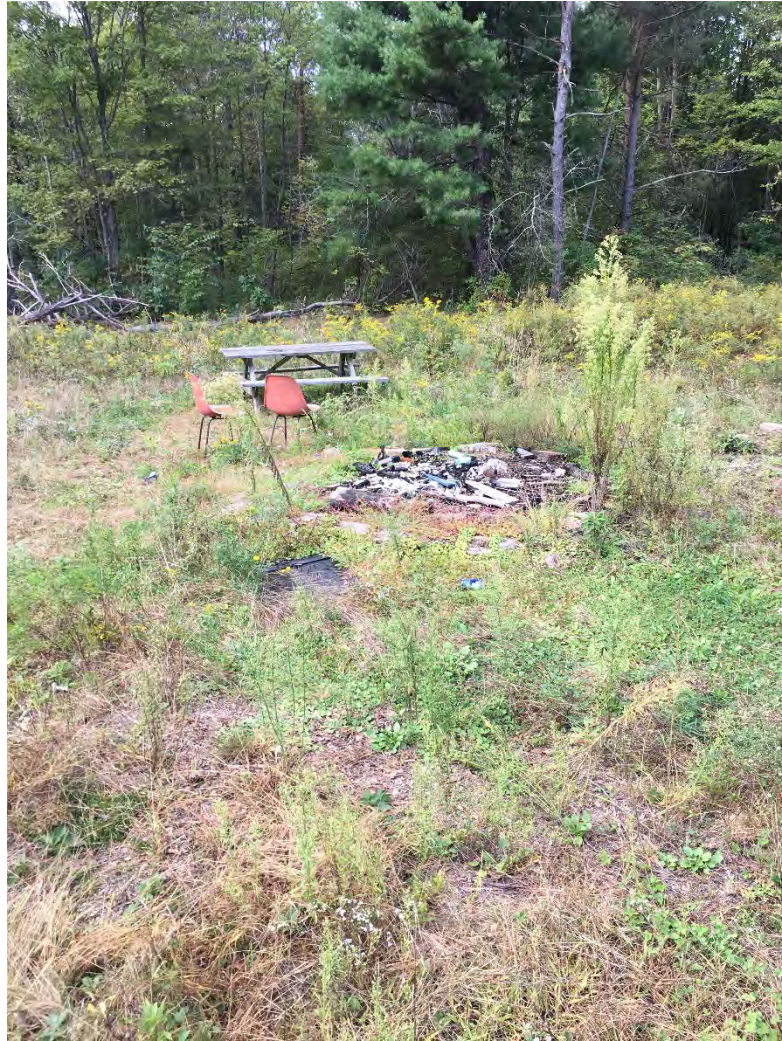
Photo 9: Looking northwest at the bonfire area outside the perimeter fence.

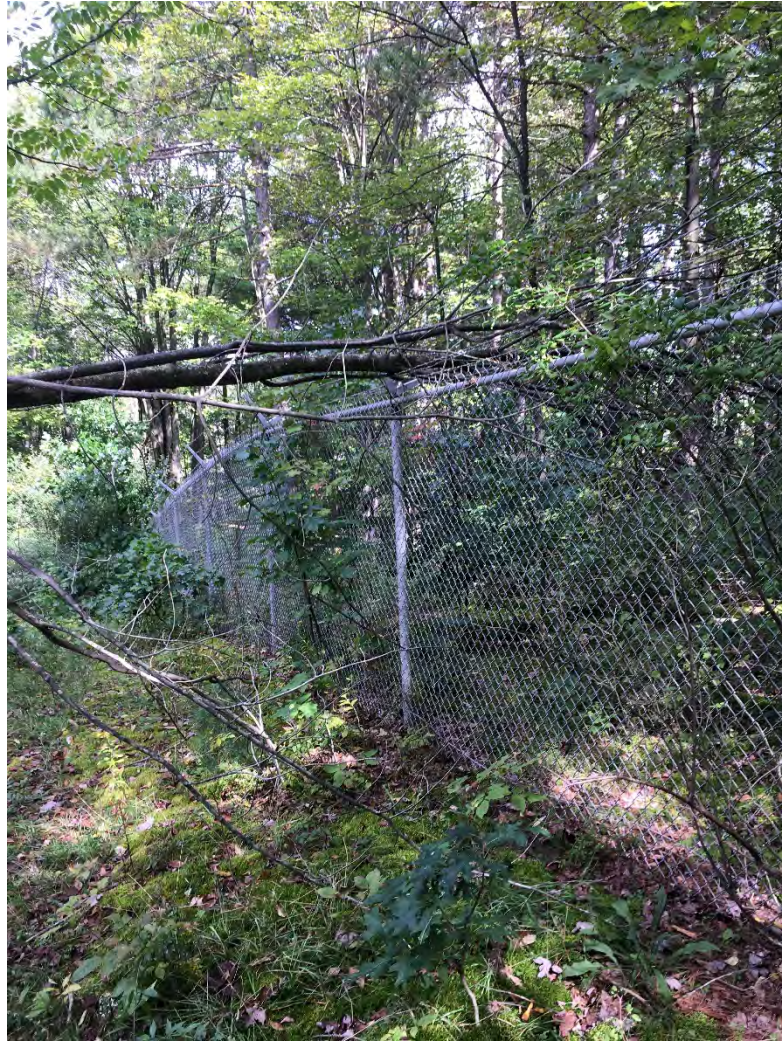
Photo 10: Small tree resting on fence in the northwest corner of the perimeter fence.
