Re: Periodic Review Report and IC/EC Certification Submittal  
IBM Gun Club, Former Burn Pit Area  
Robinson Hill Road, Union, NY 13760  
NYSDEC Site # C704044

Re: 2019 Periodic Review Report  
IBM Gun Club – Former Burn Pit Area  
Union, New York  
BCP Agreement #C704044

## **2019 PERIODIC REVIEW REPORT FORMER BURN PIT AREA**

IBM Gun Club - Former Burn Pit Area  
Union, New York

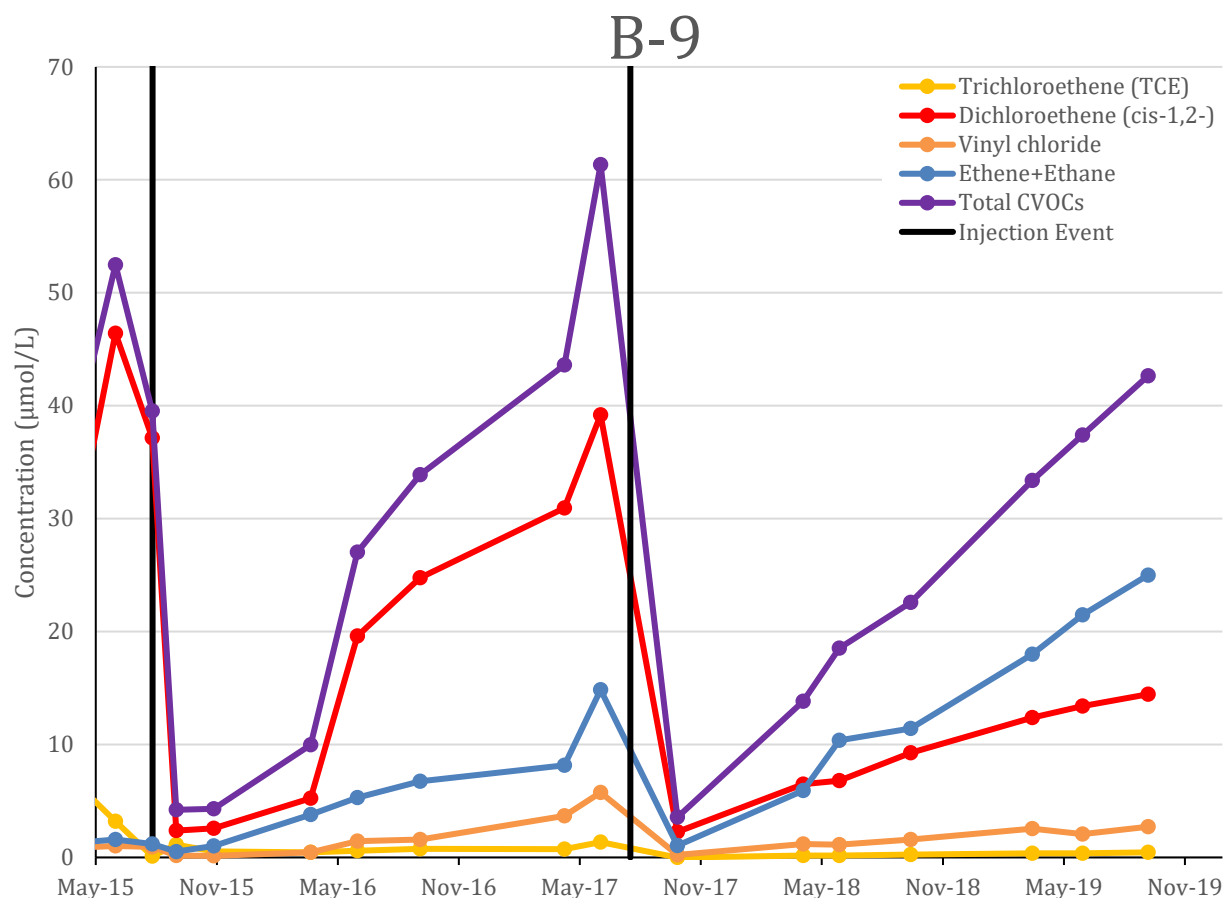
**Exhibit 3.5 – Molar Concentrations of TCE and Breakdown Products for Injection Borehole B-9-** a location in the B-series injection row exhibiting about twice the median transmissivity for the B-series boreholes.

Injection borehole B-9 exhibits high transmissivity in comparison to what is observed in the other B-series boreholes. TCE has represented less than 30% of the molar mass at this location since the first B-series injection in July 2014, down from 90% pre-injection. This well responds quickly to injection events with steeply declining VOC concentrations, while the effects are transported downgradient relatively quickly compared to other, less transmissive injection boreholes, as evidenced by the steady, relatively rapid rebound of COVC concentrations in the months after injection. Of note, terminal breakdown products are now the most prevalent, making up at least 50% of the molar mass and surpassing the proportion of cDCE since June 2018.
