Re: Periodic Review Report and IC/EC Certification Submittal
IBM Gun Club, Former Burn Pit Area
Robinson Hill Road, Union, NY 13760
NYSDEC Site # C704044

Re: 2020 Periodic Review Report
IBM Gun Club – Former Burn Pit Area
Union, New York
BCP Agreement #C704044

This letter and attachments comprise the 2020 Periodic Review Report (PRR) of the remedy status for the above-referenced site. The PRR has been prepared on behalf of IBM by Sanborn, Head Engineering P.C. (SHPC) for submittal to the New York State Department of Environmental Conservation (NYSDEC) and Department of Health (NYSDOH), collectively the Departments, in accordance with the requirements of the Site Management Plan of April 2016 (SMP). We understand that a copy of this PRR will be provided to the Binghamton Country Club (Country Club), who took ownership of the site at the end of 2015.

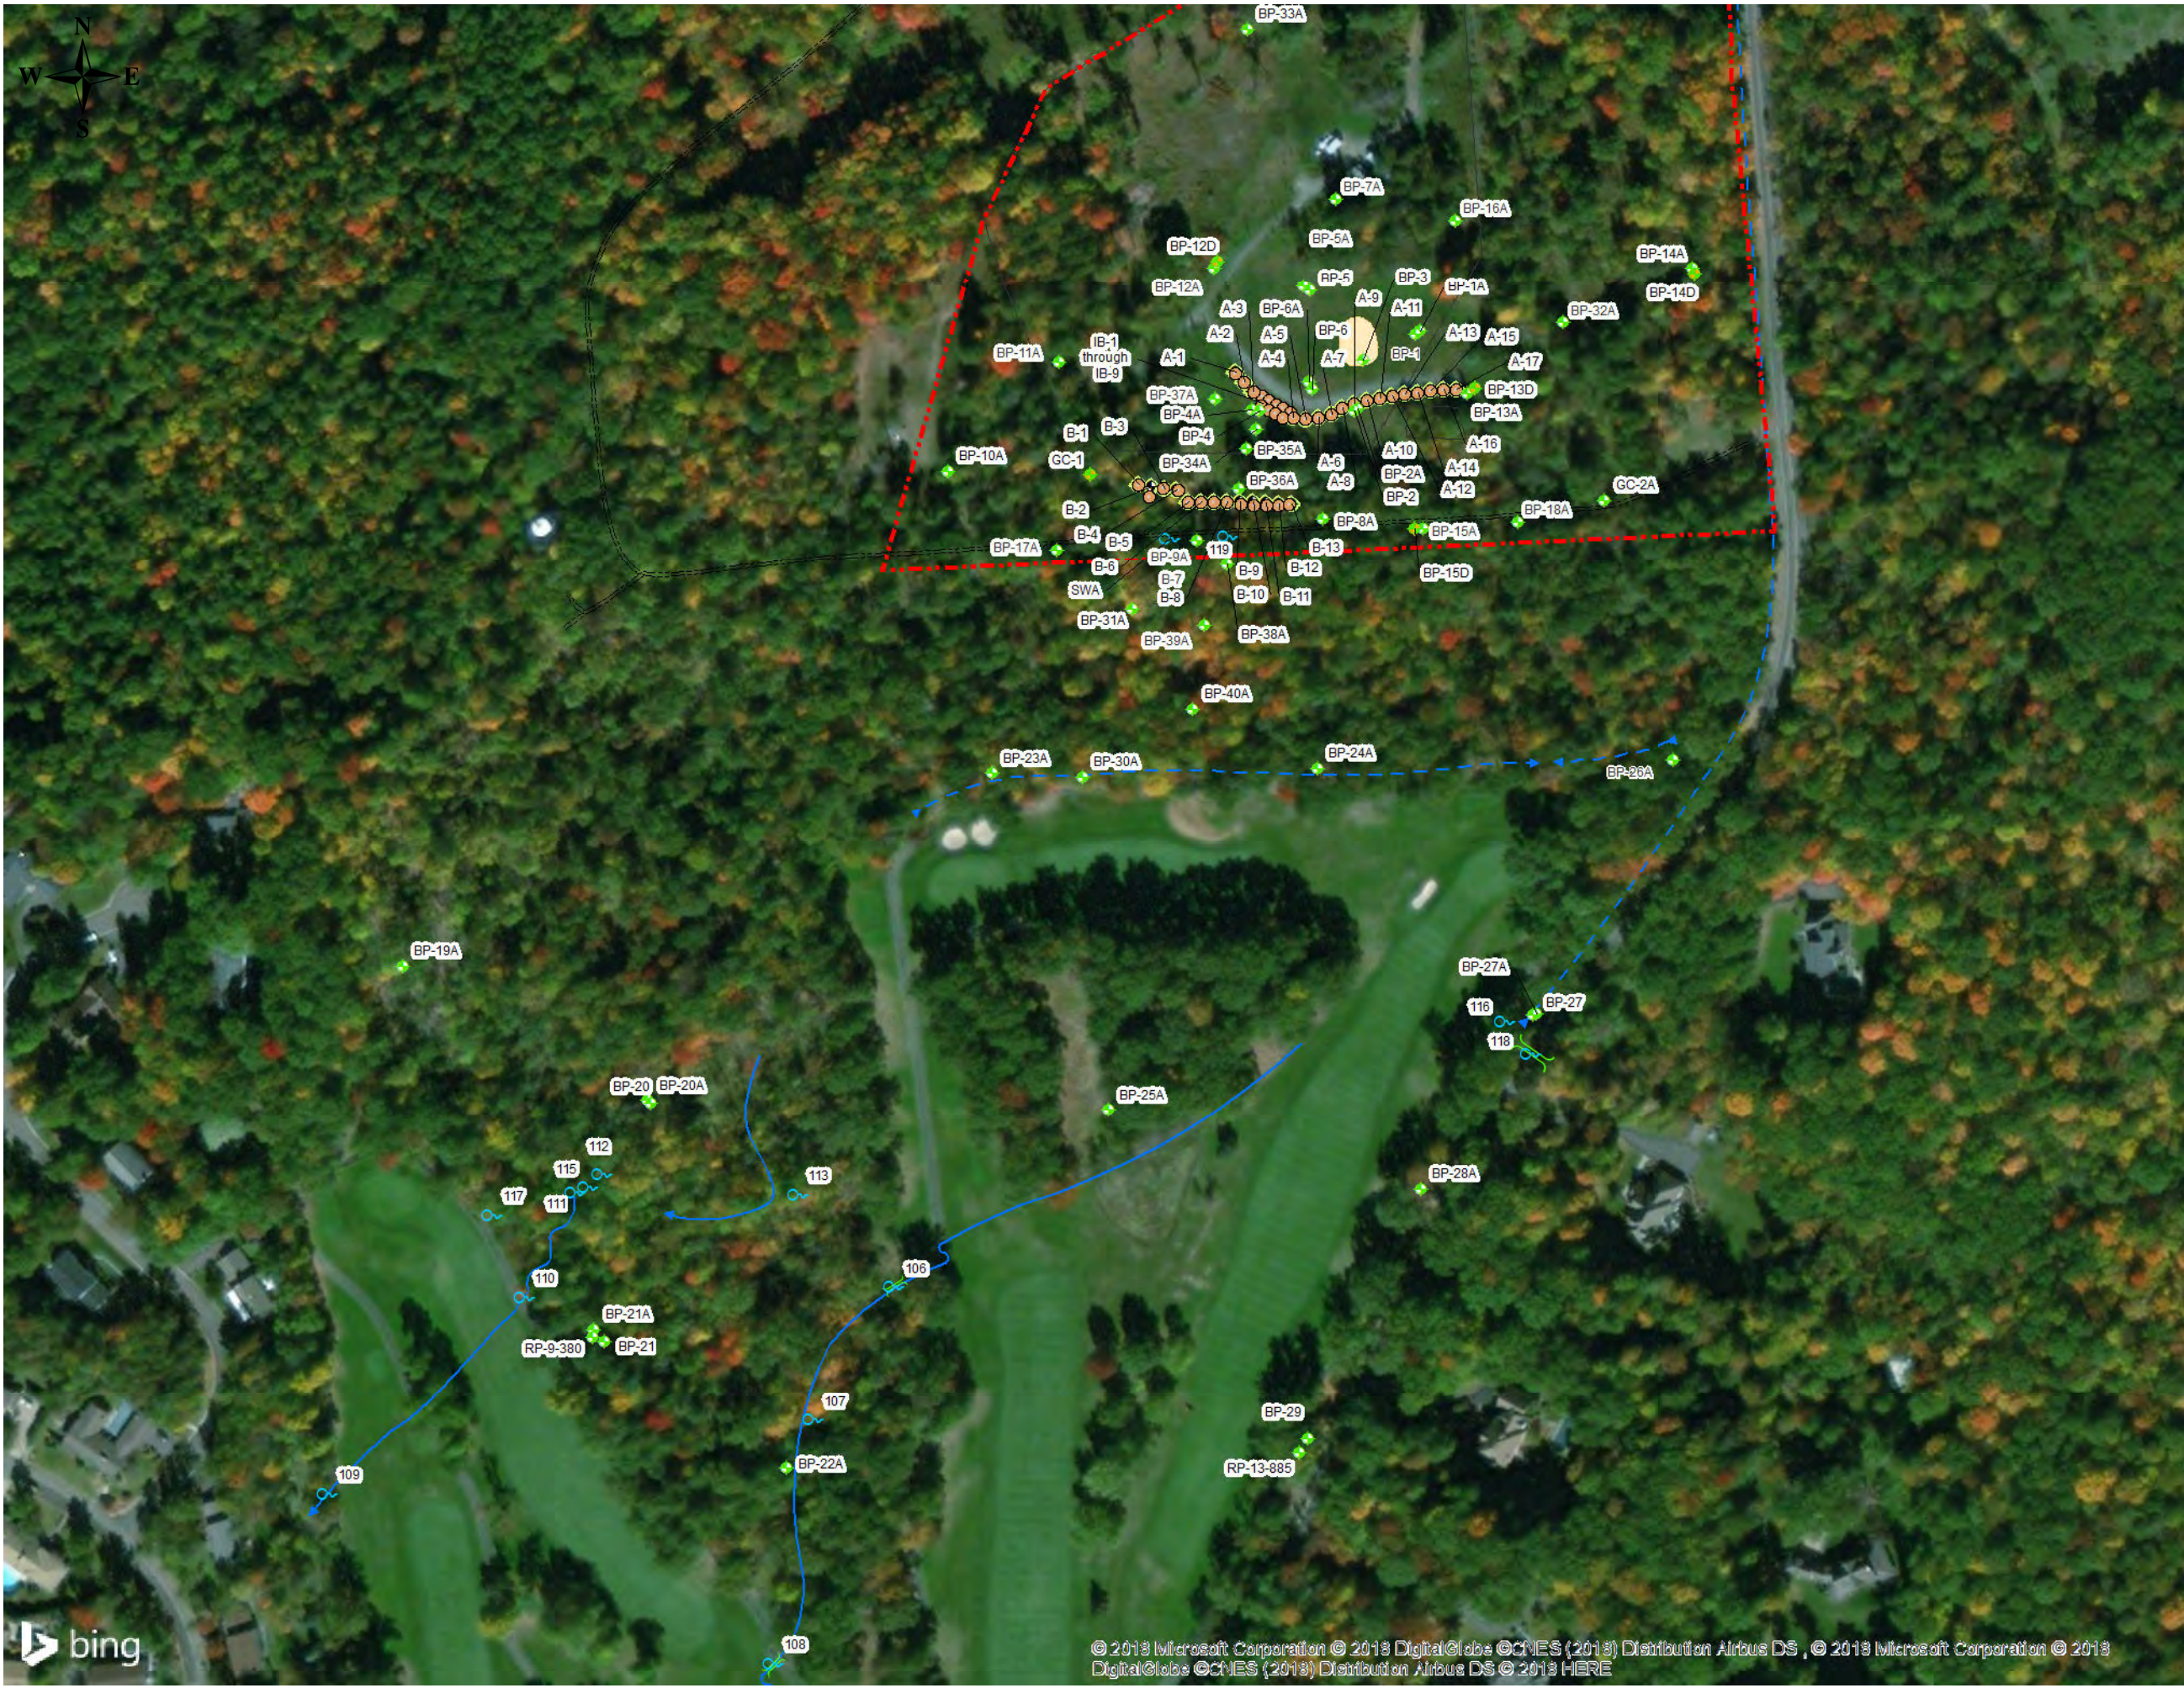
Figure 1
Monitoring Location Plan

IBM Gun Club - Former Burn Pit Area
Union, New York

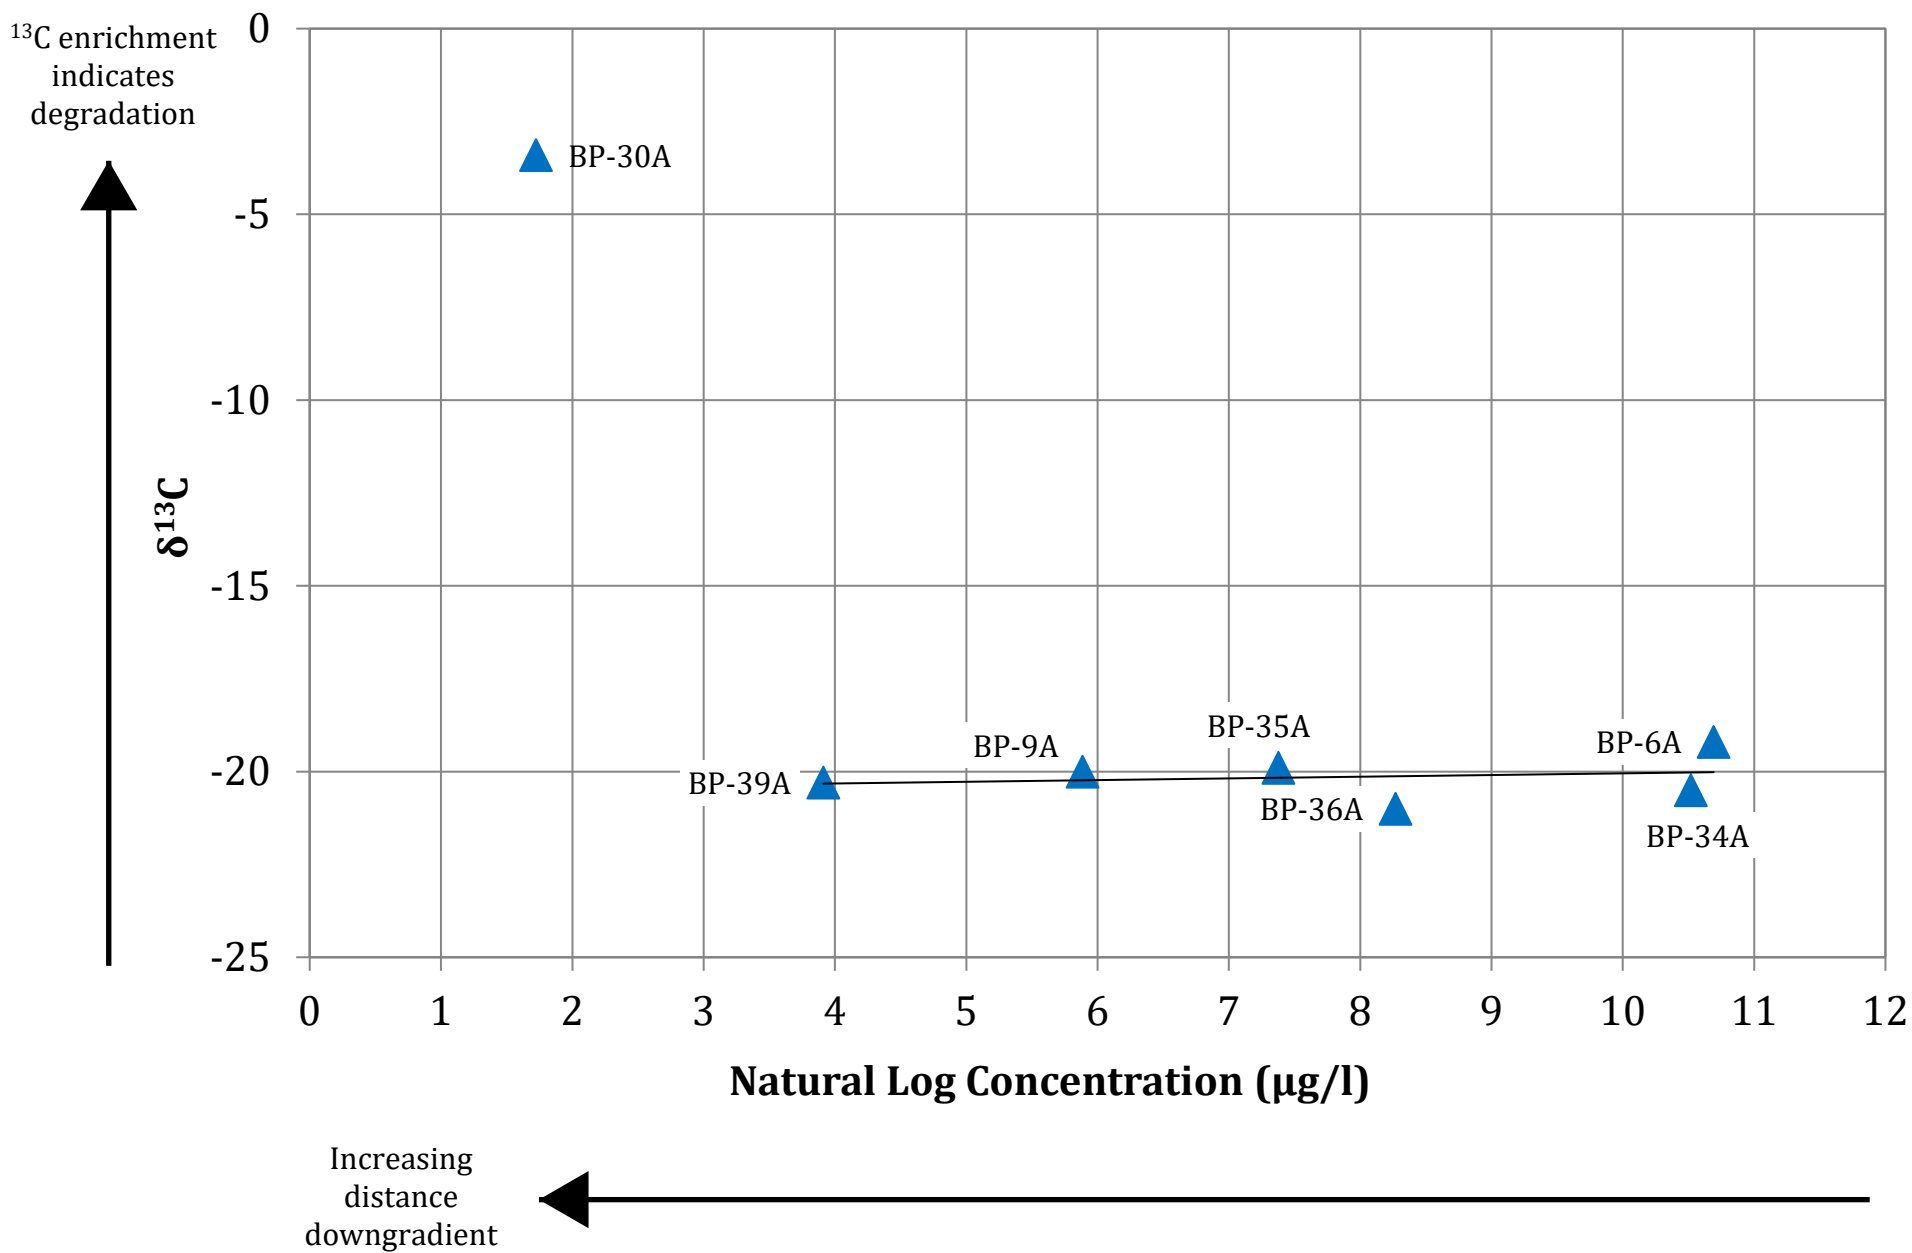
Figure A.1
April 2020 CSIA Results - TCE
Summary of Water Quality Monitoring
IBM Gun Club - Former Burn Pit Area
Union, New York

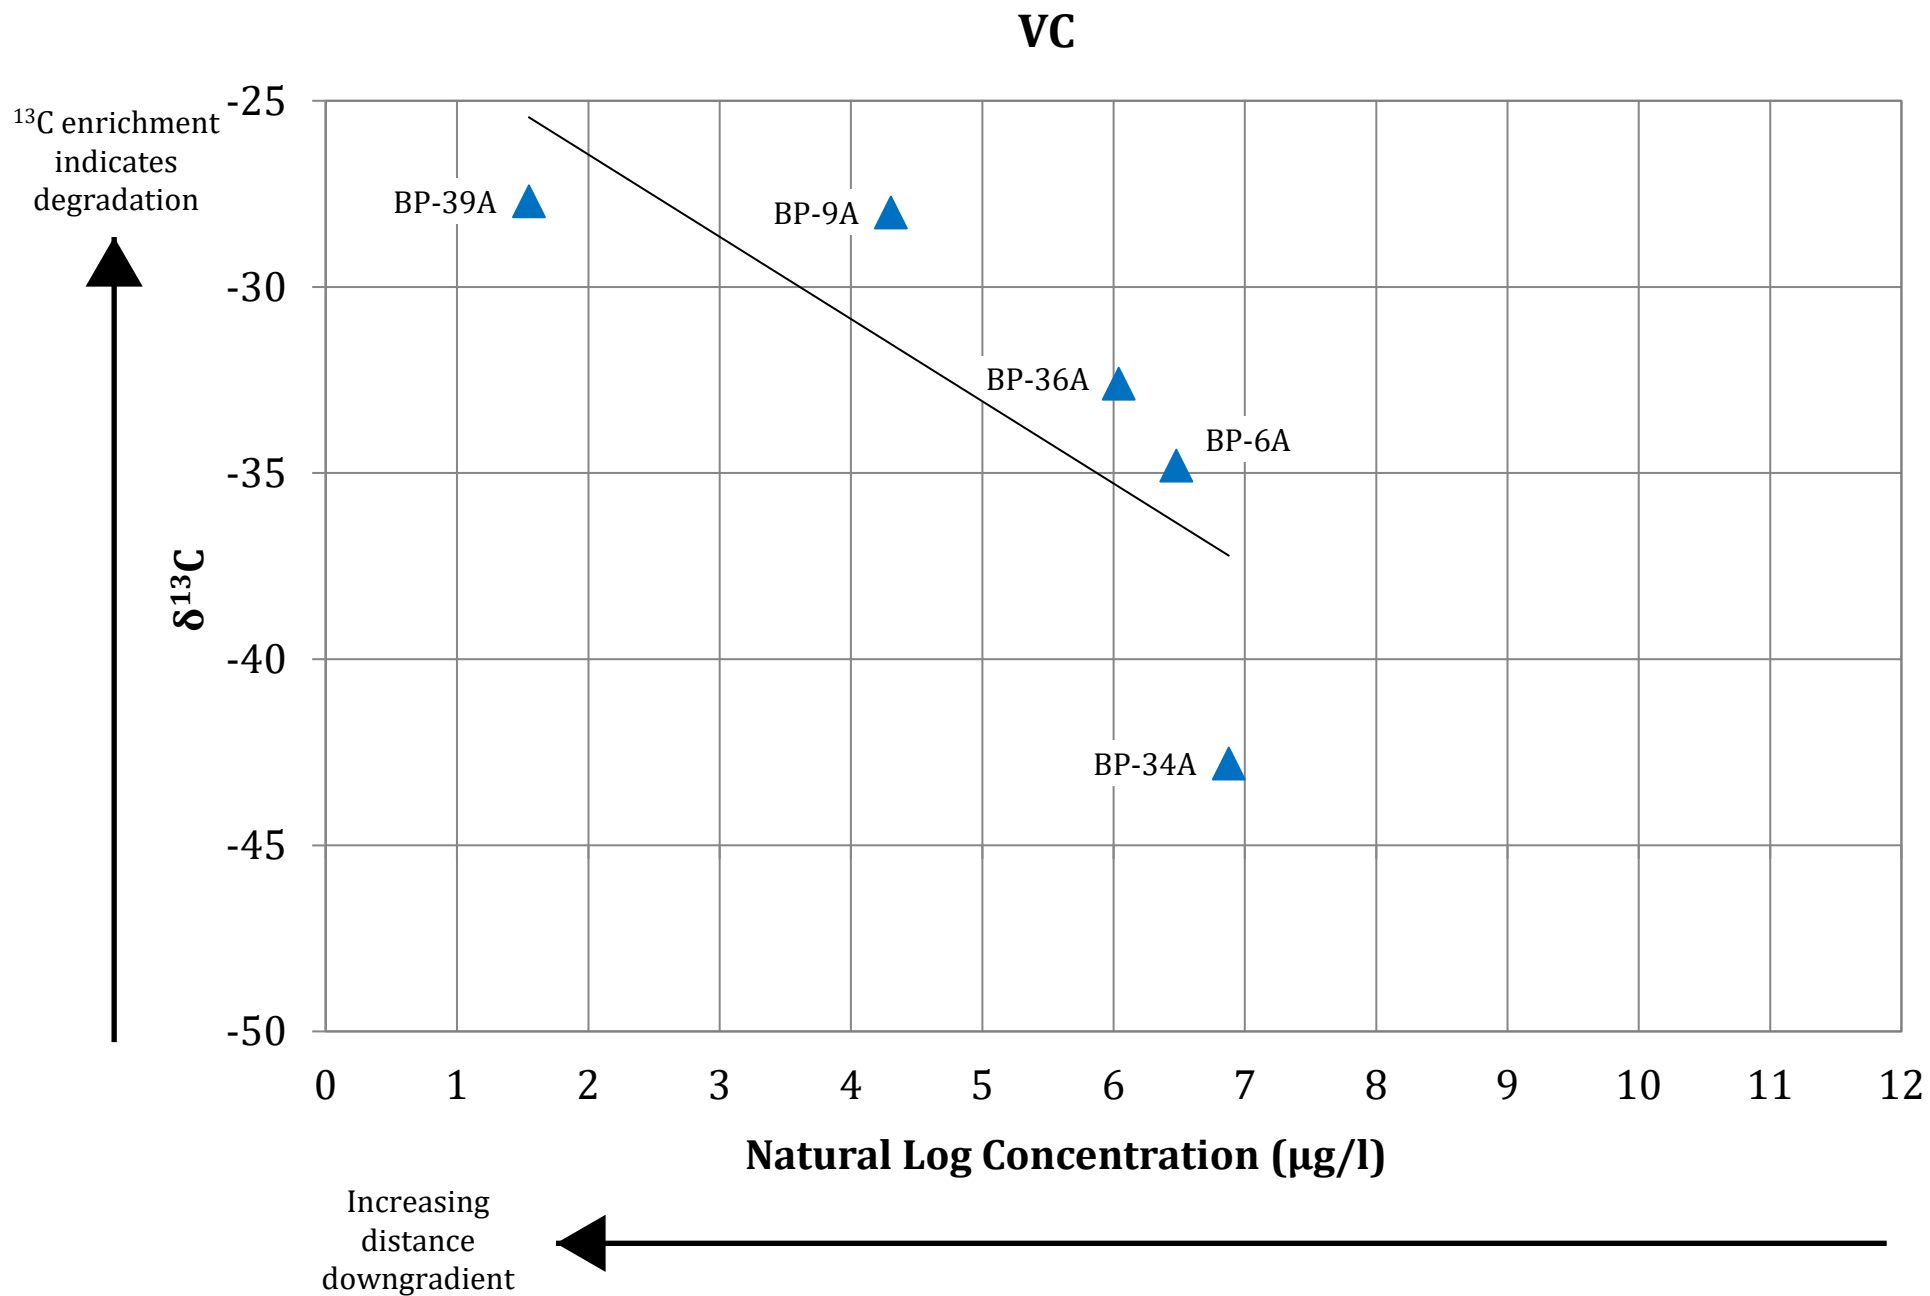
Figure A.3
April 2020 CSIA Results - VC
Summary of Water Quality Monitoring
IBM Gun Club - Former Burn Pit Area
Union, New York

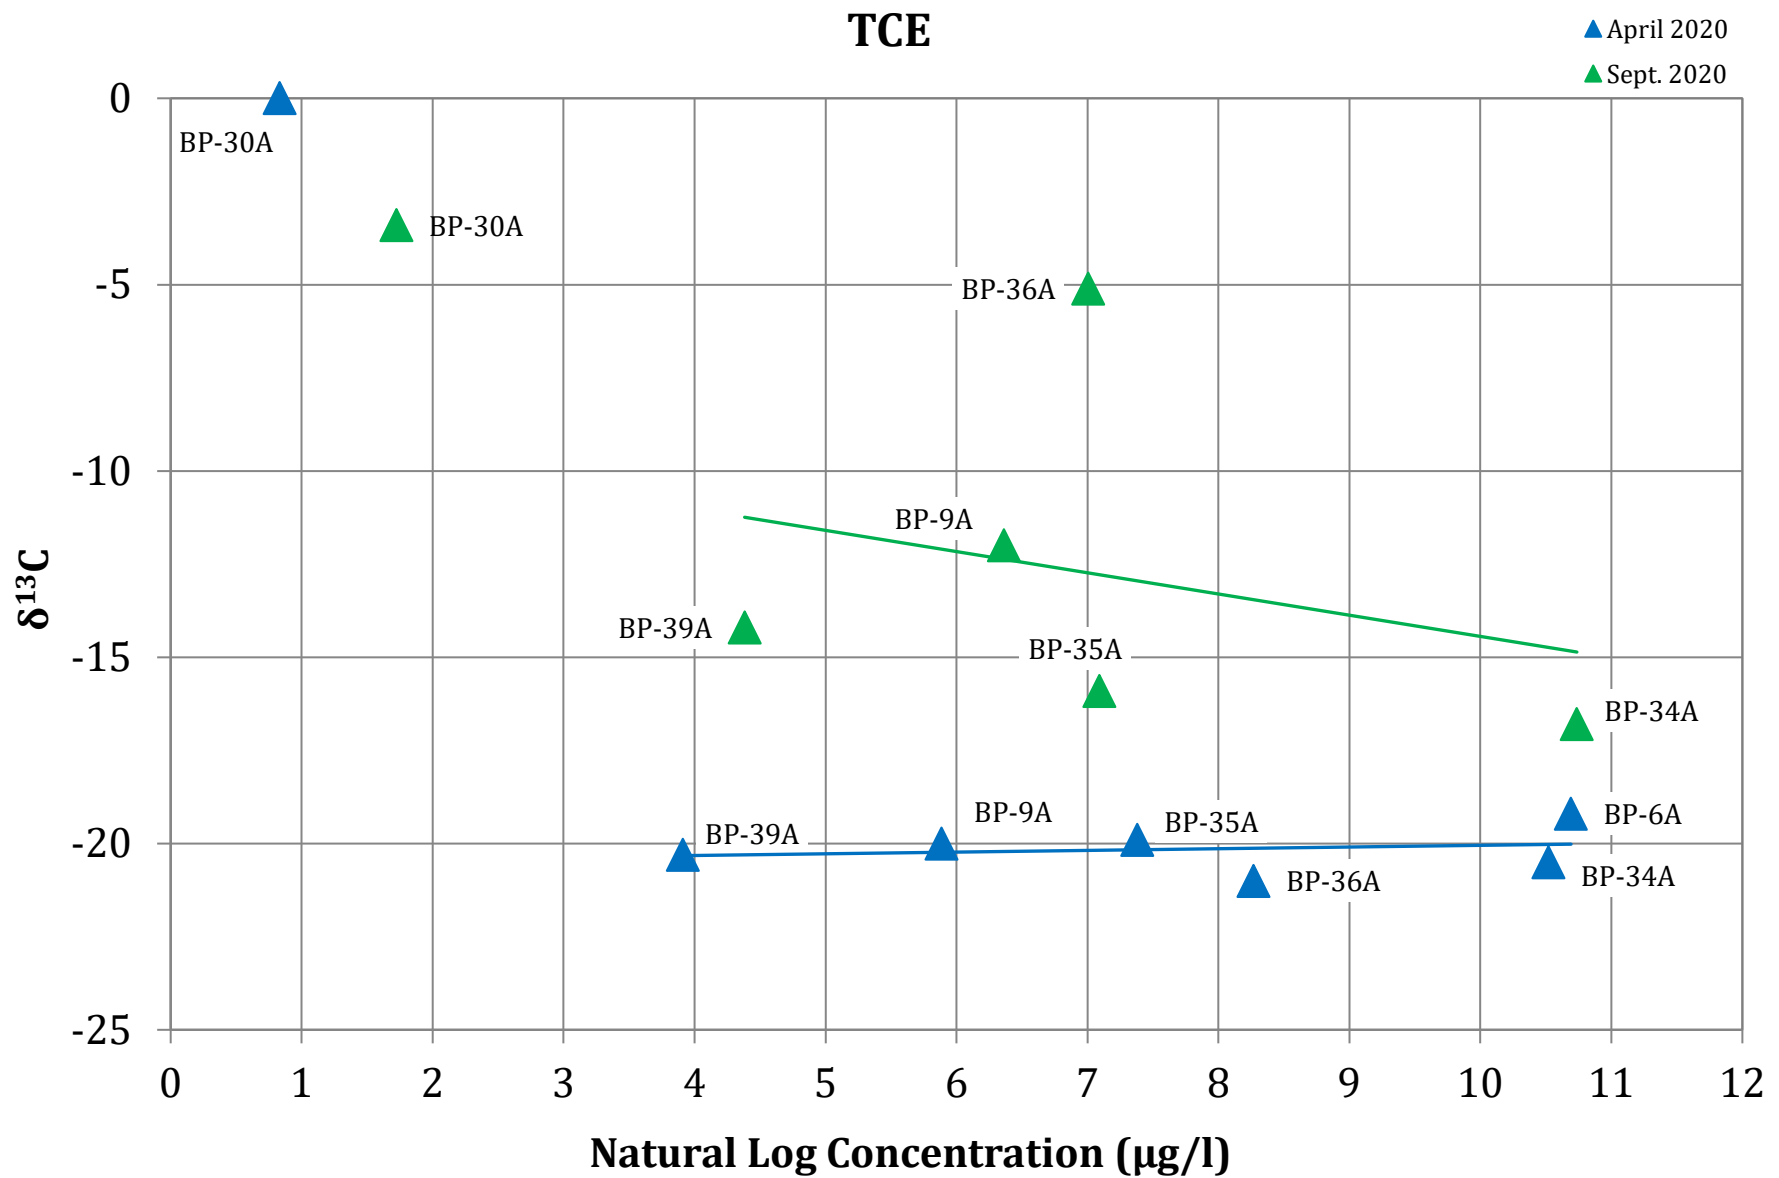
Figure 6A
September 2020 CSIA Results - TCE
 Summary of Water Quality Monitoring
 IBM Gun Club - Former Burn Pit Area
 Union, New York

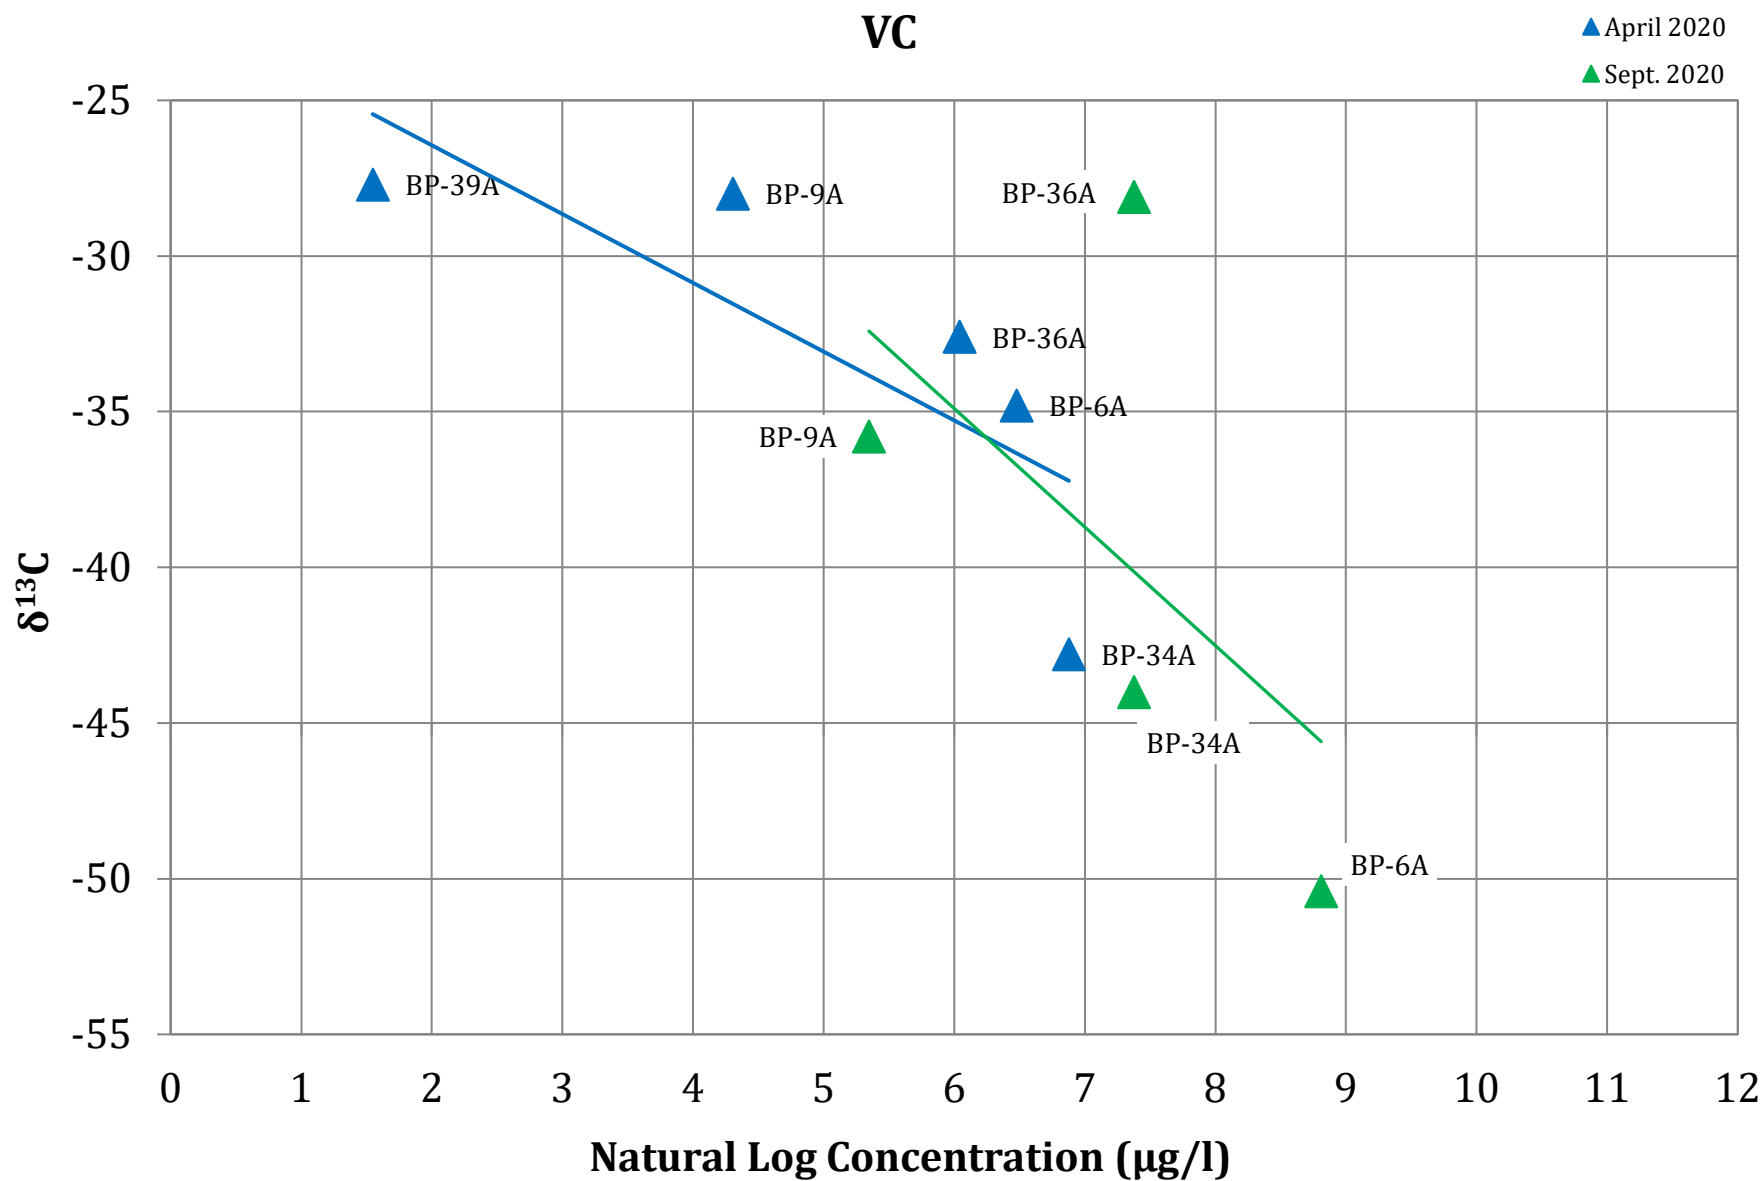
Figure 6C
September 2020 CSIA Results - VC
 Summary of Water Quality Monitoring
 IBM Gun Club - Former Burn Pit Area
 Union, New York
