May 8, 2023

Reference: 2023 Periodic Review Report
TCMF Hillcrest Facility
4 Nowlan Road
Binghamton, New York
BCP Site No. C704045

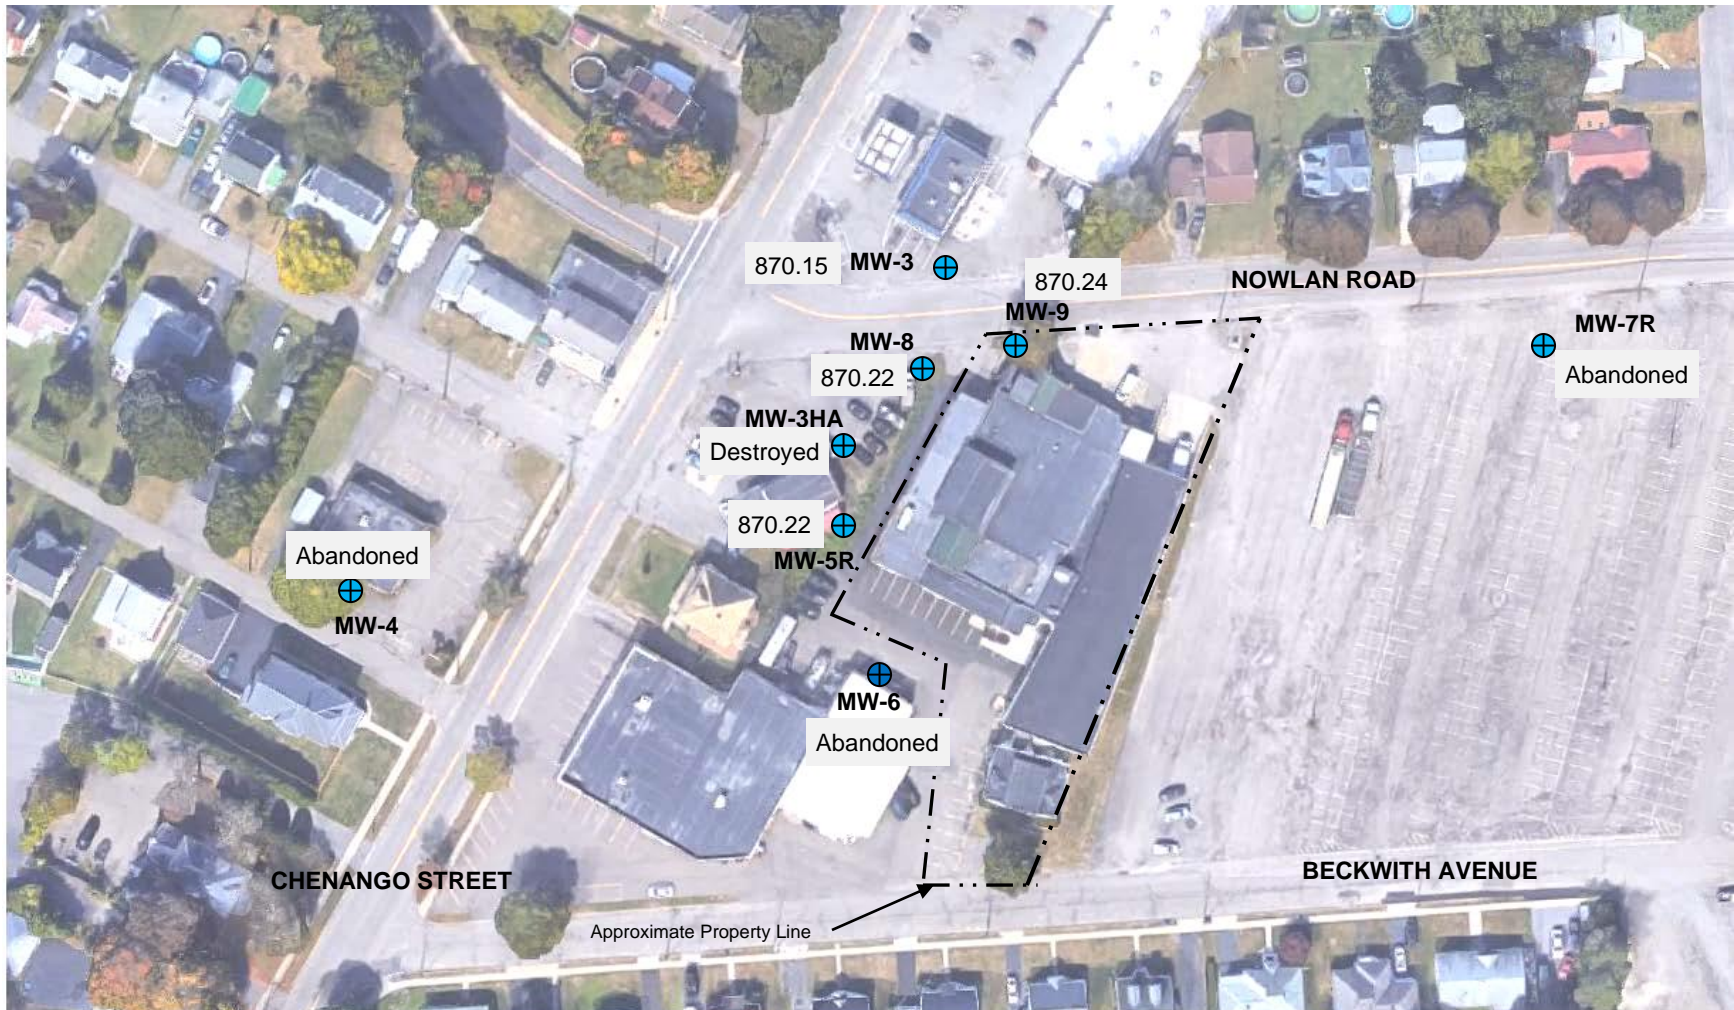
| REVIEWED BY: FCE | DATE: MAY 2022 | FIGURE NO: 2 |

Depths to groundwater were measured at each well and the data was used to develop Water Table Elevations for both events (See Figures No. 2 and No. 3, and Table 1). Note: without data from MW-7R, it is not possible to determine the direction of groundwater flow. However, the direction of groundwater flow has been historically consistent, to the west.

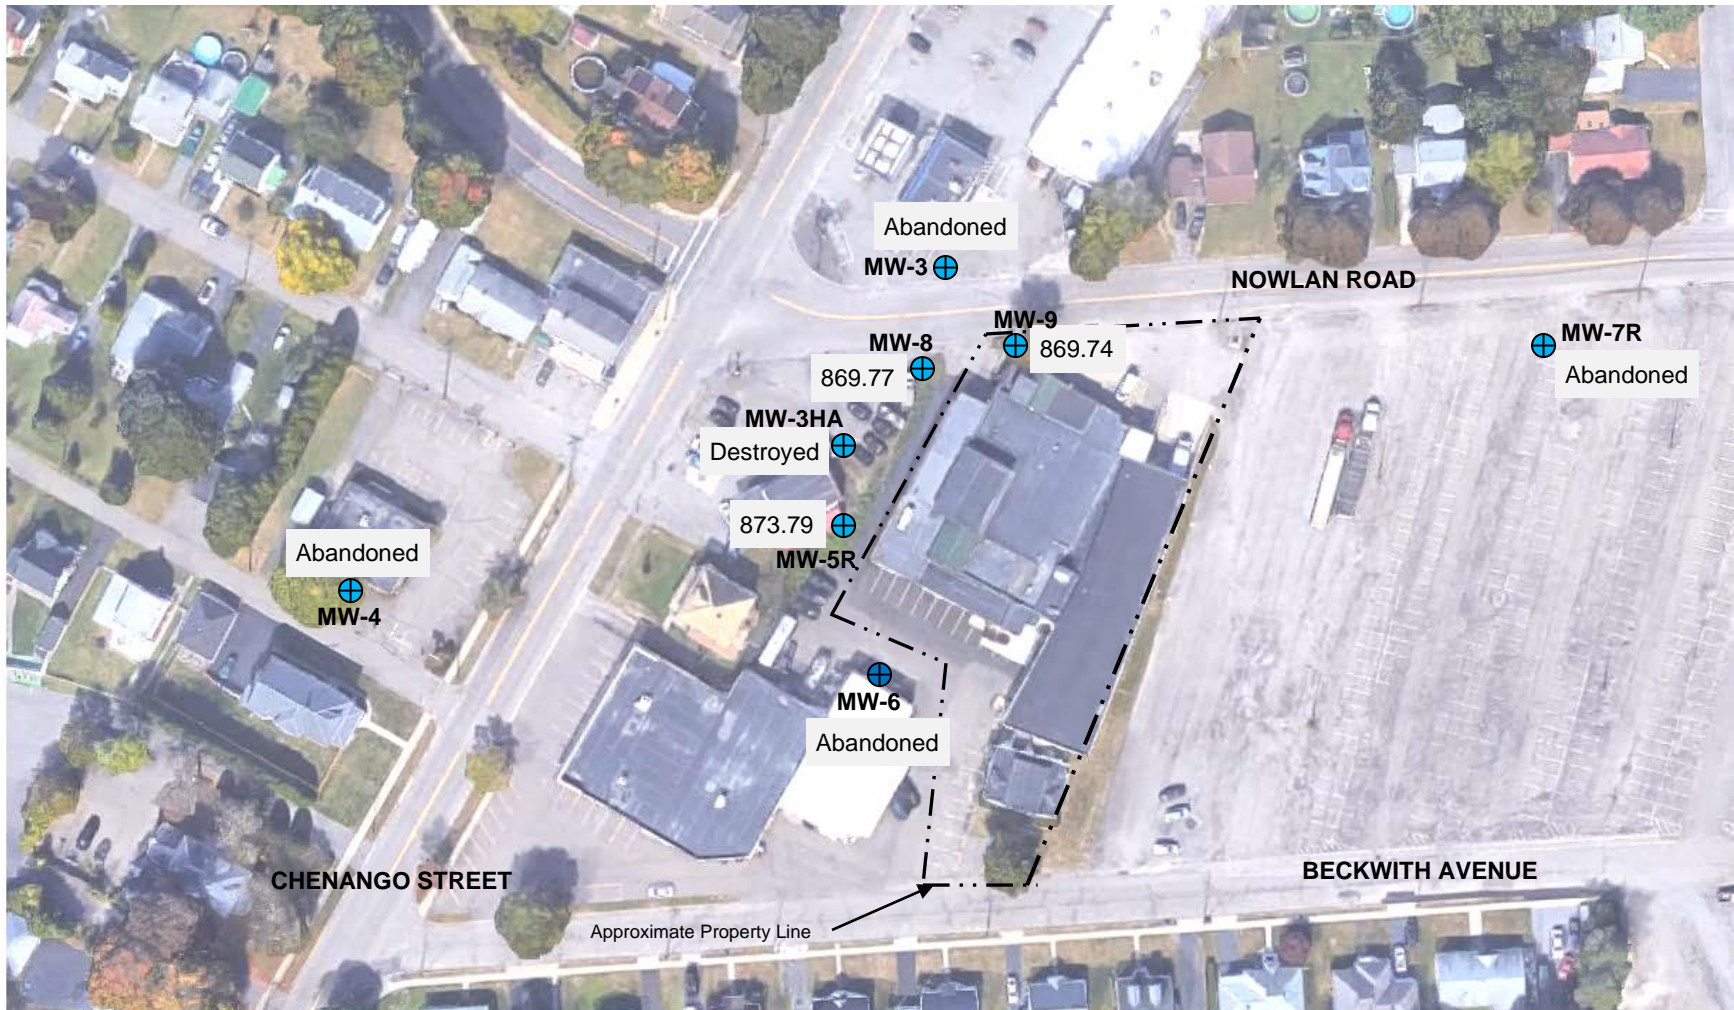
- Legend:
- Monitoring Well Location (Approximate)
 - Groundwater Contour
 - 867 Water Table Elevation, April 13, 2023
