Reference: 2024 Periodic Review Report
TCMF Hillcrest Facility
4 Nowlan Road
Binghamton, New York
BCP Site No. C704045

Introduction

Site Overview

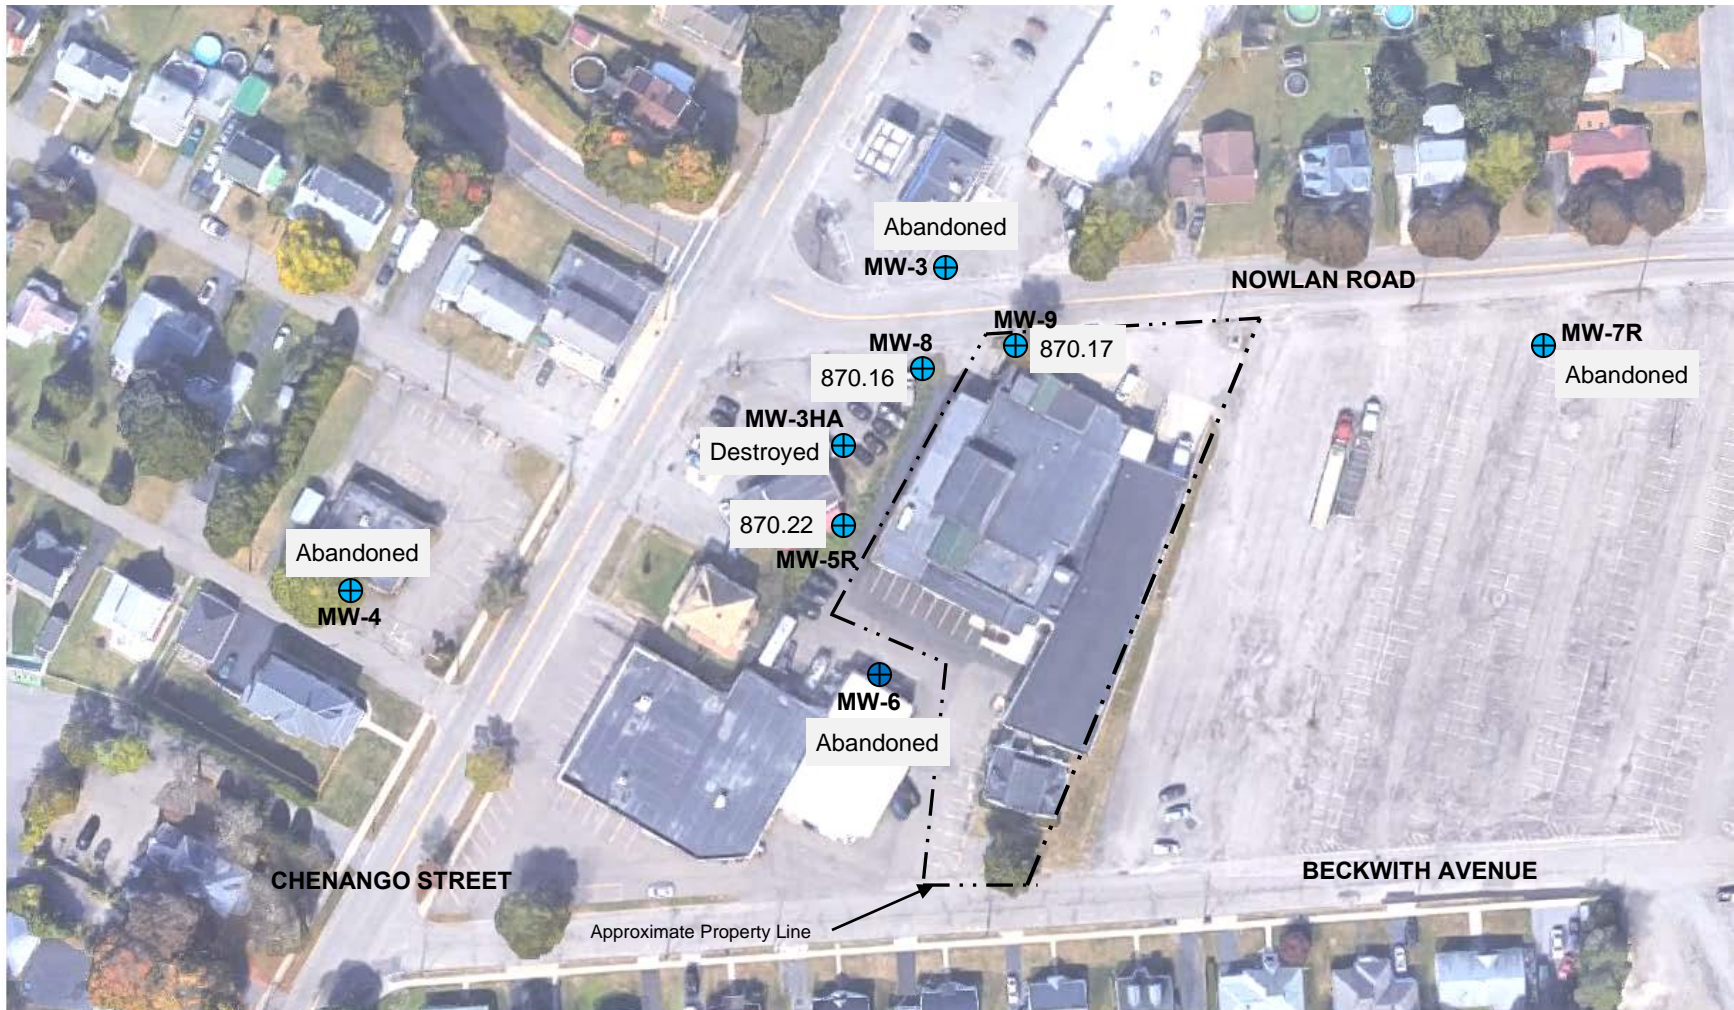
The depth to groundwater was measured at each well and the data was used to develop the Water Table Elevations for the April 9, 2024 monitoring event (See Figure No. 2 and Table 1). Note: without data from MW-7R, it is not possible to determine the direction of groundwater flow. However, the direction of groundwater flow has been historically consistent, to the west.

- Legend:
- ⊕ Monitoring Well Location (Approximate)
 - Groundwater Contour
 - 867 Water Table Elevation, April 9, 2024
