Reference: 2025 Periodic Review Report
TCMF Hillcrest Facility
4 Nowlan Road
Binghamton, New York
BCP Site No. C704045

SSD SYSTEM LOCATION MAP
Triple Cities Metal Finishing
Binghamton, New York
Site No. C704045

WATER TABLE ELEVATIONS – APRIL 2025
TRIPLE CITIES METAL FINISHING
BINGHAMTON, NEW YORK
BCP SITE NO. 704045

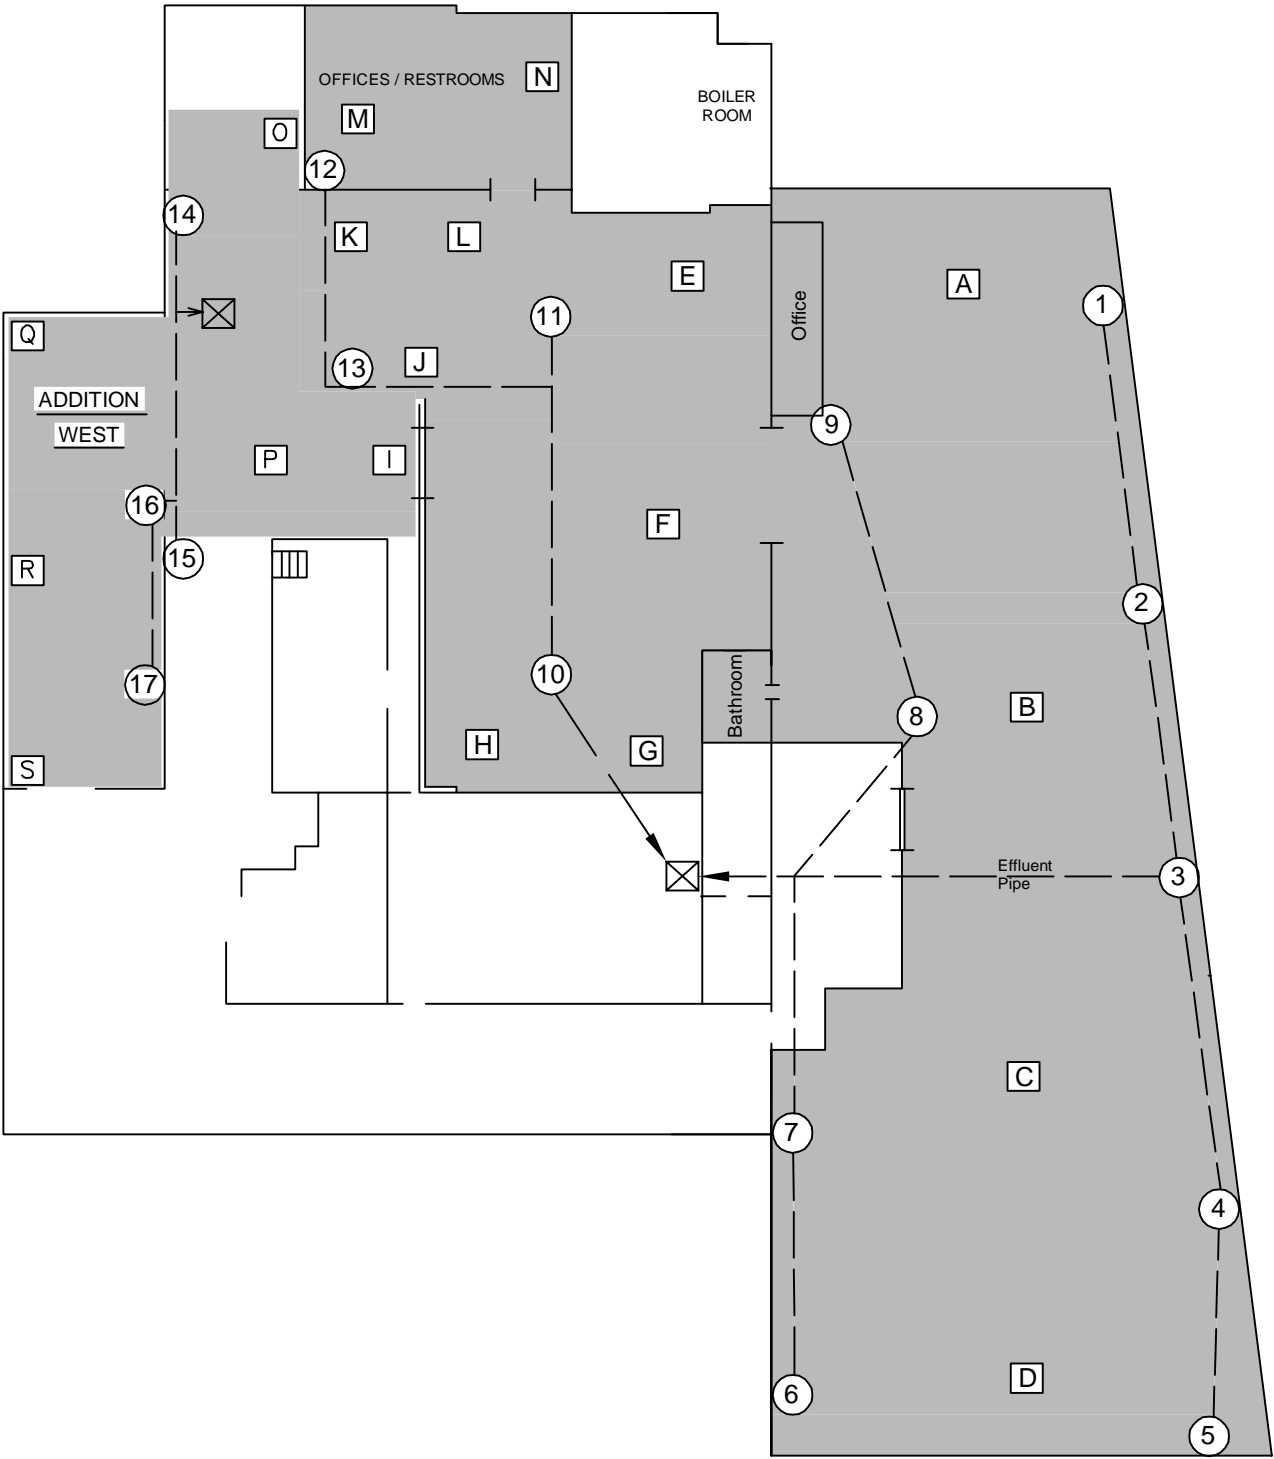
DRAWN BY: SMC/SDW	SCALE: NTS	PROJECT NO.: 99011A
REVIEWED BY: KT	DATE: JUN. 2020	FIGURE NO.: 1

The SSDS currently consists of seventeen extraction points connected to two roof-mounted blowers (see Figure No. 1). No changes to the SSDS have occurred during this reporting period.

- ① EXTRACTION POINT-4" DIAMETER PVC PIPING
- A PILOT POINT
- ⊗ ROTRON 404 AND 505 BLOWER
- OCCUPIED AREA

No damage was observed to the SSDS's piping or surface seals during the annual system inspection.

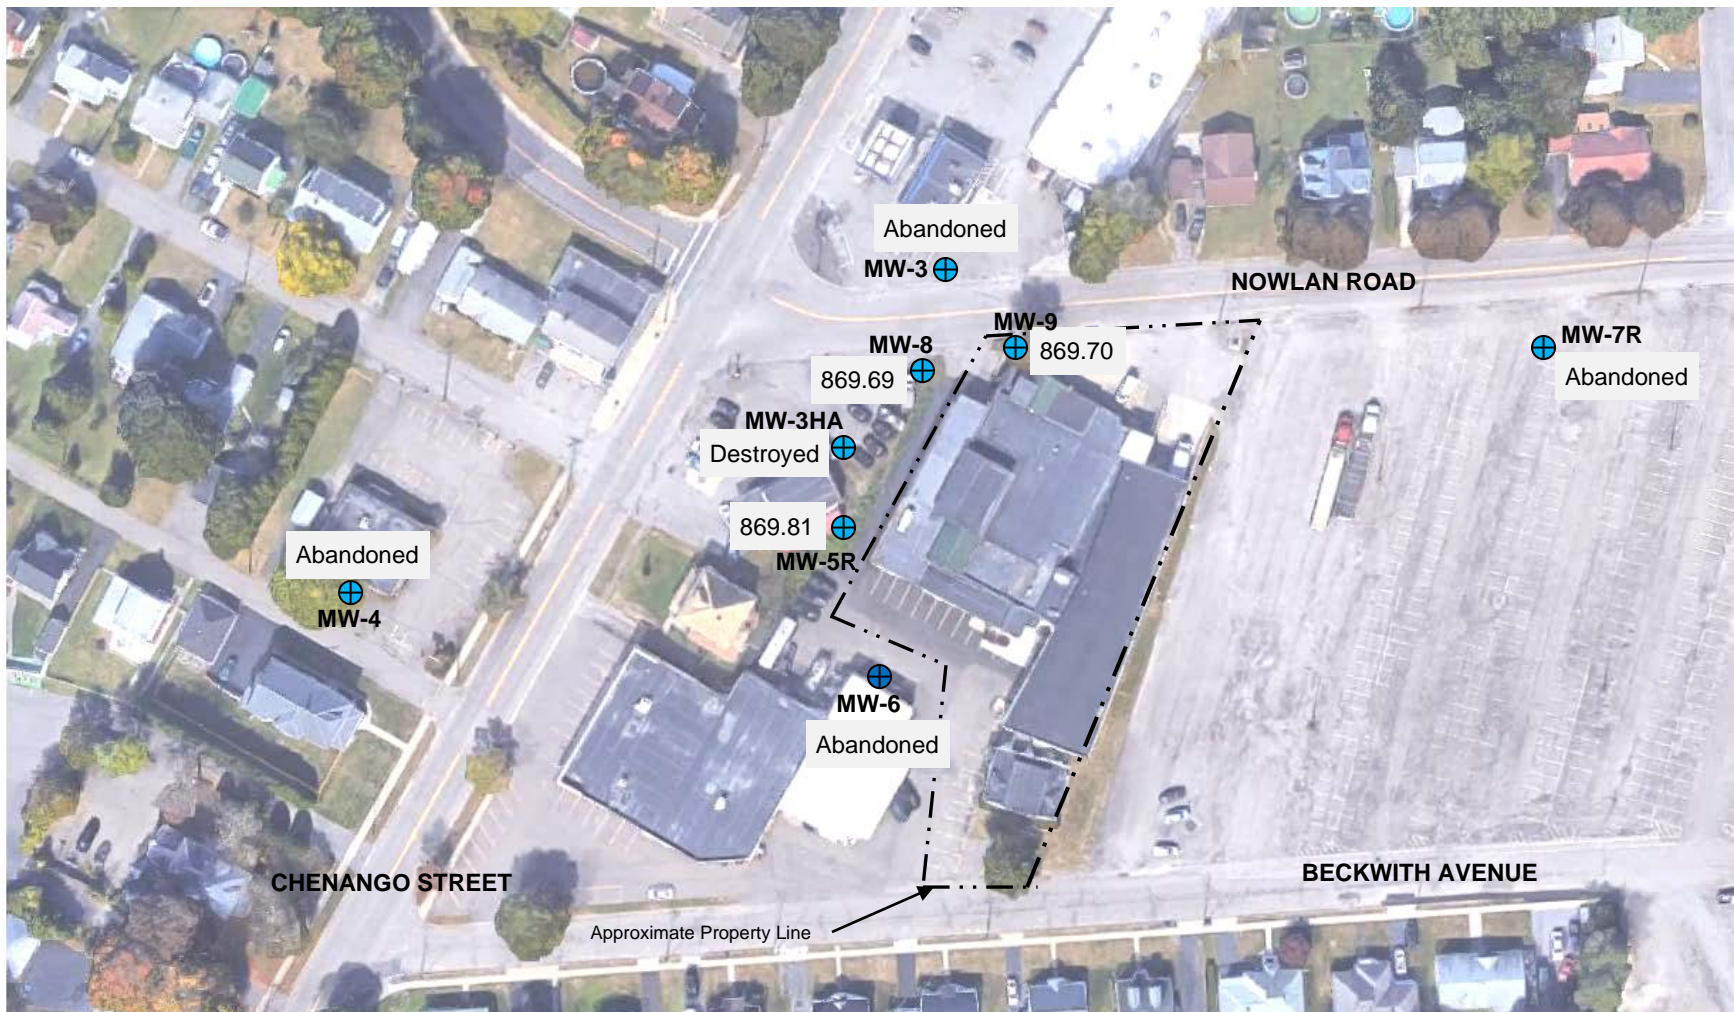
DRAWN BY: CTG	SCALE: Not To Scale	PROJECT NO: 99011A
REVIEWED BY: FCE	DATE: APRIL 2025	FIGURE NO: 2

The depth to groundwater was measured at each well and the data was used to develop the Water Table Elevations for the April 15, 2025 monitoring event (See Figure No. 2 and Table 1). Note: without data from MW-7R, it is not possible to determine the direction of groundwater flow. However, the direction of groundwater flow has been historically consistent, to the west.
