# **REMEDIAL INVESTIGATION REPORT**

**RICK'S AUTO REDEVELOPMENT  
136 – 138 East Genesee Street  
Village of Baldwinsville, Onondaga County, New York  
Brownfield Cleanup Program No. B7-0652-04-01  
DEC BCP Site No. C734085**

**CL DEVELOPMENT, L.L.C.**  
30 Oswego Street  
Baldwinsville, New York 13027

July 2005  
Revised December 2005

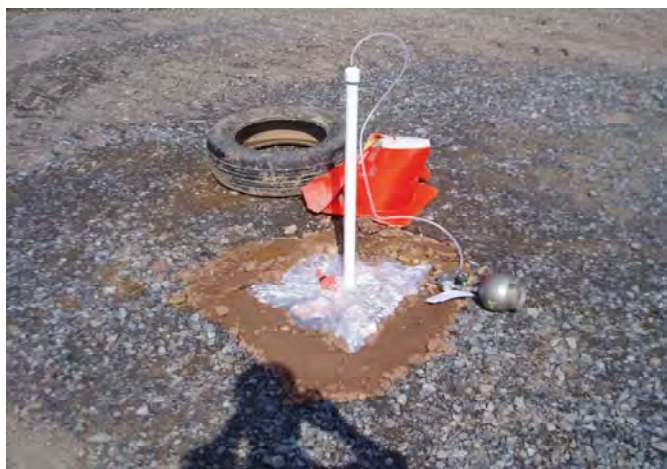
The construction of the soil vapor sampling points differed from the soil vapor sampling plan outlined in our approved remedial investigation work plan. The approved plan was modified to comply with the Draft DOH February 2005 Guidance Policy for Evaluating Soil Vapor Intrusion in the State of New York and the shallow groundwater conditions at the site. A schematic of a common soil vapor sampling point construction and a photo of the field-constructed sampling point appear below:

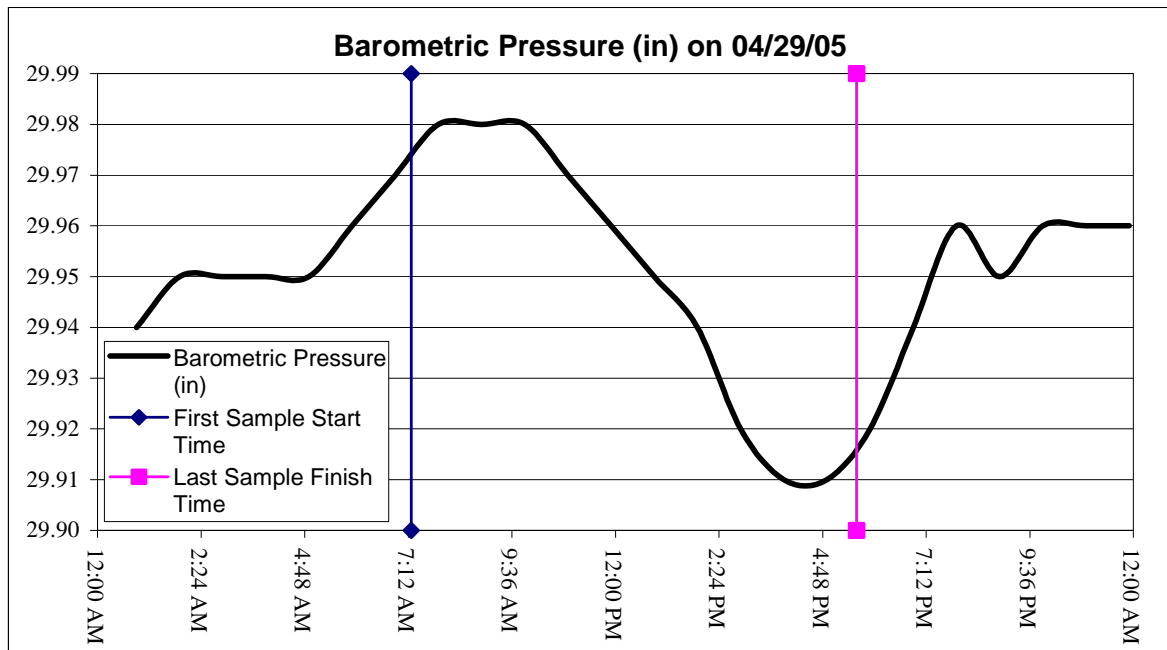
Barometric pressure for the sampling period was tracked and appears on the chart below. Collection of the first soil vapor sample began at 7:16 a.m. and collection of the last soil vapor sample ceased at 5:35 p.m. As can be seen on the chart, this sampling interval coincides with a period of falling barometric pressure.

This sampling period was selected to optimize the soil vapor sampling, as the soil vapor mobility would be toward the atmosphere and there is less likelihood of short-circuiting directly to atmosphere during sample collection.

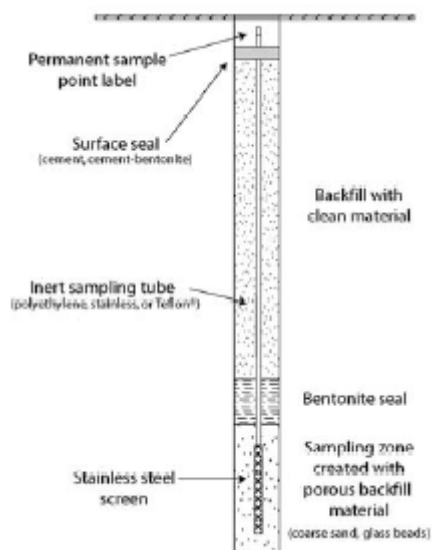
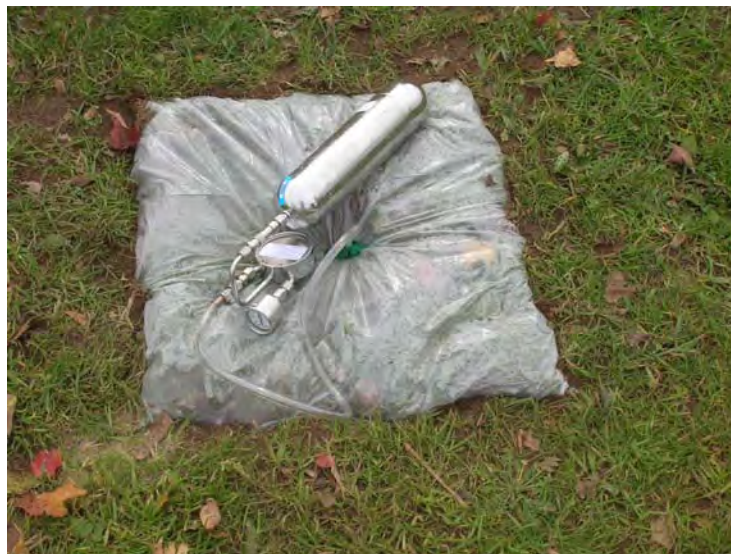
Additional soil vapor monitoring was performed on November 4, 2005 to assess off-site receptors. The construction of the soil vapor sampling points consisted of the installation of GeoProbe<sup>™</sup> sampling points in accordance with the Draft DOH Guidance Policy for Evaluating Soil Vapor Intrusion in the State of New York, dated February 2005. Soil vapor sampling point SV-12 was installed at a depth of 6.5 feet bgs. Shallow groundwater conditions at the site necessitated installation of the remaining soil vapor sampling points at depths between 3 and 3.5 feet bgs. A schematic of a common soil vapor sampling point construction and a photo of the field-constructed sampling point appear below:

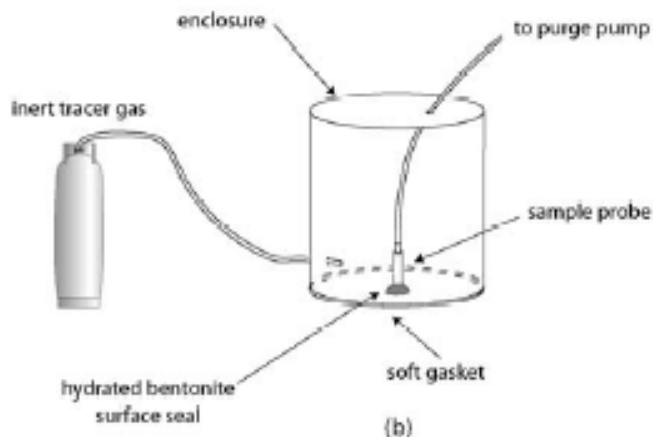
Each sampling point was purged for 30 seconds with a peristaltic sampling pump to remove “stagnant” air from the sampling location. This pump was set at a flow rate of approximately 1 liter per minute, purging an estimated 0.5 liters from each sampling point. Each sampling location was checked for gross short-circuiting by injecting 1-liter of helium gas into a 4-liter stainless enclosure obtained from the lab. A Mark 9822 helium leak detector with a detection limit of 0.01% to 100% helium was utilized to check for leaks in accordance with the procedures outlined in the Draft DOH Soil Vapor Guidance Policy mentioned above. No soil vapor sampling location exceeded 5.5% helium during the field testing (allowable maximum is 20%), indicating the construction of the soil vapor sampling points was adequately limiting short-circuiting to the atmosphere. A schematic of the tracer gas test construction appears below:

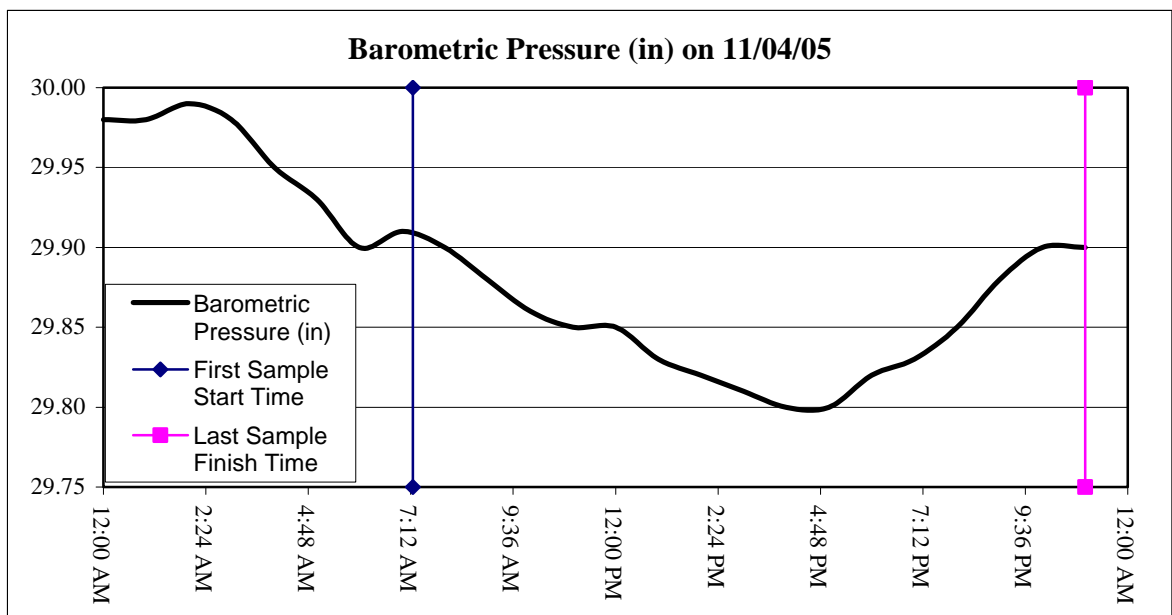
Barometric pressure for the sampling period was tracked and appears on the chart below.

Collection of the first soil vapor sample began at 7:15 a.m. and collection of the last soil vapor sample ceased at approximately 11:00 p.m. As can be seen on the chart, the majority of this sampling interval coincides with a period of falling barometric pressure.

As previously stated, this sampling period was selected to optimize the soil vapor sampling, as the soil vapor mobility would be toward the atmosphere and there is less likelihood of short-circuiting directly to atmosphere during sample collection.
