**PERIODIC REVIEW REPORT
AND
ANNUAL CERTIFICATION
FOR AUGUST 2013-AUGUST 2014**

**OIL CITY/CAROUSEL CENTER - PHASE I SITE (#C734104)
DESTINY USA, SYRACUSE, NEW YORK**

**SEPTEMBER 2014
REVISED DECEMBER 2014**

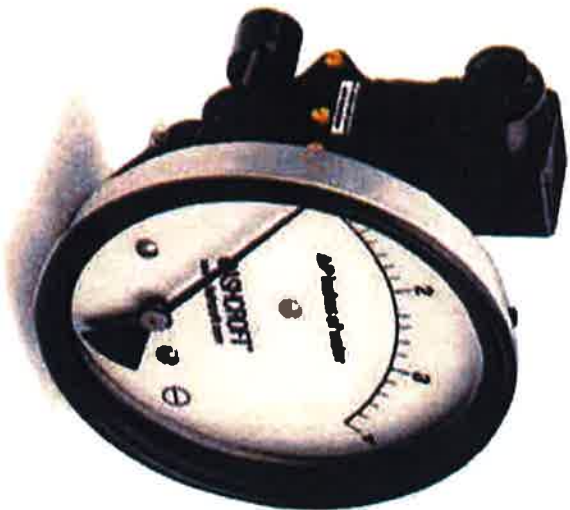
Type 1134 – 4½" Low Pressure Differential Gauge

- *Convoluted diaphragm actuator*
- *Stainless steel case*
- *Ranges from 0.6 IWD-60 IWD*
- *Static pressures up to 35 psi*
- *Glass filled nylon body⁽¹⁾*
- *Buna-N seals (others available)*
- *Superior magnets for smoother power motion*
- *Low cost reed switches available*
- *5-year warranty*
- *Flush mounting accessories standard*

The Type 1134 uses a convoluted-diaphragm design with no migration of the process media. It is recommended for low differential inches of water ranges. Body material is glass filled nylon with Buna or silicone.⁽²⁾
