Periodic Review Report and Annual Certification - September 2014 - August 2015

Site Name: Oil City/Carousel Center - Phase I

# PERIODIC REVIEW REPORT AND ANNUAL CERTIFICATION FOR SEPTEMBER 2014-AUGUST 2015

## OIL CITY/CAROUSEL CENTER - PHASE I SITE (#C734104) DESTINY USA, SYRACUSE, NEW YORK

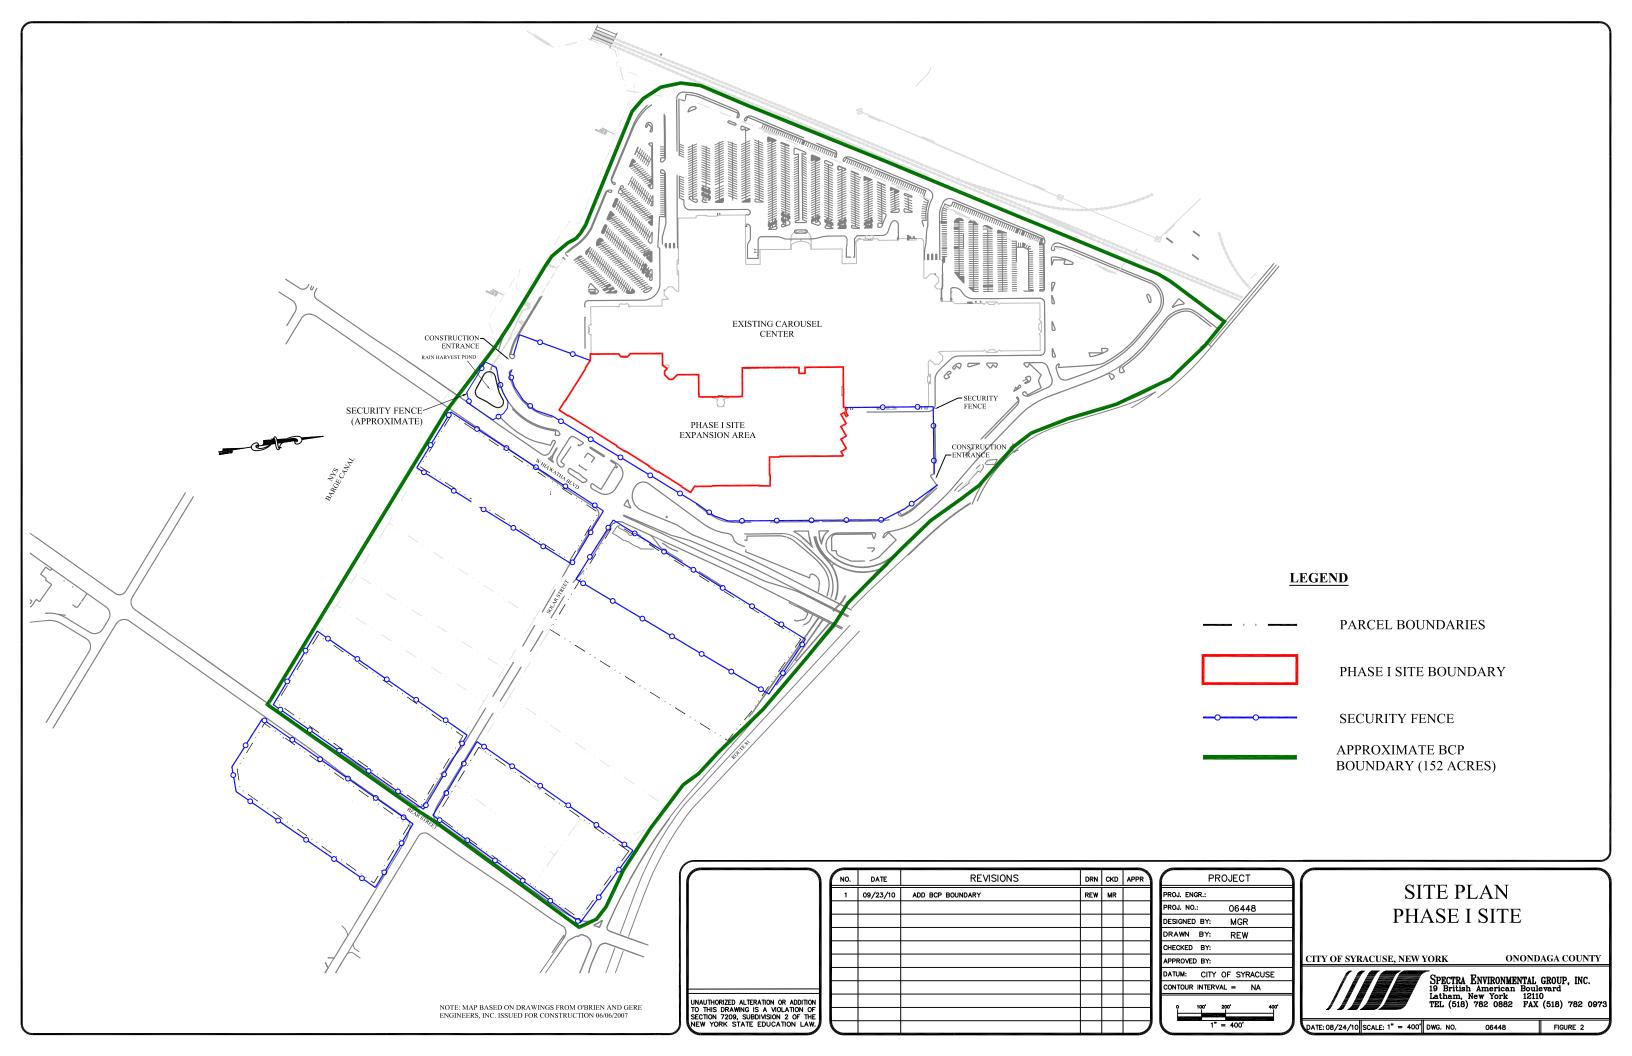
FIGURE 2 PHASE I SITE PLAN

The overall Destiny Site consists of approximately 152 acres at the southeast end of Onondaga Lake (a Class C water body). It is generally bounded by: Onondaga Lake and Conrail tracks, to the northwest; Interstate 81 (I-81) to the north and northeast; Bear Street on the south and southeast; and the New York State Barge Canal to the south and southwest. See Figures 1 and 2.

The Phase I Site is located in the southeast portion of the lands generally referred to as the Carousel Center site, between the existing Carousel Center building and West Hiawatha Boulevard. The Phase I Site consists of the area under the expansion area footprint as shown on Figure 2 "Site Plan". The remedy described in the Phase I RWP has been completed and is subject to the ongoing operation and maintenance requirements set forth in the Phase I Site Management/Operations and Maintenance Plan ("Phase I SMP"). Prior to the work described in the Final Engineering Report, the Phase I Site consisted of surface parking lots and associated driveway areas. Prior to 1990, a portion of each of the following uses was located in the area of the Phase I Site: Marley Scrap Yard, Buckeye Petroleum Tank Farm, and the Amerada Hess Petroleum Tank Farm.
