# INTERIM REMEDIAL MEASURE WORK PLAN

NYSDEC BCP SITE # C734108

AOC-4, Celi Drive BCP Site  
Town of Dewitt, Onondaga County, New York

December 2022

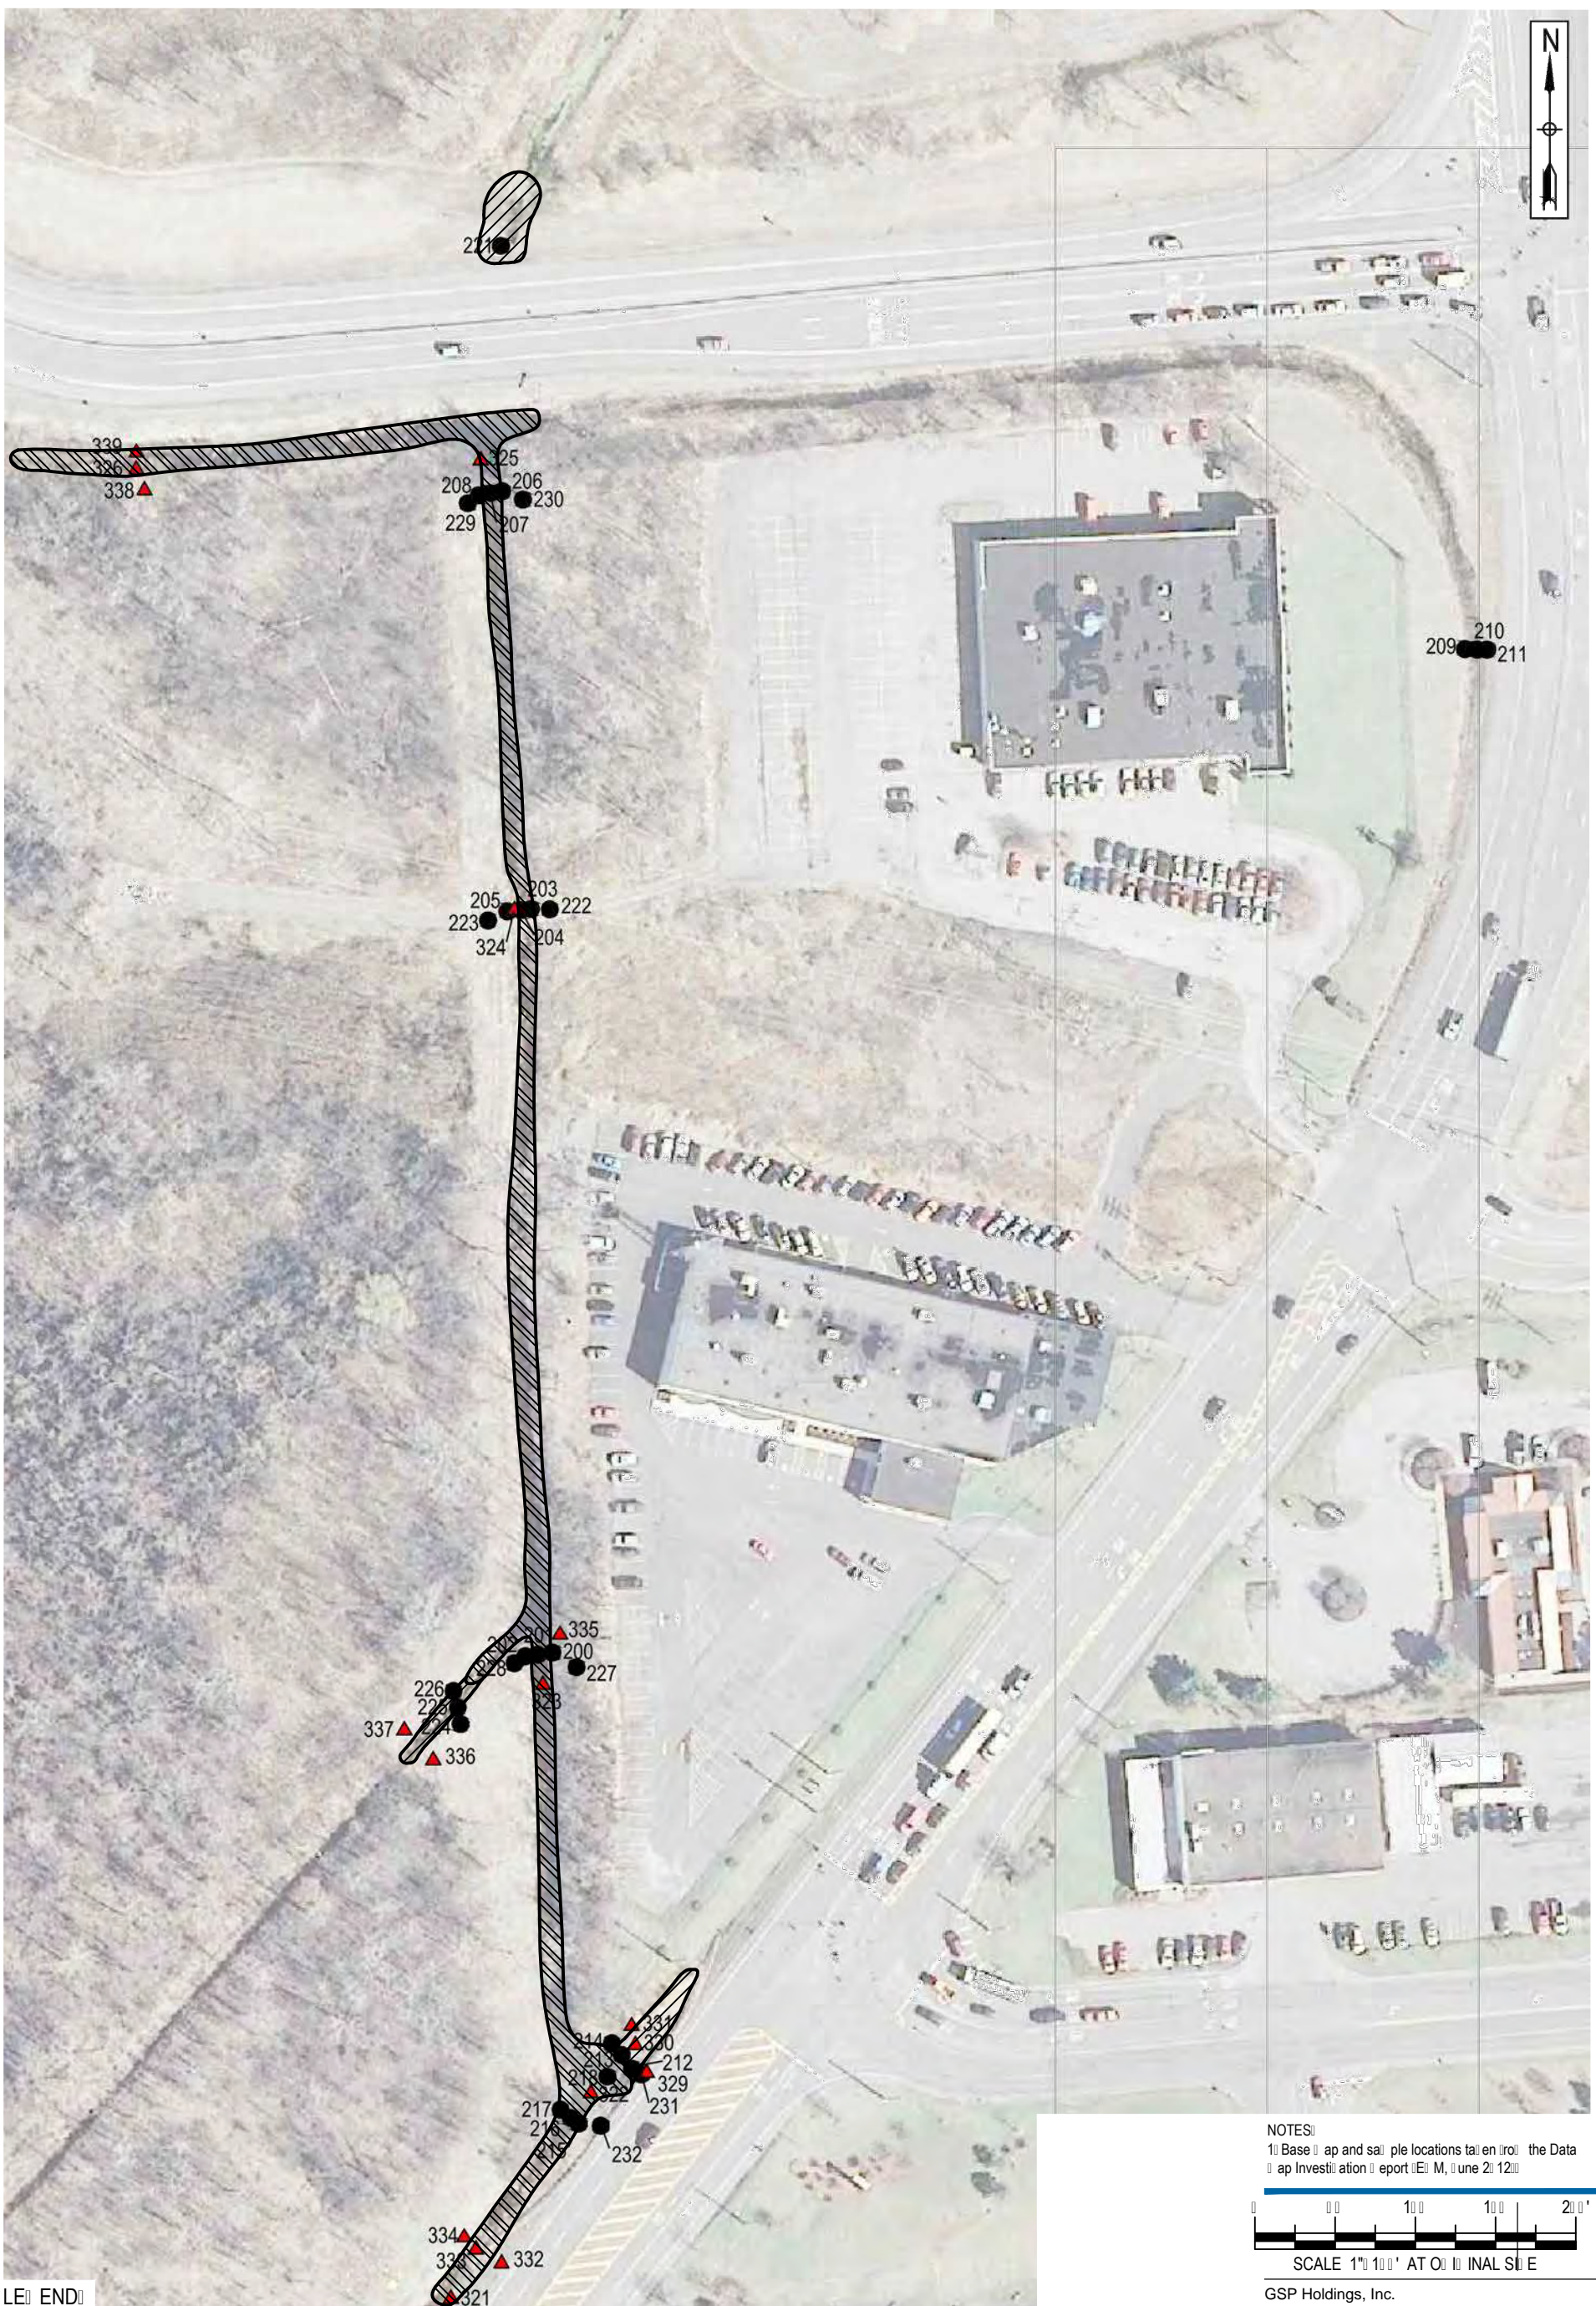
Job Number | 37-11082  
 Revision | A  
 Date | 06.06.2014 **Figure 7-4a**

- Source Identification Investigation Sample Locations (E: M, 2) (1)
- ▲ Data Acquisition Investigation Soil Boring Location (E: M, 2) (1)
- ▨ Area of Utility Excavation (1' to 1' to Meet Protection of Ecological Resources SCOs (Approximate))
- ▨ Area of Utility Excavation (1' to 2' to Meet Protection of Ecological Resources SCOs (Approximate))

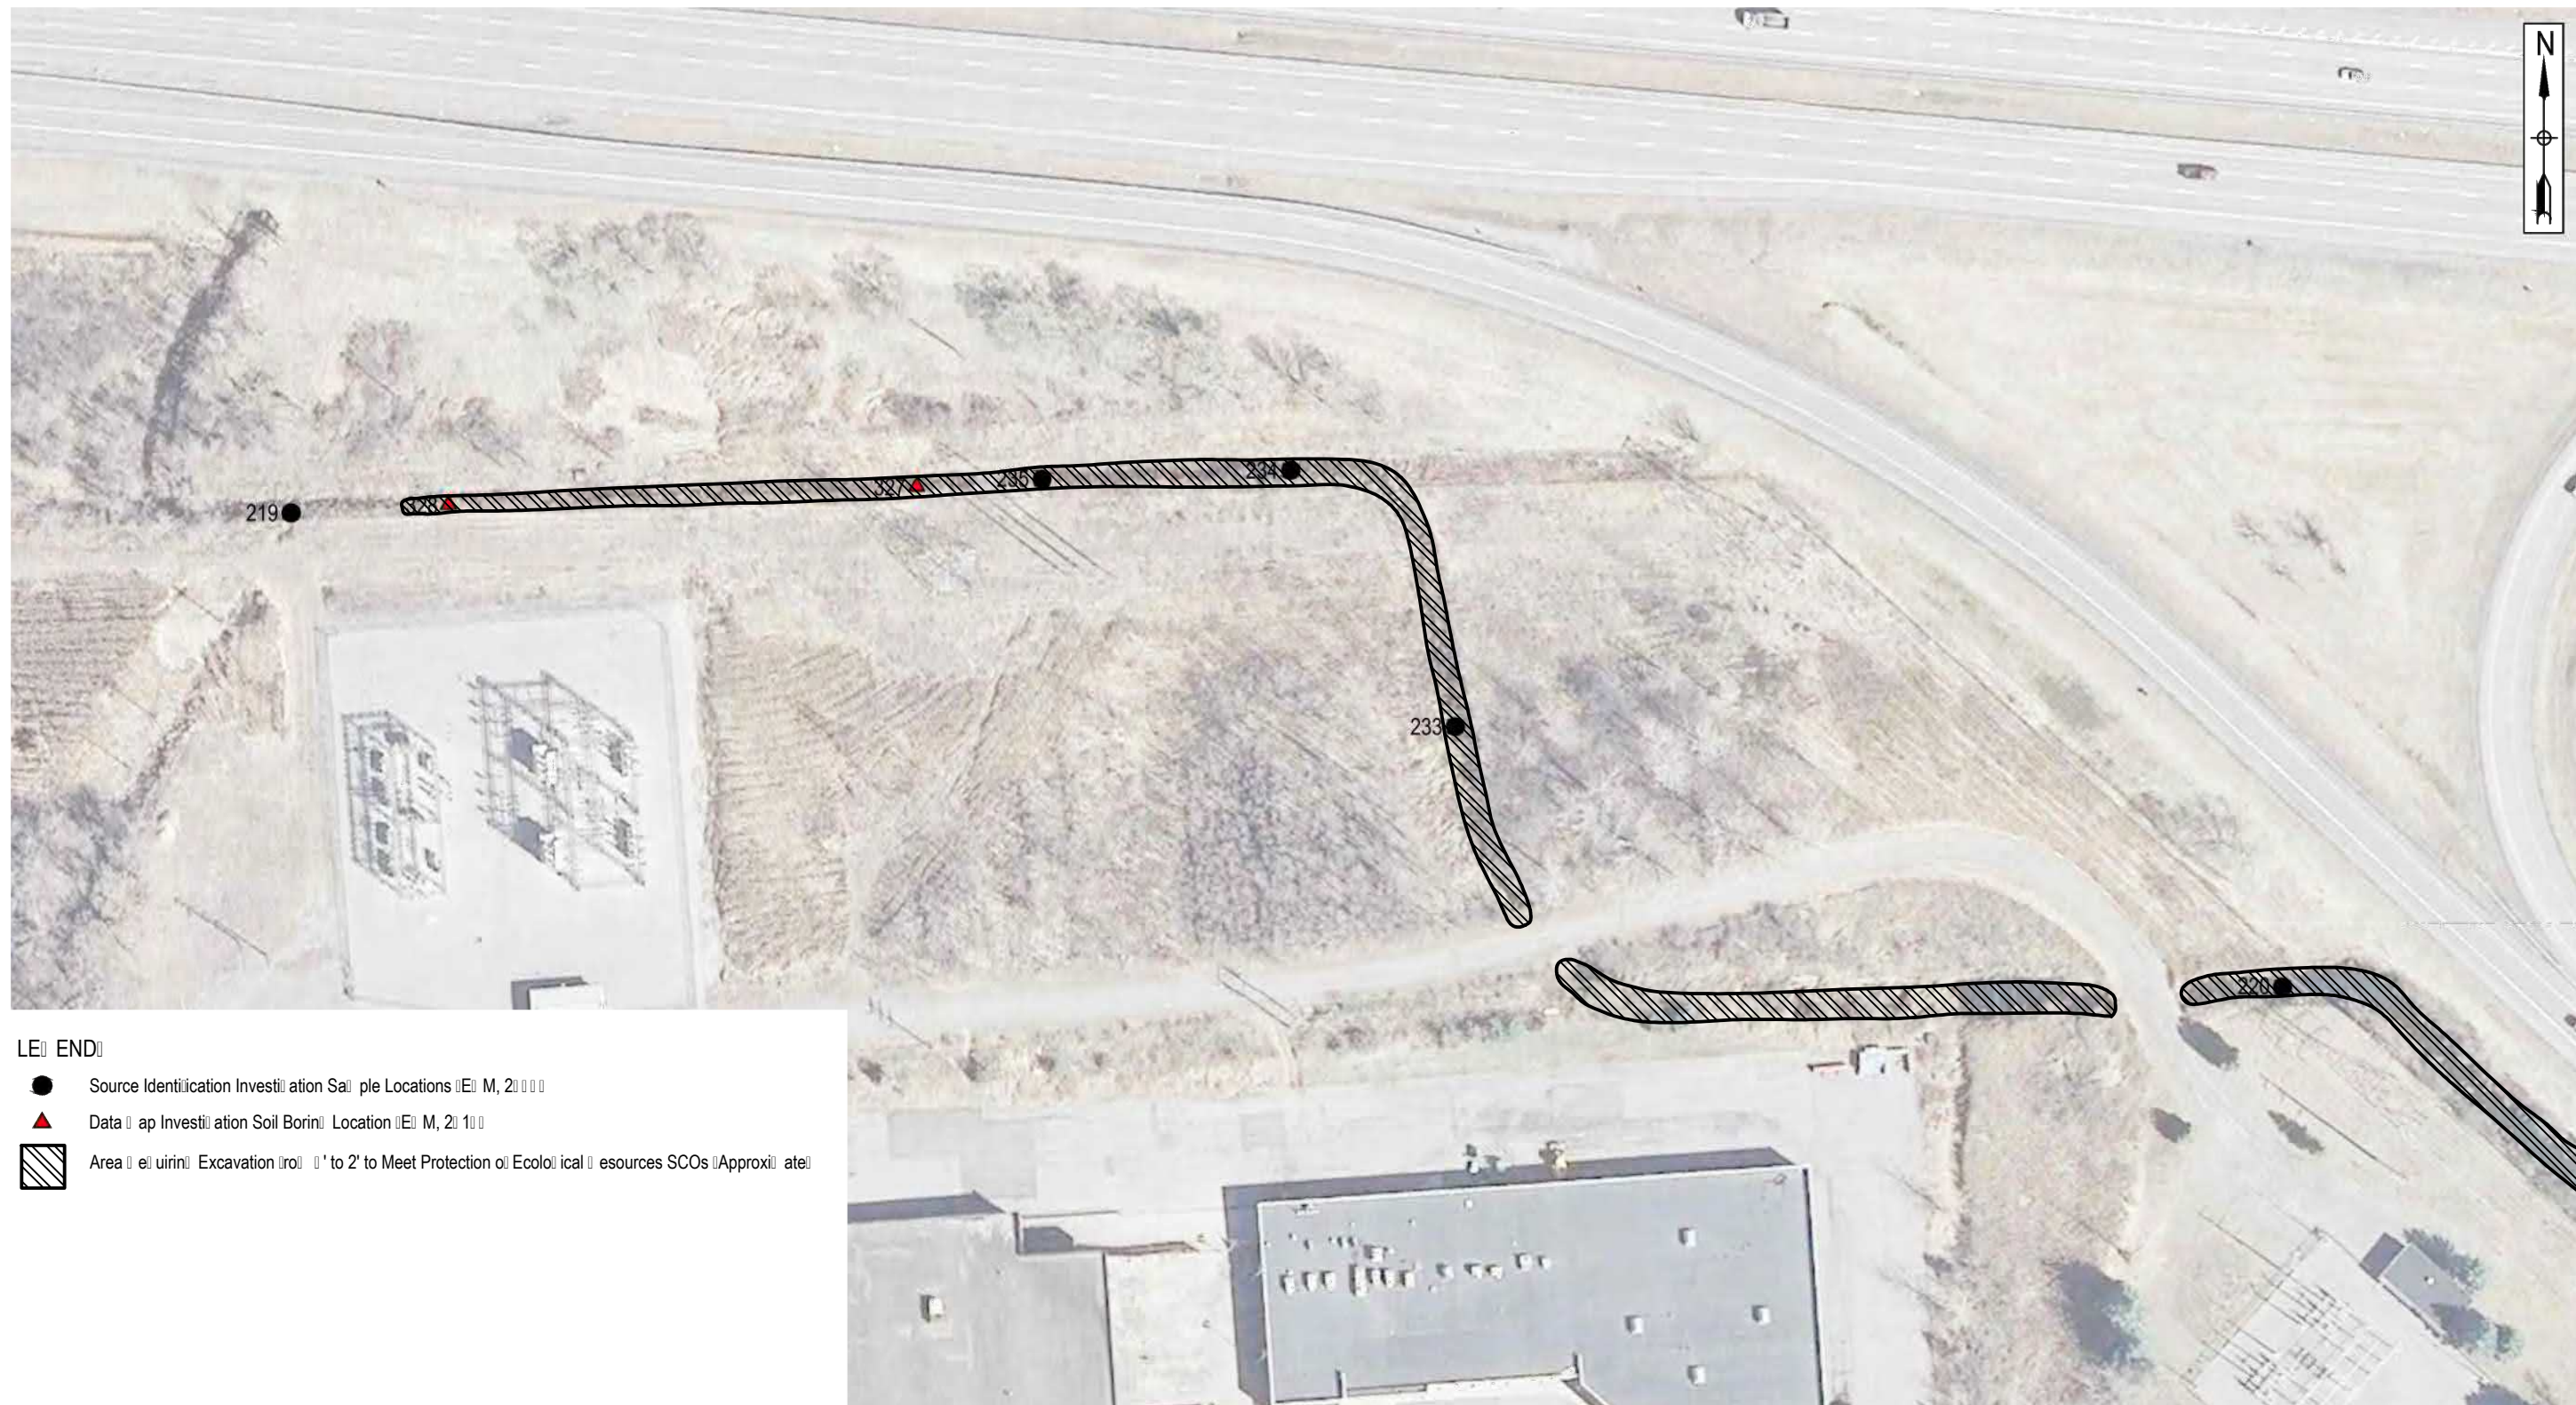
- Source Identification Investigation Sample Locations (EIM, 2010)
- ▲ Data Point Investigation Soil Boring Location (EIM, 2010)
- ▨ Area of Excavation (0' to 2' to Meet Protection of Ecological Resources SCOs (Approximate))

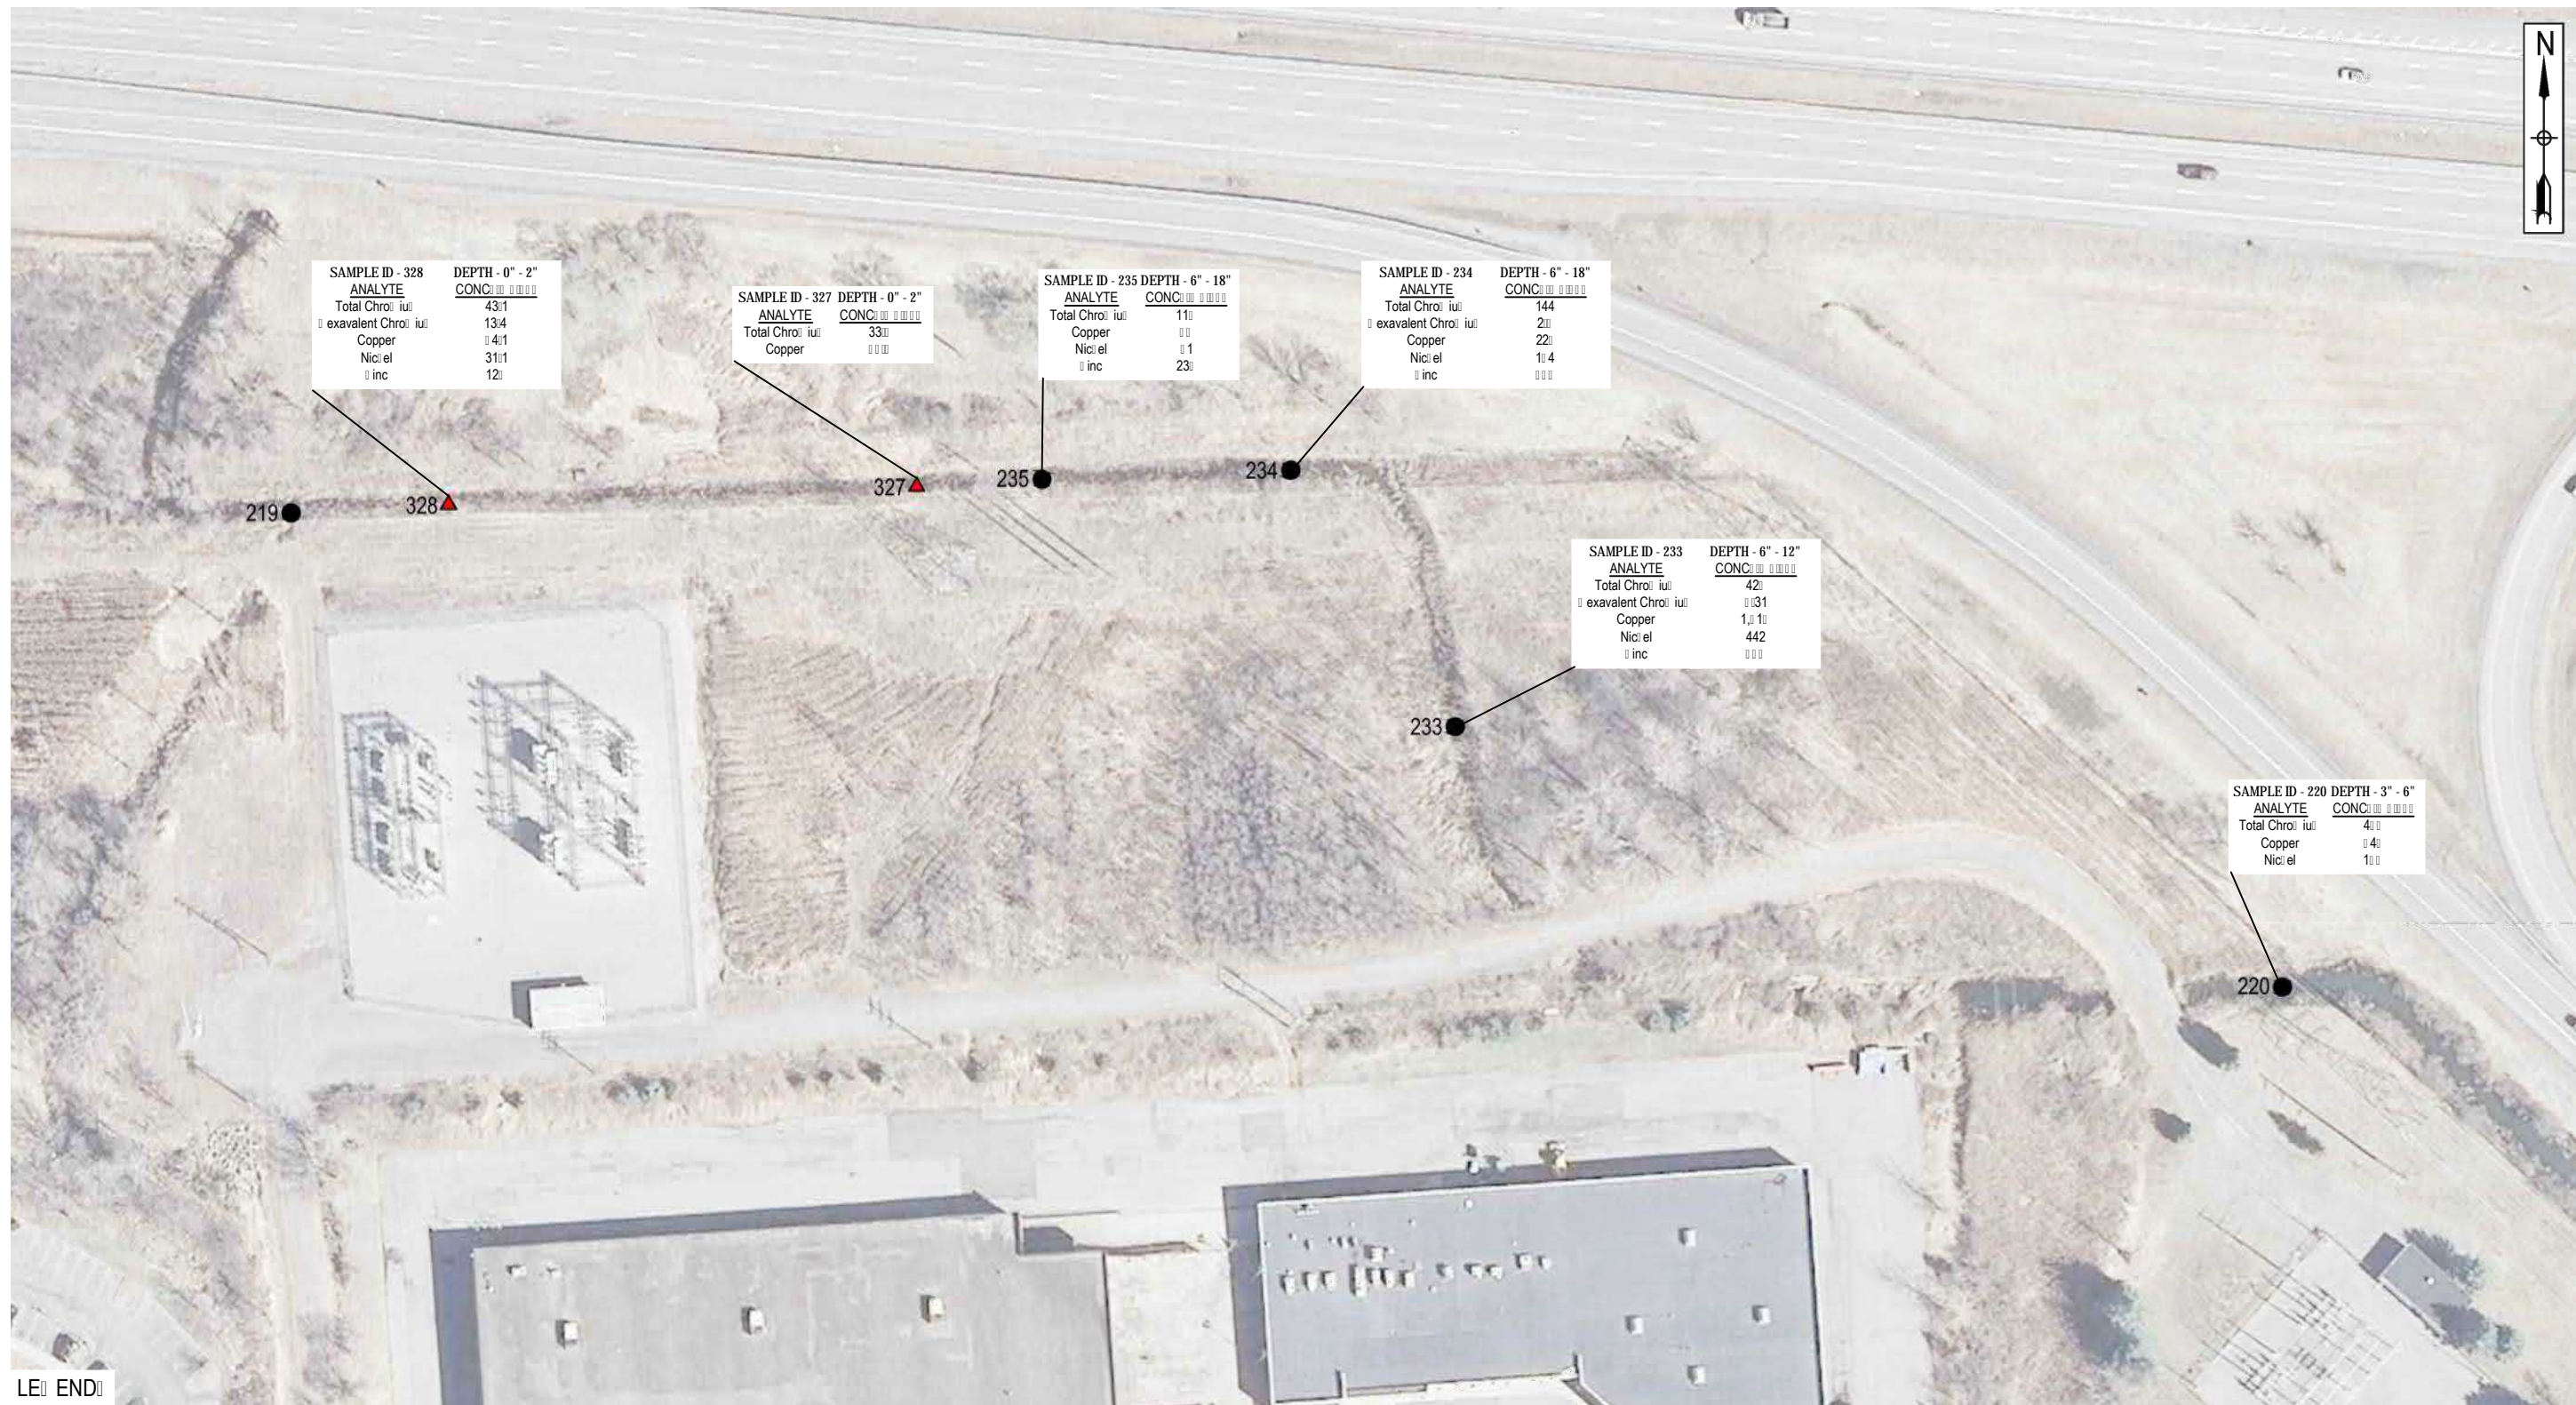
Job Number 37-11082  
 Revision A  
 Date 11.12.2013 Figure 7-1a

LEI END  
 ● Source Identification Investigation Sample Locations (EIM, 2012)  
 ▲ Data Investigation Soil Boring Location (EIM, 2012)

- Restoration to Pre-Disposal or Unrestricted SCO Conditions (Alternative 1, Figures 7-1a, 7-1b, 7-2a, and 7-2b)
- Soil/Sediment removal from the swale to Protection of Ecological Resources SCOs (Alternative 2, Figures 7-3a, 7-3b, 7-4a, and 7-4b).

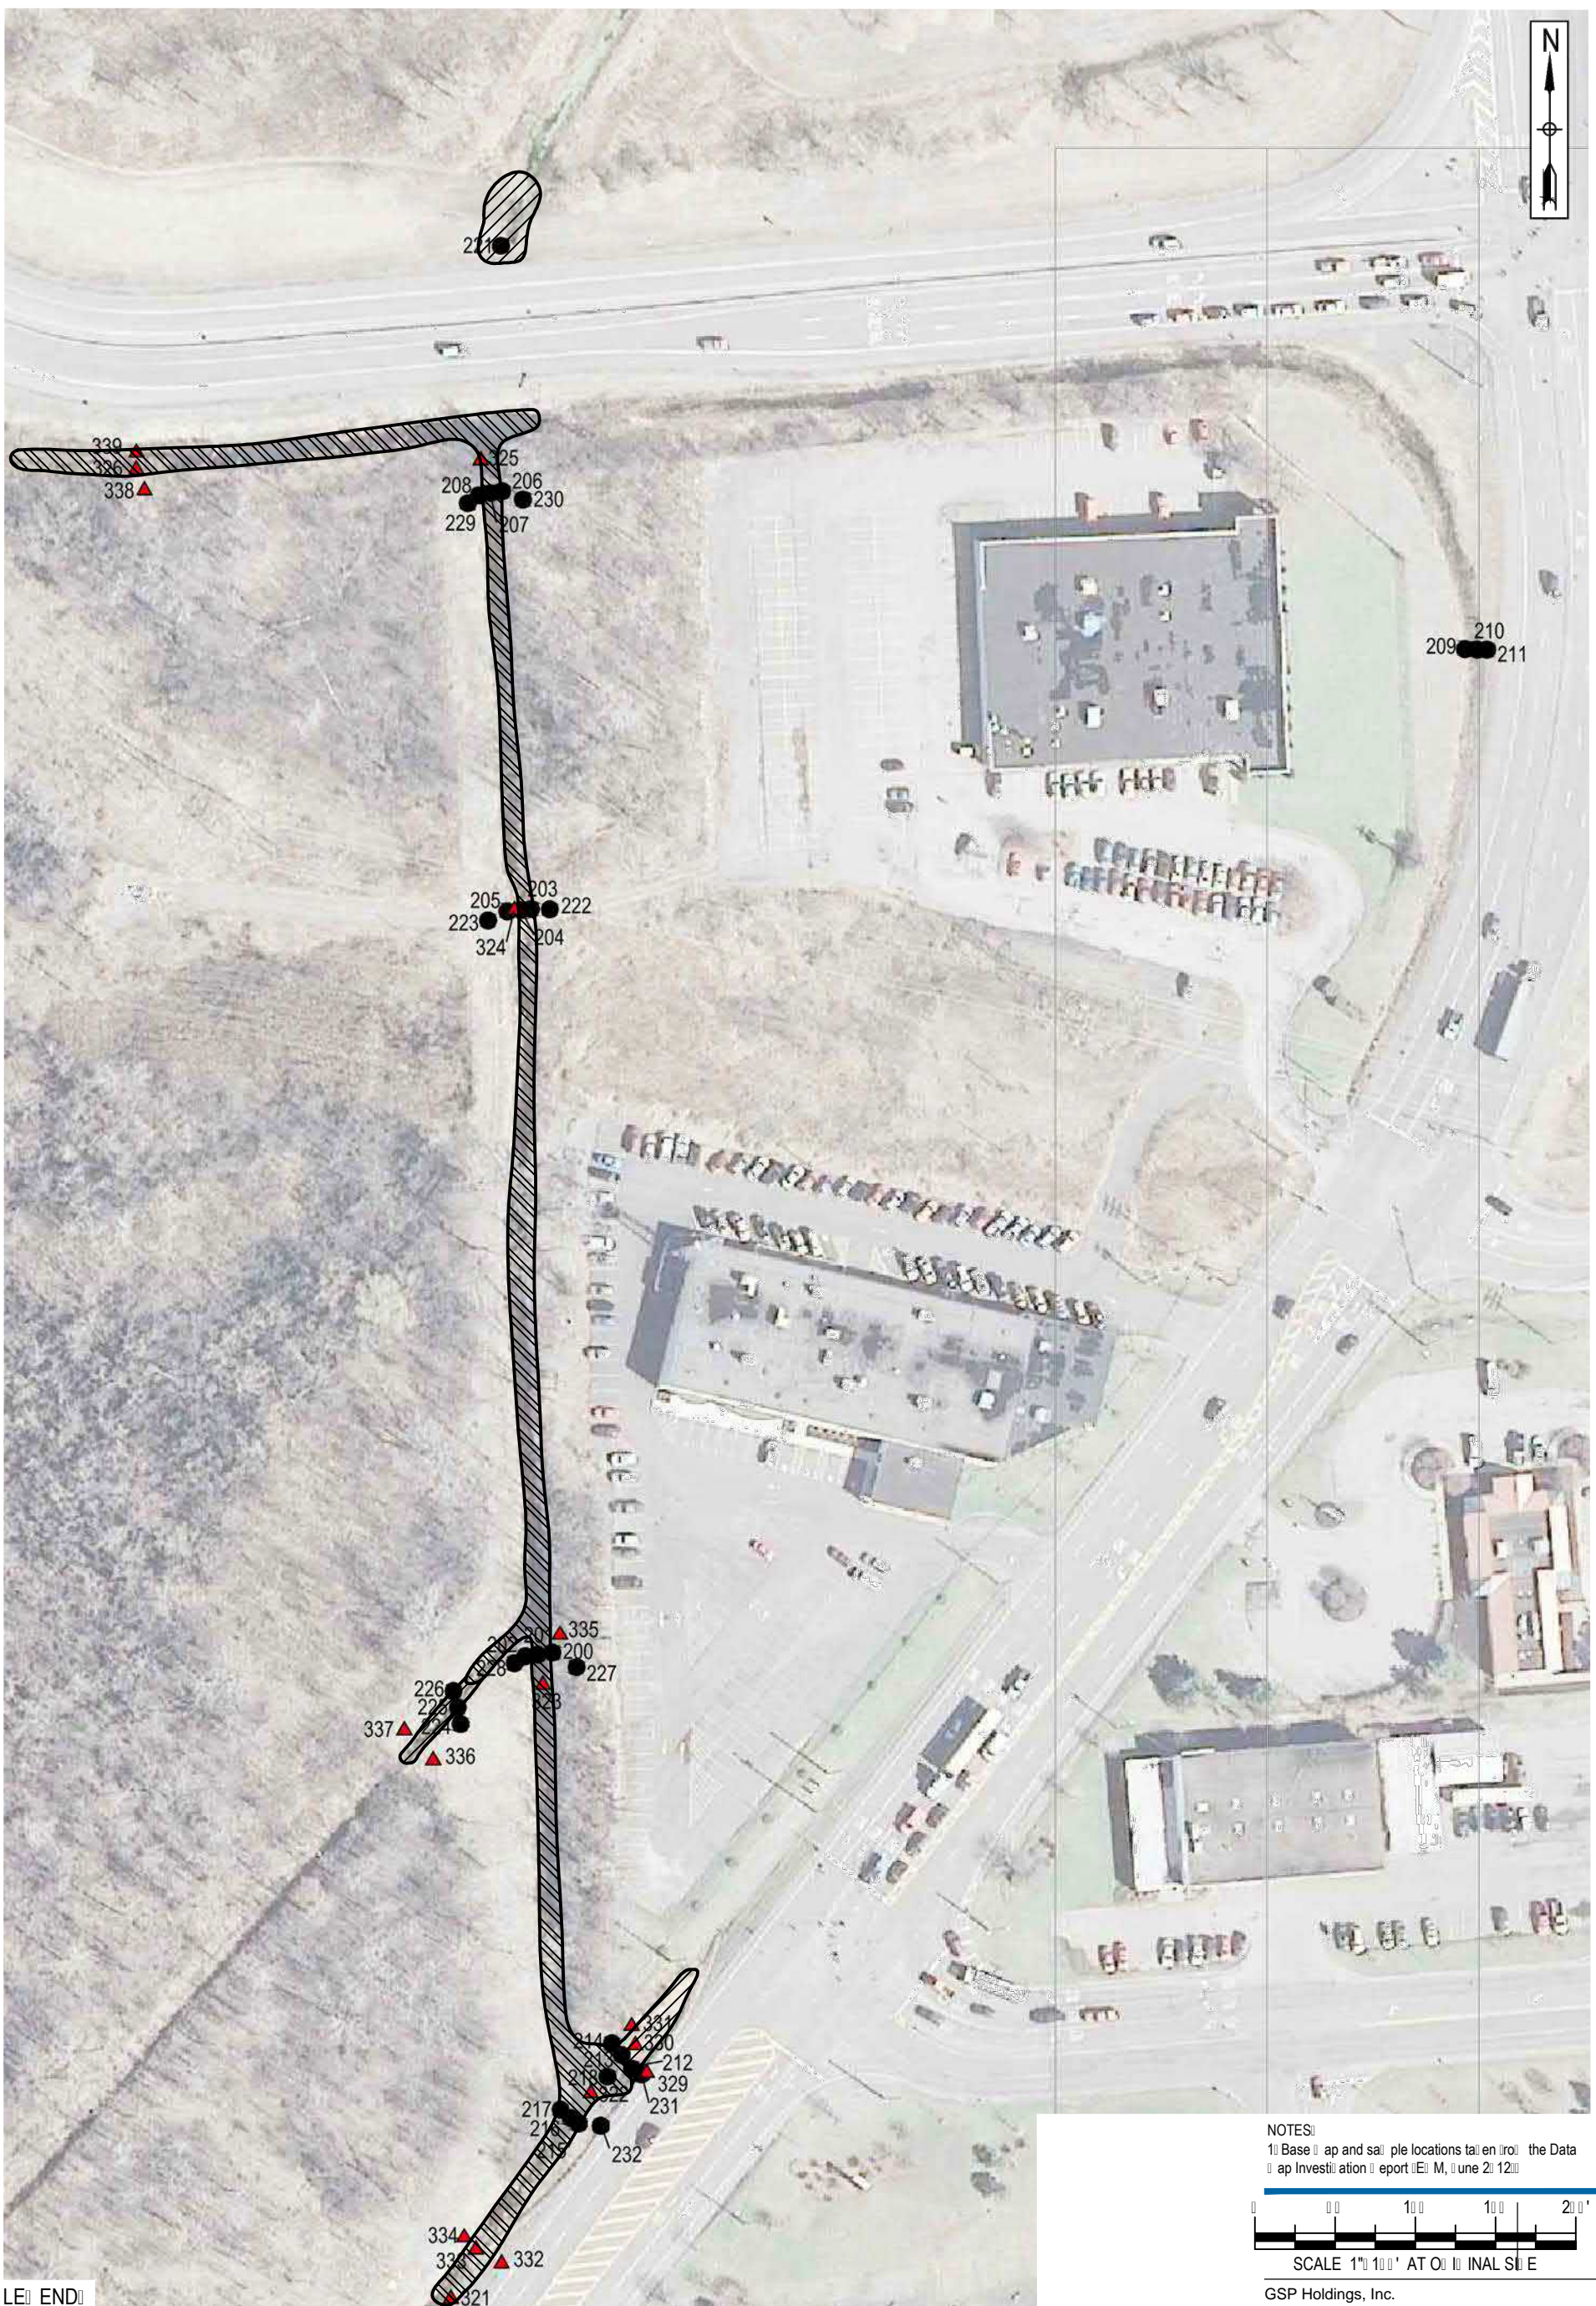
Job Number | 37-11082  
 Revision | A  
 Date | 06.06.2014 **Figure 7-2a**

- Source Identification Investigation Sample Locations (E) M, 2000
- ▲ Data Acquisition Investigation Soil Boring Location (E) M, 2010
- ▨ Area of Excavation (to 1' to Meet Unrestricted Use SCOs (Approximate))
- ▨ Area of Excavation (to 2' to Meet Unrestricted Use SCOs (Approximate))

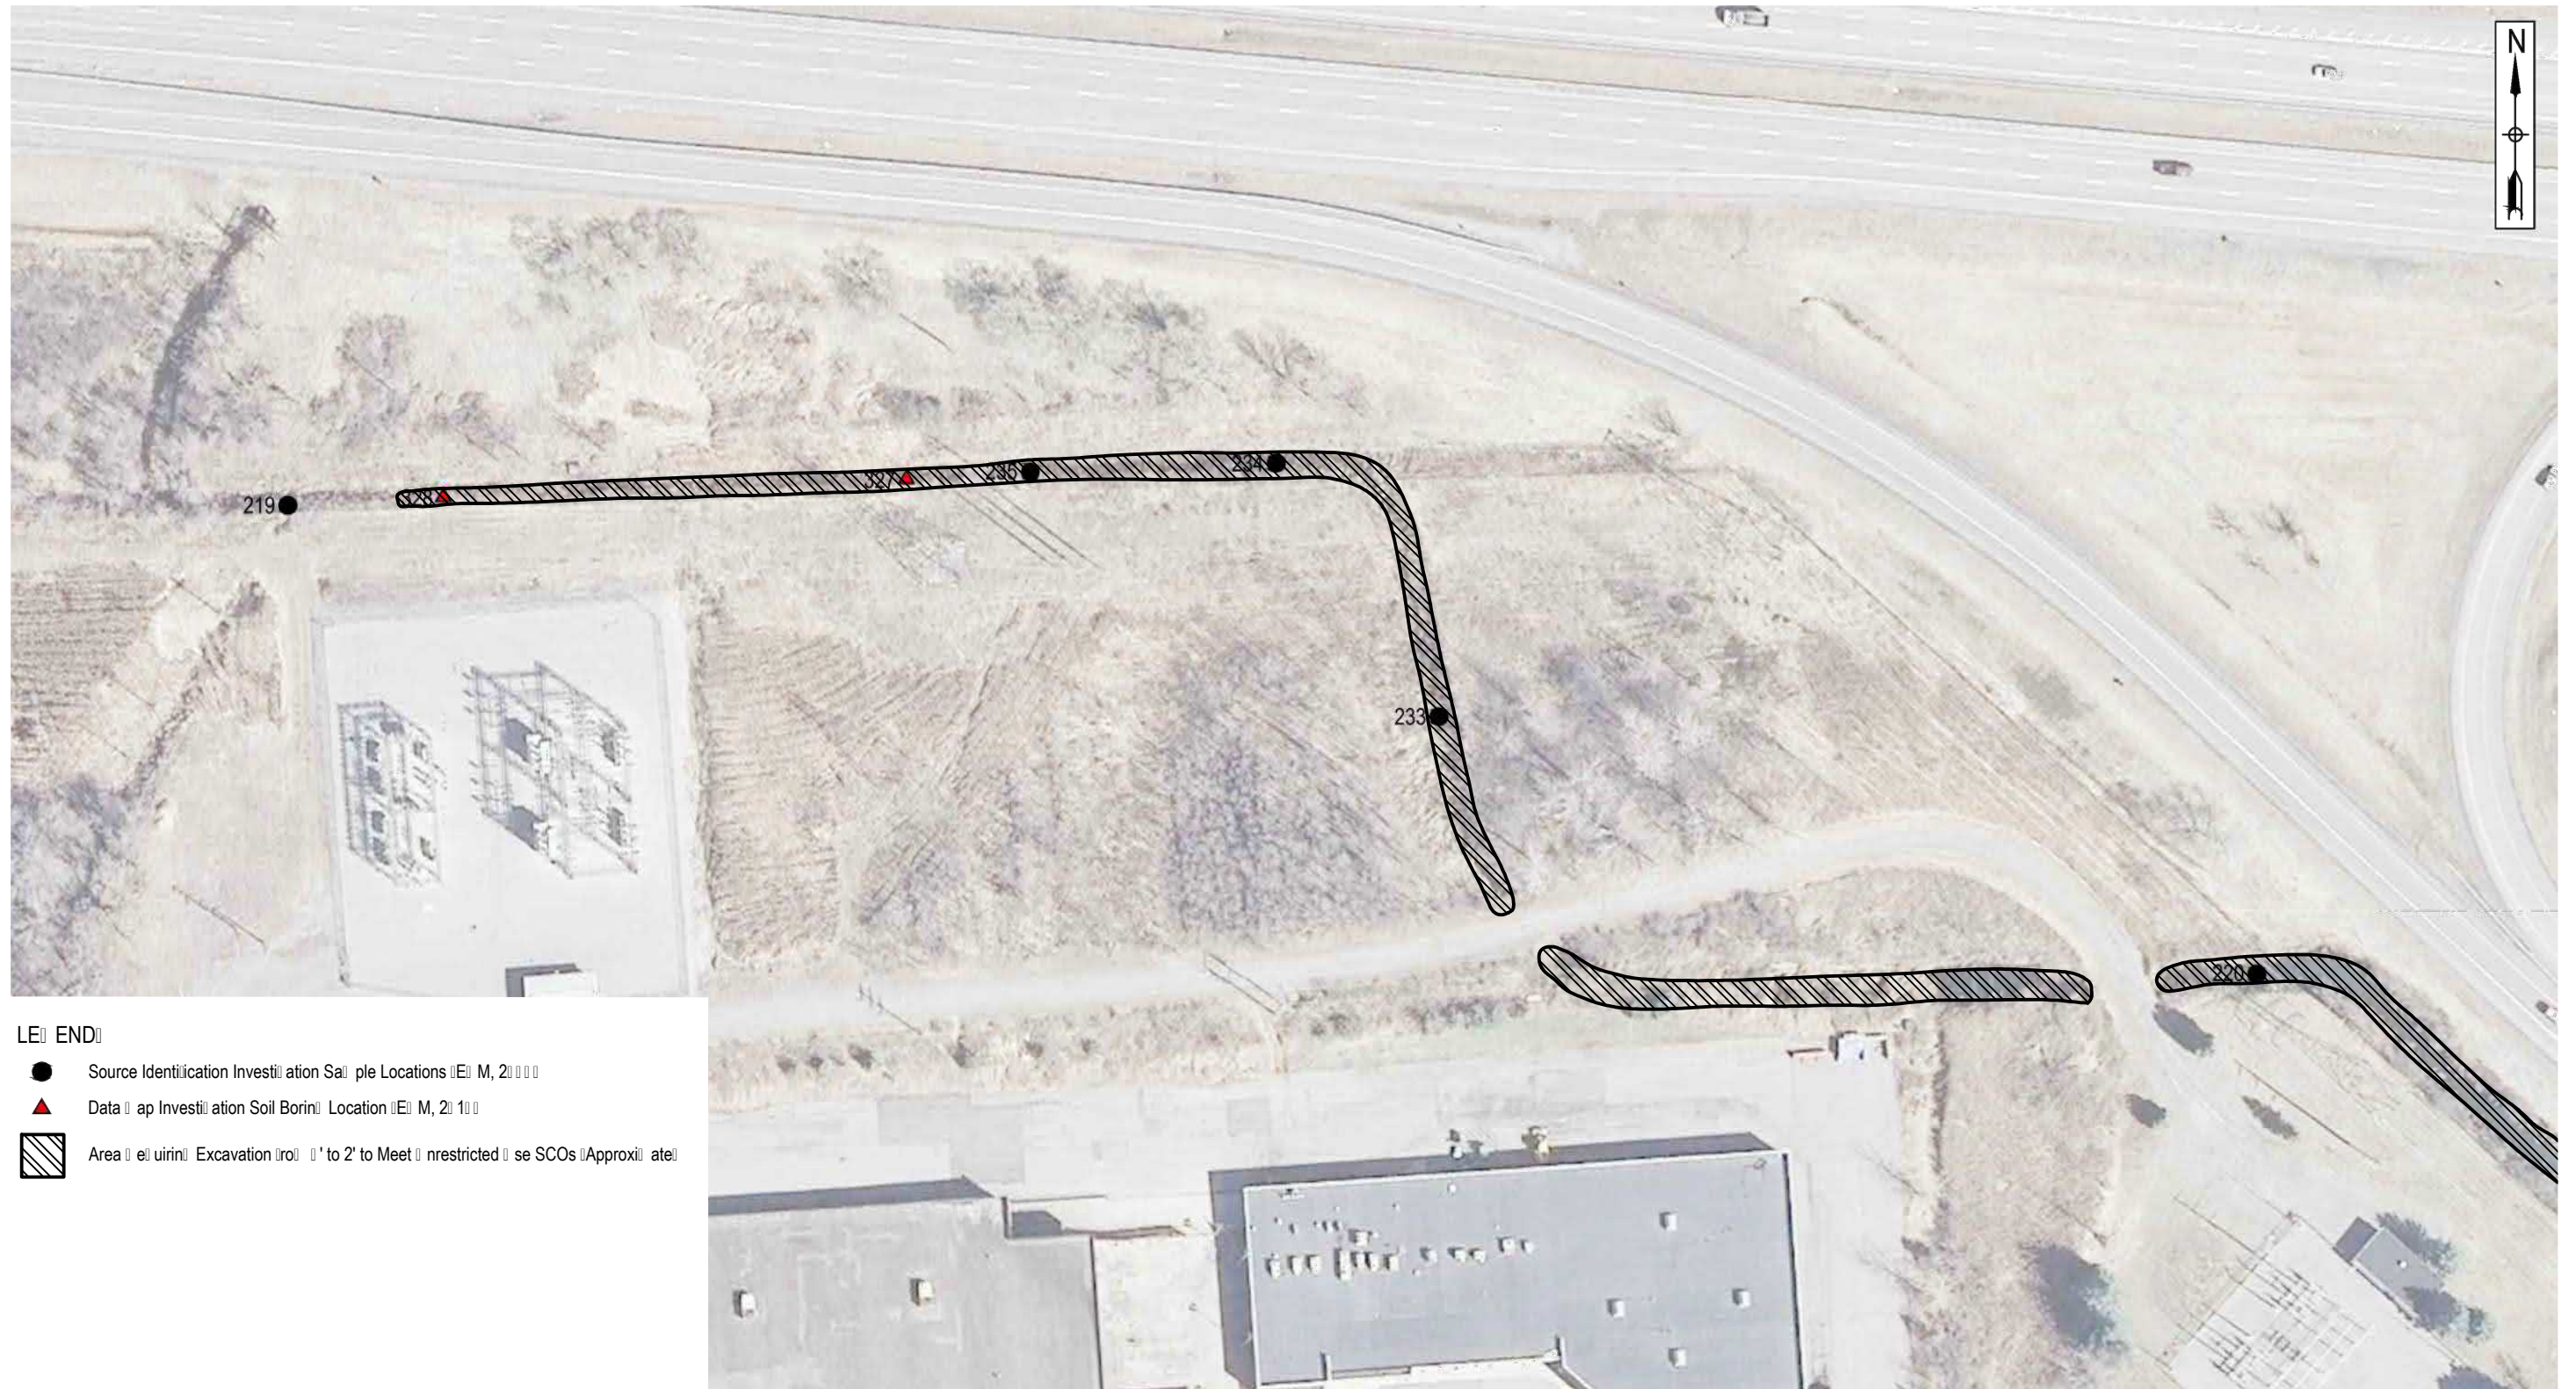
**Figure 7-2b**

- Source Identification Investigation Sample Locations (EIM, June 2012)
- ▲ Data Support Investigation Soil Boring Location (EIM, June 2012)
- ▨ Area of Required Excavation (0' to 2' to Meet Unrestricted Use SCOs (Approximate))

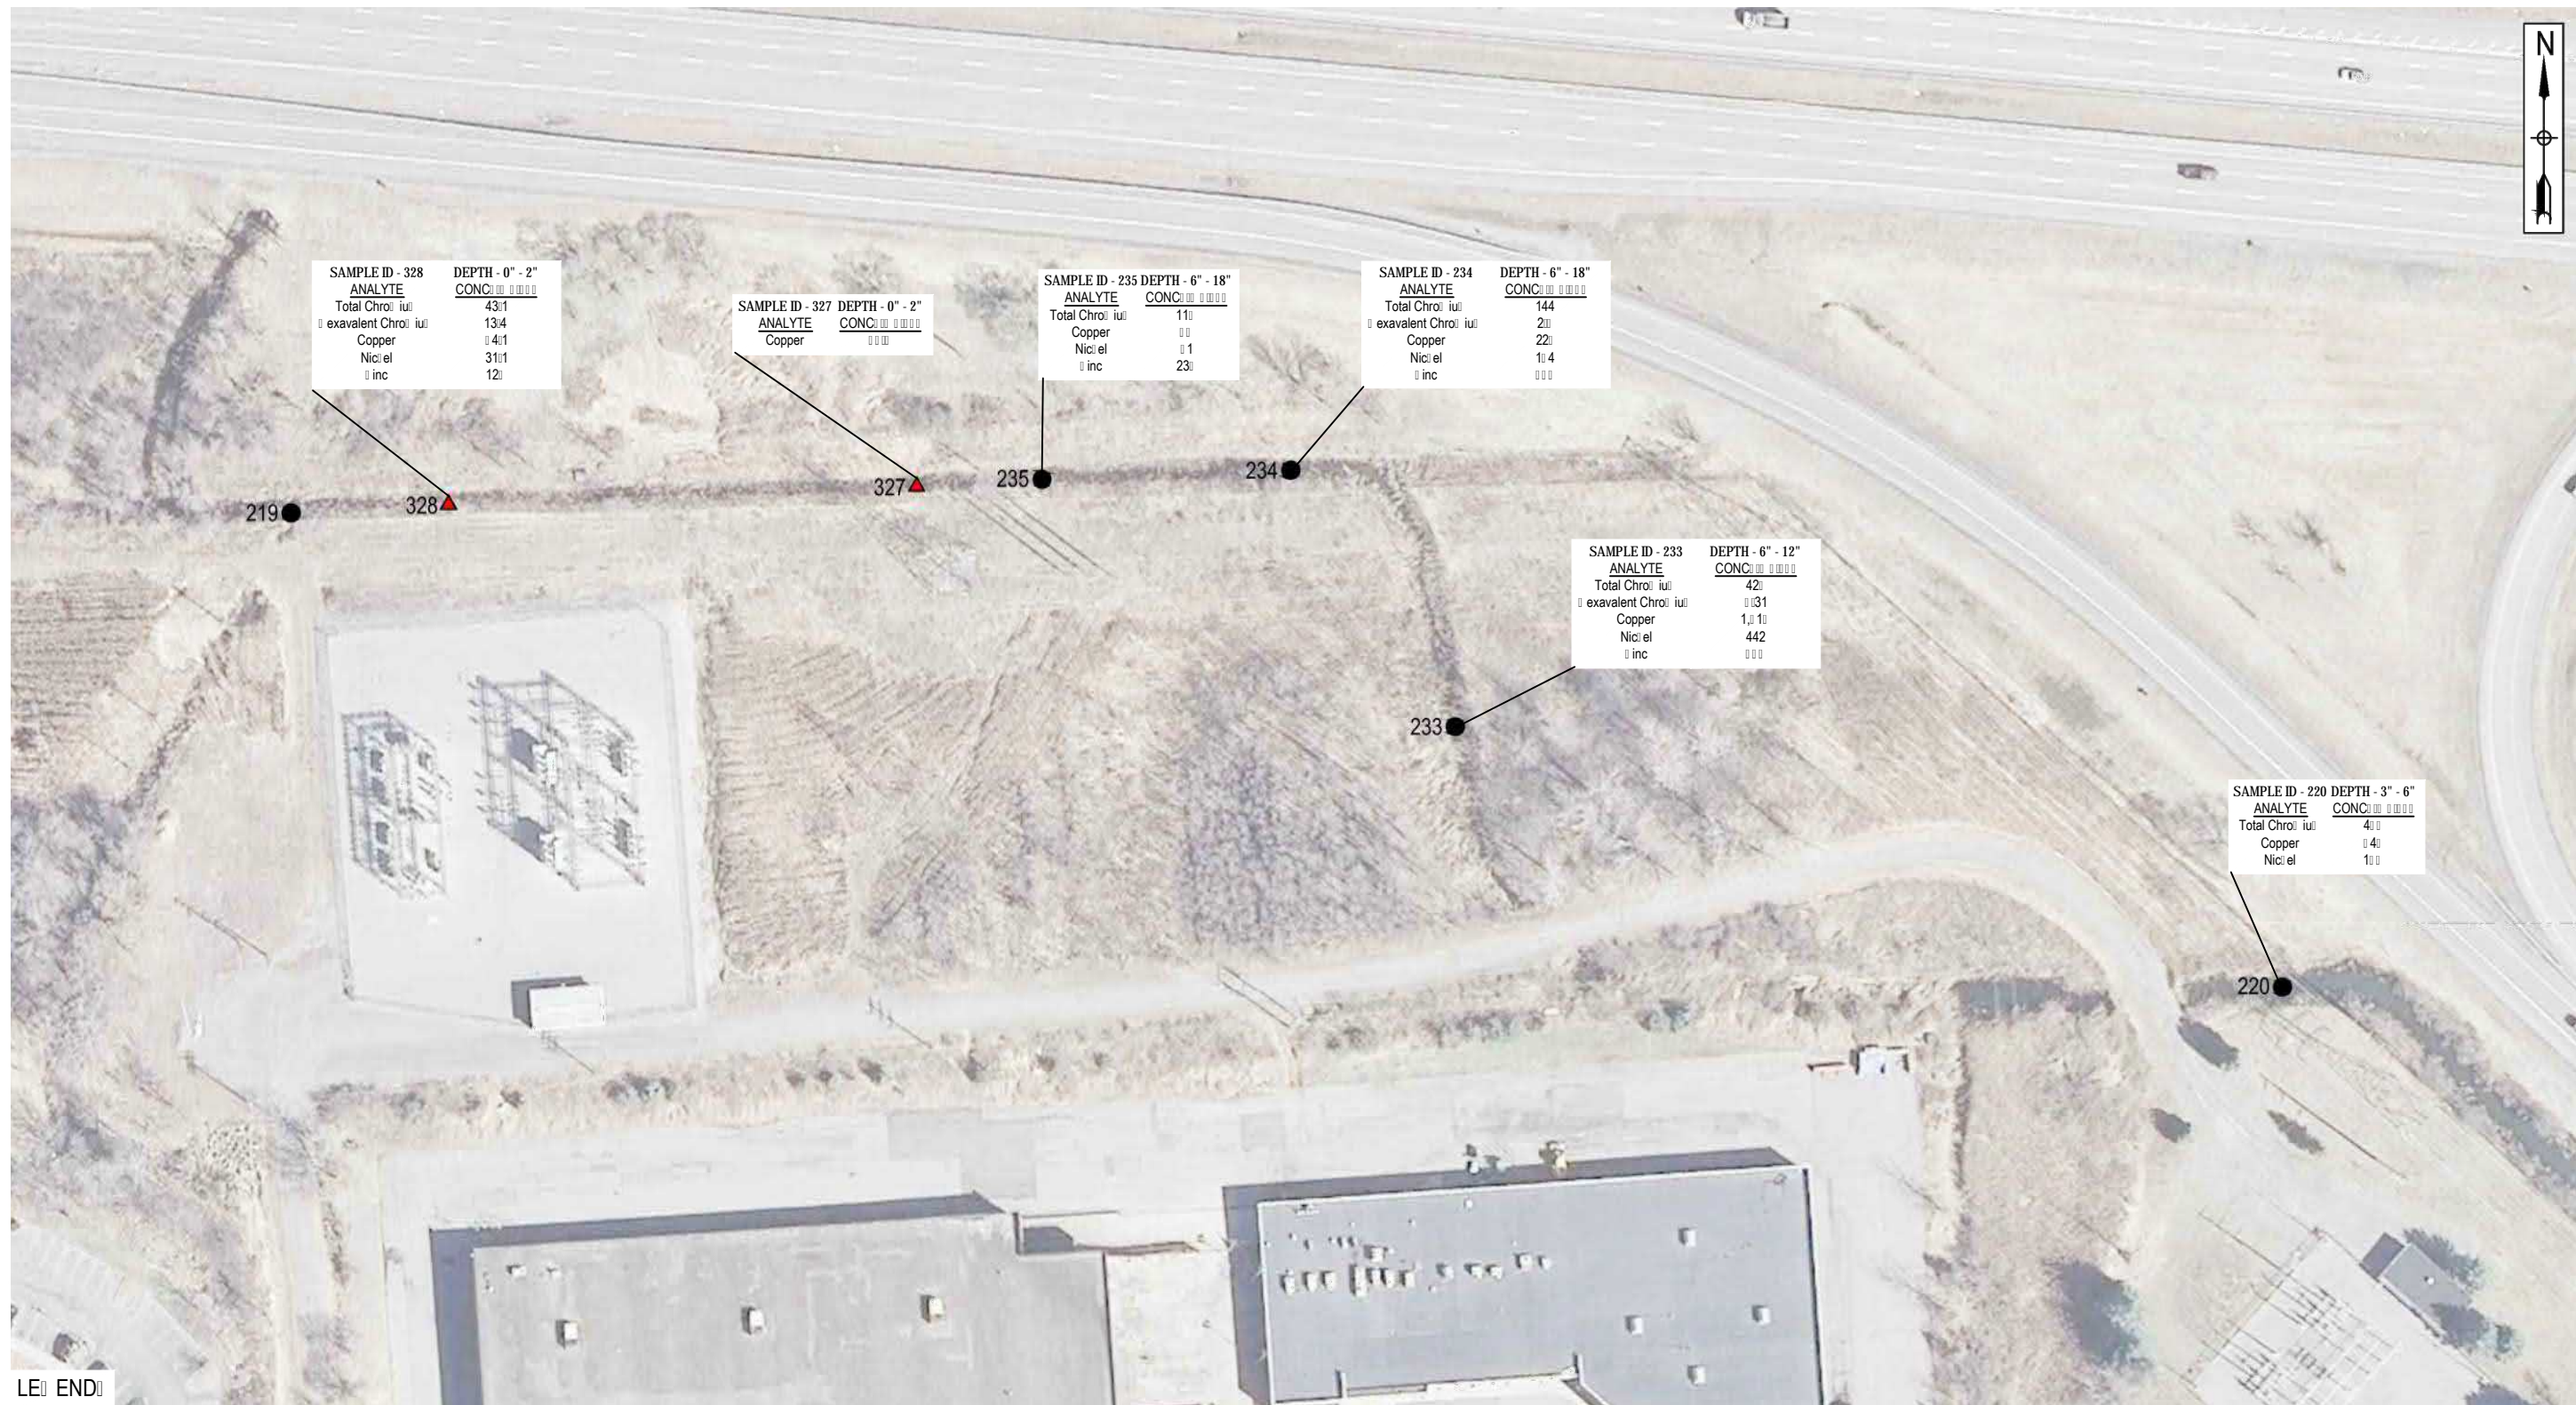
Job Number 37-11082  
 Revision A  
 Date 11.12.2013 Figure 7-3a

LEI END  
 ● Source Identification Investigation Sample Locations (EIM, 2012)  
 ▲ Data Map Investigation Soil Boring Location (EIM, 2012)
