# INTERIM REMEDIAL MEASURE WORK PLAN

NYSDEC BCP SITE # C734108

AOC-4, Celi Drive BCP Site  
Town of Dewitt, Onondaga County, New York

December 2022

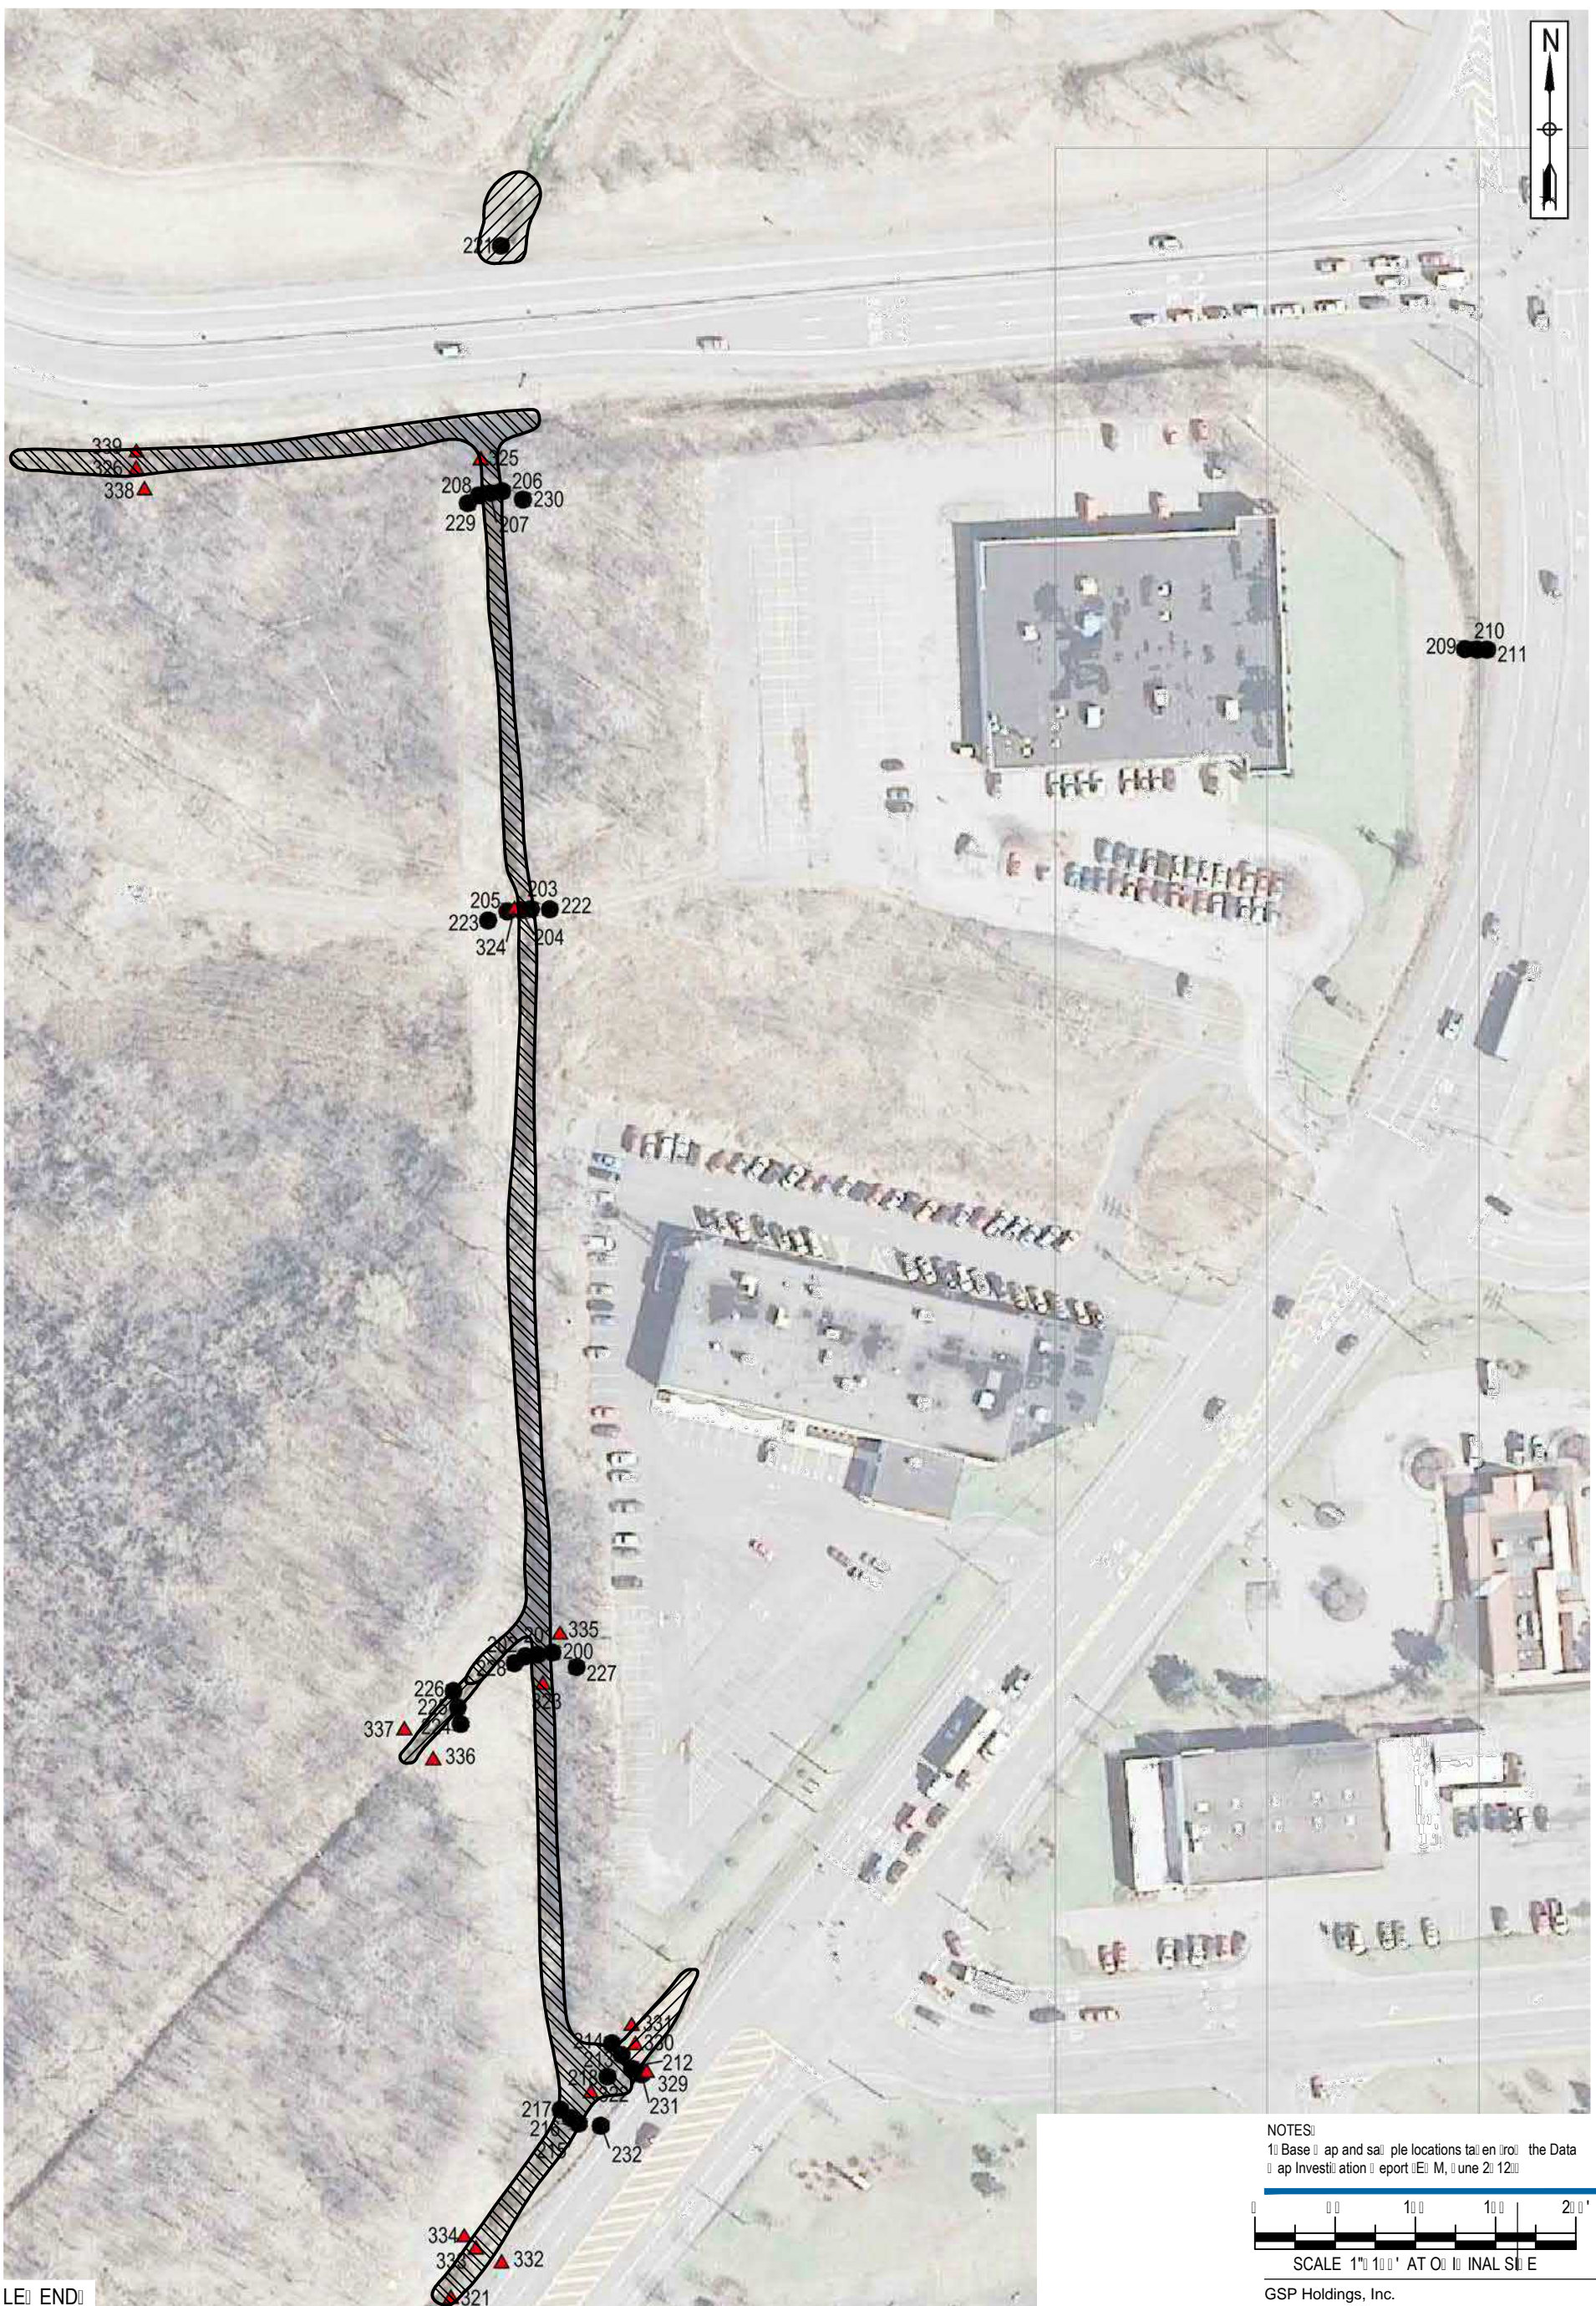
Job Number | 37-11082  
 Revision | A  
 Date | 06.06.2014 **Figure 7-4a**

- Source Identification Investigation Sampling Locations (E) M, 20' ±
- ▲ Data Investigation Soil Boring Location (E) M, 2' ±
- ▨ Area of Utility Excavation (0' to 1' to Meet Protection of Ecological Resources SCOs (Approximate))
- ▨ Area of Utility Excavation (0' to 2' to Meet Protection of Ecological Resources SCOs (Approximate))

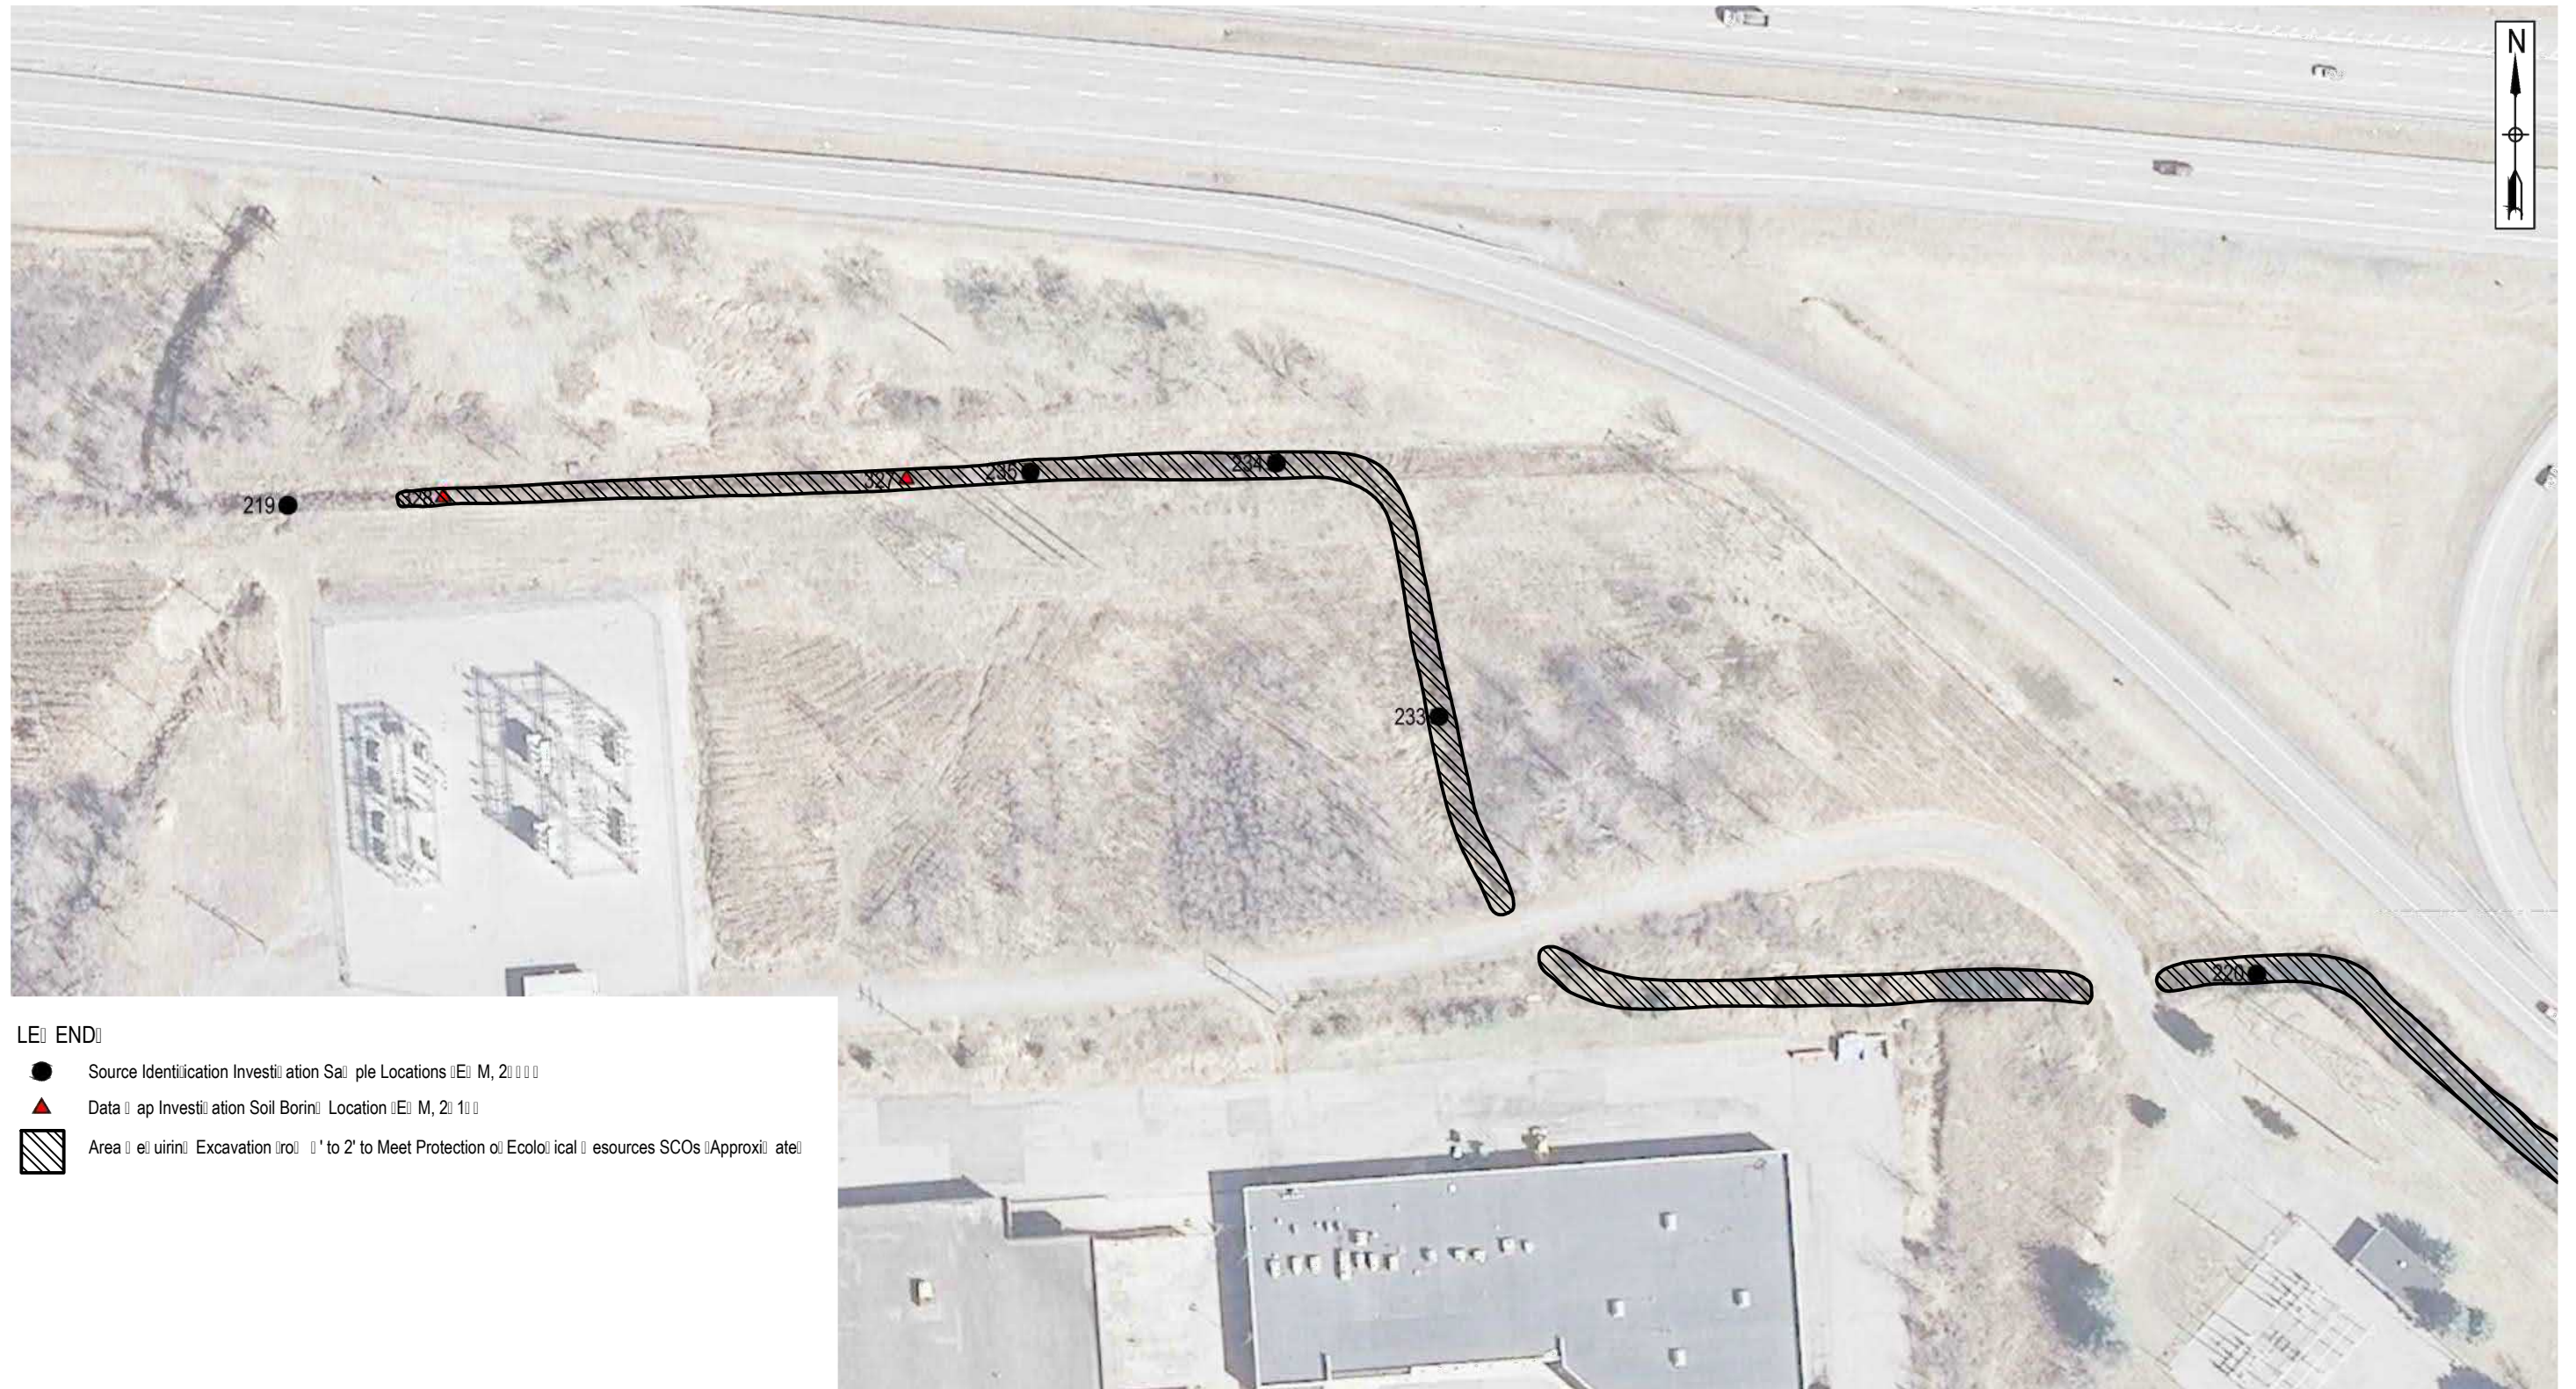
- Source Identification Investigation Sample Locations (EIM, 2011)
- ▲ Data Support Investigation Soil Boring Location (EIM, 2011)
- ▨ Area of Required Excavation (0' to 2' to Meet Protection of Ecological Resources SCOs (Approximate))

- Restoration to Pre-Disposal or Unrestricted SCO Conditions (Alternative 1, Figures 7-1a, 7-1b, 7-2a, and 7-2b)
- Soil/Sediment removal from the swale to Protection of Ecological Resources SCOs (Alternative 2, Figures 7-3a, 7-3b, 7-4a, and 7-4b).

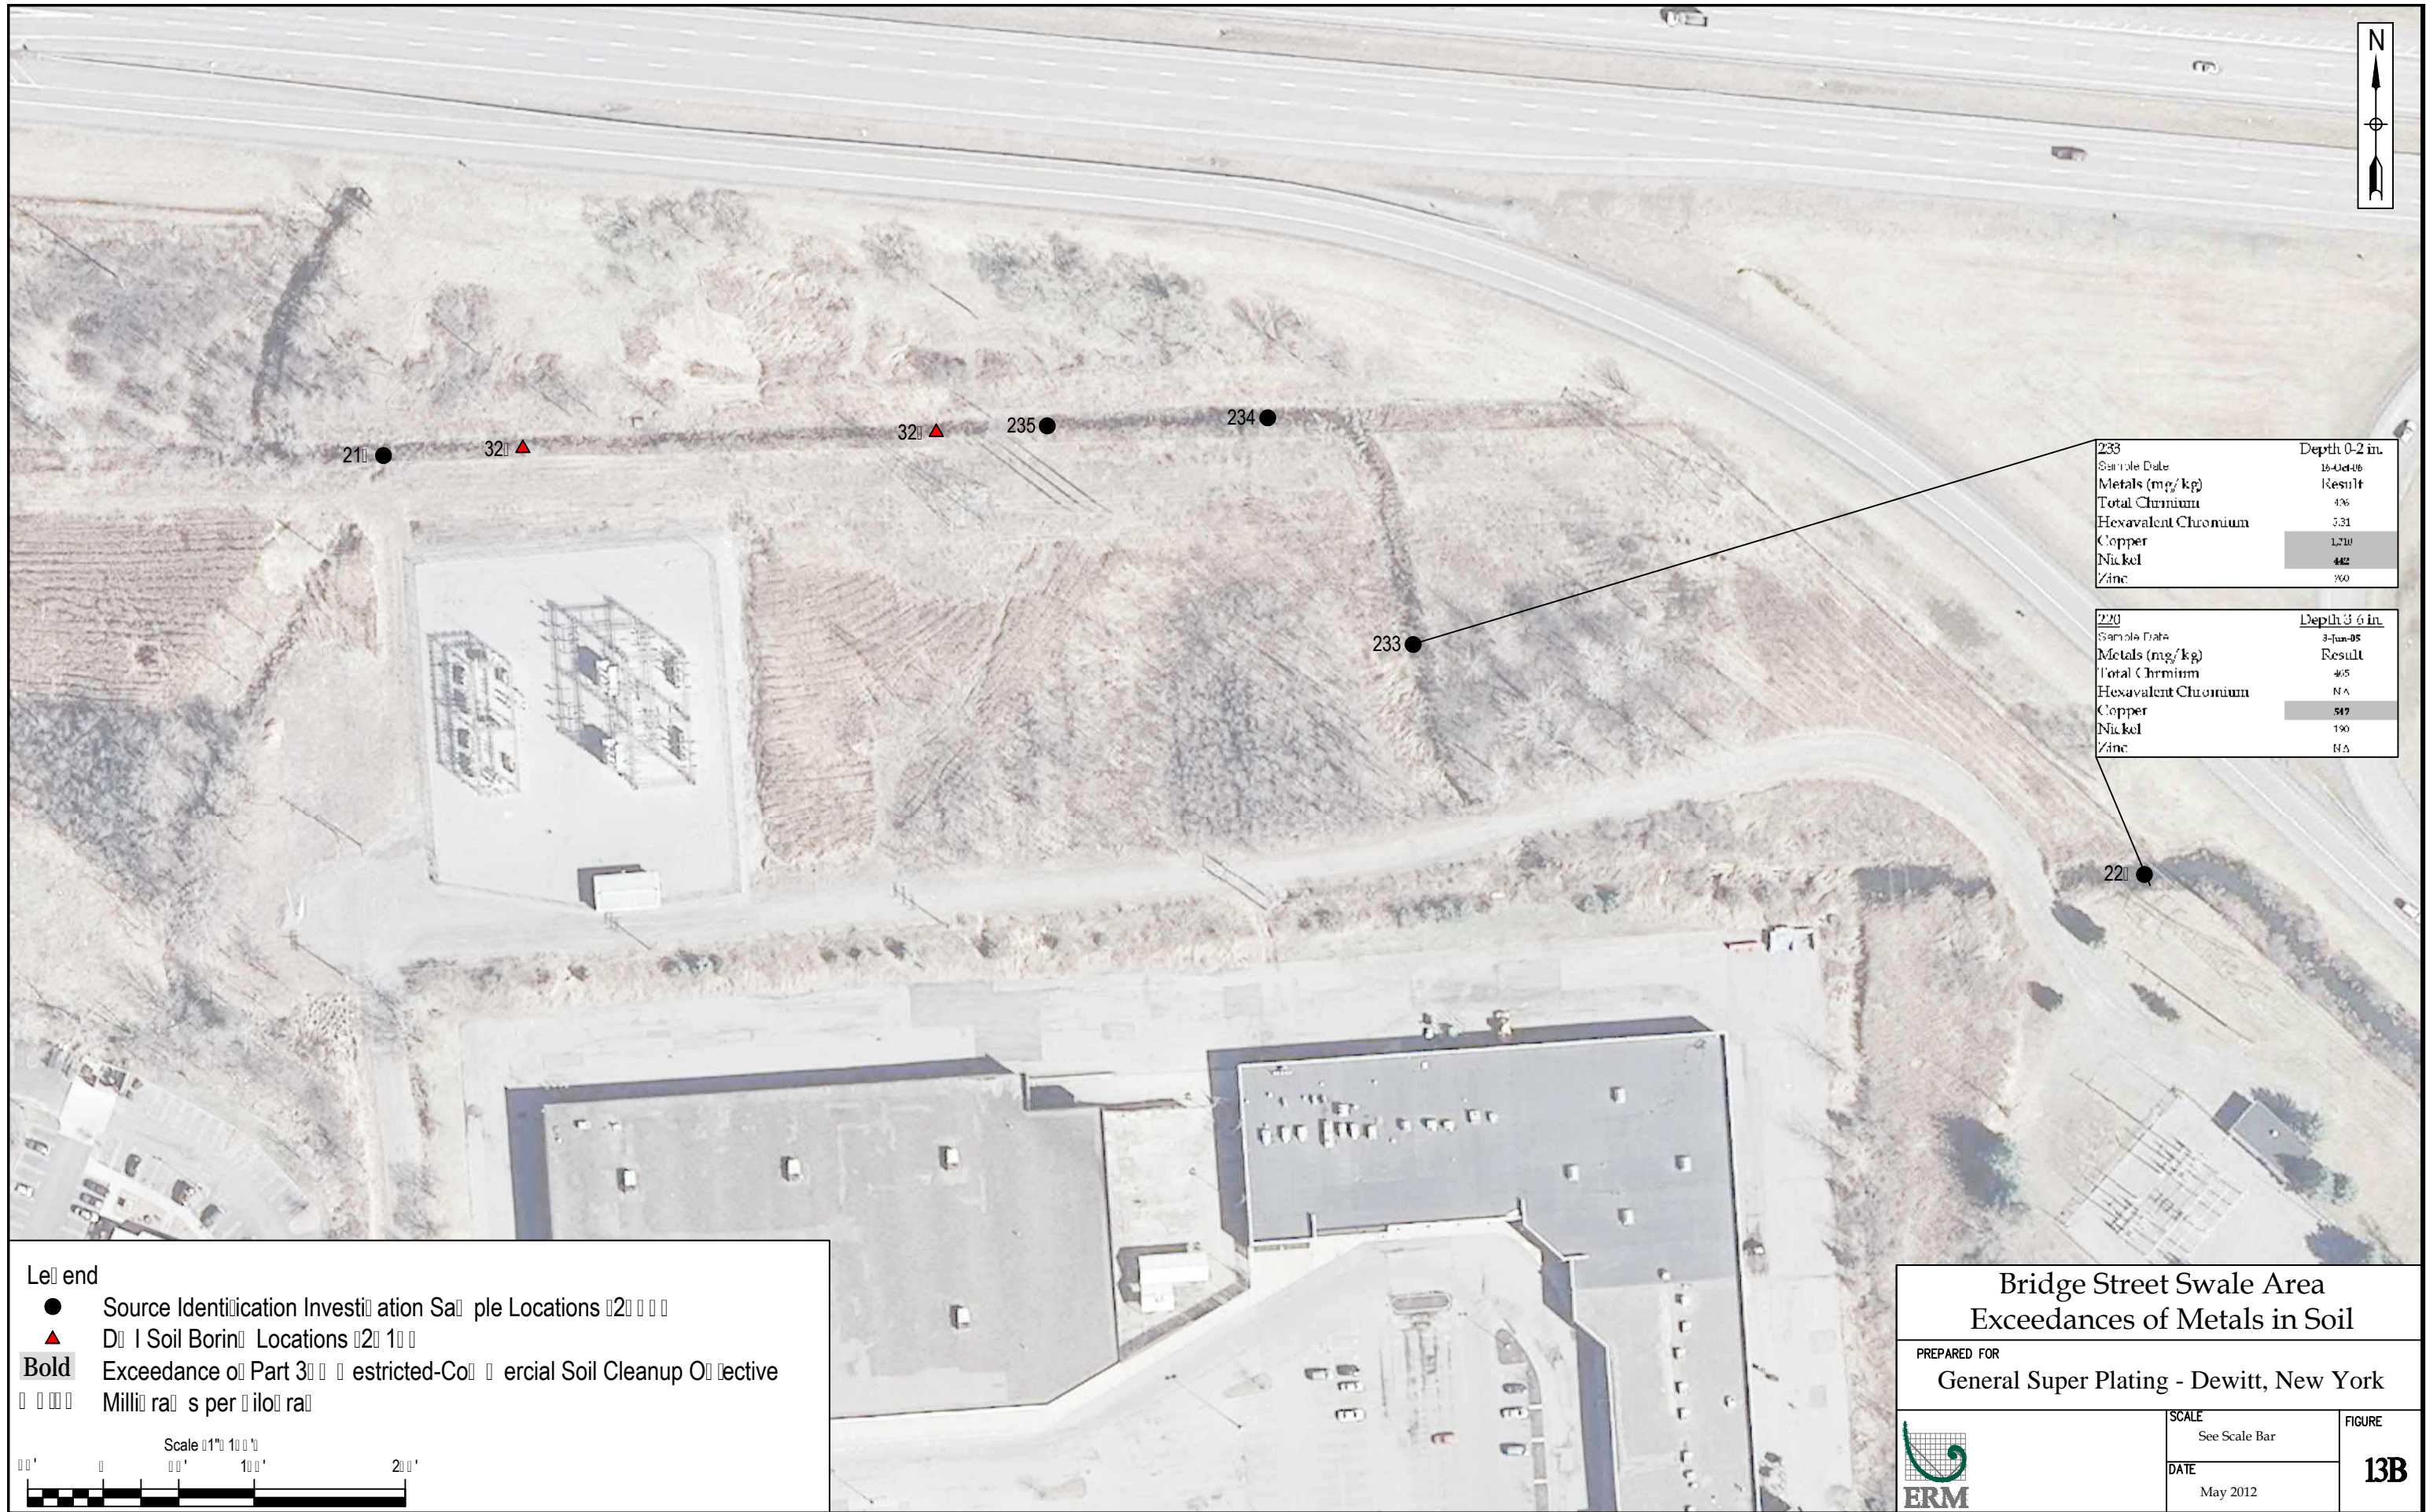
FIGURE: **13A**

233		Depth 0-2 in.
Sample Date		19-Oct-16
Metals (mg/kg)		Result
Total Chromium		436
Hexavalent Chromium		3.31
Copper		1,210
Nickel		442
Zinc		360

220		Depth 0-6 in.
Sample Date		3-Jan-05
Metals (mg/kg)		Result
Total Chromium		465
Hexavalent Chromium		N/A
Copper		547
Nickel		190
Zinc		615

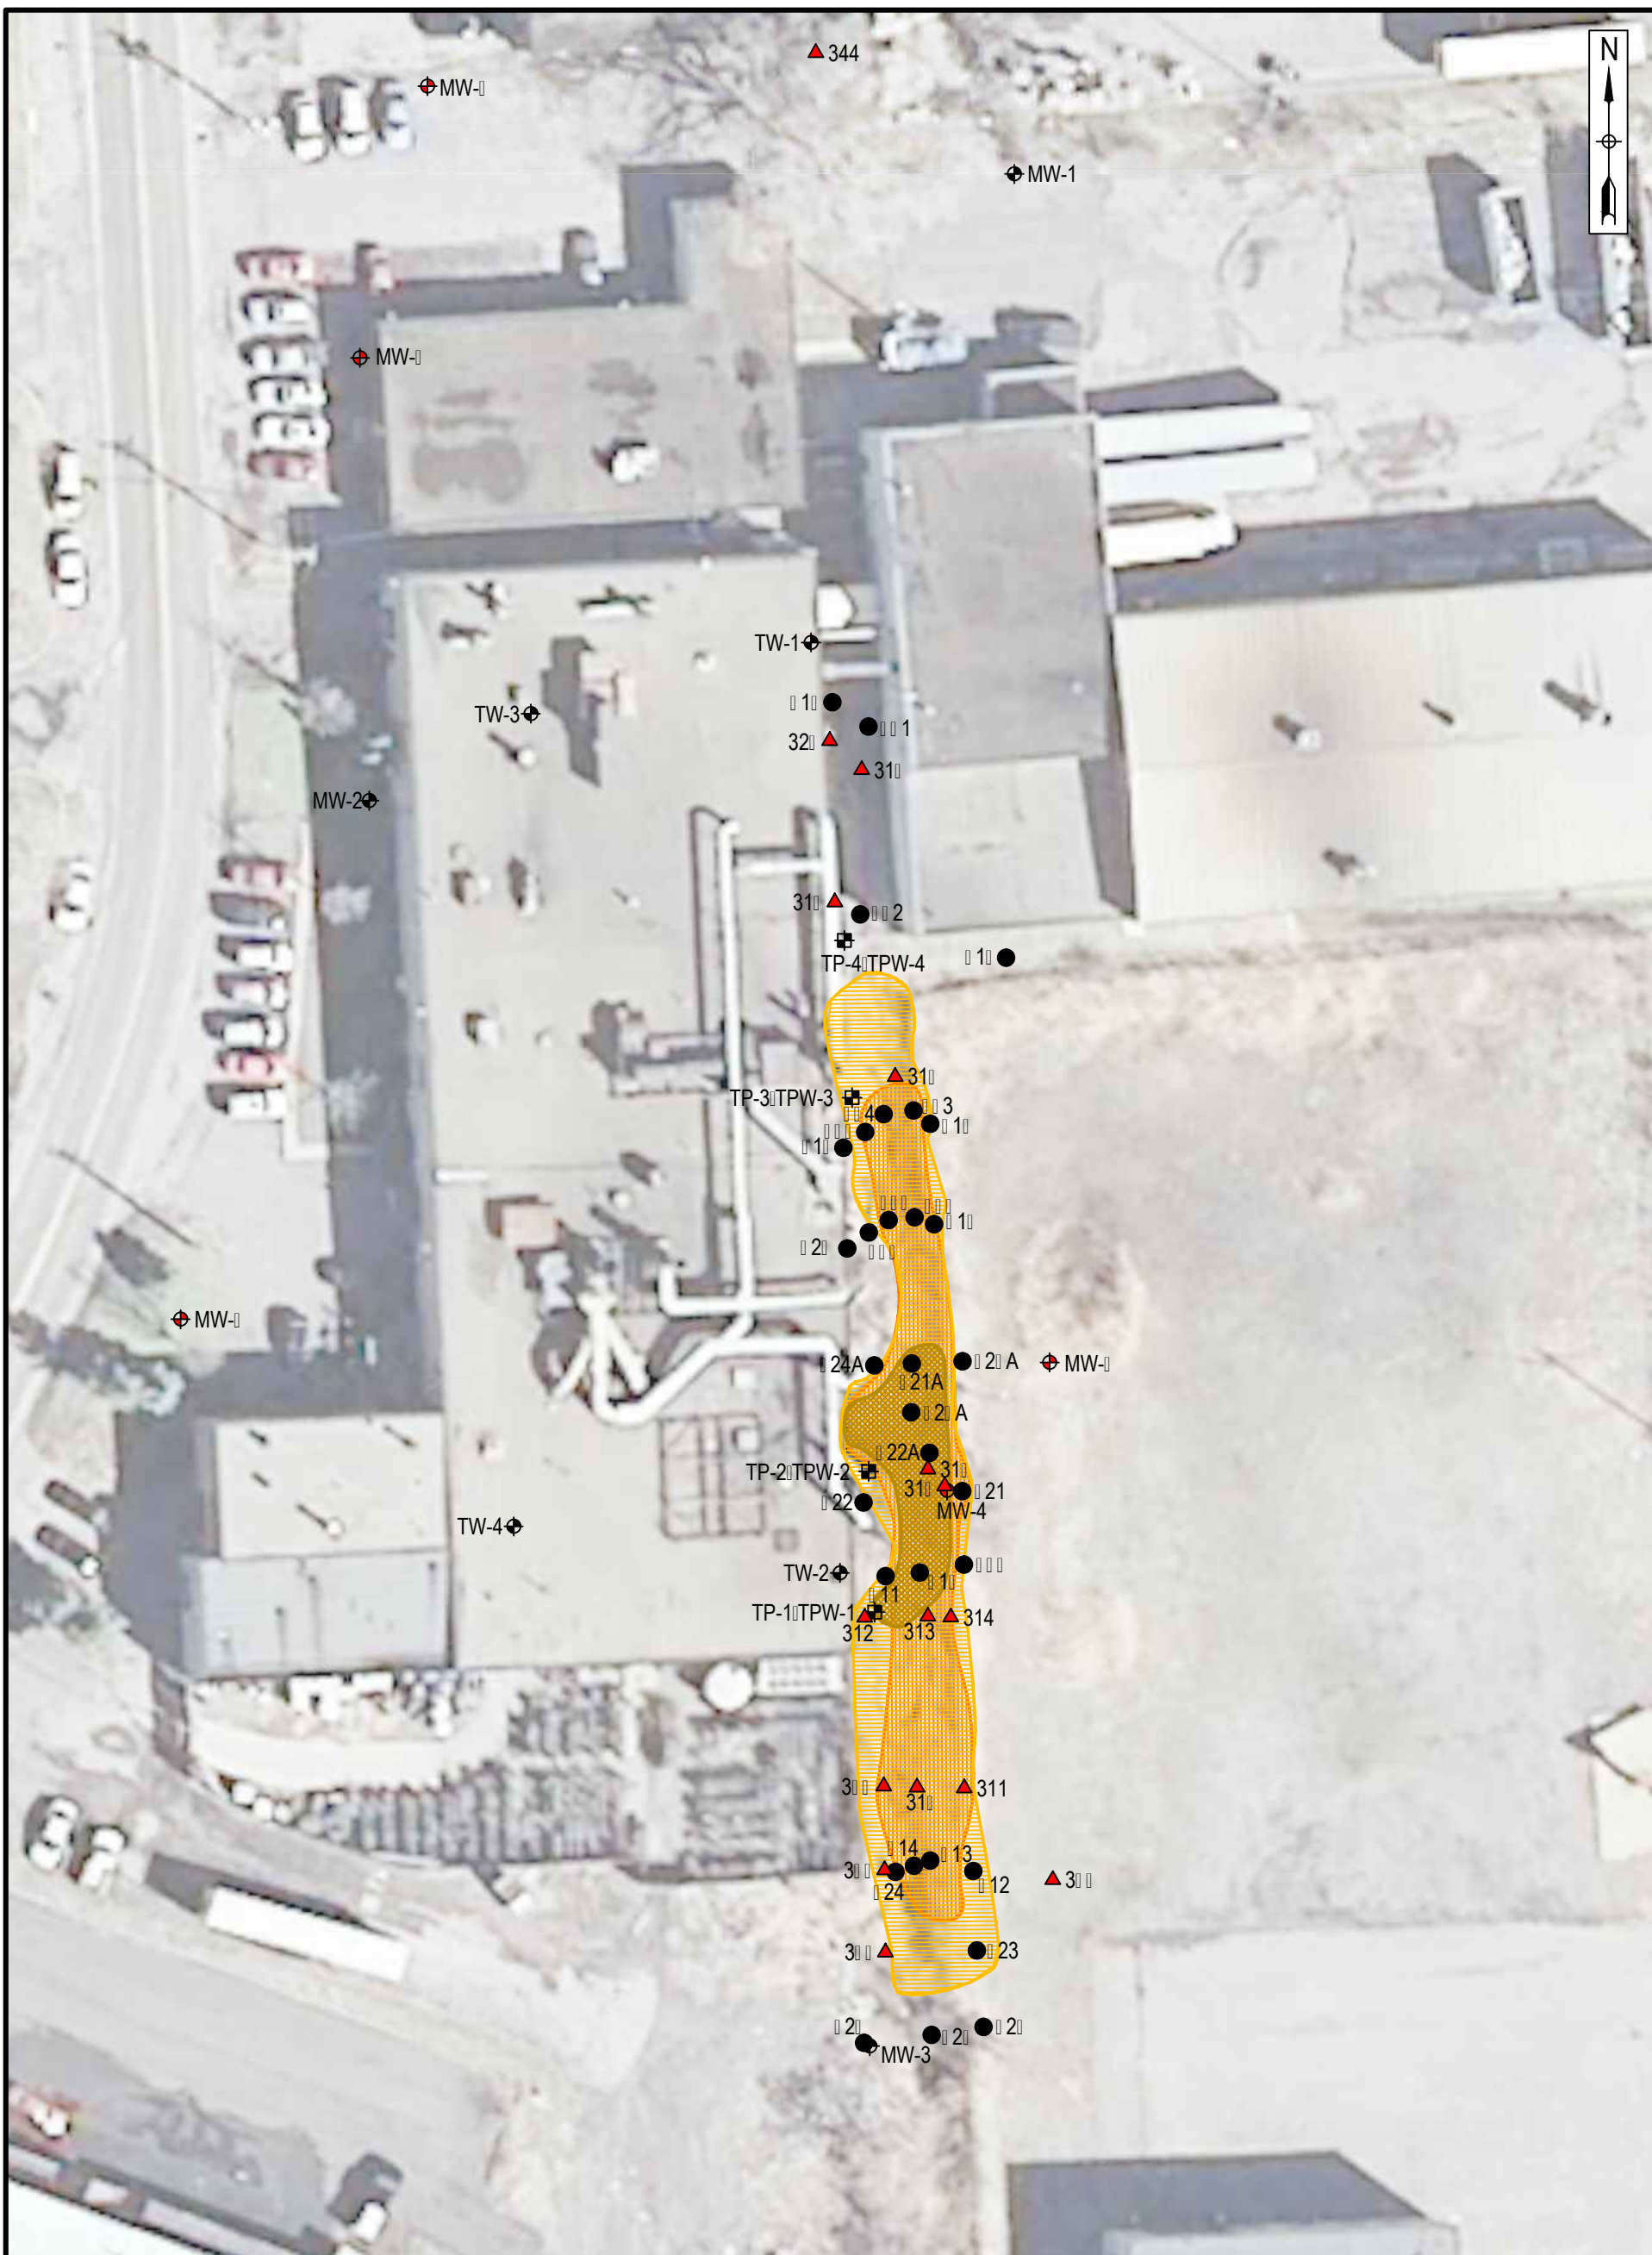
Scale	NTS
	Date	30 April 2010
		Figure 20

- Source Identification Investigation Sample Locations (20' x 20')
- ⊕ Monitoring Wells Installed (20' x 20')
- ▲ Daily Soil Borings Locations (20' x 10')
- ⊕ Daily Monitoring Wells (20' x 10')
- ▨ Proposed Excavation - 1'
- ▨ Proposed Excavation - 2'
- ▨ Proposed Excavation - 3'

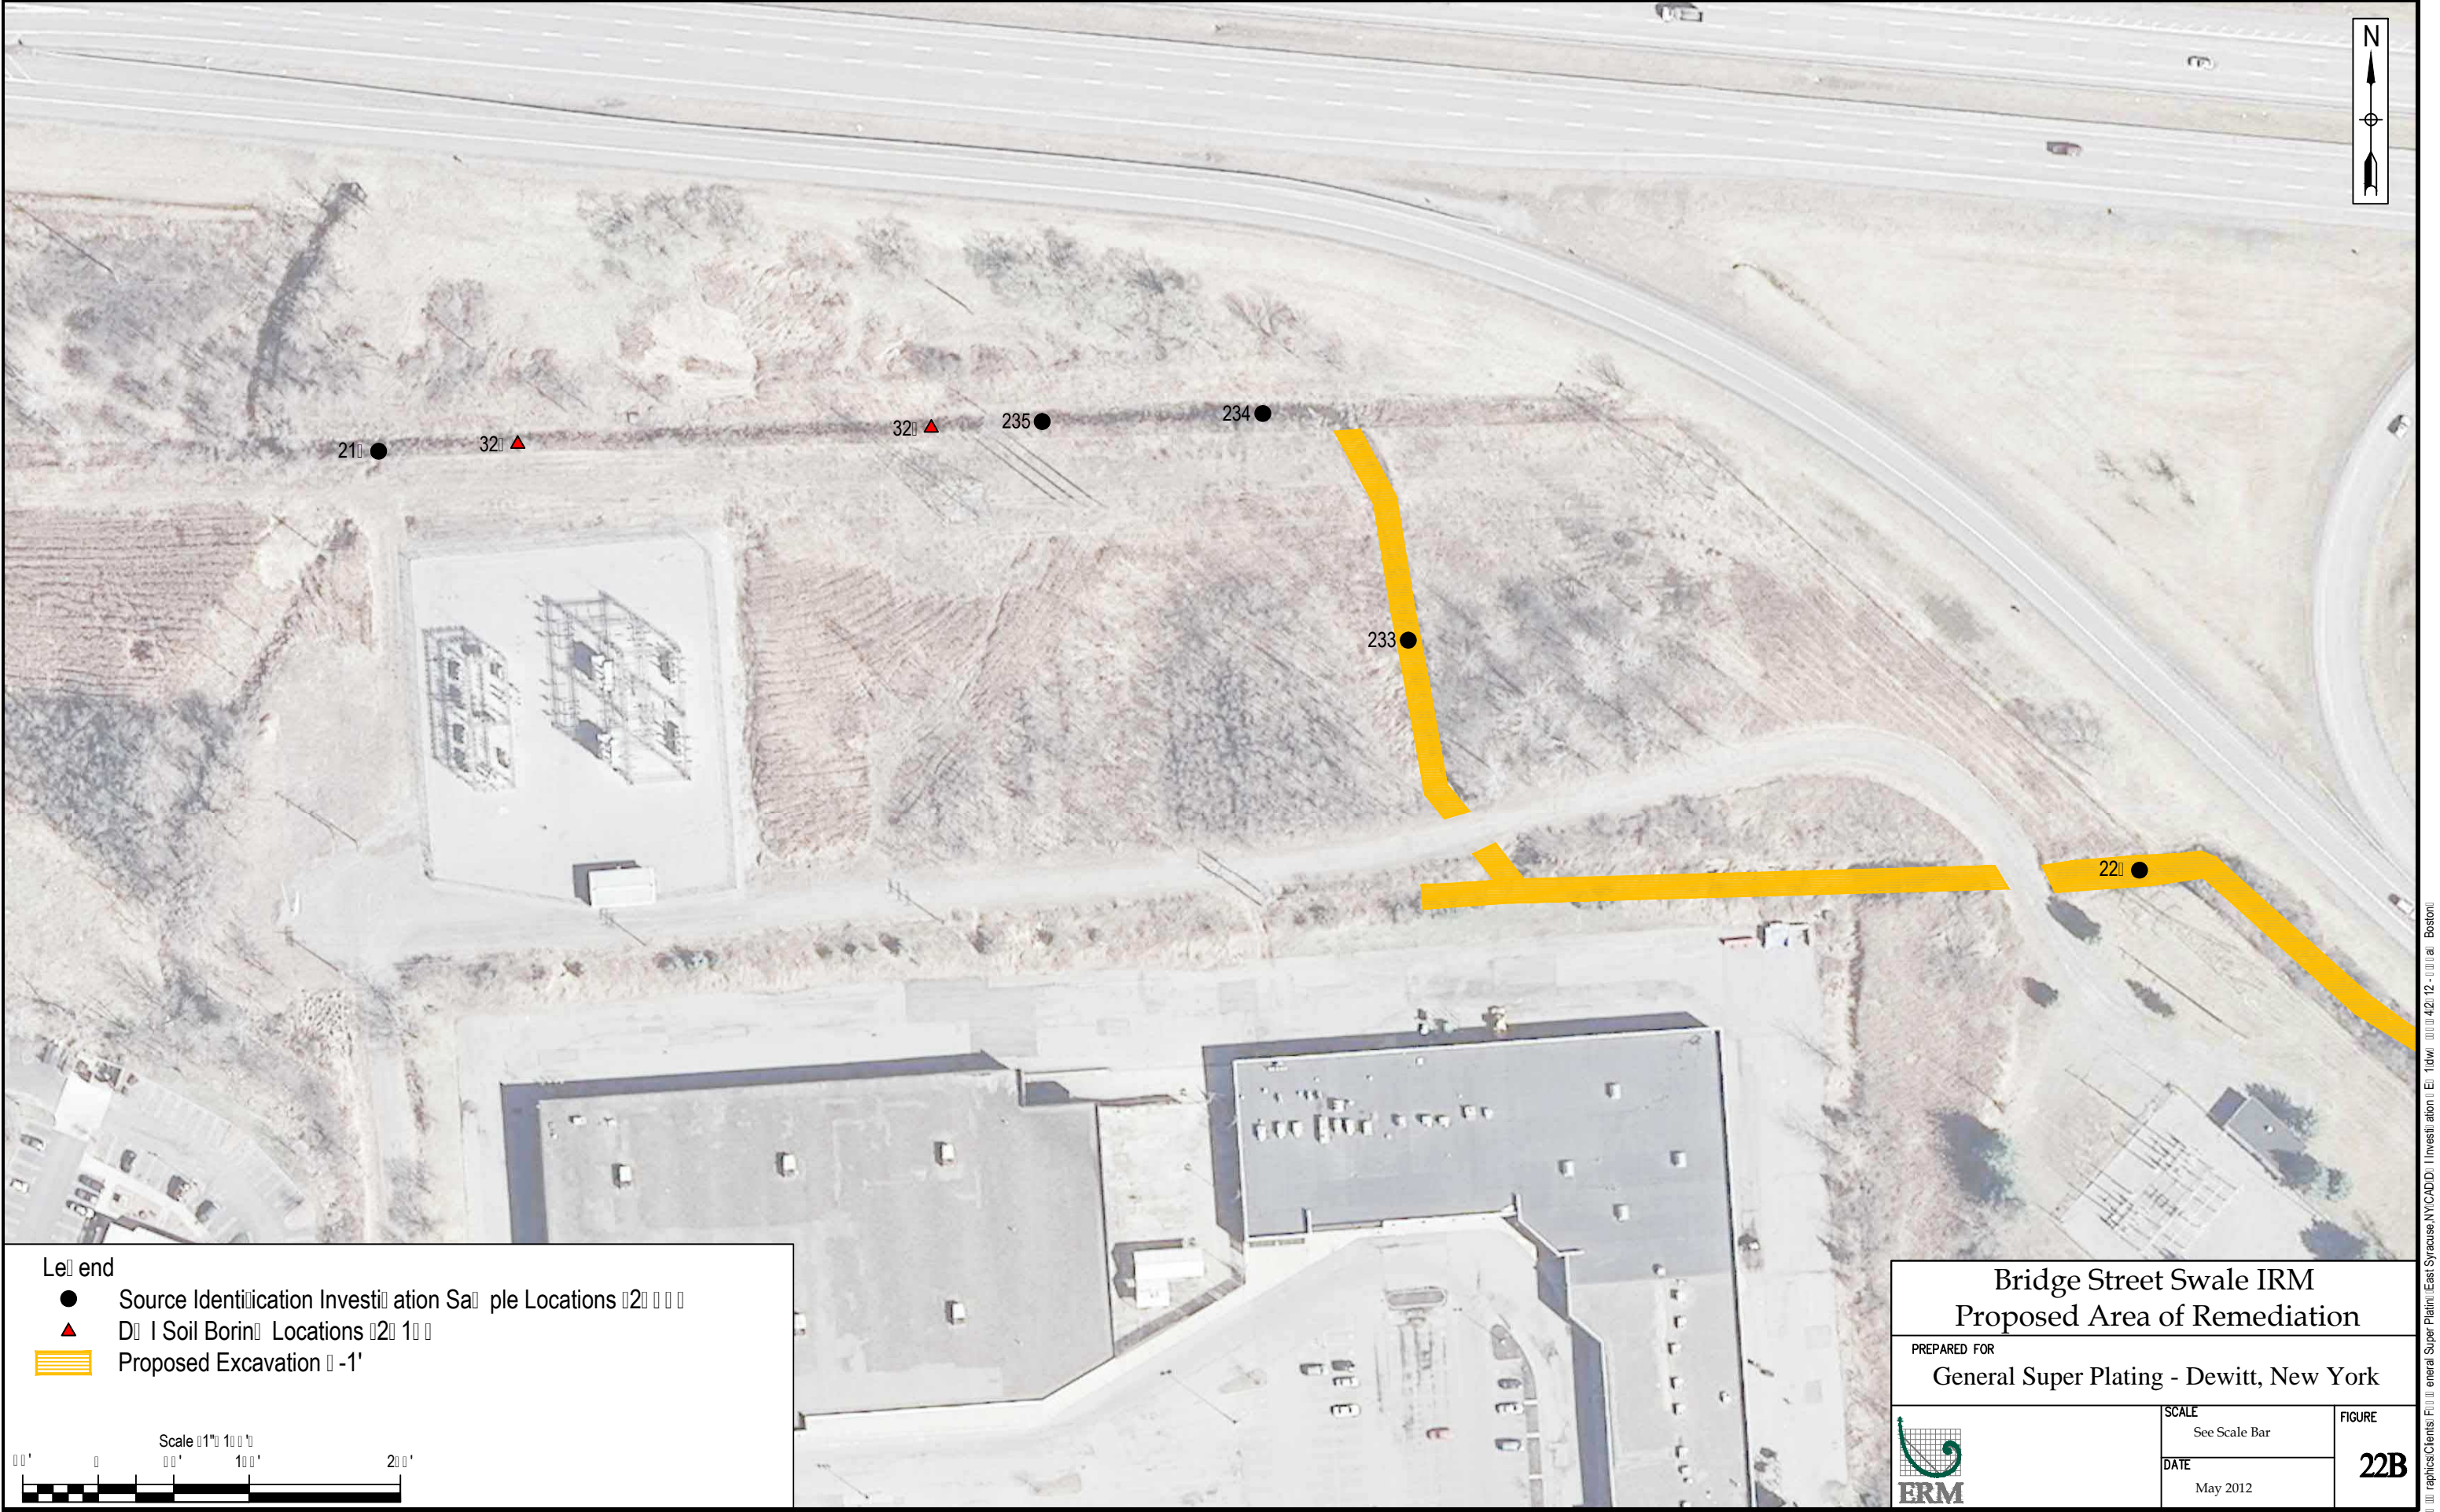
FIGURE  
**22A**

- Legend
- Source Identification Investigation Sample Locations (2000)
  - ▲ Daily Soil Borehole Locations (2010)
  - ▨ Proposed Excavation (-1')

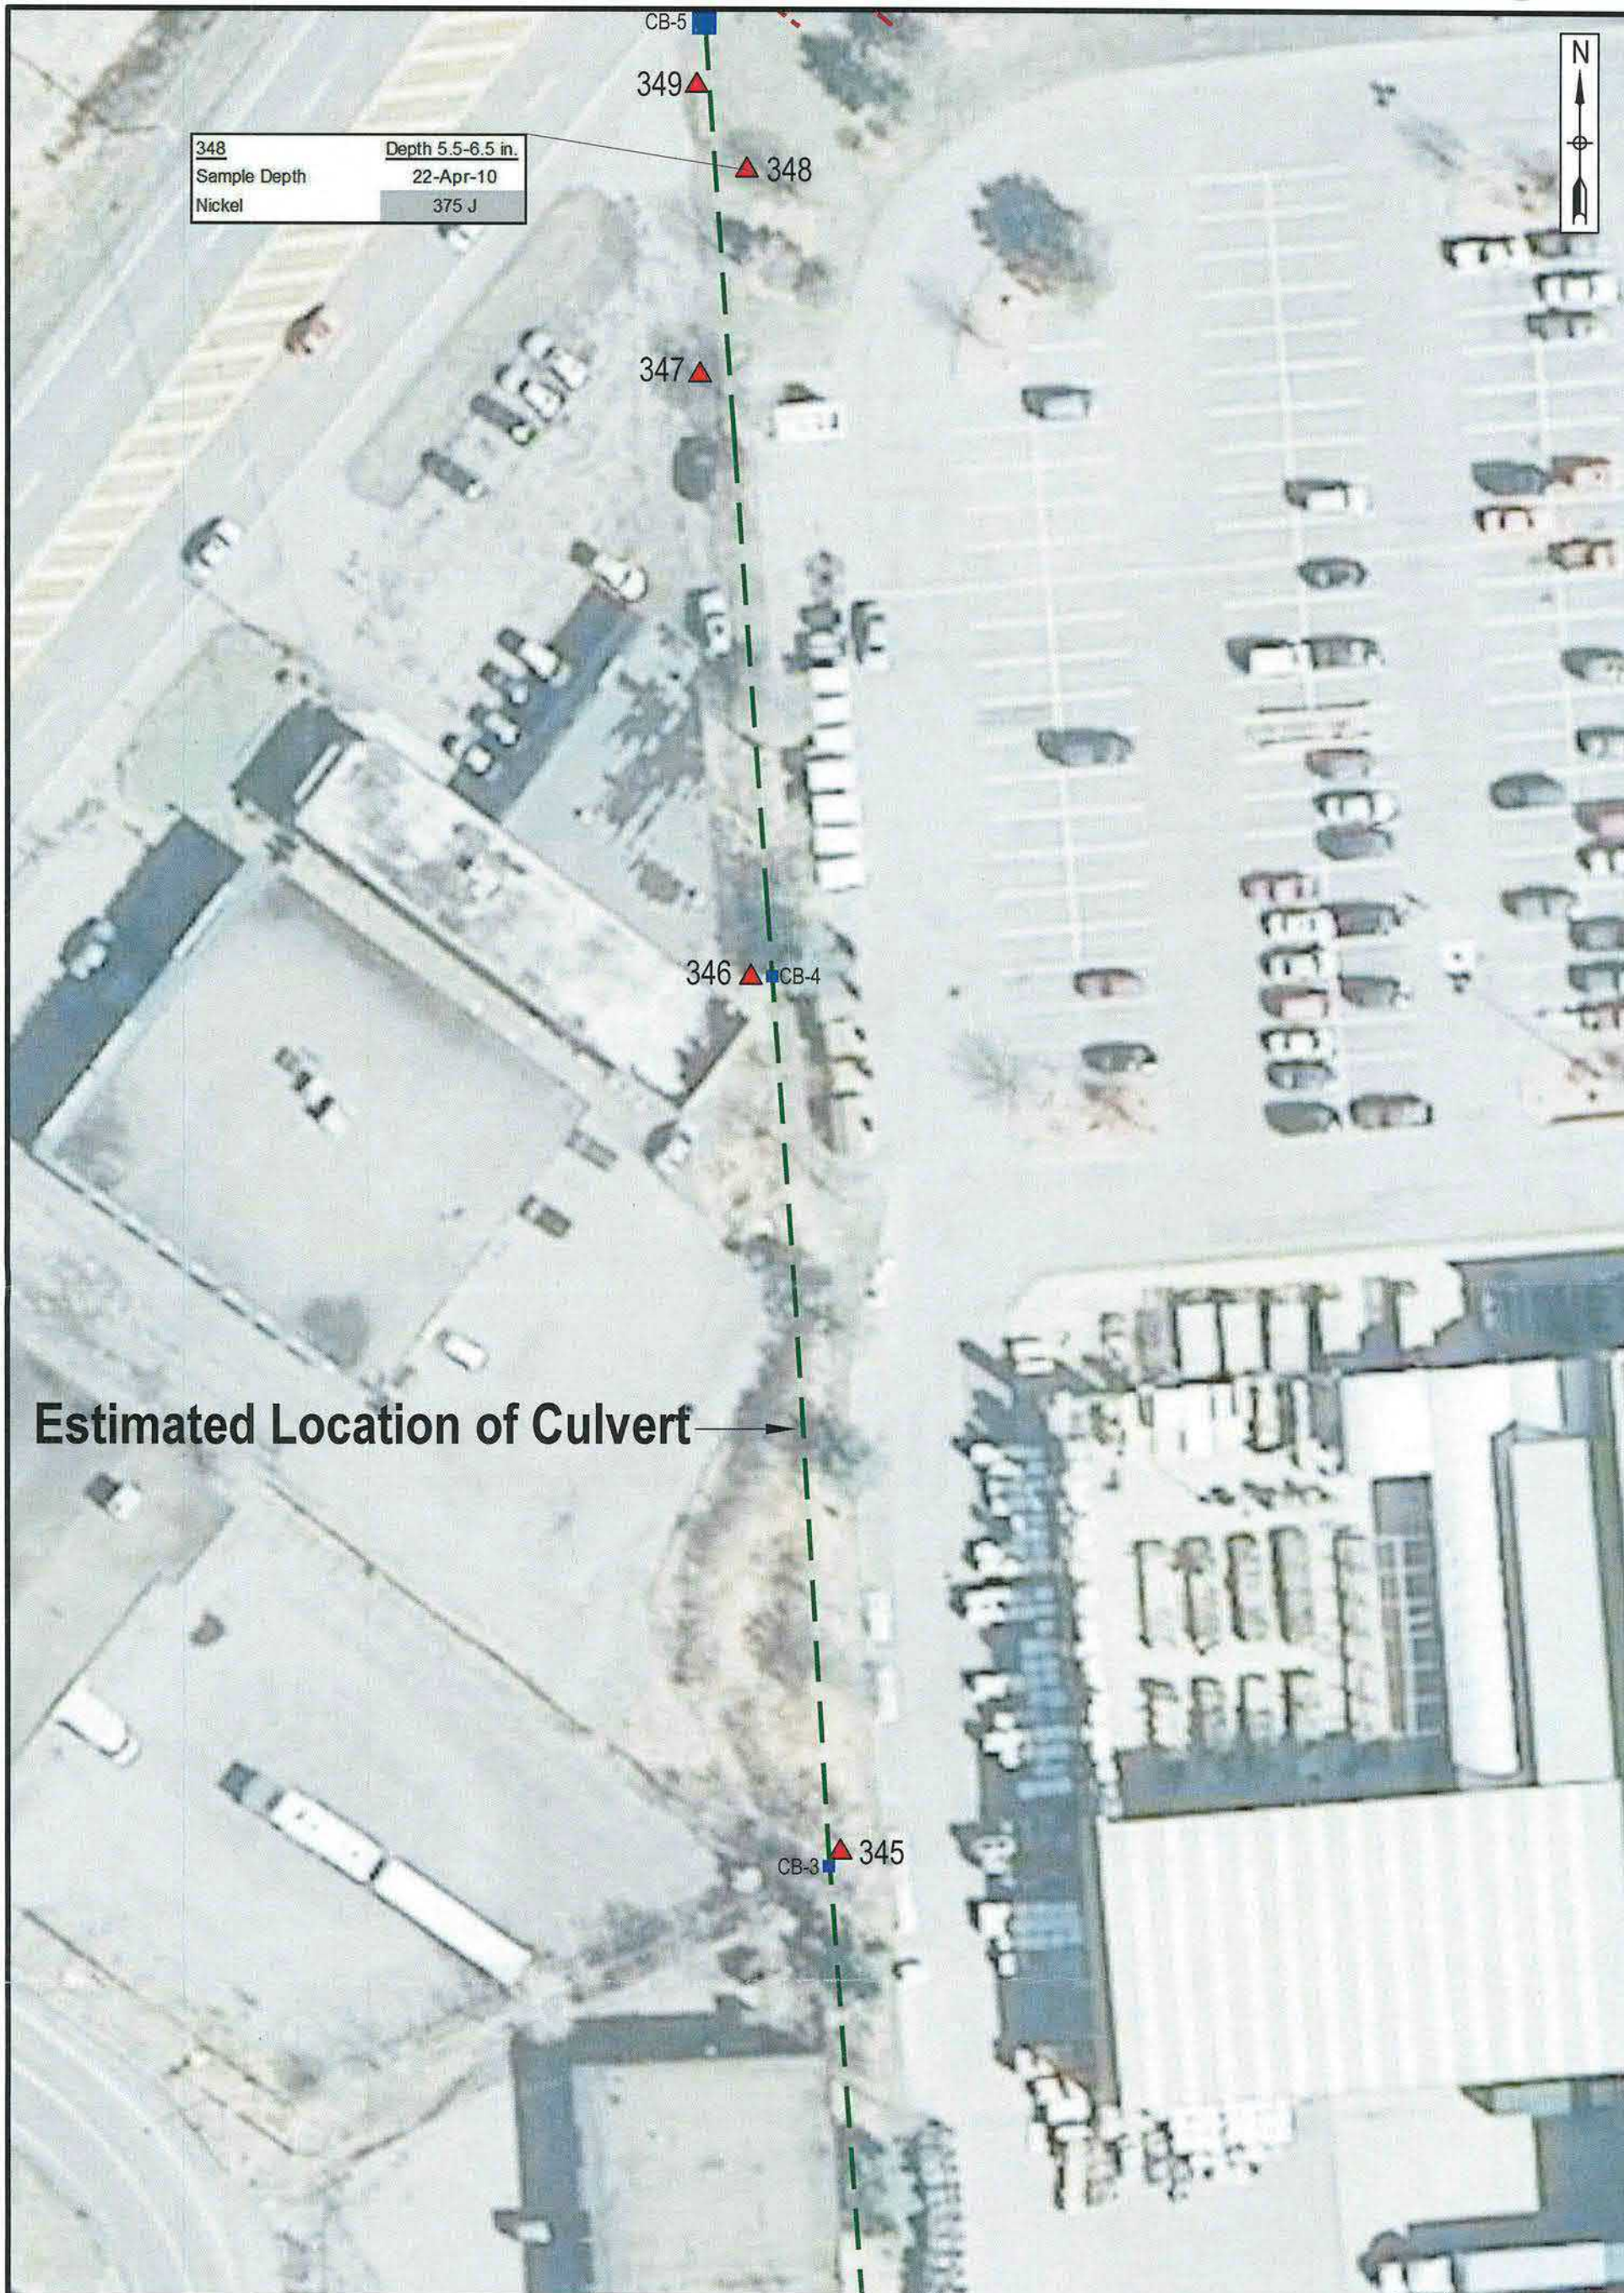
FIGURE  
**4**

348	Depth 5.5-6.5 in.
Sample Depth	22-Apr-10
Nickel	375 J

**Estimated Location of Culvert** →
